ATEC PROJECT NO. 2007-DT-ATC-XM22B-D7353  
TEST RECORD NO. WF-E-80

## ***Phase IV Jet Propellant (JP)-8***

### ***Fuel Performance Test***

### ***XM20 Bridge Erection Boat (BEB)***

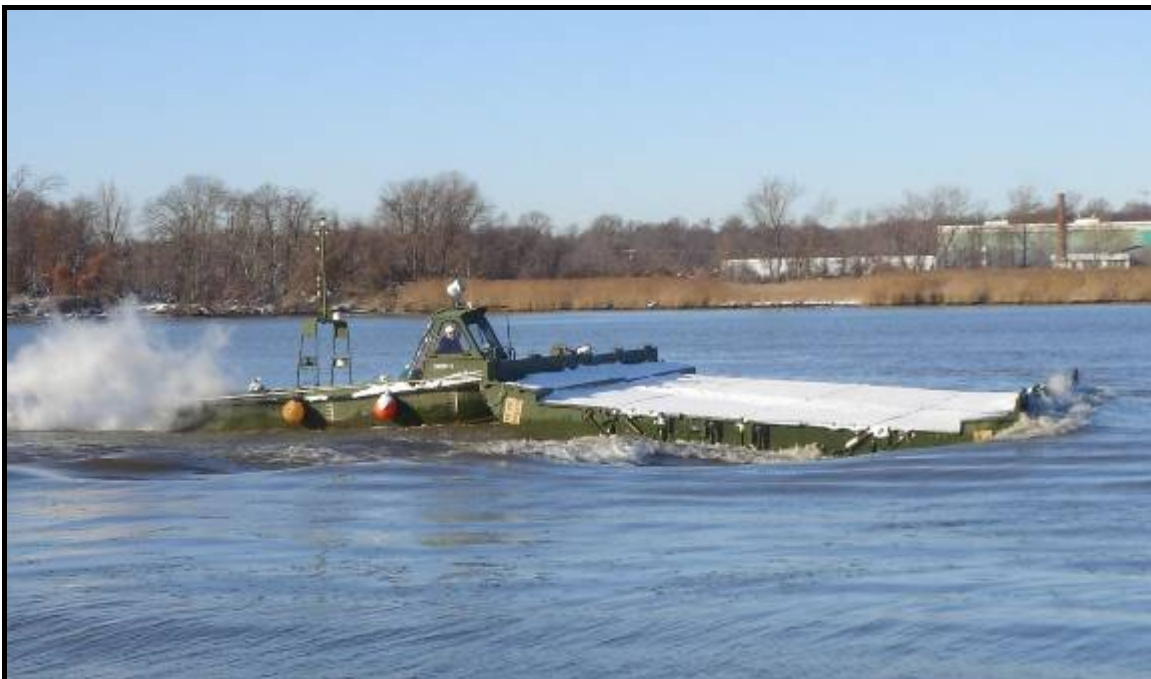
The primary mission of the bridge erection boat (BEB) is to assist U.S. Army Multi-Role Bridge Company (MRBC) units in maneuvering, construction, and operation of the improved ribbon bridge (IRB) during bridging and rafting operations (fig. 1). As a secondary function, the BEB can be used for safety boat, troop and cargo transport, and patrol and reconnaissance missions. The BEB is a 27- by 8-ft aluminum hull, twin engine, twin hydrojet powered vessel. The XM20 BEB is powered by twin Cummins 6BTA 5.9-L, six-cylinder, four-cycle 260-hp marine diesel engines equipped with in-line fuel injection pumps.

Figure 1. XM20 BEB pushing a two-bay IRB raft.

(1) Simulated rafting - full throttle operation for 37 min while pushing a two-bay IRB raft in the conventional configuration (fig. 1).
