## **Test of High Power Laser Diode Protection Circuitry Designed and Built by Science Research Laboratories**

**ARL-TR-4685**

**December 2008**

**Jeffrey O. White and Robert Dibiano**  
**Sensors and Electron Devices Directorate, ARL**

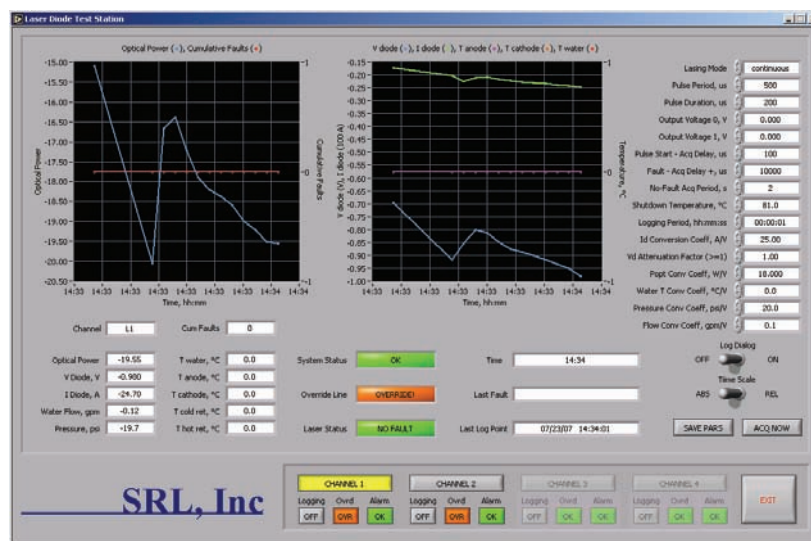
SRL supplied software that measures all the inputs every five minutes, and records the data in a Microsoft Structured Query Language (SQL) database. Data is also recorded a few ms after every fault is detected. The data is displayed in a strip chart fashion, and instantaneous readings are also provided in digital form (figure 2). Data is extracted from the SQL database via a query. The Microsoft SQL Server could run queries coincident with LD Logger.

Figure 2. SRL's LD logger user interface.

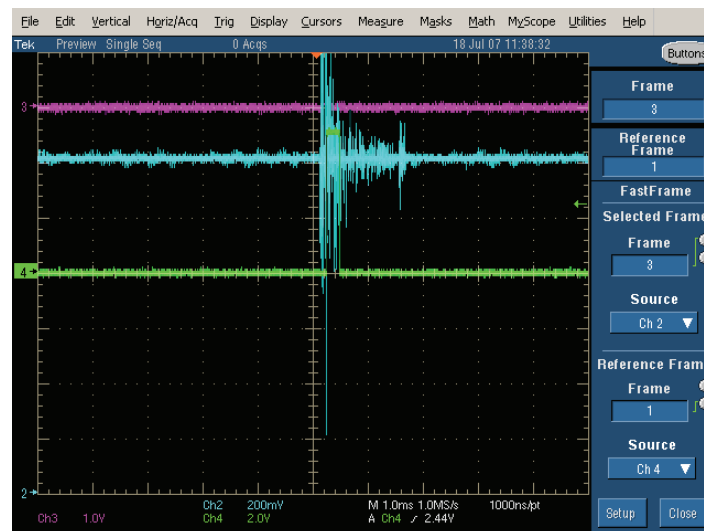
Oddly, drops in optical power were not always coincident with faults. In order to capture the transient parts of the monitored signals, we used a digital oscilloscope<sup>7</sup>, triggered with the fault signal, and programmed to store the diode voltage and optical power just before and after faults. Most of the faults seemed to be spurious fluctuations in the diode voltage due to external factors, e.g., other devices being plugged into the power strip. In one particular fault, the optical power oscillated, rather than simply dropping (figure 9).

Figure 9. Digital fault pulse (green), diode voltage (red), and optical power (blue).

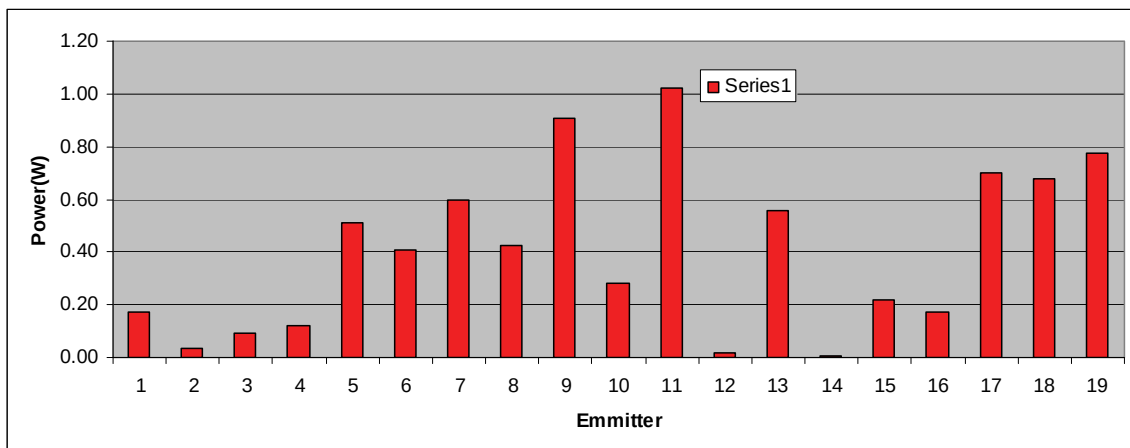
Figure 12. LD41860, post-test power per emitter at 18 A, calculated from figure 10.

From post-test images of the output facet (figure 10), we calculated the power versus current of the bar as a whole (figure 11), the power per emitter (figure 12), and the power versus current of the individual emitters (figure 13). Note that all emitters were connected in parallel, so the current per emitter is unknown. One can say, at least, that the output varied widely from emitter to emitter. Some emitters were still just starting to lase as others were rolling over, and the slope efficiencies differed as well.
