## **Opportune Landing Site Southeastern Indiana Field Data Collection and Assessment**

Lynette A. Barna, Charles C. Ryerson,  
and Rosa T. Affleck

November 2008

Final report

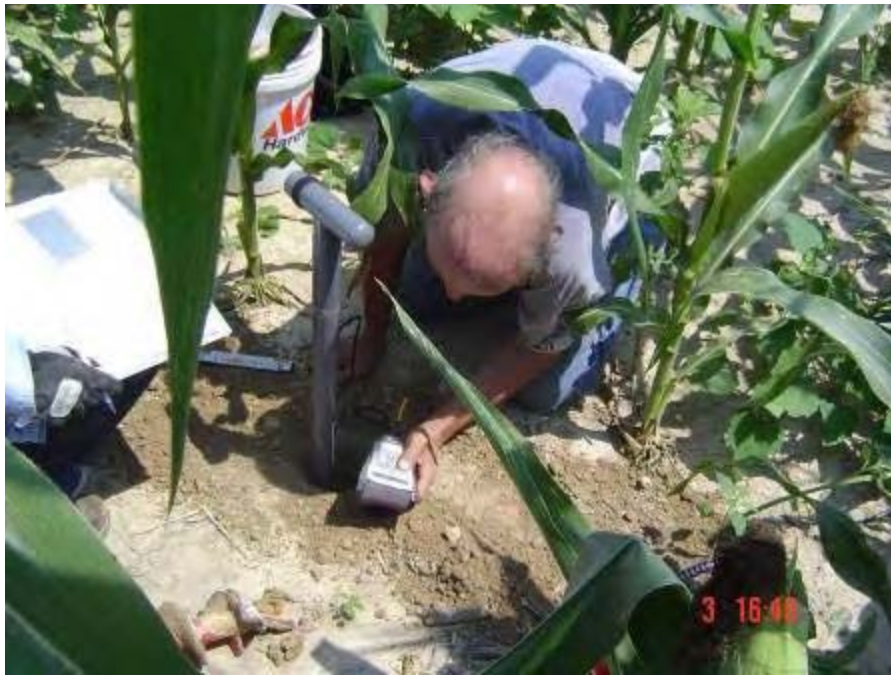
Figure 4-20. Taking soil moisture readings with a Dynamax ML2 in the auger hole (North Vernon Airport RAS, summer IOP2).

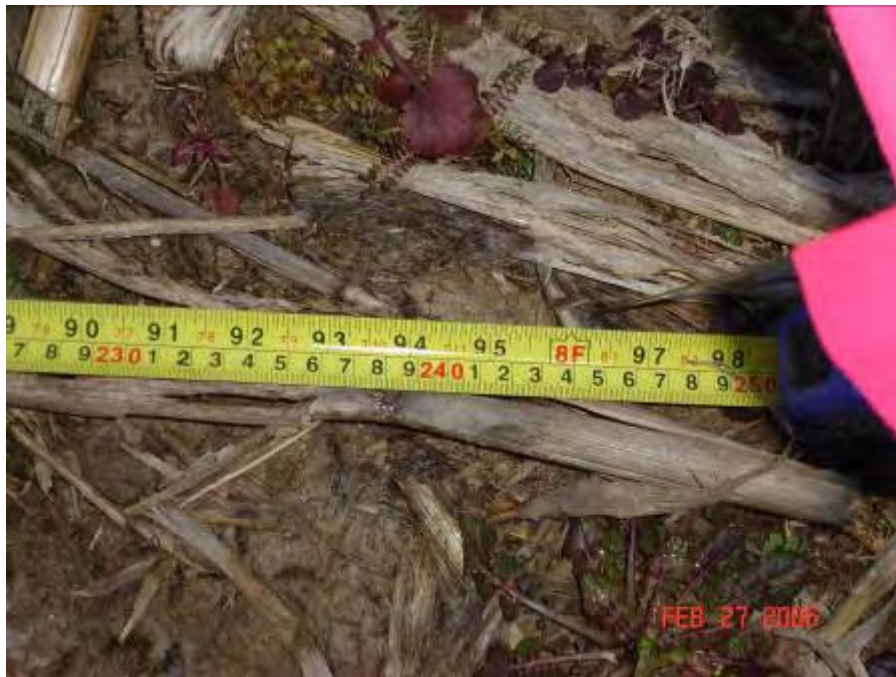
Figure 4-30. North Vernon Airport RAS surface moisture during the winter IOP4.

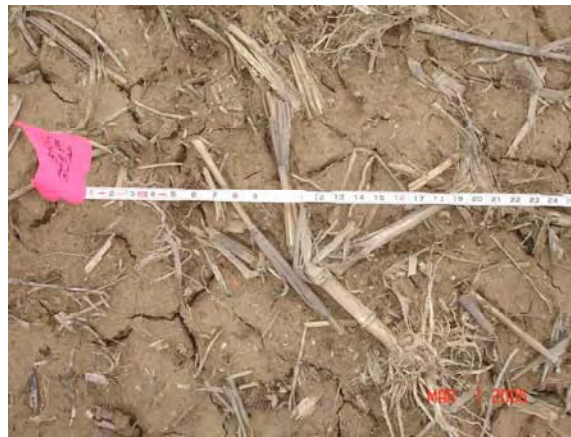
5-10e. Winter.

Figure 5-10. Site conditions of Ford Farm RAS during each IOP: (a) spring IOP1, view looking southwest down centerline from Station 300 m Centerline; (b) summer IOP2, view of weather station showing density of corn field on the left (RAS not pictured); (c) fall IOP3, view down RAS centerline looking southwest from Station 0 m Centerline; (d) winter IOP4, view down RAS centerline looking northeast from Station 600 m Centerline; (e) winter IOP4, cracked soil surface at Station 300 m Centerline.

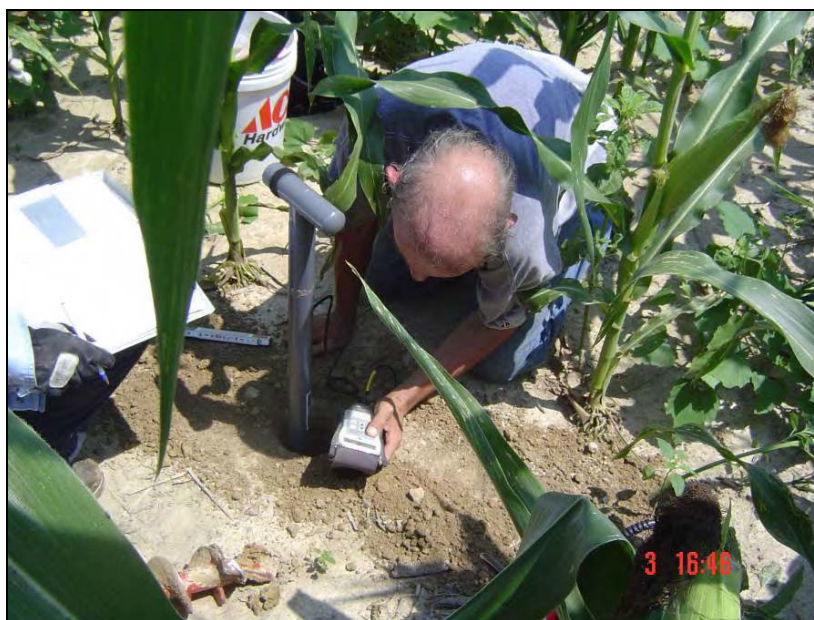
Figure D-1. Using ML2 and HH2 readout to measure soil moisture at depth within auger hole.
