*Opportune Landing Site Program*

## **Suitability Measurement and Analysis for Fort Bliss Naval Air Facility OLS**

Rosa T. Affleck, Charles C. Ryerson,  
Lynette A. Barna, and Keran J. Claffey

September 2008

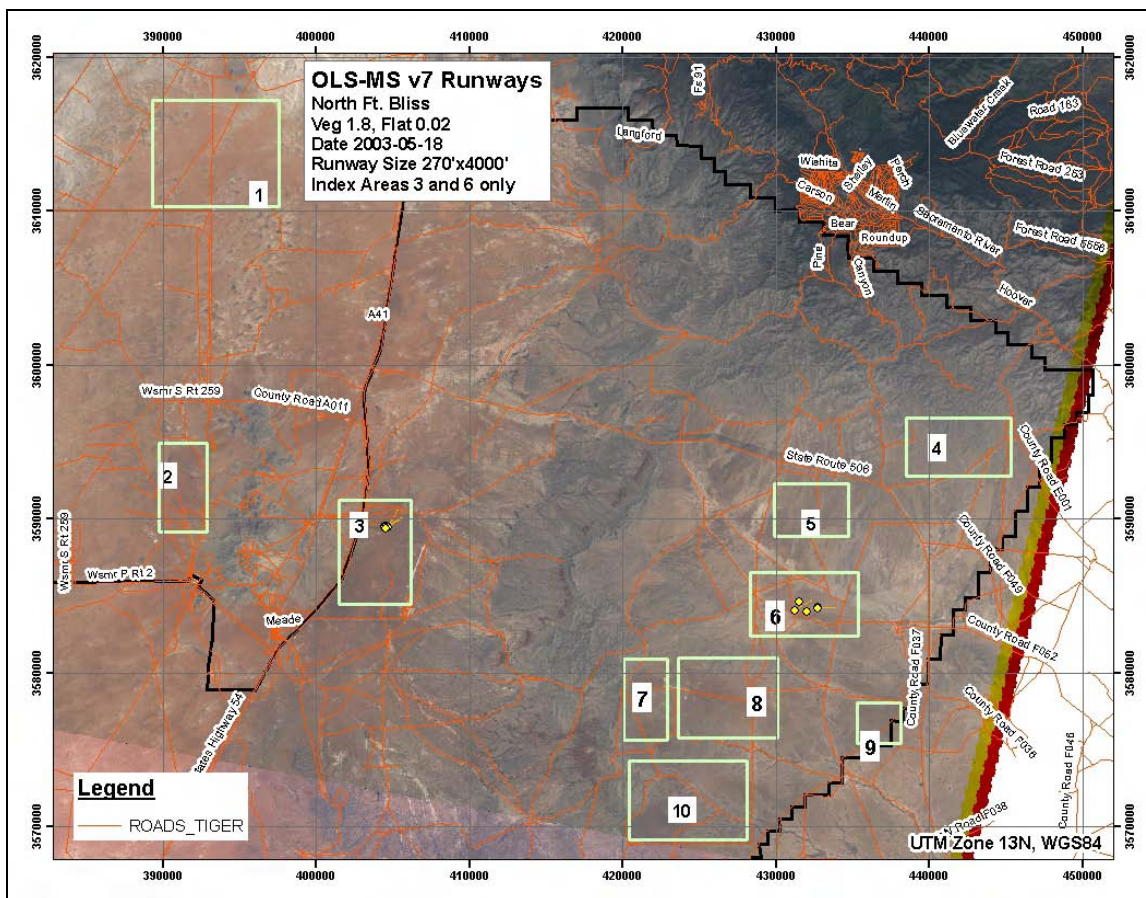
Figure 2. OLSs evaluated during the reconnaissance visit in June 2005 (areas 3 and 6).

The OLSs assessed during the second reconnaissance trip, in June 2005, were based on the LANDSAT imagery taken on 18 May 2003 for 30- by 900-m (90- by 3000-ft) and 80- by 1200-m (270- by 4000-ft) runway dimensions. During this visit, the general area containing OLSs suitable for field evaluation was in Maneuver Area 18 (Fig. 2, area 6). The Boeing software detected no OLSs using the LANDSAT imagery for 13 June 2001. Figure 3 is the close-up of Enclosed Area 6. Because of the limited number of OLSs with 80- by 1200-m (270- by 4000-ft) dimension in the area, software analysis was conducted using the 18 May 2003 LANDSAT imagery for 60- by 914-m (200- by 3000-ft) runway dimensions. Resulting OLSs for the same area (Enclosed Area 6) are shown in Figure 4.

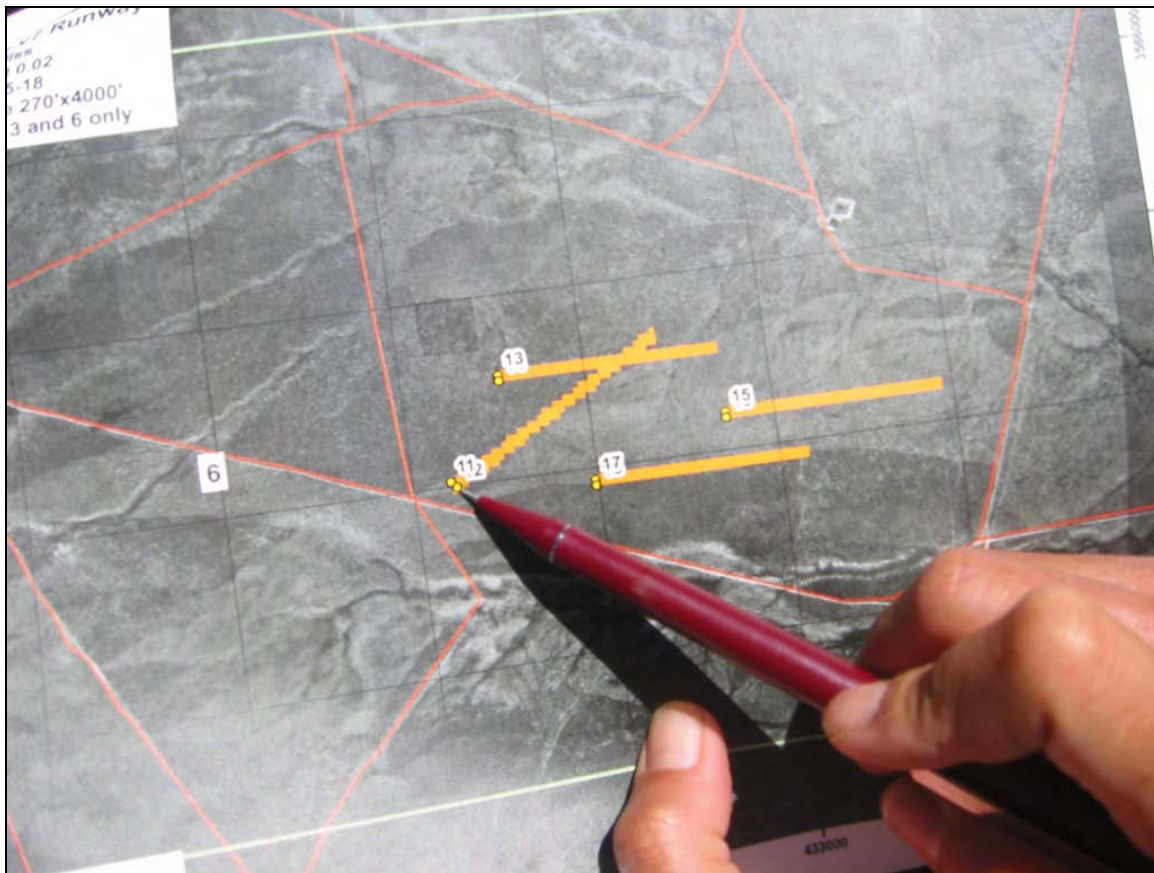
Figure 3. Close-up of area 6 with 270- x 4000-ft OLS, which were visited in June 2005 (18 May 2003 LANDSAT imagery).

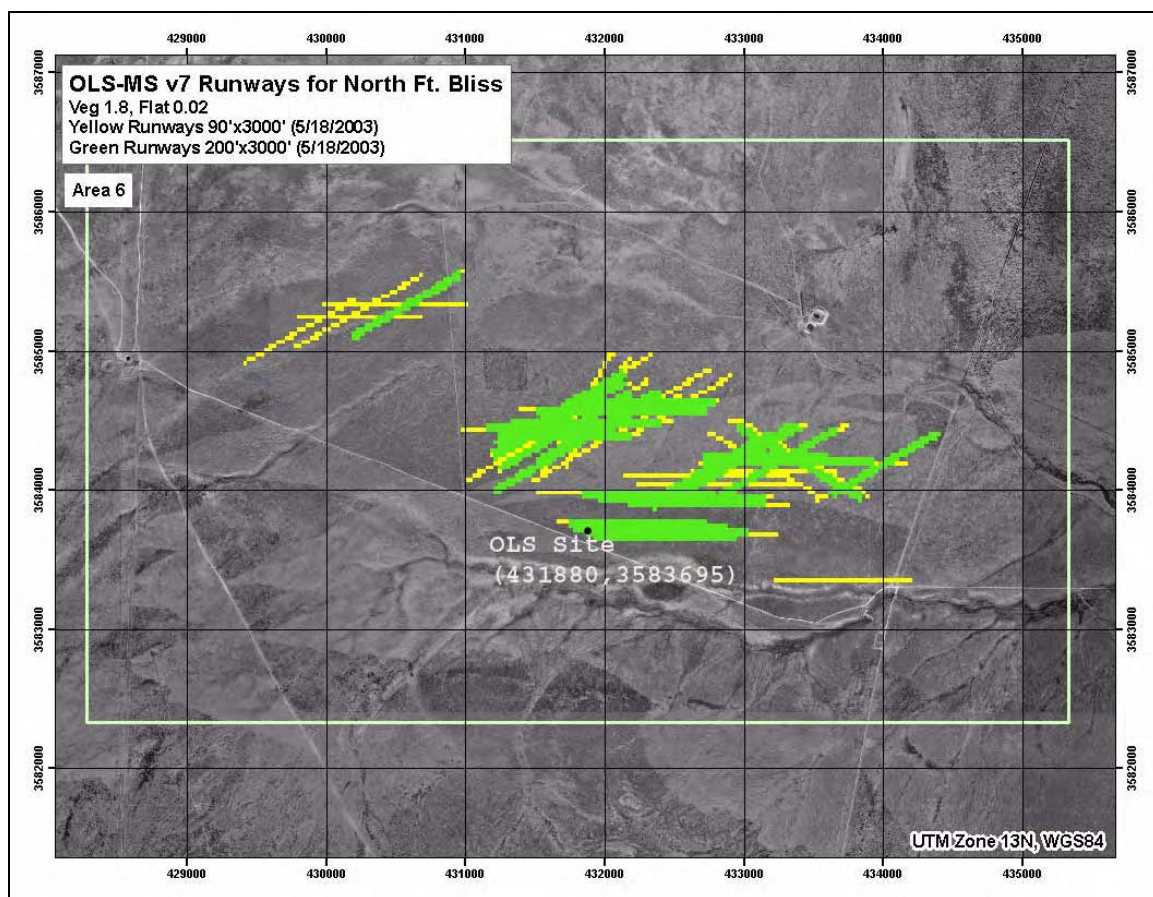
Figure 4. OLS software analysis using 200- by 3000-ft runway dimensions found many more runways (LANDSAT imagery, 18 May 2003).

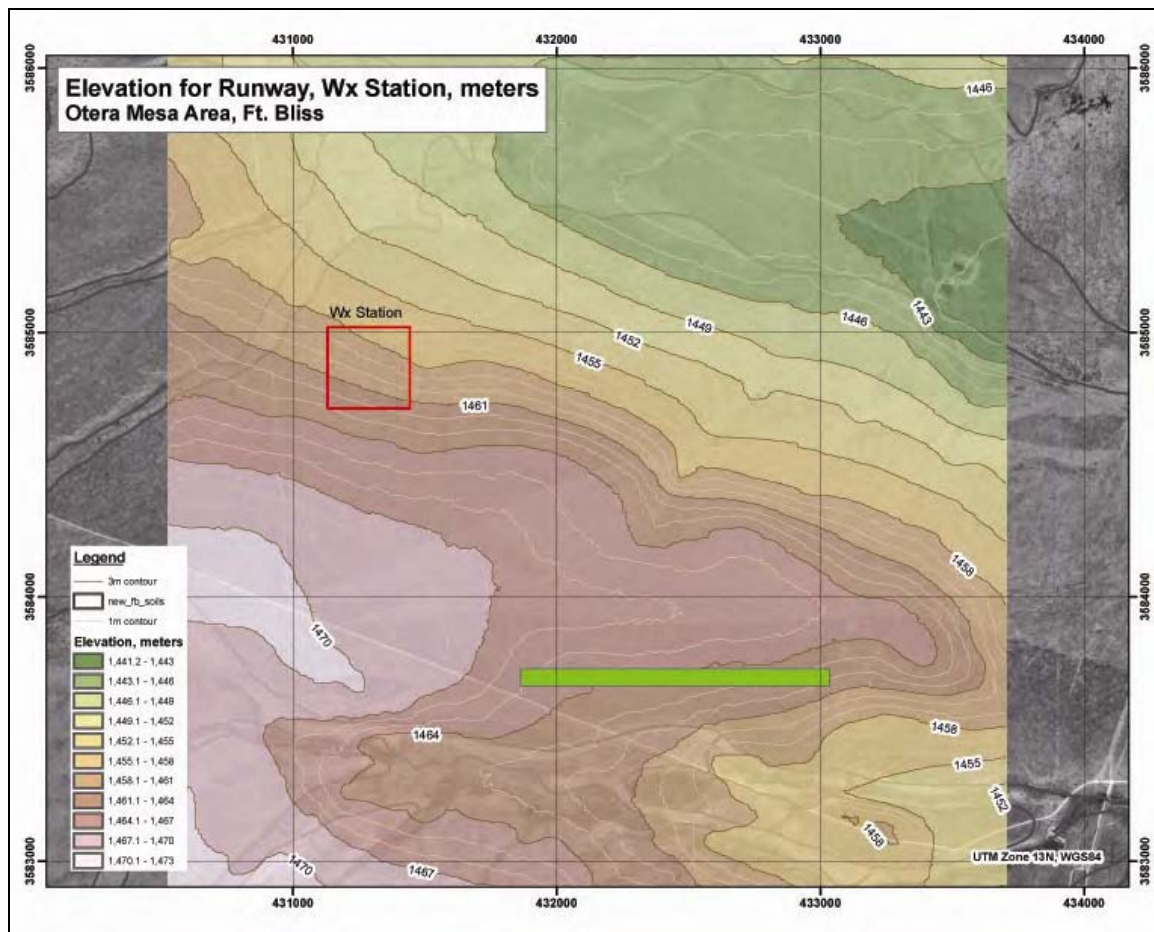
Figure 5. Fort Bliss OLS showing the RAS and fenced area where the weather station was located.

We were permitted to park the vehicles only along the side of the road. Because no off-road driving is allowed, potential RAS locations need to be located close to the road. This is also critical for logistics, hauling the instruments, and safety during field work. The area is used for training exercises and is near an active bombing range. Permission was obtained prior to the start of each field visit. The selected RAS is shown in Figure 5.

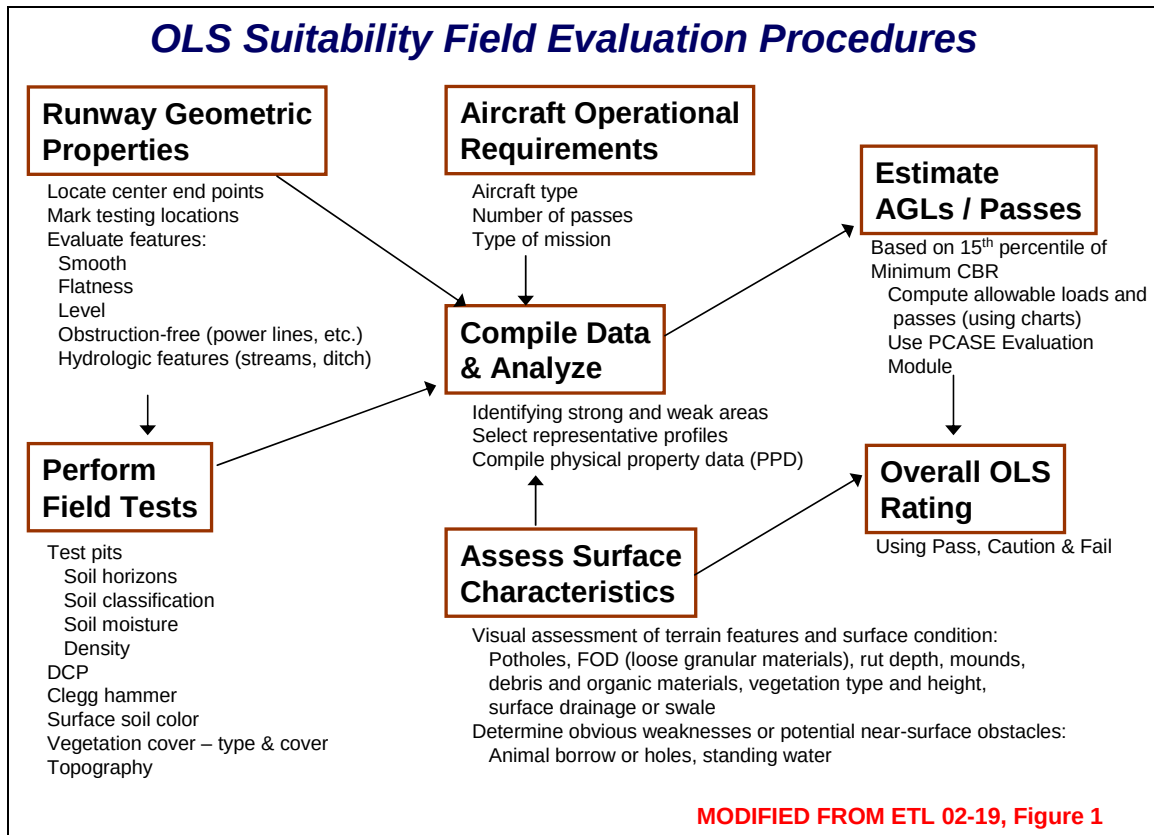
Figure 6. Procedures for determining the suitability of an OLS, modified from practice established by AFCEA in ETL 2002-19 (AFCEA 2002a).

The first step of the field evaluation was to locate and mark the center end points using the OLS coordinates with the aid of a GPS. By locating the runway end points, sampling locations then could be marked or flagged for specific intervals (stationing) along the OLS. ETL 2002-19 (AFCESA 2002a) guidelines for determining sampling locations for semi-prepared runways can be used for prioritizing to assess the critical locations of the runway. For the RAS, we adopted similar procedures. However; the sampling layout was established to allow sampling of the entire RAS using a regular grid spacing (Fig. 7). Field teams performed as many tests as time permitted, and prioritized test locations by focusing on weak soil areas first and to cover each feature or aspect of the runway.

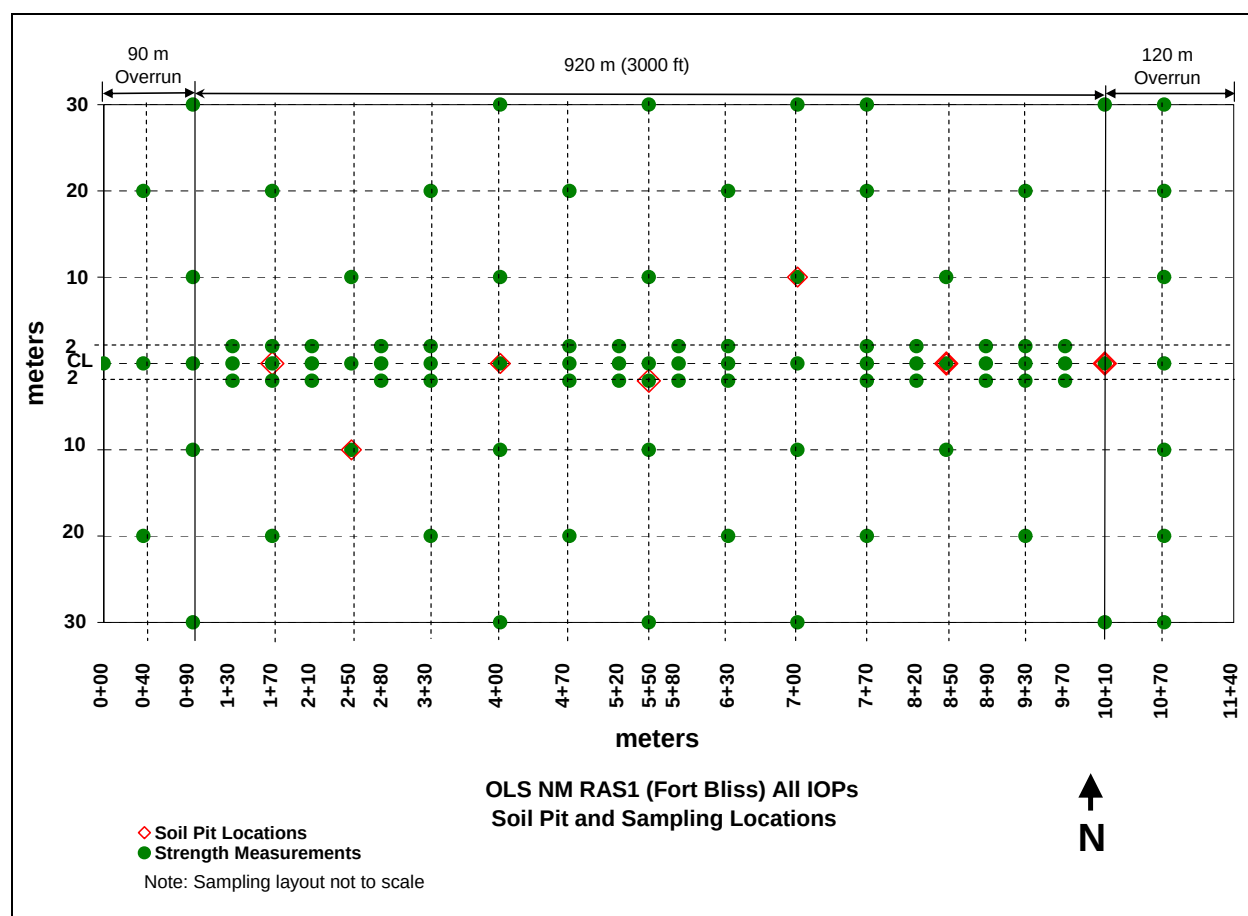
Figure 7. Sampling grid used to evaluate the RAS at Fort Bliss OLS. (Not drawn to scale.)

Using the sampling layout (Fig. 7), several soil pits were excavated to determine the stratigraphy of the soil horizons, soil texture, soil density, and soil moisture profiles. Soil texture was determined by collecting samples for laboratory analysis to determine the soil classification. Surface soil color was determined using the Munsell color chart and was not used in the analysis, but was intended to be used for another task under the OLS program. Soil density was measured primarily using a nuclear density gage and drive cylinders, which were found to be unsuitable for granular soils. Soil moisture content was measured at various depths using several methods (sensors in volumetric and gravimetric). Soil strength was measured for surface and subsurface layers using several instruments. Soil strength profiles were collected using the Dynamic Cone Penetrometer (DCP). The DCP is the standard instrument and is recommended by AFCEA to assess a runway's soil strength profile. Because of lack of confinement in soil near the surface, the actual strength of the surface layer using the DCP is at some depth depending on the soil type (Webster et al. 1994). Surface soil strength was measured using the Clegg Impact Hammer (CIH), the Static Cone Penetrometer, and a Drop cone. Both the DCP and CIH are commonly used to assess strength of mechanically compacted soils for roads and airfields. The Static Cone Penetrometer is used to assess soil strength

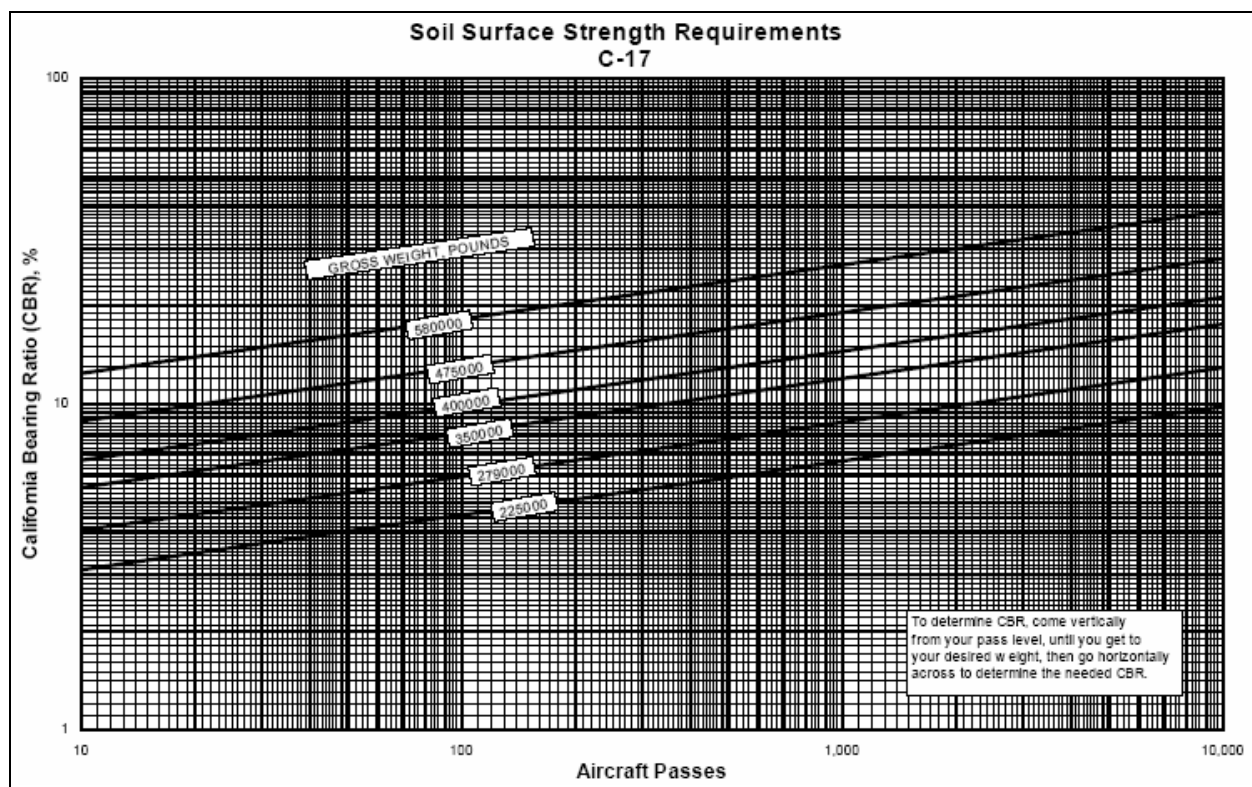
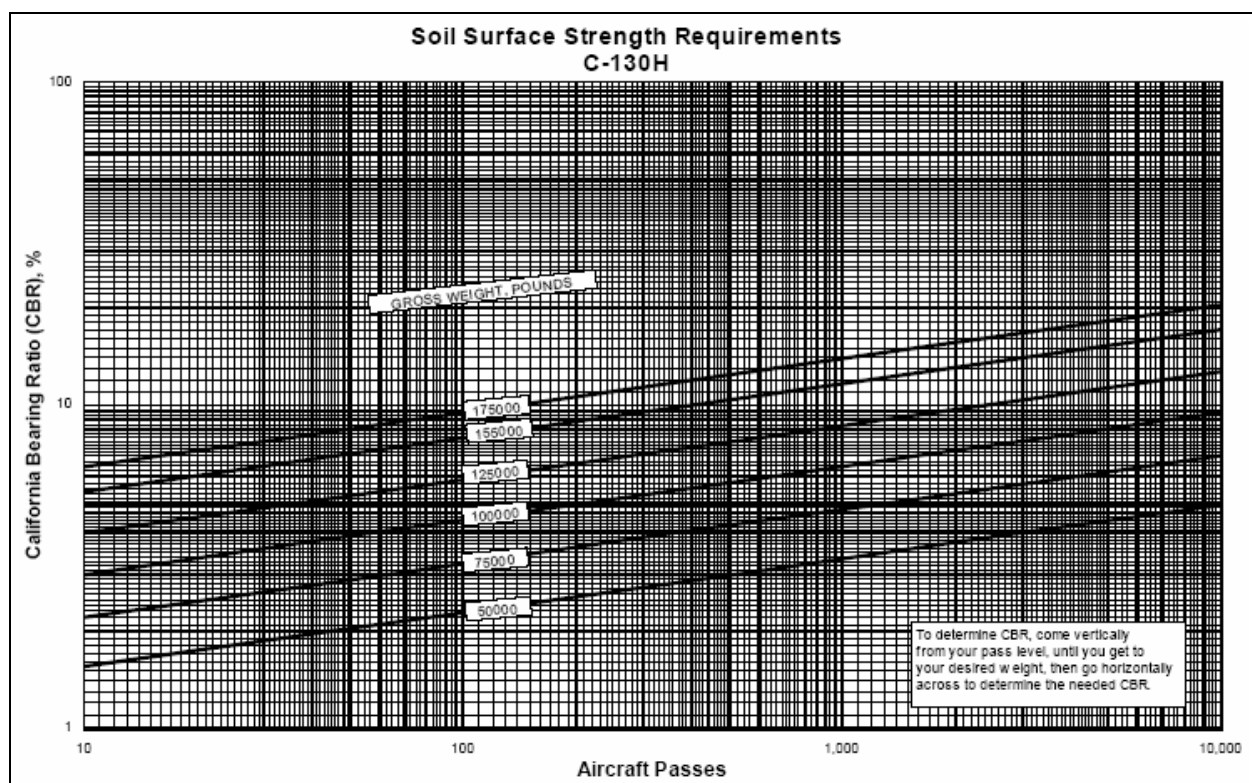
Figure 8. Soil strength on semi-prepared airfield for the C-17 and the C-130H.

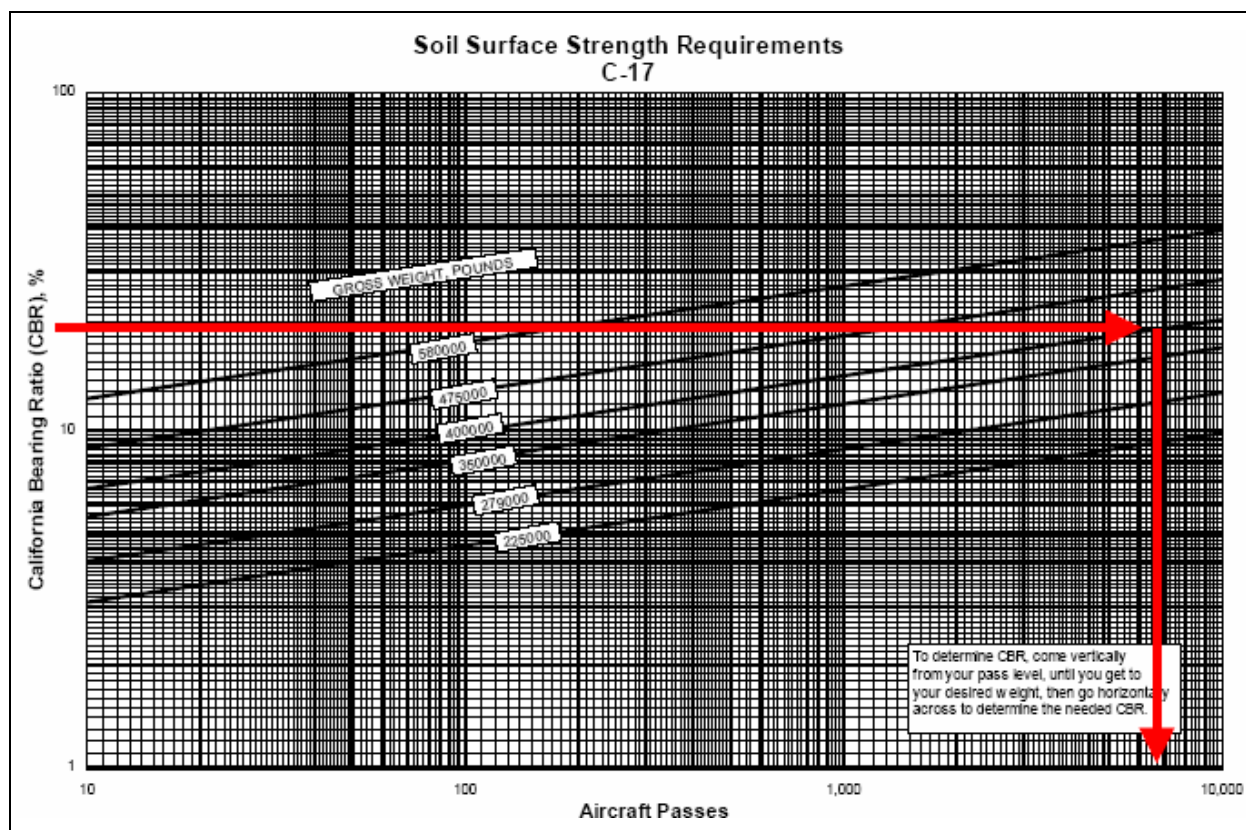
Figure 9. Sample evaluation of surface strength on semi-prepared airfield for C-17 operations.

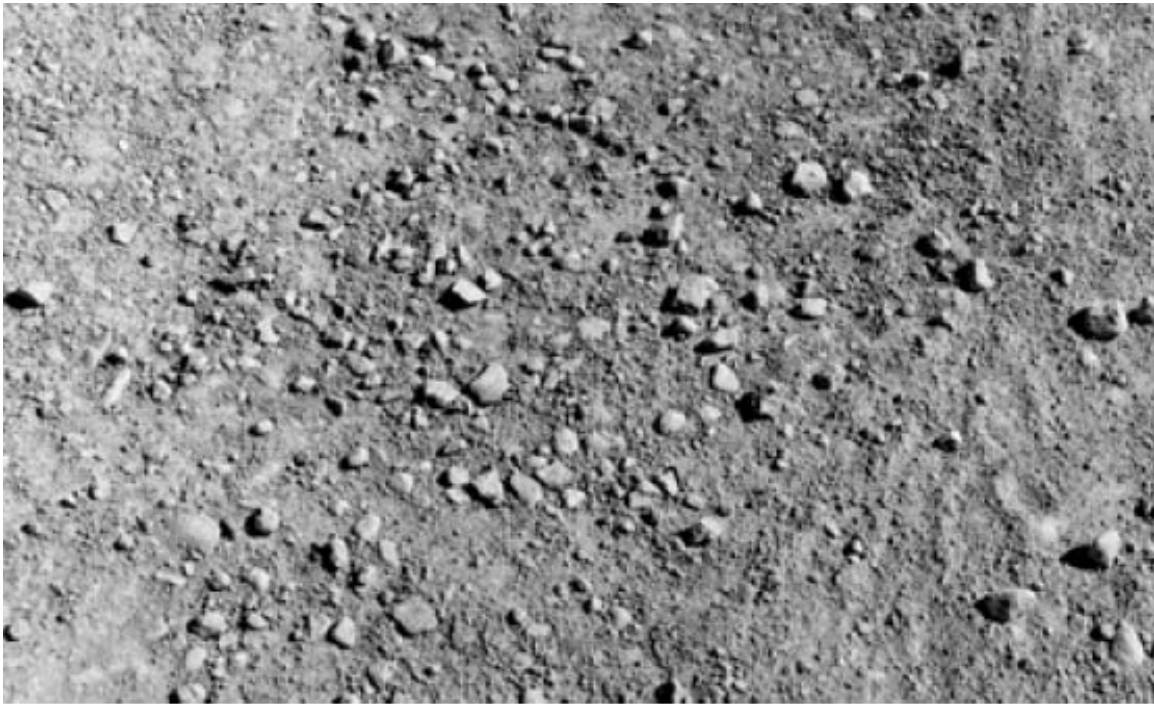
Loose Aggregate, Amber Severity

Figure 10. Picture taken from ETL 97-9 for severity rating of localized loose aggregate.

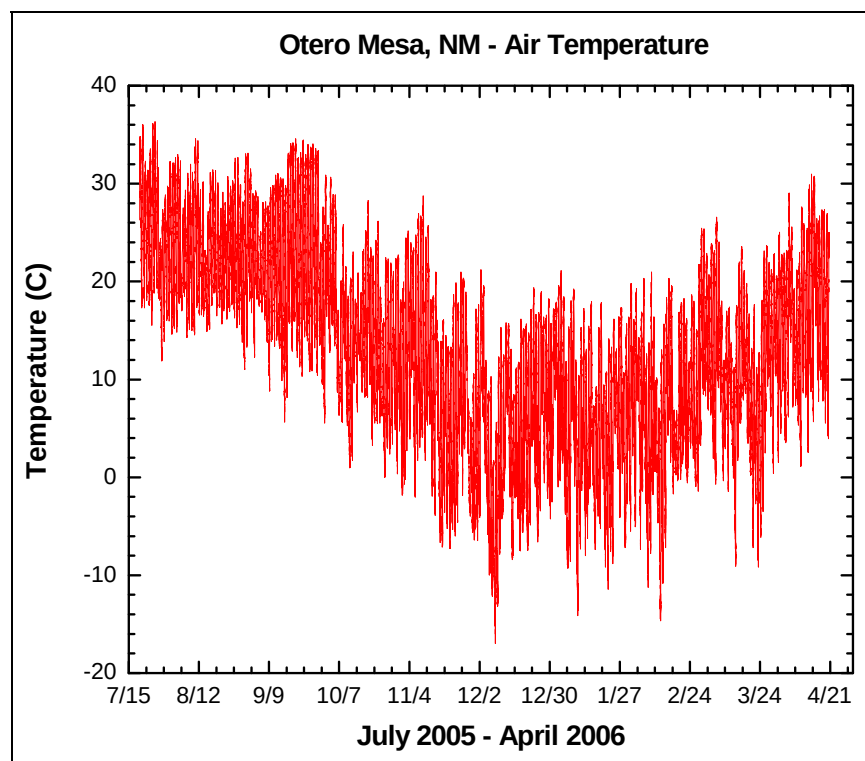
As expected, the Fort Bliss OLS at Otero Mesa was a warm, dry environment, with warmer temperatures in the summer and cooler temperatures in the winter. Air temperature was recorded every 10 seconds and averaged every 5 minutes from July 2005 to April 2006 as shown in Figure 11a. The graph shows that there were only a few days with temperatures near freezing. Contrary to what was reported by the UDSA (USDA Soil Survey 1981), this qualified as a relatively warm year. High temperatures reached near 38 °C (100 °F) in July, during IOP #1 (Fig. 11b). Cooling occurred around October 16, days before IOP #2 (Fig. 11c). The air temperature hovered around 30 °C (86 °F) during the middle of the day in the spring (Fig. 11d).

a. Continuous observation.

Figure 11. Air temperature data taken before, during, and after each IOP at Fort Bliss RAS weather observation station.

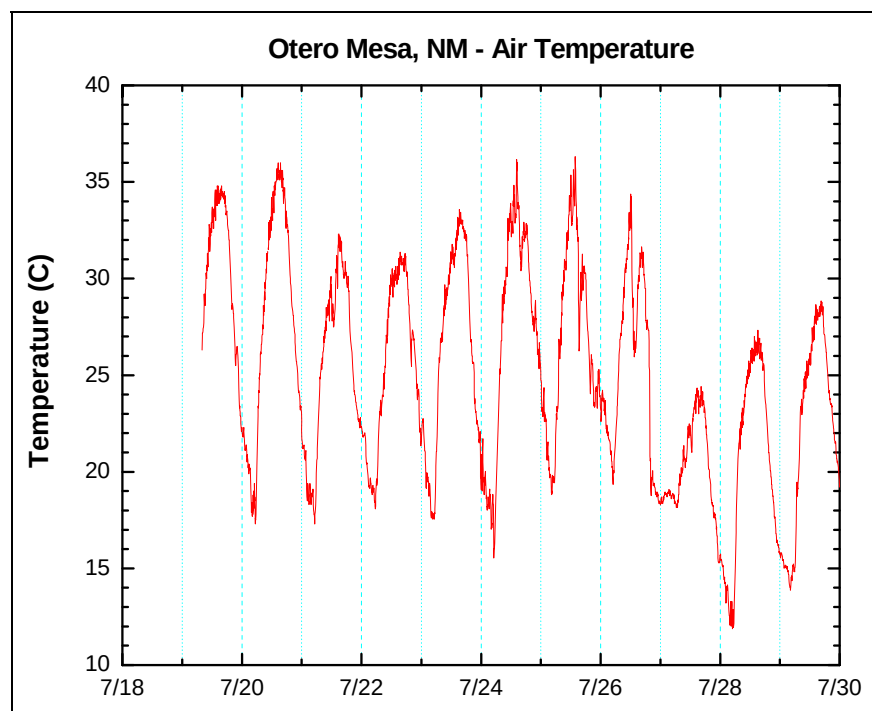
b. First intensive operational period (IOP #1) (18–21 July 2005).

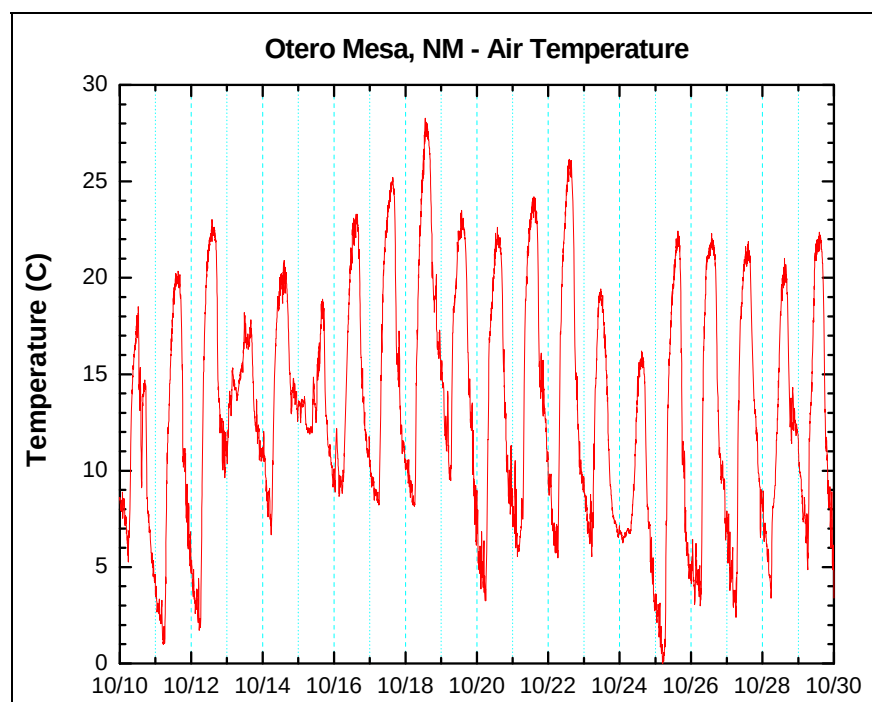
c. Second intensive operational period (IOP #2) (24–28 October 2005).

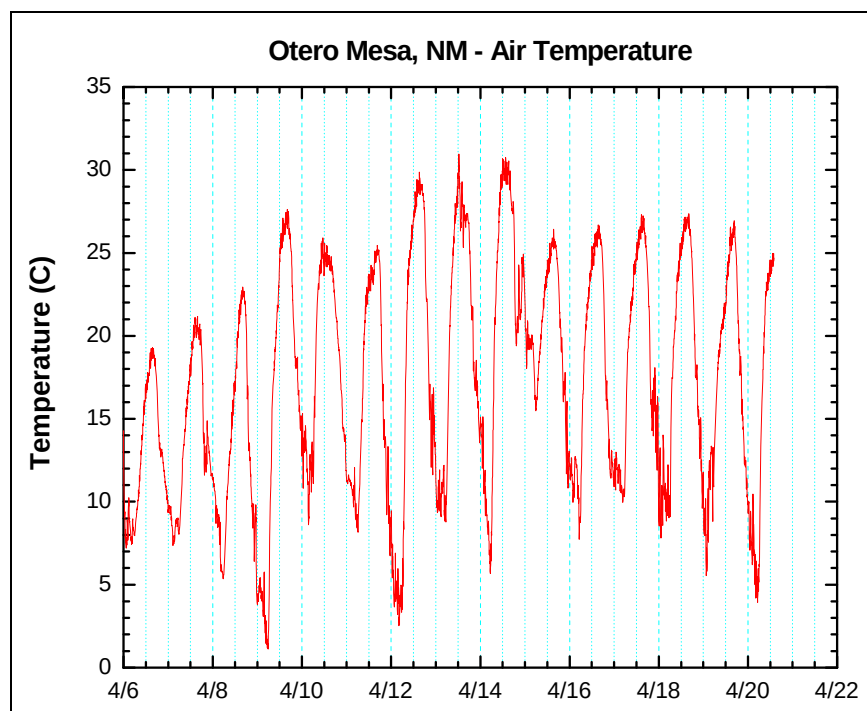
d. Third intensive operational period (IOP #3) (20–21 April 2006).

Figure 11 (cont'd). Air temperature data taken before, during, and after each IOP at Fort Bliss RAS weather observation station.

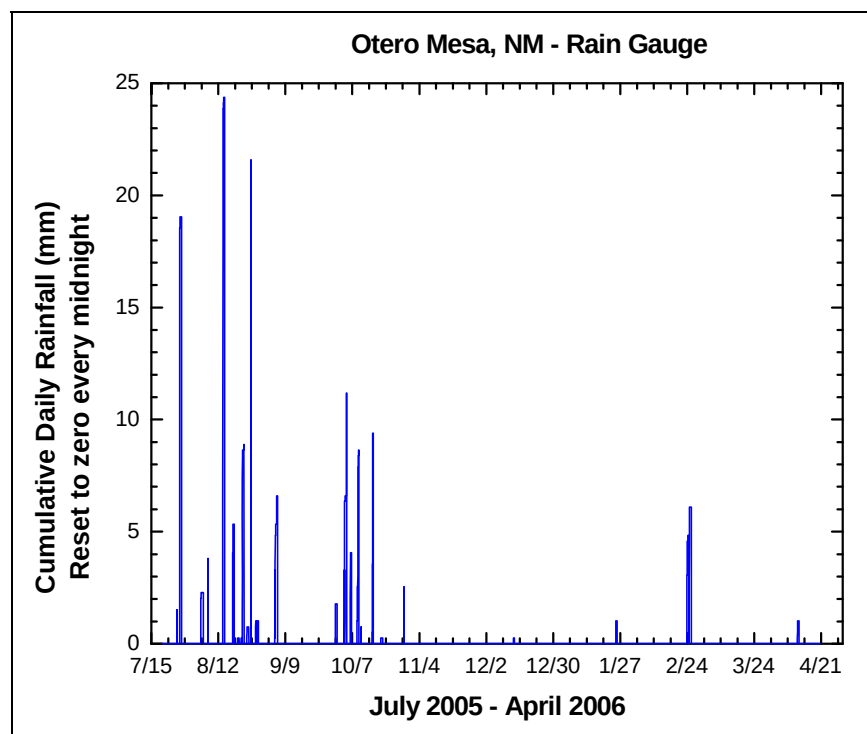
Figure 12. Precipitation data from the observation station near the RAS.

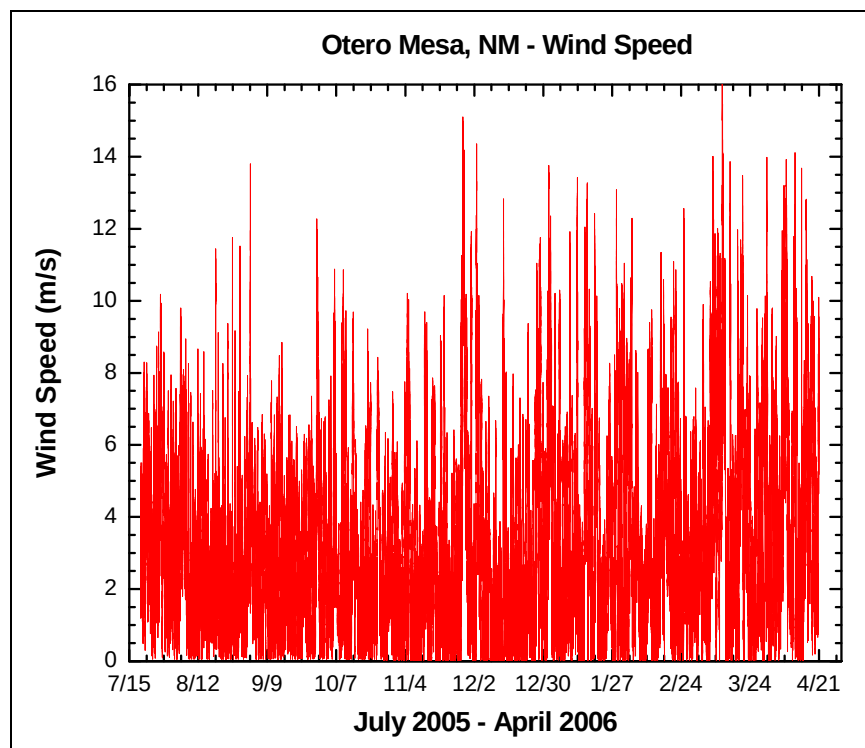
Figure 13. Wind speed observed from the weather station near the RAS averaged every five minutes for the entire monitored time.

The weather station sampled the wind data every 10 seconds and output was averaged over a five-minute period (Fig. 13). The wind speed data suggested that very light wind (less than 3 m/sec) is common in the area. However, wind speeds of 12 m/sec (27 mph) or higher occasionally occur (Fig. 13). Wind tends to pick up during mid-day and normally originates in the west and northwest. Higher wind speeds can cause dust storms in semi-arid environments with dry soils, but light breezes can improve visibility by clearing dust after disturbance from vehicular or aircraft traffic.

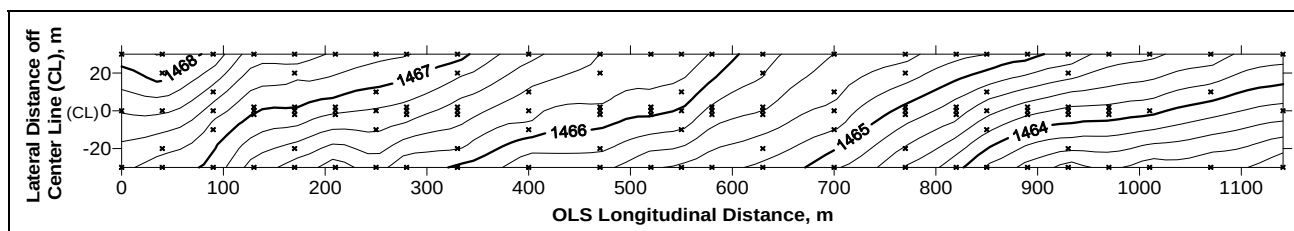
Figure 14. Contour map of the entire Fort Bliss RAS. The x symbols show where elevations (m) were taken.

The spacing for measuring the profile was solely on the perception of the data gatherer (i.e., 1-m profile readings for areas with mounds, depressions, or swales). The laser level data in Figure 15b display the mounds and surface scouring from animals along the center of the RAS. Typical surface undulations of the RAS are illustrated using the profilometer as shown in Figure 15c. The natural ground undulation is in the range of 6 and 8 cm over spans between 0.5 and 1.5 m. Some of the undulations are caused by animal holes and bare ground between vegetated areas.

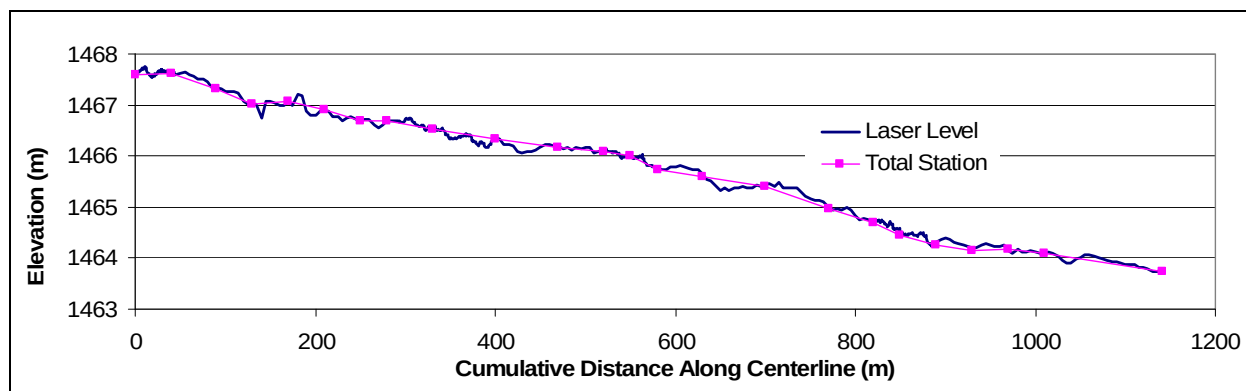
The topography of the OLS is relatively flat but gently sloping to the southeast for most of the RAS (Fig. 14). The elevation of the RAS center line from the total station data showed a gradual decrease of 3.8 m from the beginning (west) to the end (east) (Fig. 15a). The overall grade of the center of the RAS from the beginning to the end is 0.33%, which is relatively flat. To capture the micro relief or undulation and surface roughness along the centerline of the RAS, a laser profile was collected every 1 m in areas that are noticeably rough and every 5 m in areas that are relatively smooth.

a. Elevation along the OLS centerline.

Figure 15. Elevation profile along RAS center line.

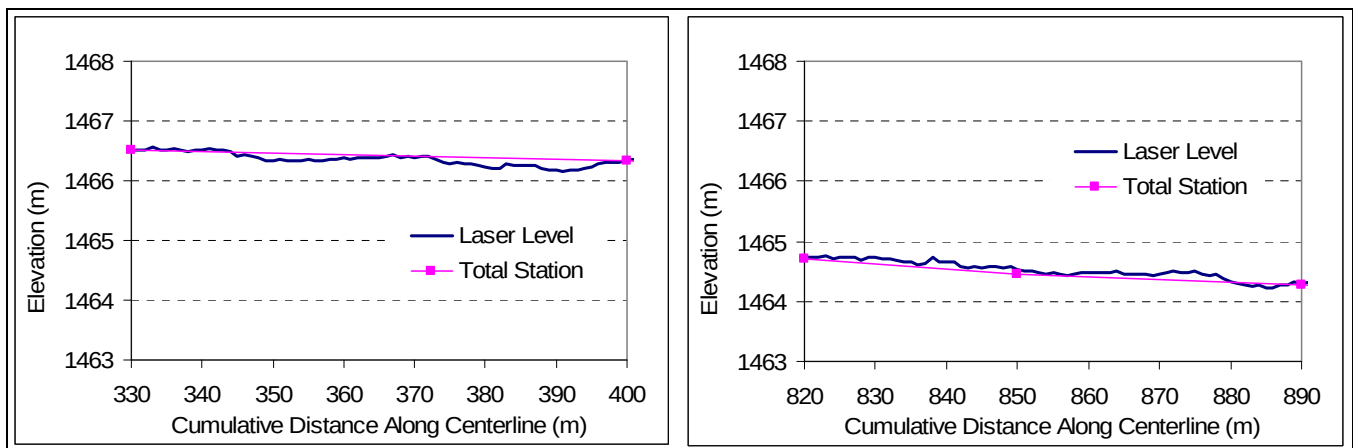
Surface roughness along the center line of the RAS is calculated using the Root Mean Square (RMS), equation (1) from the elevation data taken by laser level. The RMS value is determined to be 1.13 m along the centerline for the entire OLS.

b. Surface roughness reflected from higher sampling using the laser level.

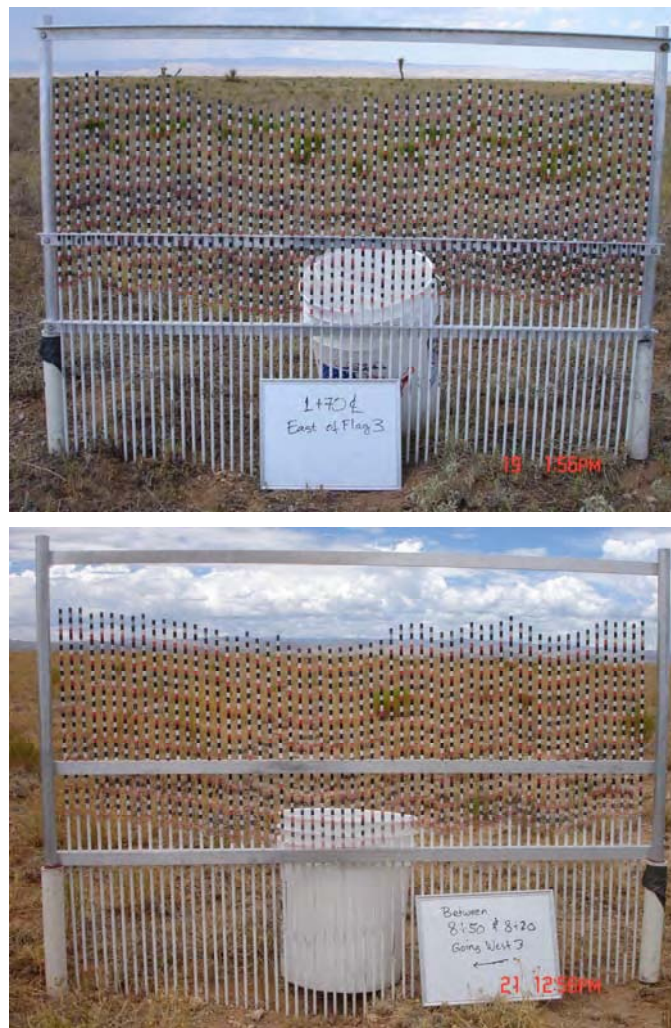
c. Surface undulation using the profilometer. The rods are horizontally spaced 2 cm apart and each rod is vertically marked at 1-cm intervals.

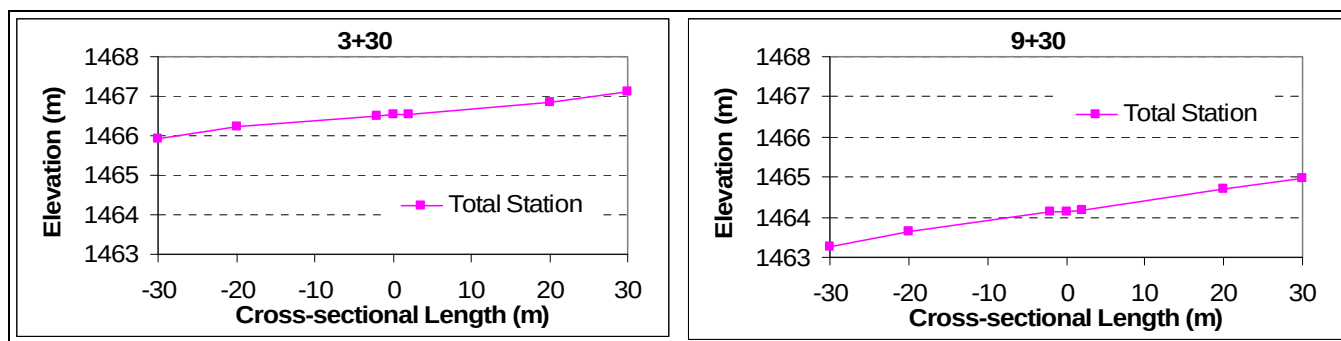
The average lateral or transverse cross-sectional grade of the OLS ranges from 1.1% to 2.8 % slope. Typical transverse profiles of the OLS are shown in Figure 16.

The maximum allowable longitudinal grade of runways is 3% maximum slope (ETL 04-7). The longitudinal grade for the Fort Bliss RAS is less than the maximum allowable. Lateral or transverse grades on this RAS also are within the bounds of the ETL criteria.

Figure 16. Typical lateral (transverse) profiles of the RAS at Fort Bliss, slope slightly to the south. Station 3+30 is 2% grade and station 9+30 is 2.8% grade.

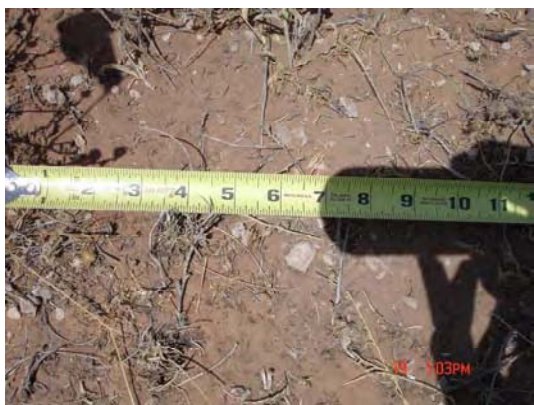
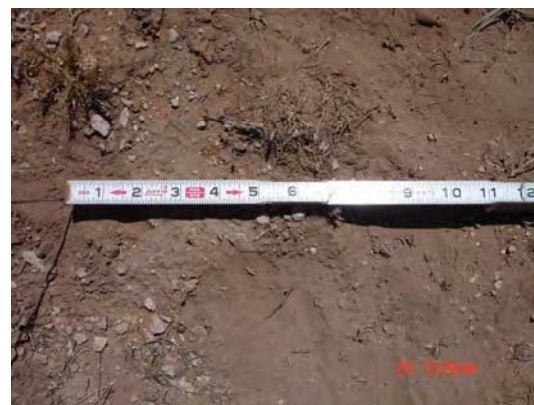
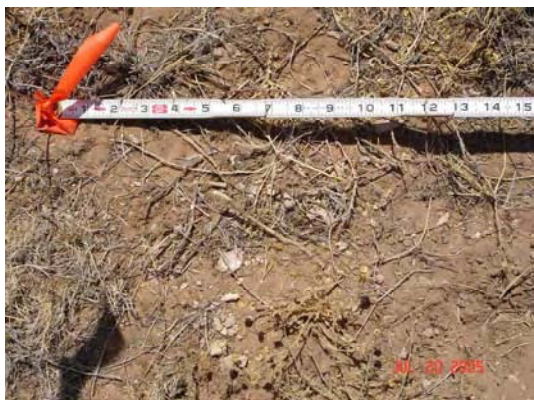
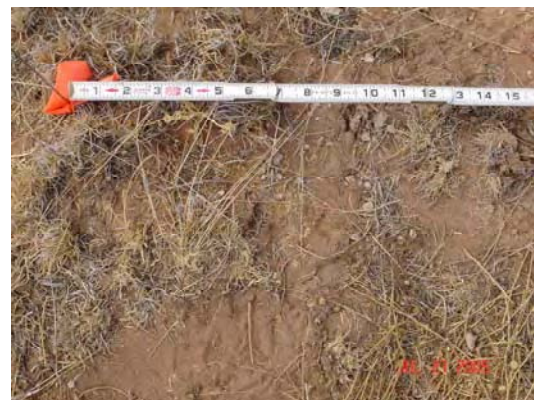
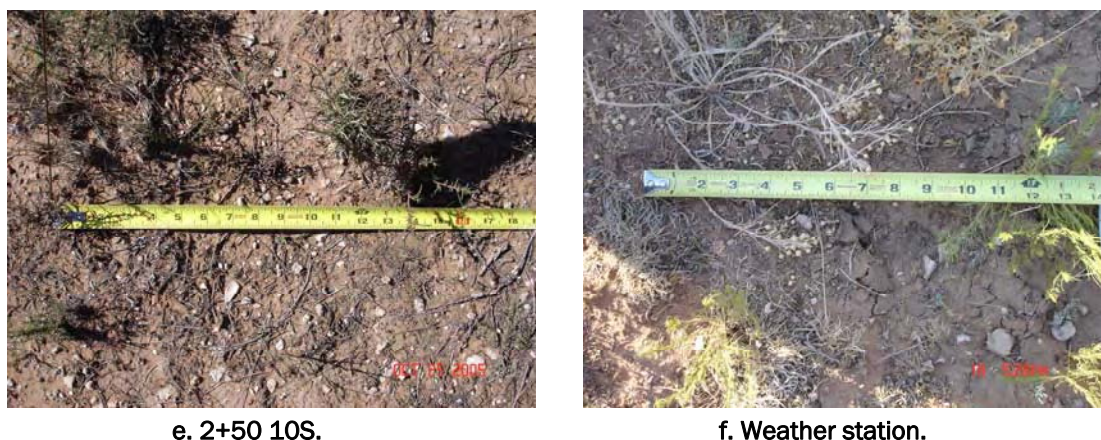
Figure 17 shows the soil exposed on the surface at five sampling points on the RAS and at the weather station. Significant amounts of exposed soil were observed on the RAS, including granular pieces of caliche materials. Some of the soil pits at a few sampling points were quite shallow because of the caliche layer, which was difficult to dig or pick through by hand.

Figure 17. Soil on the surface before digging the soil pits.

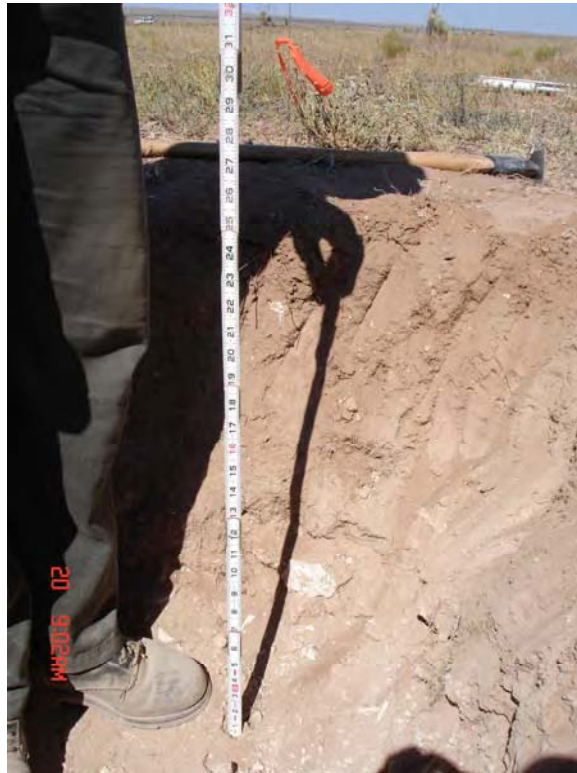
a. From the surface down to 0.686 m (27 in.).

Figure 20a shows the soil profile of the entire pit dug at station 8+50 CL. Caliche chunks were encountered 0.5 m (20 in.) below the surface. Soil samples were collected at various depths including the surface. From the grain size analysis, the soil was relatively uniform and consistent from surface down to 0.30 m (12 in.) and the gradation indicated a Silty Sand (SM) soil. However, at 0.4 m (18 in.), the soil was a more uniform sand classified as Silty Sand, SM (Fig. 20b).

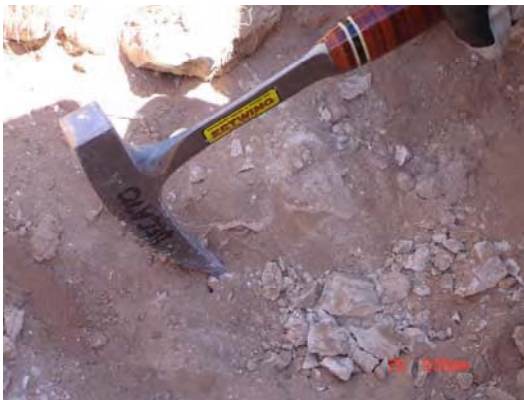
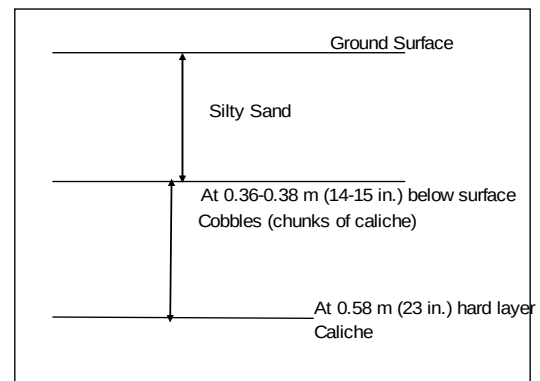
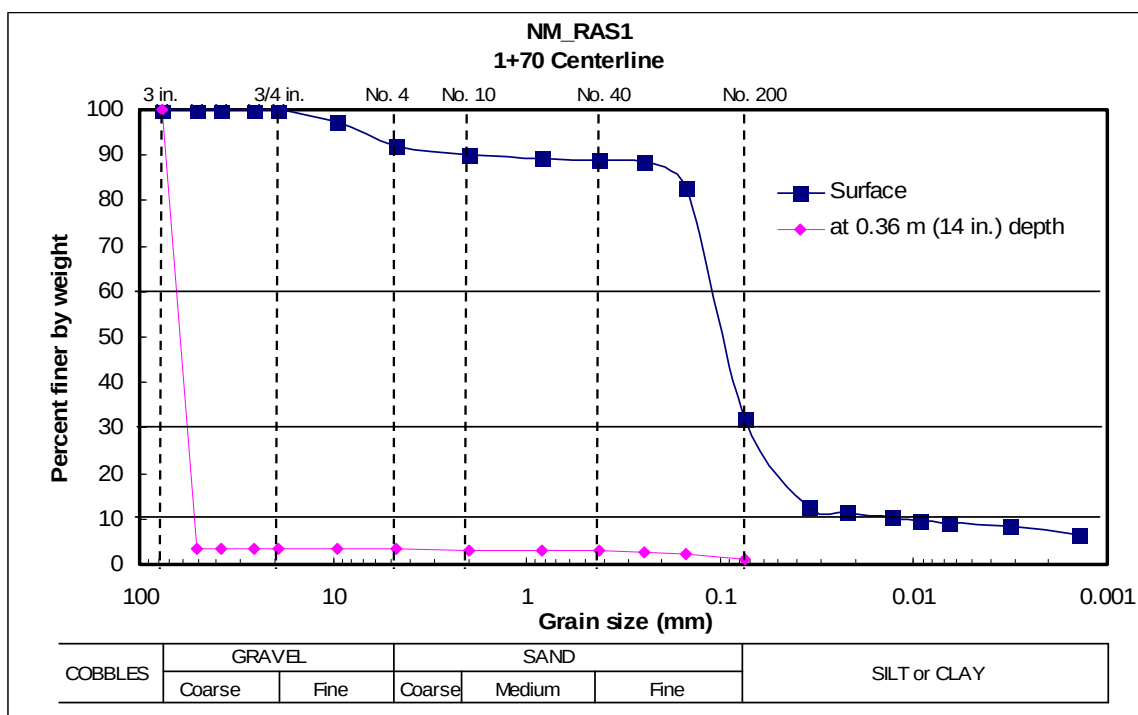
Figure 18. Soil profile at Station 1+70.

At station 1+70 CL, soil samples were taken near the surface and at 0.36 m (14 in.) below the surface (although the soil pit was dug down to 0.58 m [23 in.]). The soil profile at station 1+70 CL displays a finer soil in the upper 0.36 m, with pieces of caliche embedded in the soil immediately below it (Fig. 18a–c). The bottom of the pit was at 0.58 m, where the caliche layer was very well defined (Fig. 18b). The grain size distribution chart from the laboratory test results is shown in Figure 18d. The surface soil type based on USCS is classified as Silty Sand (SM) with a plasticity index of zero. The particle size distribution for the soil sample at a depth of 0.36 m (14 in.) contained 96.5% cobbles (materials greater than 50 mm or 2 in.) and the rest of the soil sample ranged from gravel to fine sand (Fig. 18d).

b. Caliche pieces at the bottom of the pit.

c. Soil profile in the field.

d. Results from the laboratory grain-size analysis of the soil samples.
