*Opportune Landing Site Program*

## **Suitability Measurement and Analysis for Fort Bliss Naval Air Facility OLS**

Rosa T. Affleck, Charles C. Ryerson,  
Lynette A. Barna, and Keran J. Claffey

September 2008

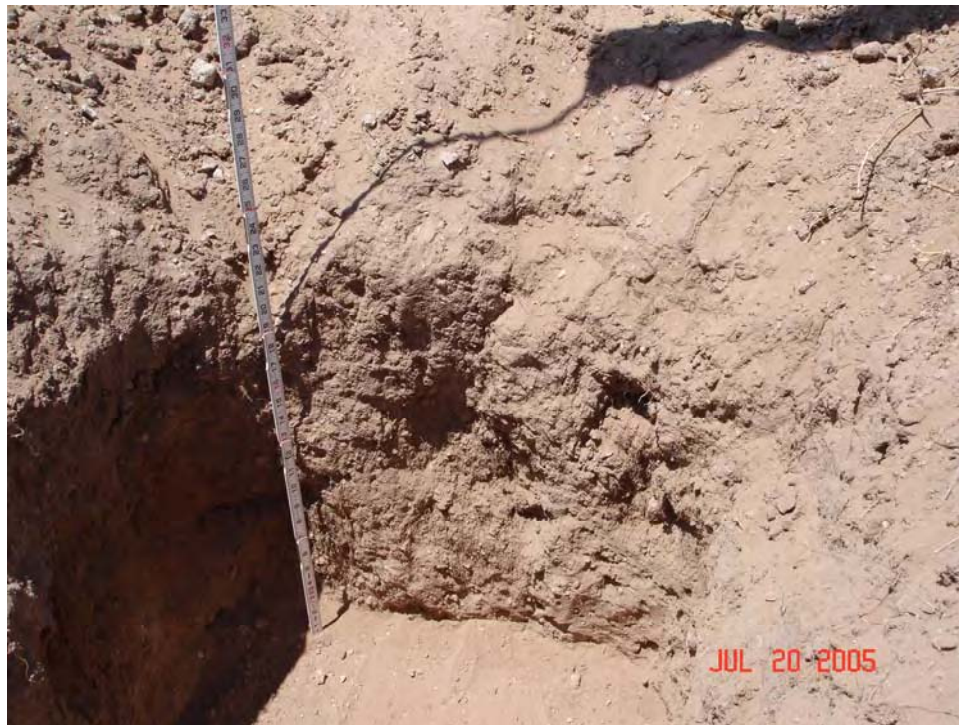
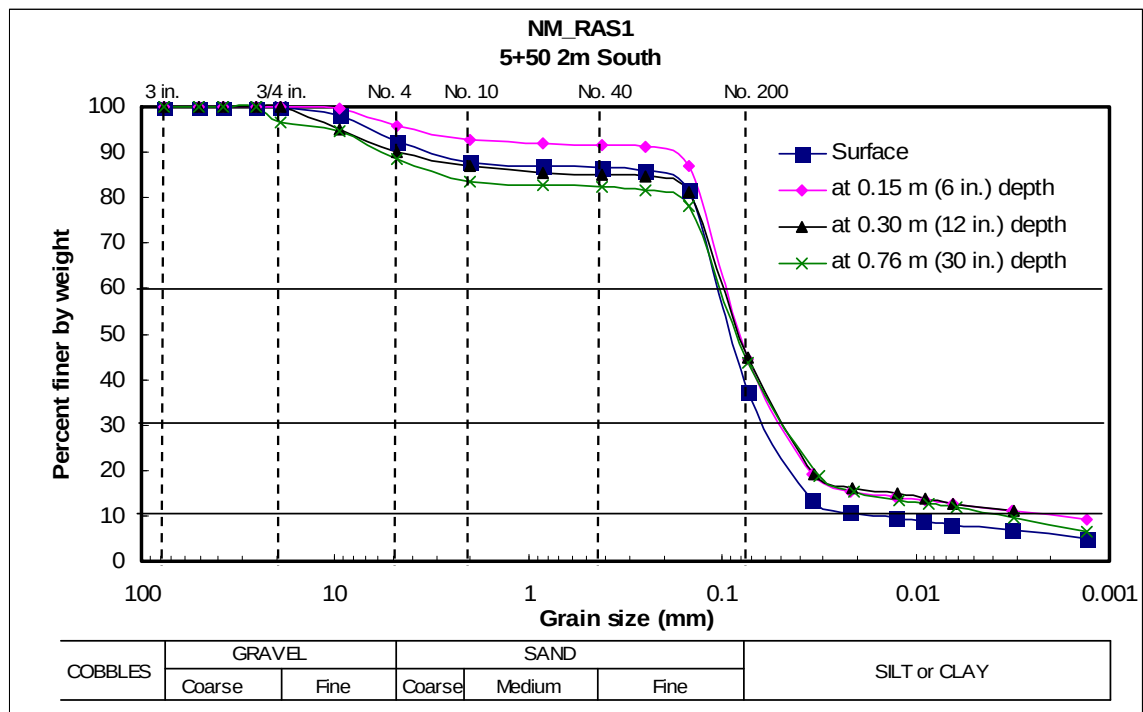
**Figure 19. Soil profile at station 5+50 2S.**

The pit at station 5+50 2S was dug to 0.914 m (36 in.) and a photo of the soil profile is shown in Figure 19a. The soil was observed to be relatively uniform and the caliche layer was not encountered throughout the depth. Soil samples were collected at the surface and at 0.15-, 0.30-, and 0.76-m (6-, 12-, and 30-in.) depths. The results from the grain size analysis of the soils collected at station 5+50 2S is shown in Figure 19b and is classified as Silty Sand (SM).

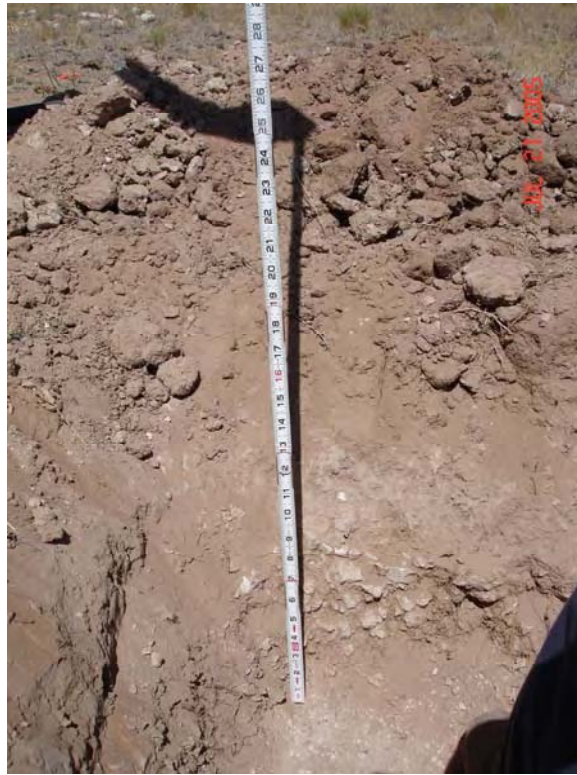
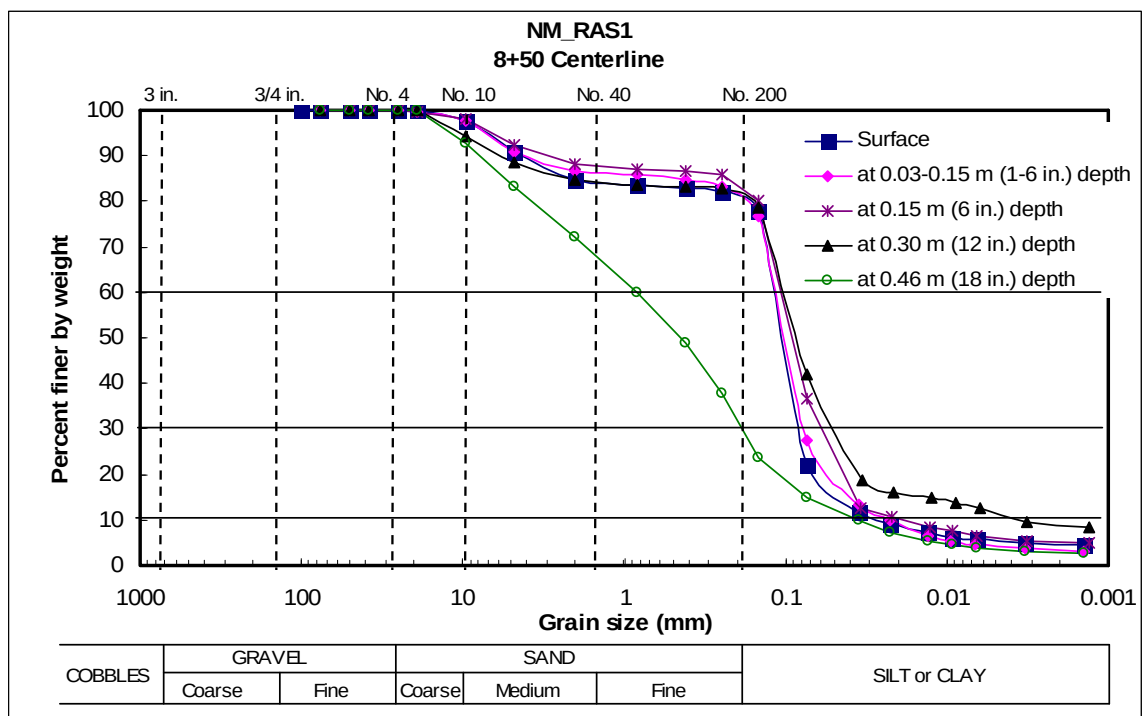
Figure 20. Soil profile at 8+50 CL.

Figure 20a shows the soil profile of the entire pit dug at station 8+50 CL. Caliche chunks were encountered 0.5 m (20 in.) below the surface. Soil samples were collected at various depths including the surface. From the grain size analysis, the soil was relatively uniform and consistent from surface down to 0.30 m (12 in.) and the gradation indicated a Silty Sand (SM) soil. However, at 0.4 m (18 in.), the soil was a more uniform sand classified as Silty Sand, SM (Fig. 20b).

a. Entire soil pit where the bottom of the pit is located at 0.5 m (20 in.) below the surface.

b. Results from the laboratory grain-size analysis of the soil samples.

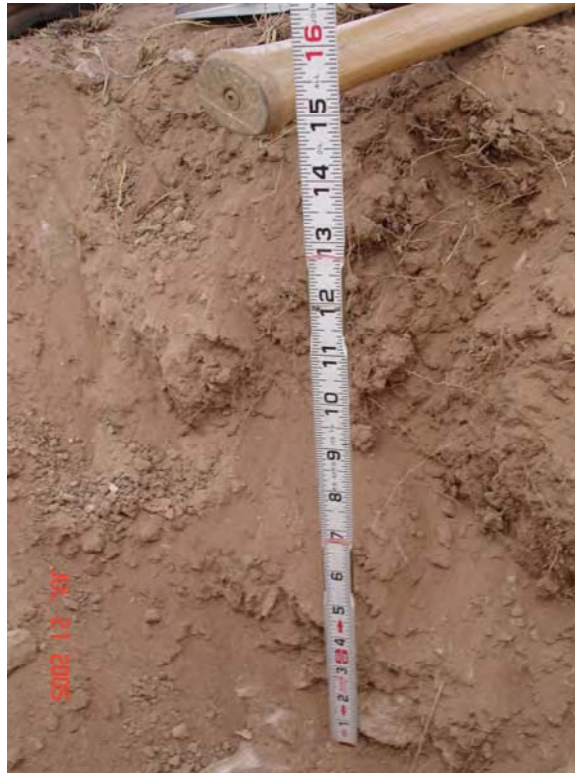
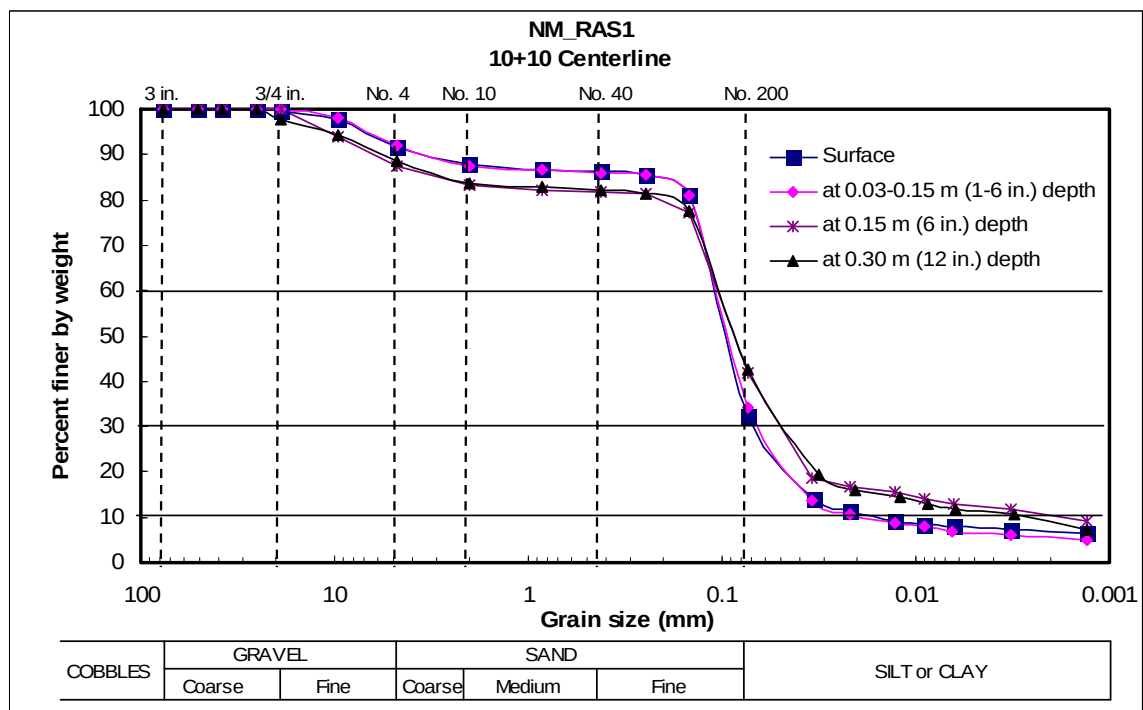
Figure 21. Soil pit at 10+10 CL down to 0.38 m (15 in.).

a. Entire profile and caliche at the bottom of the pit.

b. Results from the laboratory grain-size analysis of the soil samples.

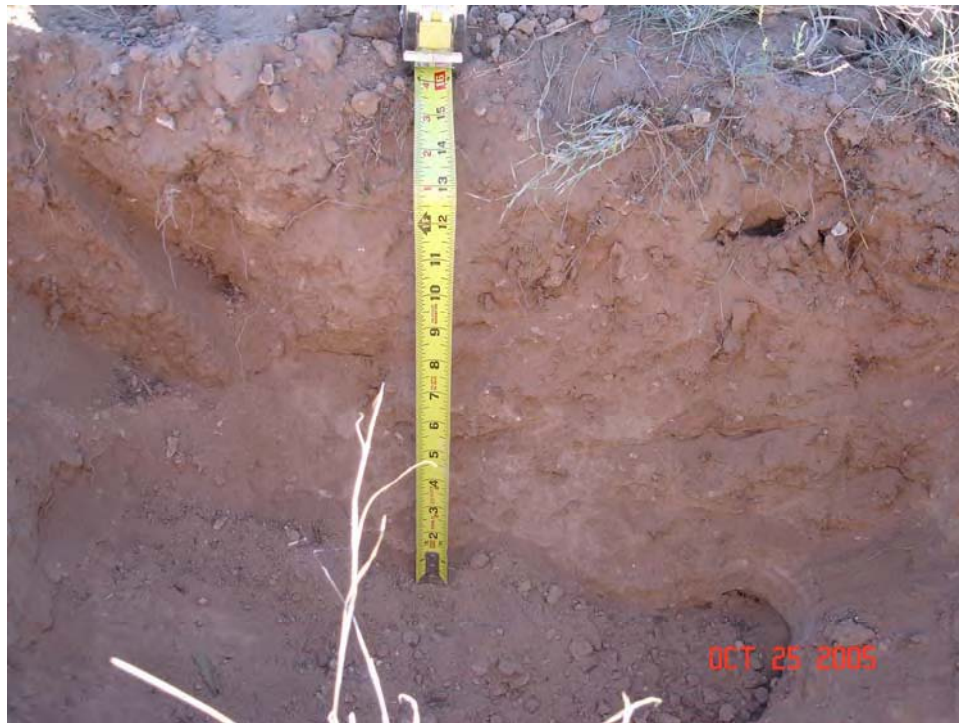
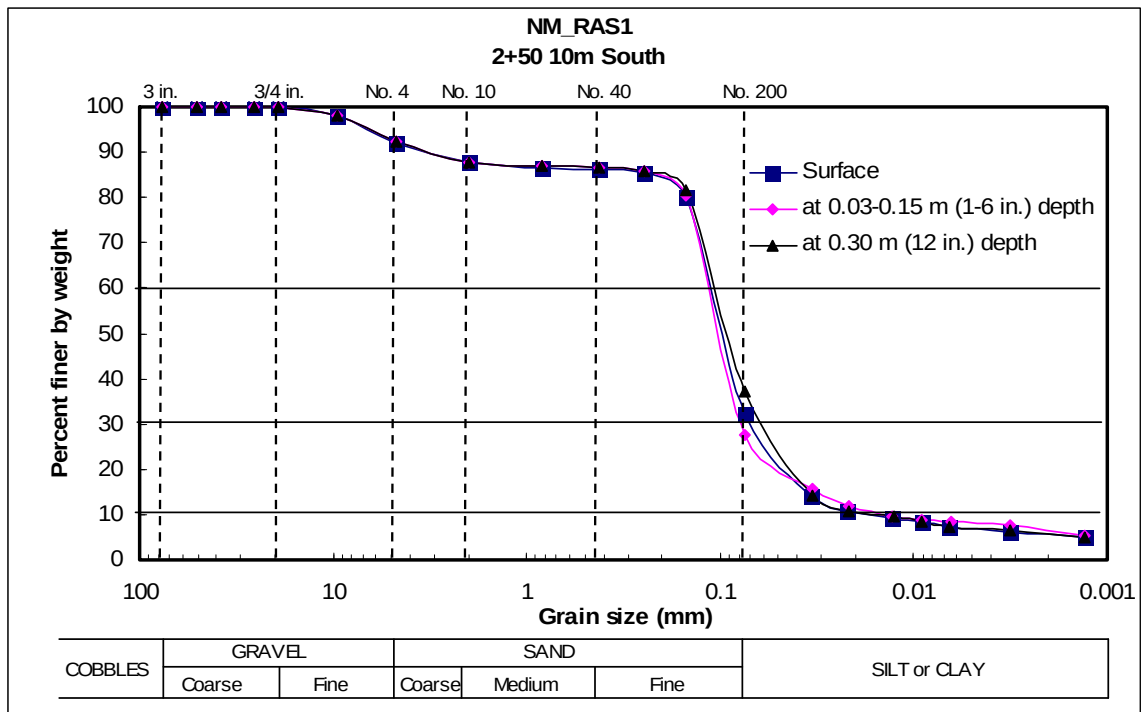
Figure 22. Soil profile at 2+50 10S, caliche layer.

Only a shallow soil pit was achieved at sampling point 2+50 10S. The caliche layer was encountered at 0.30 m (12 in.) deep, making it difficult to dig deeper (Fig. 22a). The soil from the surface to 0.3 m below is classified as Silty Sand (SM) as well (Fig. 22b).

a. Soil pit down to 0.3 m (12 in.) below the surface.

b. Results from the laboratory grain-size analysis of the soil samples.

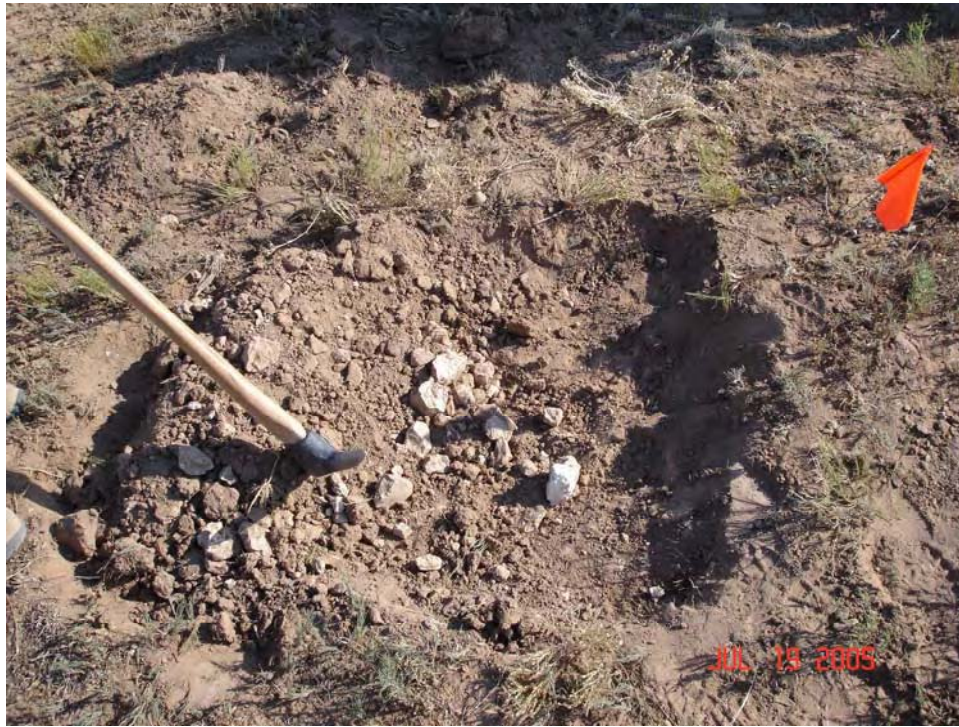
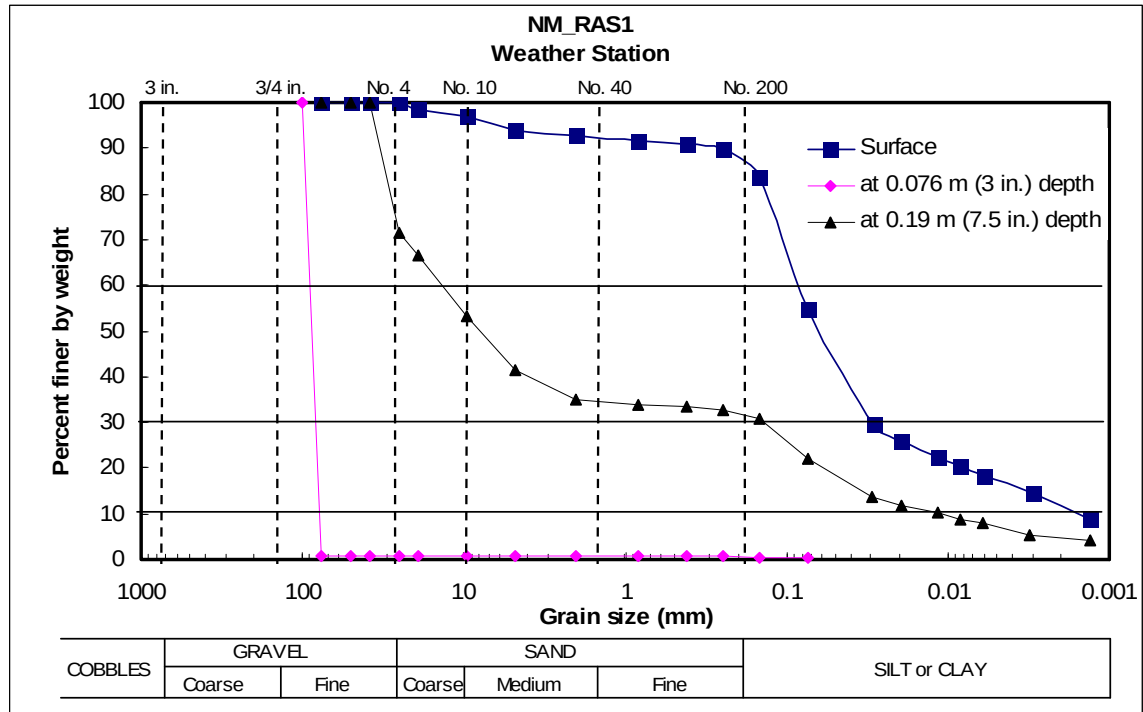
Figure 23. Soil pit at the weather station area.

The pit near the weather station was the shallowest of all of the soil pits. The caliche layer (chunks) was present near the surface at 0.076 m (3 in.), as shown in Figure 23a. The soil pit was difficult to dig deeper than 0.2 m (8 in.). The results from the grainsize analysis can be seen in Figure 23b. The soil type at the surface is a Silty Sand (SM). However, at depths where the soil was mixed with caliche pieces or chunks, the gradation became a Gravelly Silt (GM) with granular materials larger than 20 mm (0.75 in.) (Fig. 23b).

a. Caliche layer encountered very near the surface.

b. Results from the laboratory grain size analysis of the soil samples.

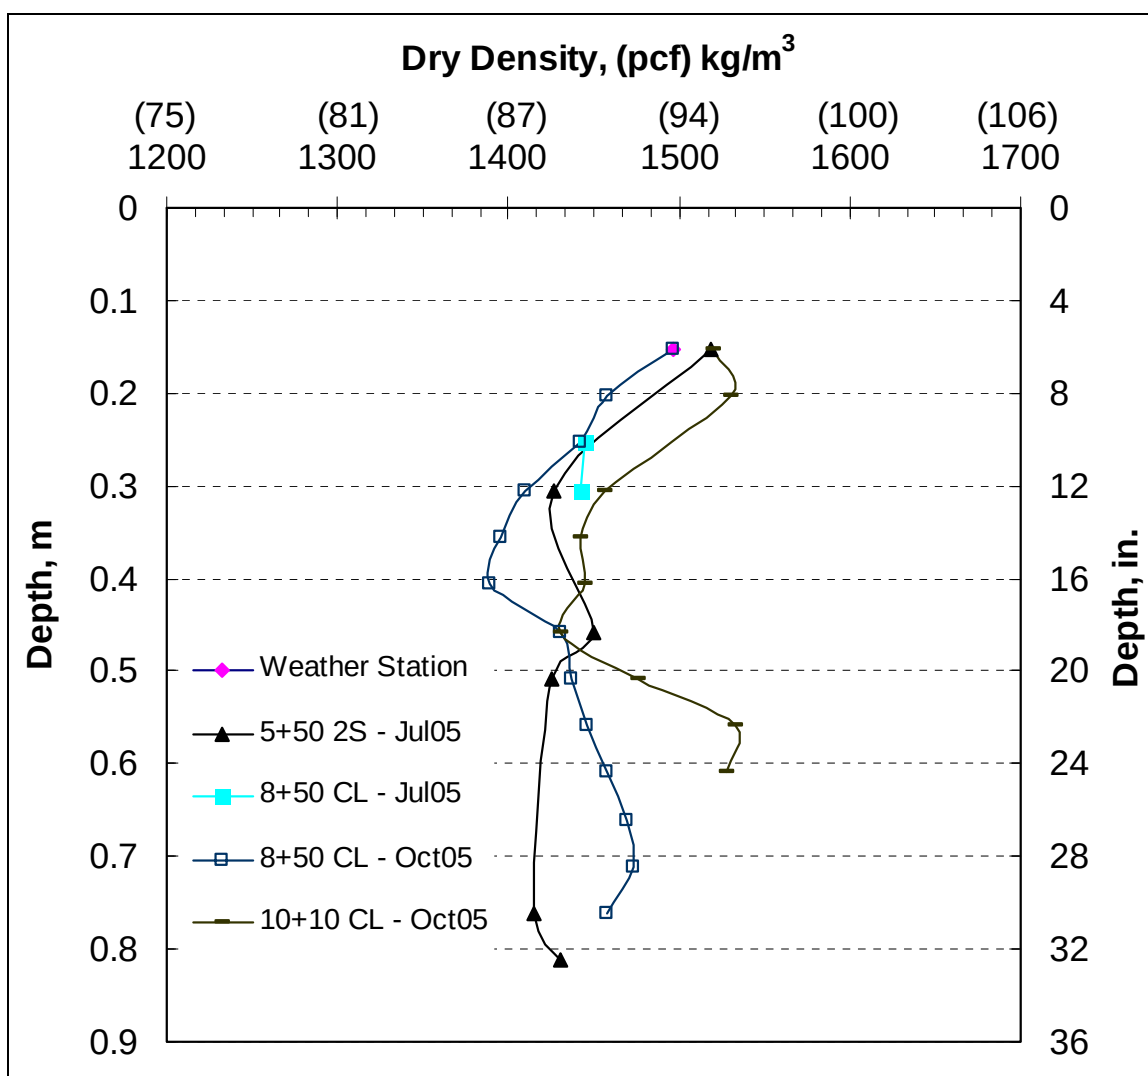
Figure 24. Soil density profiles taken using a nuclear density gage at five locations on Fort Bliss RAS.

A compaction analysis on the Fort Bliss OLS soil sample was conducted by Danyluk et al. (2008), and the result showed that the soil has an optimum density of 1884 kg/m<sup>3</sup> (117.6 lb/ft<sup>3</sup>) and a maximum moisture content of 12.6% following the modified proctor method (ASTM D1557-2). The in-situ dry density values measured on the OLS vary with depths and are significantly lower than the density from the modified proctor.

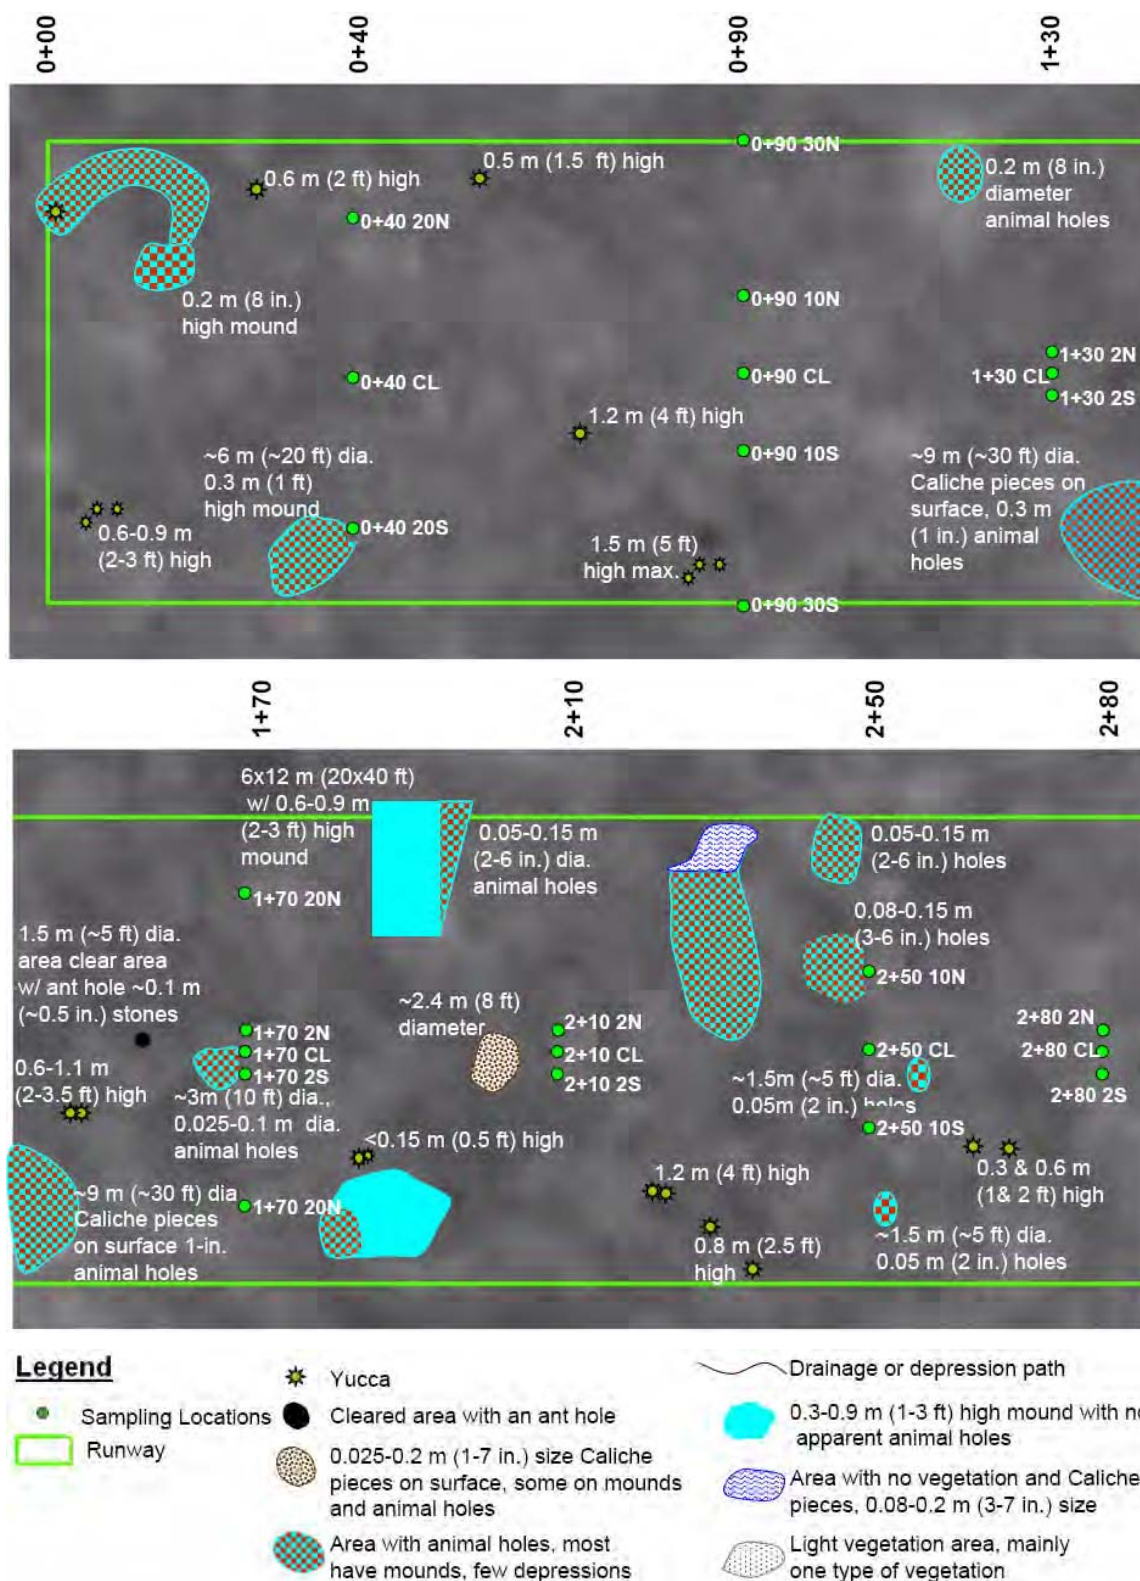
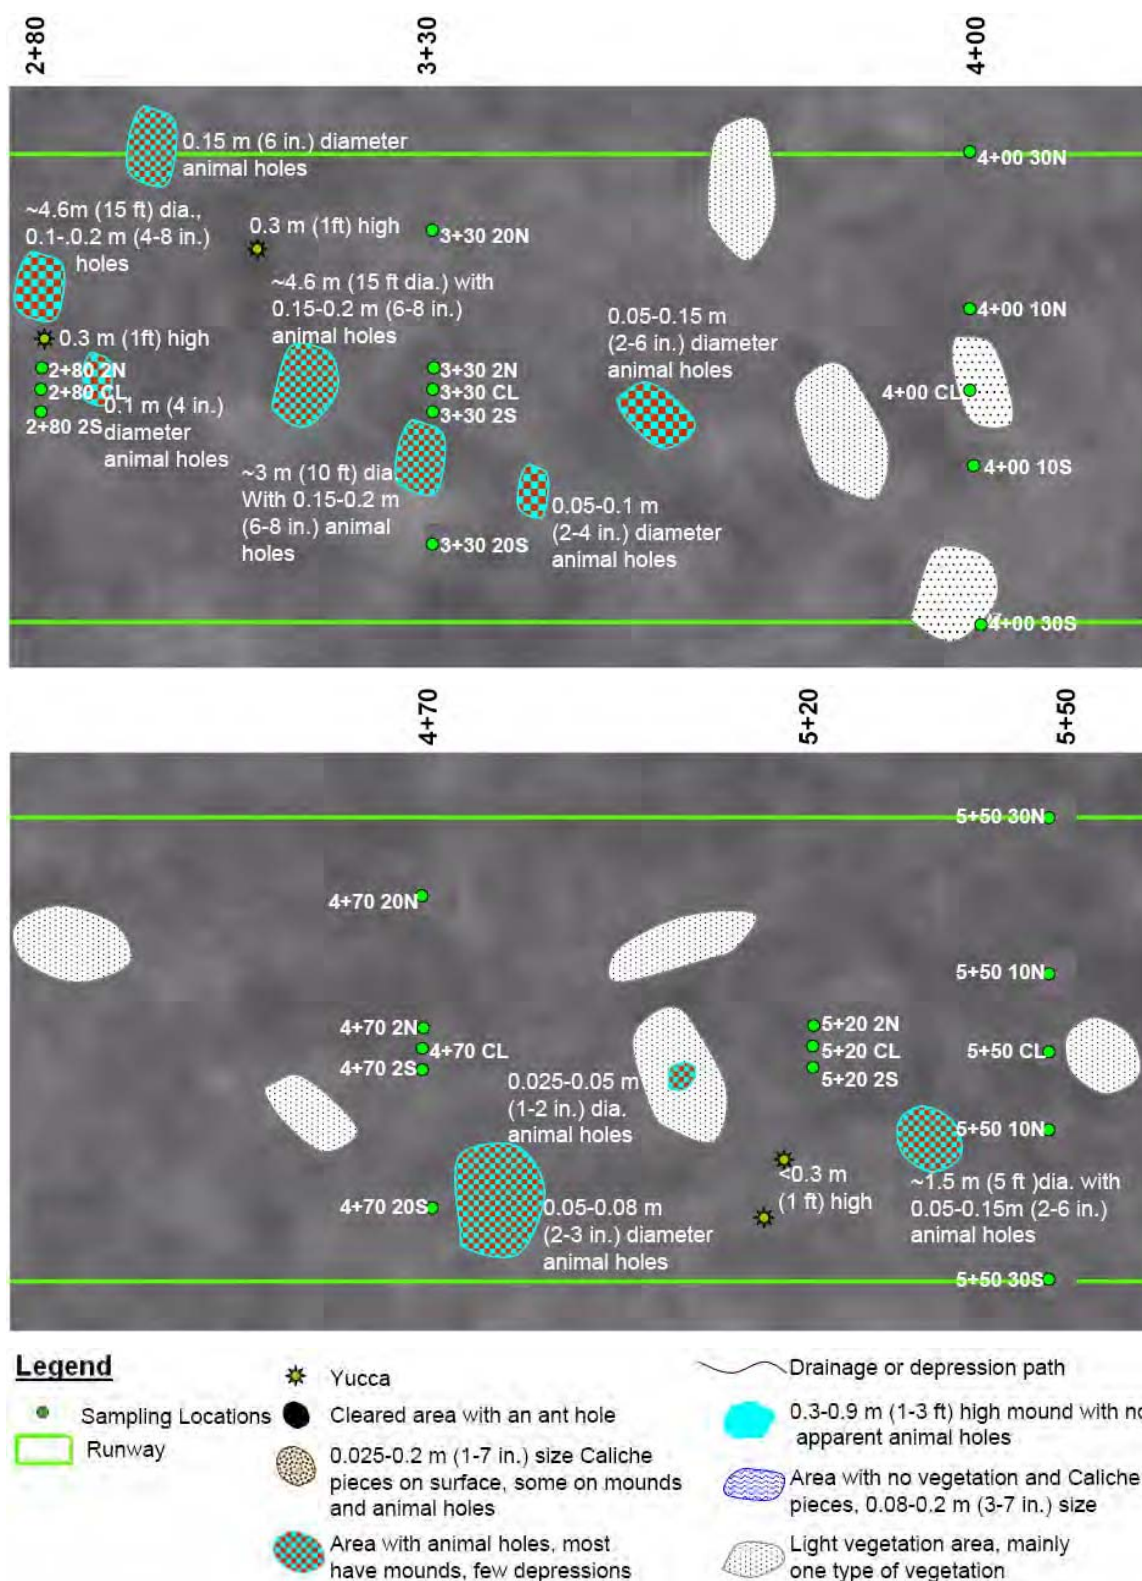
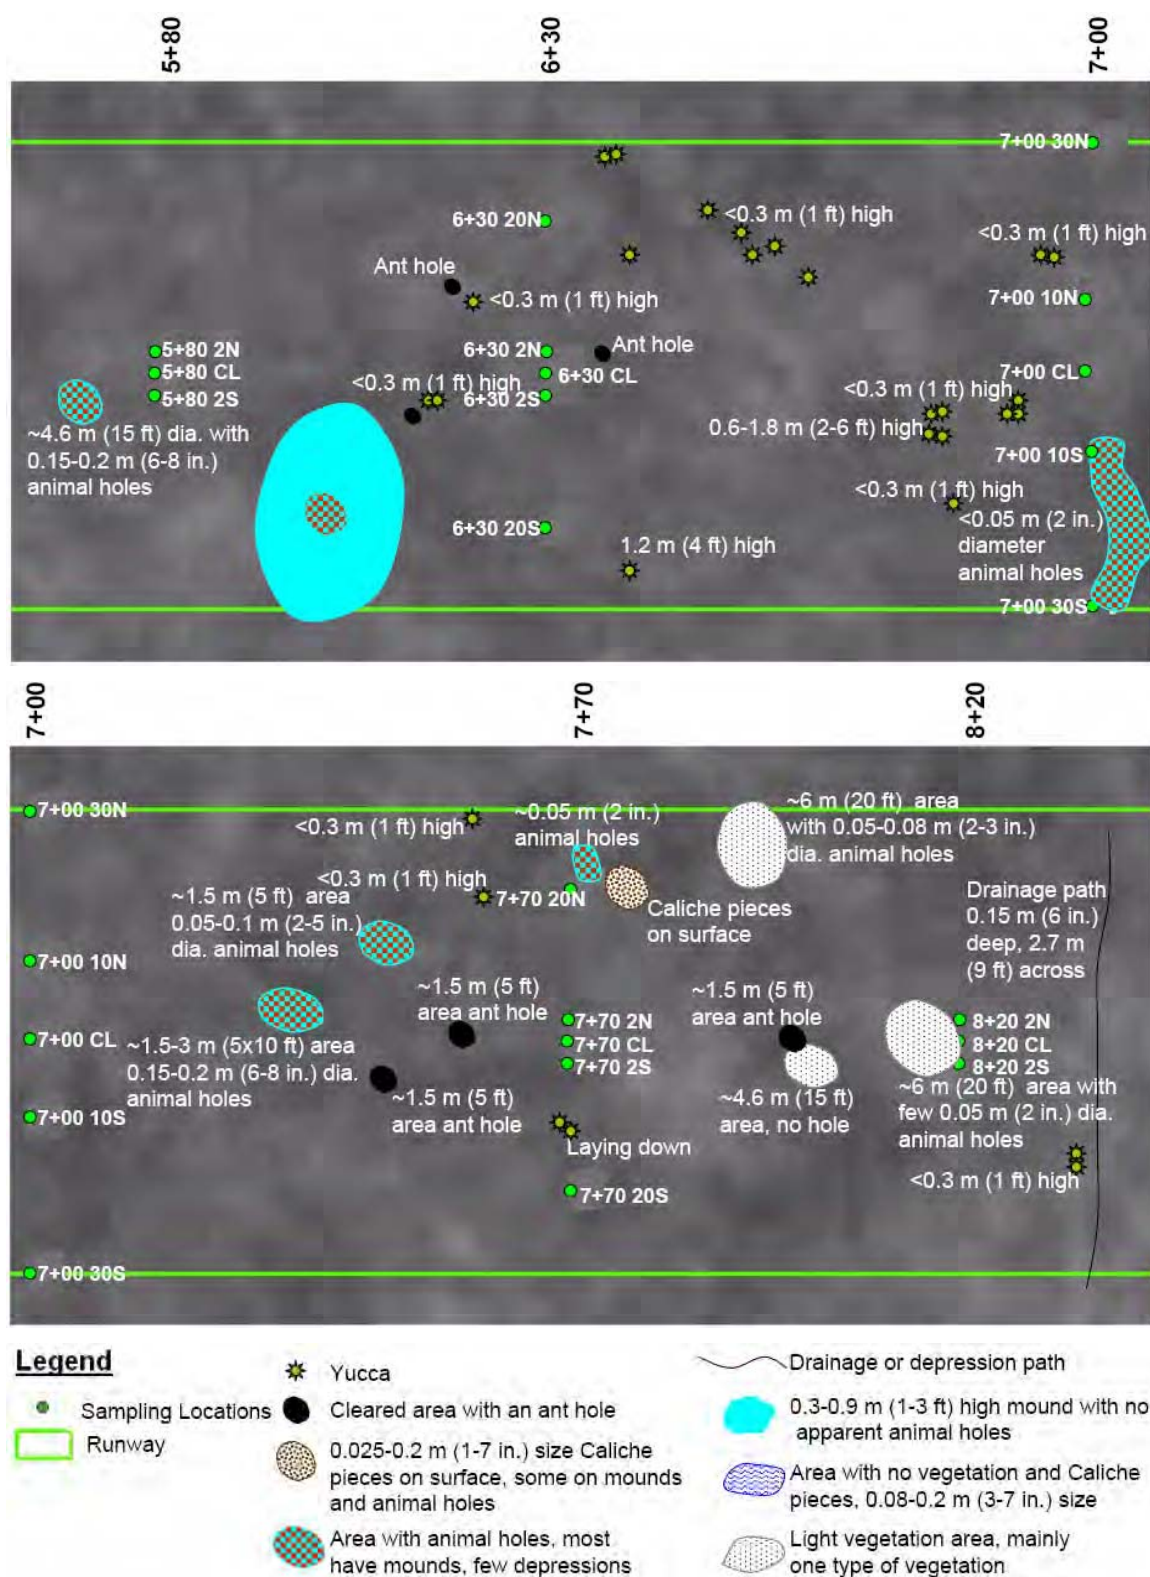
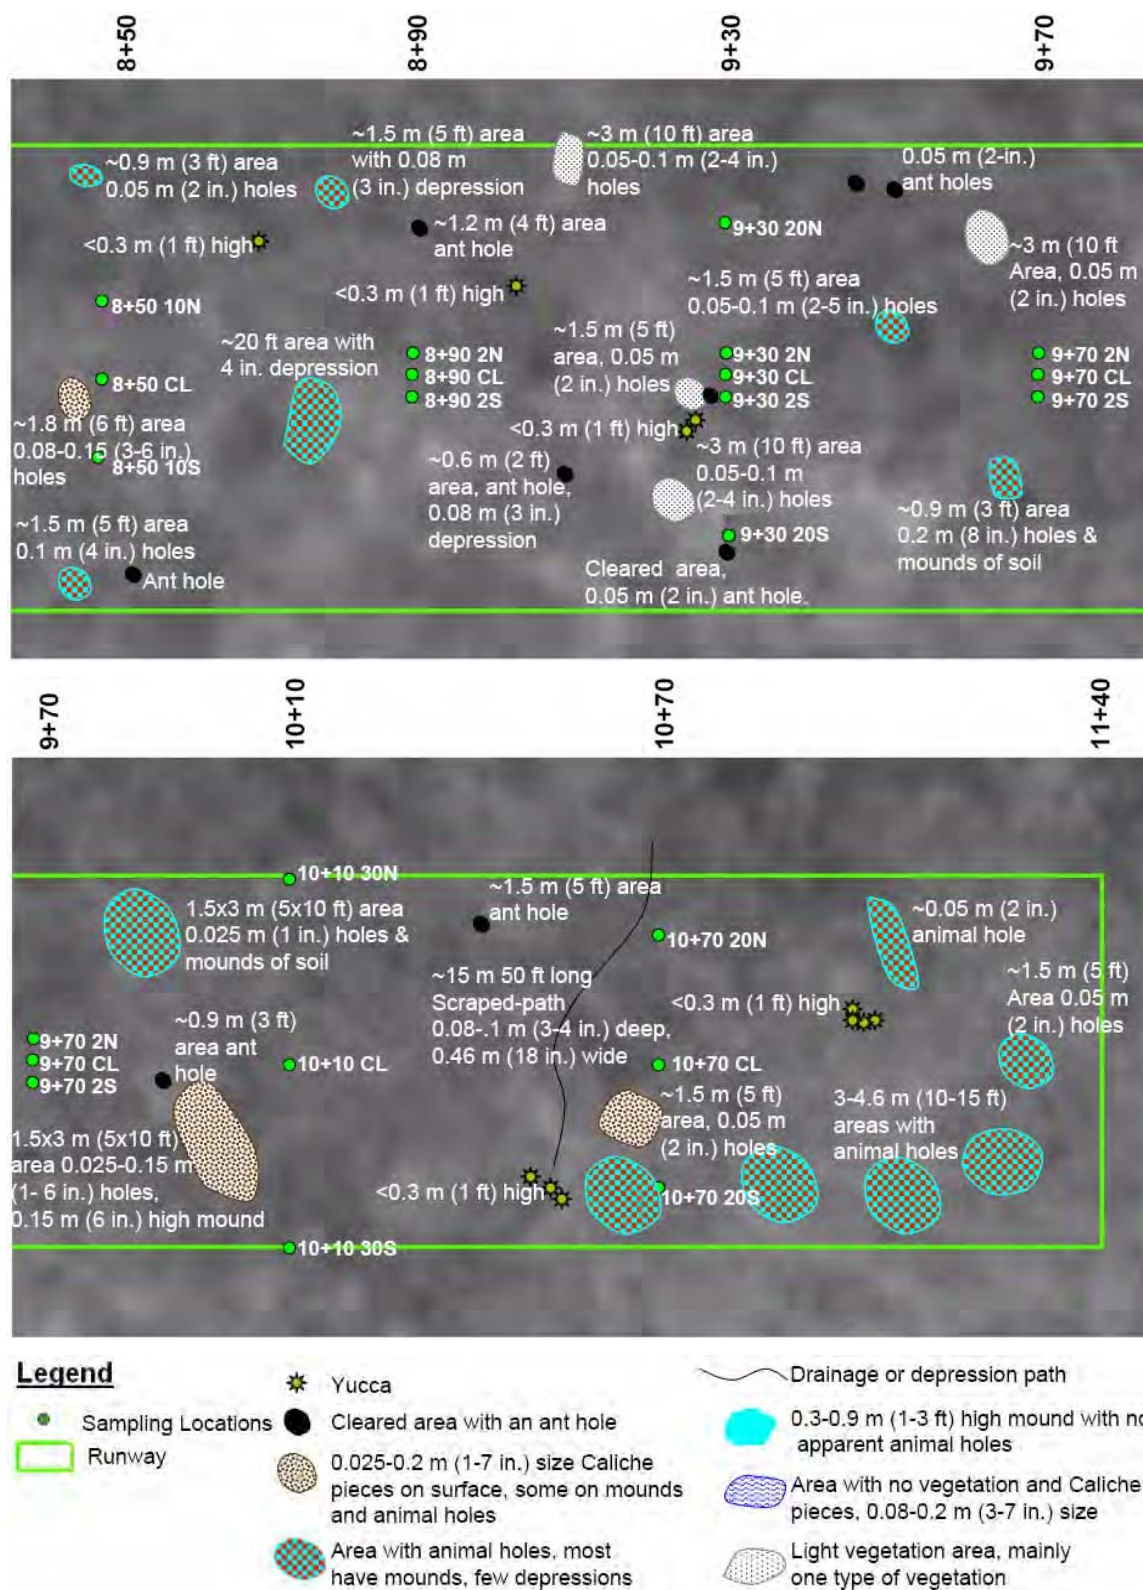
Figure 25. Symbolic representation of surface features from the visual survey along the RAS in sections.

A walk-through visual survey along the RAS was conducted to determine the surface condition of the runway during IOP #1. From the visual survey, the observer noted vegetation type, vegetation cover, tire tracks or ruts, drainage, soil scouring from water or animals, land marks, mounds, animal holes, artillery rounds, and anything else that could present a hazard to aircraft operations. A sketch was generated from the visual survey as shown in Figure 25. The sketch is a symbolic illustration of the surface features and is not drawn to precise scale. No additional visual survey was conducted in the subsequent visits because no significant changes were observed. There were areas of animal holes all over the RAS and in the area near the RAS. The holes ranged in size from 0.025 to 0.2 m (1 to 8 in.) in diameter and some had significant mounds of dirt adjacent to the holes (Fig. 26a). When we stepped on an animal burrow area, our shoes sunk in and created a depression under the footprint. The animal burrows consisted of connected animal holes with series of small tunnels creating soil voids. The depth of these burrows was difficult to survey and was not investigated, but we assumed that most burrows were above the caliche layer and may be into the caliche layer. Large pieces of caliche were often observed on the ground where mounds with animal holes were located (Fig. 26b). Another feature observed on the RAS was small holes in the middle of a cleared area, which seemed to be where ants were nesting (Fig. 26c). A more detailed compilation of photos taken during IOP #1 is shown in Appendix B. Although the thorough survey of the surface features was conducted during the first IOP (IOP #1) as illustrated in Figure 25, features such as the animal burrows and ant holes remained in the same vicinity based on the brief surveys conducted during IOP #2 and IOP #3.

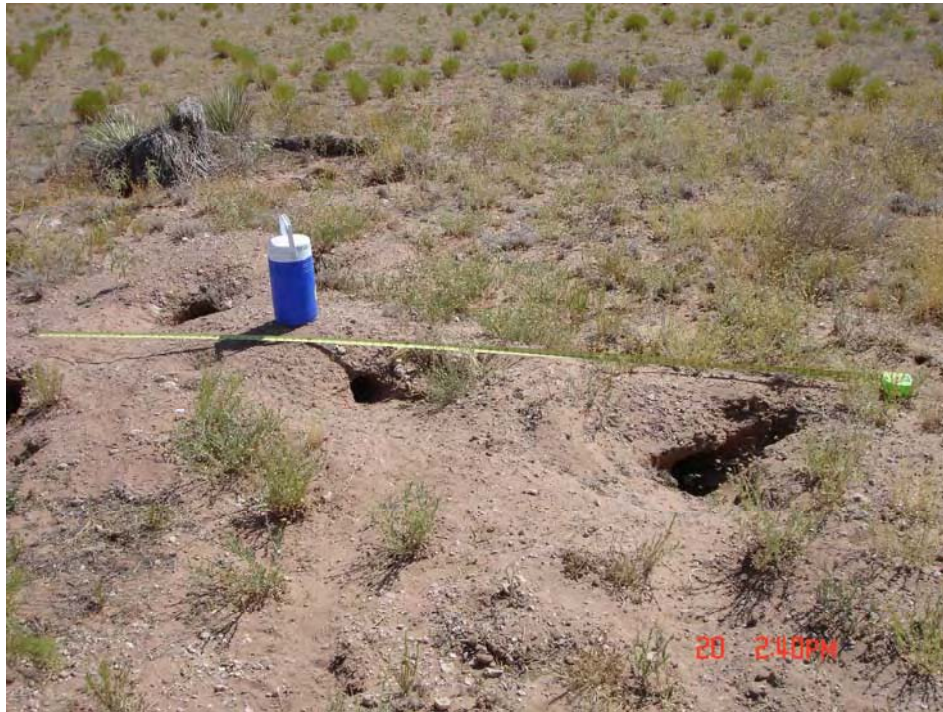
a. Soil mounds with animal holes near Station 2+80. Photo taken during IOP #1.

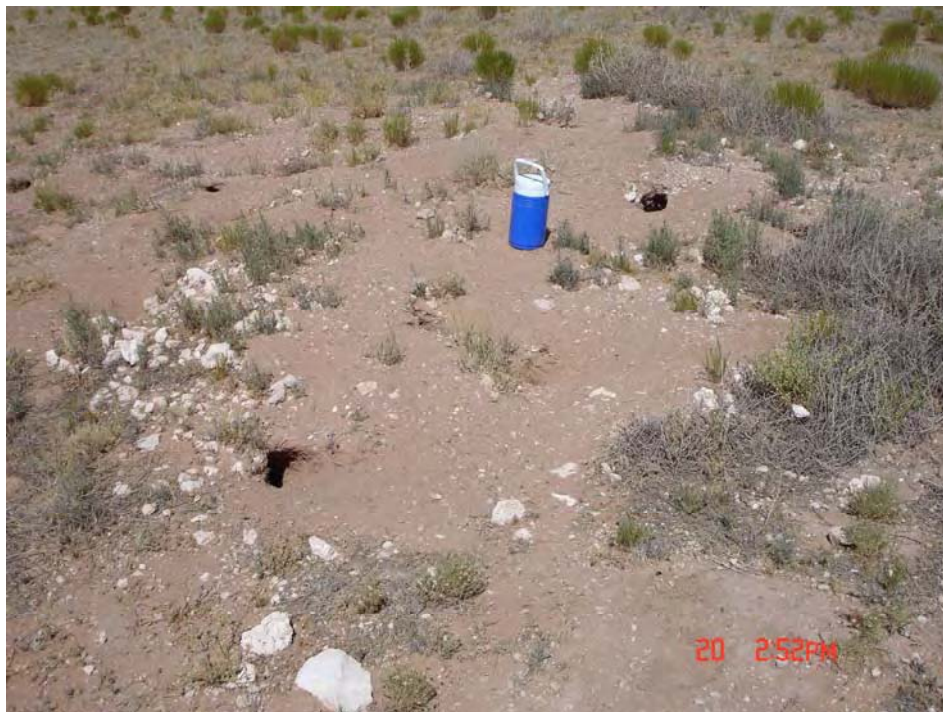
b. Large mound with animal holes and gravelly (caliche pieces) materials on the surface near Station 3+30. Photo taken during IOP #1.

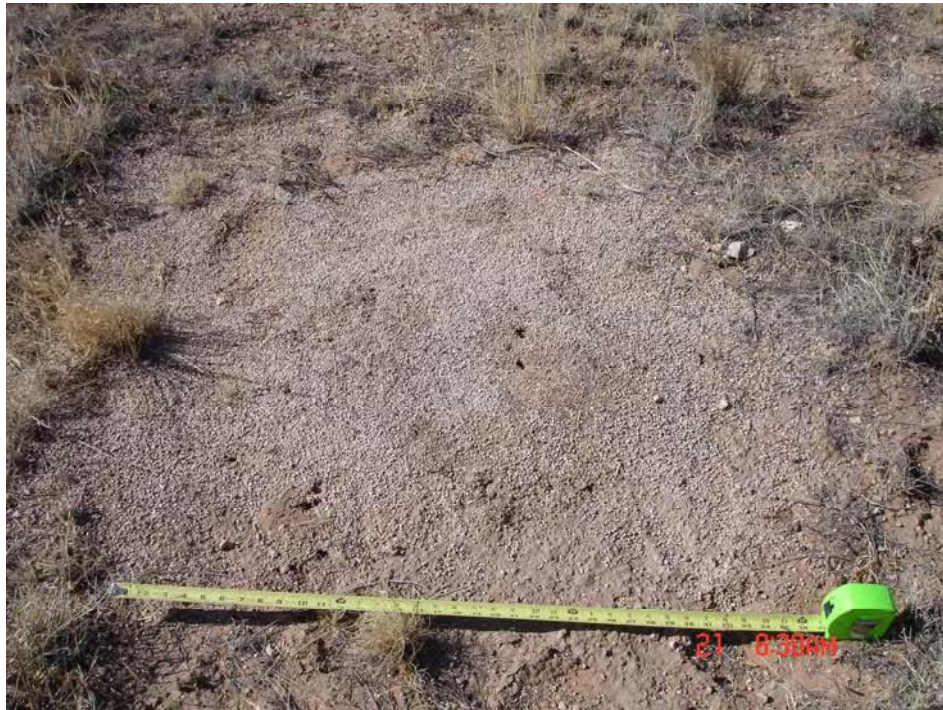
c. Example of a clear area with small holes and small caliche particles on the surface. Photo taken near station 8+20 during IOP #3.

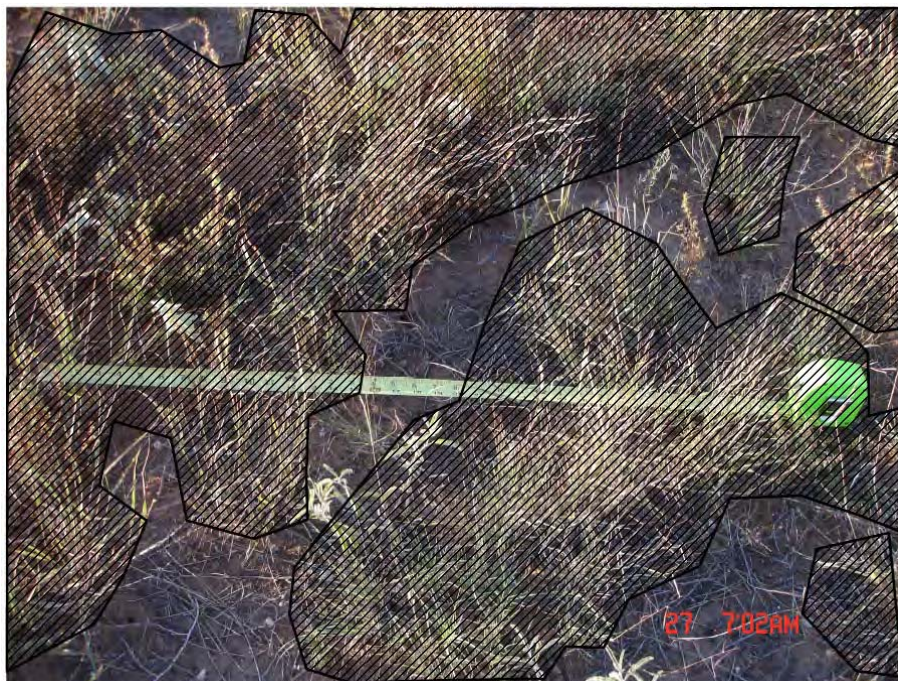
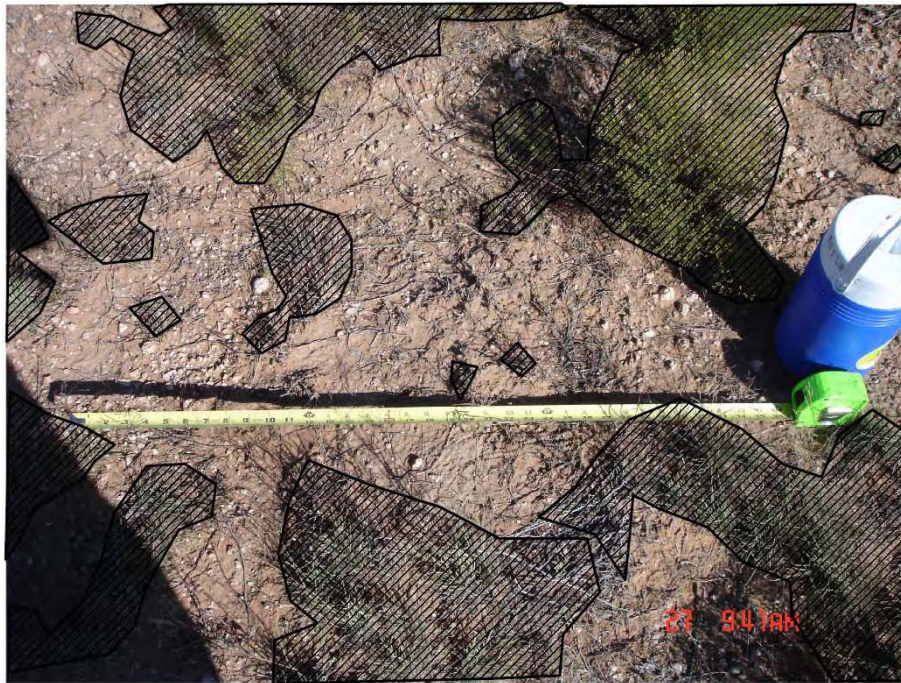
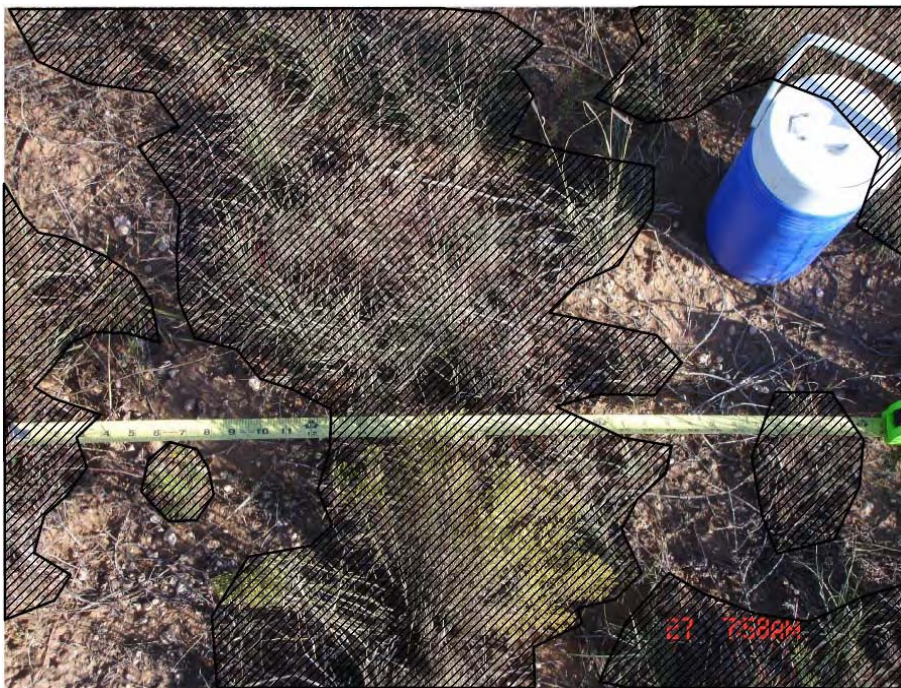
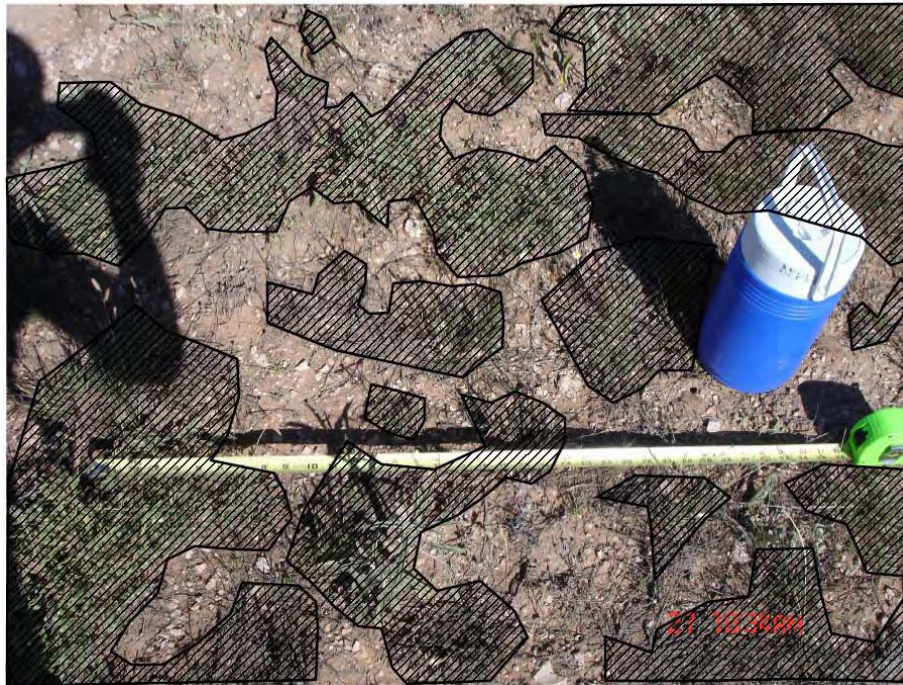
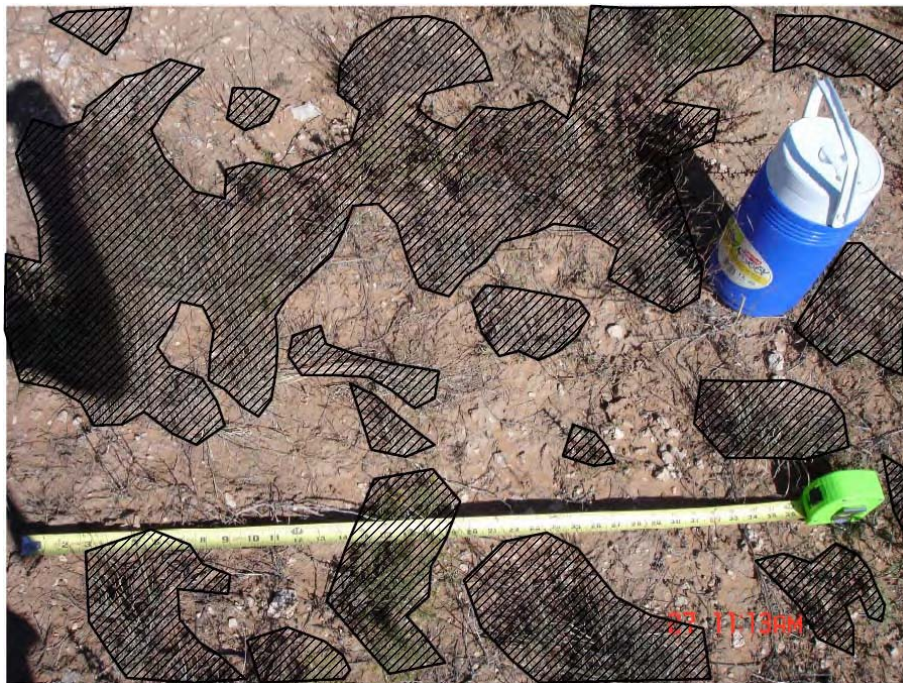
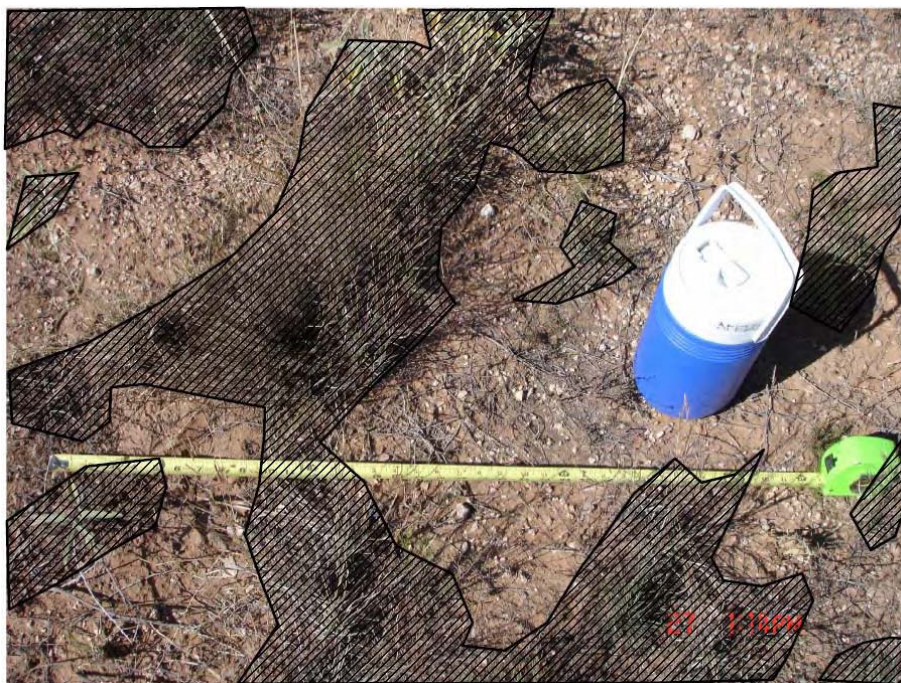
Figure 28. Vegetation cover calculated from the photos taken at six locations. Hatched polygons are digitized areas of plant cover along the RAS.

Figure 28 (cont'd). Vegetation cover calculated from the photos taken at six locations. Hatched polygons are digitized areas of plant cover along the RAS.

The variation in vegetation cover at this RAS may change from season to season, and also is dependent on disturbances generated from cattle grazing in the area. Analysis to determine the vegetation cover was conducted on photos taken during October IOP (IOP #2). A summary of the vegetation coverage is listed in Table 11. These photos were selected by dividing the RAS into six areas and a photo to represent each sectional area was randomly picked for the analysis. The vegetation cover varied throughout the RAS, as shown in Figure 28. Localized dense and sparse vegetation covers were observed on the entire RAS. Even in areas with dense vegetation cover, the ground surface was still visible between plants.
