*Opportune Landing Site Program*

## **Suitability Measurement and Analysis for Fort Bliss Naval Air Facility OLS**

Rosa T. Affleck, Charles C. Ryerson,  
Lynette A. Barna, and Keran J. Claffey

September 2008

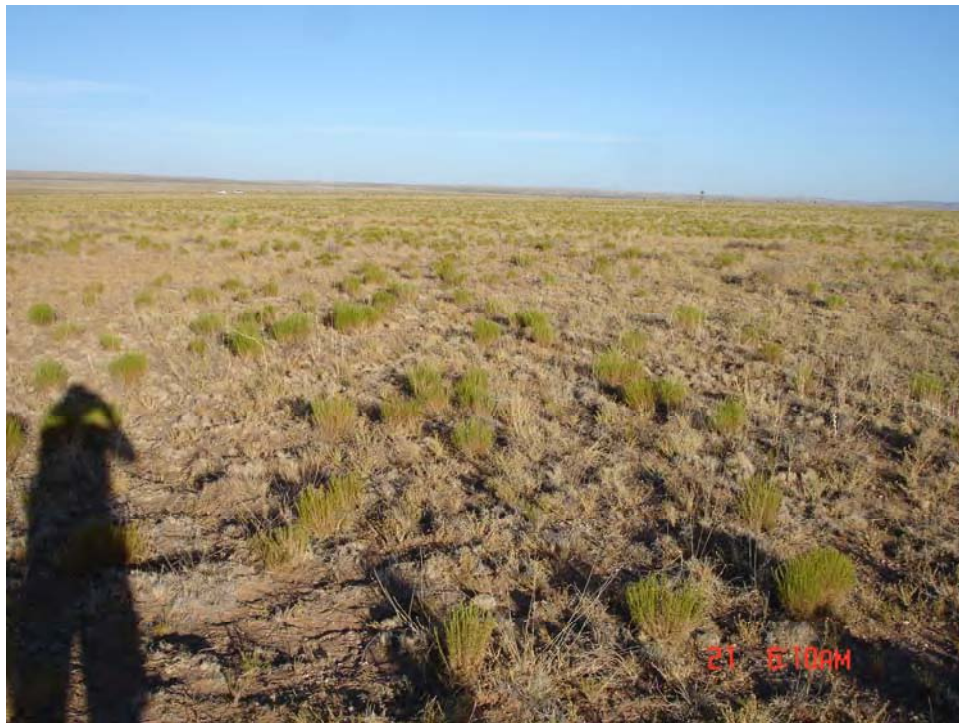
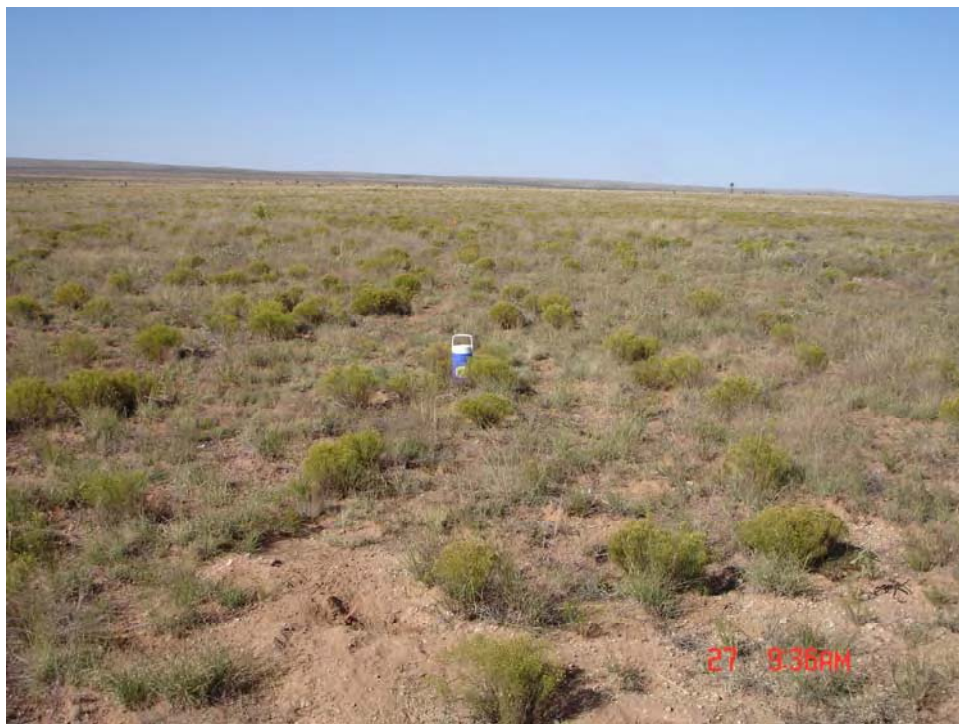
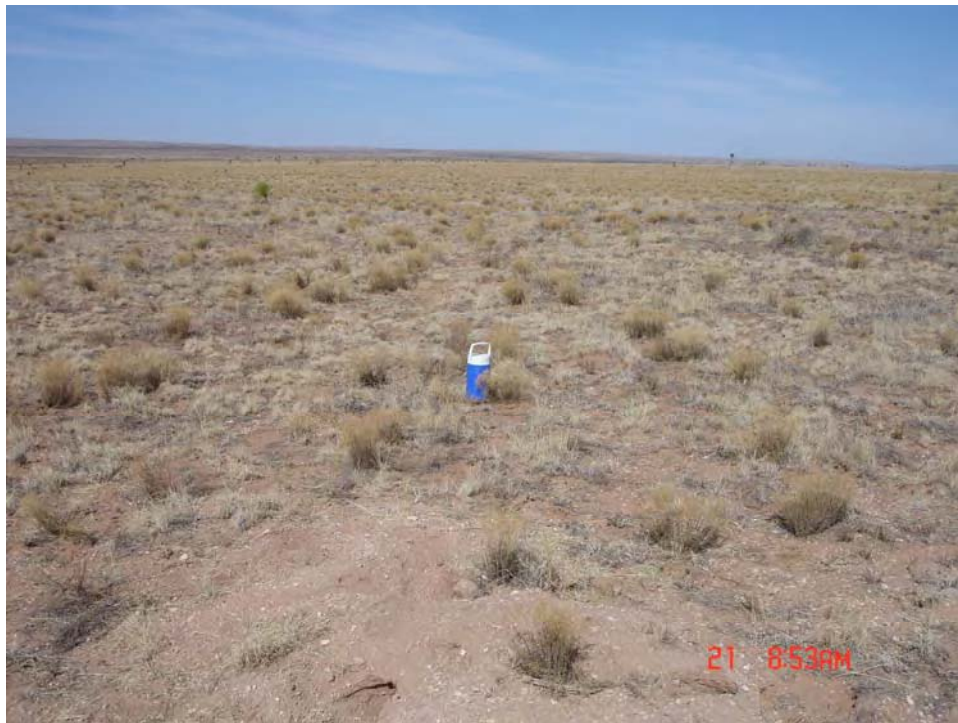
a. July 2005 at station 5+50 CL looking west.

b. October 2005, at station 5+80 CL looking west.

Figure 29. Variation in vegetation greenness during three IOPs at Fort Bliss OLS.

c. April 2006, at station 5+50 CL looking west.

Figure 29 (cont'd). Variation in vegetation greenness during three IOPs at Fort Bliss OLS.

Seasonal changes in vegetation in terms of greenness and health of the various plants were observed during the summer, fall, and spring IOPs (Fig. 29). Some plant types (i.e., *Gutierrezia sarathiodes*) remained green while others turned brown (Fig. 29a) during the summer IOP (in July). The vegetation is greener in October (IOP #2, Fig. 29b) than in July. During the third IOP (in April 2006), nearly all the vegetation was brown (Fig. 29c). This vegetation cycle is relatively typical in semi-arid environments, being tied more to moisture availability than to seasonal temperature changes.

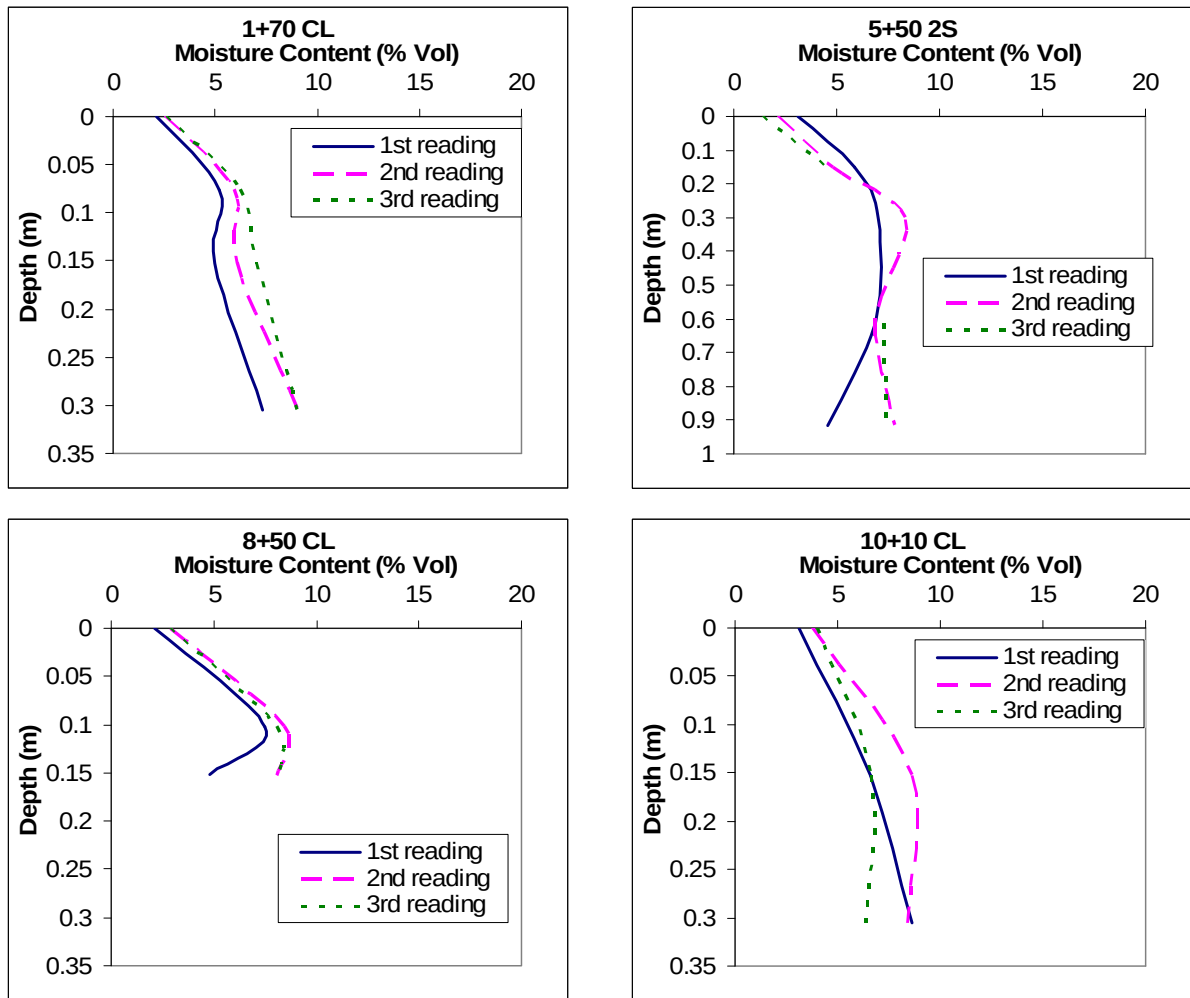
Figure 30. Moisture profiles taken from Dynamax ML2 probes during IOP #1.

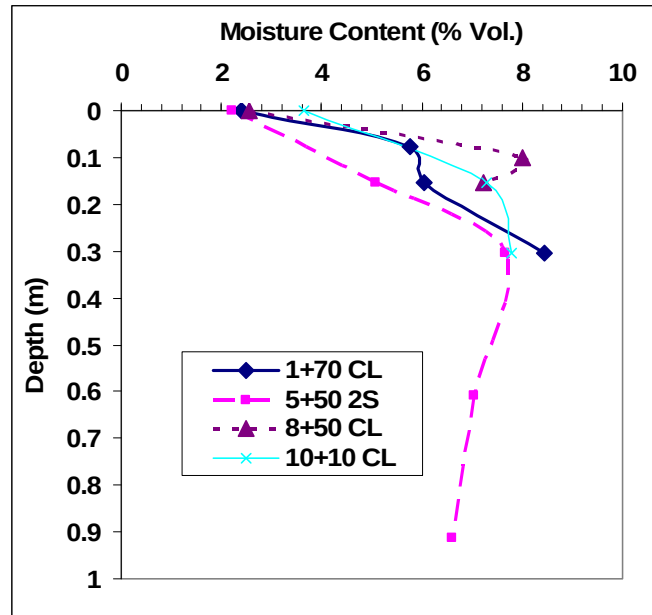
Figure 31. Average soil moisture profiles from the Dynamax ML2 probes taken during IOP #1 (July 2005)

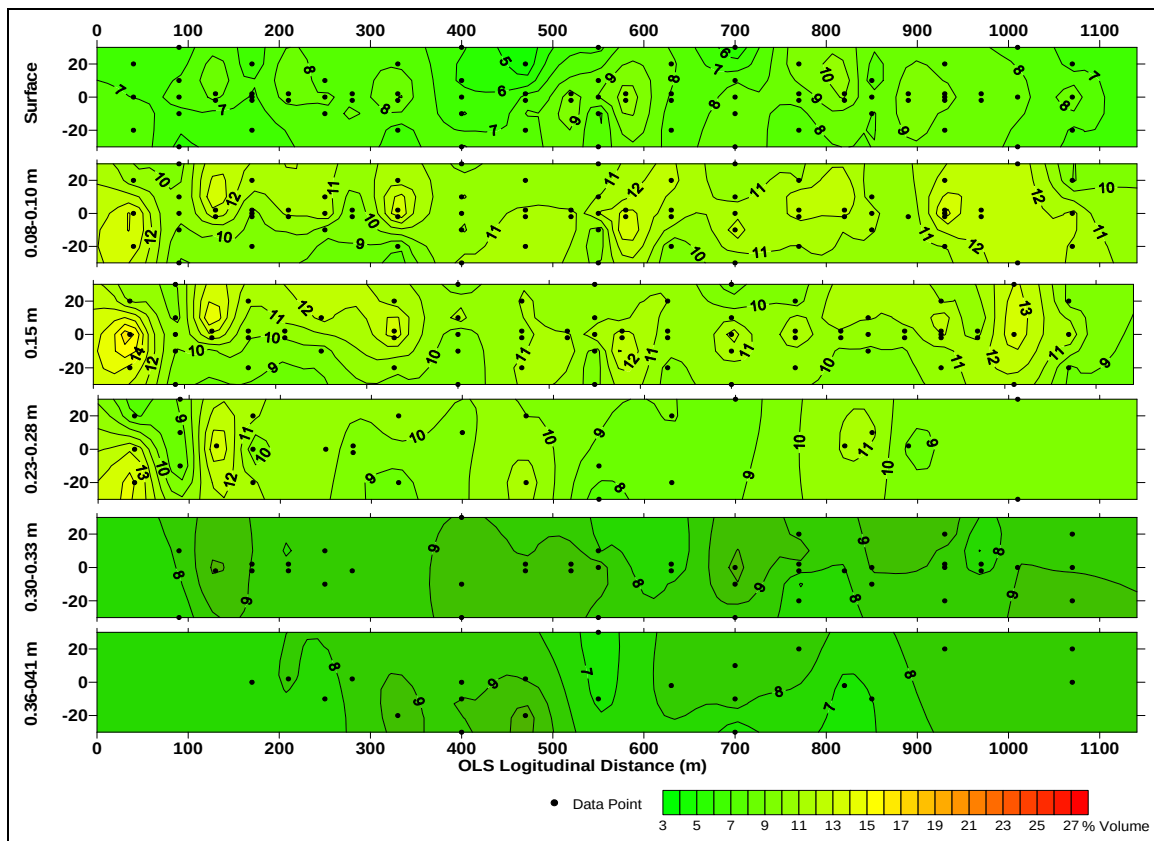
Figure 32. Profiles of soil moisture contents in % volumetric from the Dynamax ML2 taken in October 2005, as shown in contours. The dots are the sampling locations where soil moisture measurements were taken with depth in the soil.

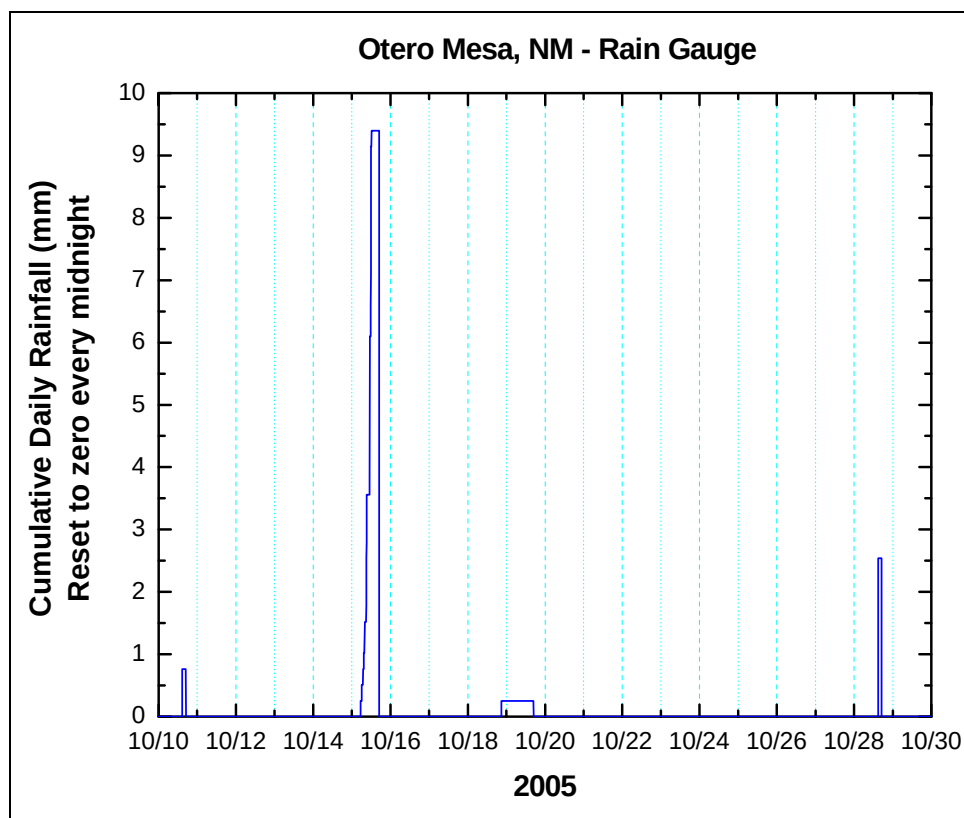
Figure 33. Precipitation observed from the weather station installed near the RAS.

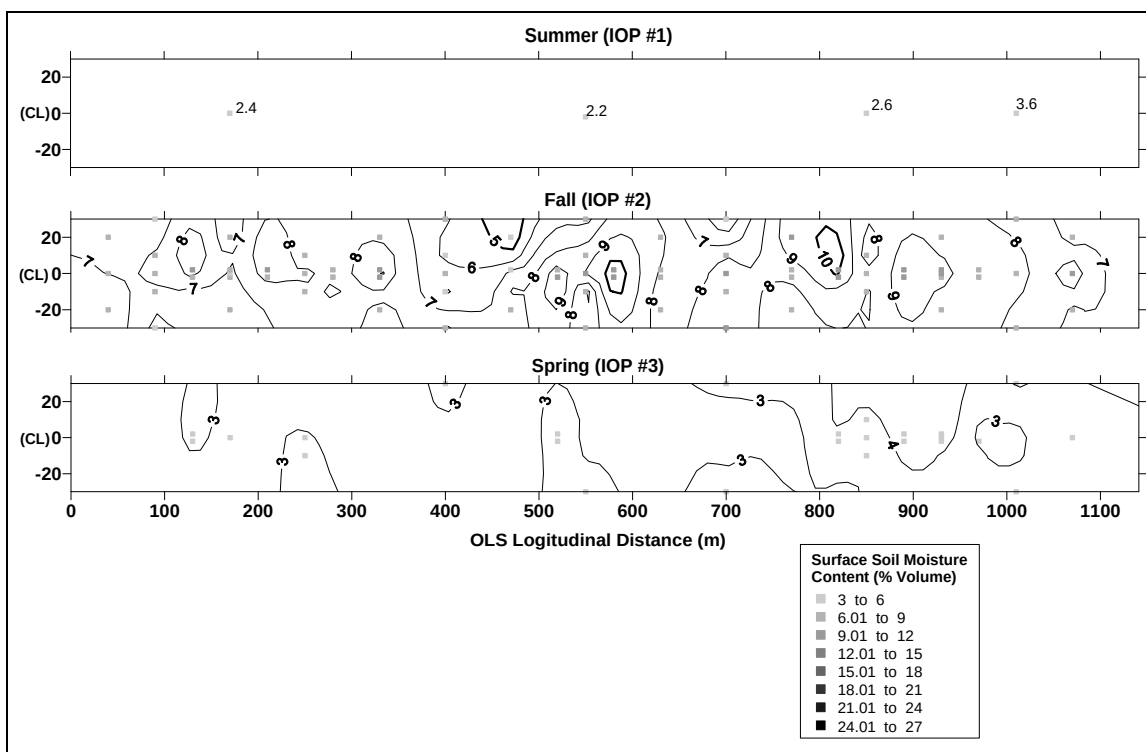
Figure 34. Surface soil moisture (in % volume) for three field visits at Fort Bliss RAS.

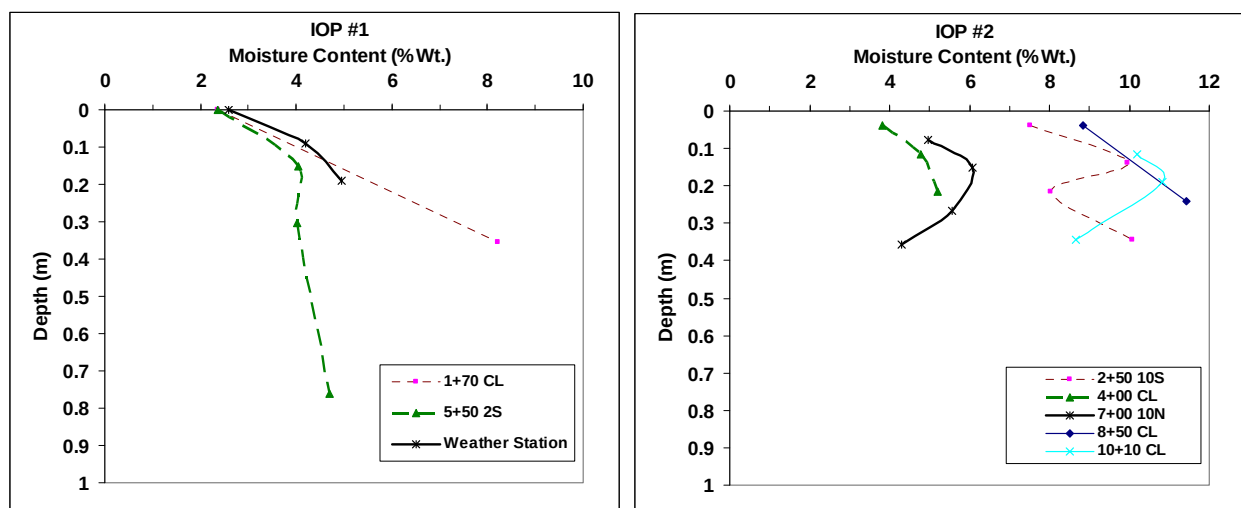
Figure 35. Soil moisture profiles using the gravimetric method from samples taken in July 2005 (IOP #1) and in October (IOP #2).

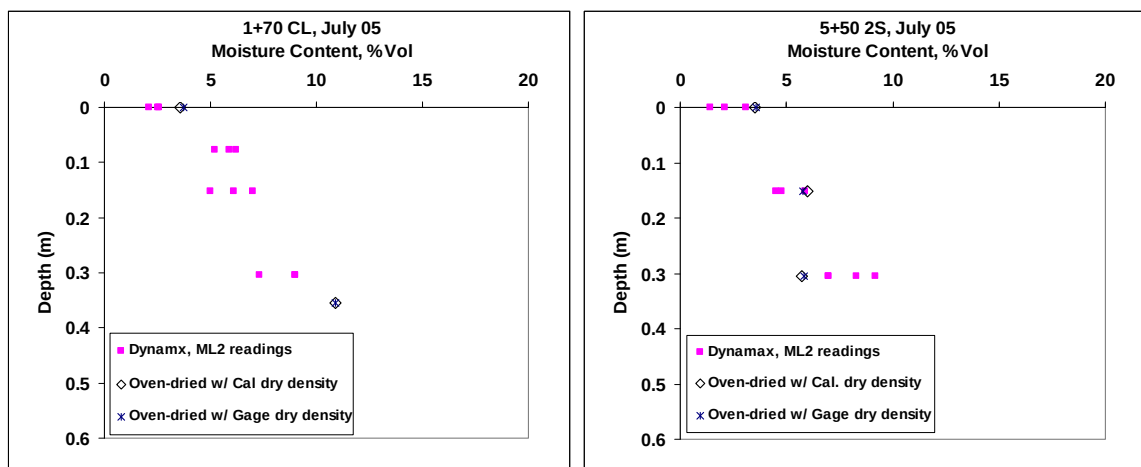
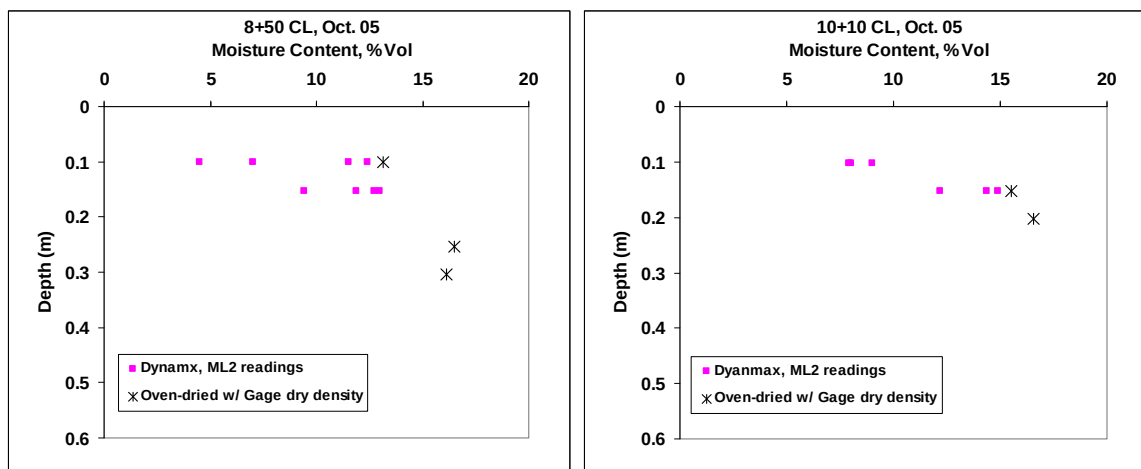
a. IOP #1.

b. IOP #2.

Figure 36. Gravimetric moisture contents converted to percent volume along with soil moisture profiles measured using the Dynamax ML2.

Soil moisture contents measured between the Dynamax ML2 and the gravimetric soil samples are found to be within 2 to 3 % water content of one another for IOP #1 (Fig. 36a). More scatter was observed in soil moisture measurements taken during IOP #2, as can be seen in Figure 36b.

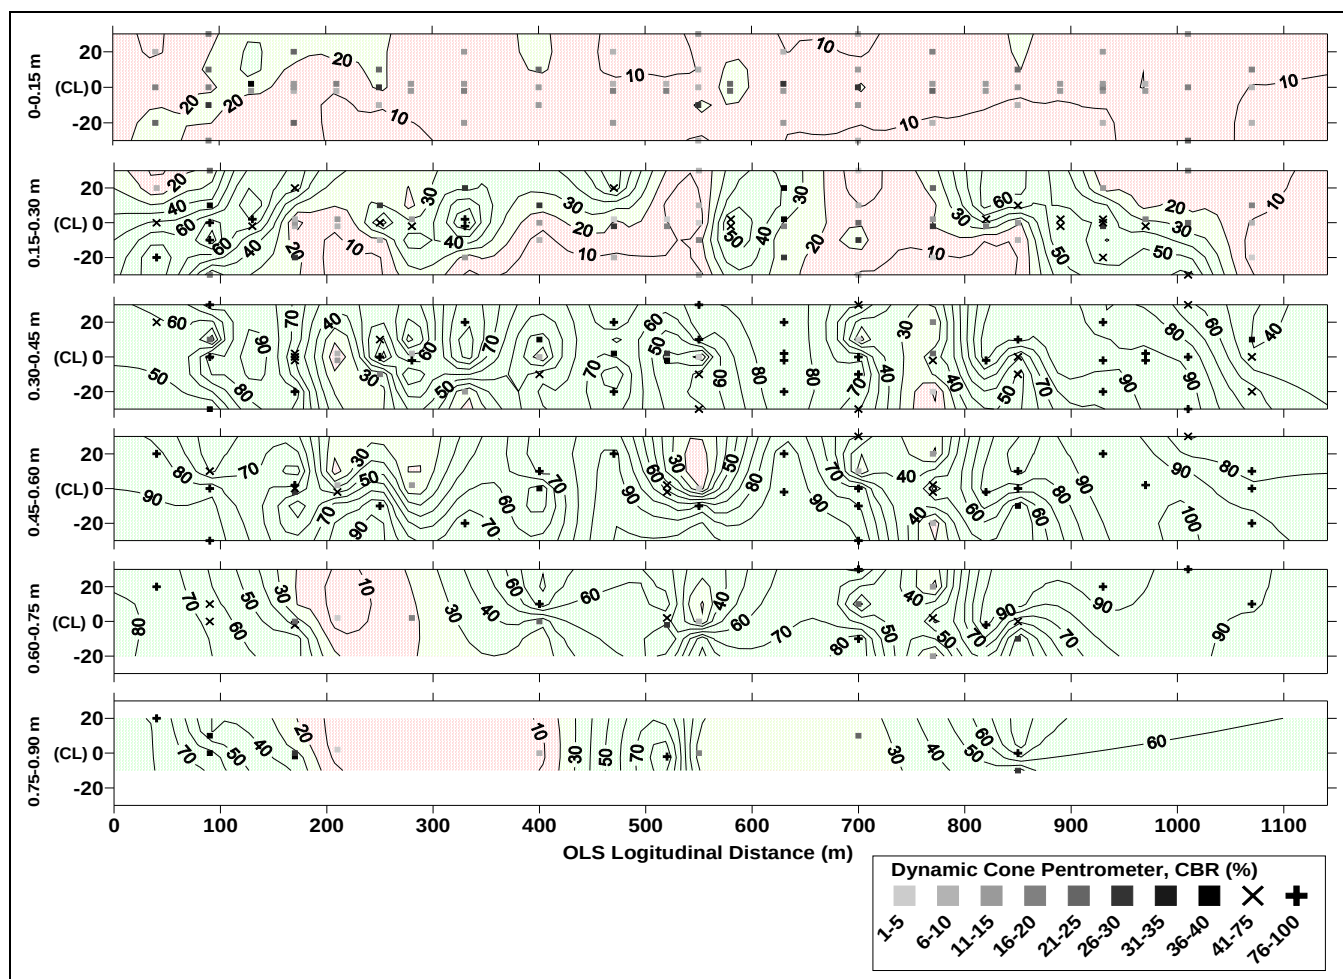
a. CBR contours for each depth range (July 2005).

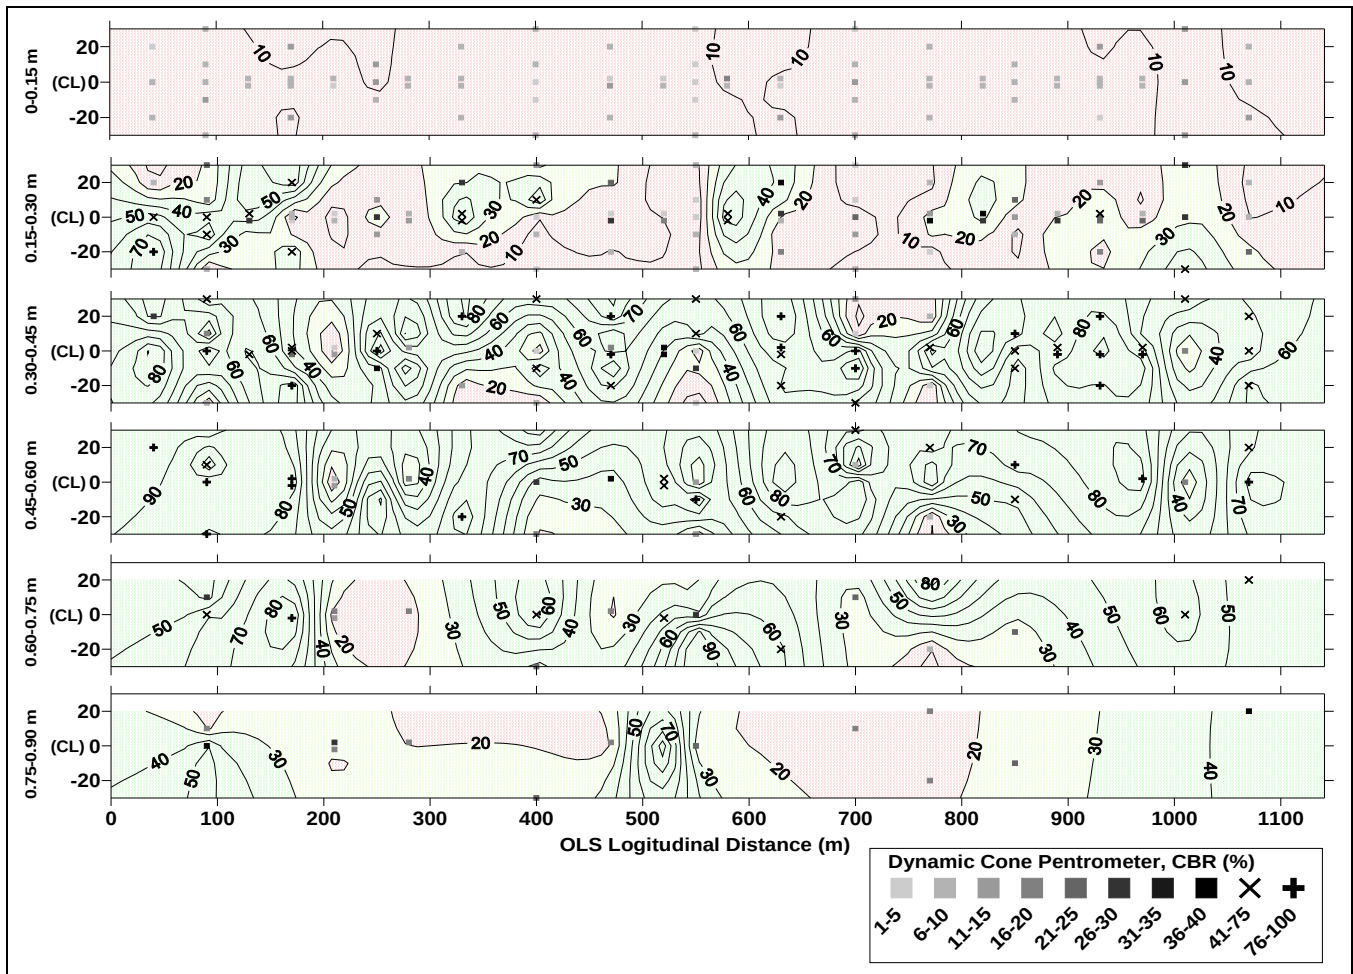
b. CBR contours for each depth range (October 2005).

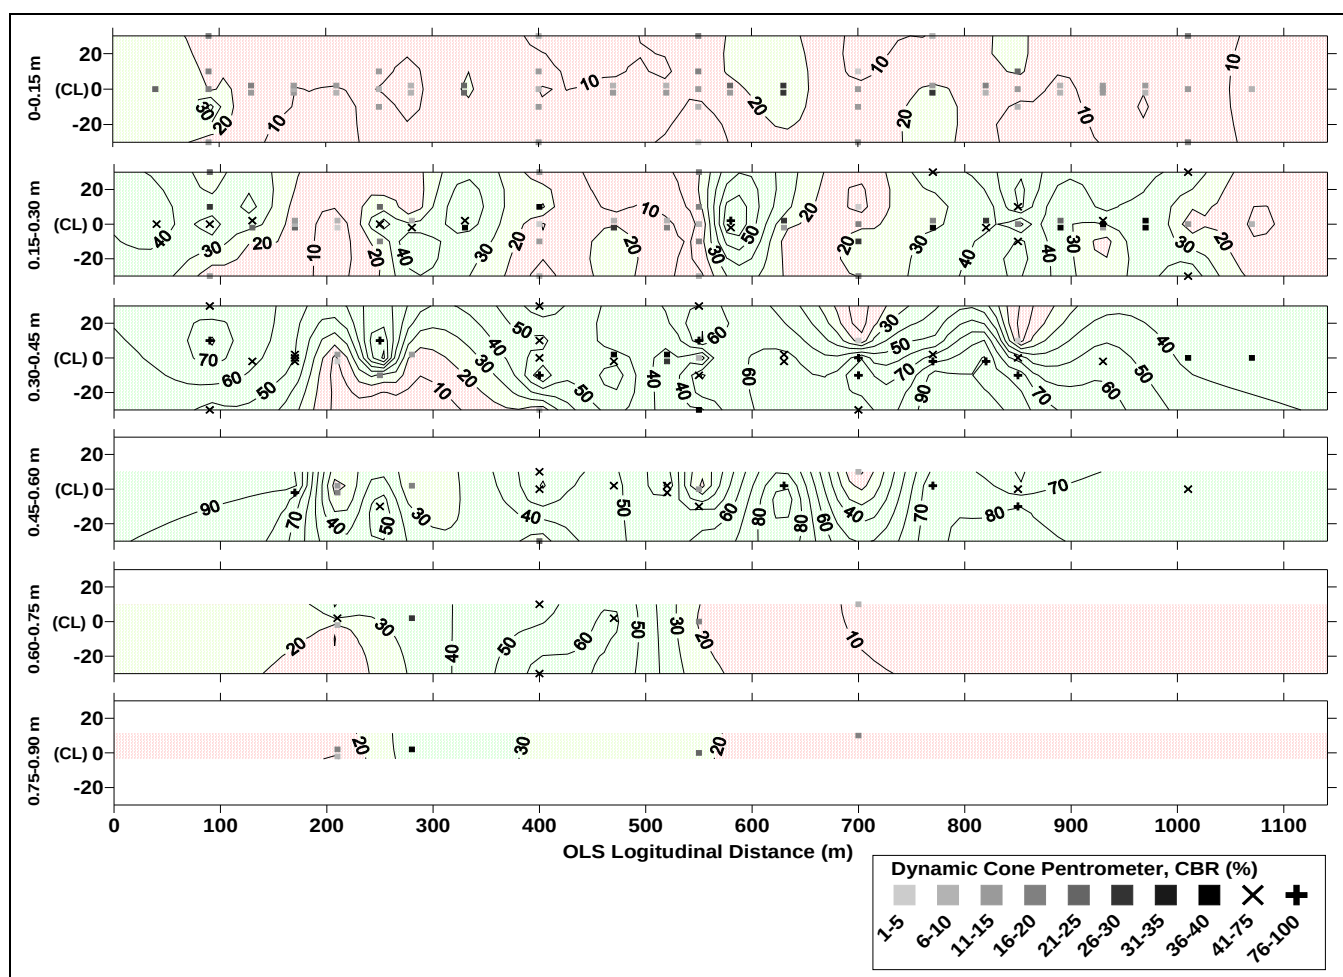
c. CBR contours for each depth range (April 2006).

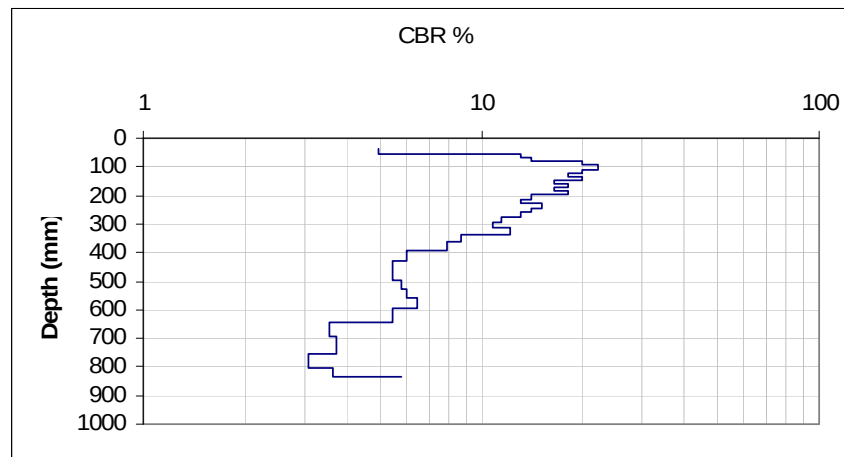
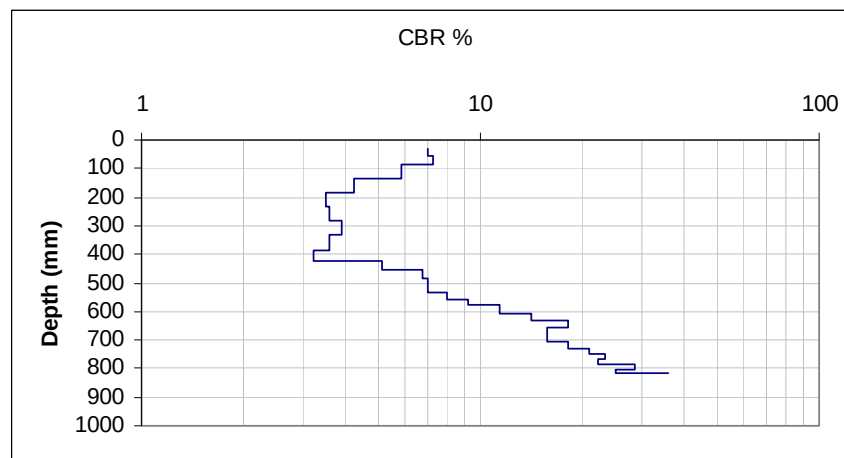
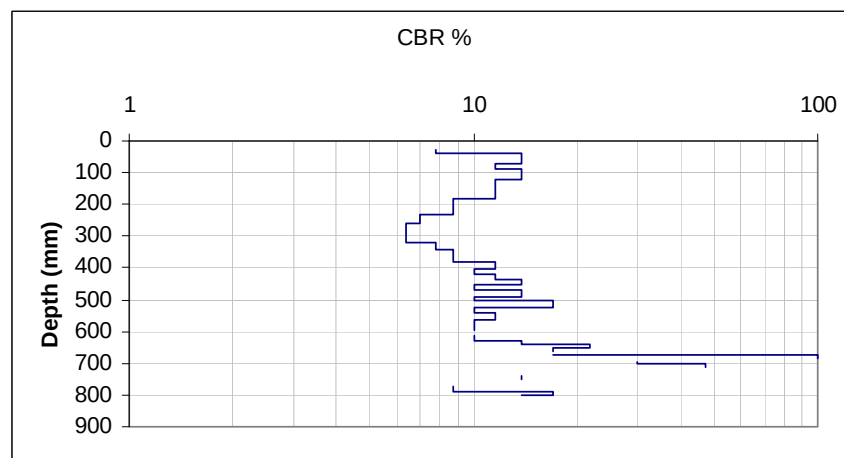
Figure 38. CBR profiles at sampling location 2+10 2N taken during the three IOPs at Fort Bliss.

CBR profiles from all the DCP data for all IOPs are compiled in Appendix D. The profiles for each sampling location can be compared for seasonal changes mainly for the soil above the caliche layer. Typical DCP profiles taken at sampling locations 2+10 2N and 8+50 CL are shown in Figure 38 and 39, respectively. At sampling locations 2+10 2N, the caliche layer is discontinuous and shows weak soil strength below the surface. At 8+50 CL, the caliche layer can be detected easily from all the DCP profiles and shows weak soil strength at the surface. The soil above the caliche layer has relative low strength. Because of the non-homogeneous condition of the soil, variation of CBR values can be observed on the DCP profiles representing the soil strength on the RAS.

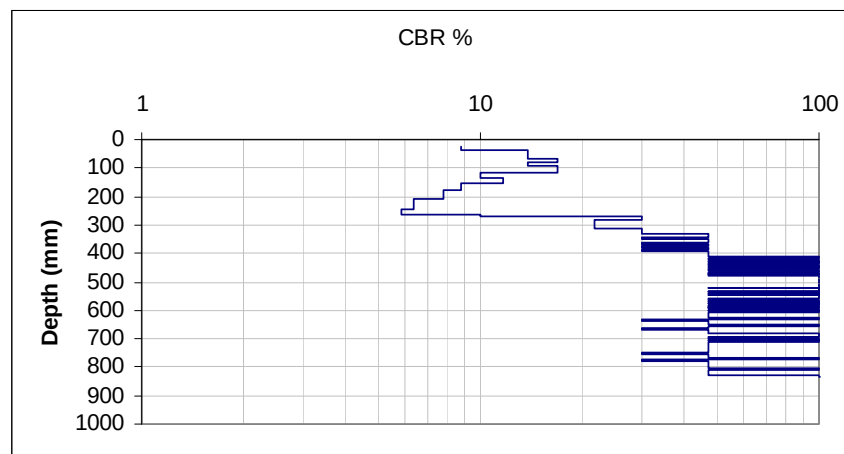
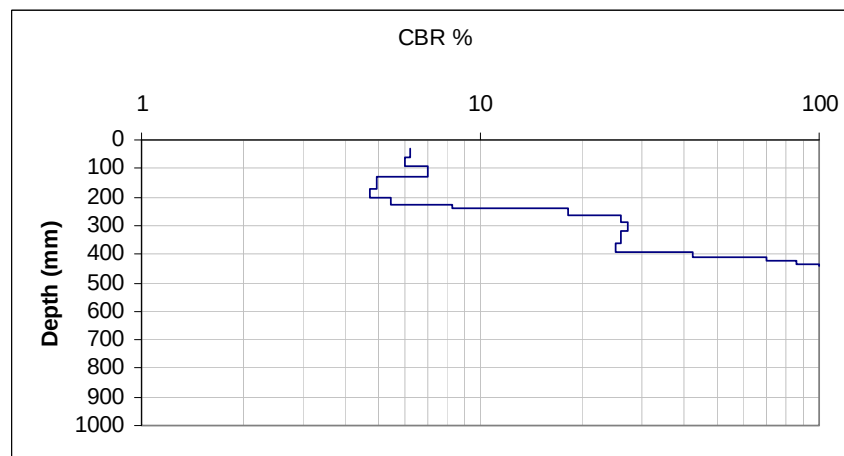
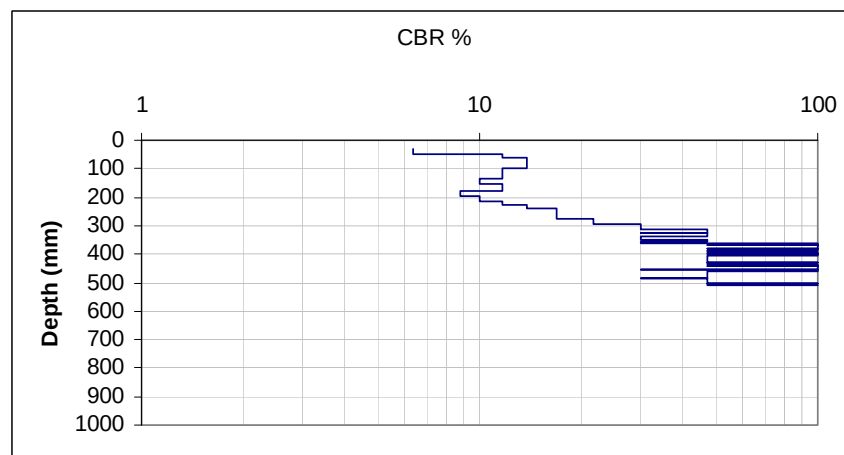
Figure 39. CBR profiles at sampling location 8+50 CL taken during the three IOPs at Fort Bliss with higher soil strength at 300-mm depth.

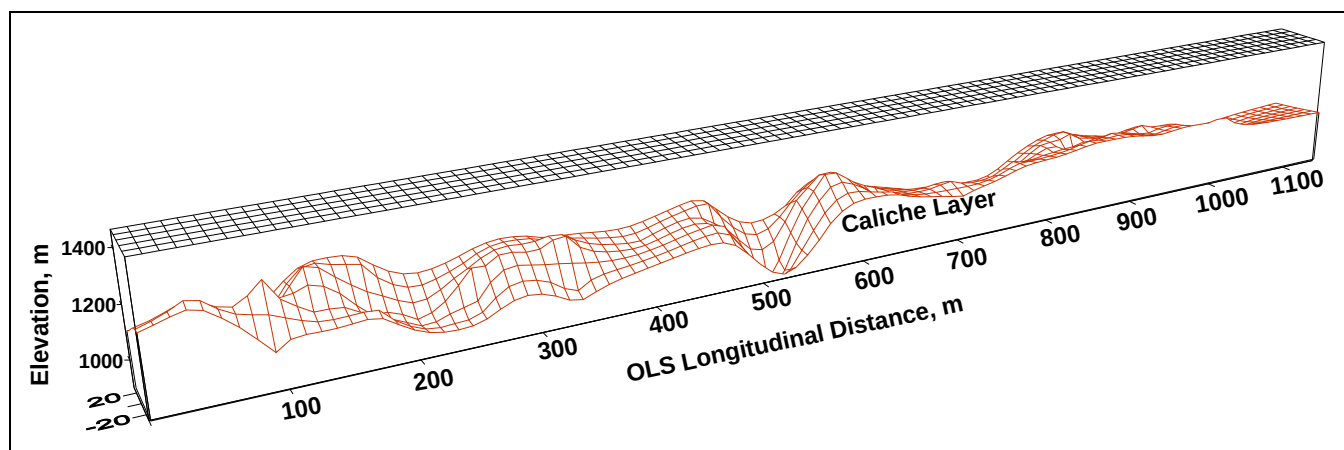
Figure 40. Profile of the topmost part of the caliche layer detected from the DCP data.

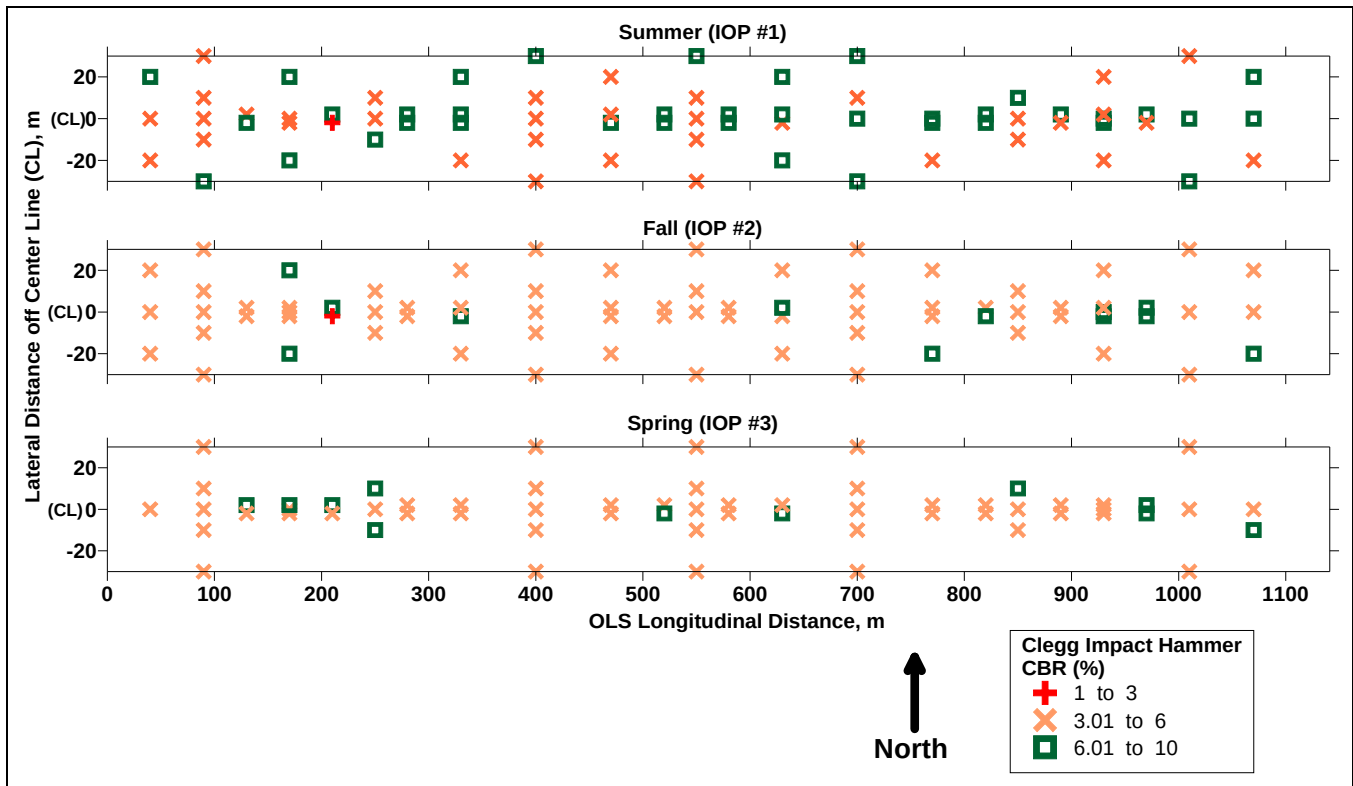
Figure 41. Soil strength for top 0.3 m (6 in.) measured from the light Clegg impact hammer expressed in CBR (%) for the Fort Bliss RAS.

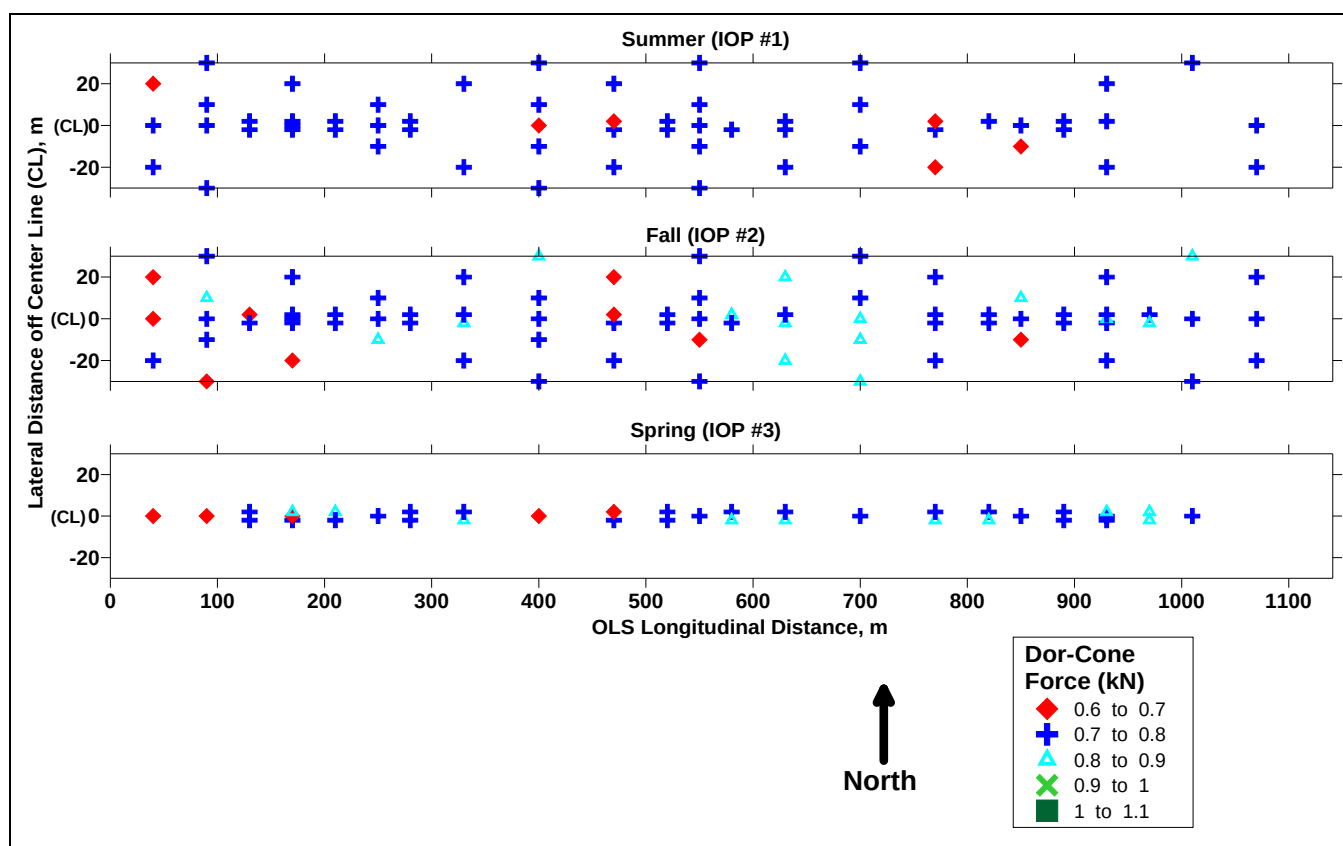
Figure 42. Calculated force indicating the surface soil strength throughout the RAS during the three IOPs.

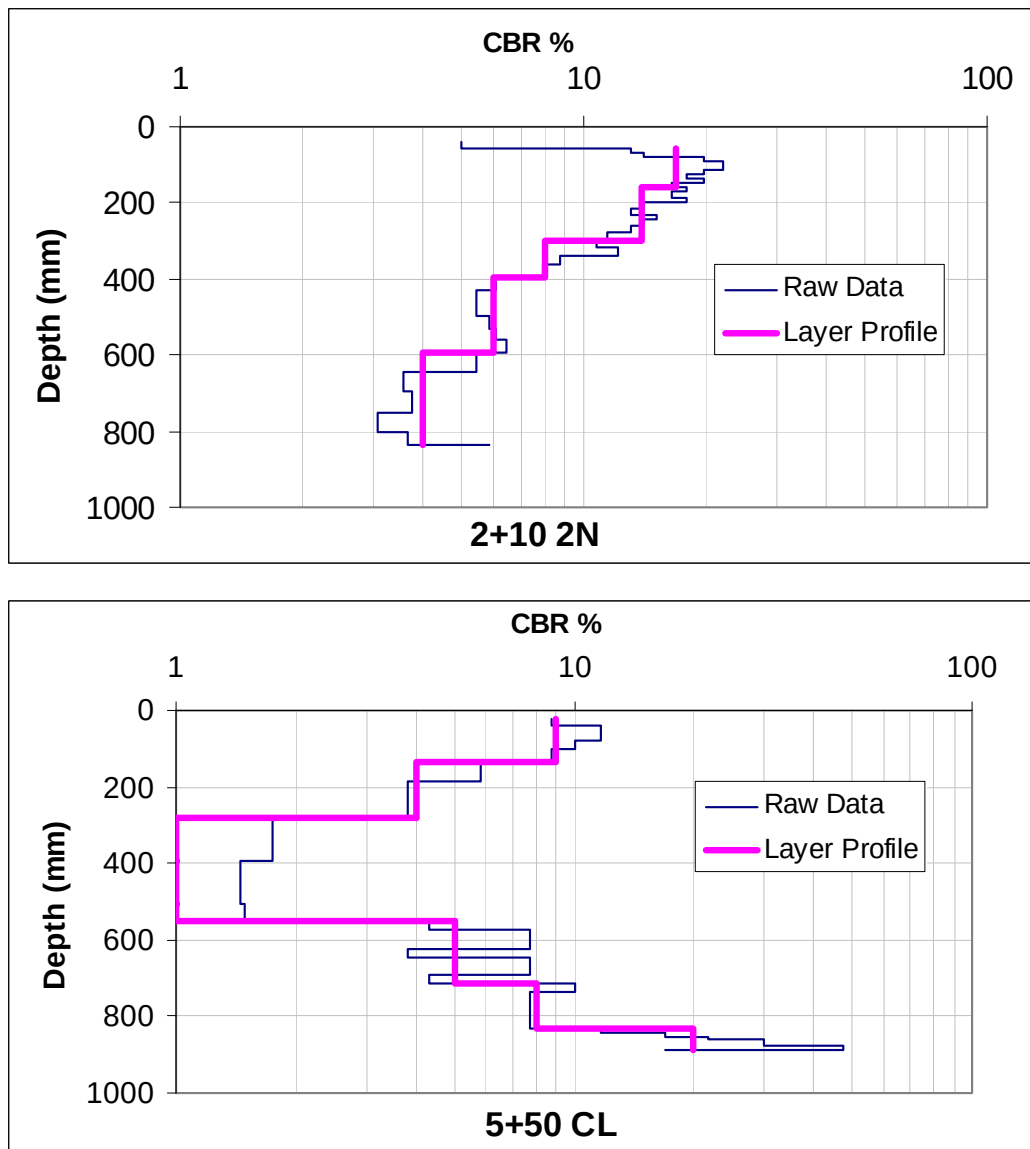
Figure 43. Selected CBR profiles showing layers with weak soil strength taken during IOP #1 at the Fort Bliss RAS.

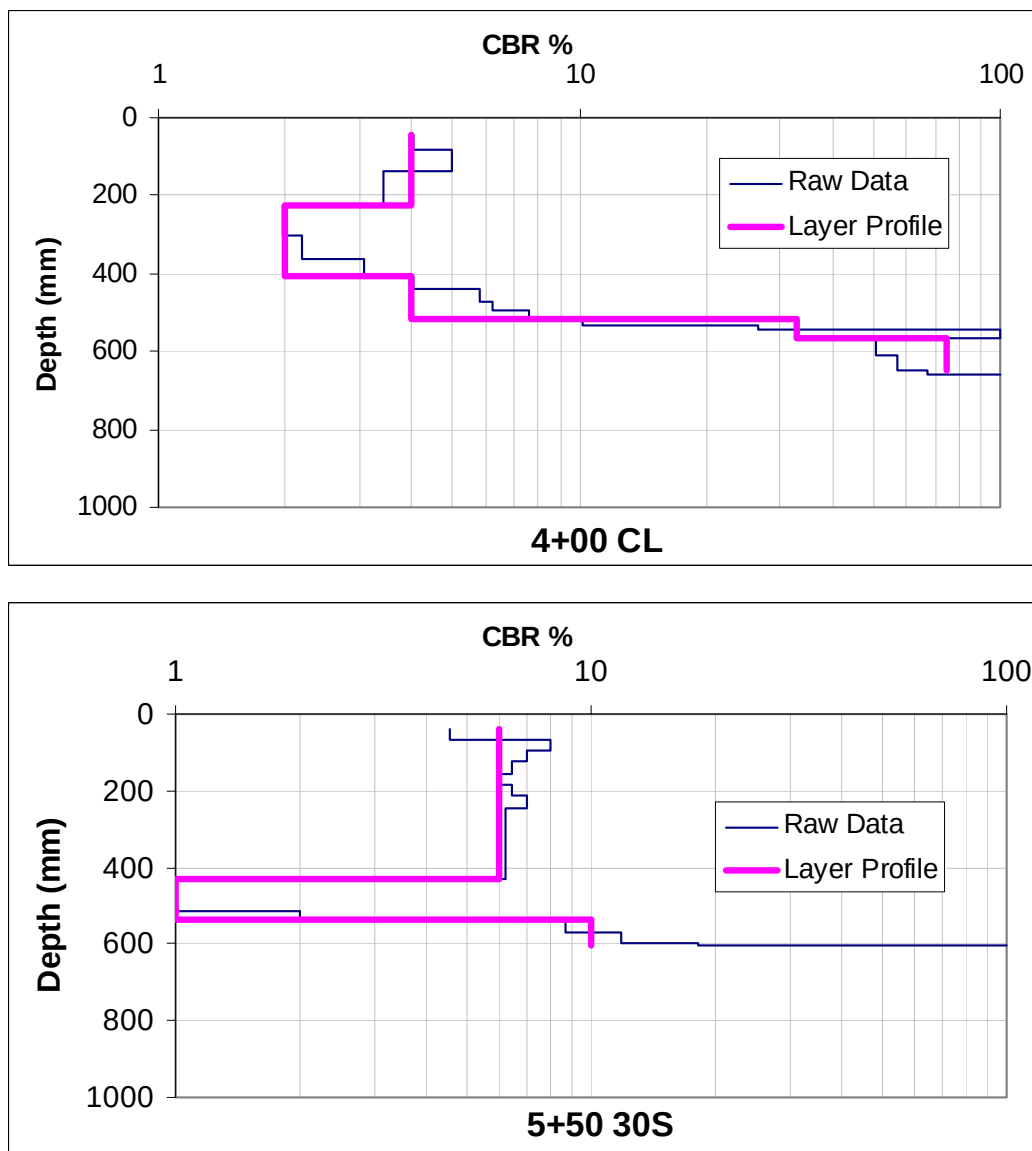
Figure 44. Selected CBR profiles showing layers with weak soil strength taken during IOP #2 at the Fort Bliss RAS.

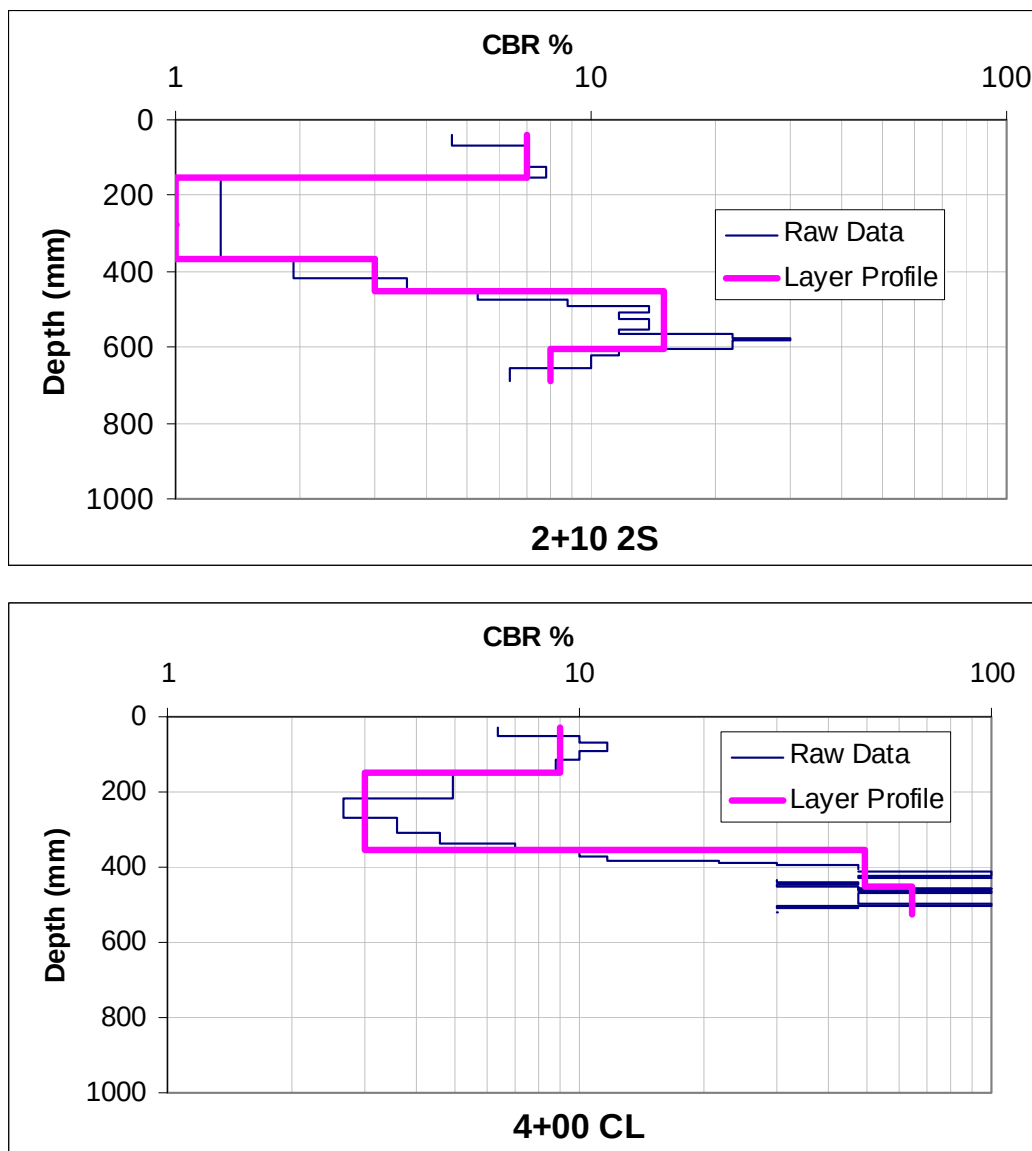
Figure 45. Selected CBR profiles showing layers with weak soil strength taken during IOP #3 at the Fort Bliss RAS.
