*Opportune Landing Site Program*

## **Suitability Measurement and Analysis for Fort Bliss Naval Air Facility OLS**

Rosa T. Affleck, Charles C. Ryerson,  
Lynette A. Barna, and Keran J. Claffey

September 2008

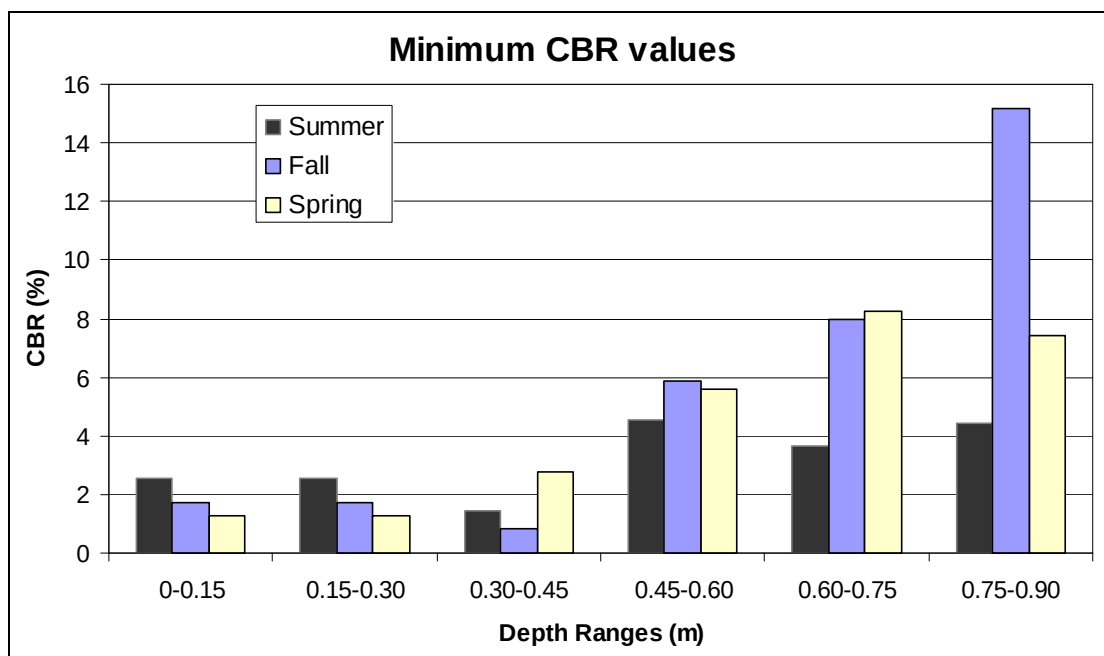
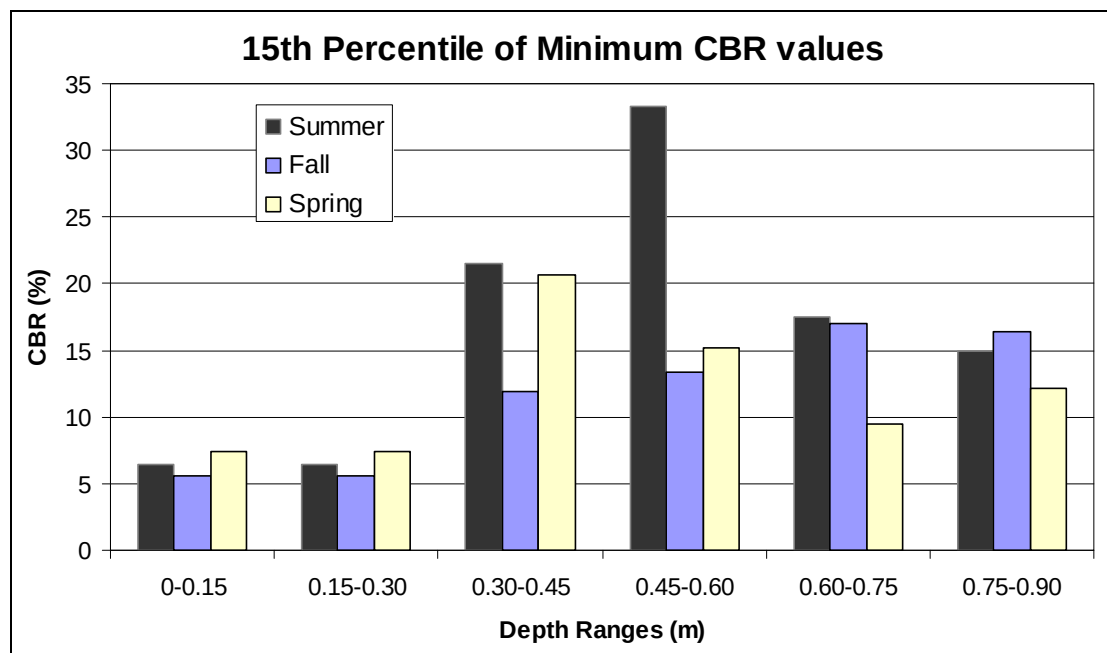
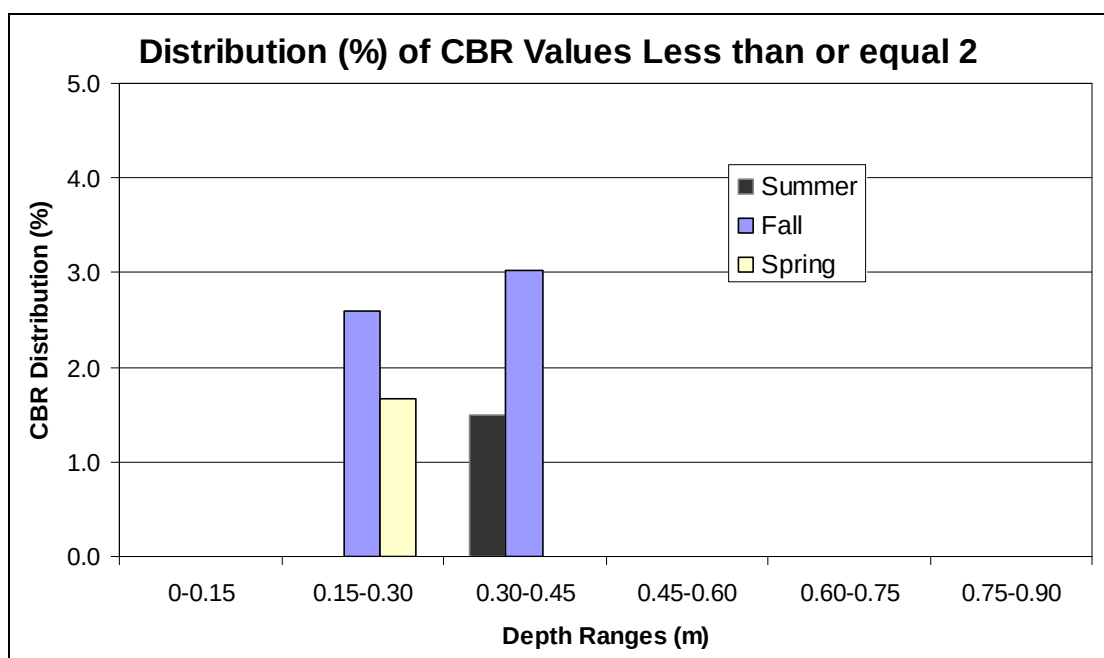
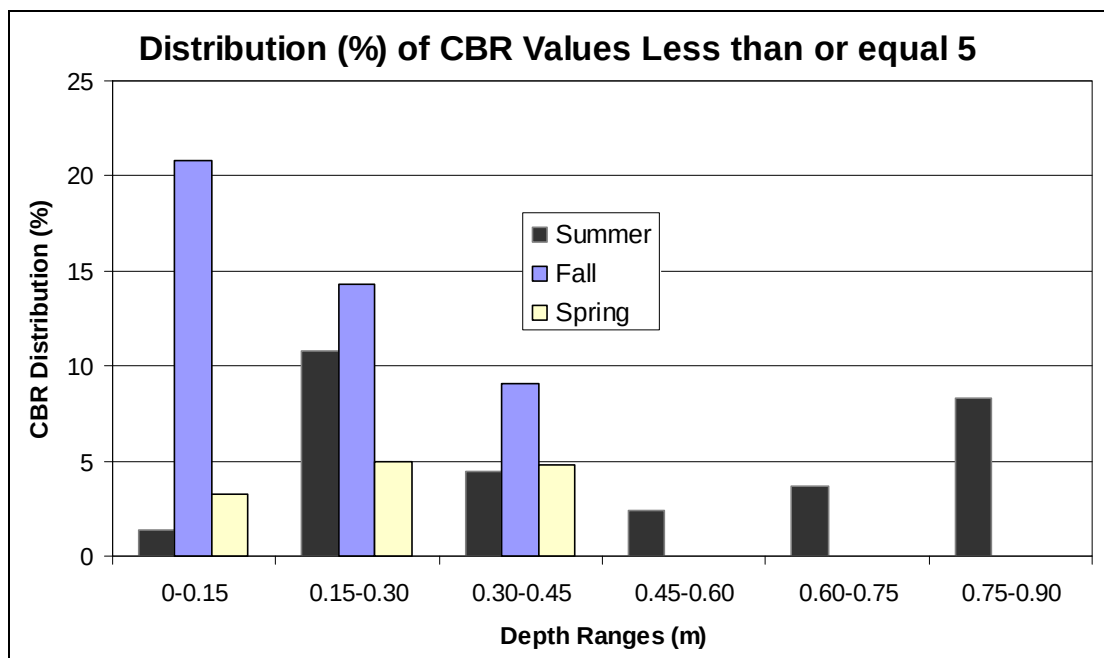
a. Minimum CBR profiles.

b. 15<sup>th</sup> percentile of the minimum CBR profiles.

Figure 46. CBR values at each depth range at RAS.

c. Number of DCP measurements with CBR value of 2 or less.

d. Number of DCP measurements with CBR values equal to or less than 5.

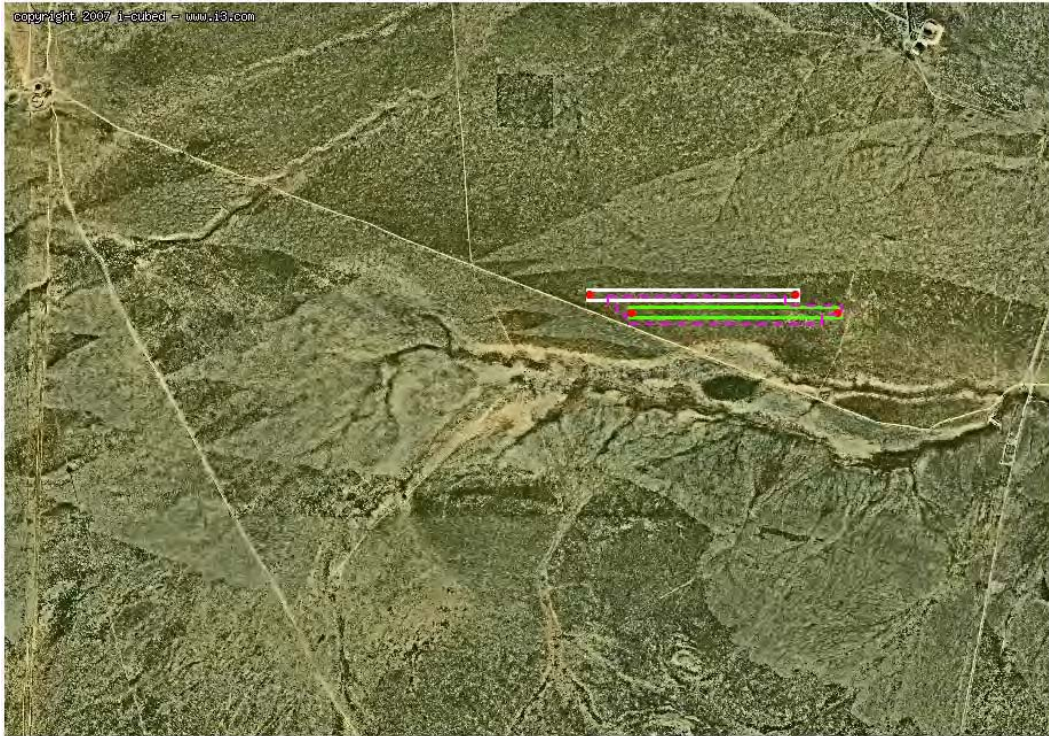
Figure 47. Shift on RAS location due to georectification level of imagery. Fort Bliss RAS Precision Corrected Imagery (PCI-RAS) in white and Systematic georeferenced (SI-RAS) in green. Field work was conducted at the SI-RAS. The magenta broken line shows the boundary of the clusters on OLSs in the area.

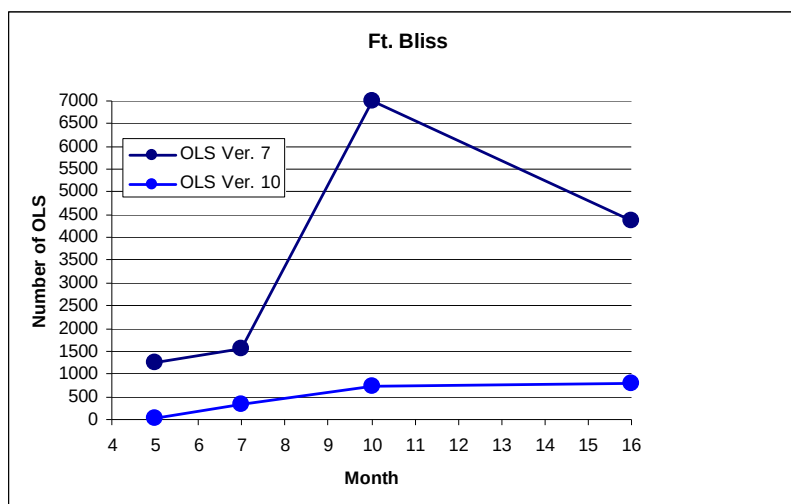
Figure 49. Number of OLSs located seasonally, by software version. June, July, and August are typically the warmest months at Fort Bliss, and July through October typically have the most precipitation.

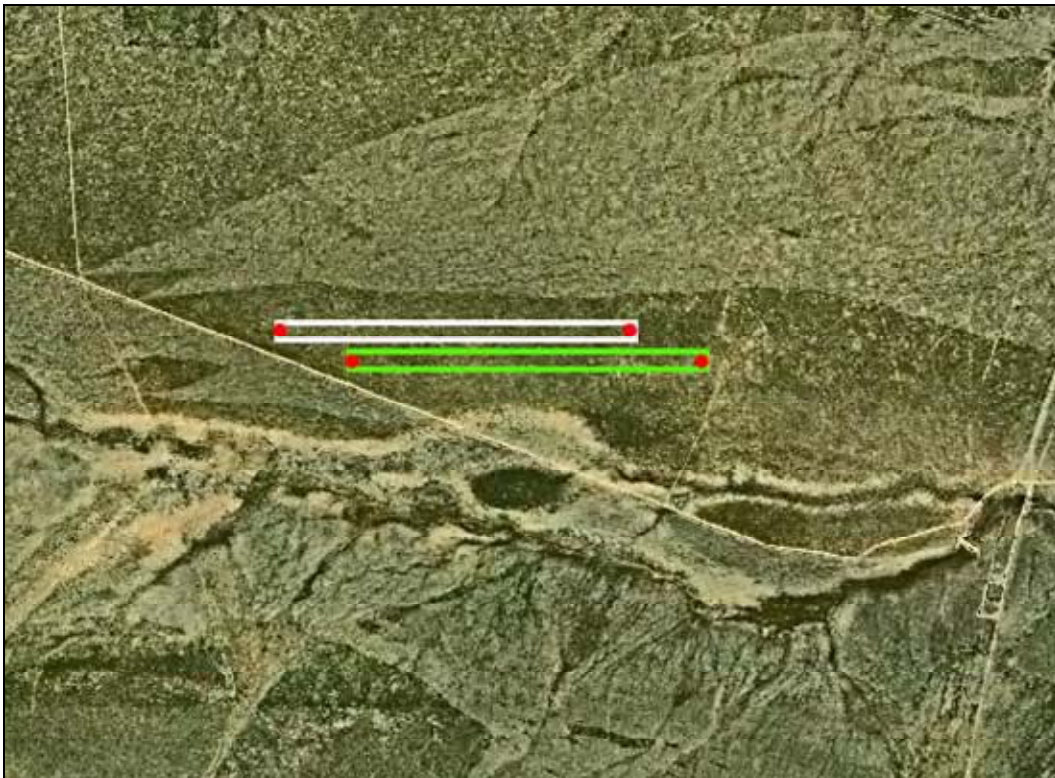
Figure 50. Fort Bliss RAS Precision georeferenced in white outline, and Systematic georeferenced in green outline. Field work was conducted at the green outlined site.

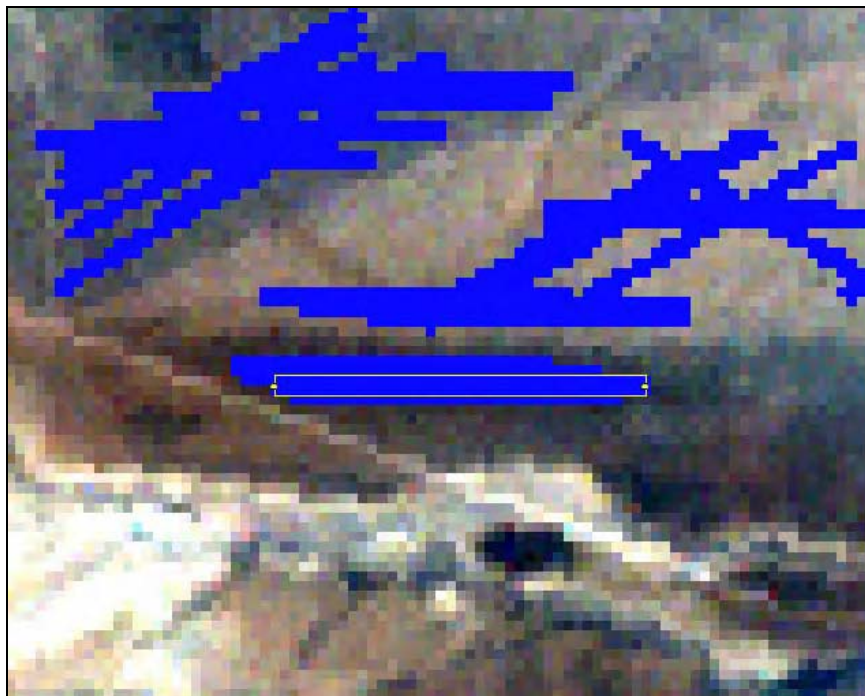
Figure 51. 18 May 2003 Landsat USGS Systematic georeferenced image with Version 7 of the OLS software. All OLSs shown are in Systematic georeferenced positions. The yellow outline OLS is the field site. Over 20 other OLSs are in the immediate vicinity of the field site.

The 18 May 2003 Landsat scene used to locate the Fort Bliss RAS shows the location of the field site in yellow outline, and locations of approximately 20 OLSs in the vicinity using OLS Version 7 software (Fig. 51). This suggests that conditions in the general area of the RAS field site are favorable to OLSs.

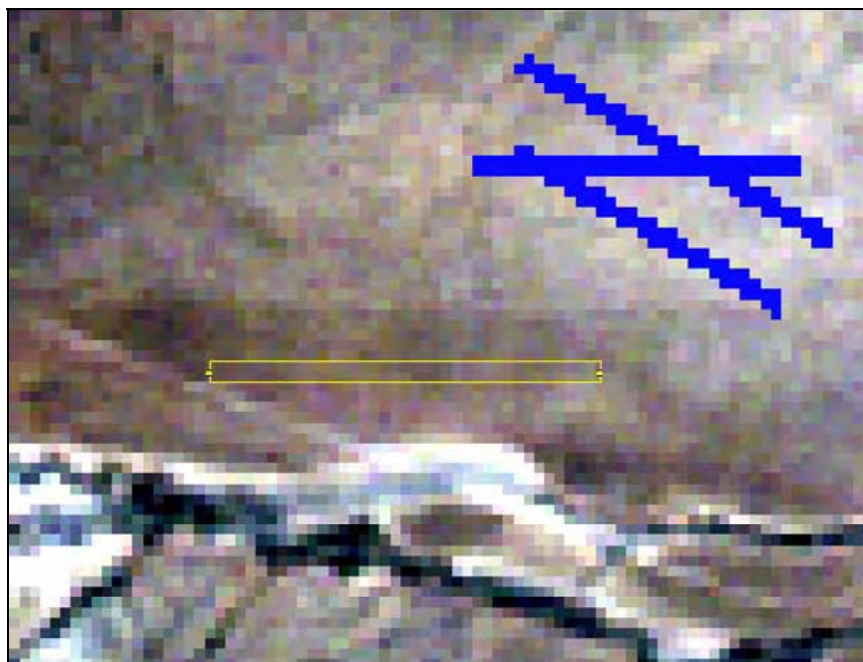
Figure 52. 2 July 2005 Landsat USGS Precision georeferenced image with Version 7 OLS software. Blue OLSs are in Precision georeferenced positions, and the unfilled yellow outline OLS is the field site from the Systematic georeferenced 18 May 2003 image (Fig. 50).

The 2 July 2005 scene shows three OLSs located in the vicinity of the field site with no OLS relocated over the RAS field site (Fig. 52). However, of the three OLSs in the vicinity, the east-west oriented OLS appears, by eye, to be in nearly the same location as an east-west OLS in the 18 April 2003 image. This supports our hypothesis that OLSs may be plotted in nearly the same location season to season, but not at exactly the same pixel coordinates. It also suggests that some OLS locations may be of sufficiently high quality that they are identified during multiple seasons (and a seasonal analysis could be used to locate these high-quality OLSs).

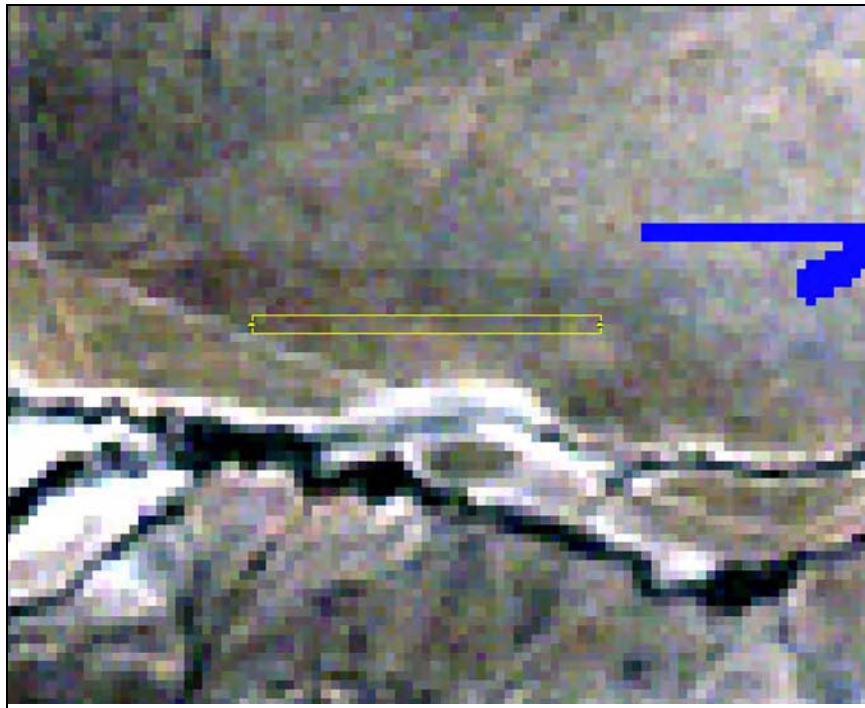
Figure 53. 22 October 2005 Landsat USGS Precision georeferenced image with Version 7 OLS software. Blue OLSs are in Precision georeferenced positions, and the unfilled yellow outline OLS is the field site from the Systematic georeferenced 18 May 2003 image (Fig. 50).

The 22 October image shows at least three OLSs to the east-northeast of the field site (Fig. 53). These overlap season to season, though not at the exact location or orientation.

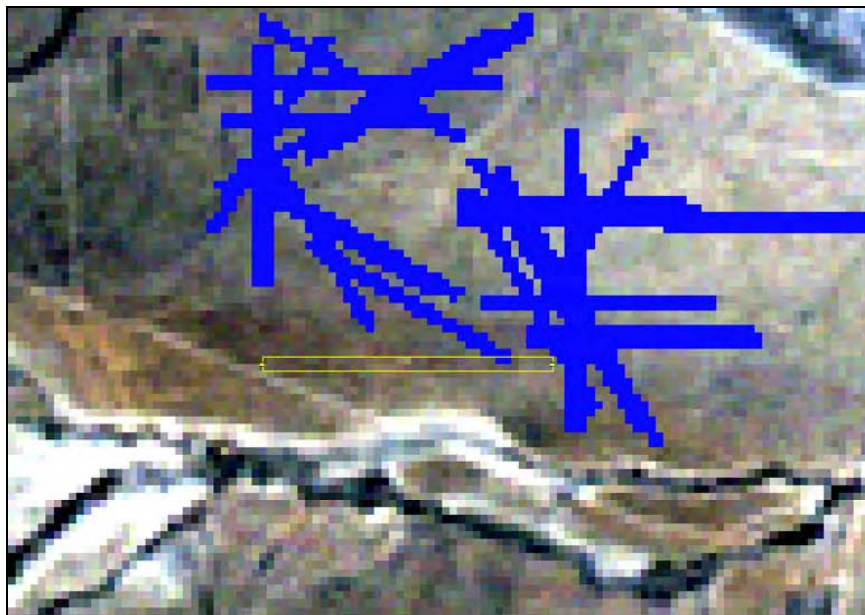
Figure 54. 16 April 2006 Landsat USGS Precision georeferenced image with Version 7 OLS software. Blue OLSs are in Precision georeferenced positions, and the unfilled yellow outline OLS is the field site from the Systematic georeferenced 18 May 2003 (Fig. 50).

The April 2006 image shows more OLSs in the vicinity of the RAS field site than any other image, with more than 20 OLSs (Fig. 54). Though it is difficult to determine whether these OLSs are at the same locations as previous OLSs without creating overlays using a Geographic Information System, the April 2006 OLSs overlap the locations of OLSs on the previous three images. Again, though no OLS is located at the same location and orientation as the field site, one southeast-to-northwest-oriented OLS does enter the field site area.

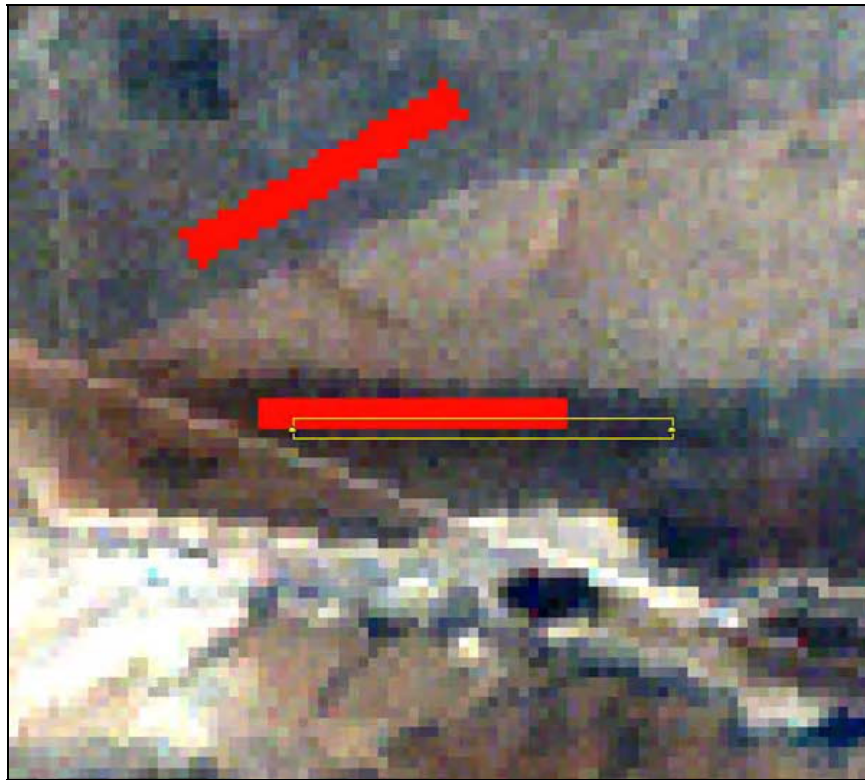
Figure 55. 18 May 2003 Landsat USGS Systematic georeferenced image with Version 10 of the OLS software. The unfilled yellow outline OLS is the field site from the systematic georeferenced 18 May 2003 image using Version 7 of the OLS software. Filled red OLSs were located with Precision georeferencing in Version 10 of the software.

Version 10 of the OLS software is more conservative than Version 7. Figure 55 shows at least two OLSs were located on the 18 May 2003 Landsat image that was used to locate the RAS field site. Figure 55 also shows that one of these OLSs overlaps much of the field site.

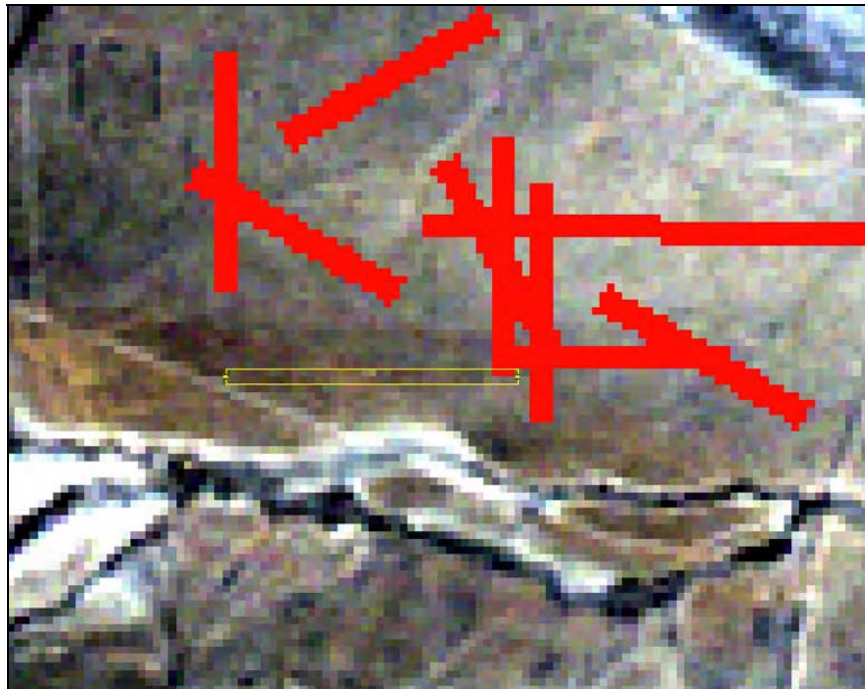
Figure 56. 16 April 2006 Landsat USGS Precision georeferenced image with Version 10 of the OLS software locating the red OLSs. The unfilled yellow outline OLS is the field site from the Systematic georeferenced 18 May 2003 image (Fig. 50).

The only other image that showed OLSs in the vicinity of the field site location with Version 10 of the software was the 16 April 2006 image. Here, about 10 OLSs were plotted in the vicinity of the field site (Fig. 56).

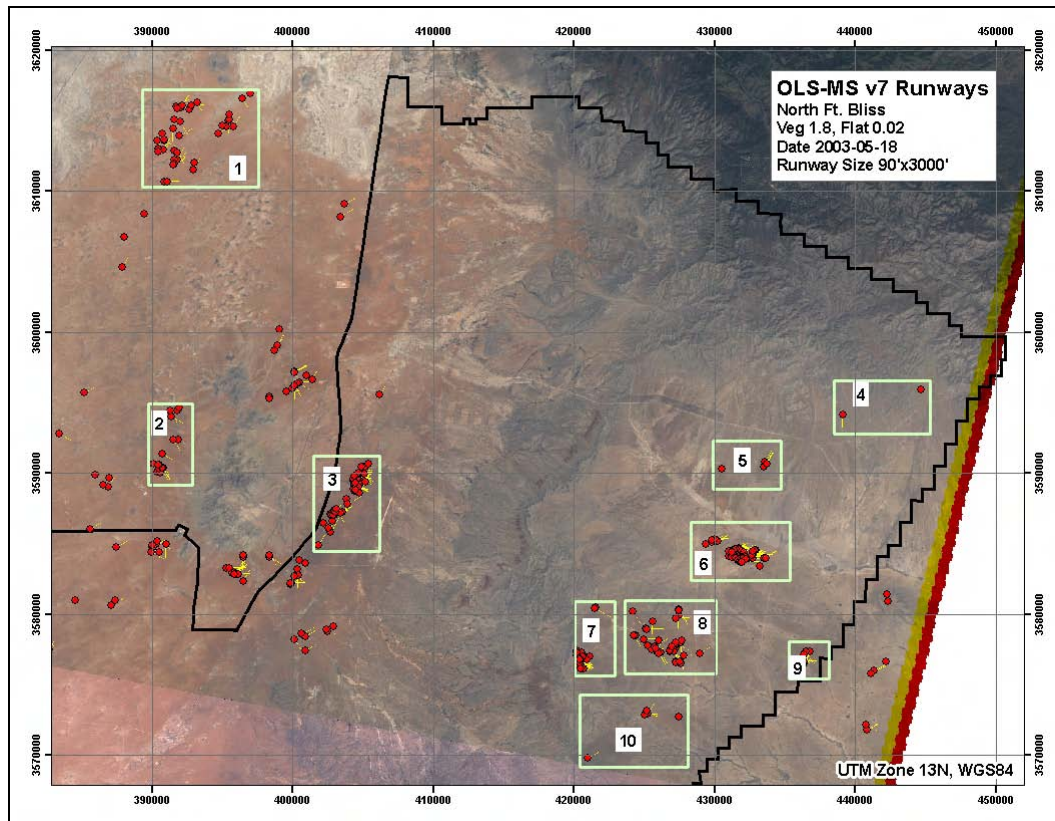
Figure A2-1. 90- × 3000-ft OLSs indicated as OLS Short.

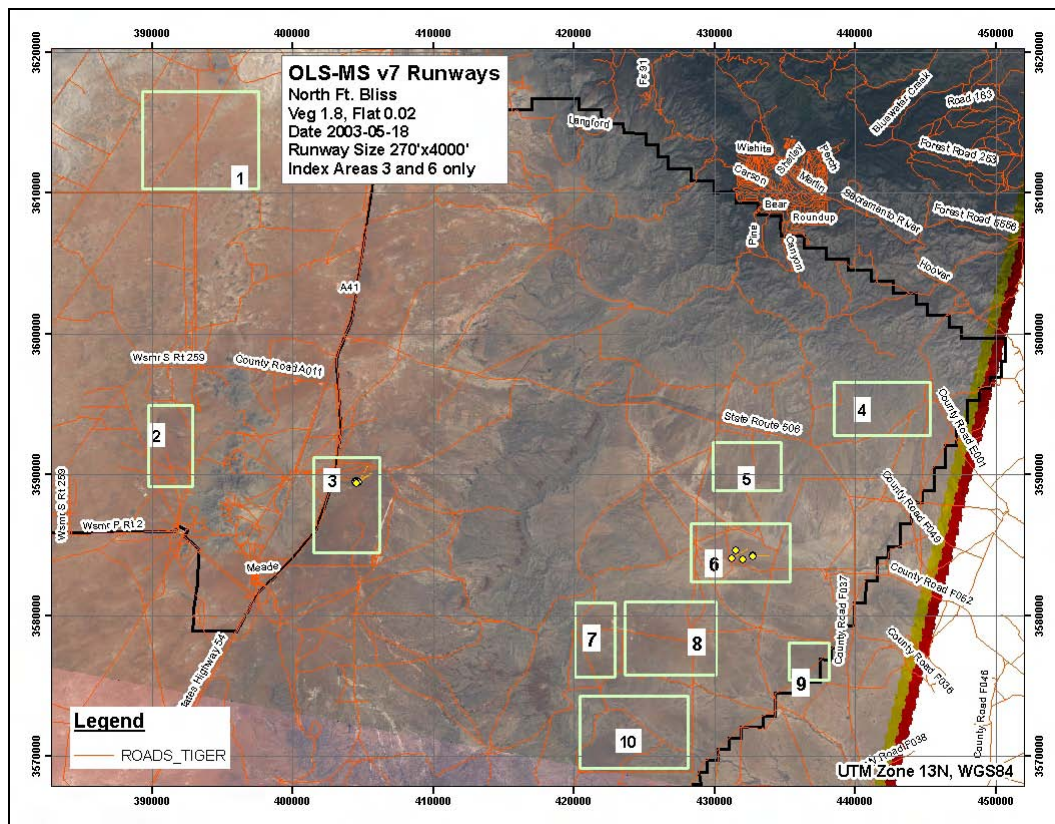
Figure A2-2. 270- × 4000-ft OLSs indicated as OLS Long.

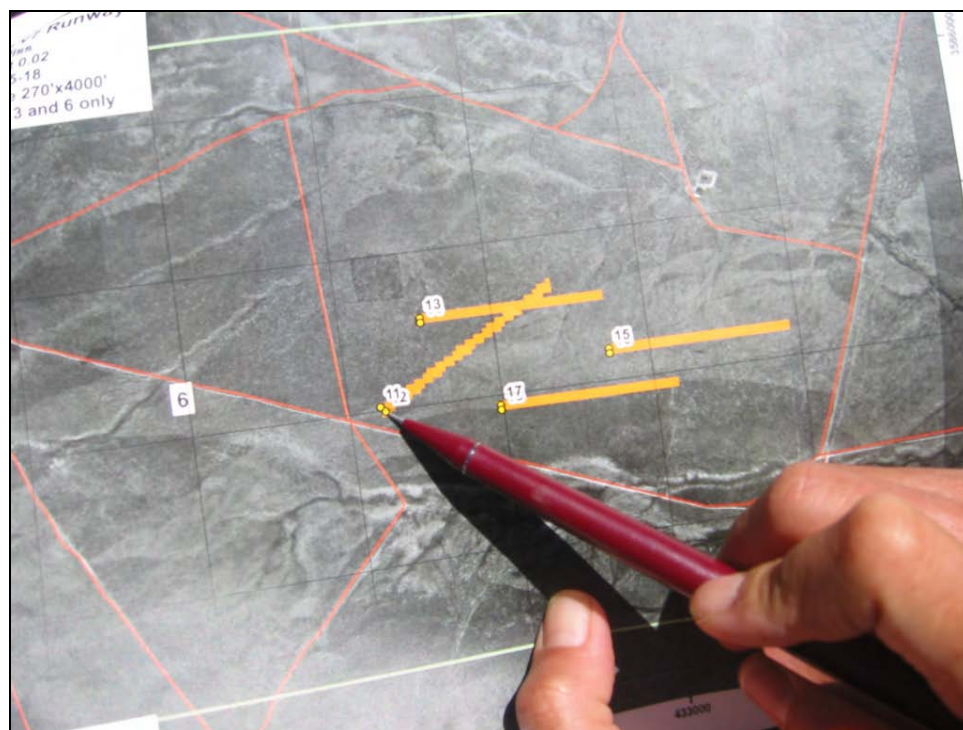
Figure A2-3. Area 6 with 270- × 4000-ft OLS.

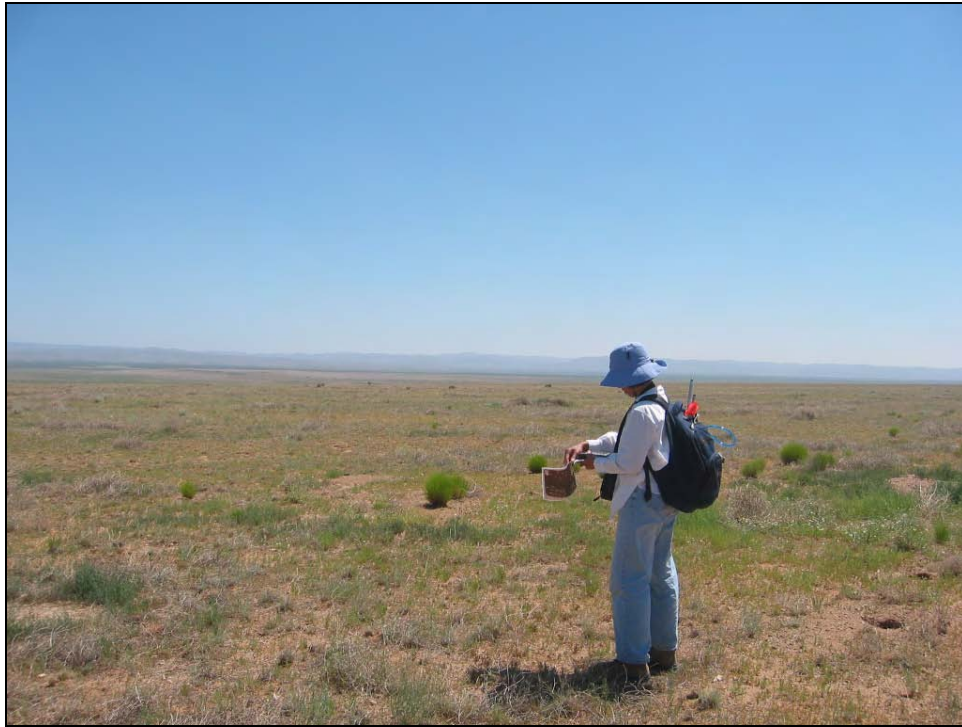
Figure A2-12. View down the throat of OLS at 230 feet from the start flag. There was rebar sticking up vertically out of the ground.

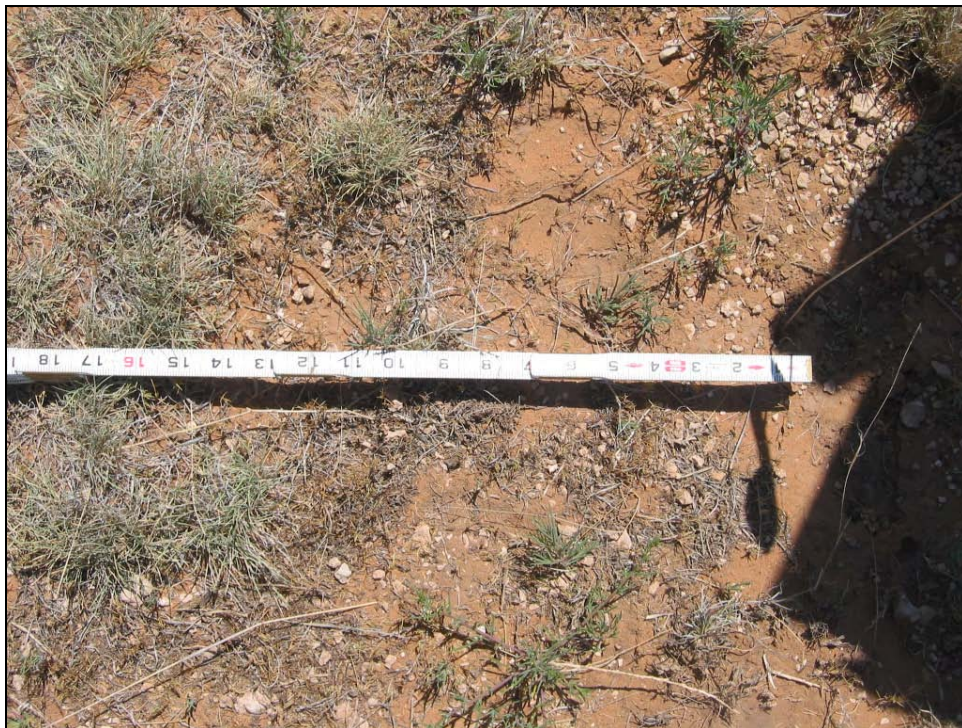
Figure A2-13. Close-up of undisturbed surface conditions within 12 inches north side of flag.

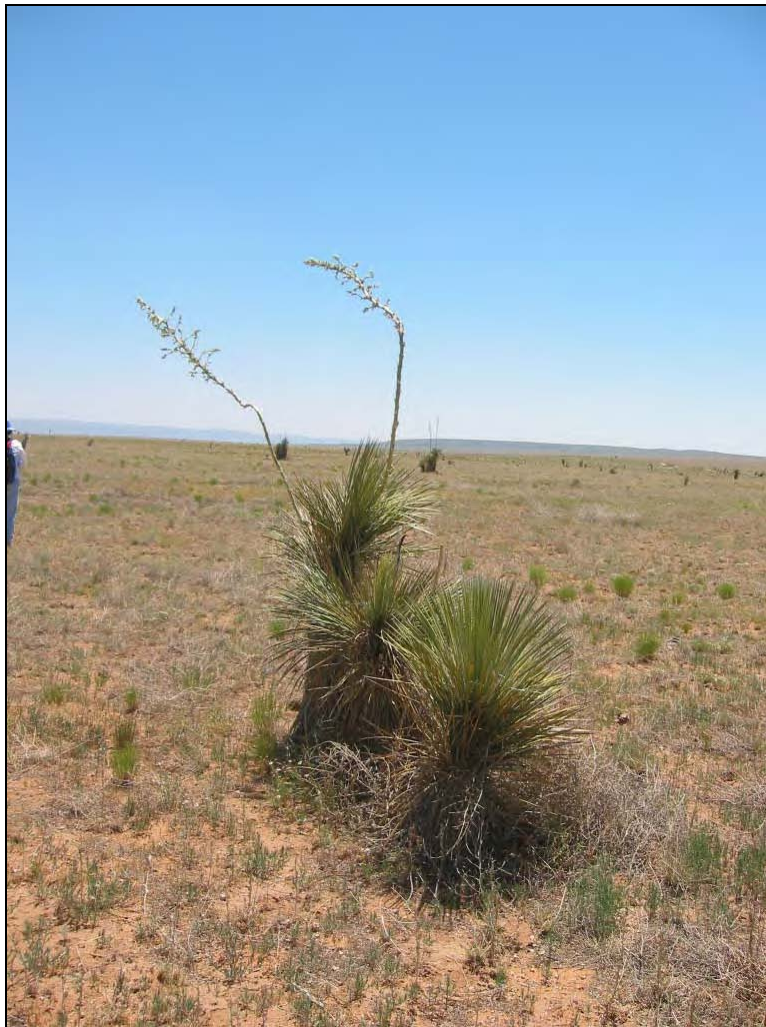
Figure A2-17. Yucca is a fibrous plant with a thick trunk and deep root system. It grows in areas of adequate moisture. The center part of the plant is quite strong and has been used as rope. The plant can reach heights of 5–10 feet, and would be viewed as an obstruction to aircraft operations. It is difficult to push down by human force. In this area the yucca were spaced several hundred feet apart; however, in the area of the OLS cluster they were spaced closer together (see next photo).

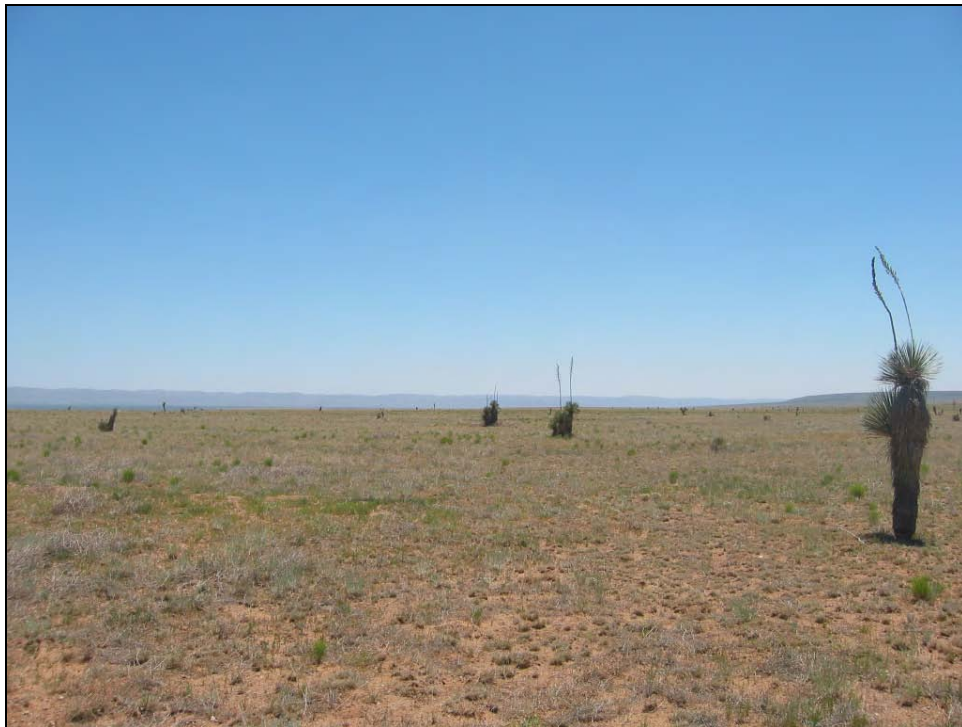
Figure A2-18. Along OLS 276-Short looking toward the east. Here, the yucca trees are spaced approximately 20–30 feet apart.

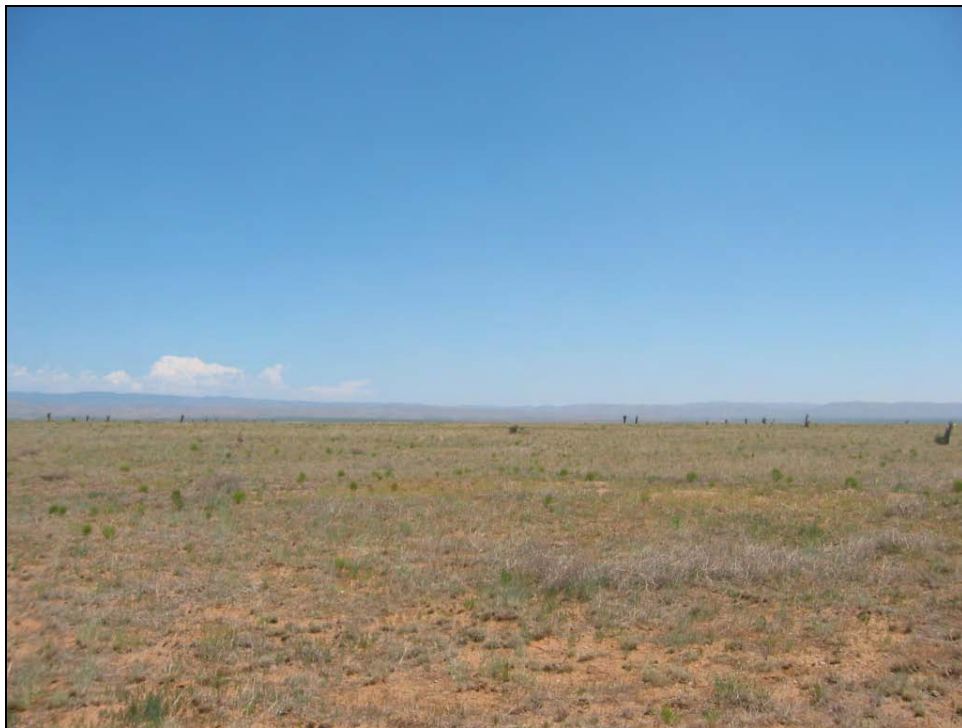
Figure A2-19. Looking slightly more to the northeast. No OLS are located here, but note the yucca trees in an almost straight line on opposite sides of the photo at an estimated distance of 200 feet apart. OLS 276-Short is just to the right of this location.

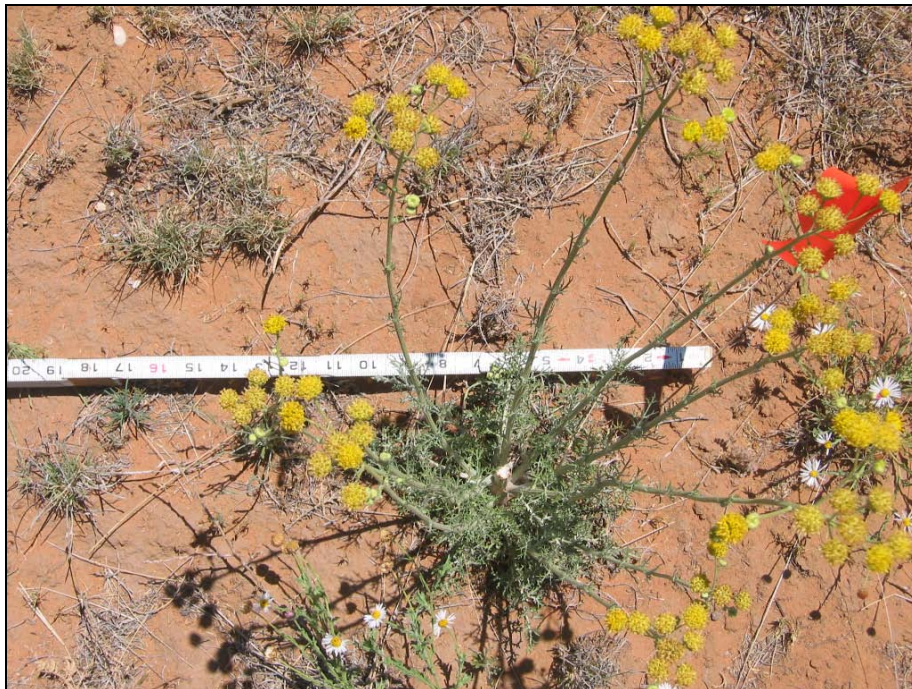
Figure A2-20. OLS 276-Short at start flag and undisturbed soil and vegetation condition on north side of flag. Munsell color chart 10YR 5/4. Field soil is identified as fine-grained soil (silty sand or silt) and a few pieces of gravelly material (caliche pieces). The soil is very dry.

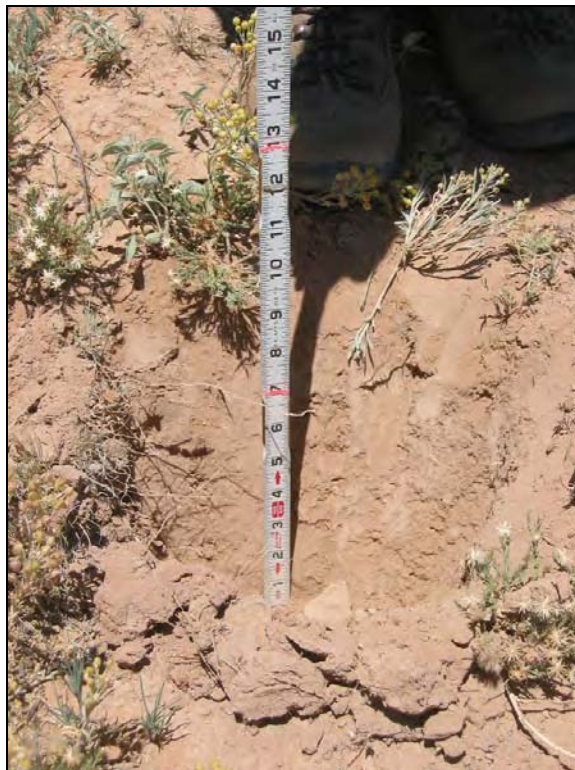
Figure A2-21. Shallow hole was dug approximately 9 inches below surface; soil felt crumbly and powdery. Affleck attempted to push a cone penetrometer and found it difficult to push after 4 inches below the surface.

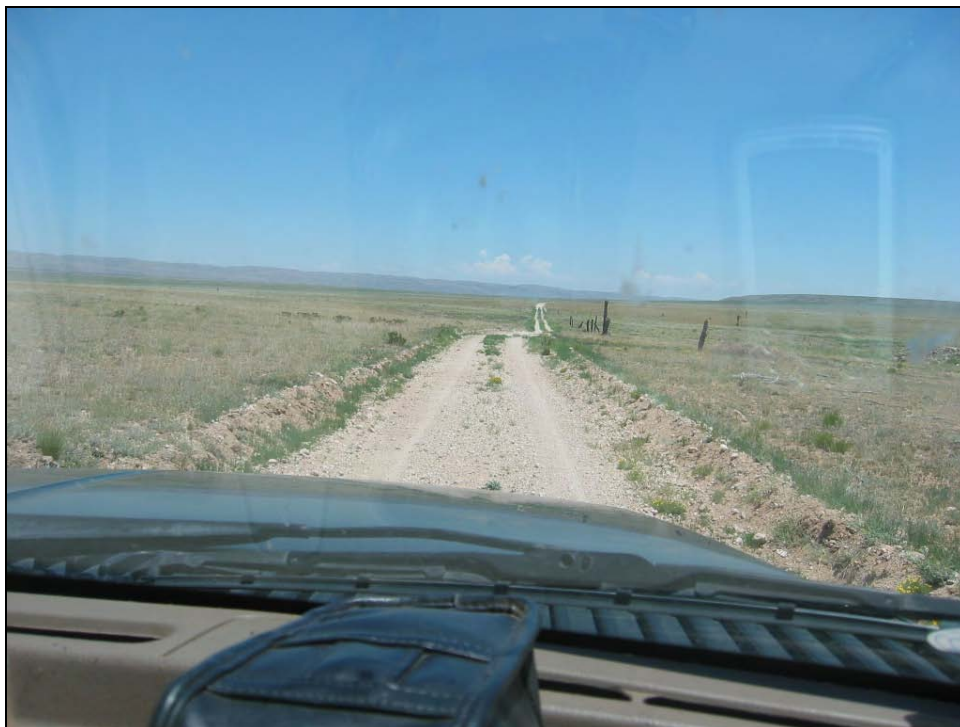
Figure A2-30. OLS 279-Short location where OLS crosses this road and a fence line at a cattle crossing. West end of OLS 279-Short is on left side and the other end is on right side.

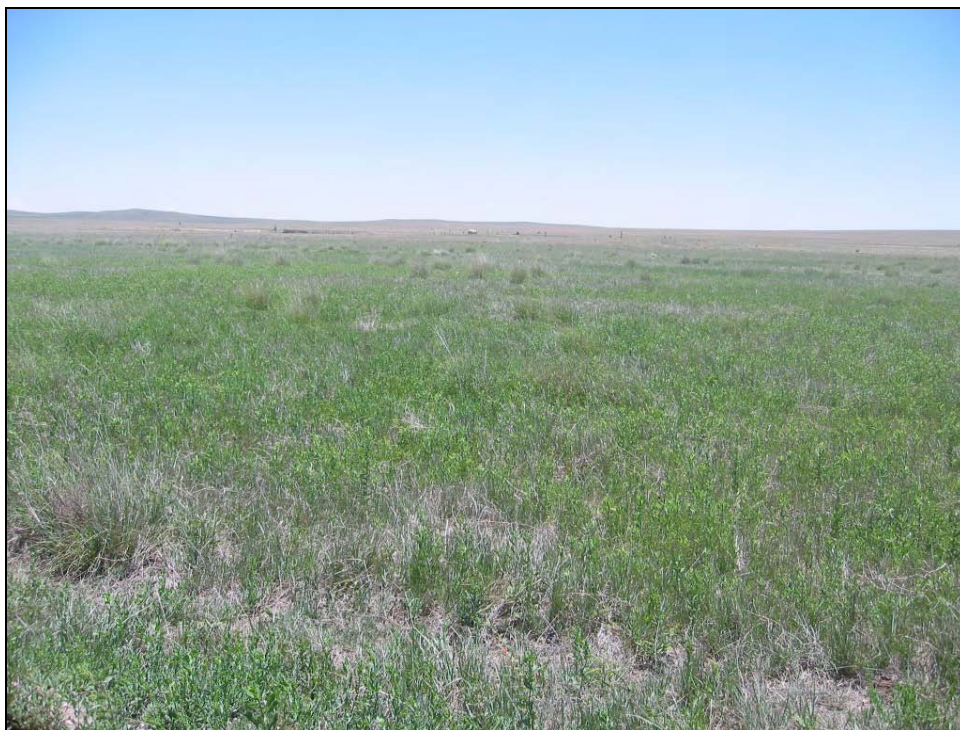
Figure A2-31. Location approximately three miles down the access road from OLS cluster 276-Short. There are no OLSs in this photograph, which illustrates the higher density of vegetation, as this area is slightly lower in elevation and is where water drains. Cattle ranch location ahead in the distance.

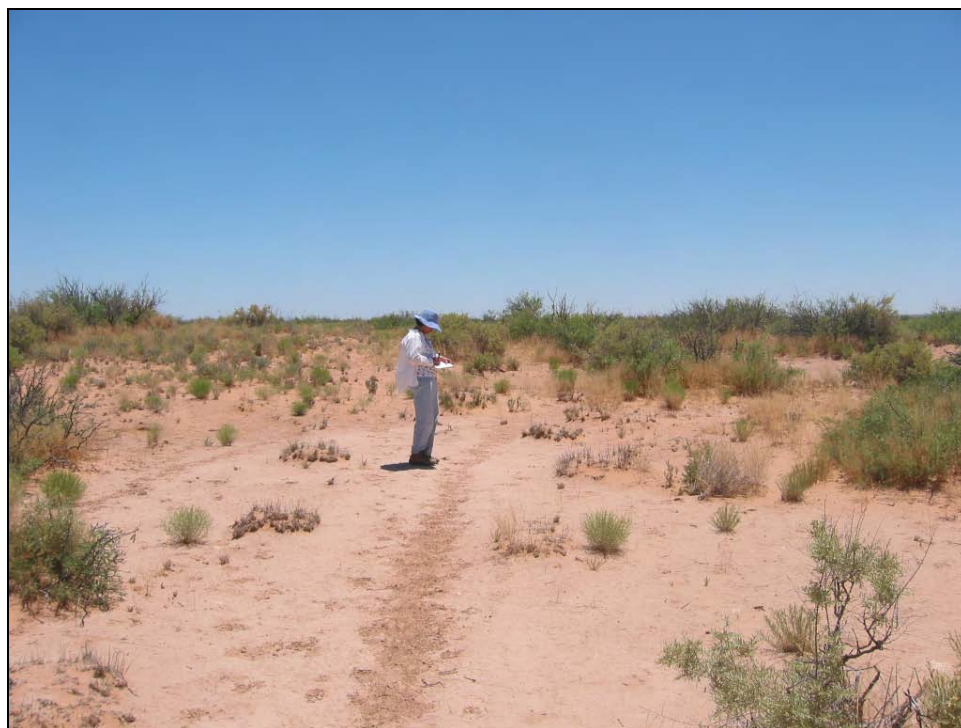
Figure A2-34. Location about 1.5 miles north of OLS 92-Short. This area is fairly flat over a large distance, but the mesquite bushes with their sharp thorns make this an unsuitable location.

Driving along Highway 54 North, we passed Area 3 and attempted to examine the OLSs. This area is on mesquite dunes and has no access (Fig. A2-33, A2-37). We also drove the north side of Area 3, approximately 1.5 miles north of OLS 92 (approximately 4–5 miles north of Wilde Benton Airstrip). We found this location was dominated by 5- to 10-ft-tall mesquite dunes that were about 5–10 ft across and spaced 5–20 ft apart (Fig. A2-34, A2-35). The soil is fine-grained silty sand (Fig. A2-36).

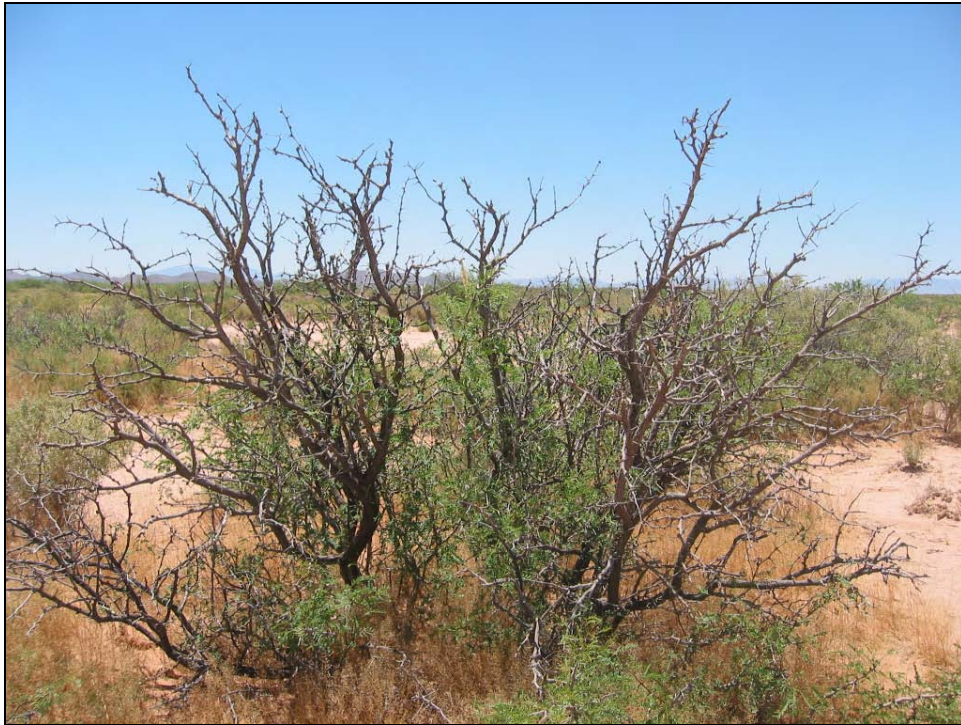
Figure A2-35. Mesquite bushes may range from 2 to 5 feet high and be spaced 10–20 ft apart.

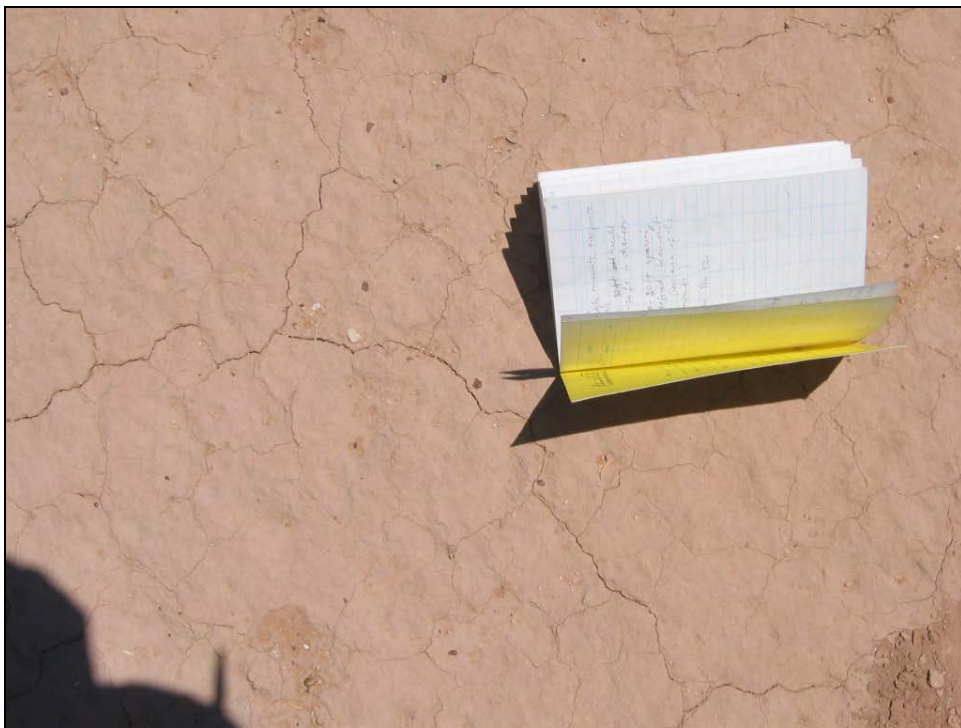
Figure A2-36. Soil surface with cracks; soil is very dry.

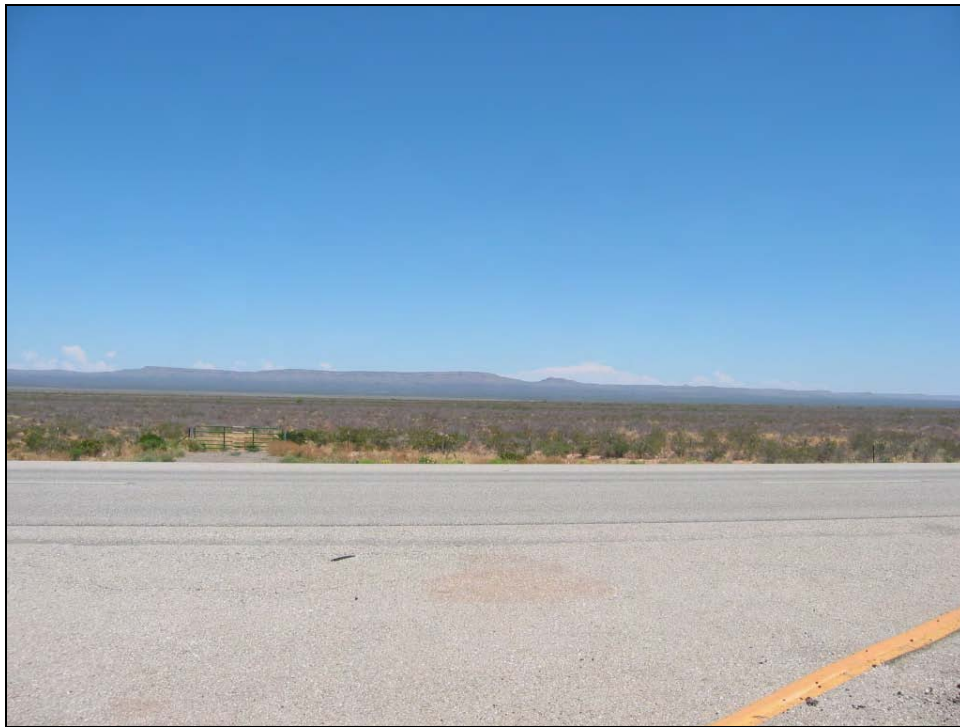
Figure A2-37. No access to OLS in Area 3 off Highway 54.

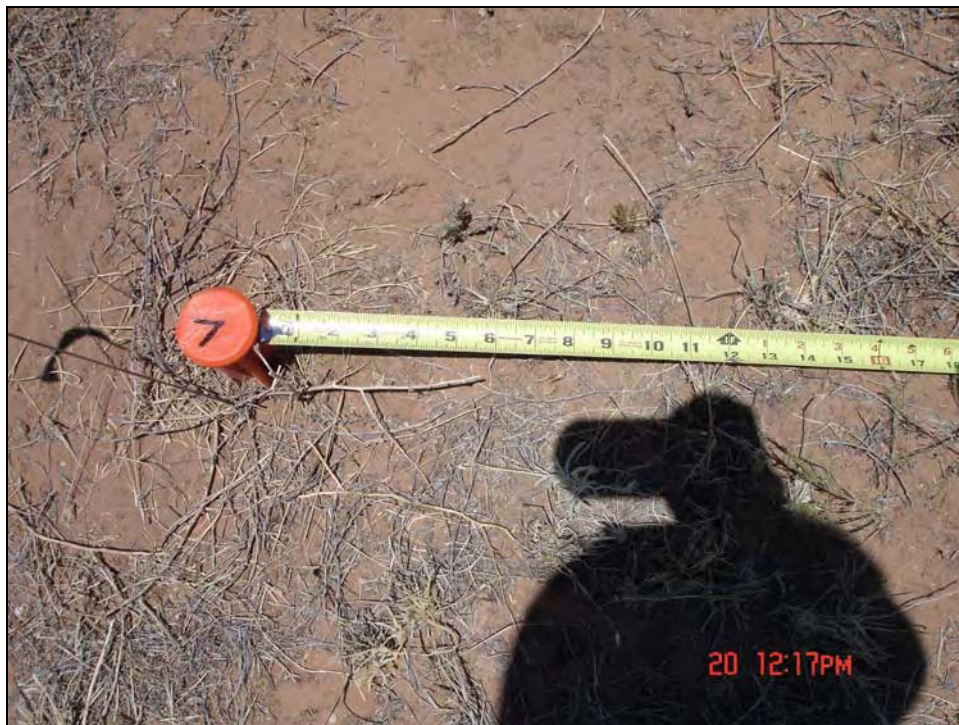
- Both live and dead plants, total vegetation cover is approximately 70–80%;
- Gently sloping to the south;
- Typical ground roughness was taken by a profilometer;
- Mounds with 3- to 4-in.-diameter animal holes on both south side and south edge of the runway;
- Few yucca;
- Reddish brown color, powdery material, silt soil on the surface.

Soil on the surface at Station 0+00 centerline.
