*Opportune Landing Site Program*

## **Suitability Measurement and Analysis for Fort Bliss Naval Air Facility OLS**

Rosa T. Affleck, Charles C. Ryerson,  
Lynette A. Barna, and Keran J. Claffey

September 2008

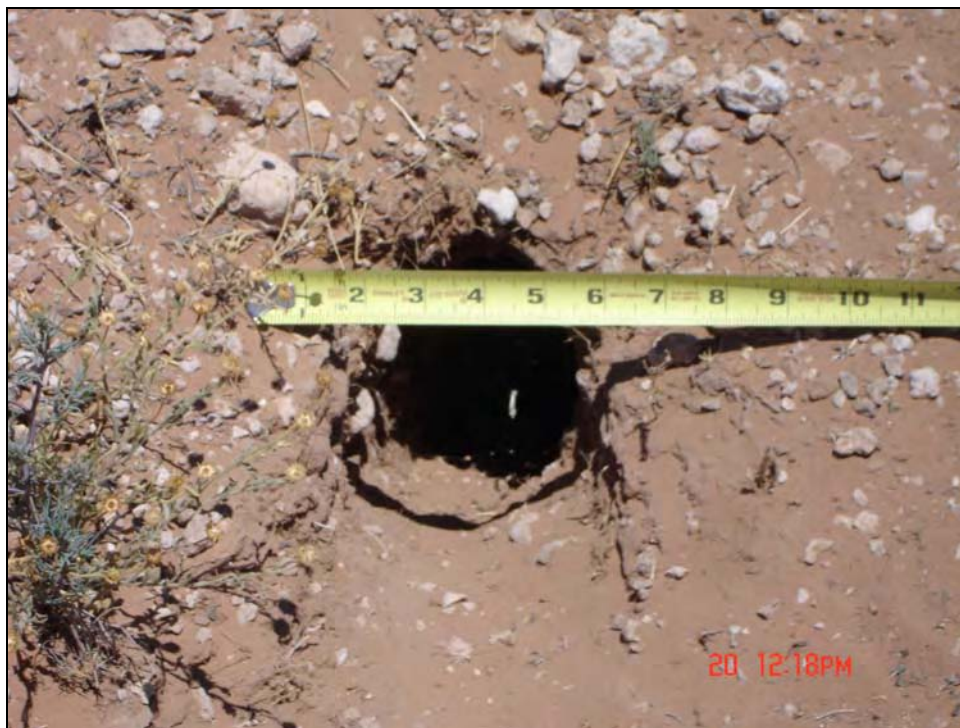
- Both live and dead plants, total vegetation cover is approximately 70–80%;
- Gently sloping to the south;
- Typical ground roughness was taken by a profilometer;
- Mounds with 3- to 4-in.-diameter animal holes on both south side and south edge of the runway;
- Few yucca;
- Reddish brown color, powdery material, silt soil on the surface.

Granular material on the surface adjacent to the animal hole.

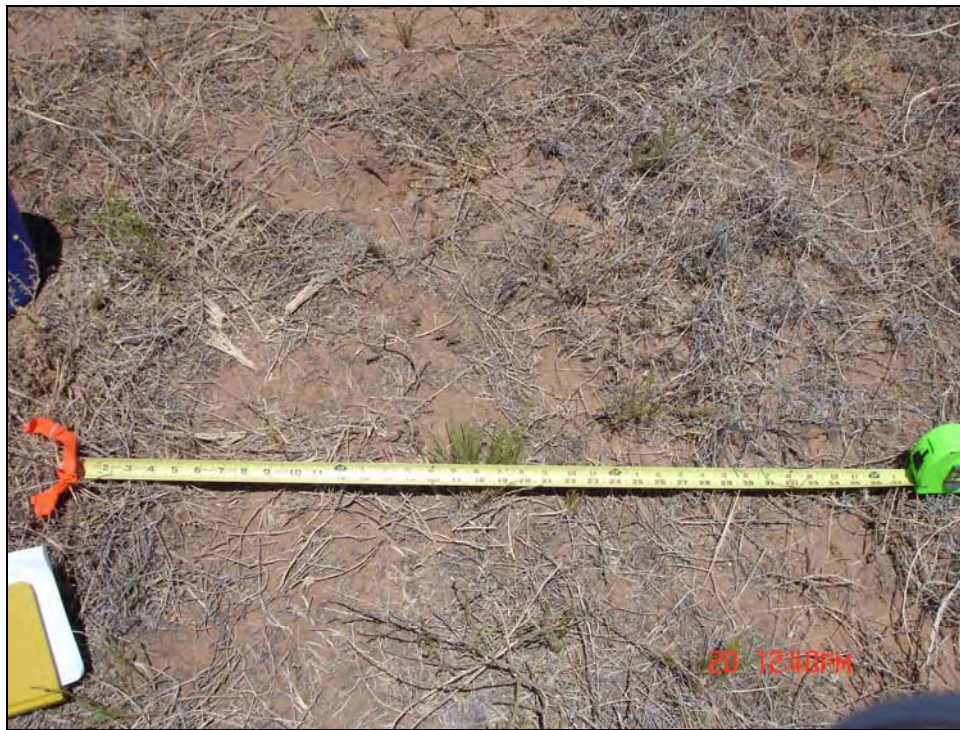
- Gently sloping to the south;
- Vegetation cover is approximately 60–70% with both live and dead plants;
- Some roughness and undulation (waviness along the runway);
- Few yucca;
- Reddish-brown color, powdery material, silt soil with granular (caliche pieces) material 0.5- to 4-in. size on the surface.

Dead and live vegetation cover and exposed soil at Station 0+40 centerline.

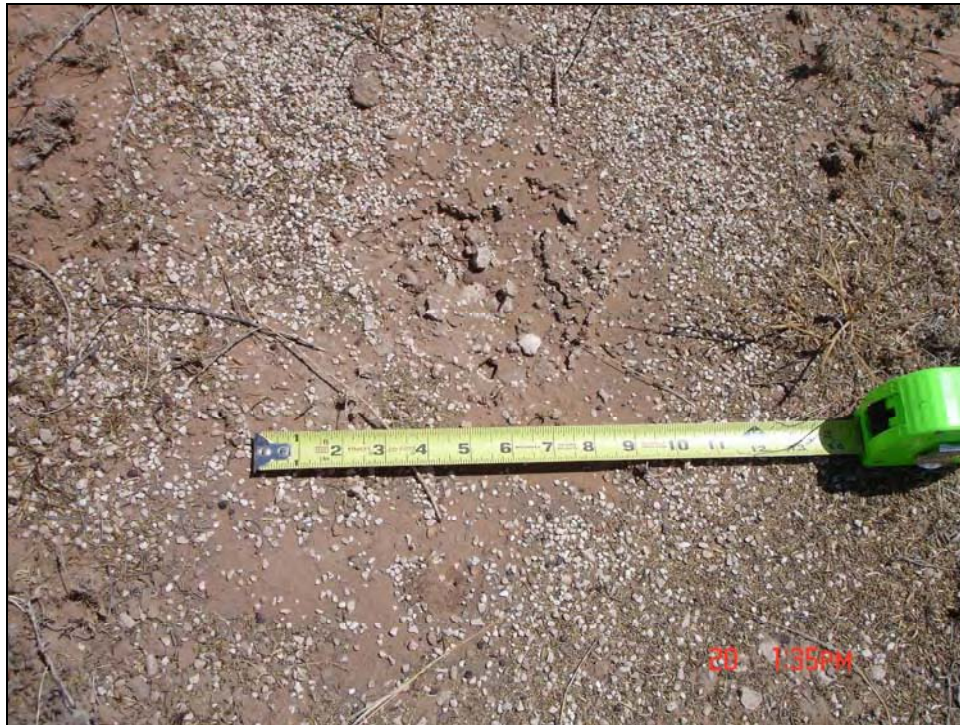
- Gently sloping to the south;
- Vegetation cover is approximately 60–70% with both live and dead plants;
- Some undulation or waviness along the runway;
- Typical surface roughness based on the profilometer;
- A couple of yucca;
- Reddish-brown color, powdery material, silt soil with granular (caliche pieces) material 0.5- to 4-in. size on the surface;
- Mounds with no distinct animal burrows located adjacent to the areas with animal holes;
- A mound with granular material (caliche pieces) ranging from 1- to 5-in. size on the surface.

Ant burrow west of Station 1+70

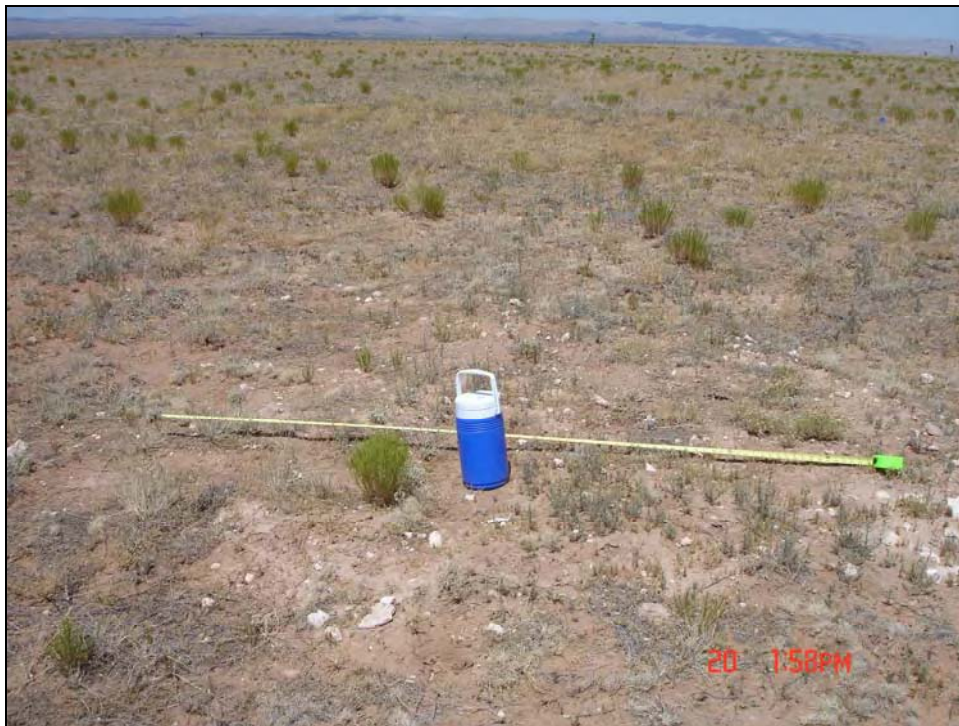
Mound with noticeable gravelly materials on the surface.

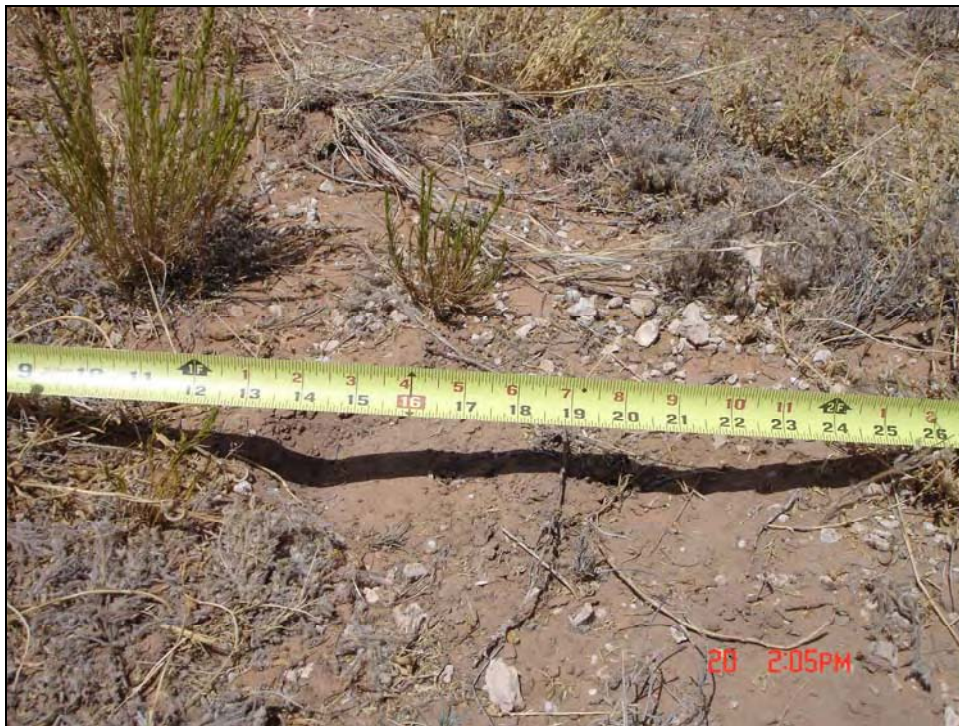
- Vegetation cover is approximately 60–70% with both live and dead plants;
- Some roughness and undulation (waviness) along the runway;
- Few yucca on the south side of the runway;
- Reddish-brown color, powdery material, silt soil with granular (caliche pieces) material 0.5- to 4-in. size on the surface;
- Mounds with animal holes ranging from 3- to 6-in. diameter;
- A patch of area with vegetation clearing and gravelly materials on the surface.

Soils and vegetation cover at Station 2+10.

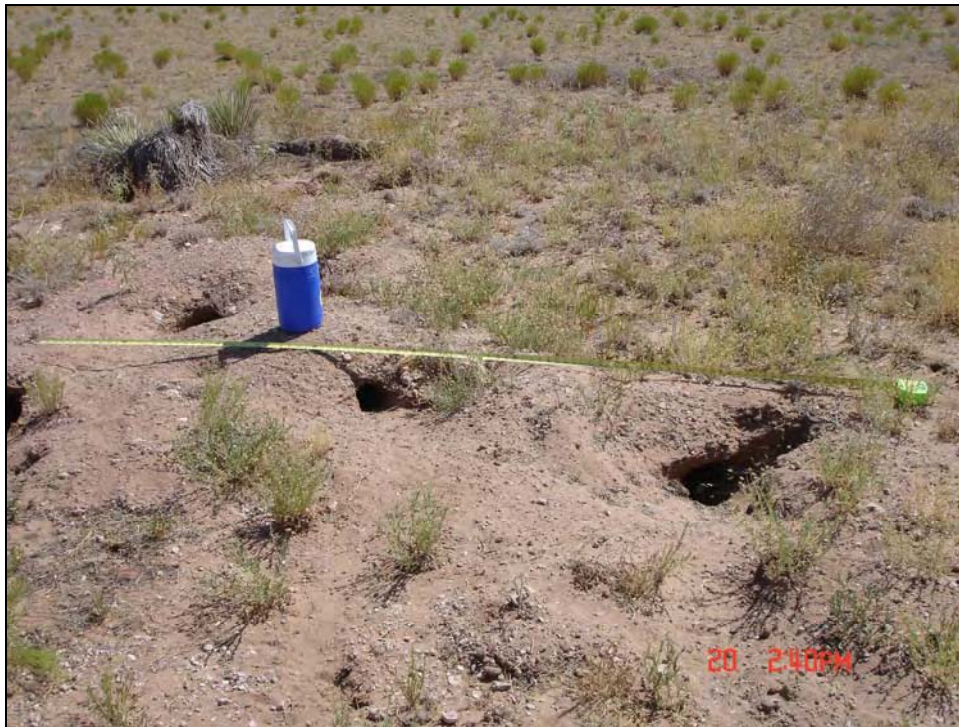
Mound with animal holes near Station 2+80.

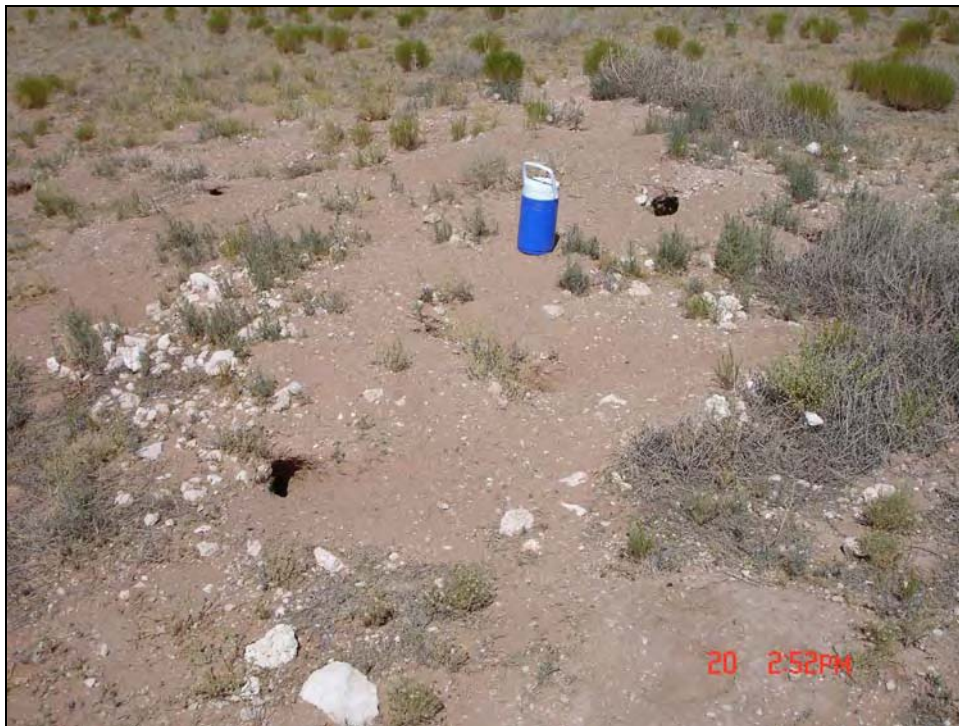
Mound with animal holes and gravelly (caliche pieces) materials on the surface near Station 3+30.

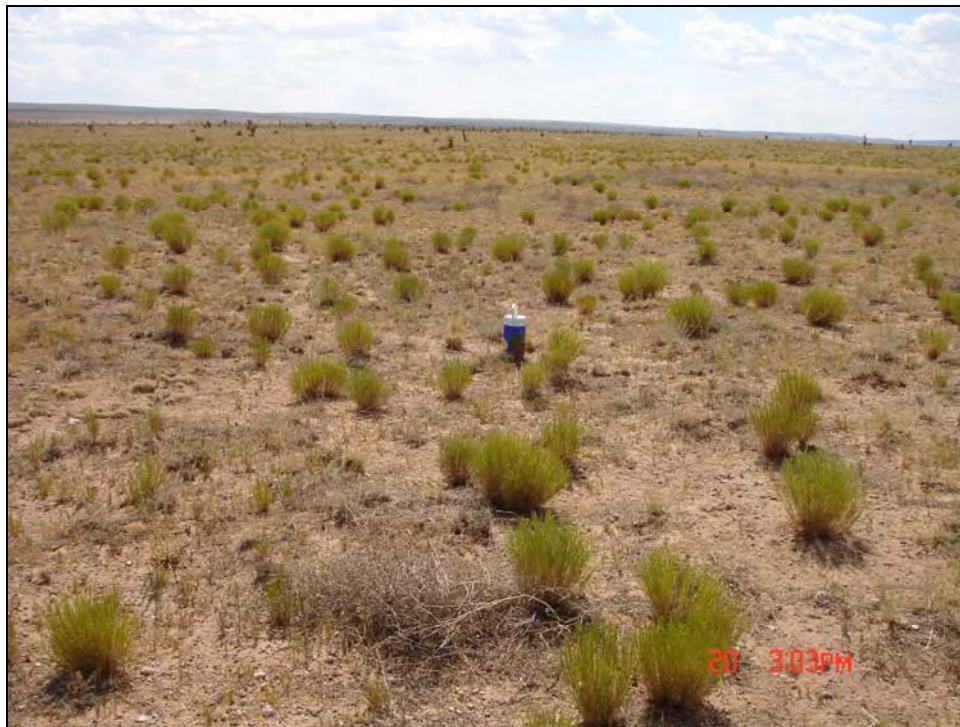
Due west at Station 3+30 along the center of the runway.

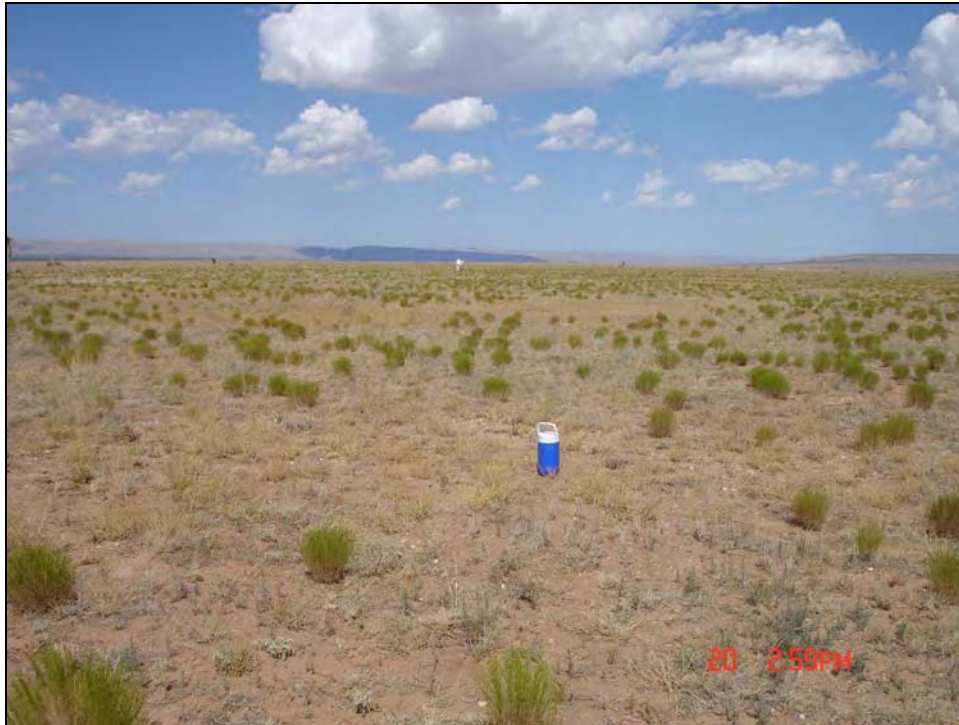
Station 3+30 centerline due east.

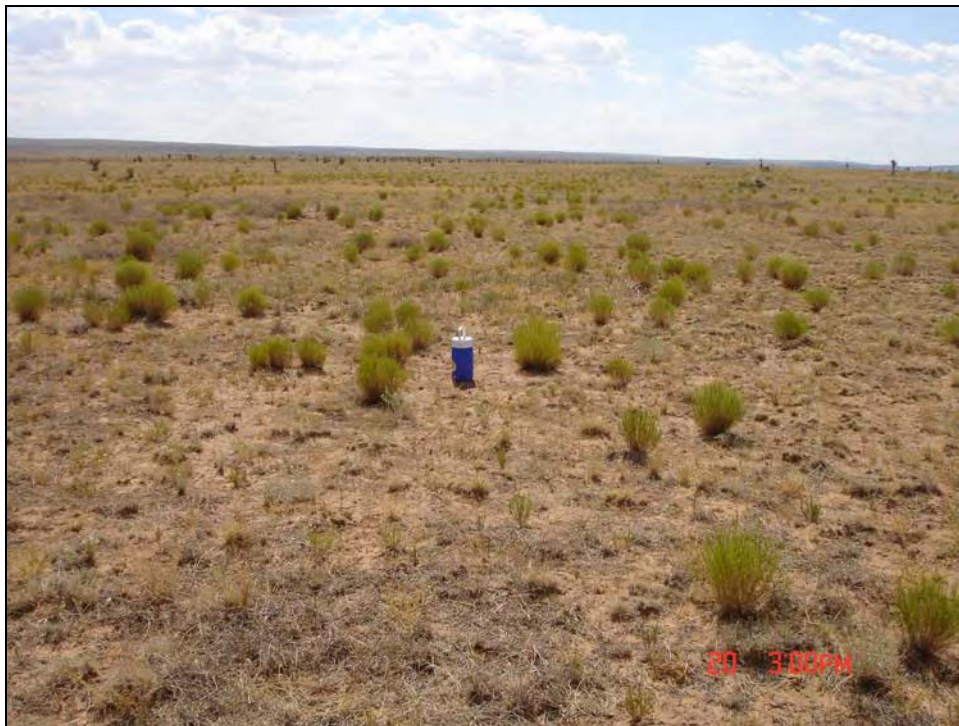
Station 3+30 centerline, due west.

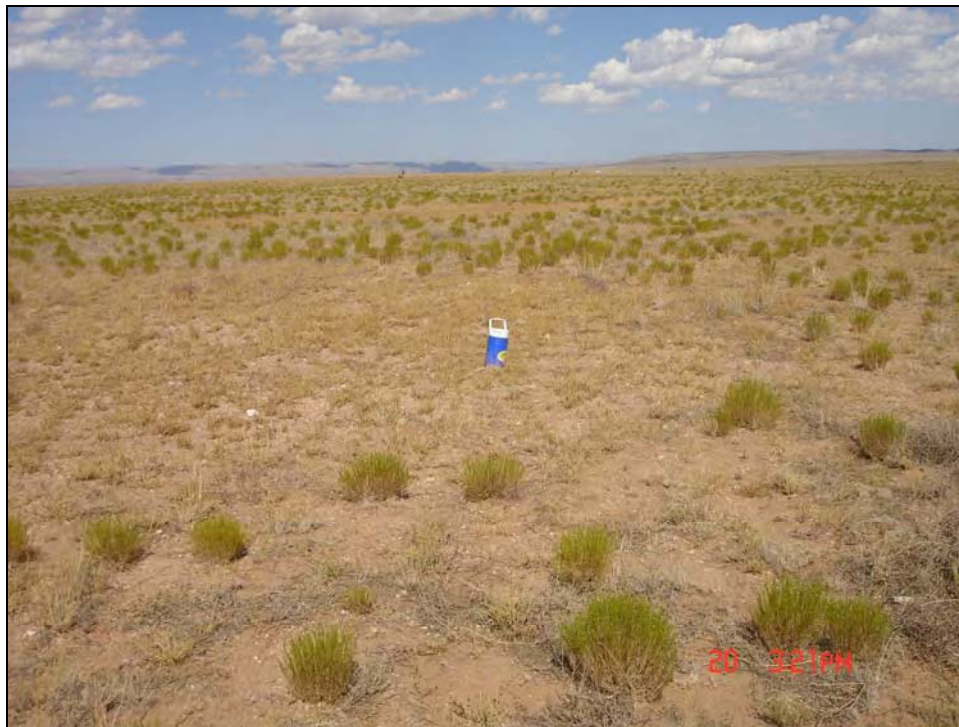
Areas or patches of mainly one type of vegetation.

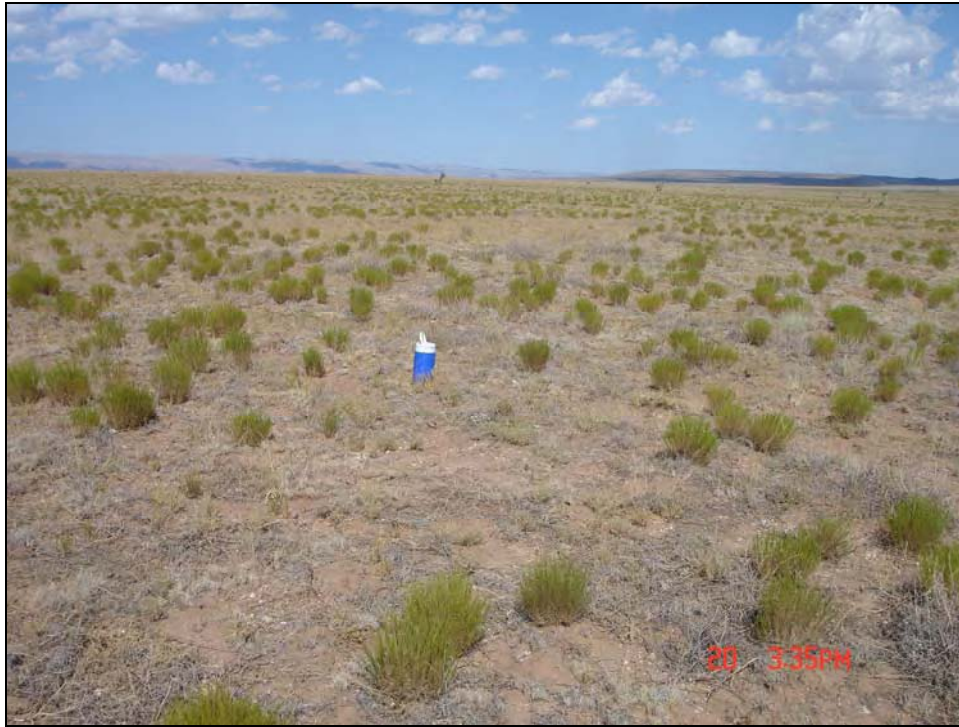
At centerline of Station 4+70 looking east.

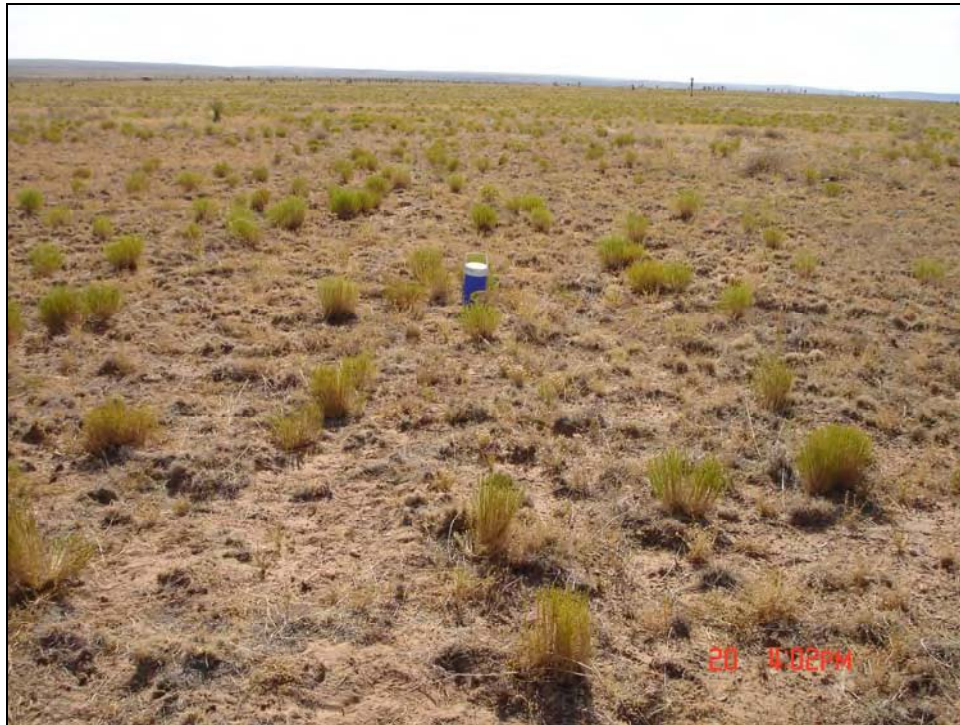
Looking west along the center of the runway at Station 5+50.

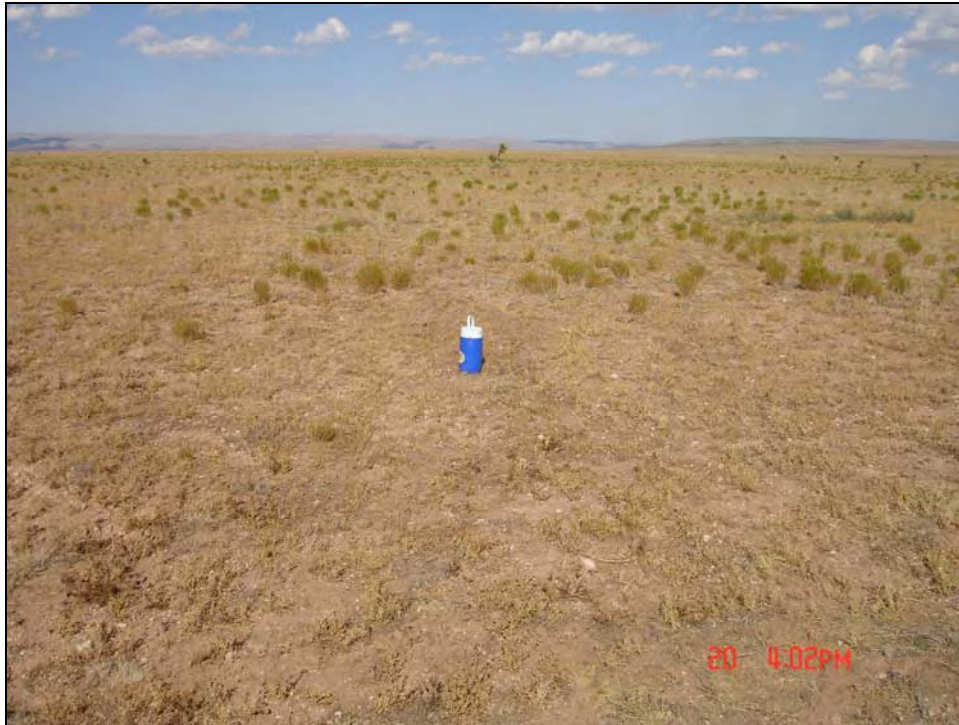
Due east along the center of the runway at Station 5+50.

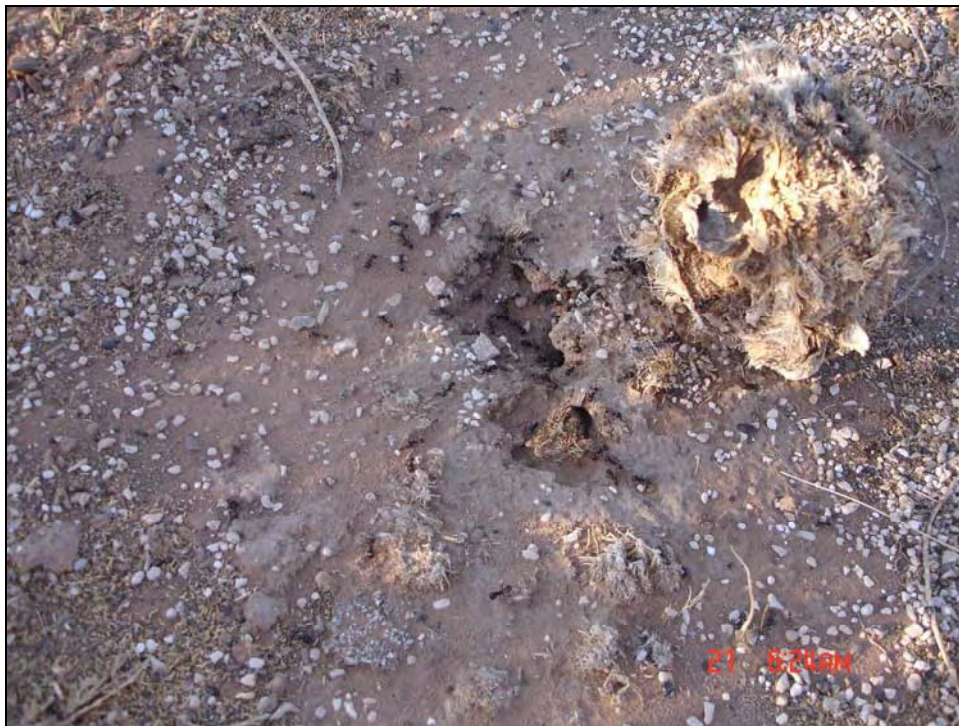
Clearing area with an ant hole in the middle.

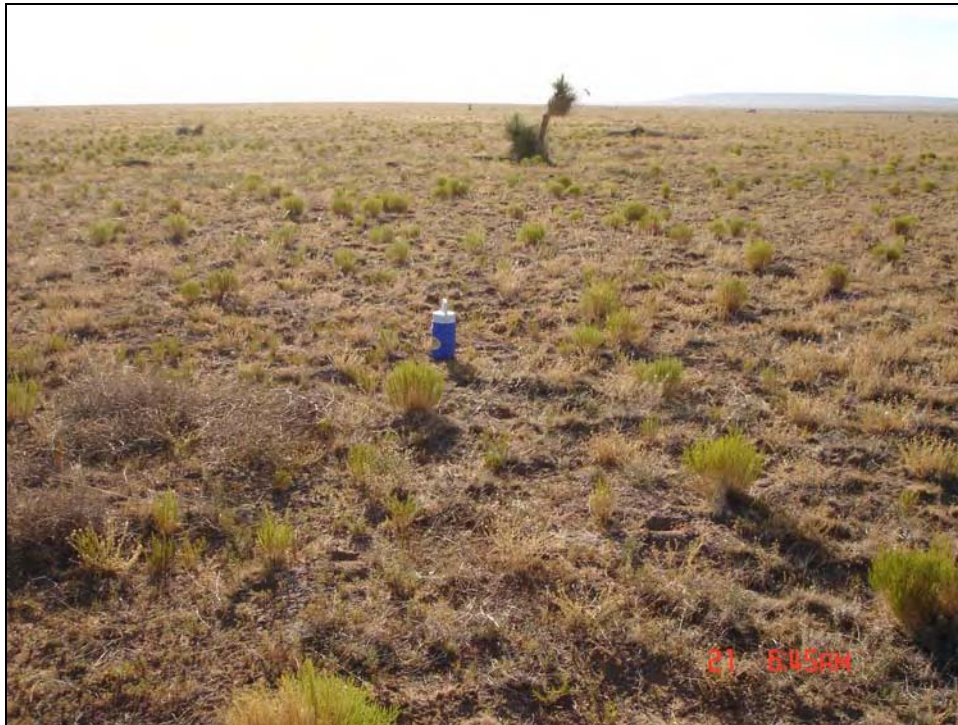
Due west at Station 6+30 along the center of the runway.

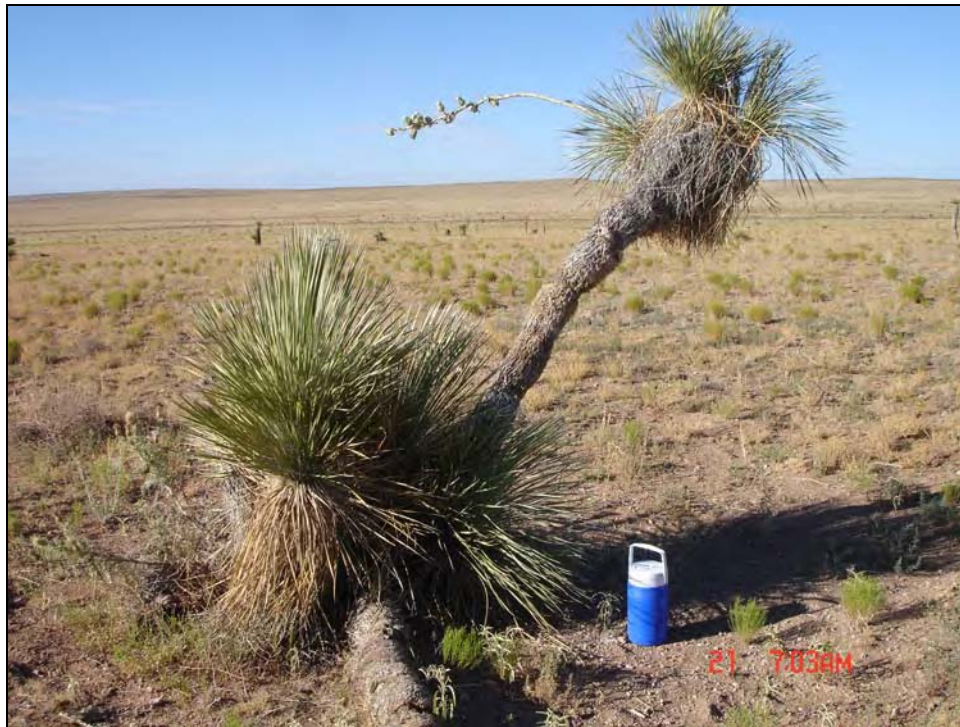
Yucca near Station 6+30.

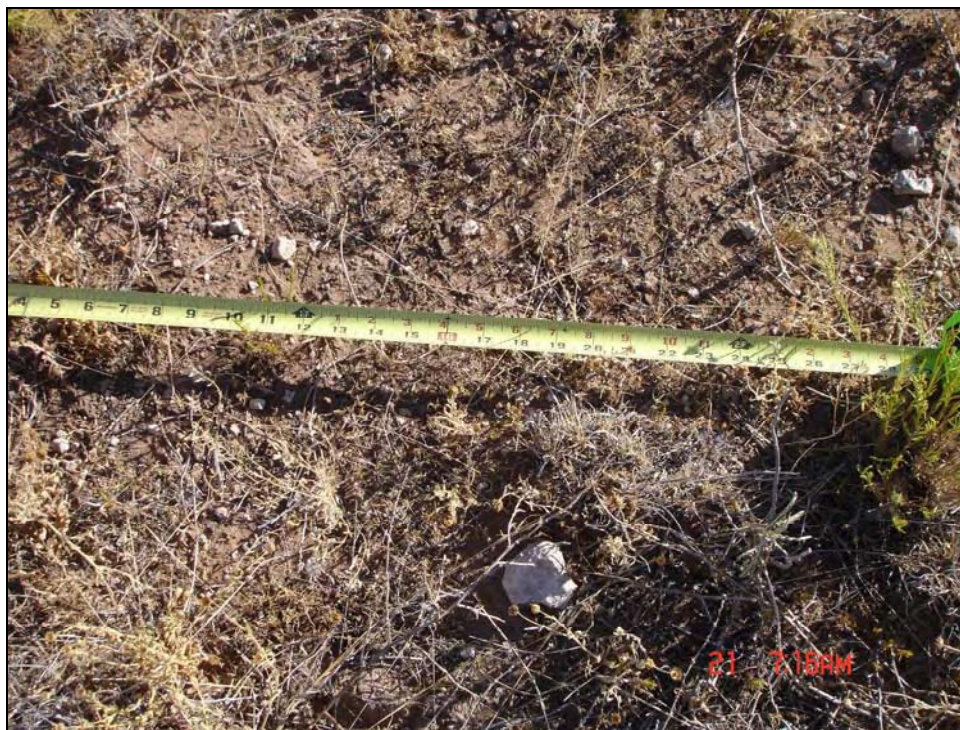
Exposed soil and caliche chunk on the surface.

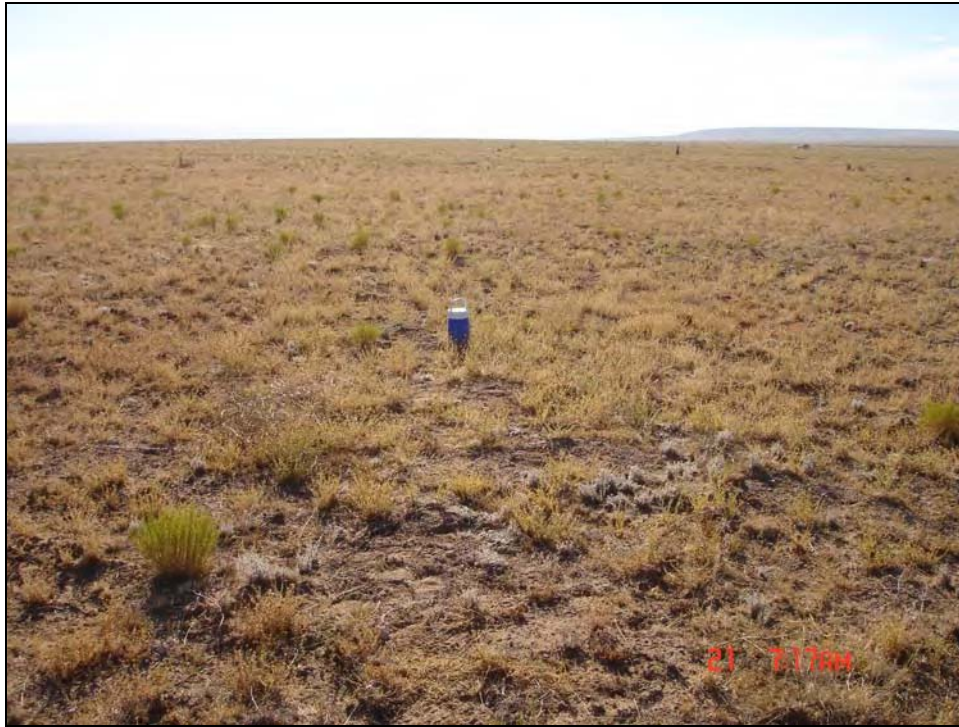
East Station 7+00 along the center of the runway.

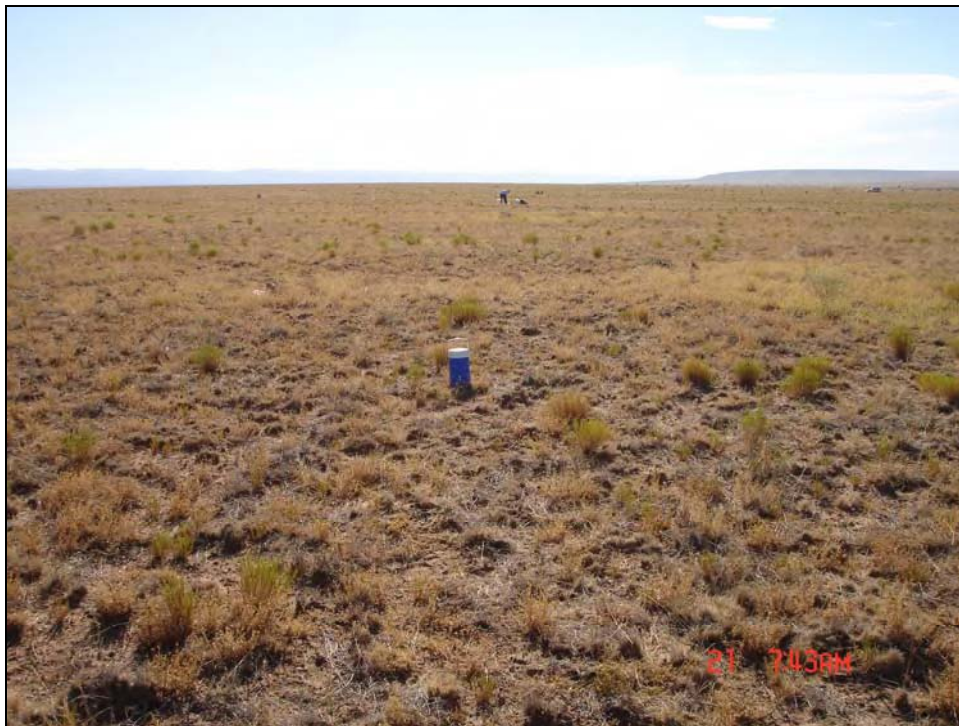
At centerline of Station 7+70 due east (with Lynette in the background at station 8+50).

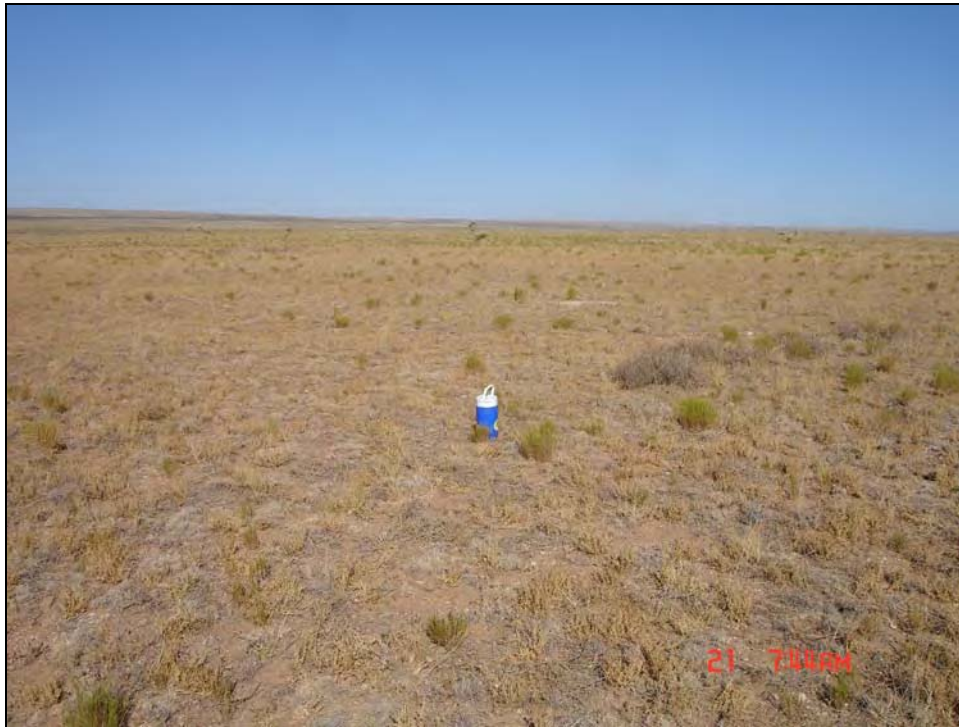
Due west along the center of the runway at Station 7+70.

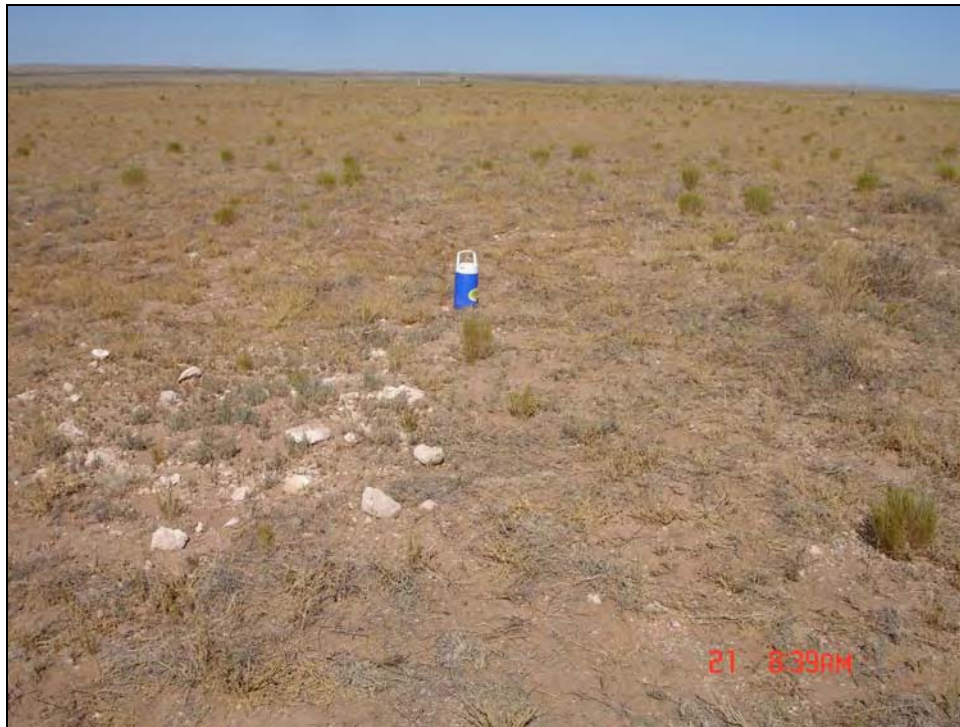
Caliche pieces on the surface; photo taken due west at station.

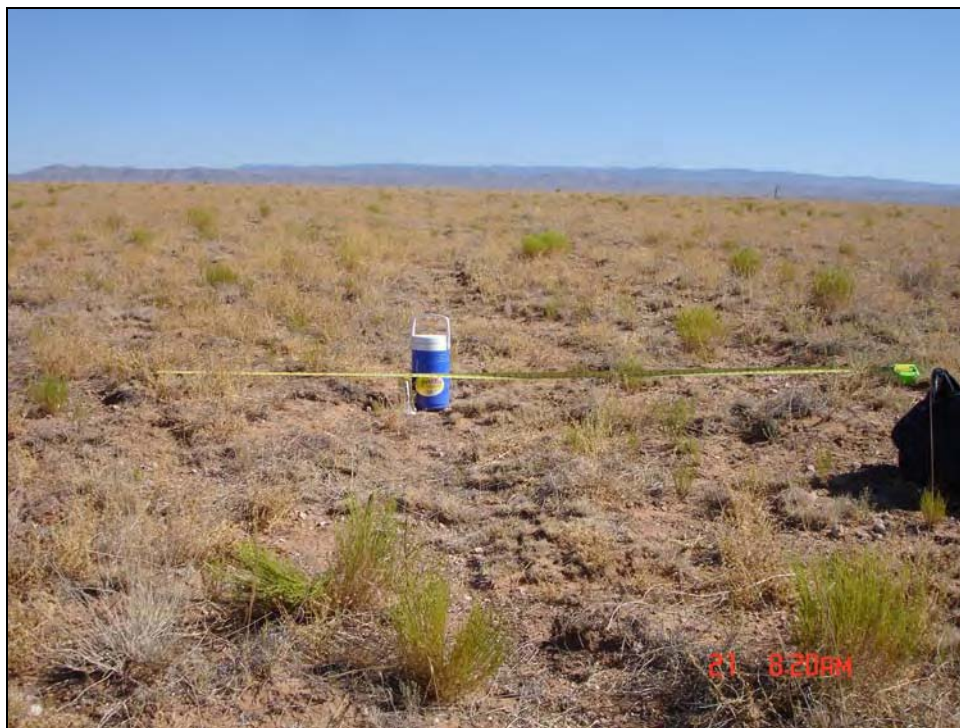
Drainage path east of Station 8+20 that runs from north to south.

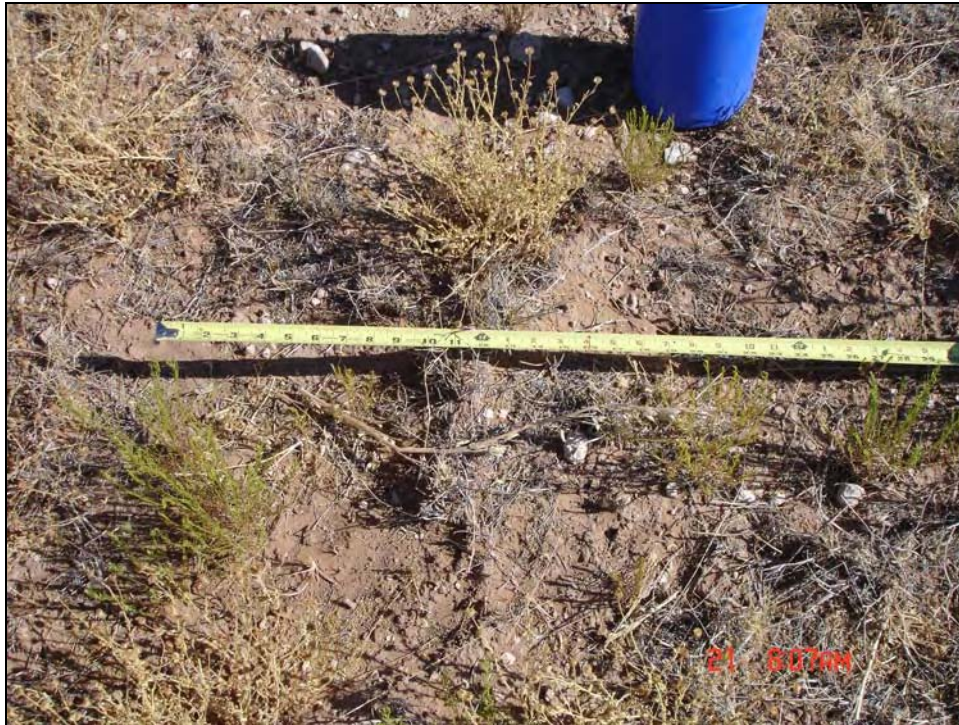
Soil at Station 8+20.

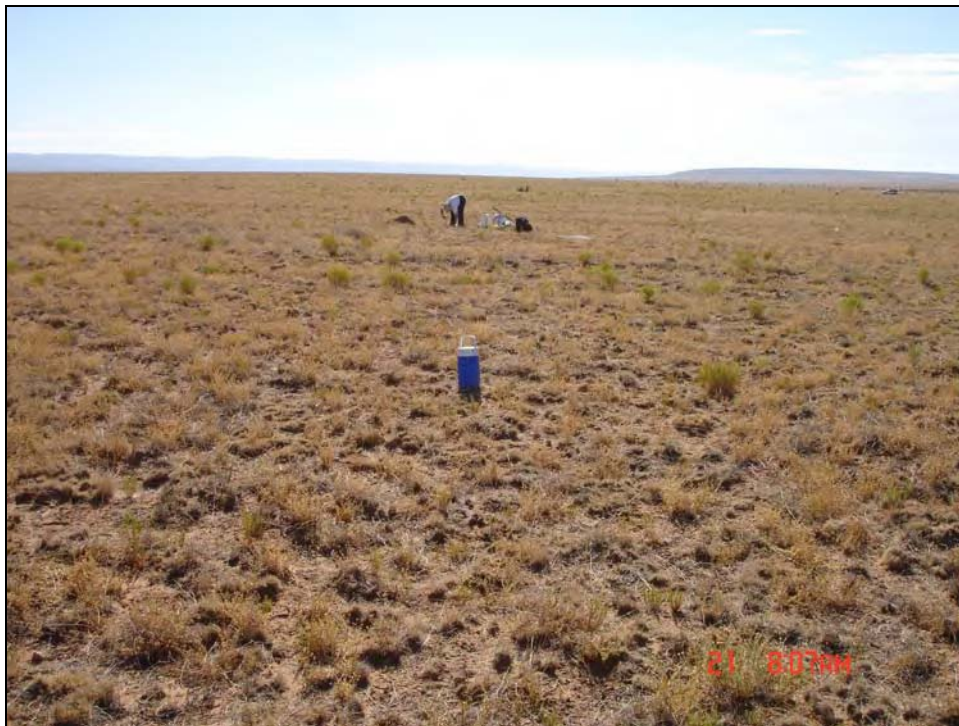
Due east at Station 8+20 centerline.

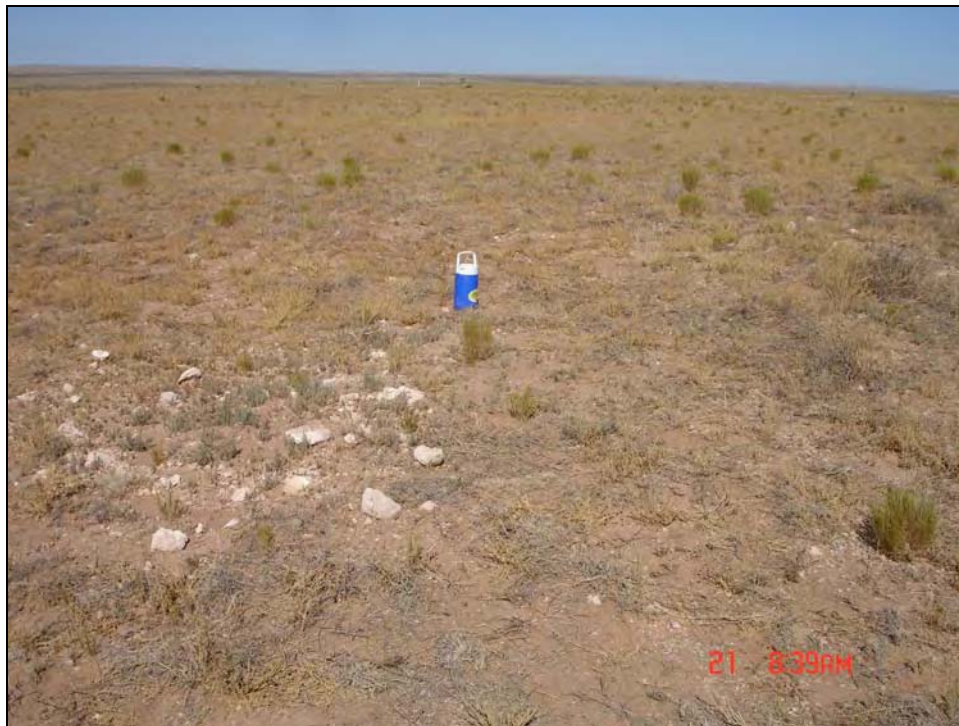
Caliche cobbles west of Station 8+50.

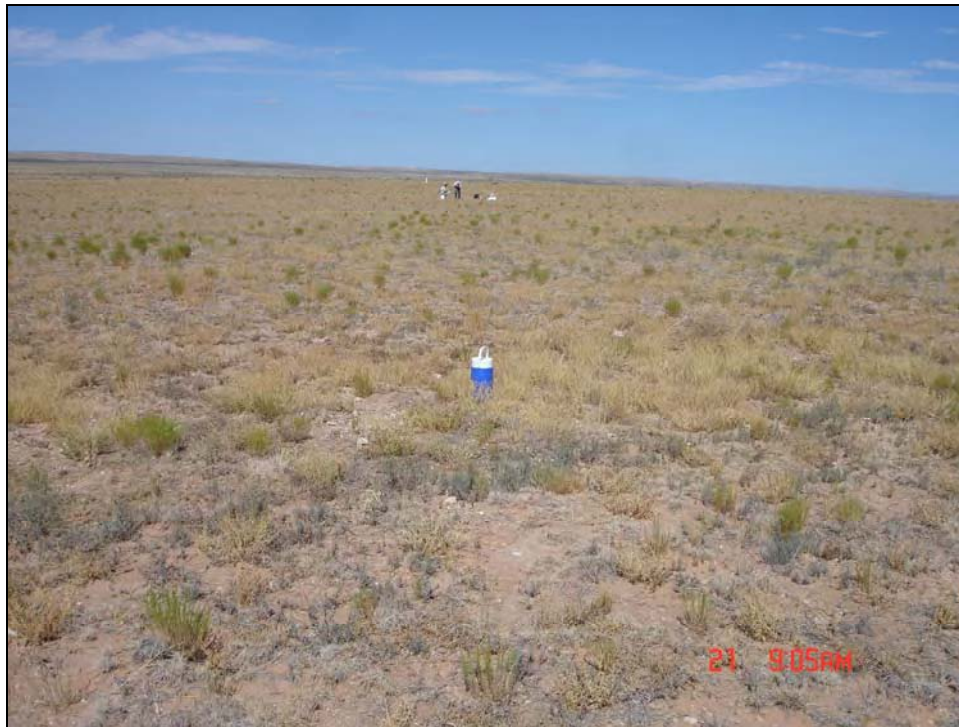
Along the center of runway at Station 9+30, due west. (People in the background are at Station 8+50.)

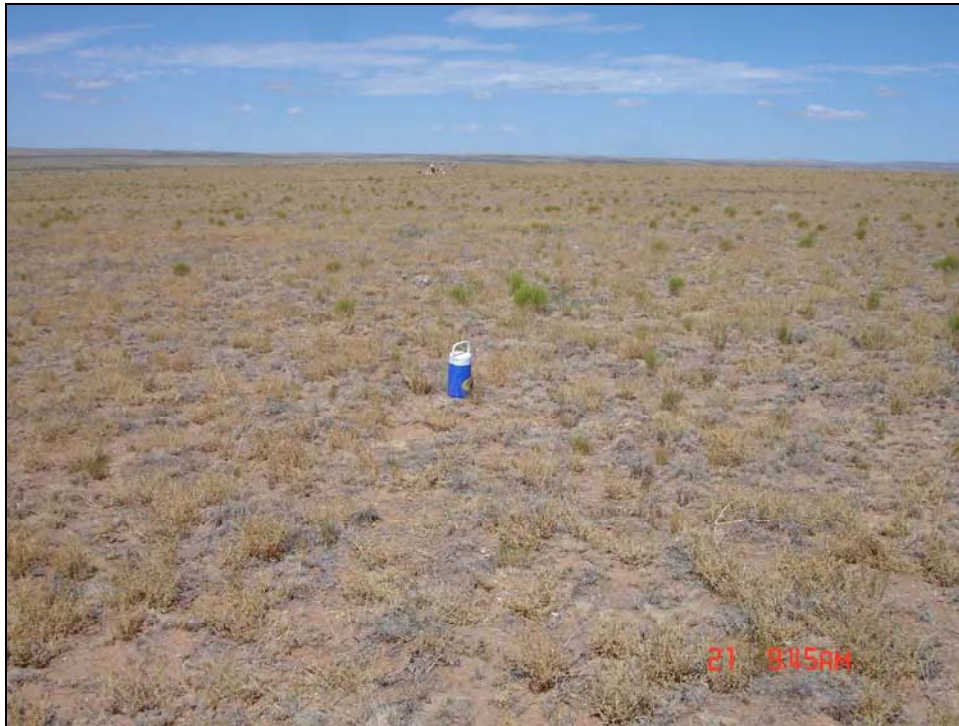
At Station 10+10, along center of runway looking west.

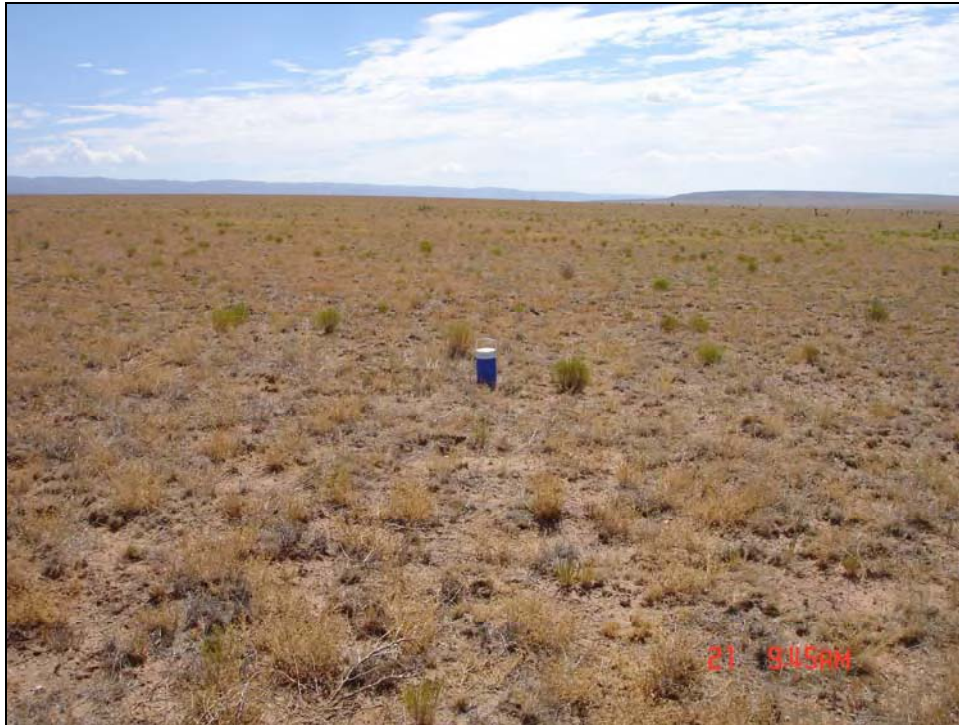
At Station 10+10 centerline, due east.

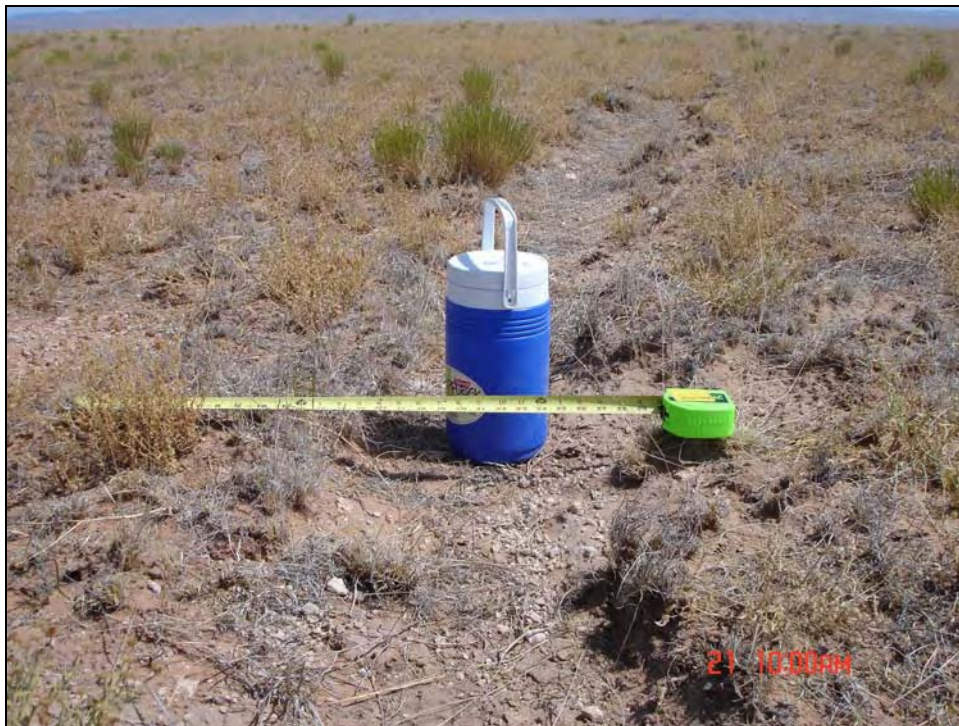
Approximately 50-ft-long scraped path west of Station 10+70.

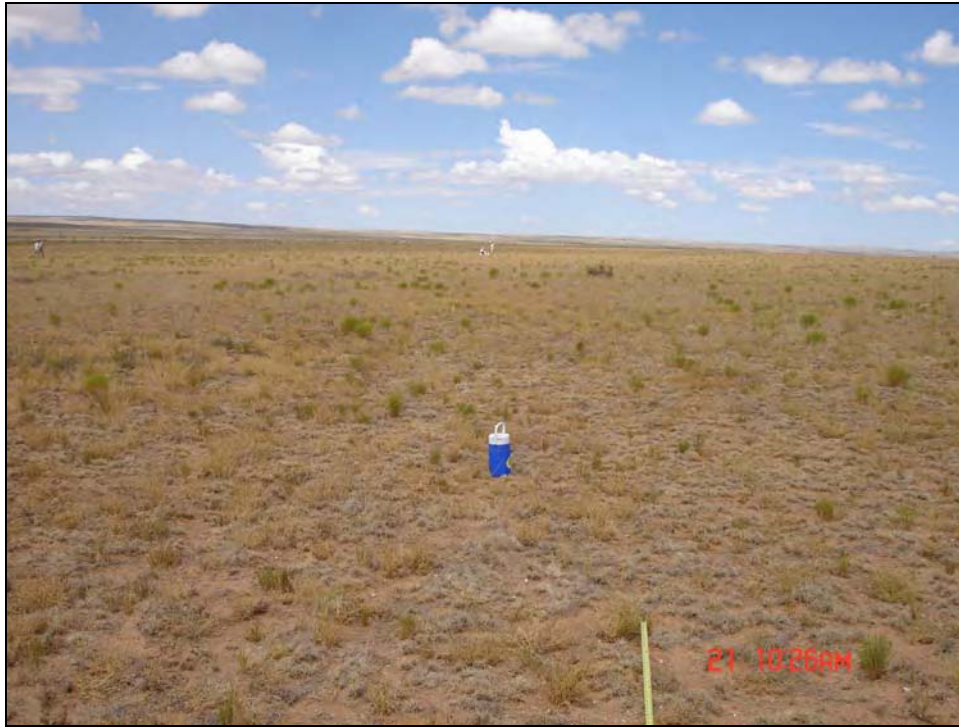
Looking west at east end of runway centerline.

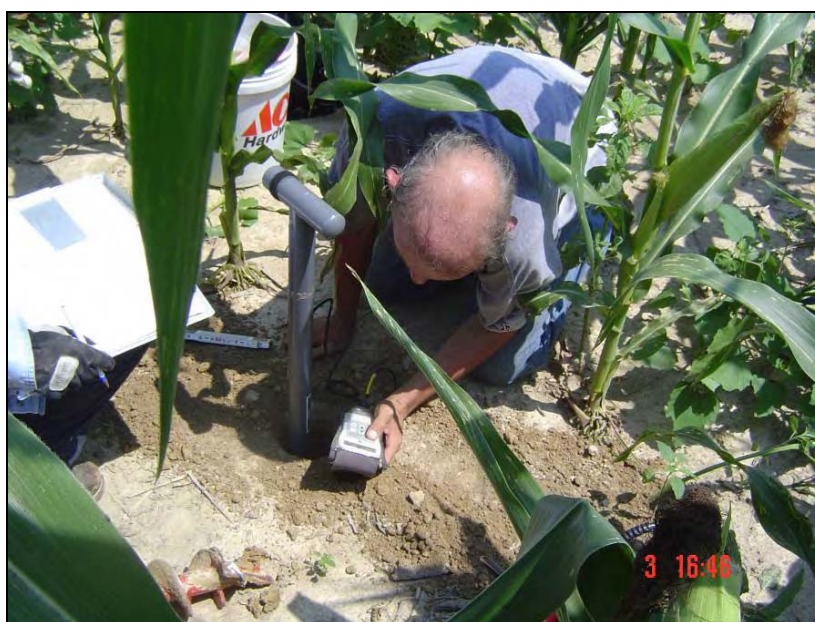
Figure C-1. Using ML2 and HH2 readout to measure soil moisture at depth within auger hole.
