*Opportune Landing Site Program*

## **Suitability Measurement and Analysis for Fort Bliss Naval Air Facility OLS**

Rosa T. Affleck, Charles C. Ryerson,  
Lynette A. Barna, and Keran J. Claffey

September 2008

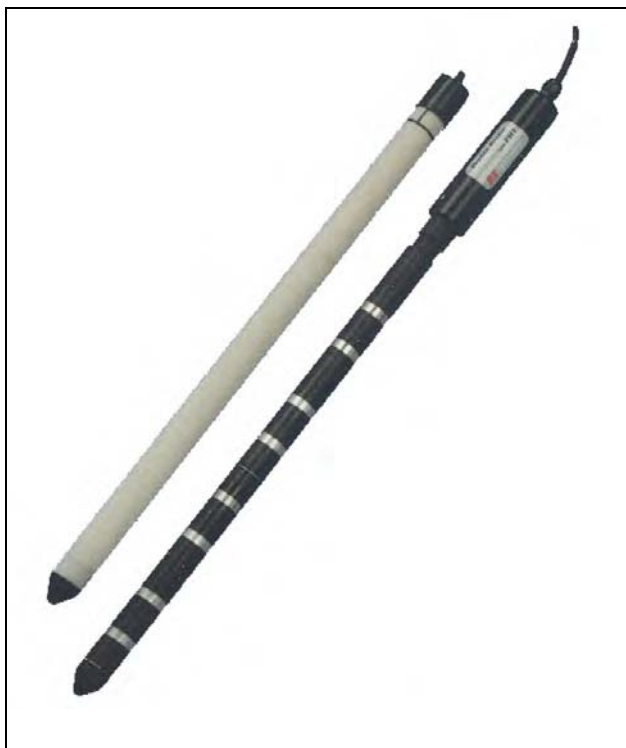
Figure C-2. Dynamax PR1 ThetaProbe inside (left) and outside (right) of access tube (Delta-T Devices 2001). The PR2 is identical in appearance.

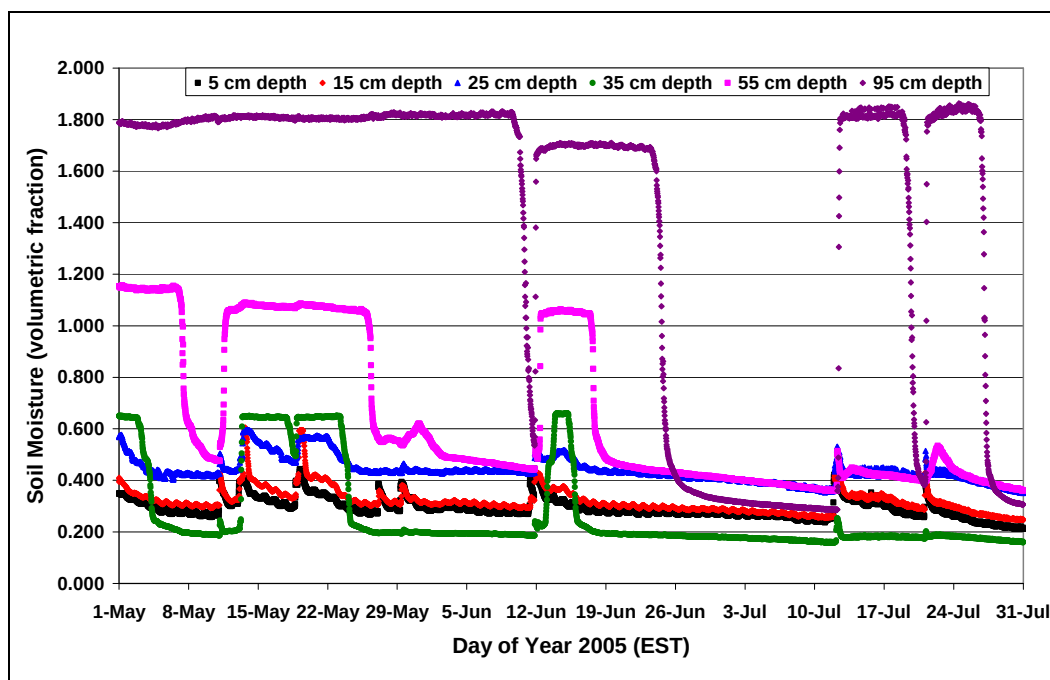
Figure C-3. Soil moisture measured by PR1 probe at North Vernon Airport. Note larger than physically possible volume fractions at depths of 55 cm and 95 cm.

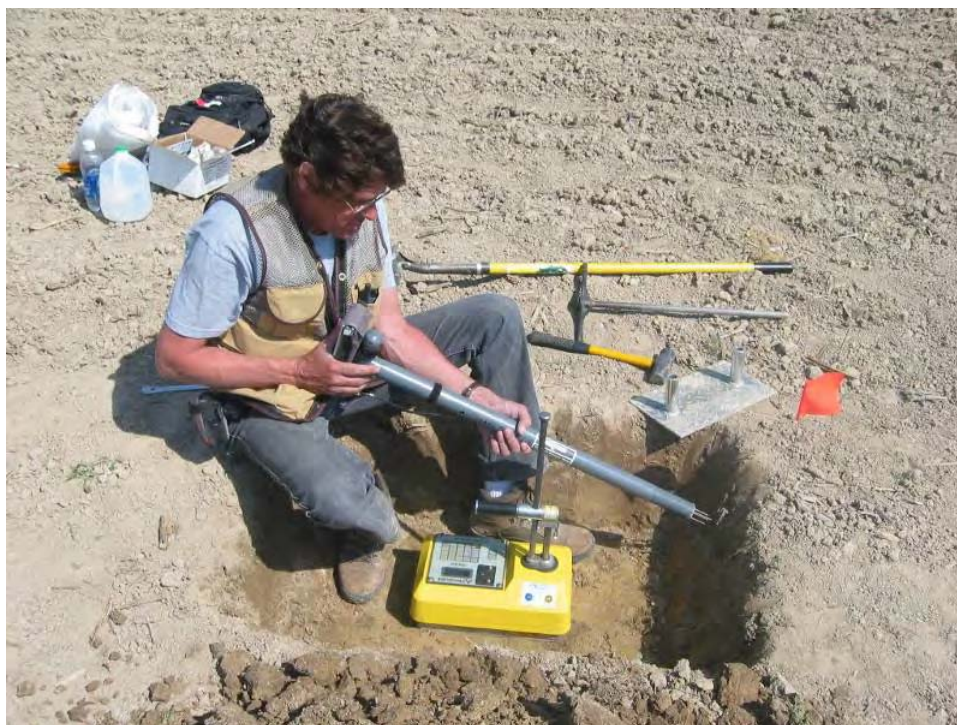
Figure C-4. Troxler nuclear gauge (yellow instrument) in moisture-reading configuration at the base of the soil pit. The Dynamax ML2 is held ready for measurement of soil moisture content, with the four stainless steel measuring rods visible at the right pit wall.

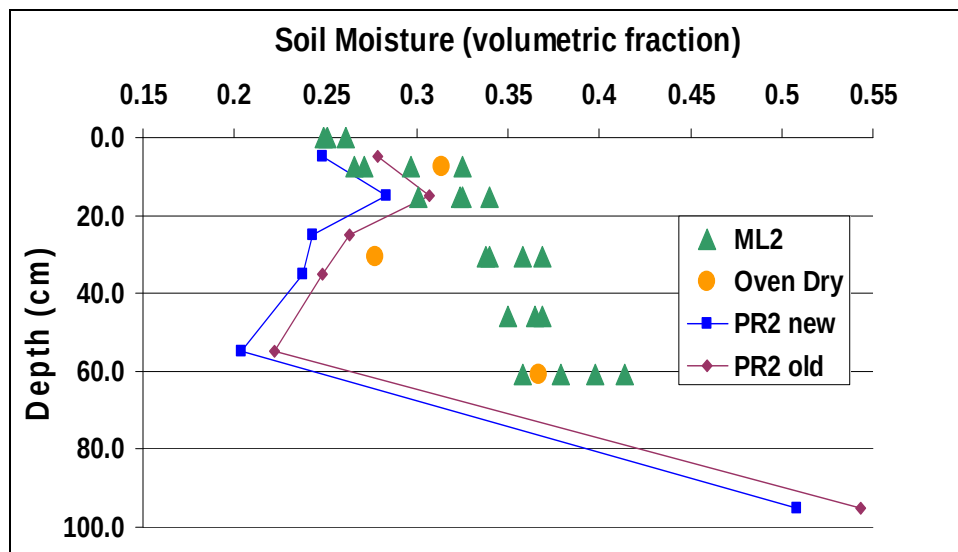
Figure C-5. Scatter of moisture readings at Ford Farm with different technologies. Note that the PR2 observations were made approximately 1 km from the other observations.

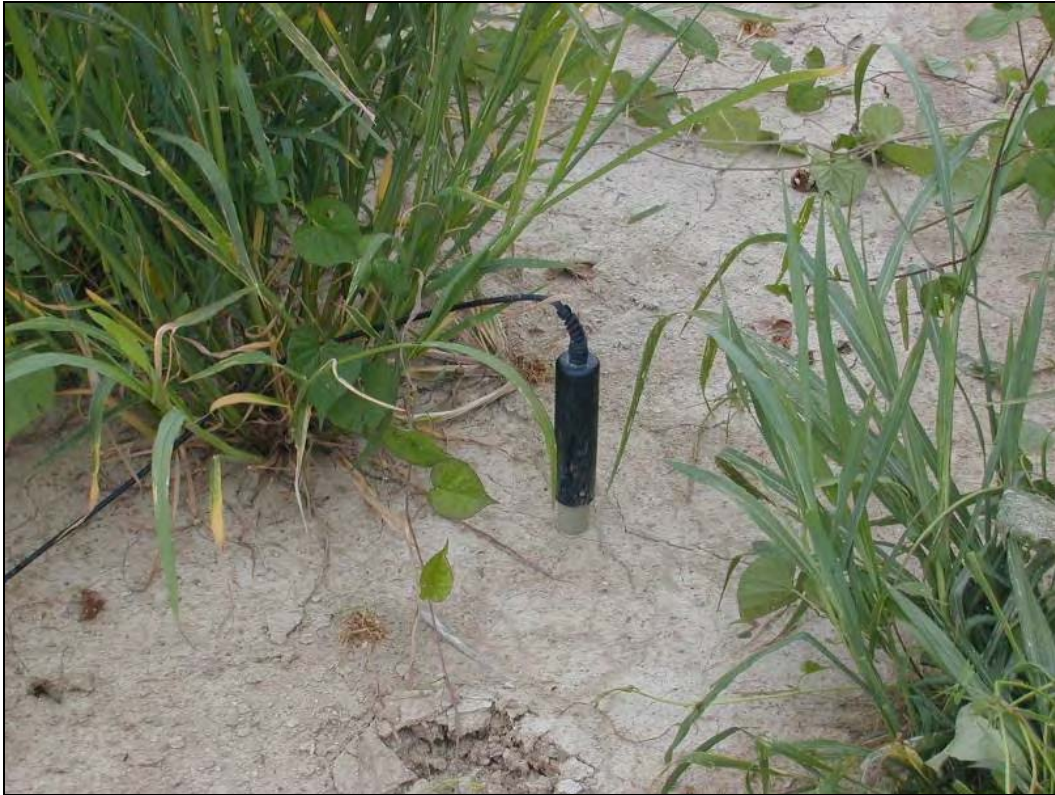
Figure C-6. Top of PR1 at North Vernon Airport protruding above soil surface when in monitoring position. White plastic sleeve is visible below dark instrument top.

The PR1 and PR2 are 1-m-long multi-depth probes with sensors arranged at 100, 200, 300, 400, 600, and 1000 mm from the top of the rod. A thin fiberglass sleeve is installed into the ground by first auguring a hole into the soil, installing, and backfilling, ensuring that no air voids occur along the length of the sleeve (Fig. C-6). The probe is either permanently placed

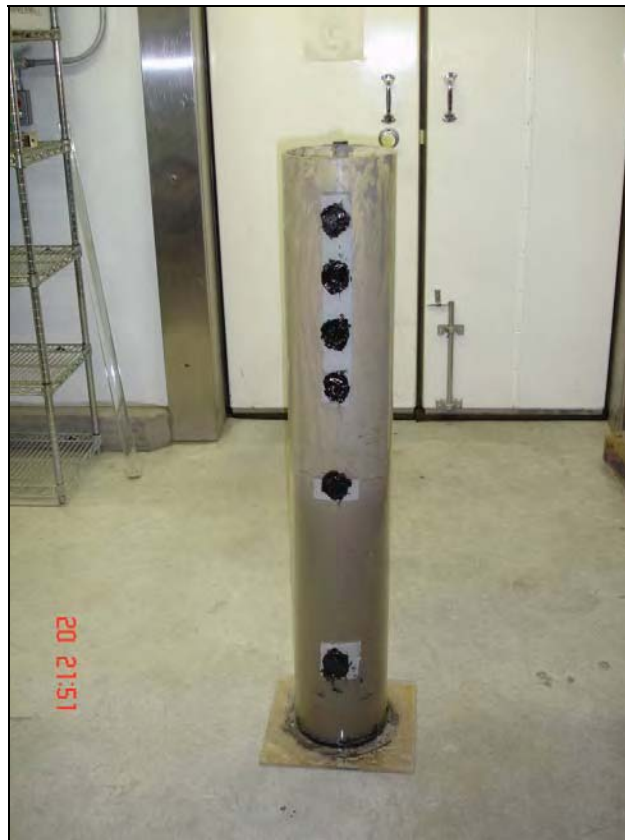
Figure C-7. Soil column for testing PR1, PR2, and ML2 probes. The PR1 and PR2 sleeve ran through the center of the column. The black, sealed holes on the side were used to measure moisture with the ML2 at the same depths as the PR1 and PR2 sensor rings.

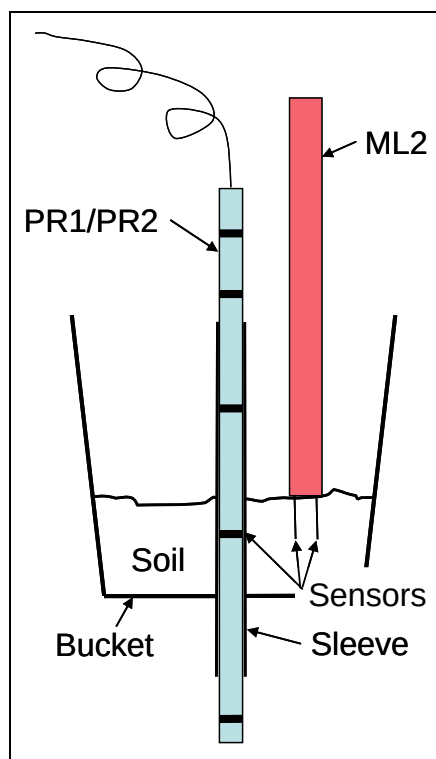
Figure C-8. Cross section of apparatus to measure soil moisture in OLS field soils with the ML2, PR1, and PR2 probes.

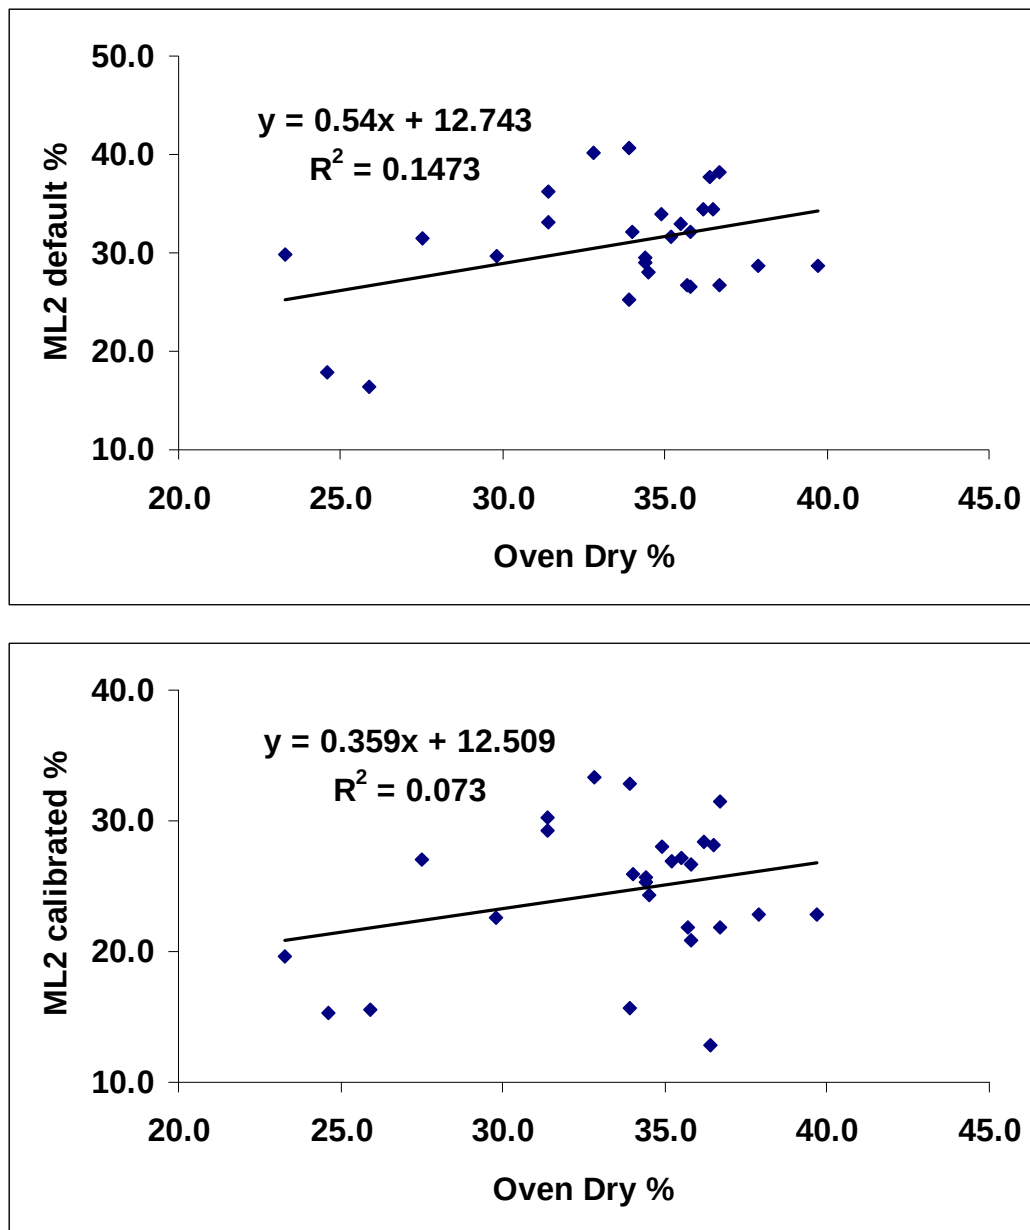
Figure C-9. Scatter plots and Pearson parametric linear regressions for North Vernon Airport moisture contents. Oven-dry versus ML2 default calibration (top) and soil-specific calibration (bottom).

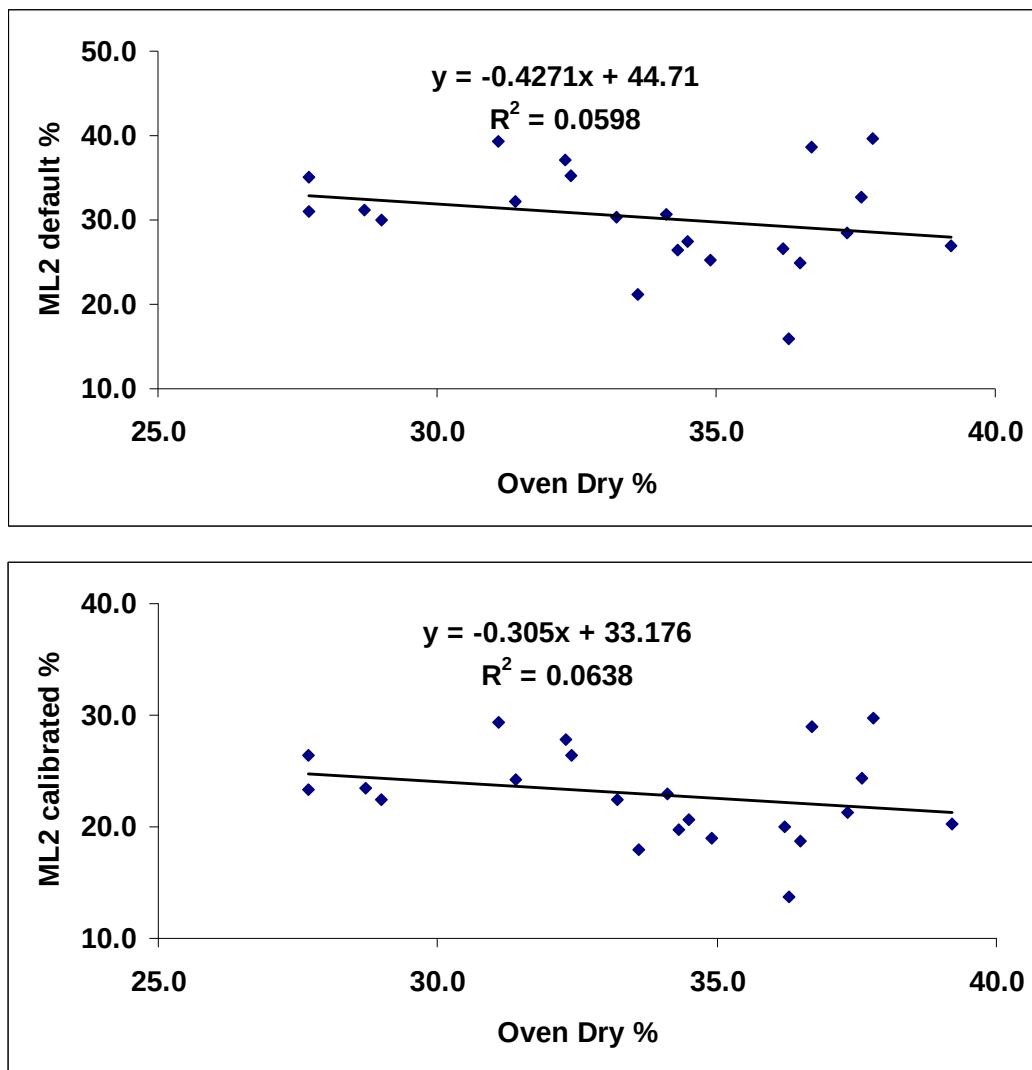
Figure C-10. Scatter plots and Pearson parametric linear regressions for Ford Farm moisture contents. Oven dry versus ML2 default calibration (top) and soil-specific calibration (bottom).

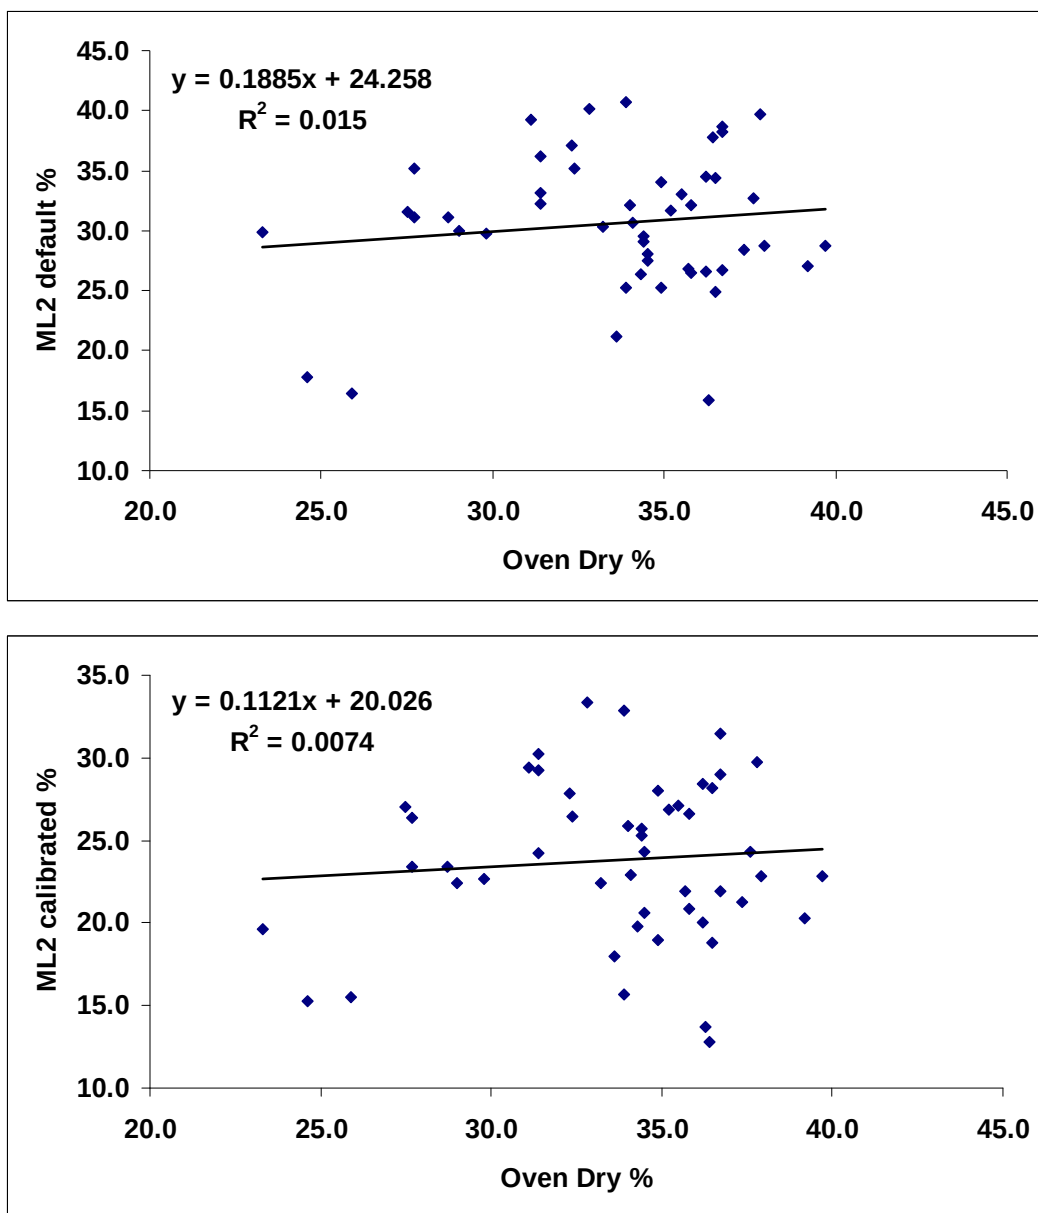
Figure C-11. Scatter plots and Pearson parametric linear regressions for the Eastern Site moisture contents. Oven-dry versus ML2 default calibration (top) and soil-specific calibration (bottom).

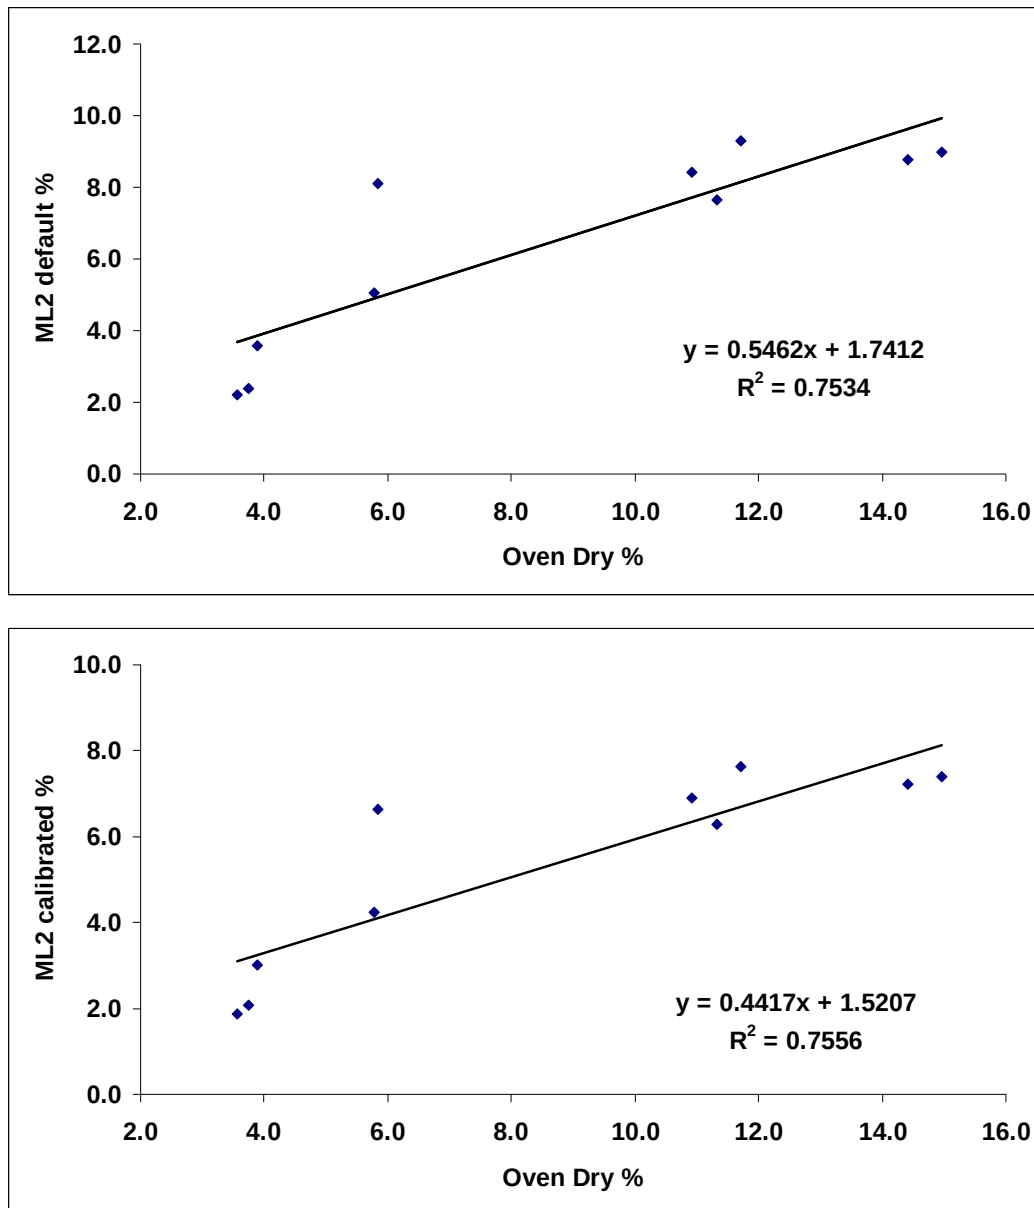
Figure C-12. Scatter plots and Pearson linear regressions for Fort Bliss moisture contents. Oven-dry versus ML2 default calibration (top) and soil-specific calibration (bottom).

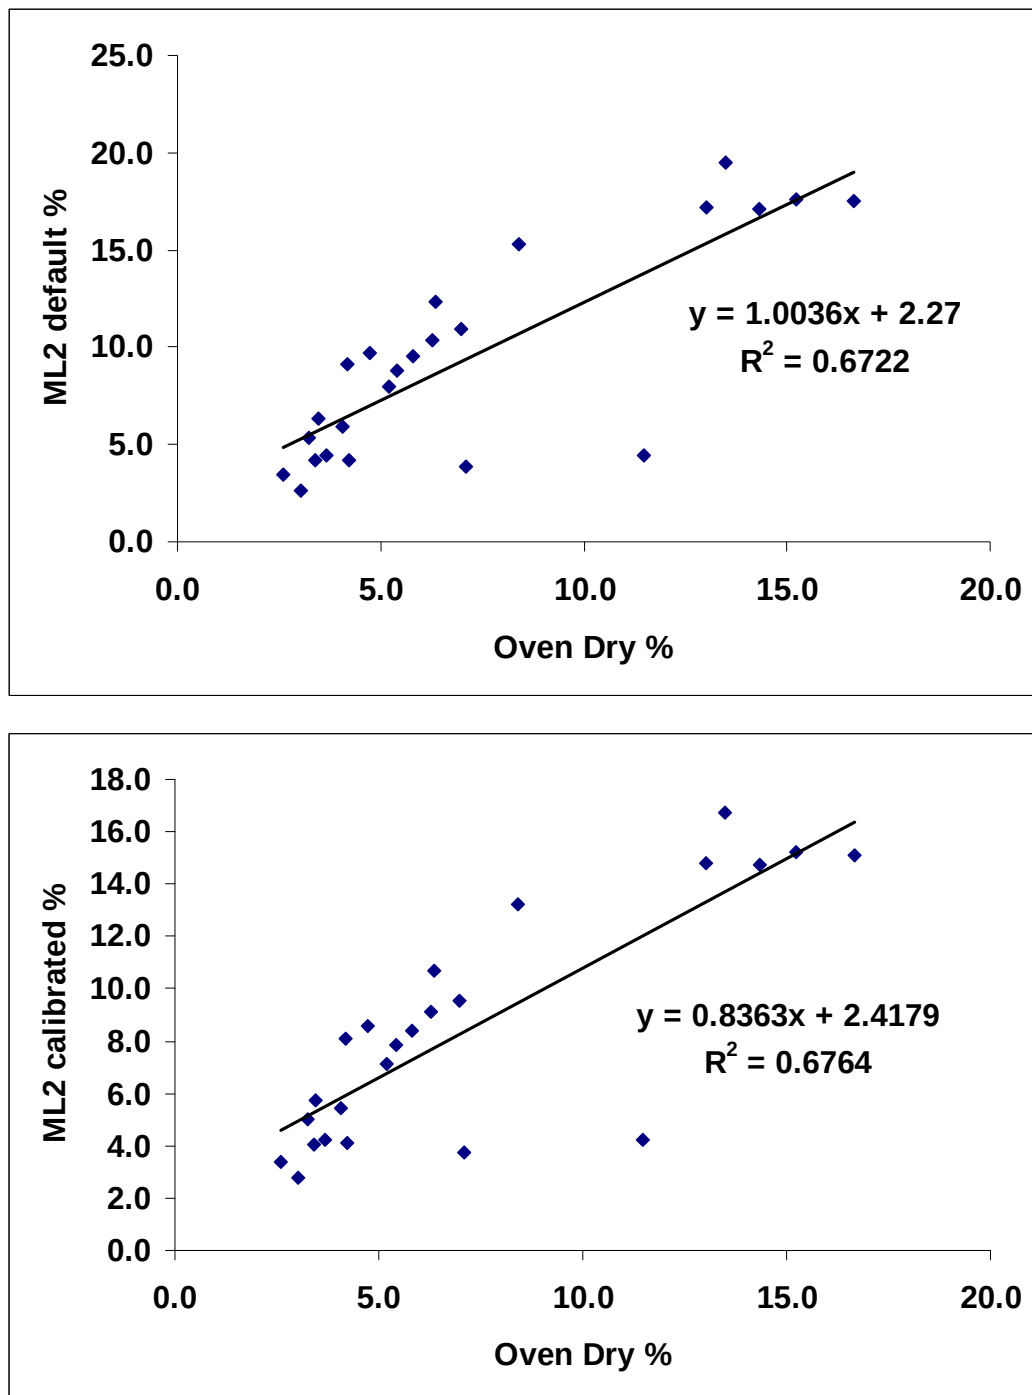
Figure C-13. Scatter plots and Pearson linear regressions for El Centro NAS moisture contents. Oven-dry versus ML2 default calibration (top) and soil-specific calibration (bottom).

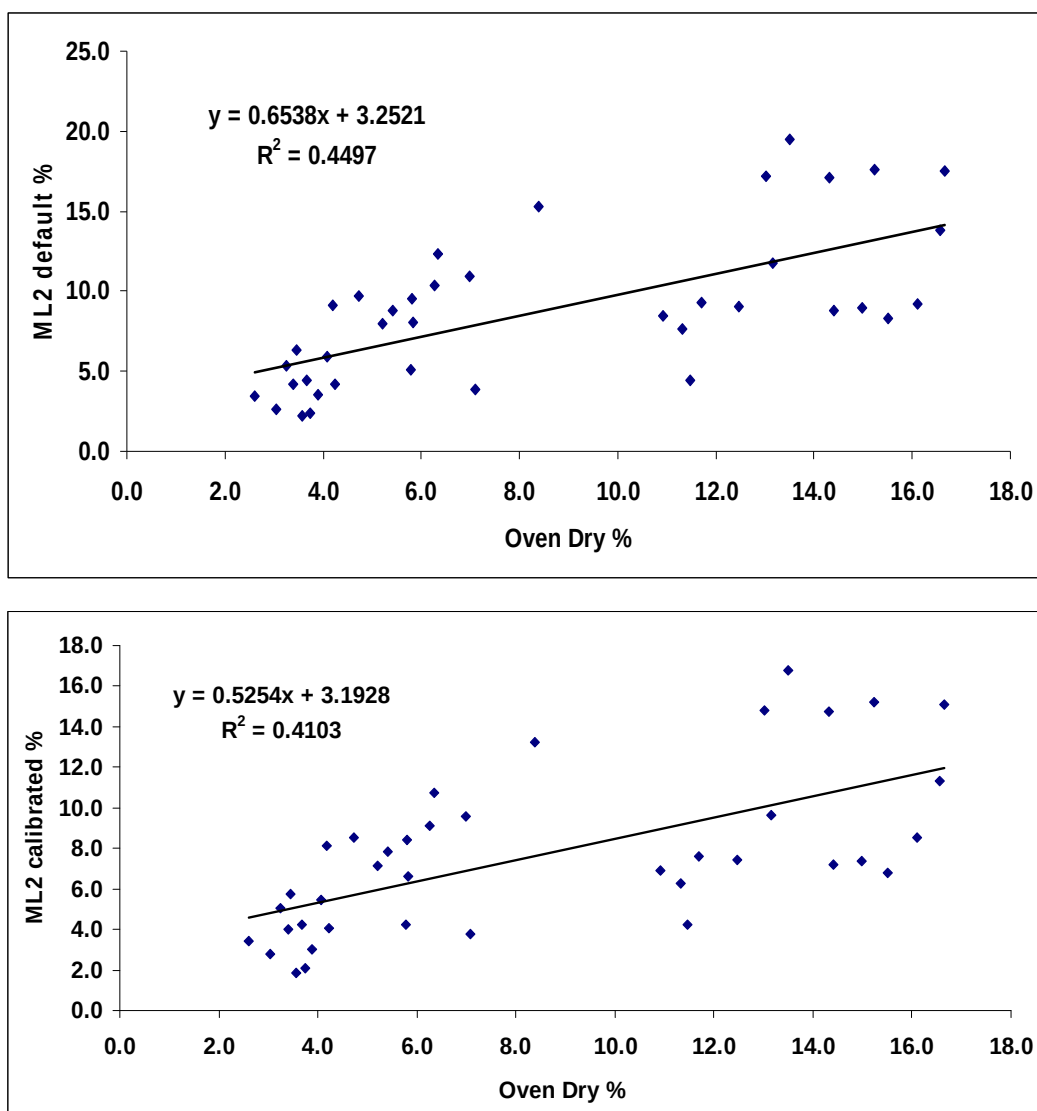
Figure C-14. Scatter plots and Pearson linear regressions for Western Sites moisture contents. Oven-dry versus ML2 default calibration (top) and soil-specific calibration (bottom).
