## FURTHER TEST RESULTS FOR PROTOTYPE GPS RUBIDIUM CLOCKS

S. Goldberg, T.J. Lynch and W.J. Riley  
EG&G, Inc.  
Salem, Massachusetts

This paper presents the results of further stability and qualification-level environmental tests on two prototype rubidium frequency standards for the GPS navigation satellite program.

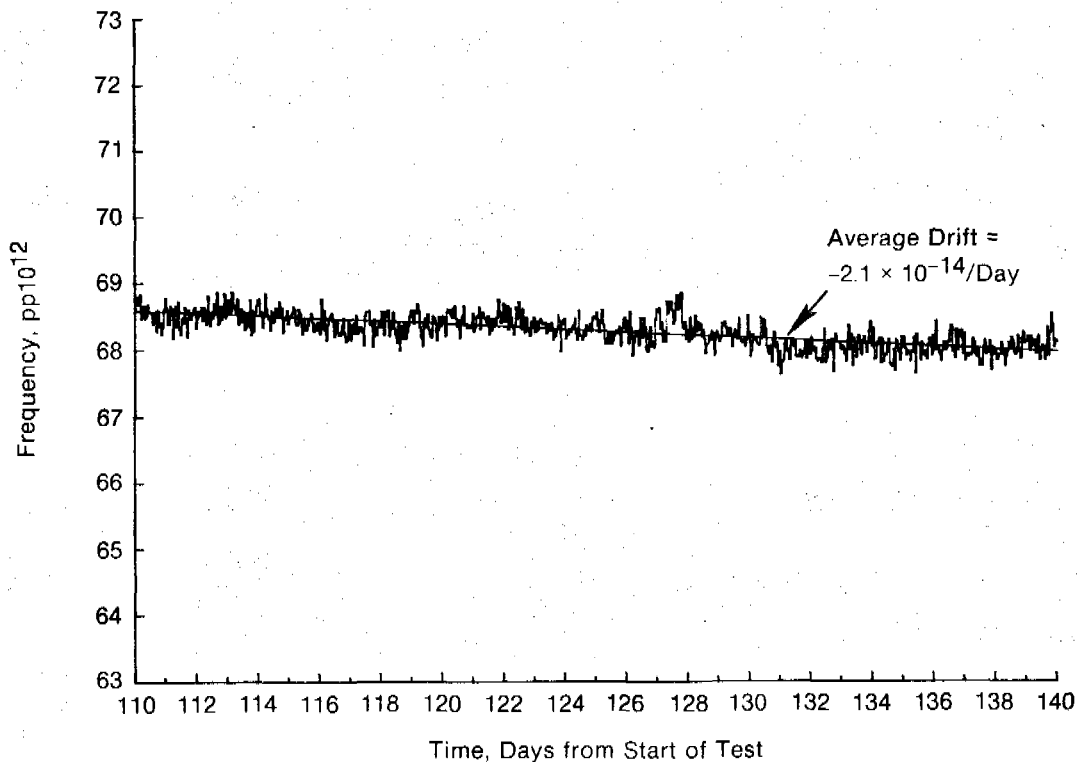
This change was highly successful. The drift observed during the last month of the stability retest was  $-2 \times 10^{-14}$ /day, as shown in Fig. 1. This is one-fifth the specified value, and an improvement of ten-to-one.

Fig. 1 - EG&G GPS RFS P-1 stability test in thermovac 2/12/85 to 3/12/85 (last month).

The unit accumulated the required 140 days of uninterrupted operation and showed excellent stability. A plot of the last month's stability record was shown in Fig. 1. The average drift during the last 30 days was  $-2.1 \times 10^{-14}$ /day, well below the  $\pm 1 \times 10^{-13}$ /day specification and  $\times 10$  lower than observed during the original stability test at NBS. This improvement is due to the lower helium permeation absorption cell envelope. The unit showed no jumps in light intensity as it did before substitution of a lamp with normal rubidium fill.

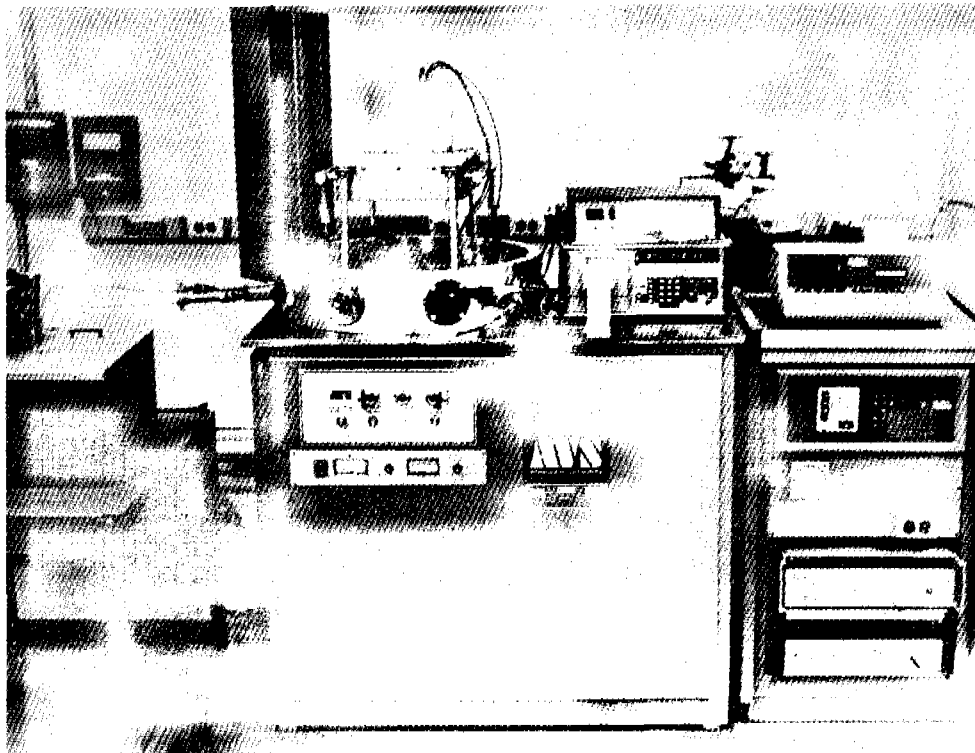
The purpose of the stability retest on Prototype No. 1 was to confirm the improvements made as a result of the frequency drift and jump investigations. This 140-day stability retest was conducted under thermovac conditions at EG&G between October 10, 1984 and March 12, 1985. The test set-up is shown in Fig. 2. The major elements of the RFS test set-up are as follows:

1. thermovac chamber with baseplate temperature controller,
2. dc power supply and battery for RFS,
3. ground tuning simulator,
4. frequency measuring system,
5. monitor data logger, and
6. uninterruptible power system for computer.

The test set-up is similar to the one used for the original stability test at NBS.<sup>(4)</sup> The main difference is that the reference for the frequency measurements is a single cesium beam standard. This is adequate to determine the frequency drift and jump characteristics of the RFS under test, but the single cesium reference has insufficient stability to define the short- and medium-term performance of the RFS.

Fig. 2 - 140-day thermovac stability test set-up at EG&G.

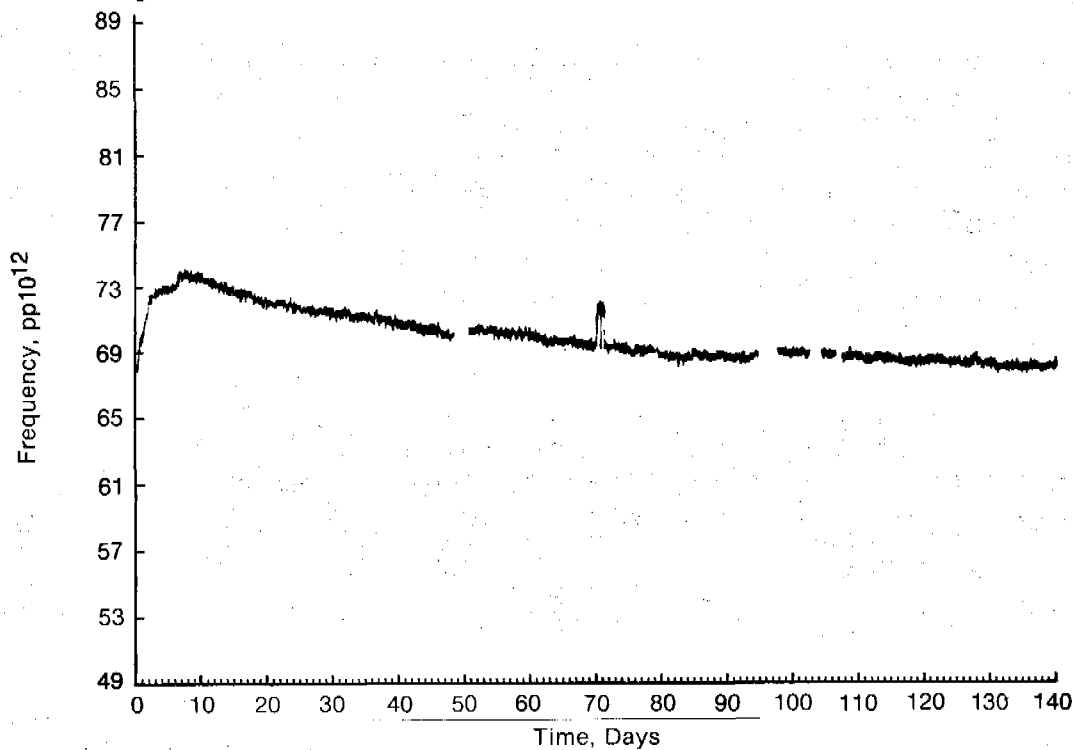
The complete frequency record for the 140-day stability retest of Prototype No. 1 is shown in Fig. 3. This record shows the  $\tau = 1$  hour frequency data versus a HP 5061A option 004 cesium standard. The gaps in the record are due to failures of the thermovac chamber, the frequency measuring system, or unlock of the cesium standard. The longest gaps in the record are during periods of partial loss of vacuum. The excursions at days 70-71 are due to the RFS itself. The short-term scatter is determined primarily by the cesium reference.

The record begins on October 22, 1984 shortly after turn-on and pump-down, following installation of a new lamp and absorption cell. The new lamp replaced one having excessive rubidium fill that caused occasional jumps in light output and frequency. The new absorption cell replaced one made from a type of glass more permeable to helium, which was the dominant drift factor.

The unit required about 1 week to settle in frequency and about 3 weeks to reach a steady drift below the  $1 \times 10^{-13}$ /day specification limit. Operation was uneventful for the first 48 days of the test.

Fig. 3 - EG&G GPS RFS P-1 stability test in thermovac 10/22/84 to 3/12/85.

During days 49-50, the unit experienced a partial loss of vacuum. The pressure inside the bell jar increased to about 50 Torr, which caused thermal and barometric changes inside the RFS. After repair of the thermovac system, the RFS frequency and all monitor readings returned to normal. There was no permanent frequency offset or change in drift or scatter. The continuity of the test was therefore not affected.

During days 70-71, the unit showed two separate frequency excursions of about  $+2 \times 10^{-12}$  and back that lasted for several hours. Each transition was abrupt and involved only the RFS signal and frequency. There was no change in the light or any other monitor indication. There was no permanent frequency offset or change in drift or scatter. During the excursions, the signal change was about -8%. Such a signal change (without a light or temperature change) is almost certainly due to a change in cavity microwave power.

On days 94-97 there was another episode of poor vacuum. The RFS monitors and frequency recovered normally after good vacuum was restored.

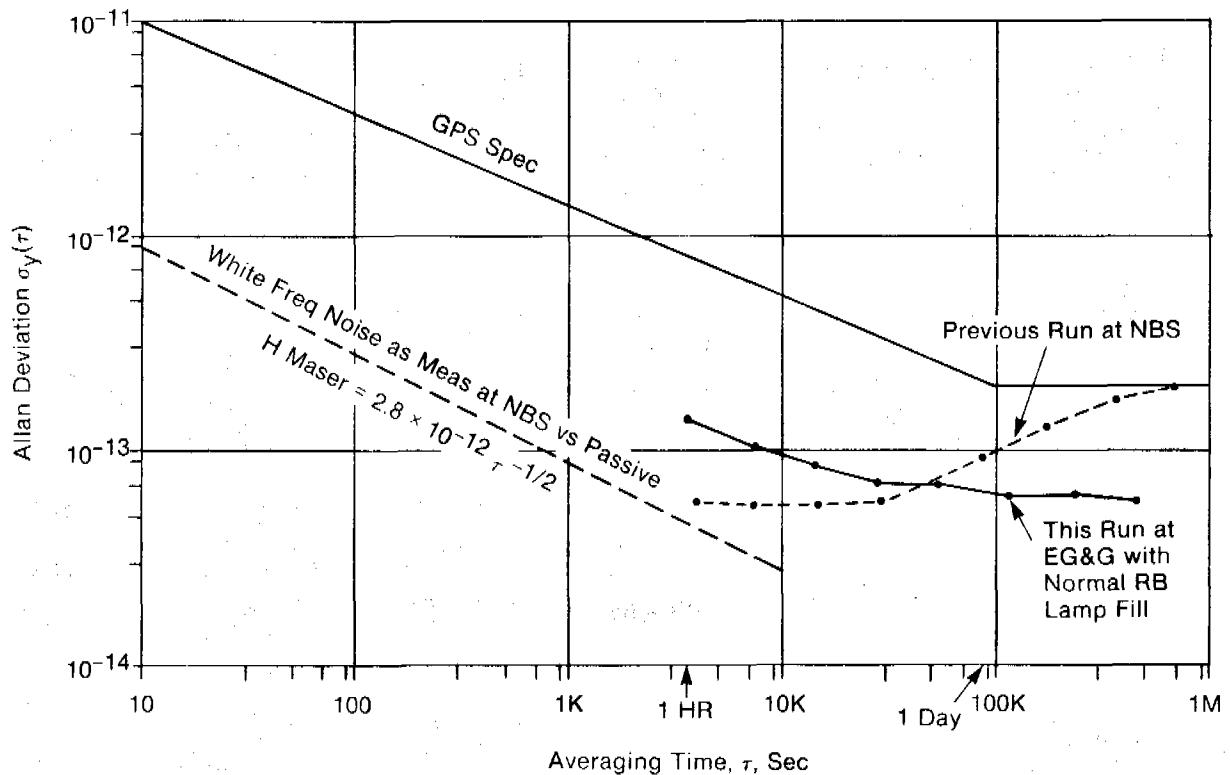
A plot of the time-domain stability is shown in Fig. 4. The stability is considerably better than the previous run for long averaging times, due primarily to the absence of the lamp-induced frequency jumps. The medium-term stability is limited by the single cesium reference.

Fig. 4 - Drift-corrected time domain frequency stability of EG&G GPS RFS P-1.

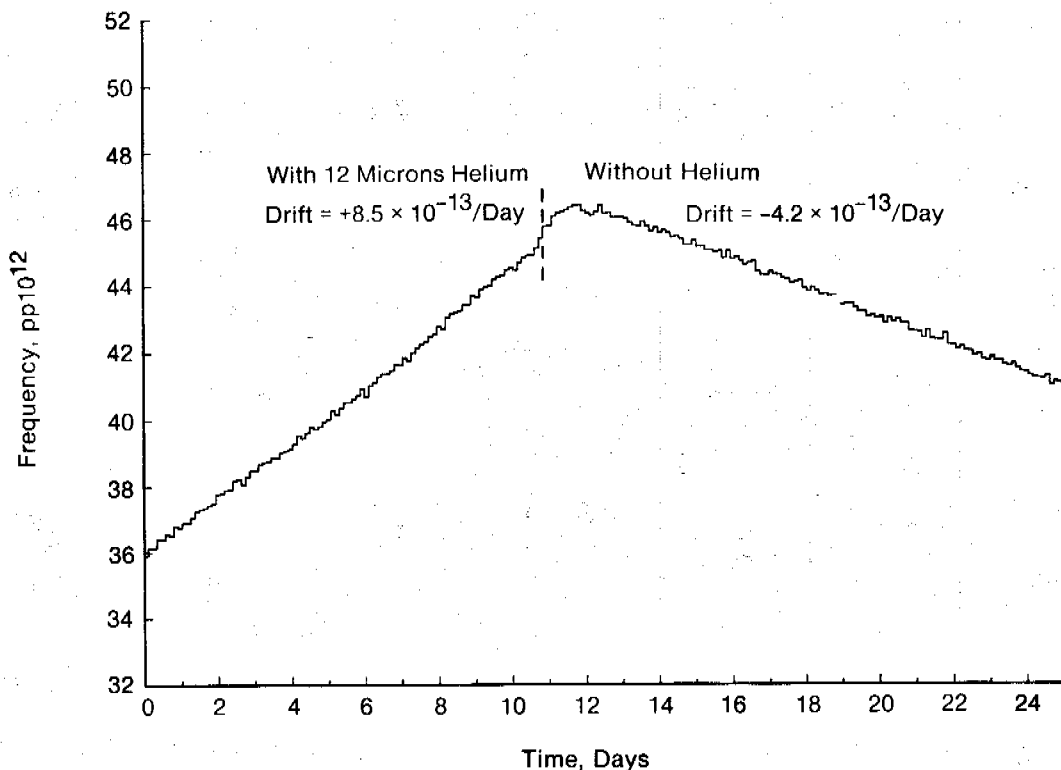
Testing was performed on EG&G GPS RFS Prototype No. 2 to determine if helium permeation of the absorption cell could be a cause of frequency drift. A helium bottle with a pressure regulator and flow meter was connected to a vacuum regulator and a micrometer leak valve to the vacuum system to allow flow of helium into the thermovac chamber surrounding the RFS. The chamber was evacuated and helium was allowed to flow into the chamber with the valve to the diffusion pump partially closed. The settings of the various regulators and valves were adjusted until a steady pressure of about 12 microns of helium was achieved. (This is about 3X the concentration of helium in air.) Pressure was set initially using a Granville-Phillips Series 275 Vacuum Gauge and monitored using the vacuum system thermocouple gauge; pressure values should be considered nominal only. As shown by the first eleven days of Fig. A1, the RFS frequency exhibited a drift of  $+8.5 \times 10^{-13}/\text{day}$  while exposed to 12 microns of helium.

Fig. A1 - EG&G GPS RFS P-2 stability with and without helium 5/12/83 - 6/6/83.

The helium flow was then shut off, and the chamber pumped down to hard vacuum for the remainder of the 24-day test period. Upon exposure to hard vacuum, the RFS frequency drift changed in magnitude and direction to  $-4.2 \times 10^{-13}/\text{day}$ .

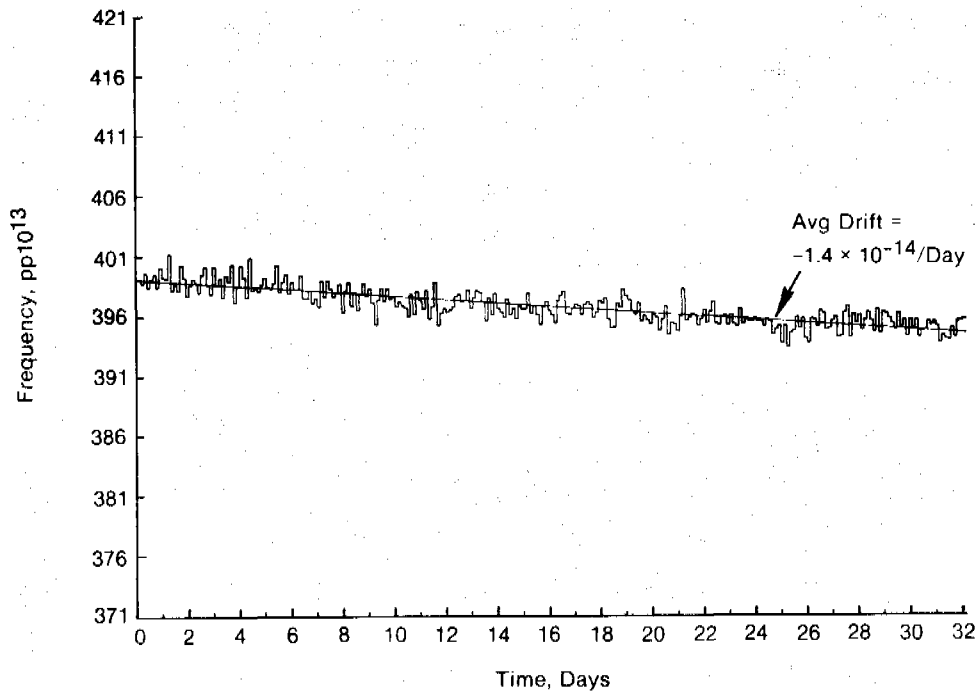
Helium was again introduced into the chamber in an attempt to eliminate the drift. Using the two drift values corresponding to helium pressures of 12 microns and 0 (hard vacuum), the required pressure was calculated to be about 4 microns, which would presumably be the partial pressure of helium inside the absorption cell. The results of the first month of test are shown in Fig. A2, which shows  $\tau = 10^4$  seconds frequency data versus a laboratory cesium standard. The RFS frequency exhibited a very low and stable drift.

Fig. A2 - EG&G GPS RFS P-2 stability in 4.5 microns He 6/16/83 to 7/18/83.

These results show that helium permeation can be a significant contributor to the drift of a rubidium frequency standard. The observed drift with and without helium is in good agreement with that predicted by considering the pressure shift coefficient of helium (+720 Hz/Torr)(6) and the helium permeability of the absorption cell envelope at its operating temperature.
