## **Fort Gordon Woodworth Library**

Historic Building Survey

October 2008

WOODWORTH LIBRARY  
(Building No. 33500)

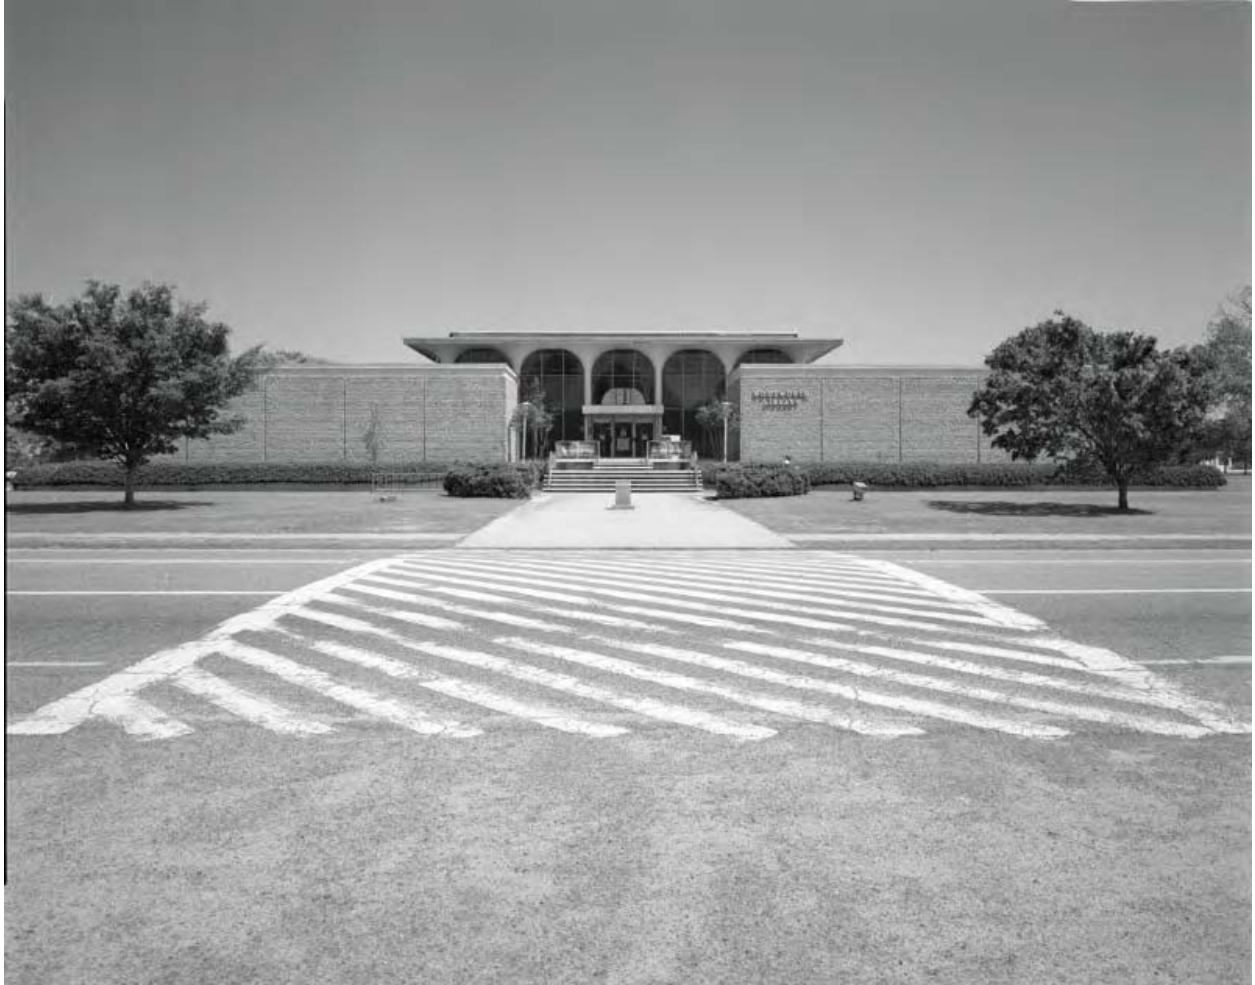
**Photo 1 – exterior general view of west main façade, view to east.**

The west elevation (Photo 1, Photo 2, and Photo 3) is the main entrance into the library. This elevation displays the most architecturally interesting features. The main entry is recessed and is located in the center of the west elevation. The entry is defined by three double-height, arched, plate glass and aluminum windows framed by concrete mushroom columns, a metal canopy, an elevated porch paved with slate tiles, concrete and metal steps, and metal handrails (Photo 2). The tiled porch measures 22'-0" wide by 18'-0" deep. The metal canopy is 7'-4  $\frac{1}{2}$ " above the porch and is 1'-3  $\frac{1}{4}$ " thick. The main entrance into the library is composed of three plate glass and aluminum doors. Formed concrete planters are located on either side of the main entry. Both planters are 74'-9  $\frac{3}{4}$ " wide by 8'-0" deep. The planters located on the west elevation were designed with four additional round concrete planter pads; two on each side of the entry. Original metal lettering spelling out "Woodworth Library" is anchored to the ashlar-cut granite veneer panels to the right of the main entry (Photo 4). There are two original light fixtures positioned on either side of the entry (Photo 5).

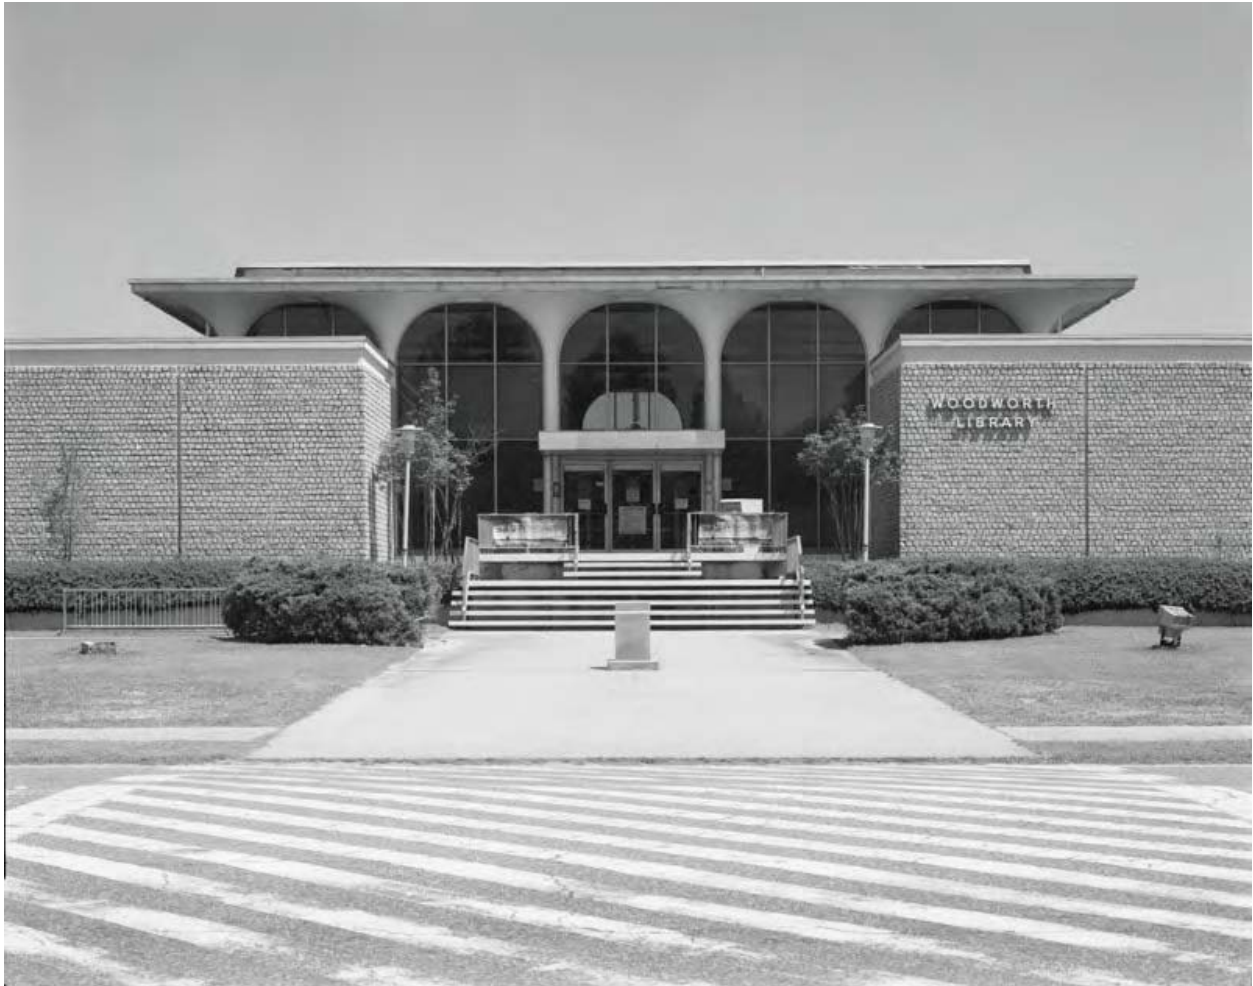
**Photo 2 – exterior detail of center west facade and main entry, view to east.**

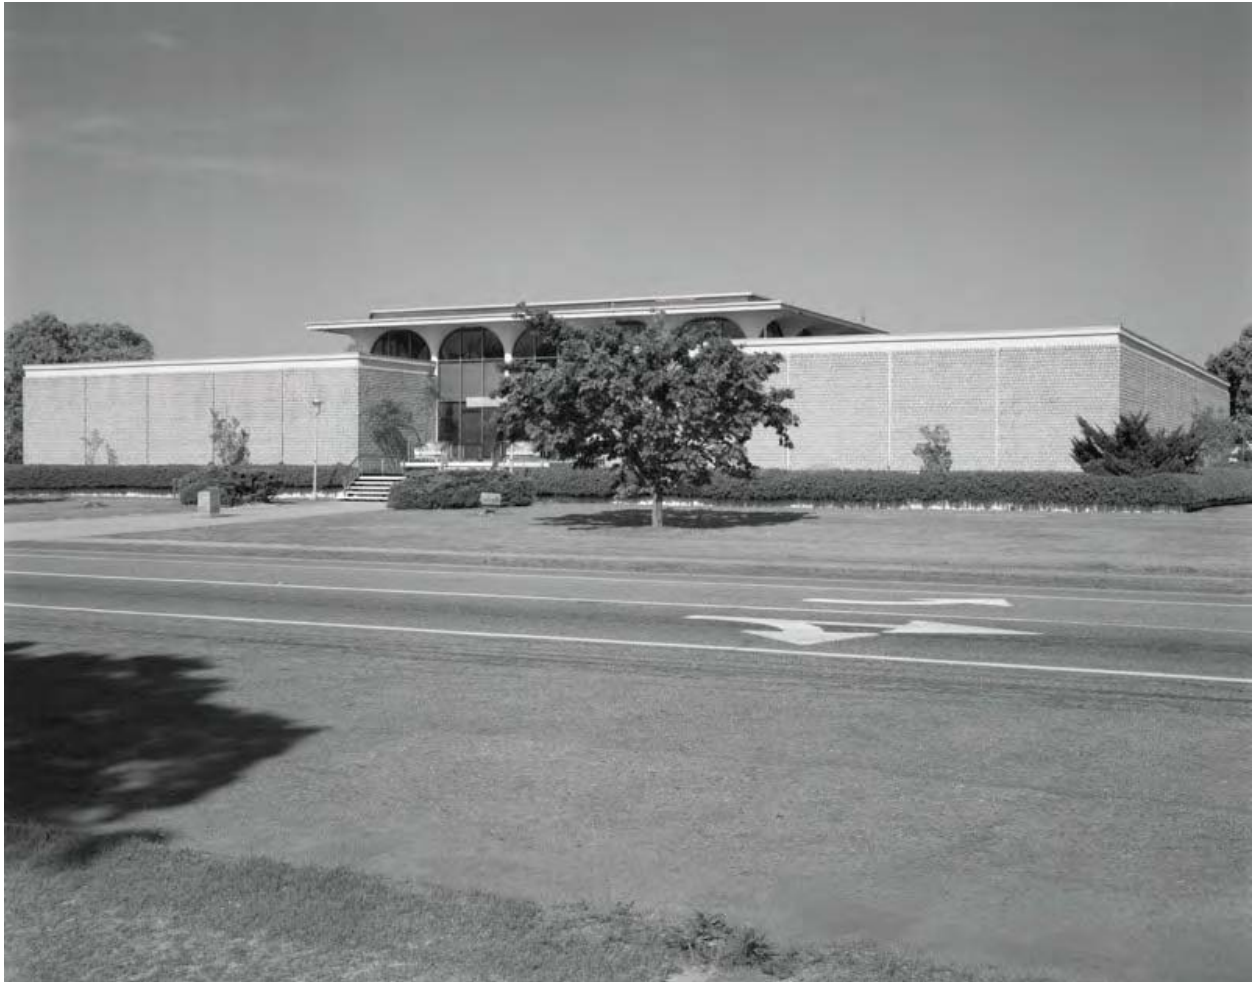
**Photo 3 – exterior general oblique view of west facade and south face, view to northeast.**

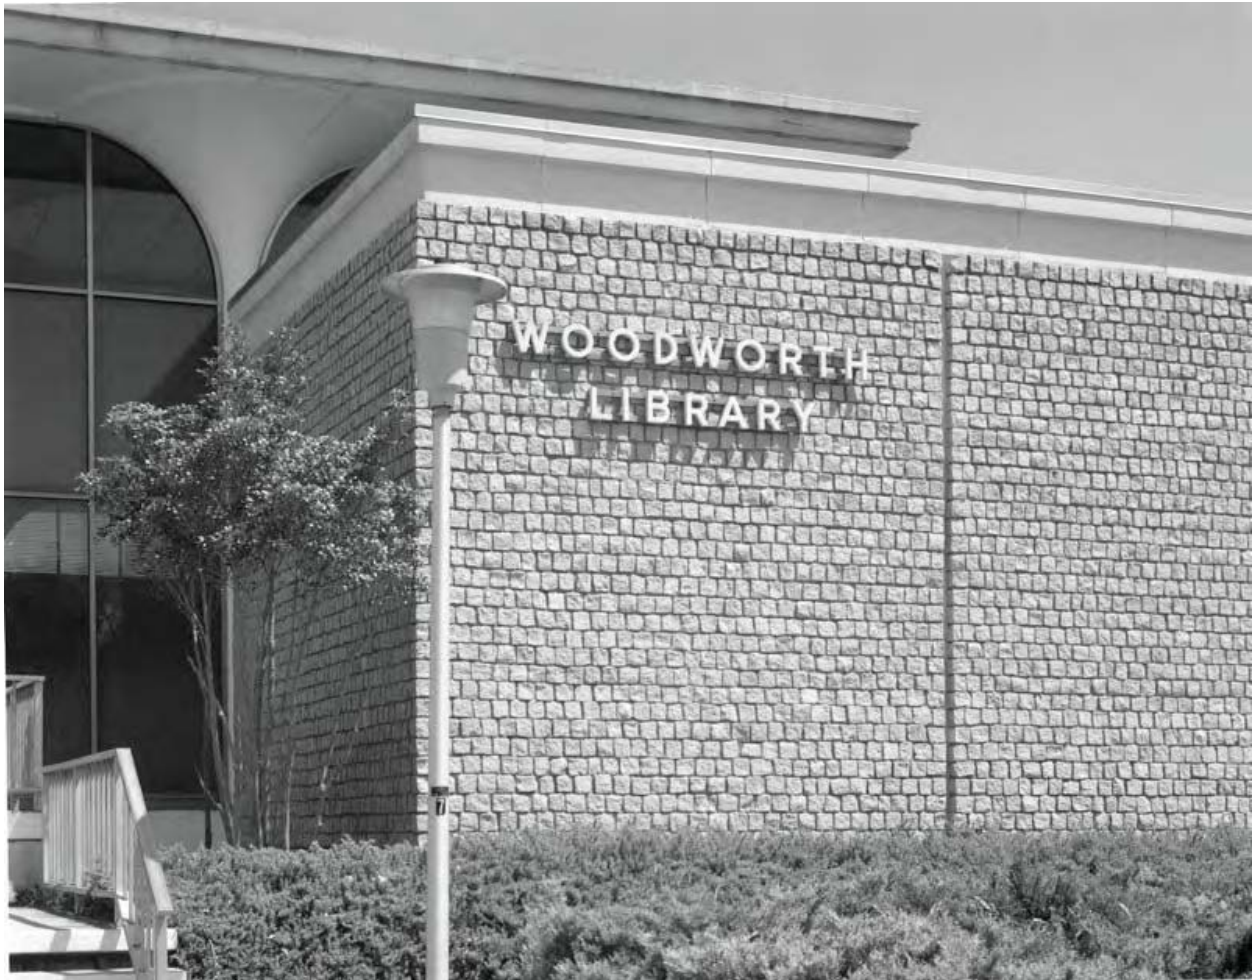
**Photo 4 – exterior close view showing building name “WOODWORTH LIBRARY” in full relief aluminum letters, west facade, view to southeast.**

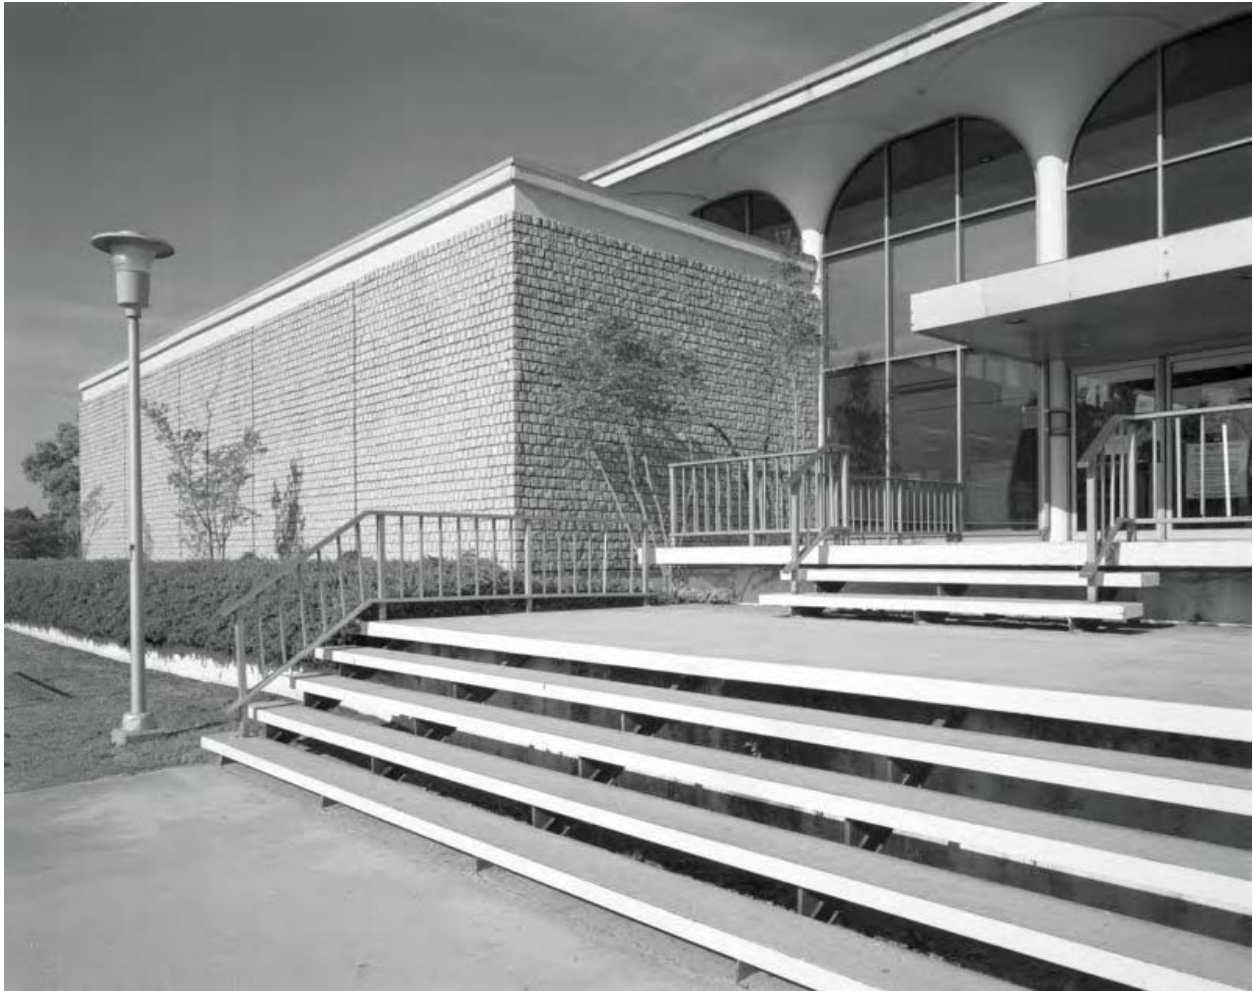
**Photo 5 – exterior detail, main central entry area with stairs showing ashlar granite panels northeast module projecting to west, view to northeast.**

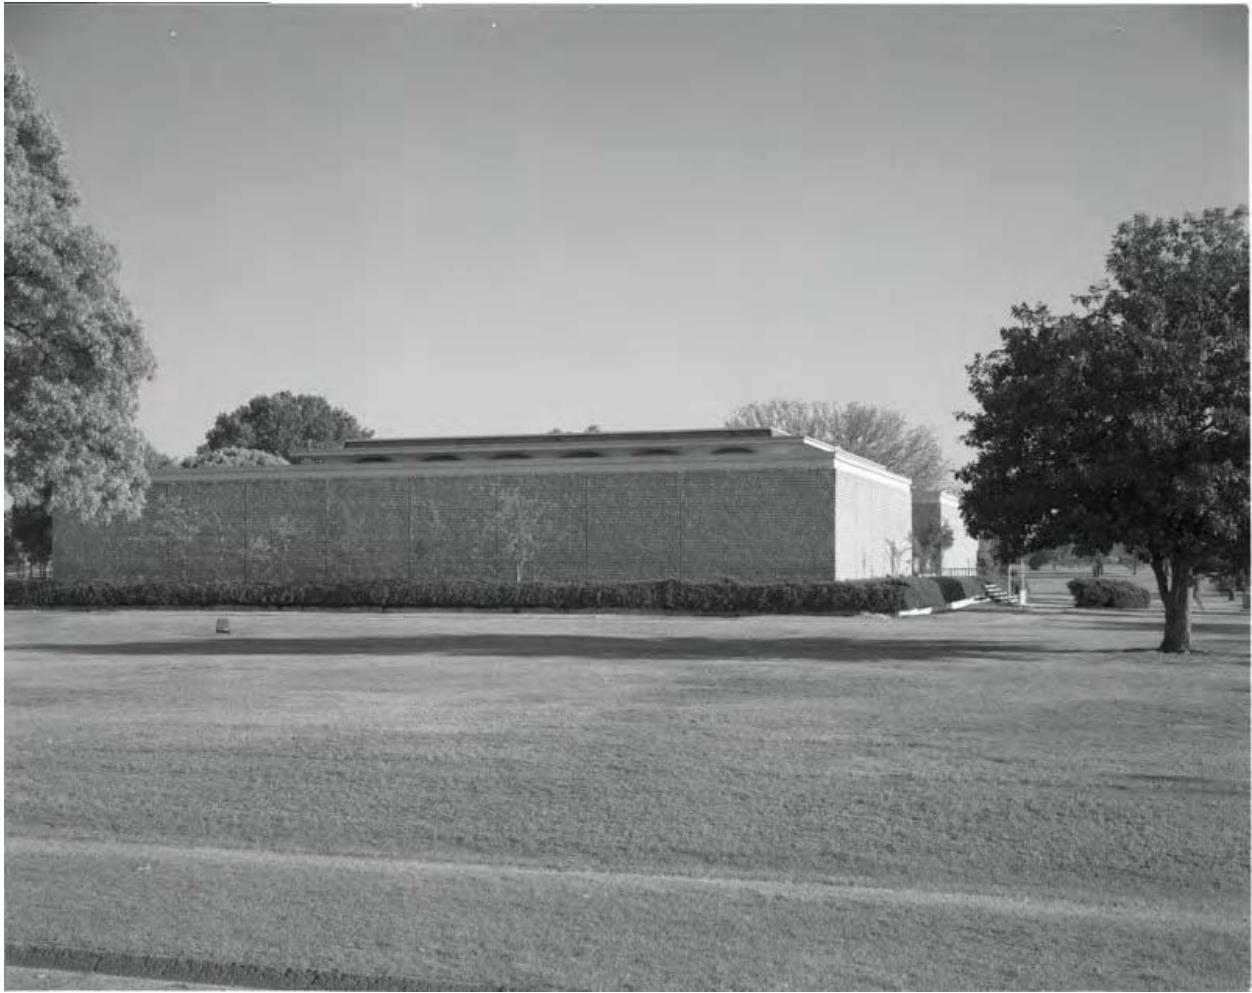
**Photo 6 – exterior general view south side and west facade right, view to south.**

The north elevation (Photo 6) is a solid wall of ashlar-cut granite veneer panels with no window or door openings. Each panel is 12'-0" wide. The exterior wall is 109'-7 1/2" long. The concrete planter box stretches 127'-3" across the elevation and is 7'-0" wide. There are five arched windows visible above the one-story roof height.

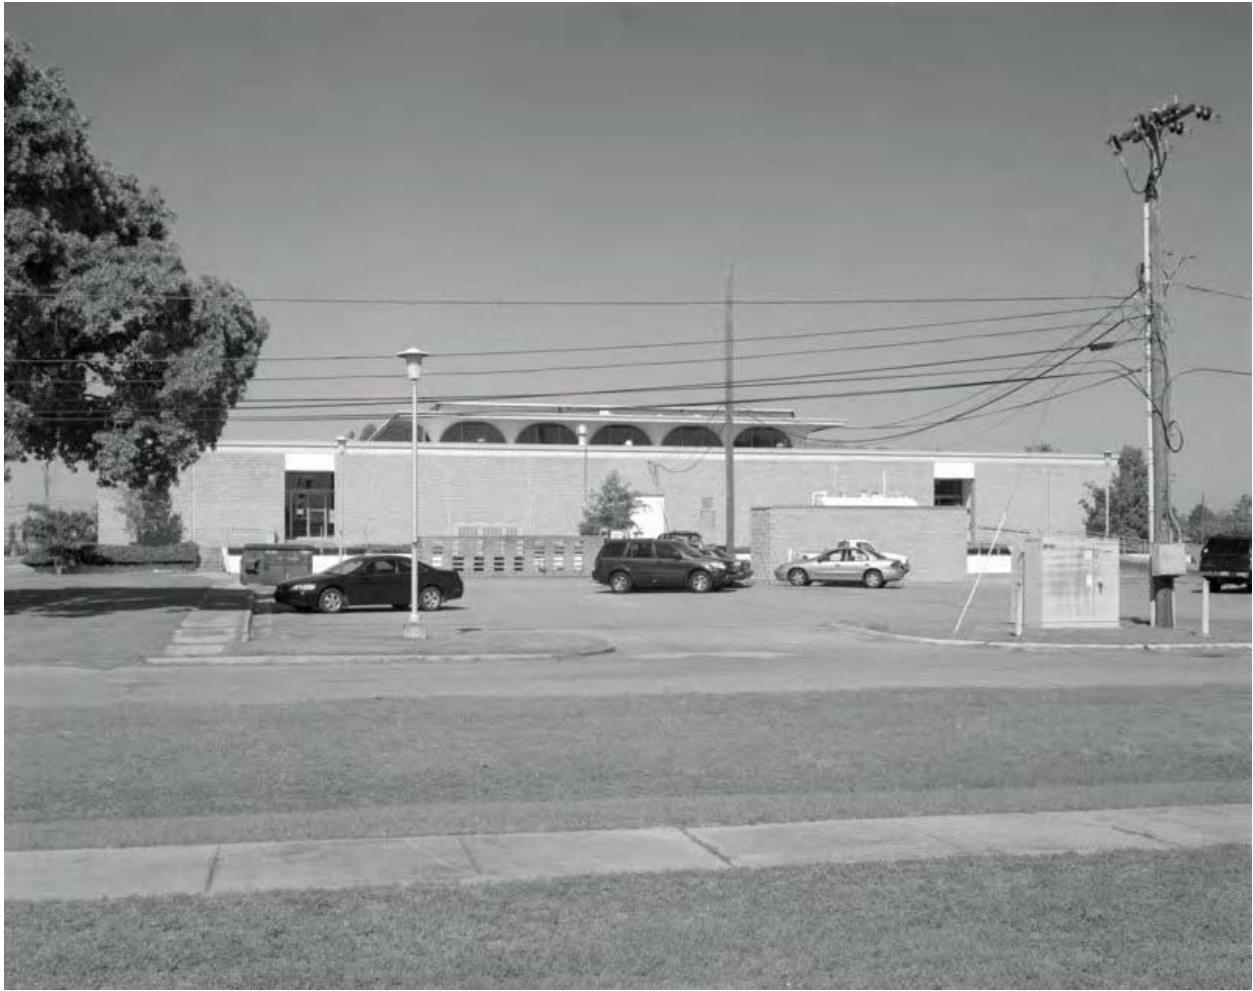
**Photo 7 – exterior general view east elevation with loading dock, note clerestory and arches above, view to west.**

The east elevation (Photo 7) is where the service area is located. The east elevation faces a small, open, paved parking lot. The exterior wall is covered with ashlar-cut granite veneer panels. There are two elevated and recessed service entries and a set of mechanical doors on the east wall. The entry on the left side of the elevation is 25'-5 3/4" from the left side of the elevation. This entry is the main loading dock area (Photo 9). The entry is 7'-0" wide composed of two plate glass and bright aluminum doors, two large sidelights, and one transom. There are two original light fixtures above the entry. There is a set of poured concrete steps located to the left of this entry and a concrete platform in front of the doors to

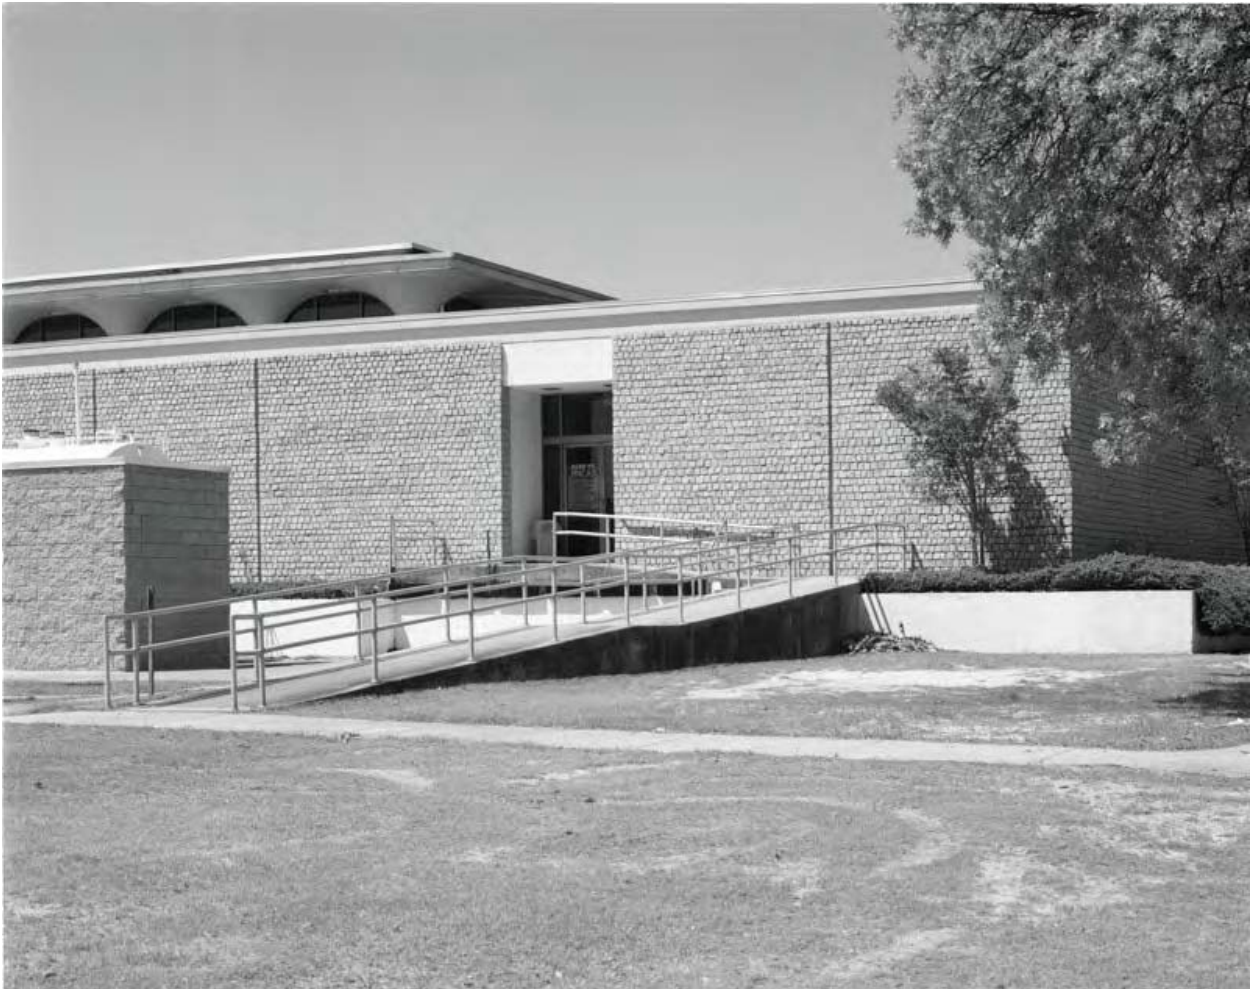
**Photo 8 – exterior detail east side, north end, with ADA ramp and employee/service entrance, view to southwest.**

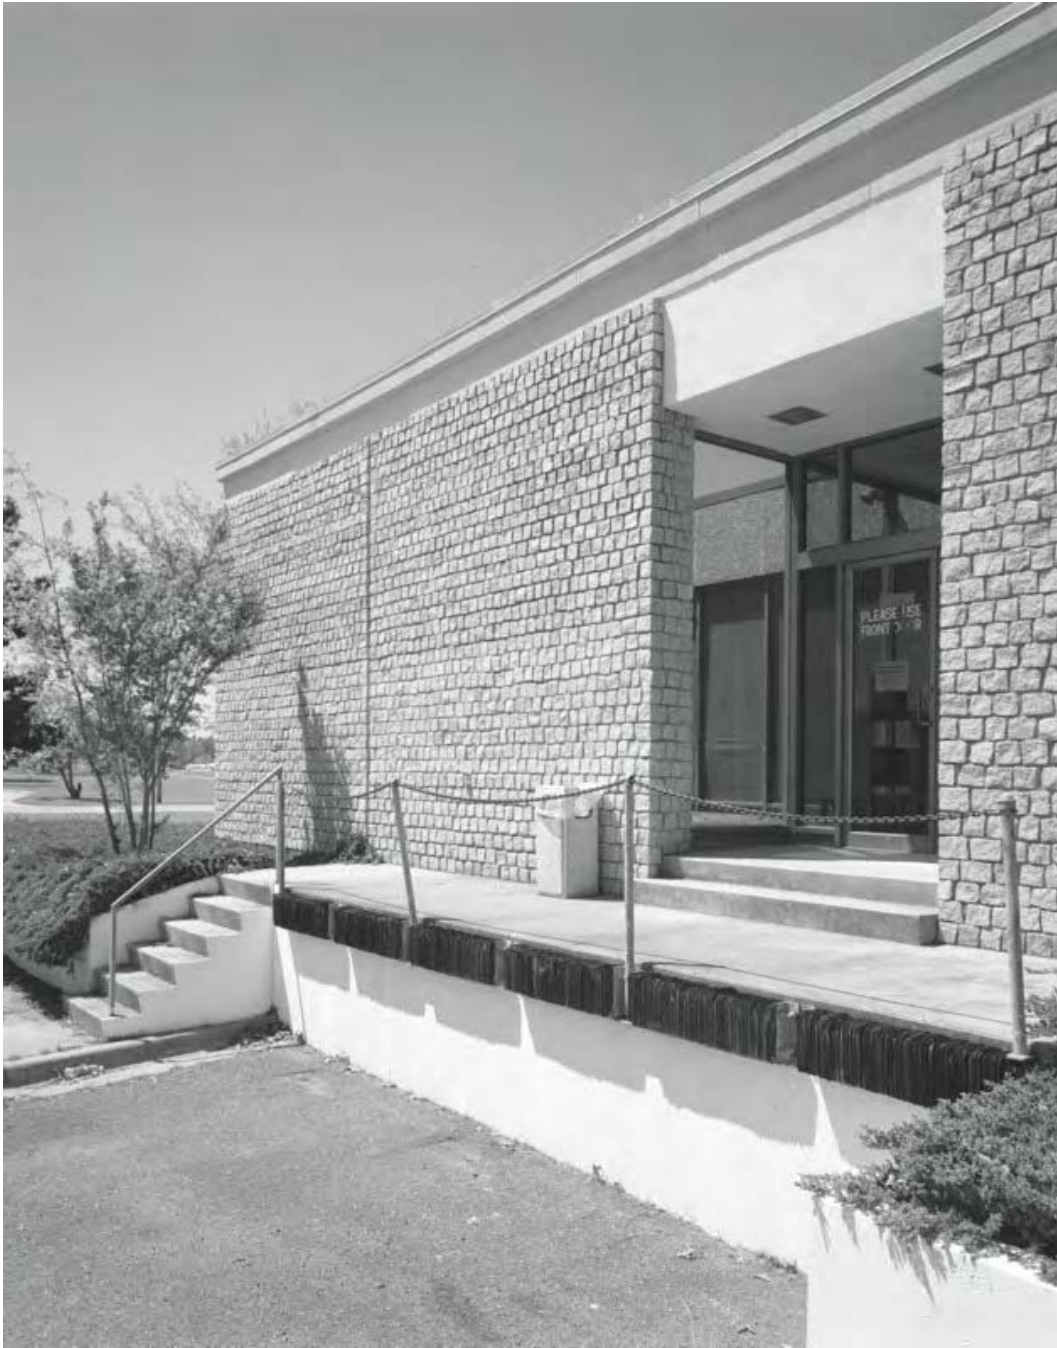
**Photo 9 – exterior detail, loading dock at south end of east elevation, showing stairs and recessed entry, view to southwest.**

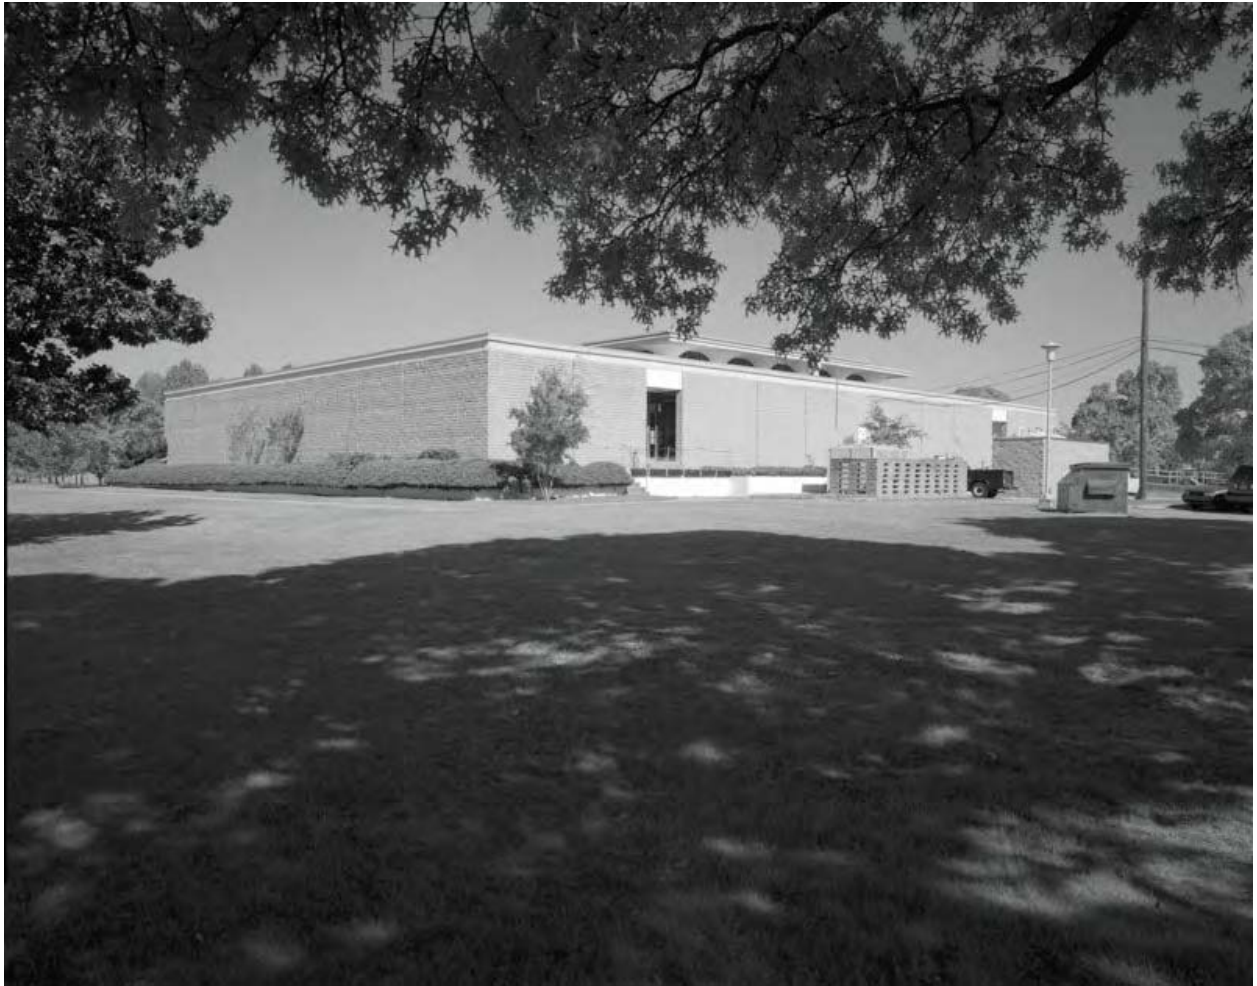
**Photo 10 – exterior general oblique view south and east elevations, view to northwest.**

The south elevation (Photo 10) mirrors the north elevation. The south wall is a solid wall of ashlar-cut granite veneer with no window or door openings. Each panel is 12'-0" wide. The concrete planter box stretches 109'-7  $\frac{1}{2}$ " across the elevation and is 7'-0" wide. There are five arched windows visible above the one-story roof height (Photo 11).

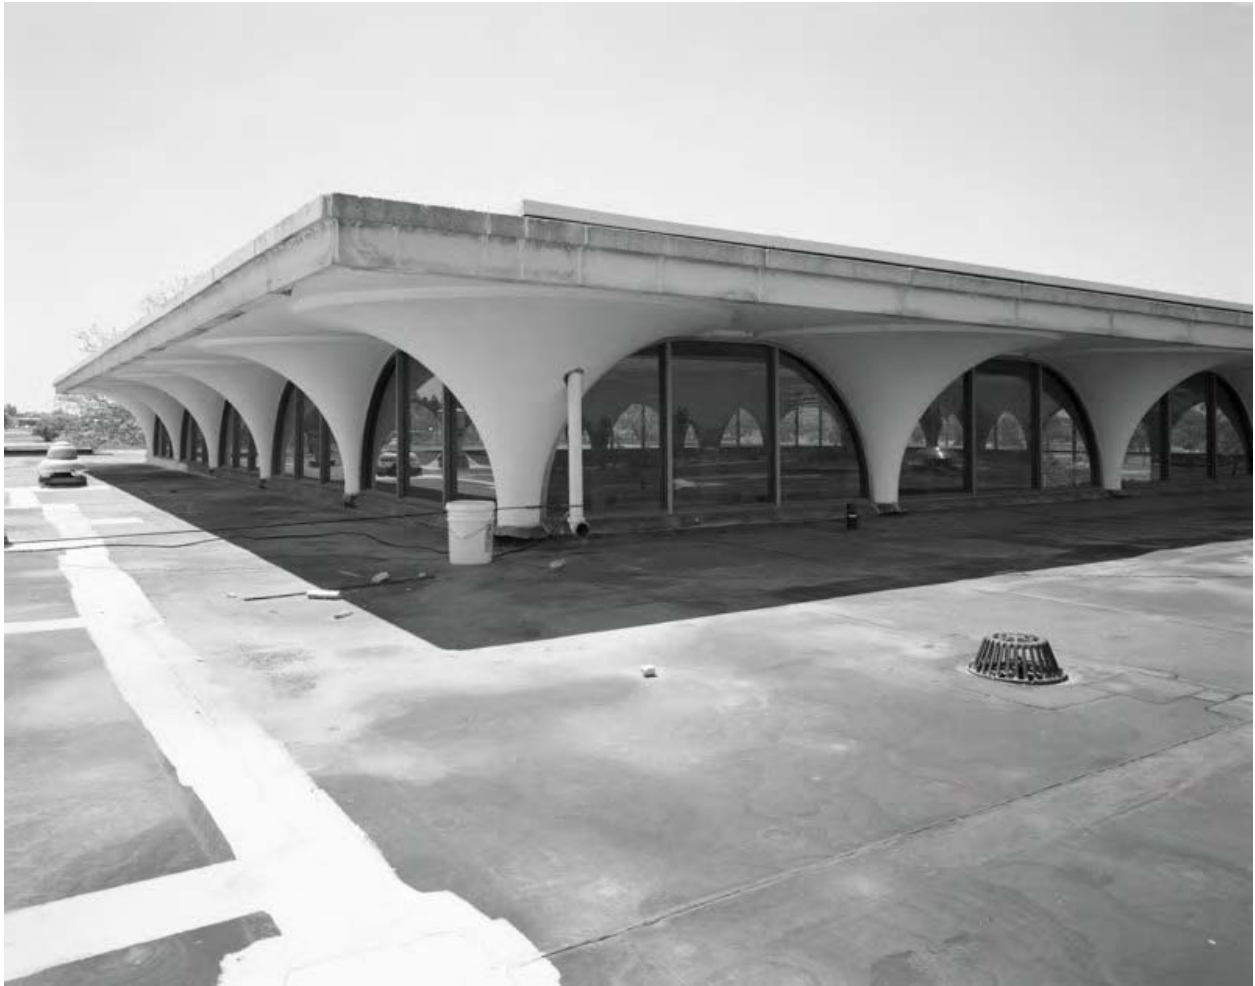
**Photo 11 – exterior detail on roof showing tops of “mushroom” capitals forming clerestory, view to southwest.**

- c. Windows: There are not many windows on the four exterior walls of the library; however, the defining feature of the building is the concrete mushroom columns that frame large arched windows. The north, south, and east elevations mirror each other with similar window types and patterns. The five arched windows on these elevations are visible above the one-story roof height. These arched windows are divided into three separate pieces of glass by aluminum framing. The framing is 0'-2" wide. Each window is 10'-3 3/4" wide and 4'-4" tall (Photo 11).

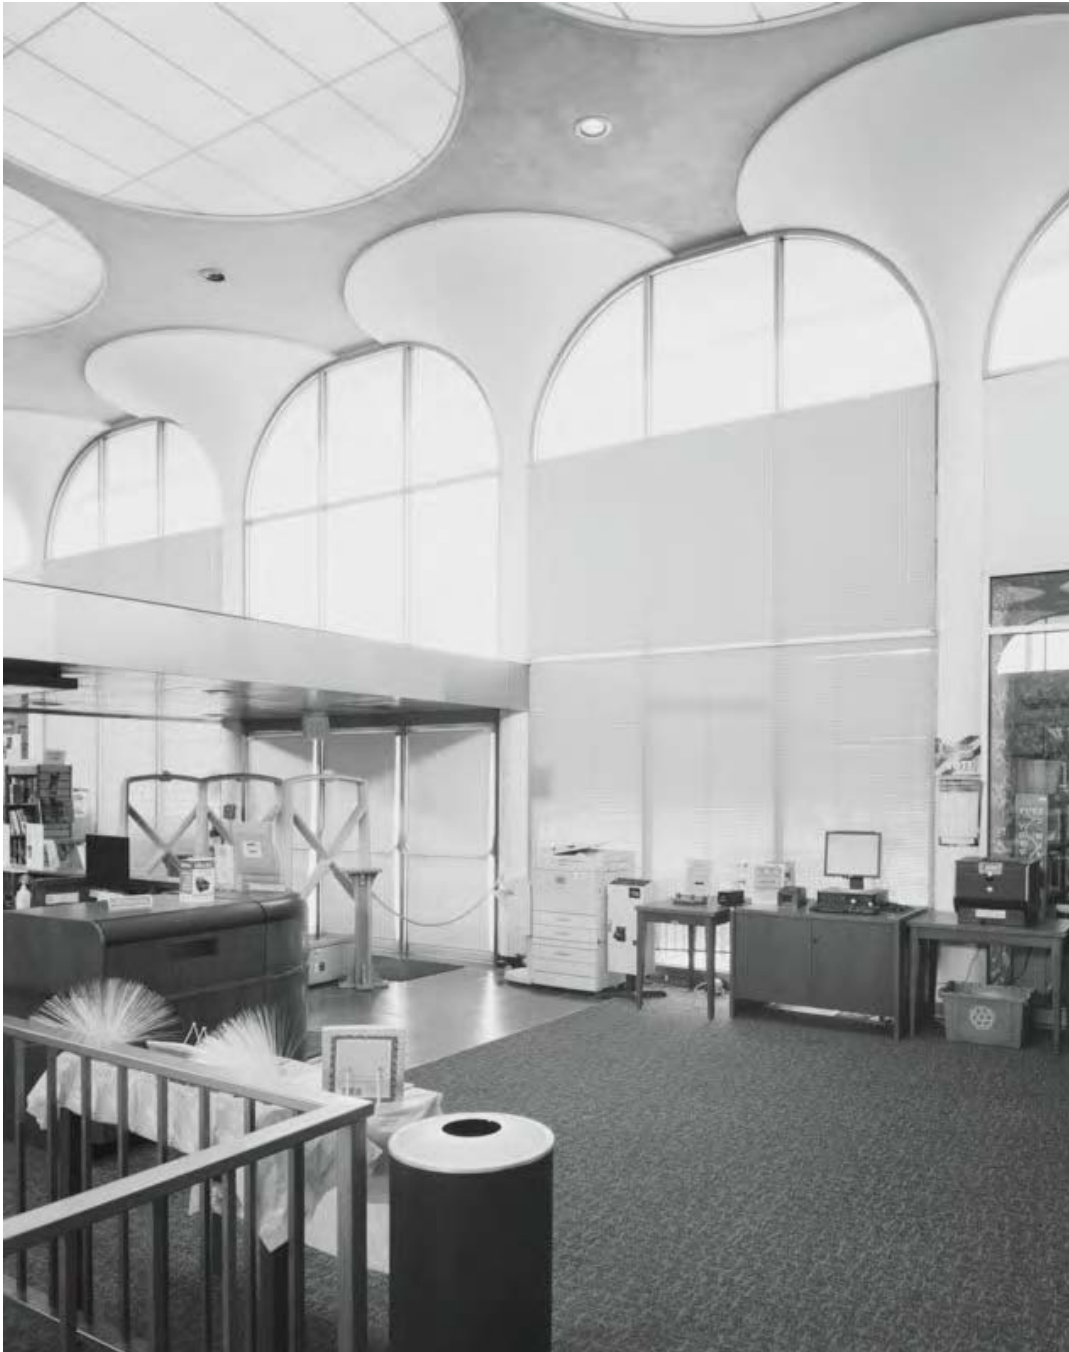
**Photo 12 – interior general view of entry/lobby area, view to southwest.**

The main circulation desk is located on the west side of the plan and is defined by a wood desk and a flat pressed aluminum canopy (Photo 12). The canopy extends from the main entry doors on the west wall over the entry area and circulation desk (Photo 13). Canned recessed lighting is fitted into the underside of the canopy. The enclosed spaces are located along the perimeter of the plan.

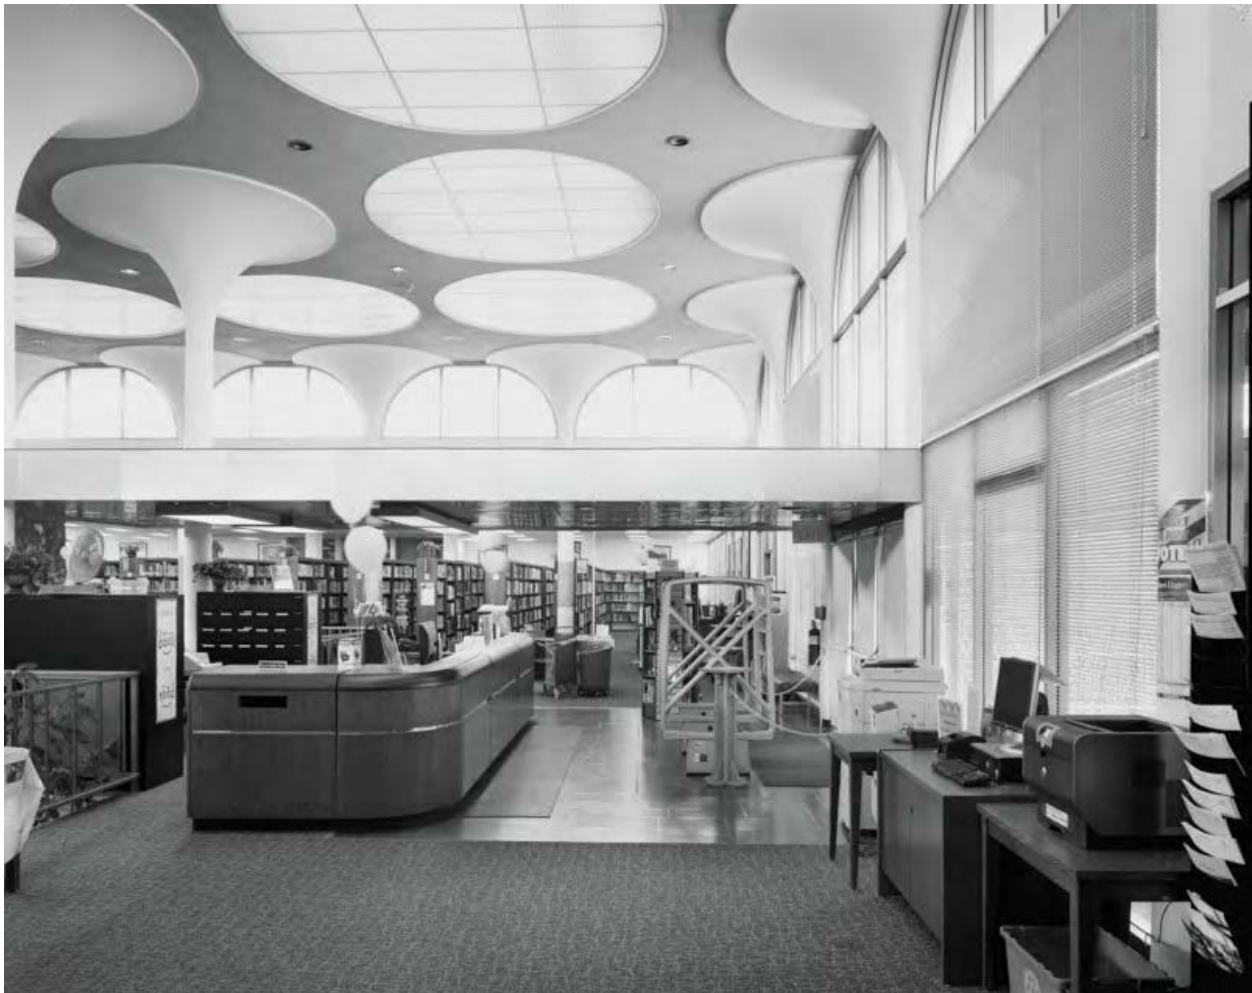
**Photo 13 – interior general view showing entry area and reception desk with cantilevered overhang continuing from exterior, view to south.**

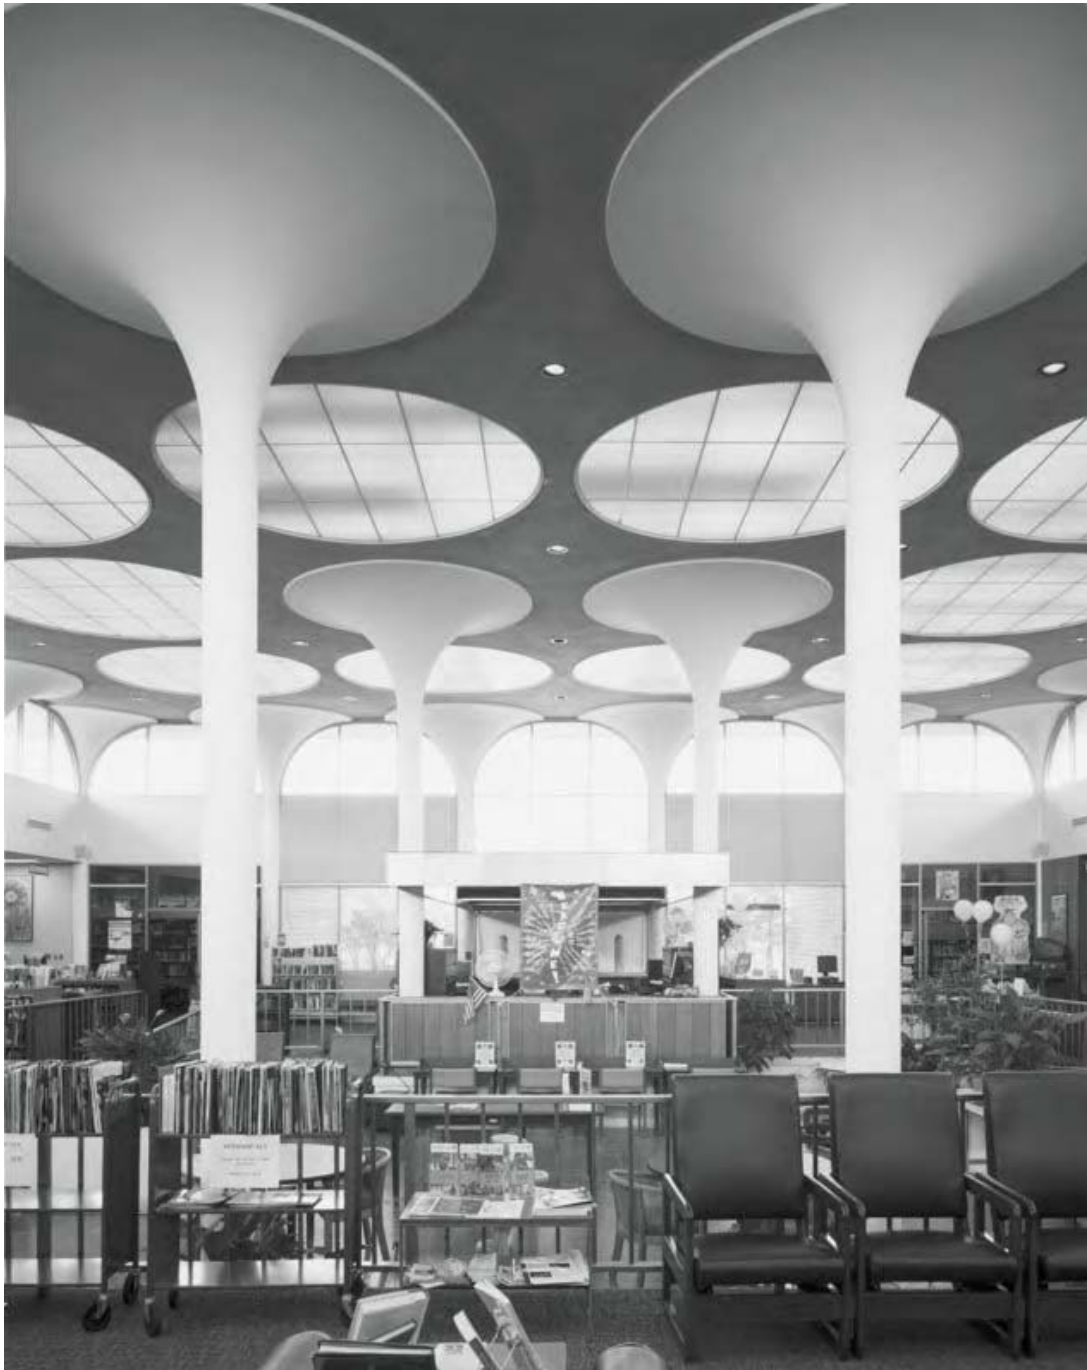
**Photo 14 – interior view along central axis from east wall toward reception area view to west.**

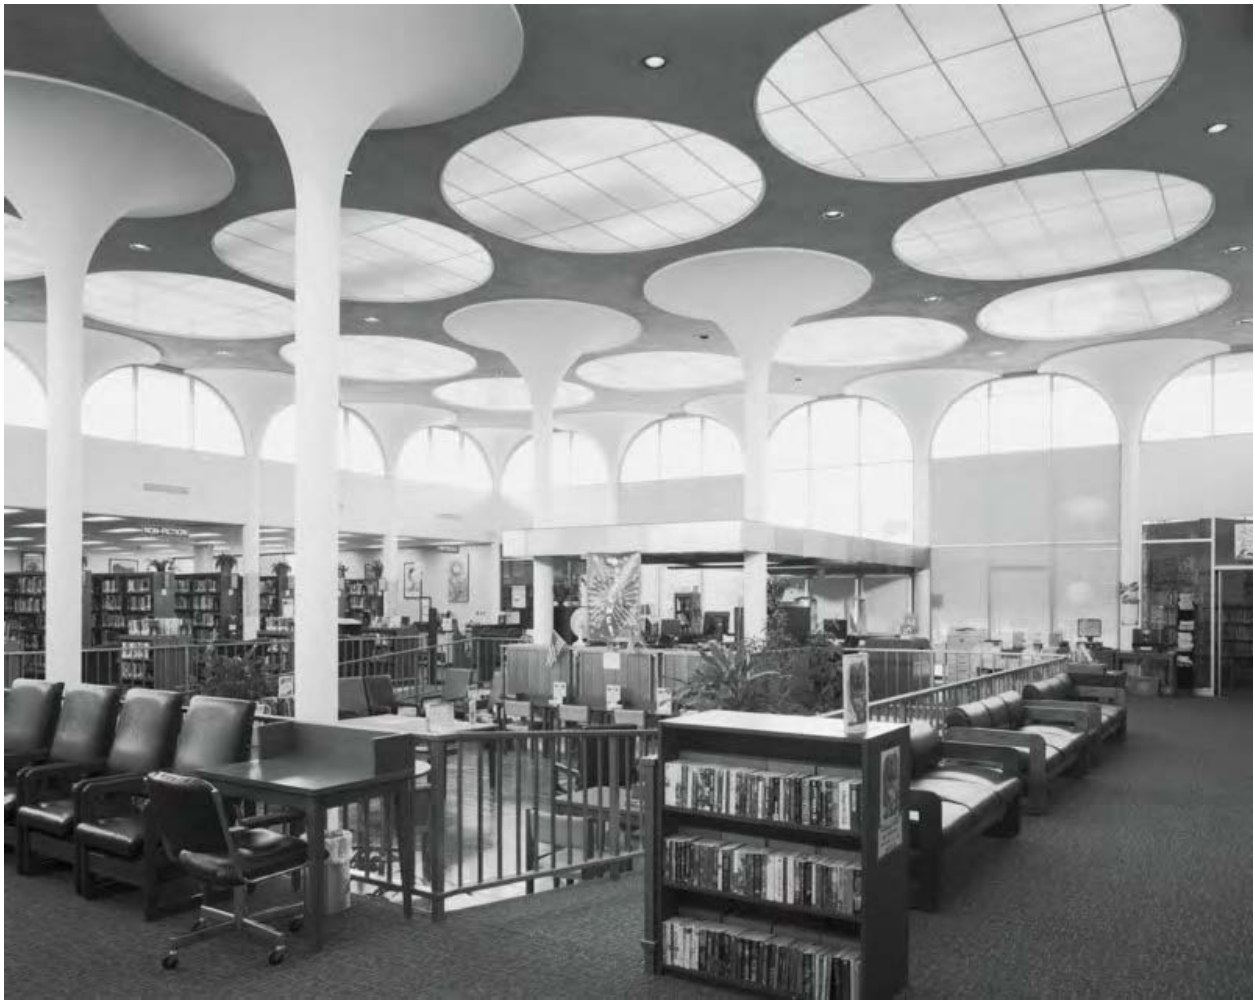
**Photo 15 – interior general view from southeast corner, view to southwest.**

4. Structural System, Framing: The exterior walls of the library are composed of concrete block. The double-height of the central roof is supported by twenty-two round concrete columns that measure 12" in diameter. The columns are 12'-0" apart. The columns mushroom out to 5'-0" on each side of the center line of the column (Photo 15).

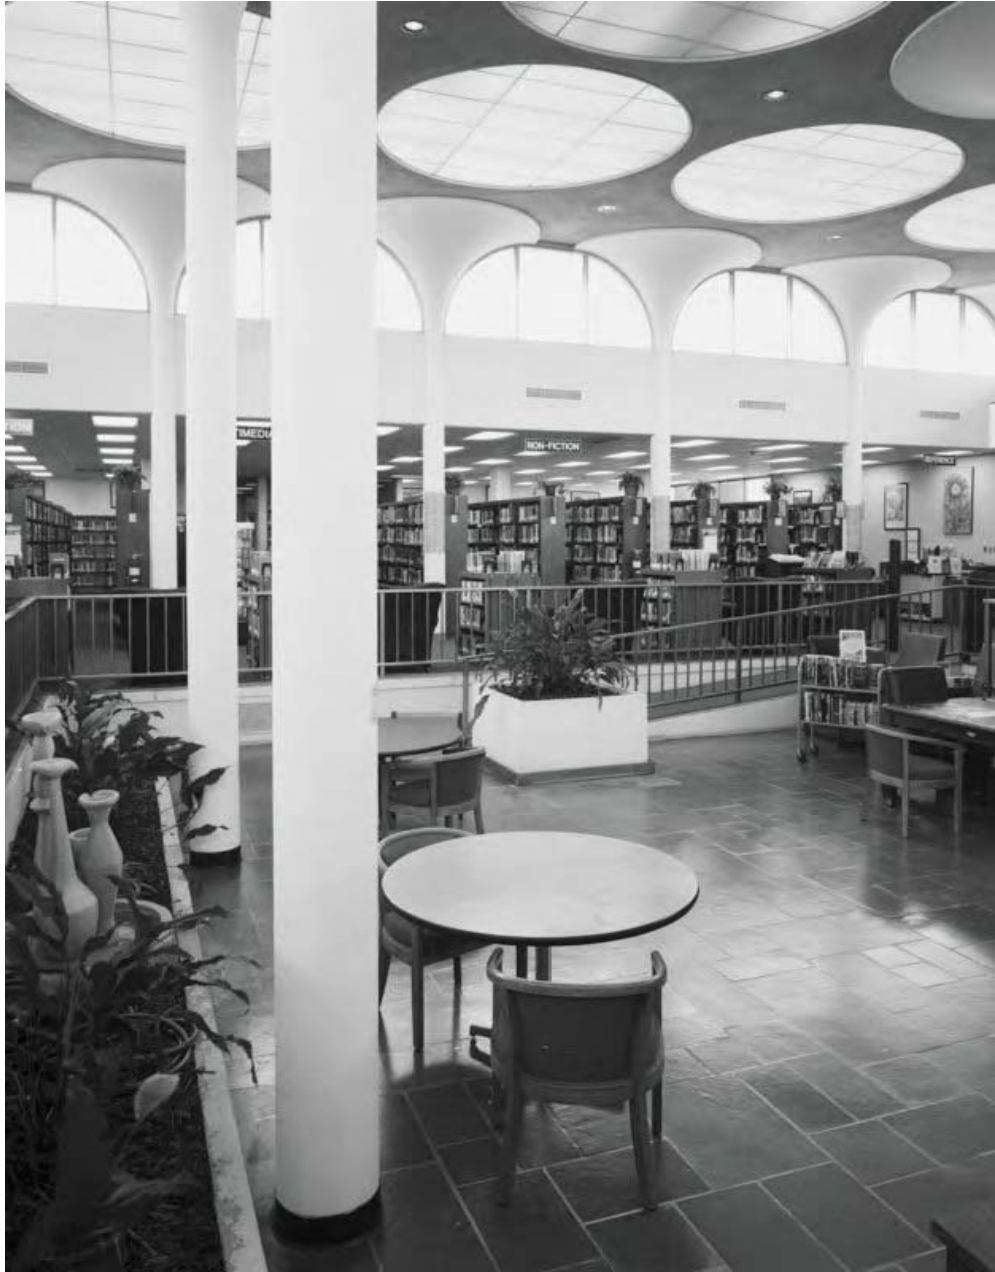
**Photo 16 – interior view, sunken reading area showing intact planter to left and original ramp on south side, view to southwest.**
