## **Fort Gordon Woodworth Library**

Historic Building Survey

October 2008

WOODWORTH LIBRARY  
(Building No. 33500)

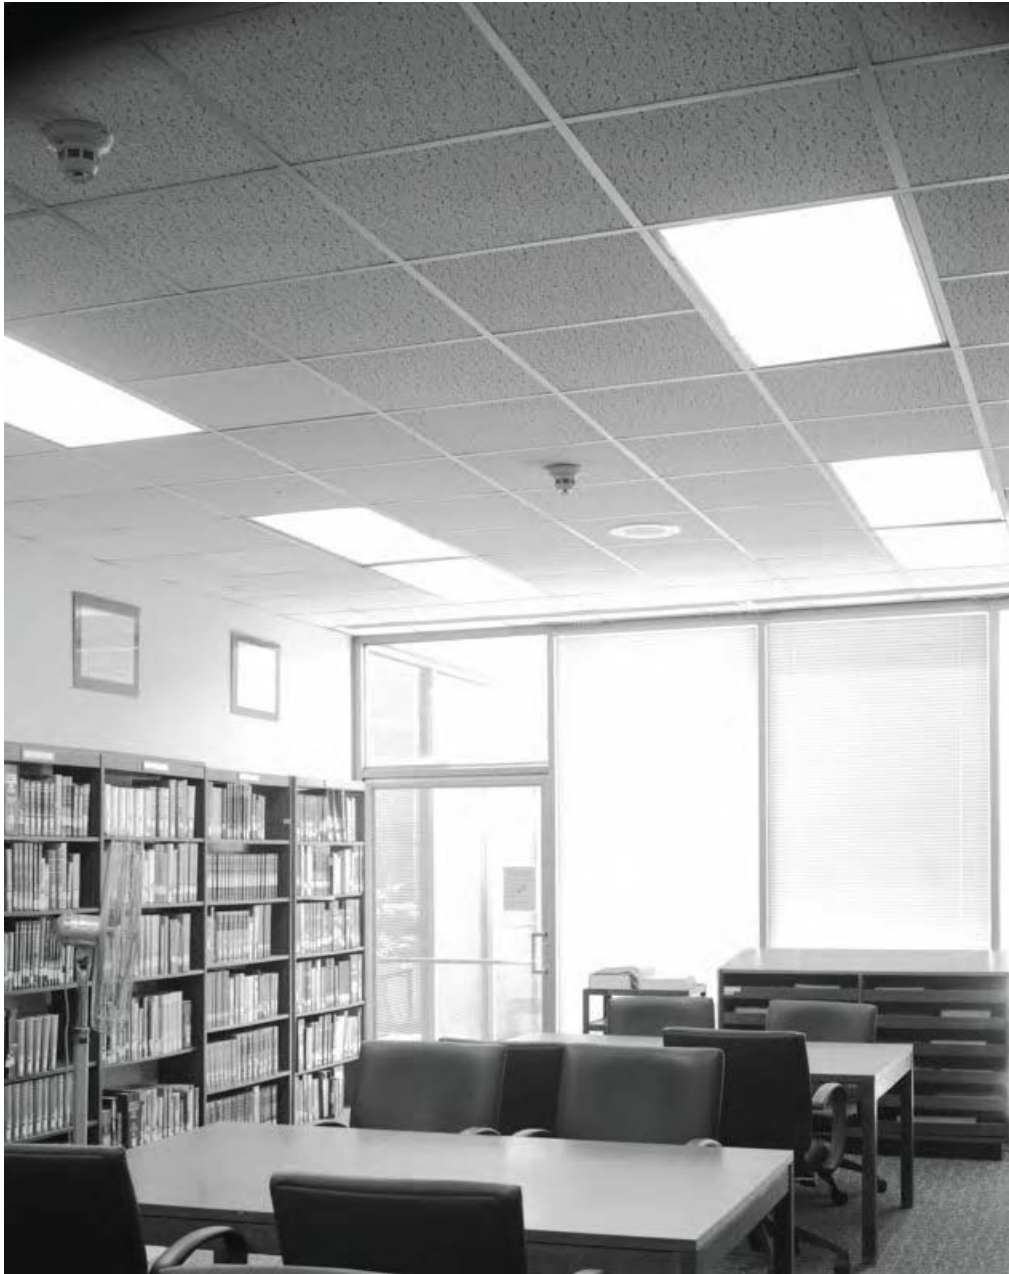
**Photo 17 – interior detail, originally “music room”  
showing south glazed wall with door access to enclosed  
courtyard, view to southeast.**

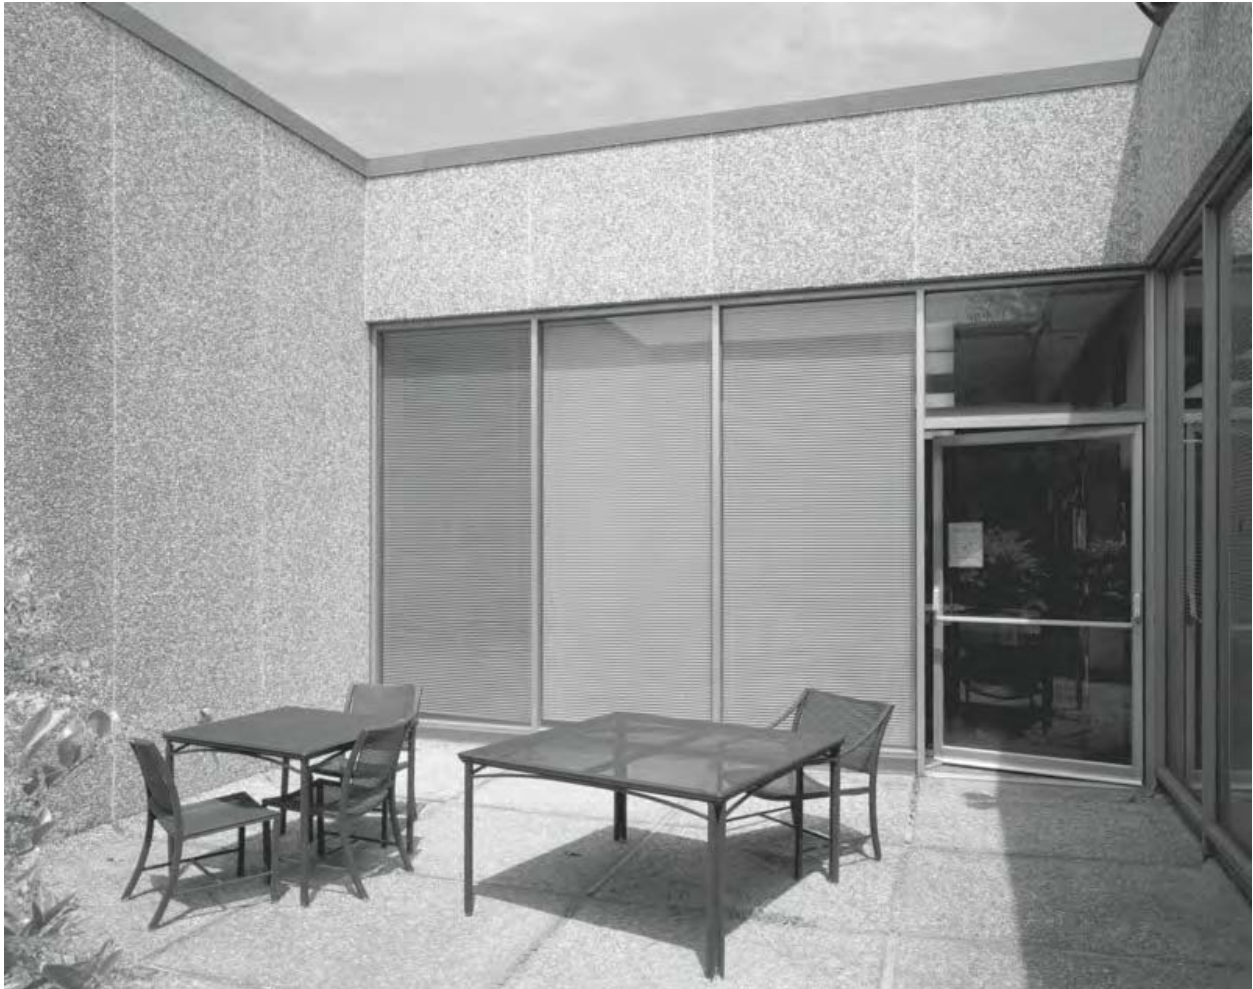
**Photo 18 – detail enclosed exterior courtyard at southwest corner of building, accessible via “music room” (photo #17), view to northwest (note intact vintage metal chairs and tables, see Photo 24 for historic view).**

The west side of the plan consists of a children's room, the main entry, the reference room, and two courtyards. The children's room is located on the west wall north of the main entry and measures 35'-4" x 17'-6". Two small storage closets are located along the east wall of the room. The reference room is located on the west wall south of the main entry and measures 35'-4" x 17'-6" (Photo 17). One courtyard is accessed through the children's room, while the other one is accessed through the reference room (Photo 18).

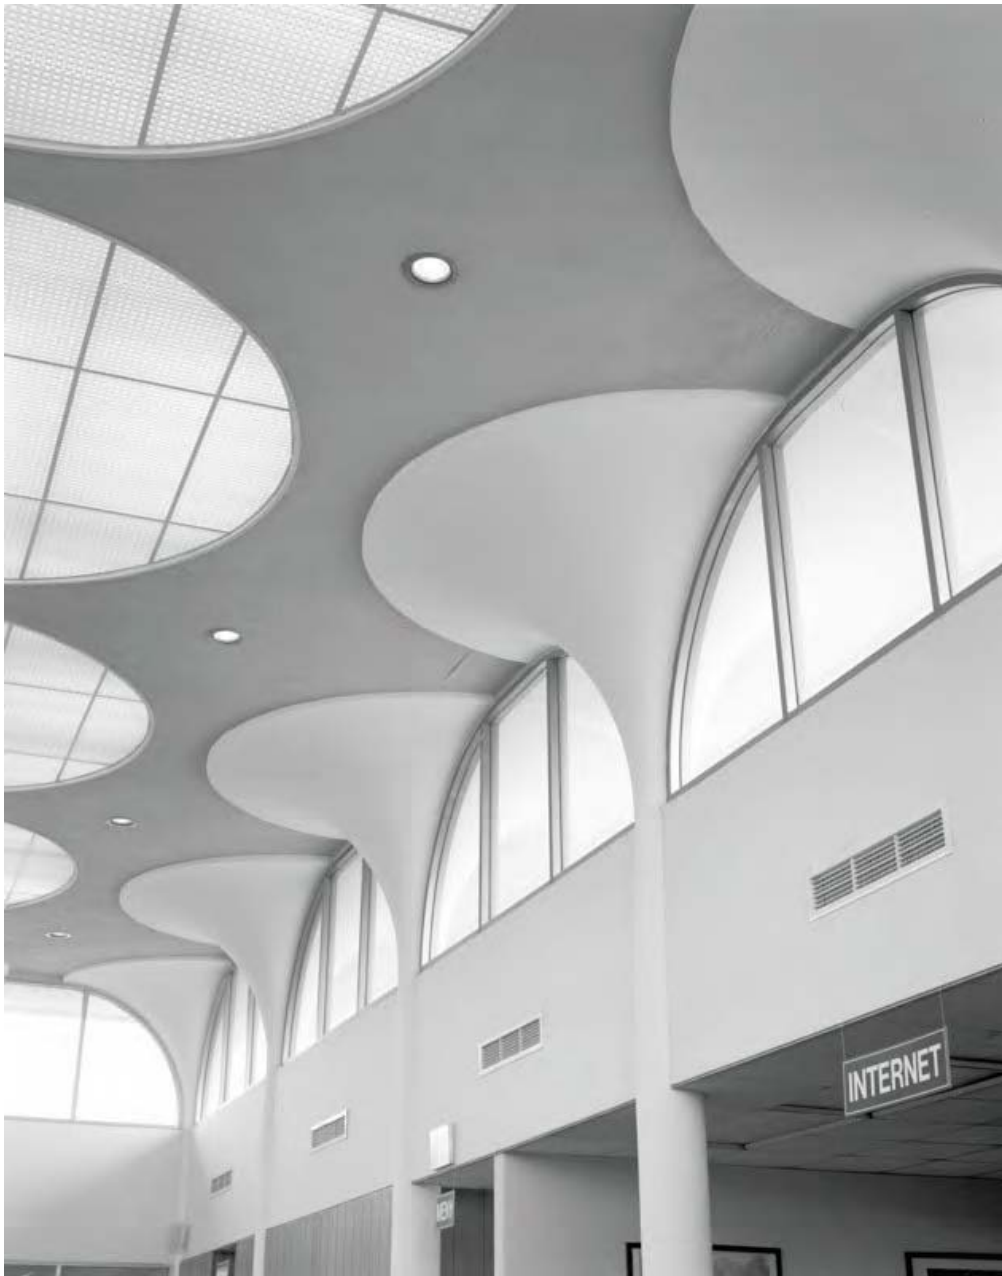
**Photo 19 – interior detail, column tops at north side of clerestory section, forming arches for glazing panels, view up and to northwest.**

with a mixture of drywall and wood paneling. A 3'-0" plaster band encompasses the central reading room. The band is located above the ceiling height of the perimeter rooms and is below the groups of arched windows of the double-height roof (Photo 19).

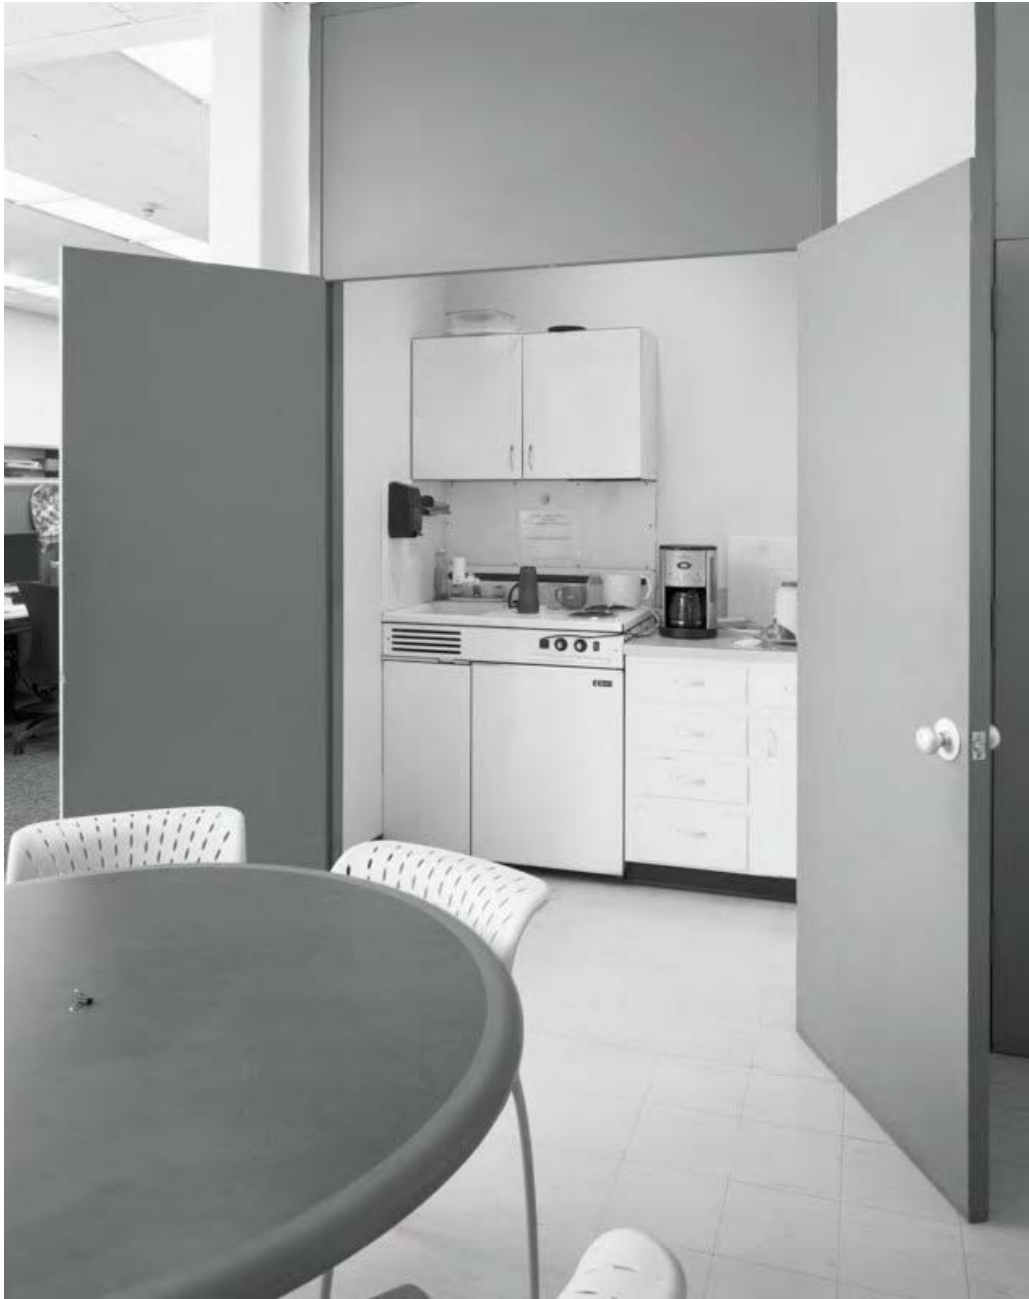
**Photo 20 – interior detail, original kitchen in employee lounge area, view to northeast (see Photo 25 for historic view).**
