# INVESTIGATION INTO THE EFFECTS OF VHF AND UHF BAND RADIATION ON HEWLETT-PACKARD (HP) CESIUM BEAM FREQUENCY STANDARDS

Andrew Dickens  
United States Naval Observatory  
and  
University of Virginia

*This paper documents an investigation into reports which have indicated that exposure to VHF and UHF band radiation has adverse effects on the frequency stability of HP cesium beam frequency standards. Tests carried out on the basis of these reports show that sources of VHF and UHF radiation such as two-way hand held police communications devices do cause reproducible adverse effects. This investigation examines reproducible effects and explores possible causes.*

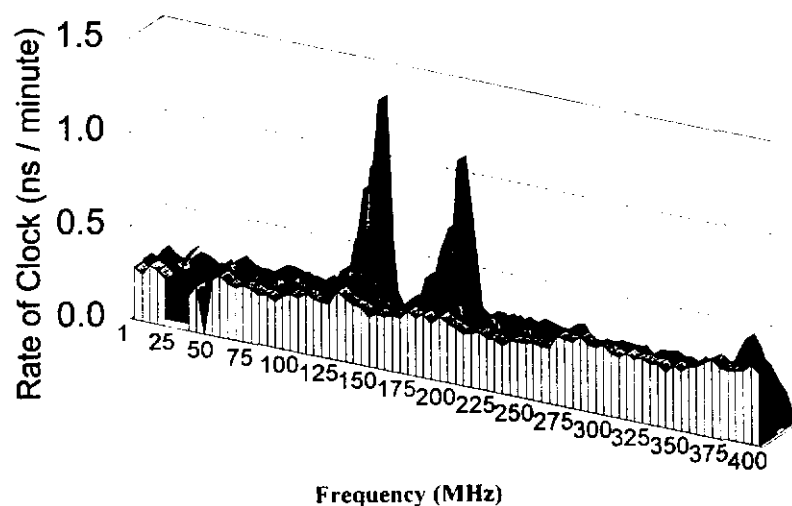
Figure 1 : Clock Rate vs. Frequency and Power

## Clock Rate vs. Frequency and Power

■ +20dBm ■ +15dBm ■ +10dBm ■ +5dBm

It was found that the clock exhibited sharply accelerated rates around two particular frequencies (Figure 1). The first was at 128 MHz, and the second was around 150MHz.

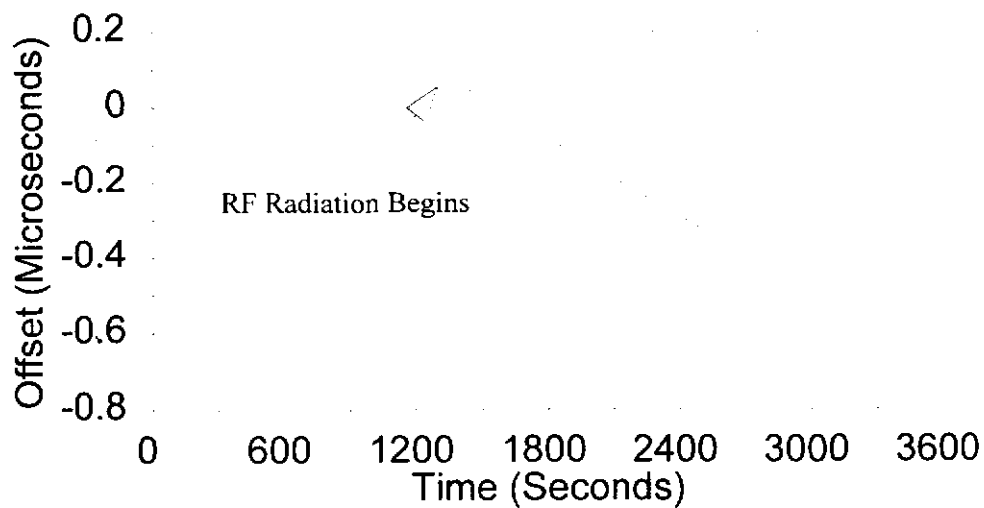
Figure 2 : UHF Response

## 5061B Offset

2 Watt UHF Radio Five Feet Away

A two watt hand held UHF radio, operating on a frequency of 462.575 MHz, was obtained. This radio is of the type often used for job site communication. After obtaining the natural rate of the clock, the UHF radio was placed five feet from the front of the clock and keyed. The time interval between the clock under examination and the USNO MC was recorded several times per second by the data acquisition system (DAS). The collected time interval data clearly showed that the rate of the clock accelerated dramatically from the normal rate when the UHF radiation was applied, and returned to its normal rate after the radiation ceased. This response of the 5061B is shown in Figure 2. The time offset that had been acquired while the RF was present remained. Repeated tests of varying lengths were conducted and produced similar results.

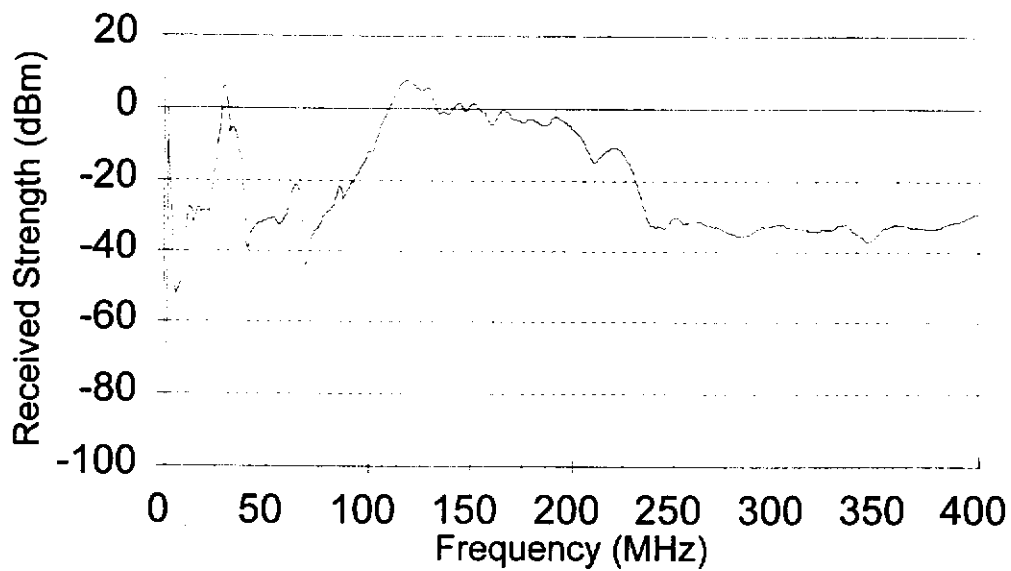
Figure 5 : Antenna Frequency Response

# Antenna Frequency Response

+20dBm Two Feet Separation

In order to know the real RF strength that was incident upon the clock for any frequency, the frequency response of the antenna needed to be calculated. A matched straight antenna was fabricated and was placed two feet away, parallel to the transmitting antenna. The receiving antenna was connected to an HP 8562 spectrum analyzer. The magnitude of the signal at this antenna was recorded as the signal generator was swept across the frequency band of interest. The matched nature of these antennas allows correction to be made for the characteristics of the antenna. The frequency response plot is shown in Figure 5.
