## **Underwater Remediation of Energetic Items/ Substances in a Water-Filled Limestone Quarry**

### **INTRODUCTION**

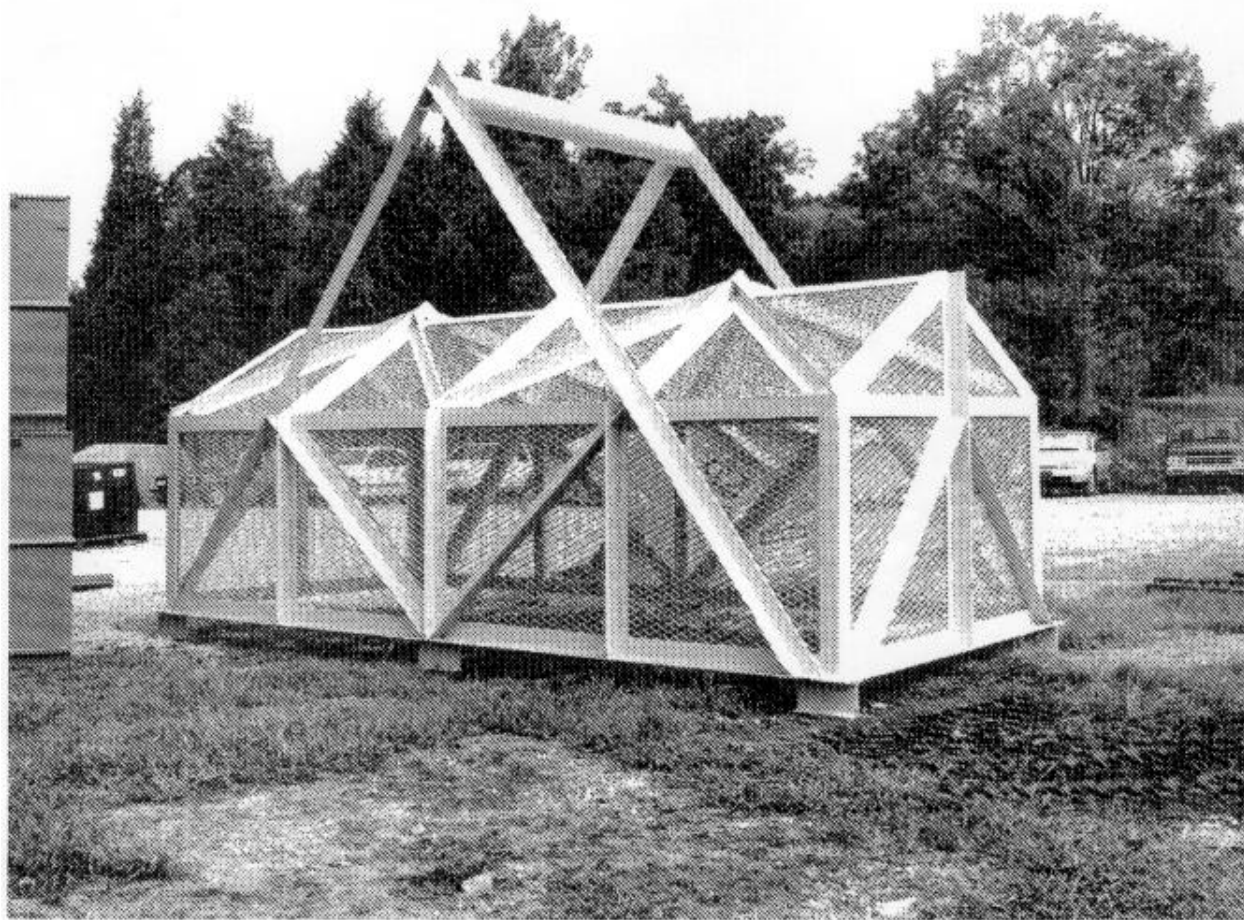
VIEW OF EXPLOSIVE RETENTION BASKET (Fig. 7)

Prior to setting of any of the underwater charges a large heavy explosive retention wire mesh metal basket was placed over the vessel. The underwater explosive retention basket is shown in Fig. 7. This mesh basket would prevent a vessel that contained a water reactive material (alkali metal) from filling with hydrogen and migrating to the quarry surface. All explosive charges were placed on the vessels utilizing the remotely operated ROV manipulator. The explosive retention basket was placed over the vessel with the pontoon barge grapple.
