HIGH PERFORMANCE MAGAZINE CERTIFICATION TEST OF NONPROPAGATION WALLS

Robert N. Murtha
Naval Facilities Engineering Service Center, Port Hueneme, California 93043

ABSTRACT

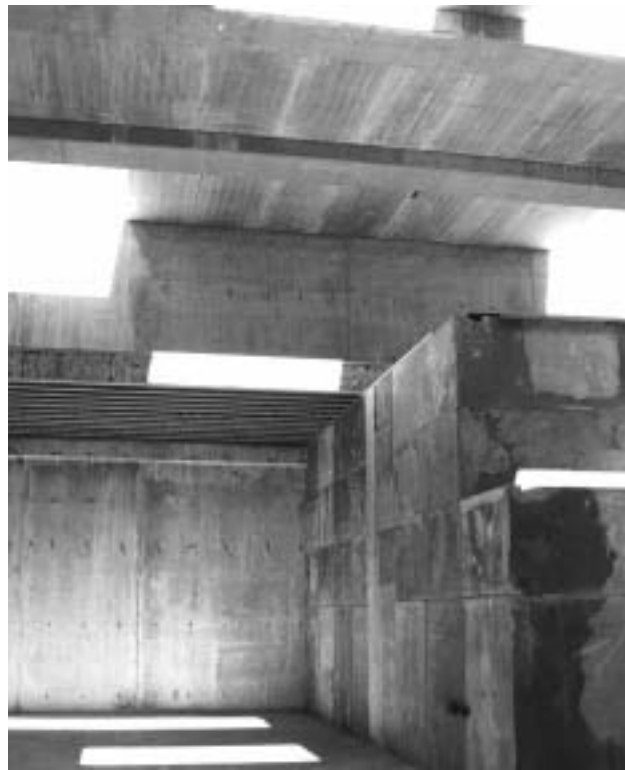
Figure 12. Portion of aisle wall.

A plan view and sections of the CT1 nonpropagation walls are shown in Figures 5 through 8. The walls were built from precast, wire mesh reinforced, CBC hollow blocks which were stacked and then filled on-site with a heavy core fill (steel grit or sand). The blocks were manufactured in a precasting facility in Thompson, Ohio. The mixer consisted of a 1cubic yard off center tub mixer with a central discharge. To achieve flow of the CBC into the 1.5-inch-thick webs, the forms were mounted on low frequency oscillating tables for the casting. The demolded blocks were cured under a water mist for 48 hours before finishing. Each CBC block had 18-in.-thick walls parallel to the acceptors and thin structural webs in the depth of the wall. The HP Magazine prototype aisle wall cross-section (8-ft total thickness) for mitigating the conventional 30,000-lb donor load is 3 ft of CBC (18 in. per each block face) and 5 ft of steel grit fill (SAE size S170; density = 285 pcf \pm 10 pcf). The cross-section (5 ft-8 in. total thickness) of the HP Magazine prototype cell wall is 3 ft of CBC and 2 ft-8 in. of steel grit. However, in CT1, only the walls around the donor are required to prevent SD from the donor to acceptors in Cells A1, A2, A3 and A4. The walls between Cells A1 & A4, A2 & A3 and A1 & A2 must only prevent SD between low explosive weight acceptors (in the event that there is SD to one acceptor). Therefore, the walls separating acceptors were filled with lower weight sand (density = 105 pcf \pm 5 pcf). Also, since the height of the CT1 donor and acceptor stacks were less than 10 ft, only the first 10 ft of elevation of the donor walls were filled with steel grit with the top 5 ft-6 in. filled with sand. Figure 5 shows the fill material of each wall. A photograph of a portion of the aisle wall is shown in Figure 12.

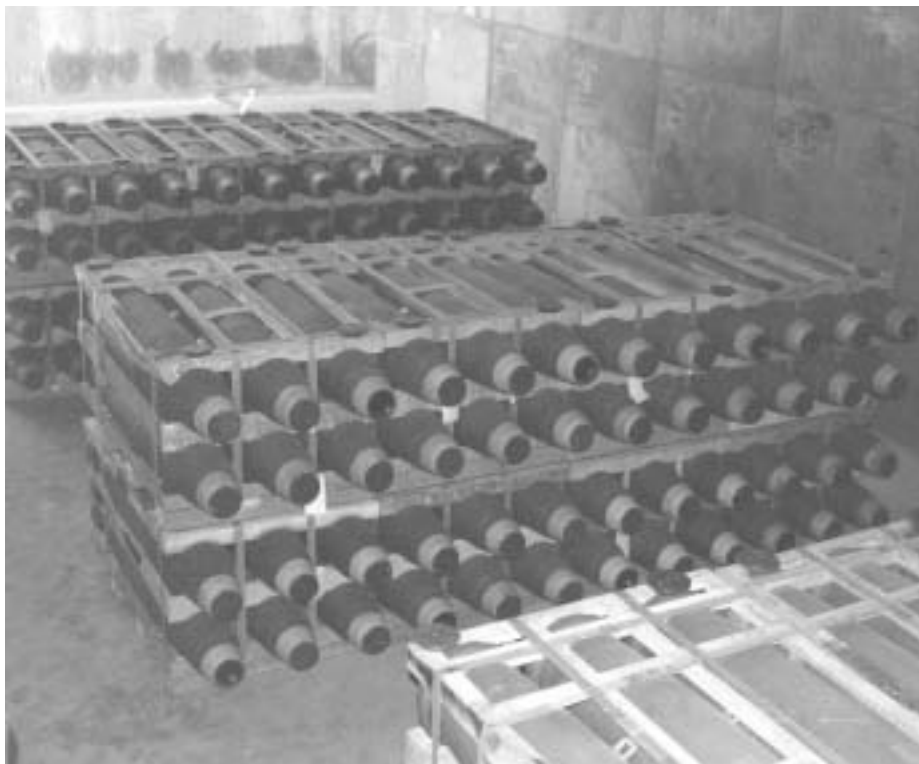
Figure 14. Mk82 donor ordnance.

The CT1 donor is the critical HP Magazine storage cell donor for the design of nonpropagation aisle and cell walls. The critical loads come from the maximum design storage density of Mk series bombs (30,000 lb = Net Explosive Weight (nominal) in a 38 ft-6 in. x 20 ft (LxW) cell). The high charge weight in a relatively small cell produces the highest design aisle and cell wall loads and the critical environment on the acceptors. The CT1 donor was 144 (24 pallets) tritonal-filled Mk82 bombs with a total NEW of 27,648 lb. Figure 13 shows the CT1 donor stowage plan for Cell D. A photograph of the donor ordnance is shown in Figure 14.

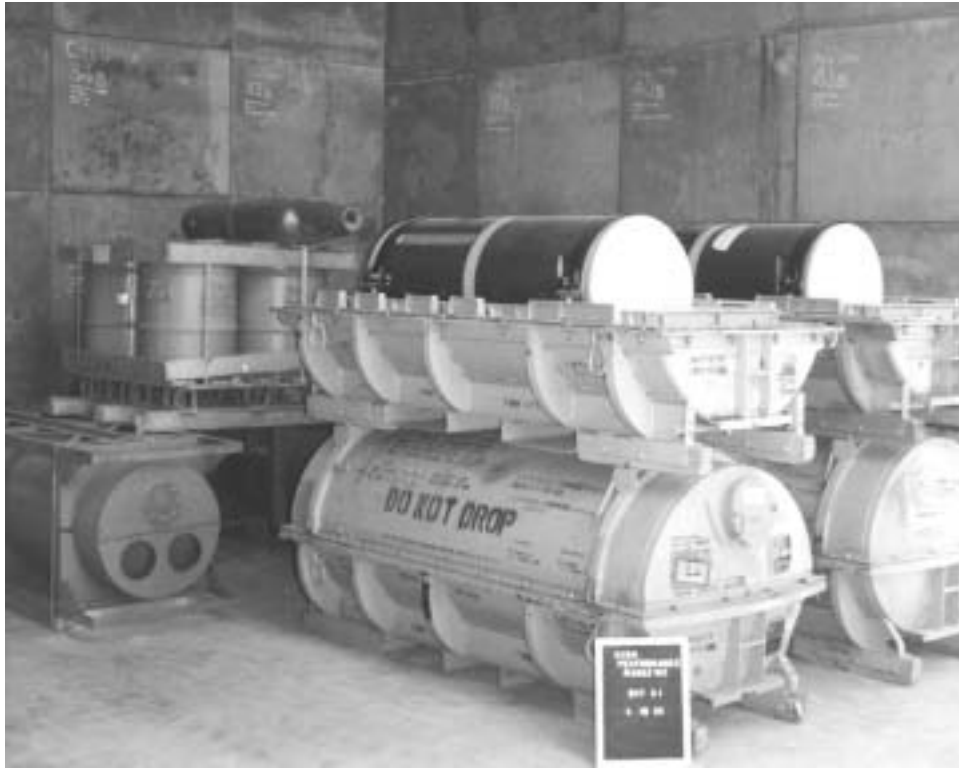
Figure 15. Acceptor ordnance inside Cell A1.

- **Cell A1.** This cell tested SG 8 acceptors (Mk55 mines and Mk103 & Mk107 torpedo warheads) opposite an aisle wall. All acceptors were oriented parallel to the aisle wall. A photograph of the ordnance in Cell A1 is shown in Figure 15.

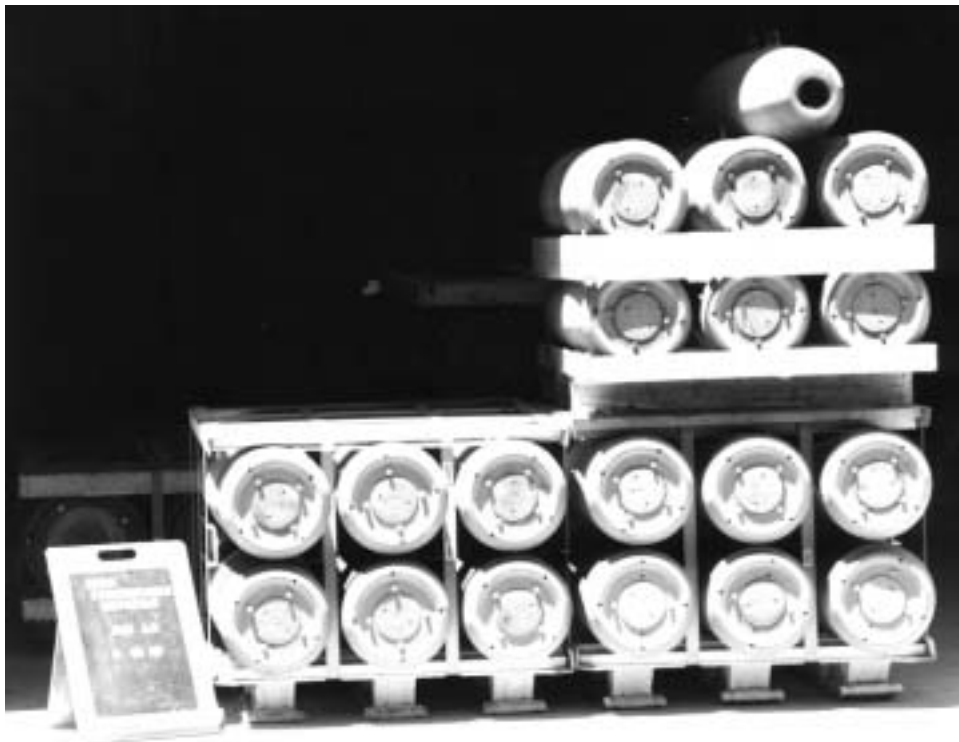
Figure 16. Acceptor ordnance inside Cell A2.

- **Cell A2.** This cell tested SG 4 acceptors (Mk82 and Mk83 bombs) opposite an aisle wall. All acceptors were oriented parallel to the aisle wall. Since the M107-155mm projectiles are considered more critical opposite a cell wall and since they are a recovery hazard, they were not placed in Cell A2. A photograph of the ordnance in Cell A2 is shown in Figure 16.

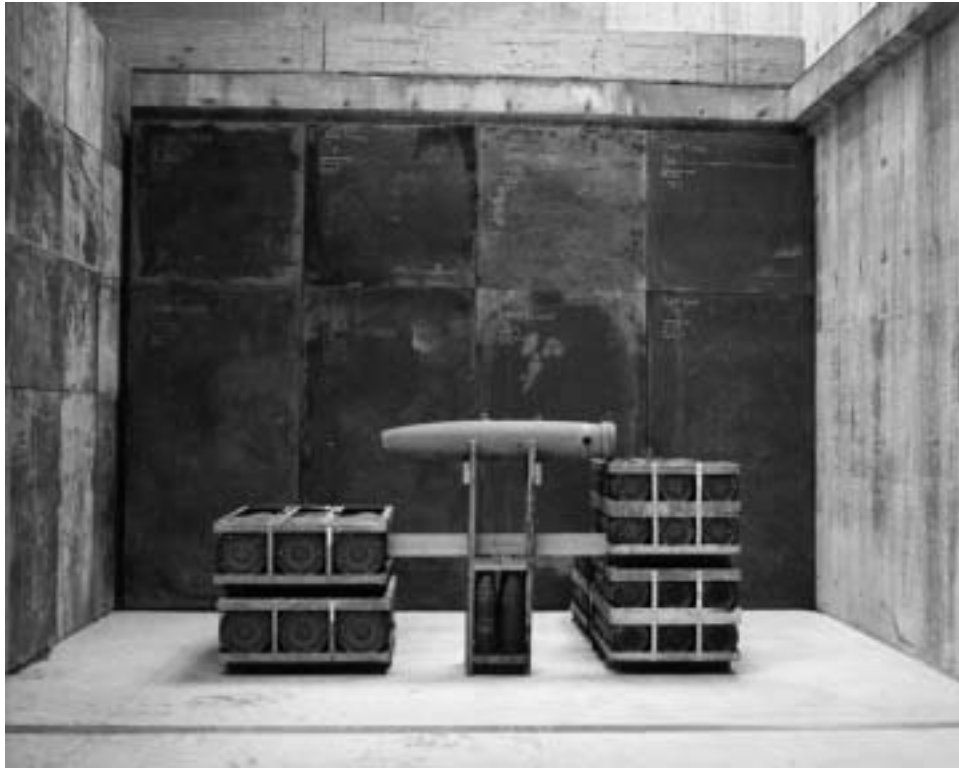
Figure 17. Acceptor ordnance inside Cell A3.

- **Cell A3.** This cell tested SG 4 acceptors (Mk82 and Mk83 bombs, and M107-155mm projectiles) opposite a cell wall. The bombs were oriented perpendicular to the cell wall. The M107-155mm projectiles, which are stored vertically, were therefore parallel to the cell wall. Since the loading environment behind a cell wall is greater than behind an aisle wall (and the M107 projectile is parallel to both), Cell A3 was considered more critical than Cell A2. A photograph of the ordnance in Cell A3 is shown in Figure 17.

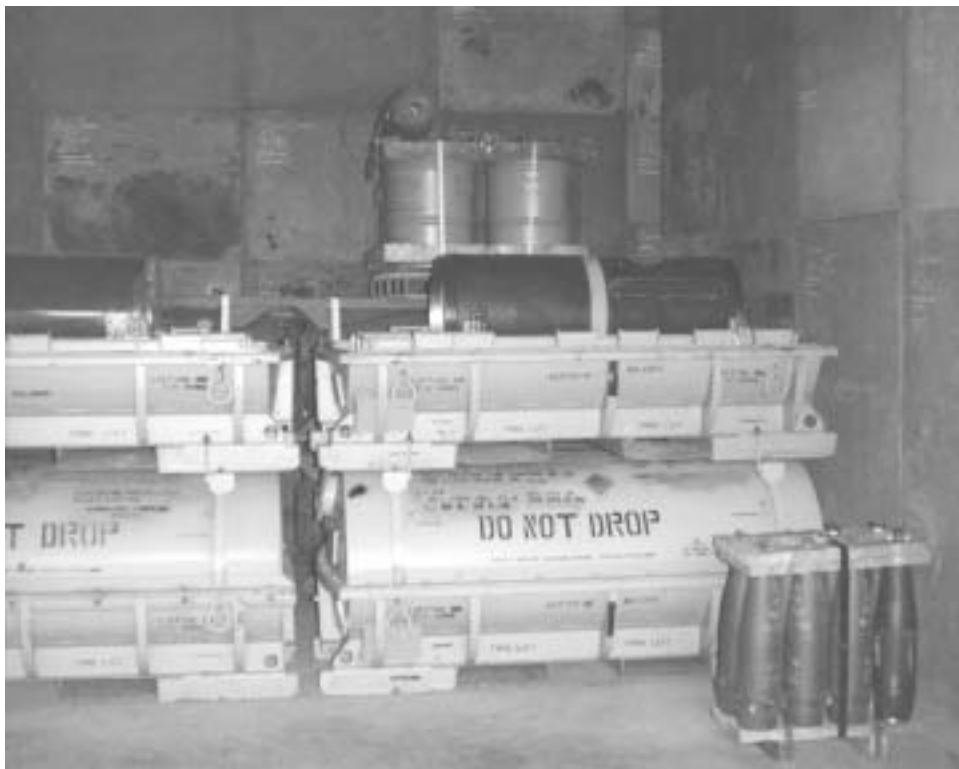
Figure 18. Acceptor ordnance inside Cell A4.

- **Cell A4.** This cell tested SG 8 acceptors (Mk55 mines and Mk103 and Mk107 torpedo warheads) opposite a cell wall. The Mk55 mines and Mk107 torpedo warheads were oriented perpendicular to the cell wall. The M103 torpedo warheads, which are stored vertically, were therefore parallel to the cell wall. Five live and three inert instrumented M107-155mm projectiles were located in Cell A4 for post-test evaluation of acceptor loading and response. A photograph of the ordnance in Cell A4 is shown in Figure 18.

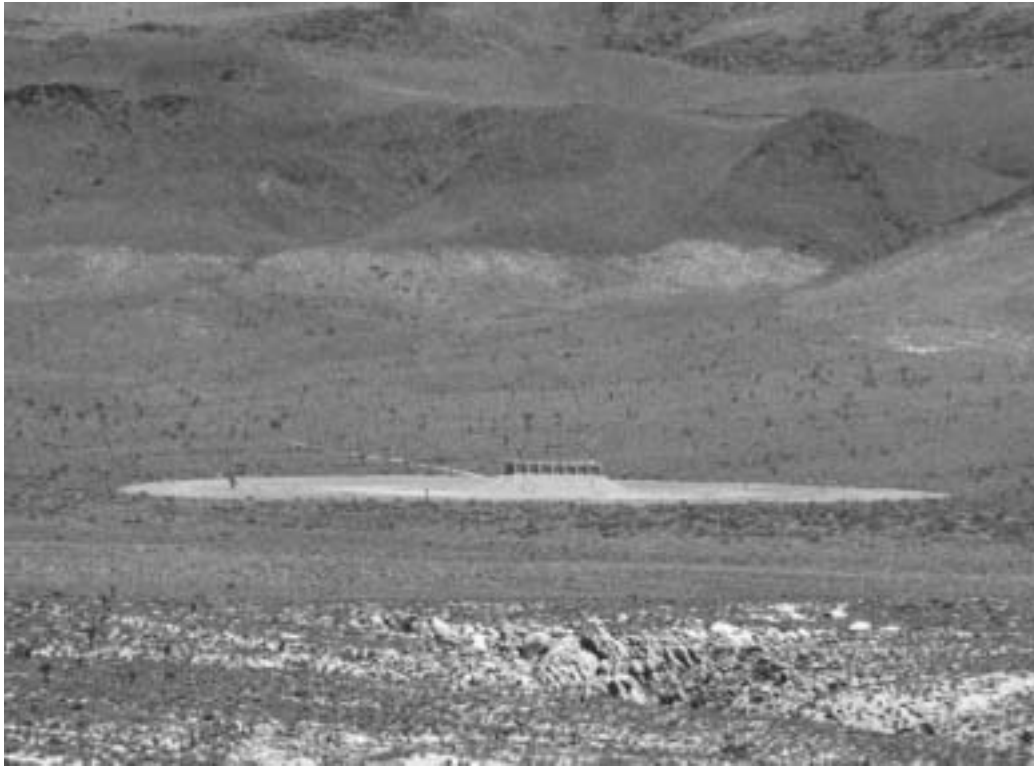
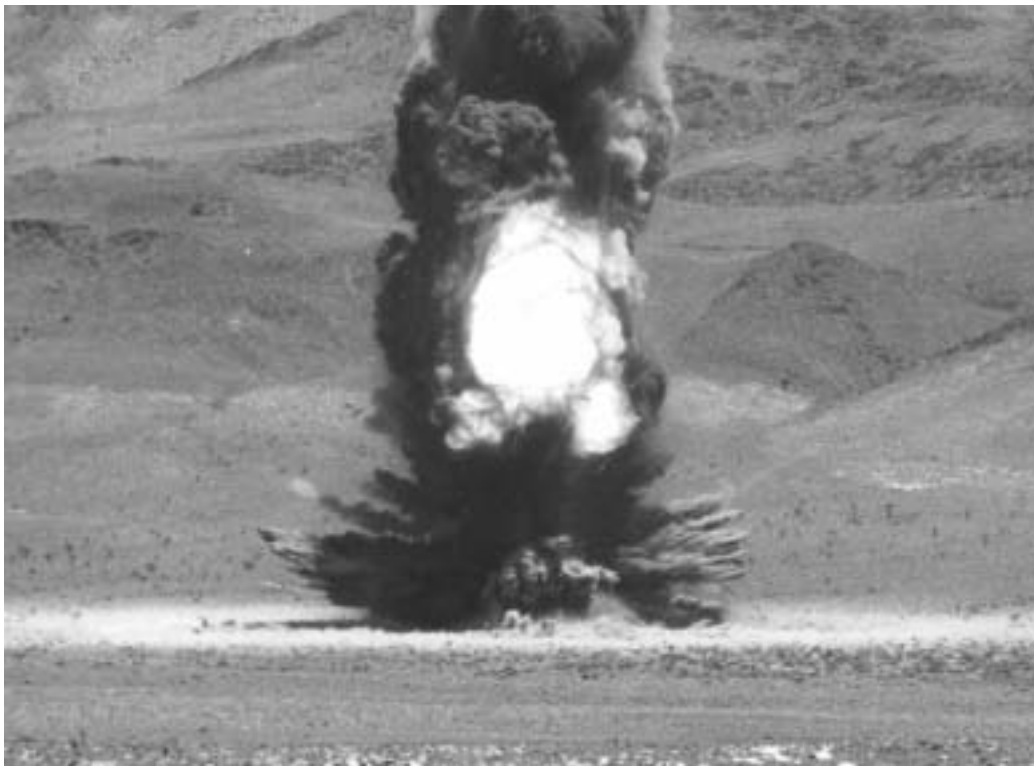
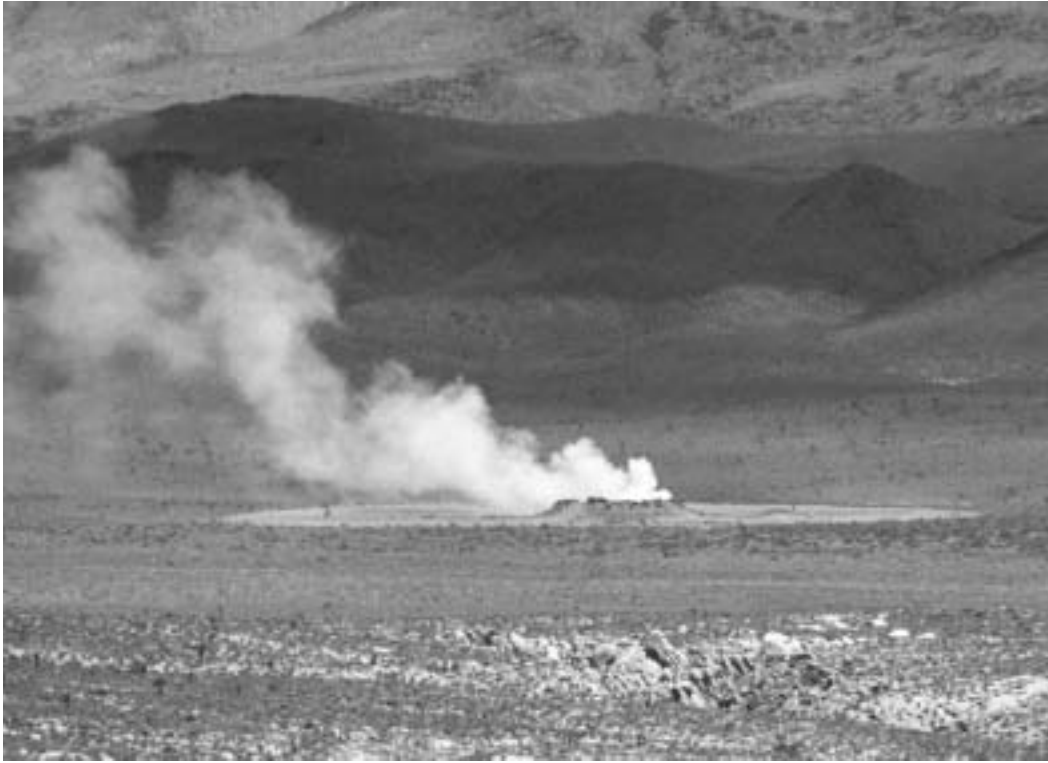
Figure 19. CT1 site: Pre-detonation.

Figure 20. CT1 site: Fireball.

Figure 21. CT1 site: Burning ordnance.

The test was conducted on 28 June 1995. All 144 Mk82 donor bombs were successfully detonated. A 3-shot sequence of far-away photographs of the test is shown in Figures 19, 20, and 21. The photograph in Figure 21 was taken several minutes after detonation and shows smoke from the burning of some of the thin-case acceptors. Although this burning phase lasted for about 35 minutes, there were no signs of any detonations of acceptors. Closer views of the interior damage to the CT1 structure are shown in Figures 22 and 23. These two photographs show the exterior walls resting against the soil berm after separating from the footing and lifting up from 5 to 10 feet. Almost all of the acceptor ordnance (except some ordnance in Cell A4) was found within or nearby the boundary of the original structure. Six thin-case acceptors from Cell A4 were found along the 90° azimuth between 40 and 550 feet from the structure. All the thick-case projectiles from Cell A4 were found along the 0° azimuth between 130 and 300 feet from the structure.

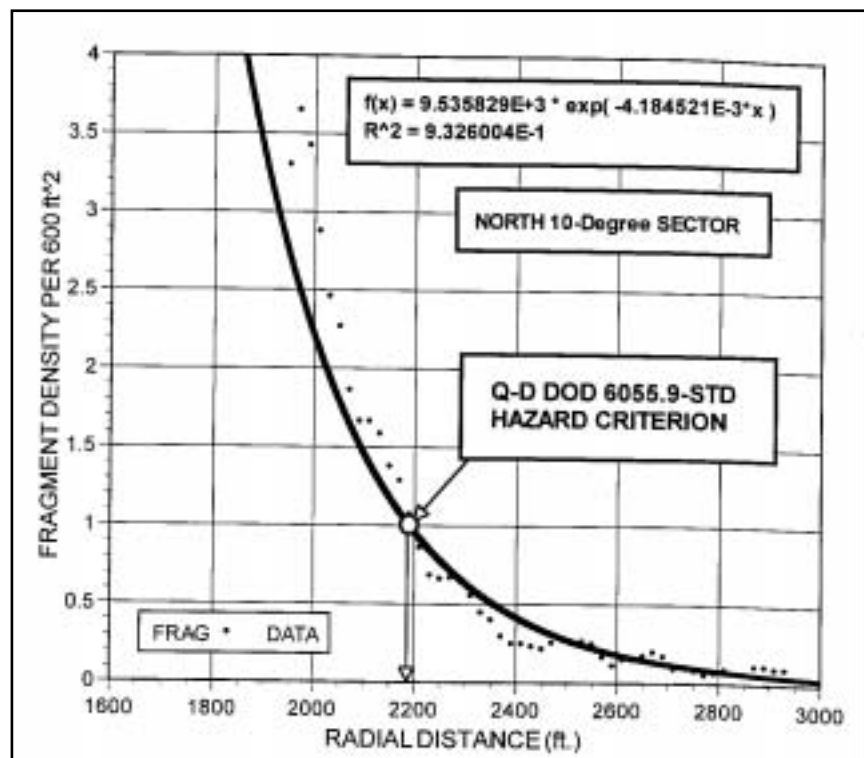
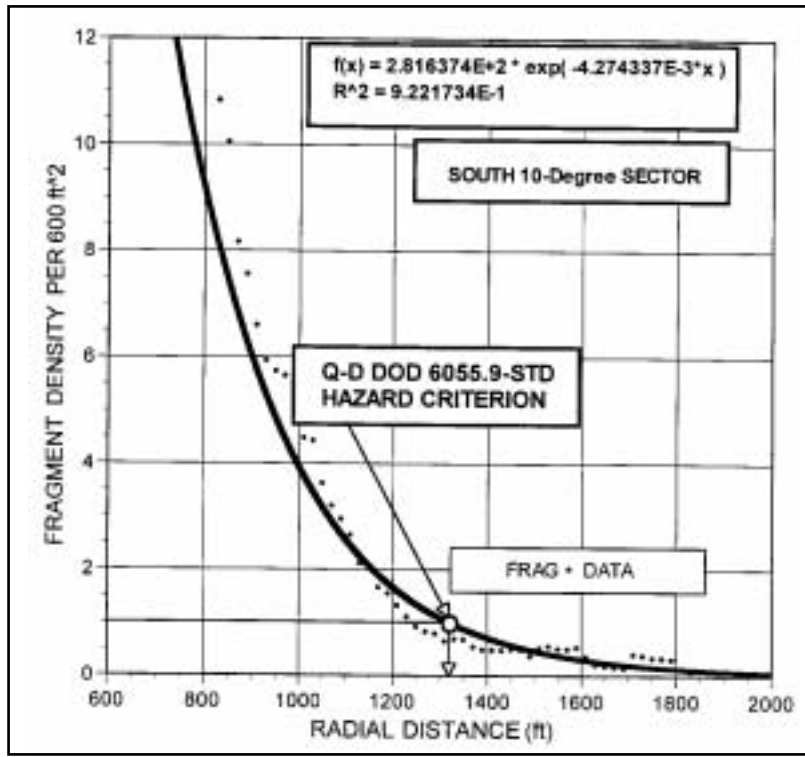
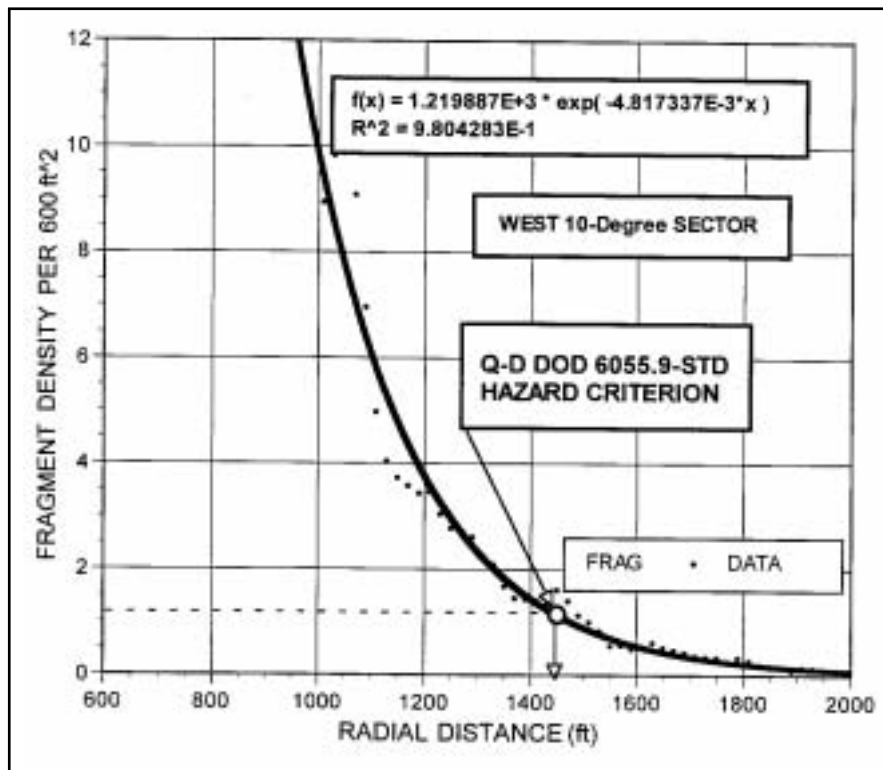
Figure 28. Debris areal number density distribution: Front sector.

Figure 29. Debris areal number density distribution: Back sector.

Figure 30. Debris areal number density distribution: Side sector.

was used. For such statistical analysis, values of constants are calculated so that the sum of the square of the errors given by $[g(x_i) - \ln(y_i)]^2$ is minimized. The statistical fit and corresponding square of the correlation factor for each set of data from the three sectors are shown by the inserted equations $f(x)$ and R^2 in Figures 28, 29, and 30. From these equations, the Q-D values defining the hazard criterion in the three debris recovery sectors were calculated as:

- Front Sector (0°): D = 2,190 ft
- Back Sector (180°): D = 1,320 ft
- Side Sector (270°): D = 1,475 ft

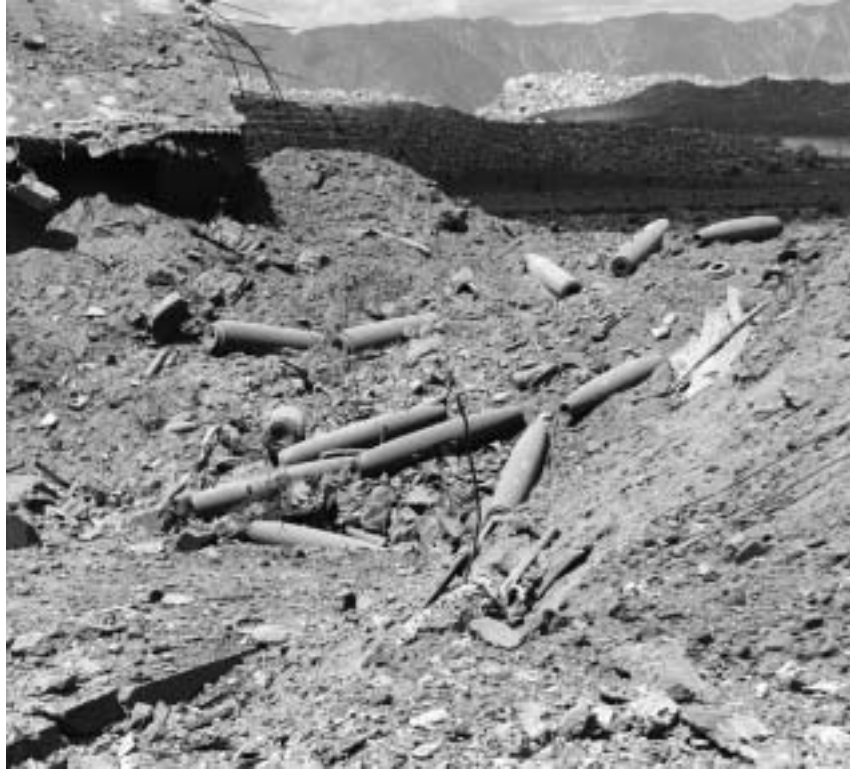
Figure 31. Mk82 and Mk83 bombs from Cell A3.

All of the thick-case acceptors were recovered intact following the test. Visible damage to these acceptors was minor and limited to scarring of some cases and shearing off of several lifting lugs. A photograph of the ordnance in Cell A3 is shown in Figure 31. These bombs were resting on the remains of the soil berm behind the CT1 structure's sidewall. Pre-test predicted deformations (100 x diameter change /original diameter) for these acceptors ranged from 23-30 percent. These values exceeded the 25 percent threshold established from previous flyer plate tests. However, since the predicted procedure has been consistently conservative from previous tests, it was expected that actual deformations would not exceed the 25 percent threshold. Pre-test predicted pressures of the explosive fill were less than 3 Kbar (threshold = 4 Kbar).

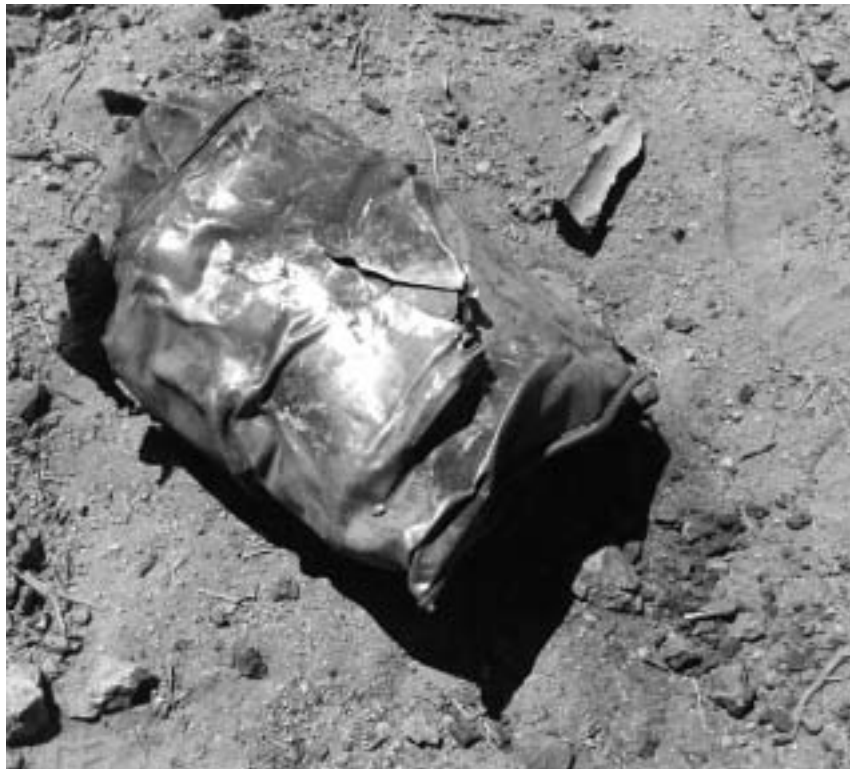
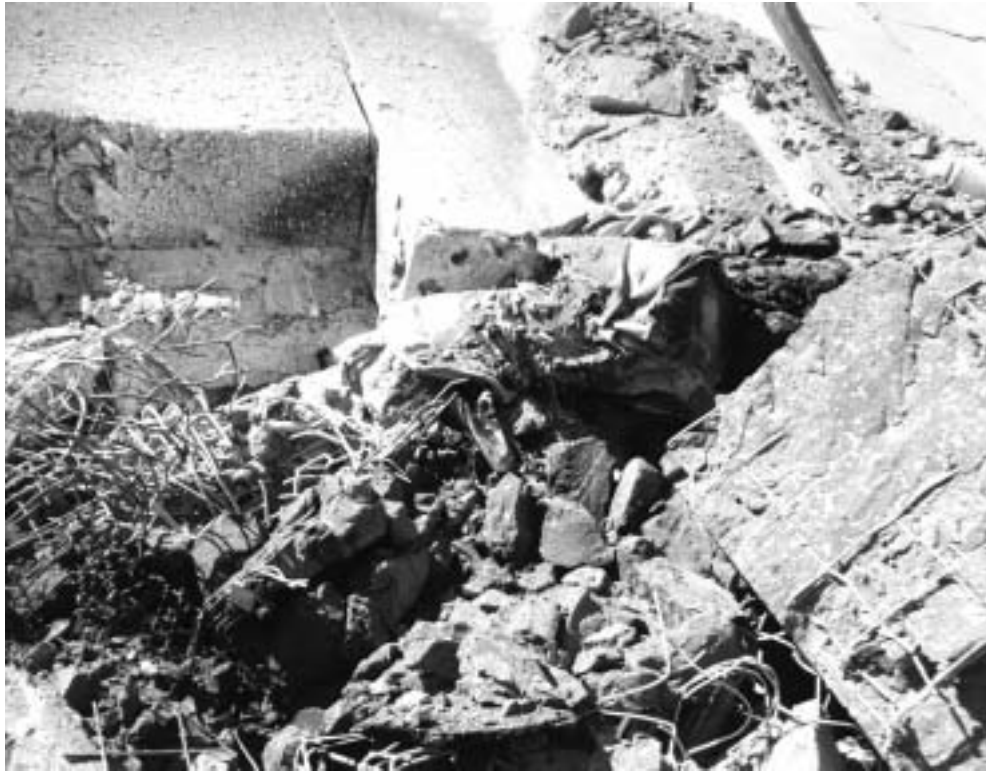
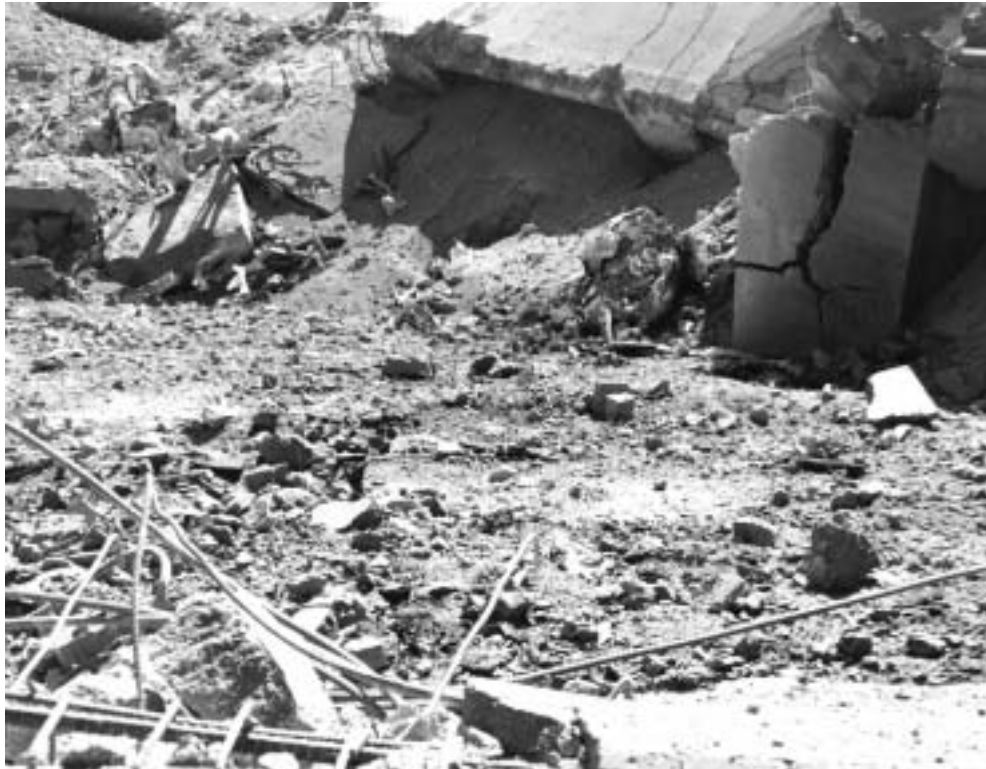
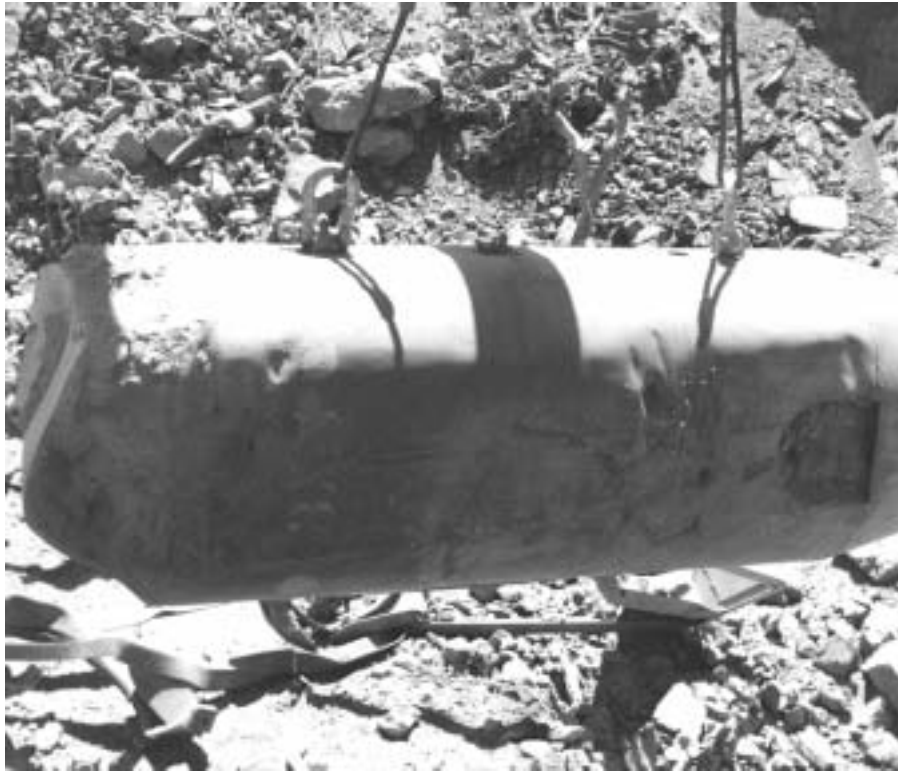
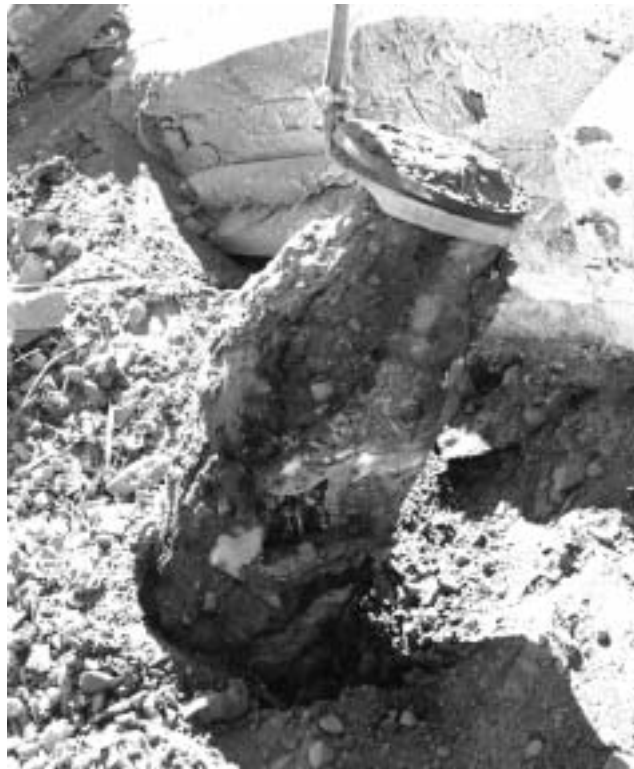
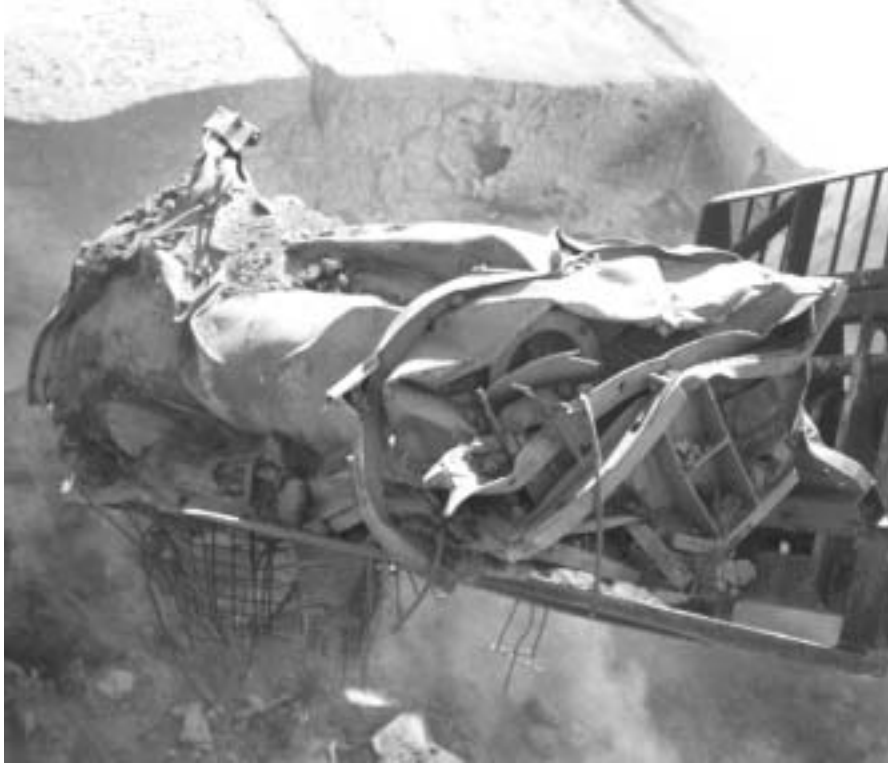
Figure 32. Mk103 torpedo warhead from Cell A4.

Figure 33. Mk103 torpedo warhead from Cell A1.

Figure 34. Two Mk55 mines from Cell A4.

Figure 35. First Mk55 mine from Cell A1.

Figure 36. Second Mk55 mine from Cell A1.

Figure 37. Mk107 torpedo warhead from Cell A1.

As predicted, the thin-case acceptors suffered more extensive damage. Typically these acceptors cracked open, but any reaction of their explosive contents was limited to burning, not detonating. Pre-test predicted case deformations ranged from 24-35 percent. Based on flyer plate tests of the Mk107 torpedo warhead, casing ruptured at 10 percent deformations. However, detonations were not expected because predicted explosive fill pressures never exceeded 3 Kbar. A photograph of a broken Mk103 torpedo warhead and some unburned PBXN-103 explosive fill from Cell A4 is shown in Figure 32. This warhead was recovered outside the structure. A photograph of a badly burned Mk103 torpedo warhead from Cell A1 is shown in Figure 33. This warhead was found resting against the base of the rear wall CBC liner. A photograph of two burned Mk 55 mines from Cell A4 is shown in Figure 34. Photographs of the two recovered Mk55 mines from Cell A1 are shown in Figures 35 and 36. These mines were both partially buried under the structure rubble. A photograph of a recovered Mk107 torpedo warhead from Cell A1 is shown in Figure 37. It also was partially buried under the structure rubble.
