ECBC-TR-670

### EFFECTS OF VAPORIZED DECONTAMINATION SYSTEMS ON SELECTED BUILDING INTERIOR MATERIALS: CHLORINE DIOXIDE

February 2009

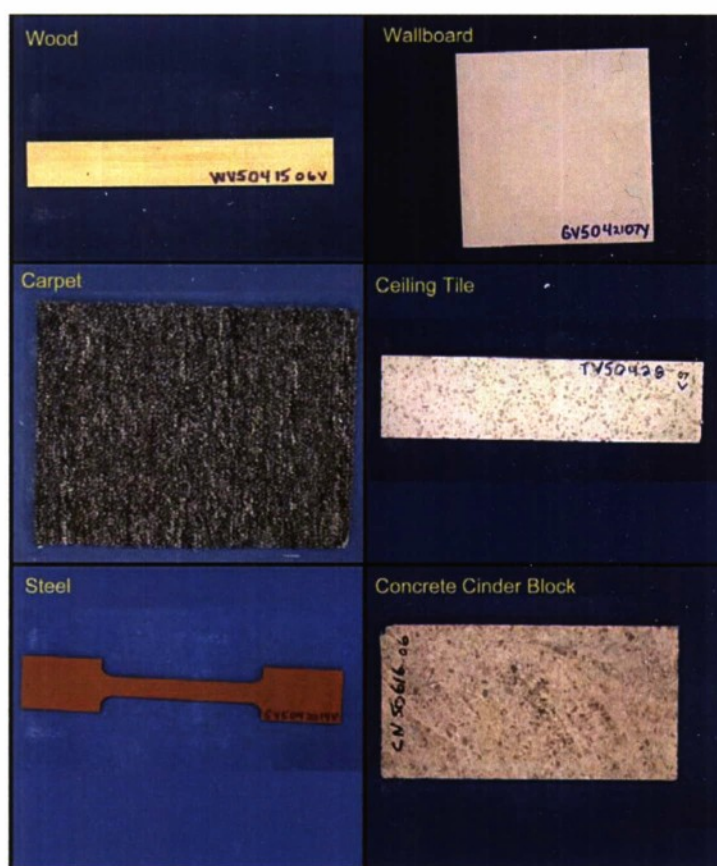
**Figure 1.** Representative photograph of the test coupons.

\*Coupons are not shown to scale

The Material Compatibility studies also investigated materials related to electrical breaker connections, such as intact circuit breakers and component metals aluminum, copper, and steel. The circuit breakers were one-pole circuit breakers (HOM120, 2400 W, 120/240 V, 20 A).

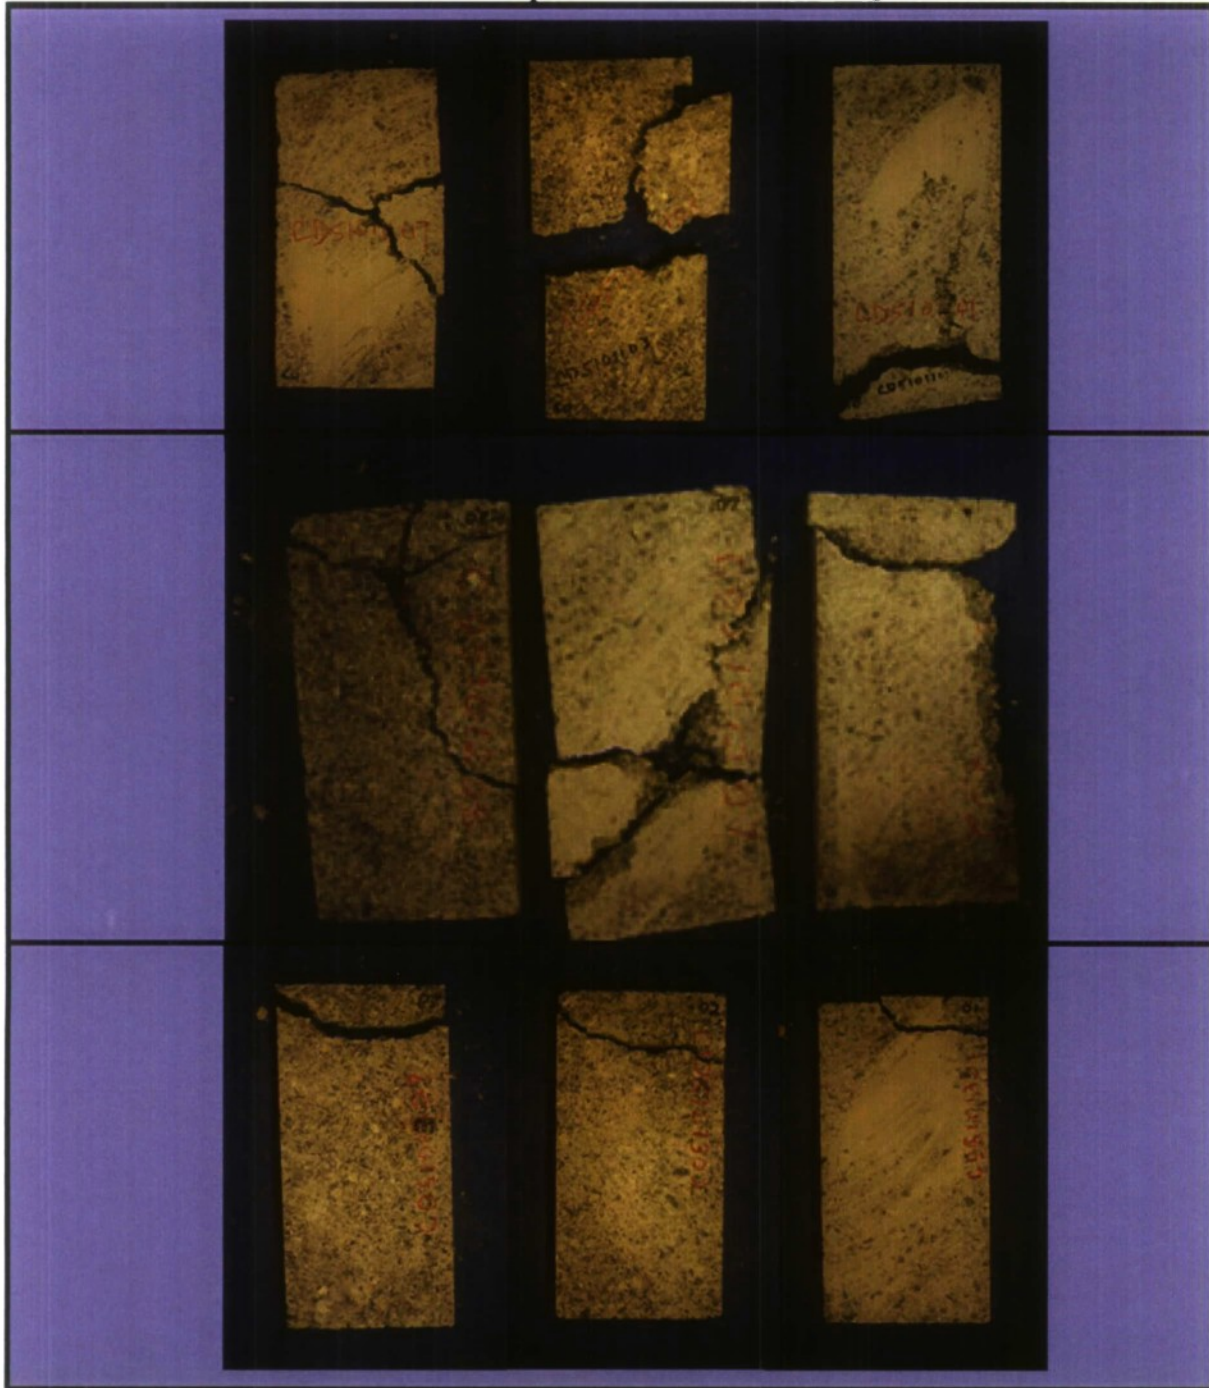
#### Concrete cinder block coupon location of break: $\text{ClO}_2$ control set

There is no requirement for reporting the location of the break; however, concrete block is a variable material and differences in location were observed. This appendix provides additional information through test photographs. Yellow arrows are used on samples where the photograph contrast may not clearly show the location of the break.

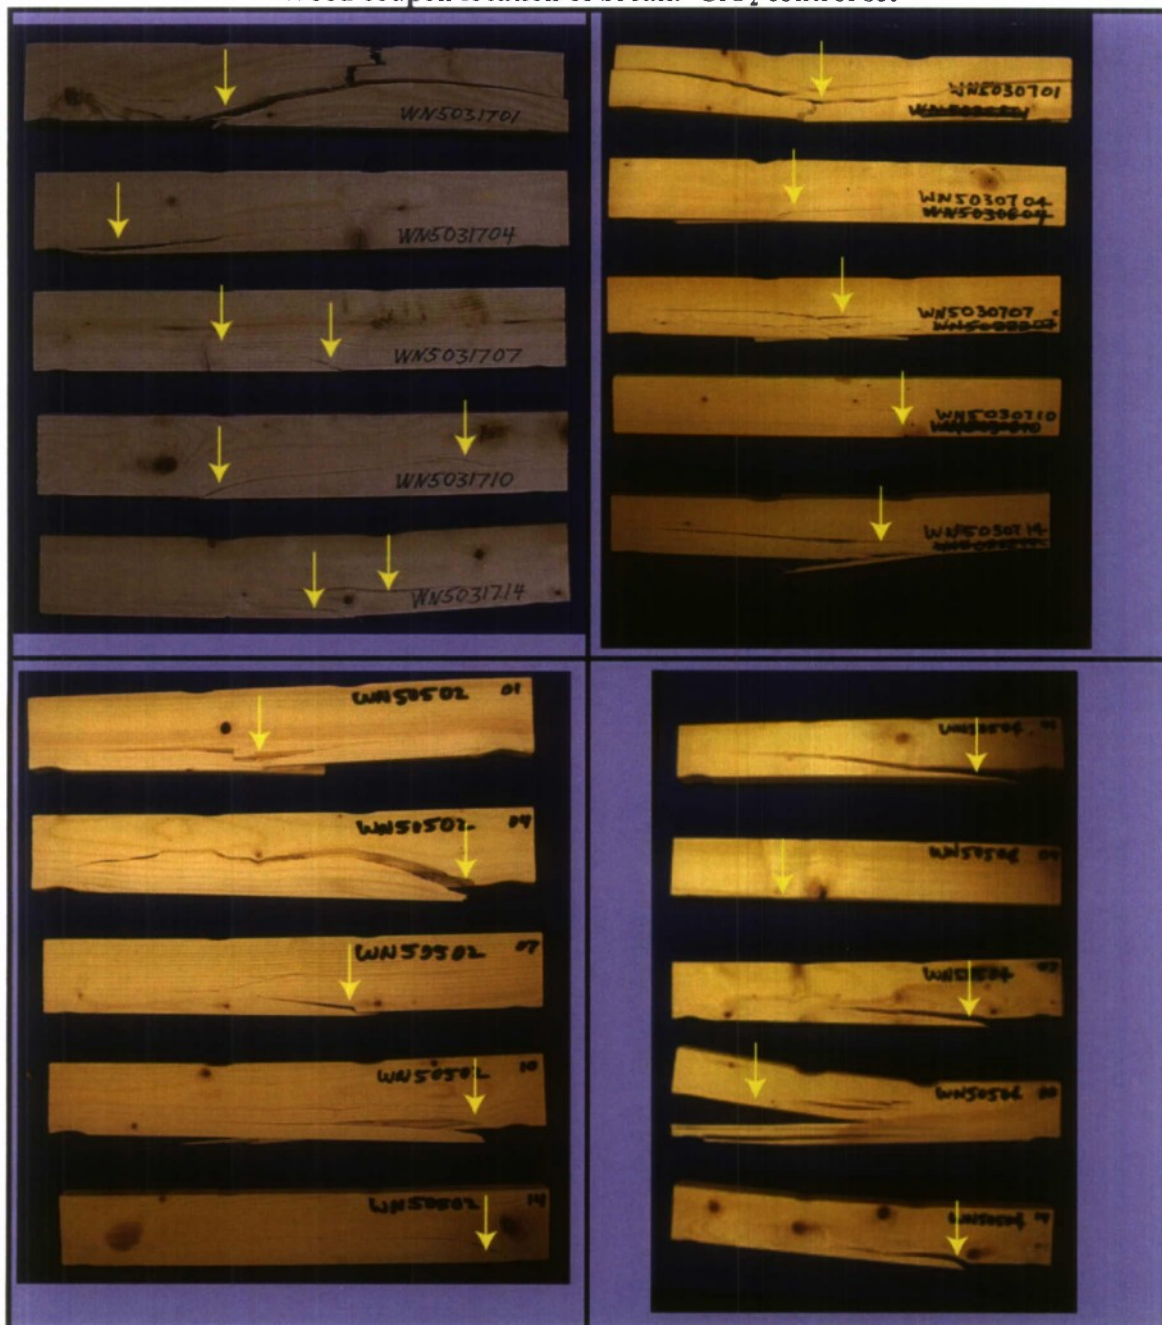
Wood coupon location of break: ClO<sub>2</sub> control set

The ASTM test method requires reporting the location of the break for each wood sample. This appendix provides this reporting information in pictorial form. Yellow arrows are used on samples where the photograph contract may not clearly show the location of the break.
