# Phase Zero Final Report

Recommendations on Composite Socket  
Fabrication based upon Experimental Results

Christopher William Norfolk, PhD, and Jon Osborn, MS, MBA  
SCRA / ARDI  
20 June 2009

# **MECHANICAL TESTING OF PROSTHETIC COMPOSITE TRANS-TIBIAL SOCKETS**

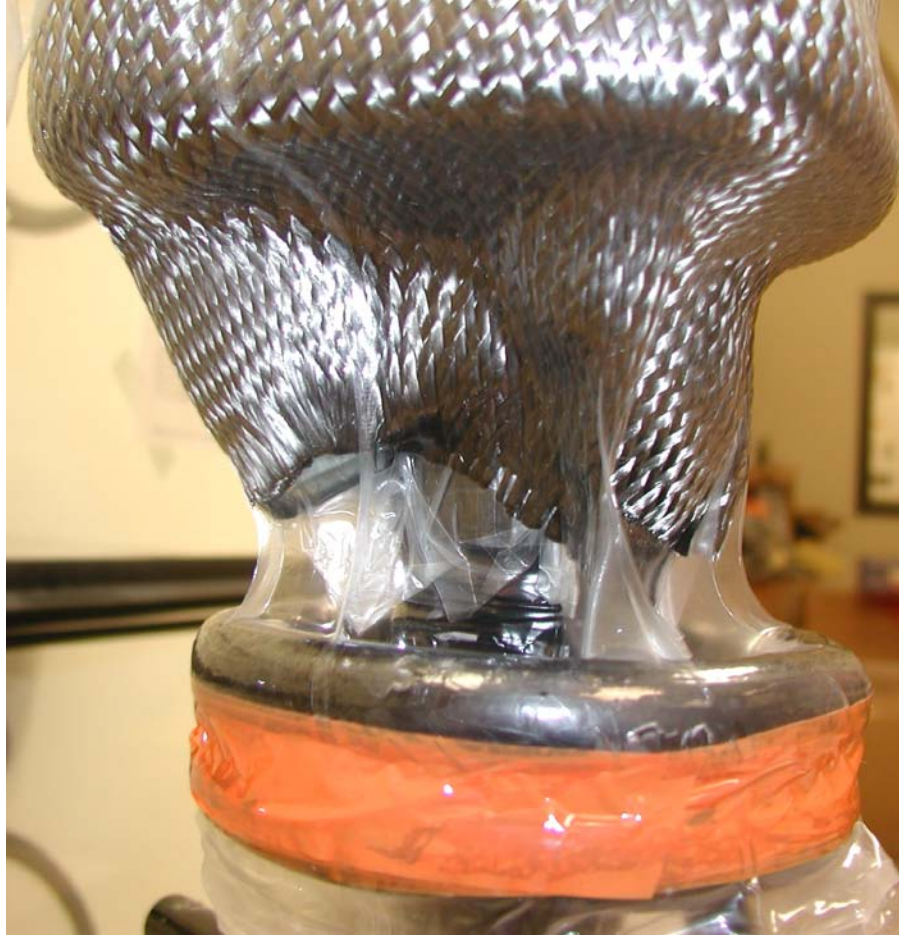
is secured in place at the bottom, and stretched tightly at the top, this collapsing effect under vacuum pressure can cause the bag to stretch and pop. This has resulted in the use of very small vacuum pressures during socket manufacturing, when compared to more traditional VARTM processing. A picture of the bag collapsing at toward the mounting pipe is shown below.

**Figure 2: Illustration of the collapse of the vacuum bag**

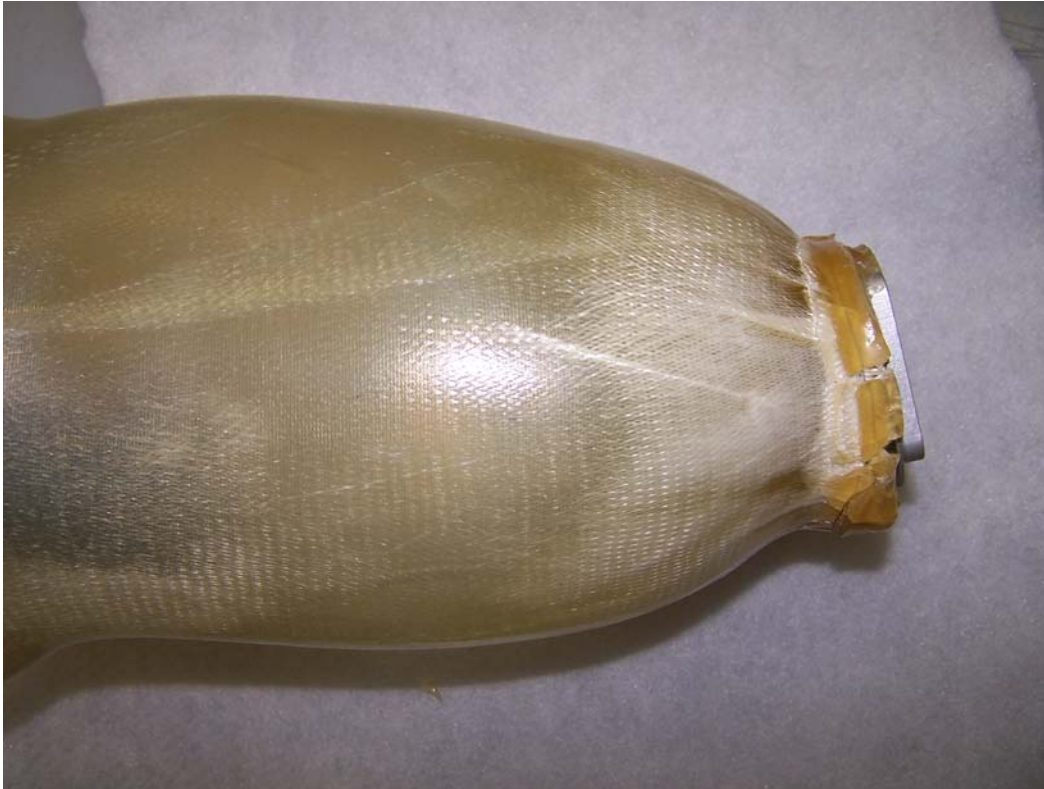
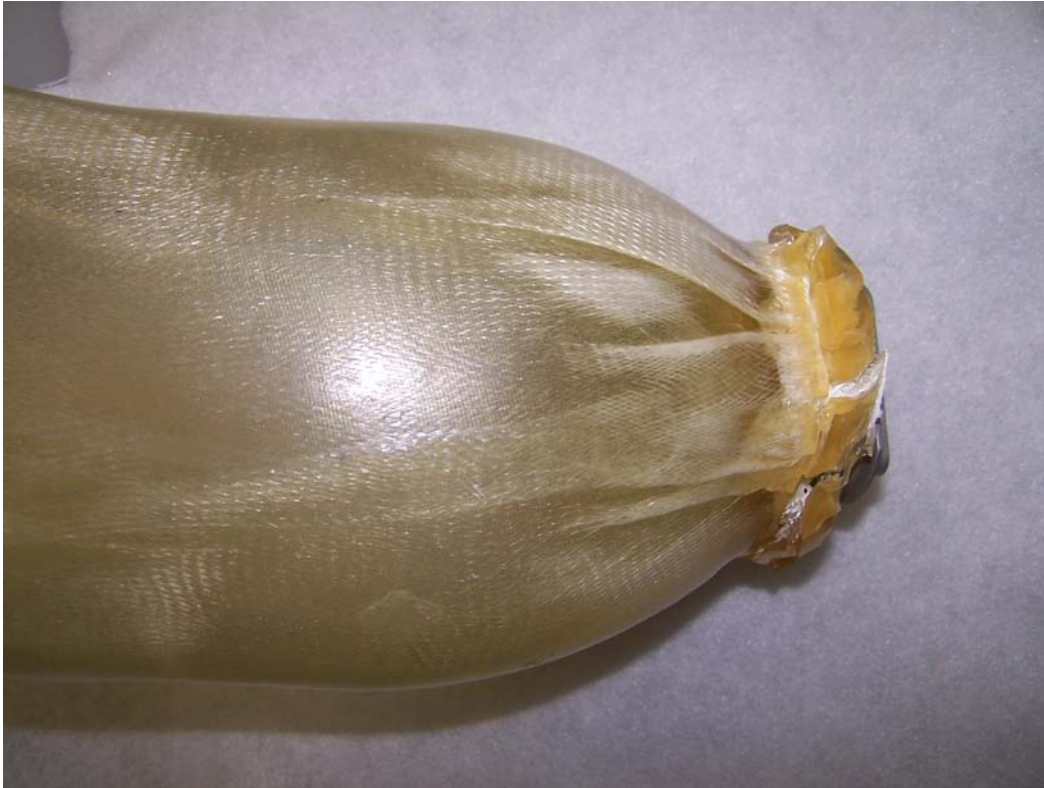
The fourth socket was fabricated from a single infusion of CMRK resin; two layers of fiberglass were placed under the attachment plate, and a single layer of fiberglass was tied into the attachment plate. The purpose of this socket was to explore the lower limit of socket strength, as this socket was envisioned to be the lowest strength socket which would ever be used clinically, and indeed is thinner than any socket I have observed. However, it was important to determine if the testing apparatus would be capable of applying loads which would fail any sockets. The ultimate strength of this socket was -8,197.7 N, which is 125% more than the P4 requirement of -3,623 N. The failure occurred at the

distal end, in the layers which were tied into the attachment plate. Note the appearance of large cracks and pulled fibers at the distal side of the attachment plate.

**Figure 12: Medial close up of the failure of Socket #4**

**Figure 13: Posterior close up of failure of Socket #4**

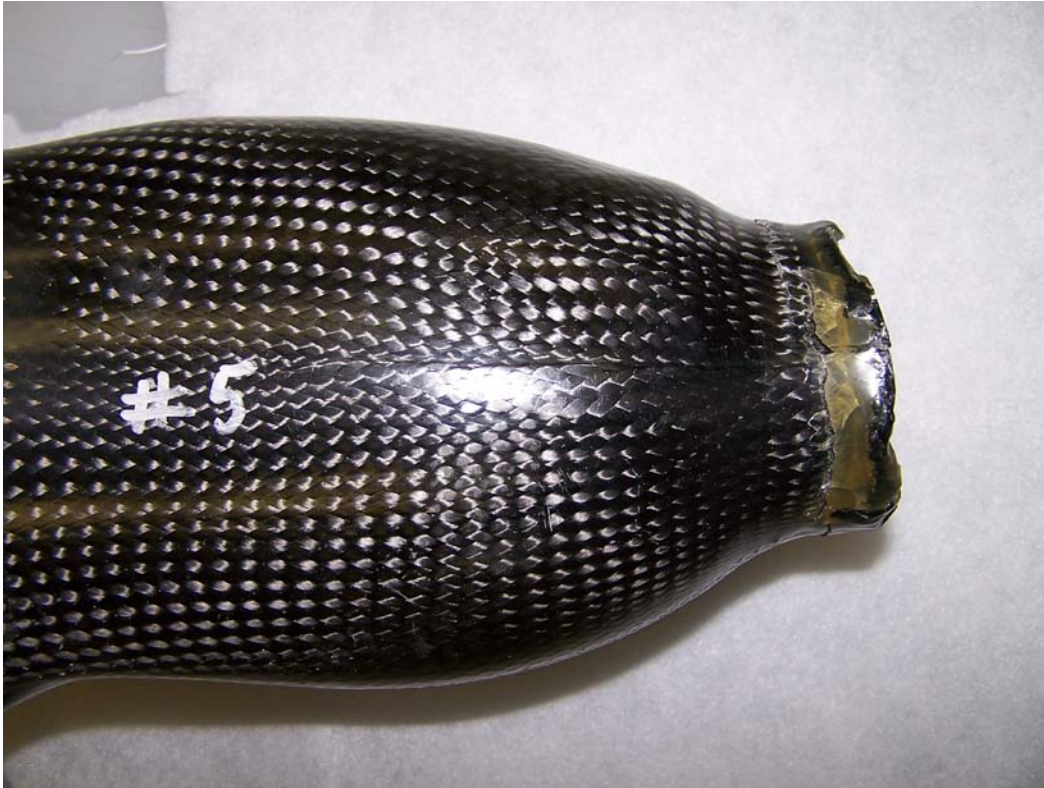
The fifth socket was fabricated using a single infusion of the CMRK resin. The reinforcement fabric used was the baseline carbon sleeve which has a tow size of 12k. Two layers were placed under the attachment plate, and a single layer was tied into the plate. It was also projected that this socket would be relatively weaker than socket #1, as there would be less carbon used in the fabrication. The socket's ultimate strength was -8,706.7 N, which is 140% more than the P4 loading required, and was indeed less than the ultimate strength of socket #1. The failure mode was again at the distal end where the attachment point was secured to the composite structure. The figure below shows a concentration of damage at the posterior near the attachment point.

**Figure 14: Medial close up of the failure of Socket #5**

The series represented by sockets #4 and 5 explore the relative strength gained by using carbon over fiberglass. Their ultimate strength is very similar for the same number of layers arranged in the same configuration, and using the same resin. The carbon has only a slight advantage. However, the fiberglass fabric used has a much smaller tow size, and as a consequence, three fiberglass layers represent much less total material than three carbon layers. The advantage of the carbon over the fiberglass appears to be extremely small, with respect to the static strength.

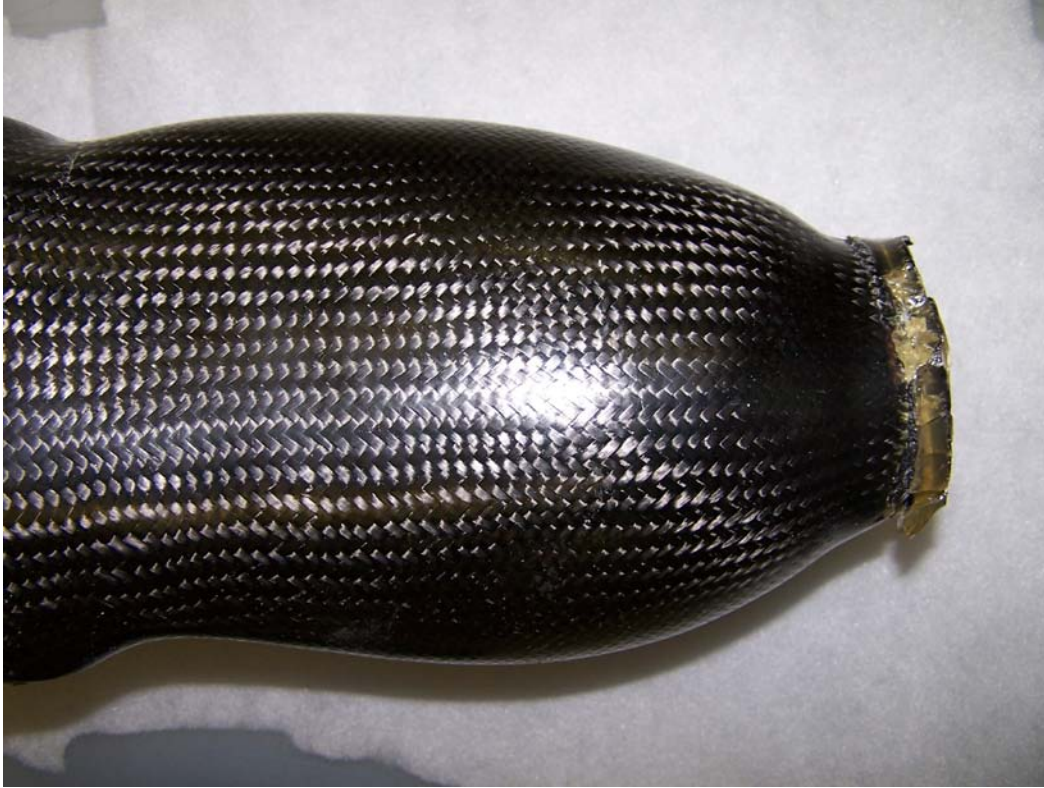
The sixth socket was fabricated using a single infusion of the CMRK resin. The reinforcement fabric used was a lightweight carbon sleeve which has a tow size of 6k. Two layers were placed under the attachment plate and a single layer was tied into the plate. It was also projected that this socket would be relatively weaker than both socket #1 and socket #5, as there would be less carbon used in the fabrication. The socket's ultimate strength was -6,279.7 N, which is 70% more than the P4 loading required. The failure mode was again at the distal end where the attachment point was secured to the composite structure. Note the concentration of damage at the posterior.

**Figure 15: Medial close up of the failure of Socket #6**

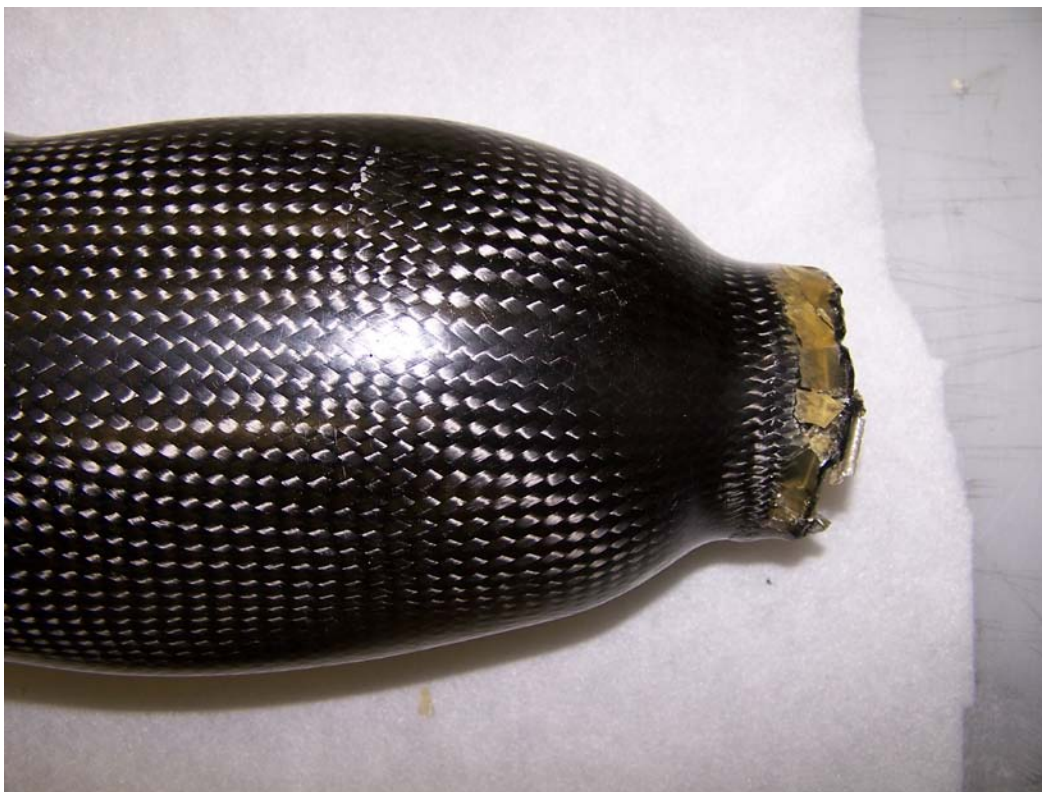
The ninth socket was fabricated using a double infusion of the CMRK resin. Two layers of carbon were placed under the attachment plate and infused in the first infusion. An additional layer of carbon was tied into the attachment plate and infused in a second infusion. The ultimate strength was -8,682.2 N, which is 140 % of more than the P4 loading required and statistically indistinguishable from socket #5. The failure mode was again at the distal end where the attachment point was secured to the composite structure. Note the concentration of damage at the distal end.

**Figure 16: Lateral close up of failure of Socket #9**

The series represented by sockets #4 and #9 explores the effect on the static strength of a single infusion versus a double infusion fabrication mode. At the interface between two infusions, the bond

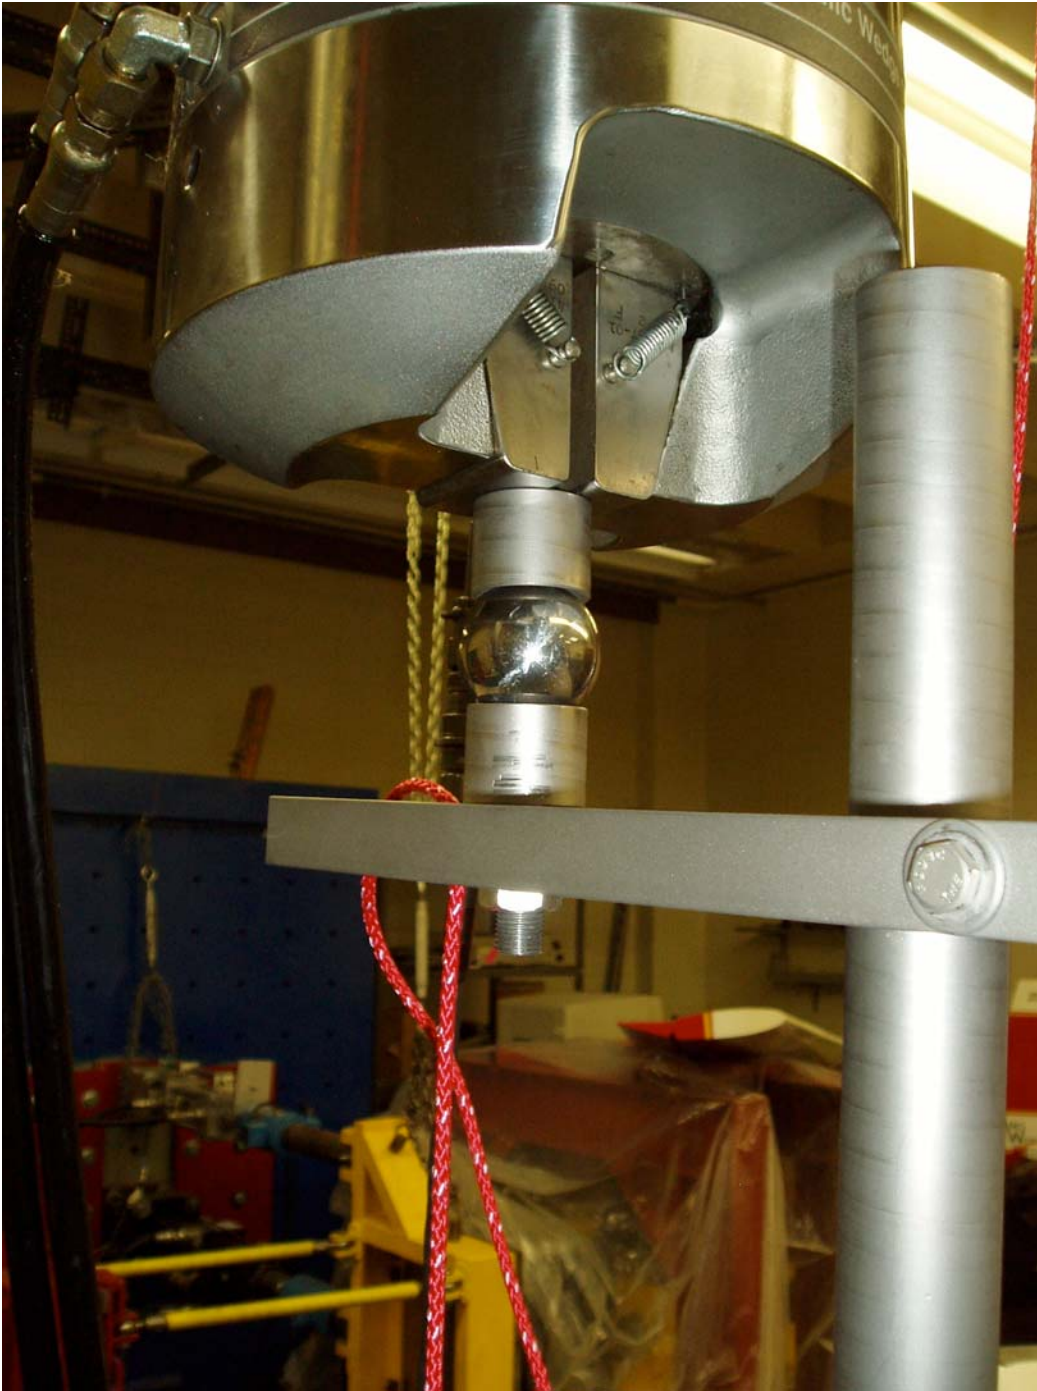
**Figure 2. Distal end load fixture detail.**

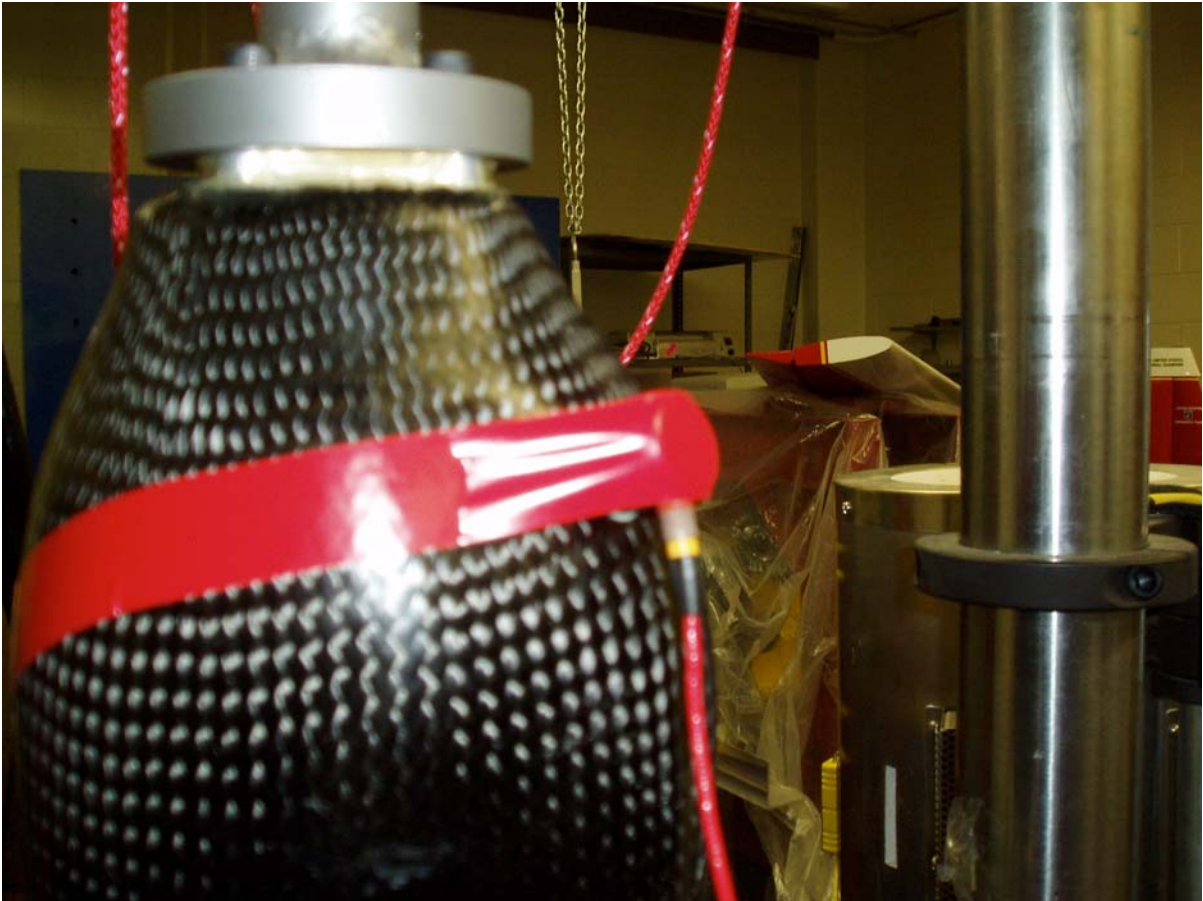
**Figure 4. Acoustic emission sensor placement.**

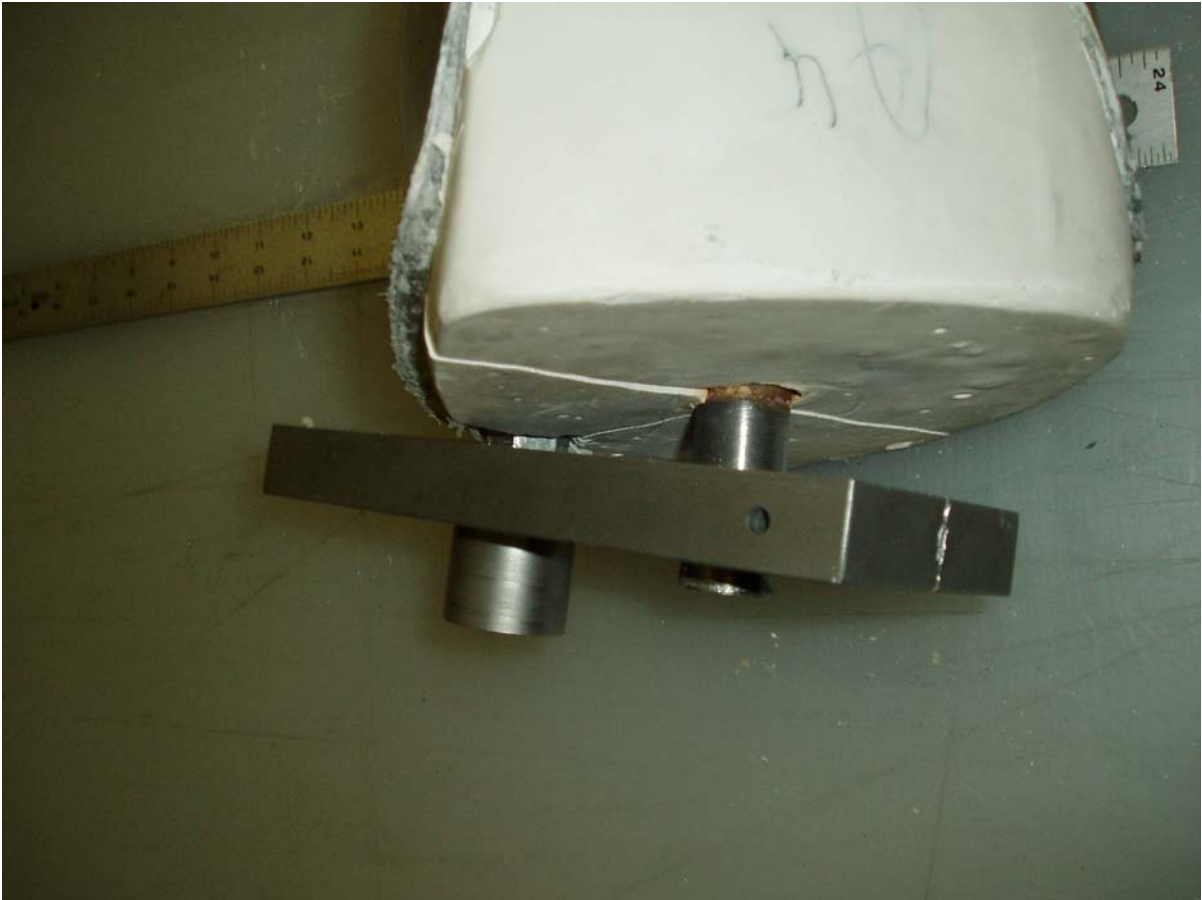
**Figure 9. Steel shank plastic deformation and plaster mold cracking for socket #4.**

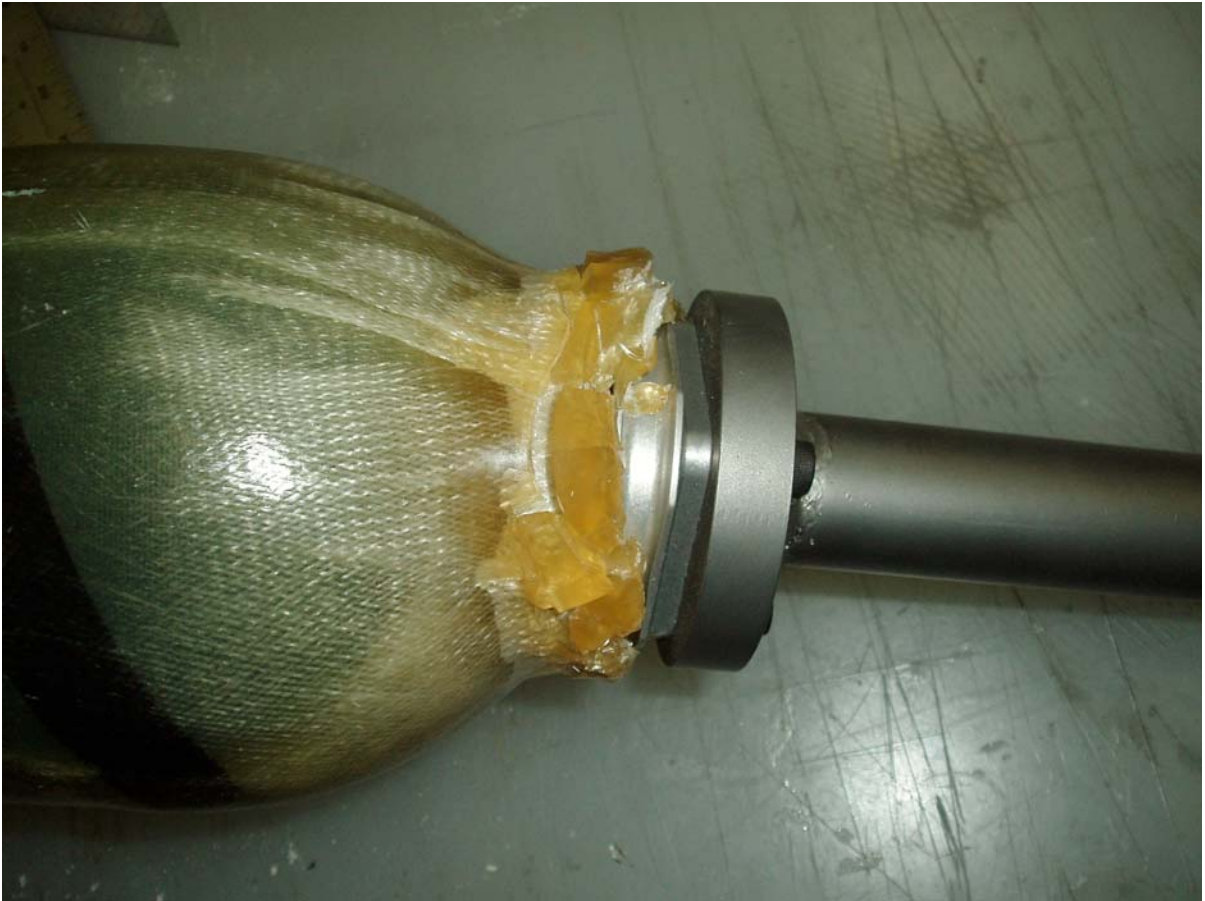
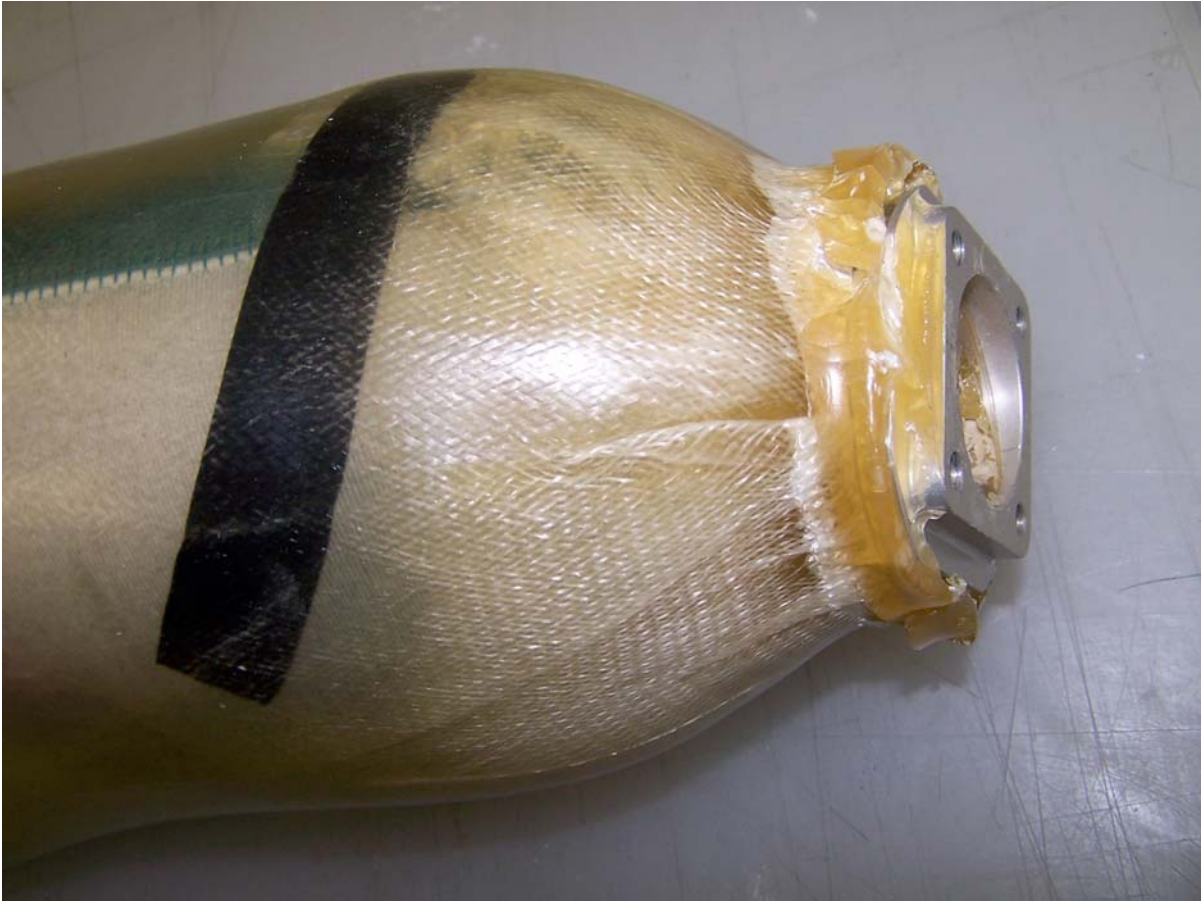
**Figure 10. Failure region close-up view for socket #4.**

**Figure 11. Failure region close-up view for socket #4.**

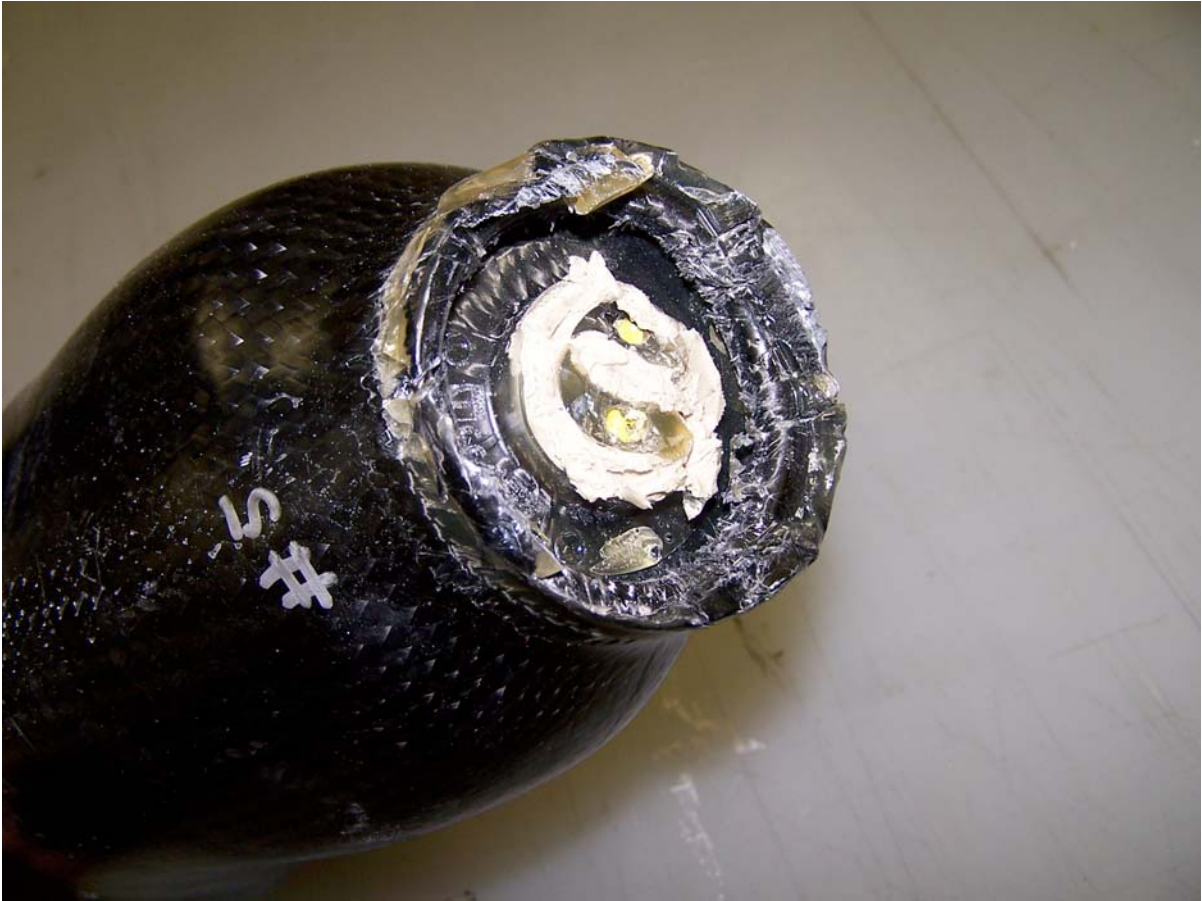
**Figure 15. Failure region close-up view for socket #5.**

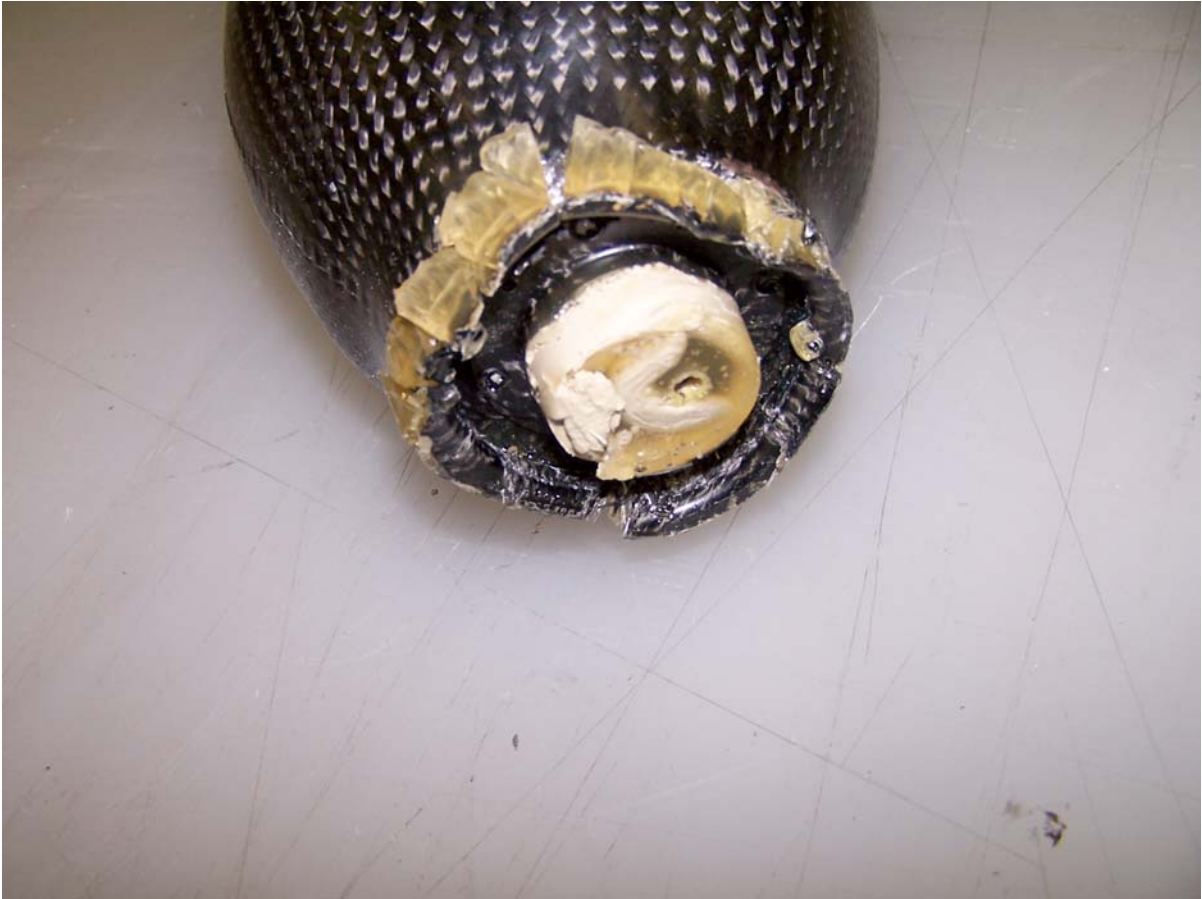
**Figure 19. Failure region close-up view for socket #6.**

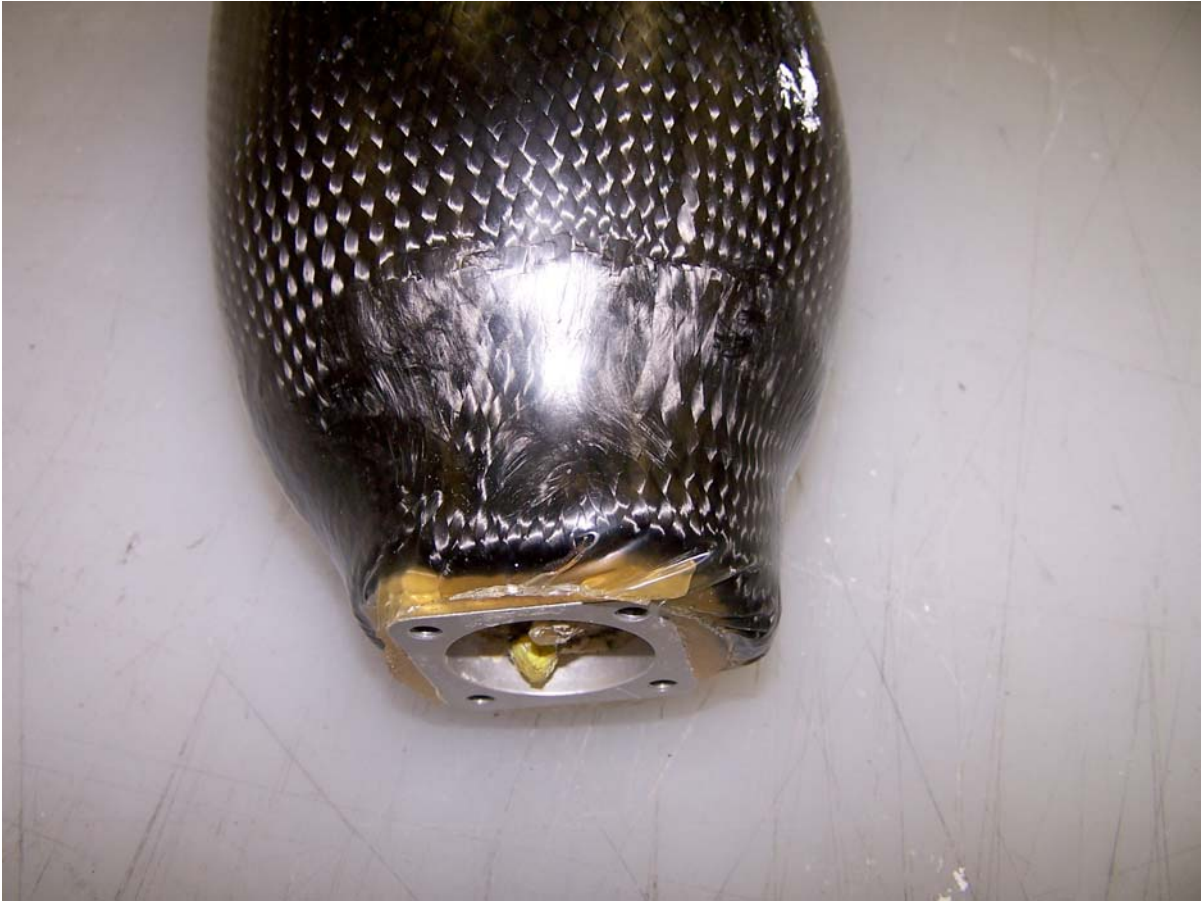
**Figure 23. Distal region close-up view for socket #7.**

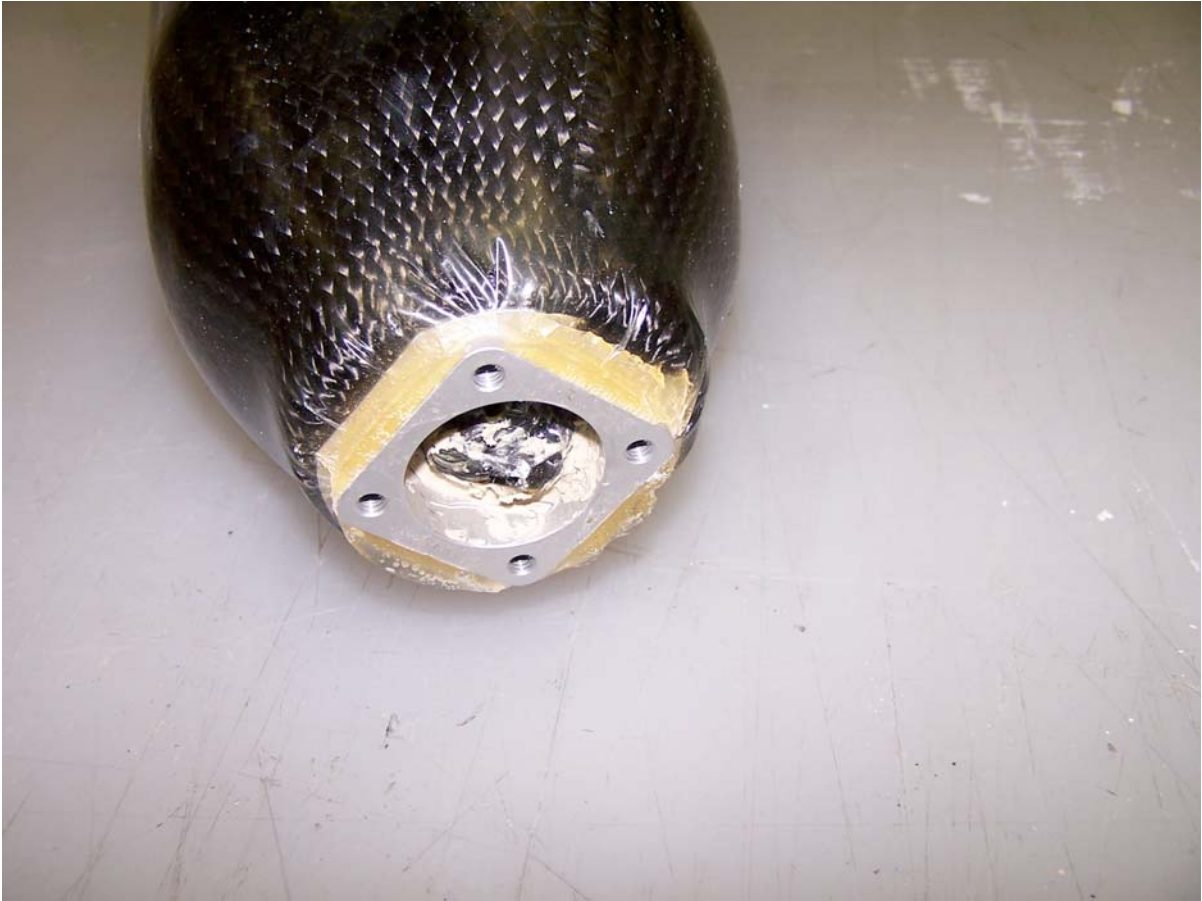
**Figure 27. Distal region close-up view for socket #8.**

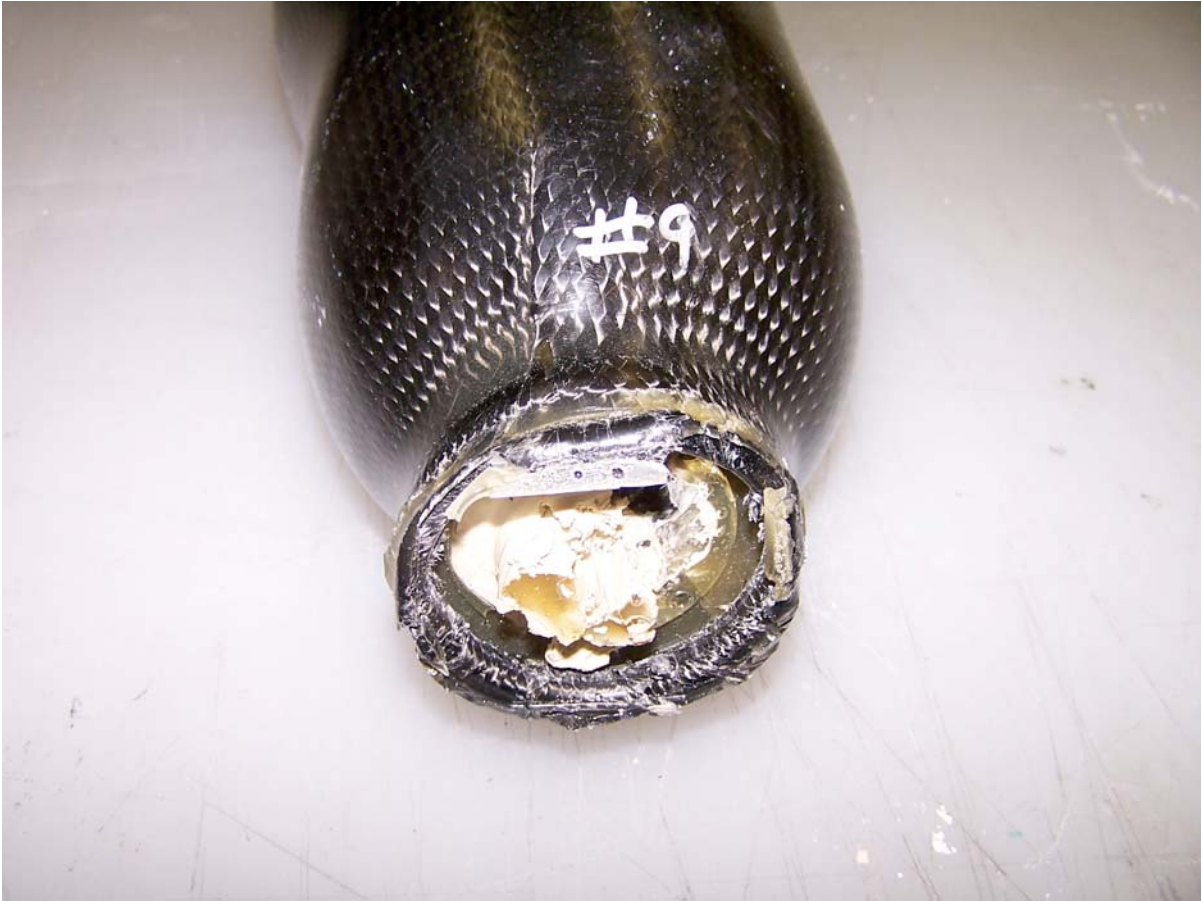
**Figure 31. Failure region close-up view for socket #9.**

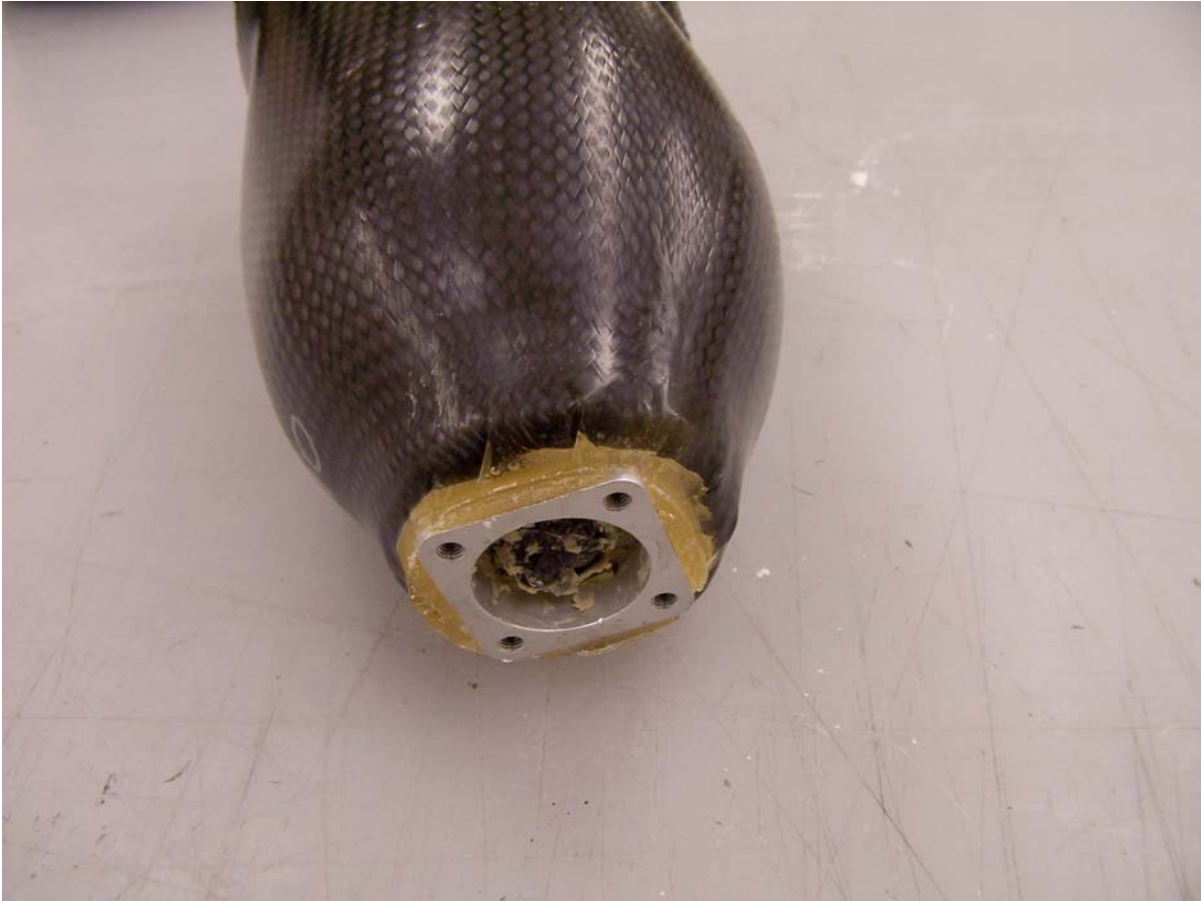
**Figure 35. Distal end close-up view for socket #10.**

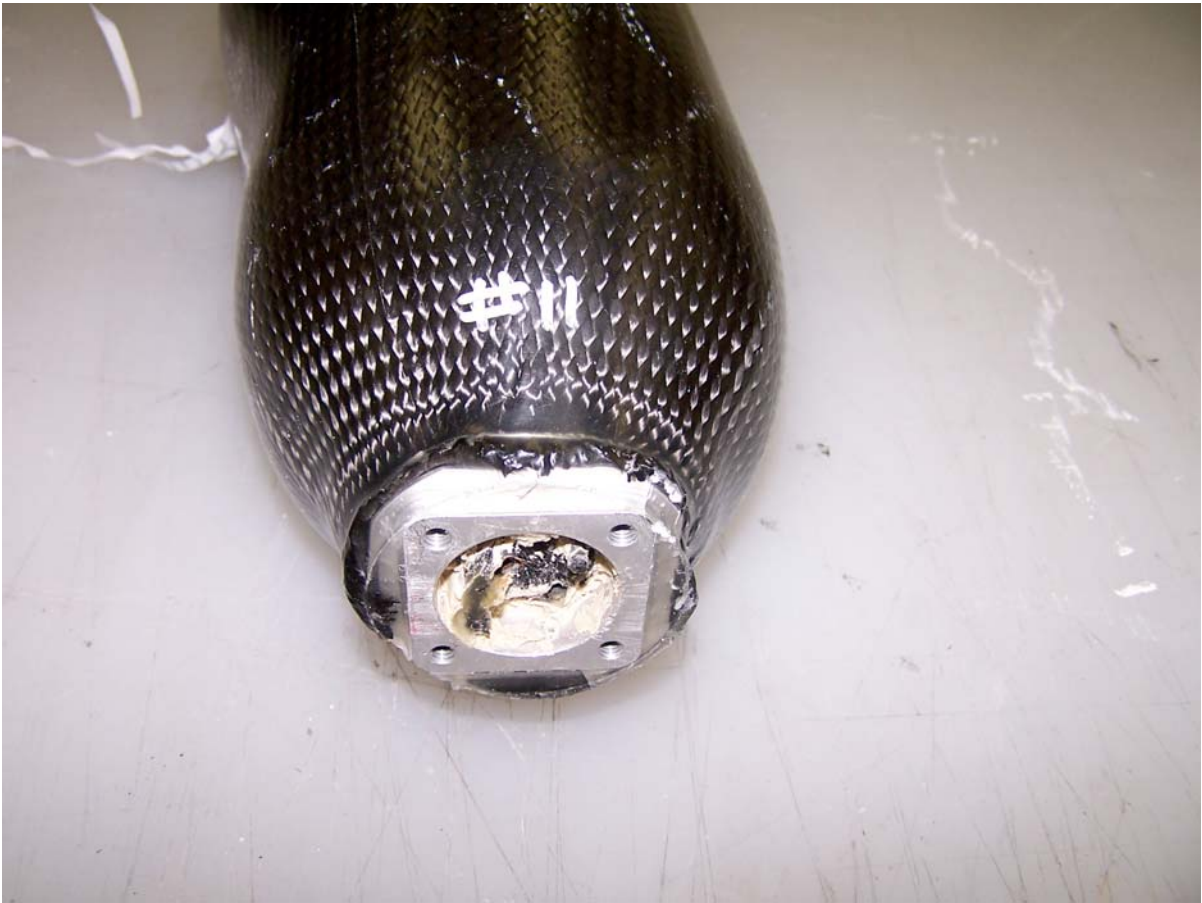
**Figure 39. Distal end close-up view for socket #11.**

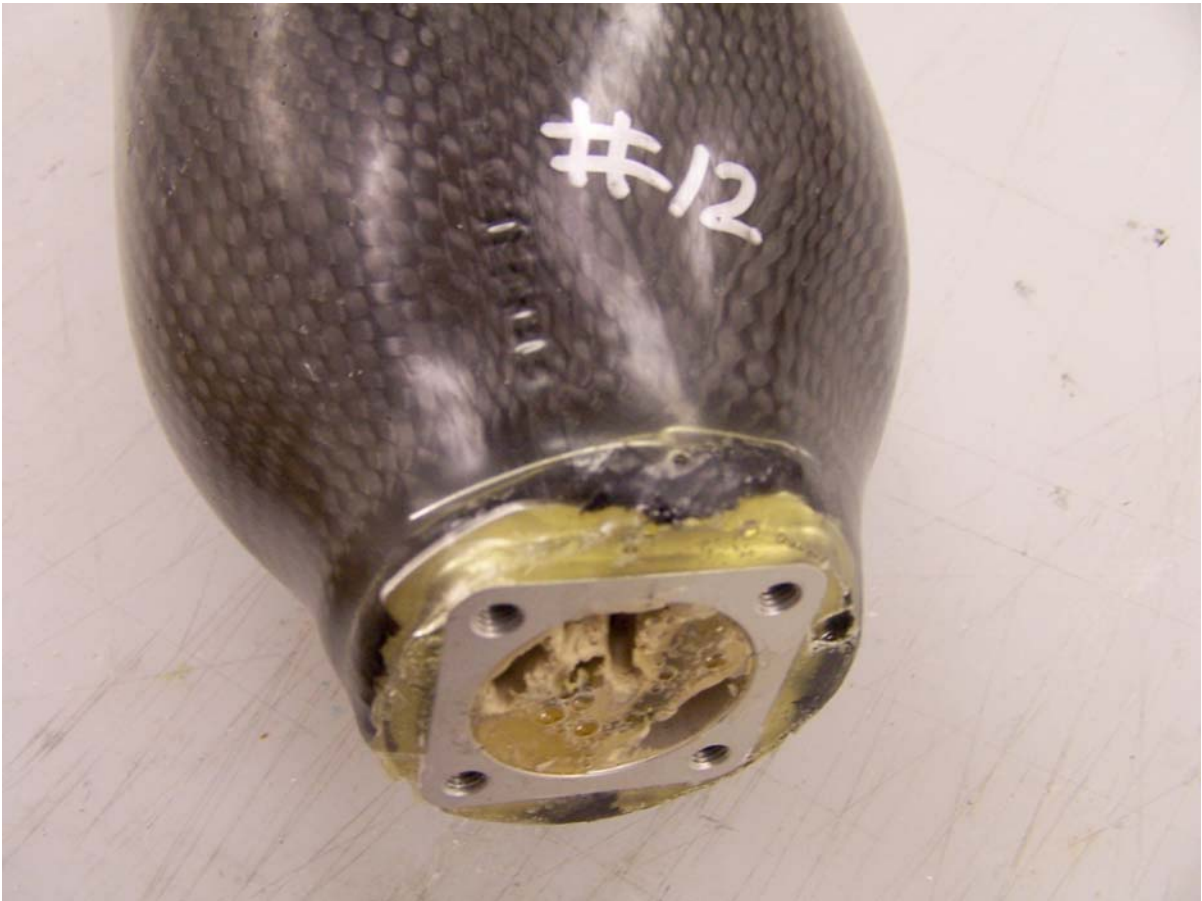
**Figure 43. Distal end close-up view for socket #12.**
