**Experimental Determination of AH-64 Apache  
Tailshaft Hanger Bearing Vibration Characteristics  
with Seeded Faults**

**by Brian Dykas, Timothy Krantz, Harry Decker, and David Lewicki**

**ARL-TR-4865**

**June 2009**

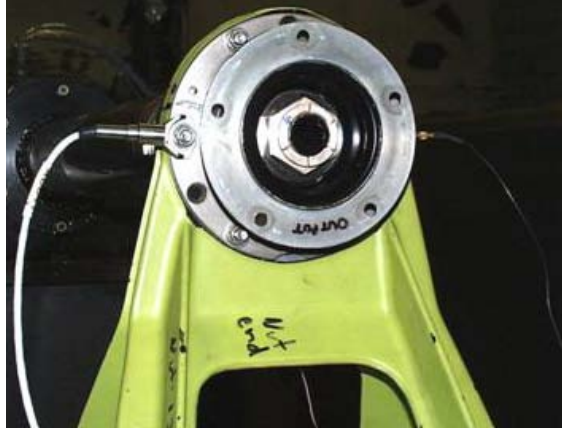
Figure 3. Orientations of two accelerometers attached to the hanger assembly

The test bearing was instrumented with two separate accelerometers mounted on the Apache hanger bearing assembly. One accelerometer was that supplied with a Vibration Management Enhancement Program (VMEP) system, to mimic the on-wing instrumentation (7). This sensor was located at the 9 o'clock position and is mounted in the same manner as on the aircraft (figure 3). The second accelerometer was a high frequency response accelerometer attached to a separate data acquisition system, located at the 3 o'clock position, and it was attached by drilling and tapping the bearing hanger assembly to accept a mounting stud. This allows for collection of VMEP data as well as high frequency raw data for further analysis and manipulation.

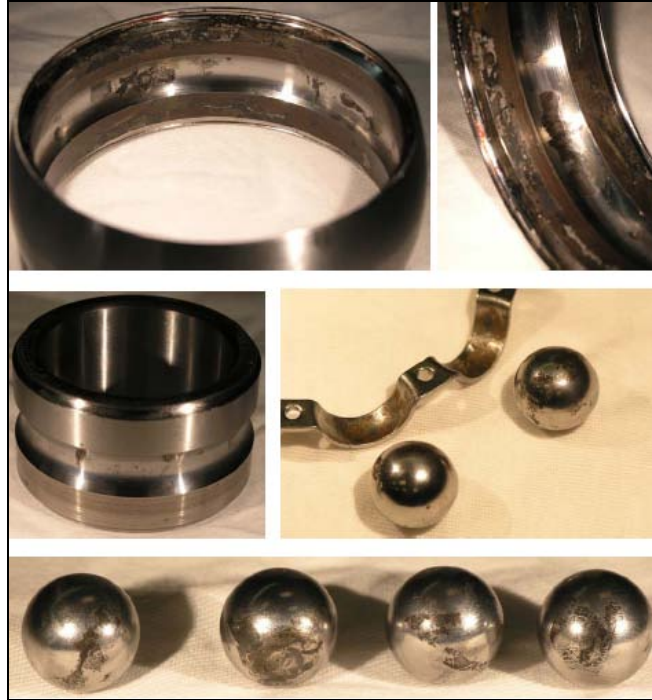
Figure 12. Photographs of corrosion damage to bearing 019-ARL-RS after post-test disassembly.

After the vibration signature tests were completed, one bearing prepared according to each method was disassembled and cleaned in an ultrasonic bath to be able to better inspect and quantify the severity of corrosion damage. The disassembly photographs of 019-ARL-RS are shown in figure 12, and corroborate the pretest visual inspection of the grease and the vibration data. Corrosion damage was found on both races, the cage, and the balls. The inspection of 018-ARL-SW did not show any corrosion damage to the bearing components, as was expected based on the pretest grease visual inspection and the vibration test data.

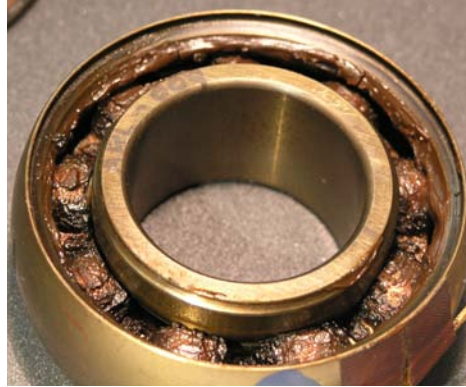
Figure 17. Grease appearance after 1600 hr of elevated temperature (accelerated life) operation.

conducted. Figure 17 shows the grease appearance after 1600 hr of run time at light load and high temperature. The increased temperature acts to accelerate the life of the grease, decreasing the required test time. To date, the bearings have operated remarkably well given the severity of lubrication degradation.
