# **A Feasibility Study into the Active Smart Patch Concept for Composite Bonded Repairs**

**Air Vehicles Division  
Defence Science and Technology Organisation**

**DSTO-TR-2247**

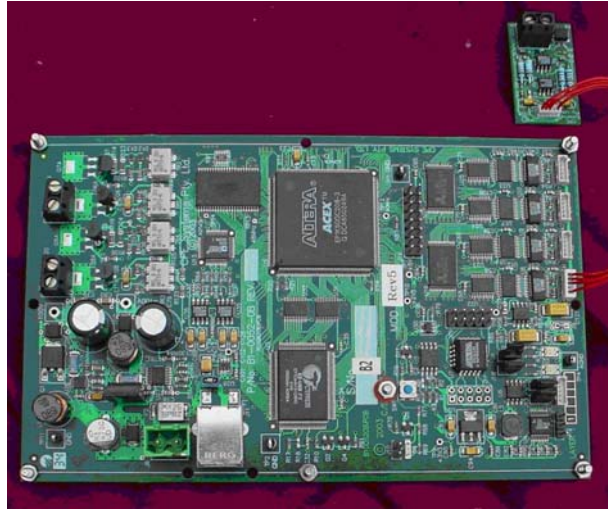
**Figure 5:** *AUSAM board shown with smaller signal conditioning circuit.*

The piezoelectric elements are controlled through a device called the AUSAM (Acousto Ultrasonic Structural health monitoring Array Module), developed through a collaborative effort between the DSTO and local industry. Shown in Figure 5, the module provides for autonomous control of two send and four receive elements, and can operate synchronously with other modules to accommodate larger transducer numbers. Communication with the device occurs via a USB link to a computer, which also provides electrical power to the

device. Amplifiers on the module can drive typical piezoelectric capacitive loads ( $1-10\text{ nF}$ ) at near  $100\text{ V}$  to frequencies beyond  $2\text{ MHz}$ .

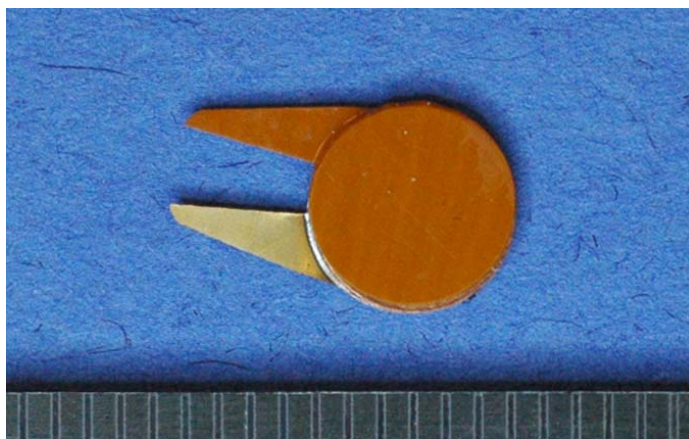
*Figure 23: Packaged 6.35 mm diameter piezoceramic disc.*

electrode may be acceptable for laboratory work where the sample is not exposed to sustained cyclic mechanical loading, but is inadequate for any long-term in-service structural application. To address mechanical and environmental durability concerns, it is customary now to encase or package piezoelectric elements in a polymer dielectric film containing integrated conductive tracks. The commercial SMARTlayer® [8] concept follows this approach. The footprint of a single element is however quite large and poses some concern in relation to its possible impact on the structural integrity of the host. A less obtrusive packaging approach was developed recently through a collaborative effort between the DSTO and MiniFAB. The footprint of the device is only marginally larger than the piezoceramic disk element itself (see Figure 23), which serves to reduce its structural impact on the host. Trials are currently underway to assess the mechanical durability of these elements under representative aircraft spectrum loading. The preliminary results of this work are encouraging and a full account of the completed trial will be reported elsewhere.
