**AFRL-RX-TY-TP-2009-4552**

# **EXPEDIENT SPALL REPAIR METHODS AND EQUIPMENT FOR AIRFIELD PAVEMENTS**

**Michael I. Hammons**  
**Air Force Research Laboratory**

A paper prepared for the 2010 Annual Meeting of the Transportation Research Board

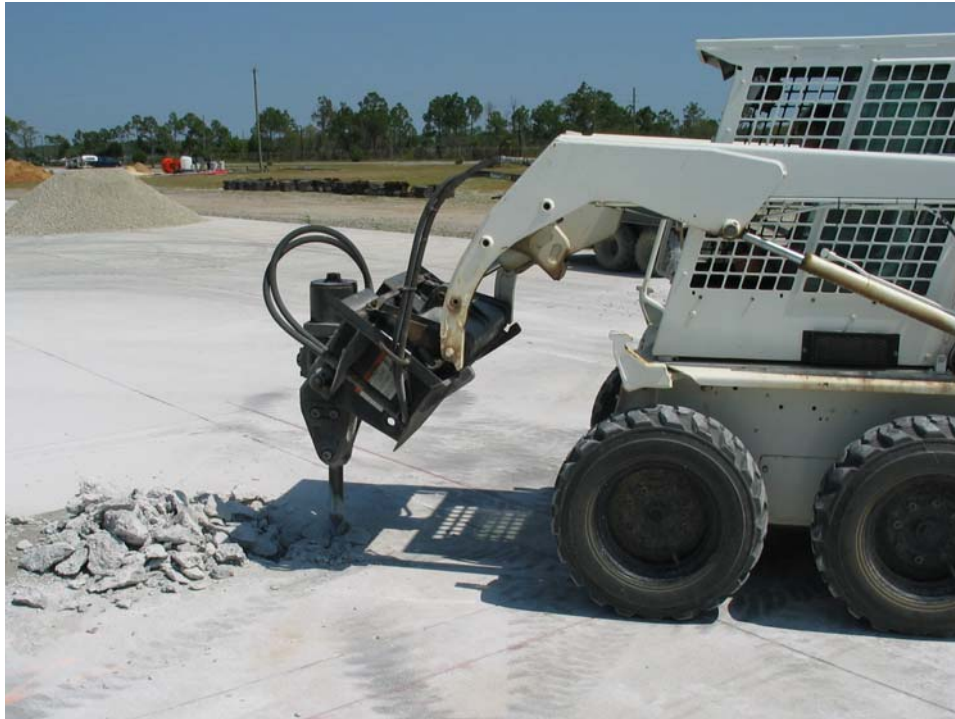
**FIGURE 1 Hydraulic Breaker.**

The spall was prepared using a hydraulic percussion breaker fitted to a wheeled skid steer loader as shown in FIGURE 1. The breaker was powered by the auxiliary hydraulic system on the loader. The breaker had an operating weight of 736 lbs and produced 1310 blows per minute at a hydraulic flow rate of 17.2 gallons per minute yielding approximately 300 ft-lbs of impact energy. The diameter of the nail-type breaker probe was 2.56 inches. Final clean up was performed with a shovel, broom, and shop vacuum.

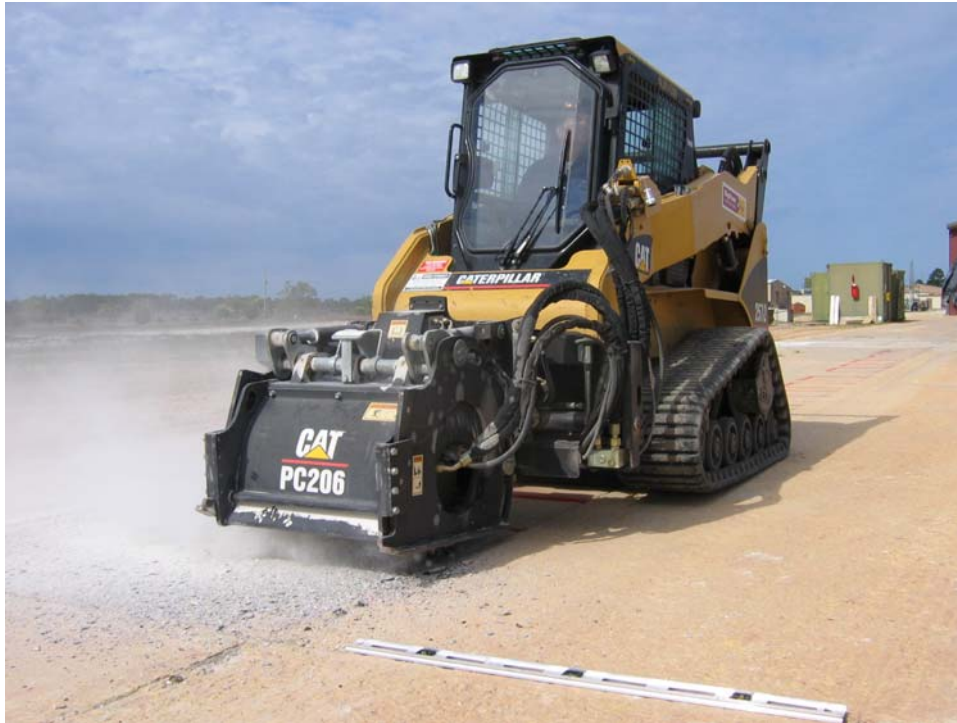
**FIGURE 2 Cold Planer.**

Another set of holes was excavated using a Caterpillar Model PC206 Cold Planer powered by a CAT 257B high flow skid steer loader as shown in FIGURE 2. The hydraulic system on the loader was operated at the high setting (26 gallons per minute at 3,335 psi). The cold planer, designed for restoration of asphalt and concrete surfaces for small paving jobs, has a drum width of 24 inches. The drum featured 60 carbide-tipped conical bits. The skid steer loader moves backwards while lowering the drum in to the concrete. During the course of the excavation the cold planer depth adjustment was set to 4½ inches, because it appeared that the milling debris was precluding the planer from achieving its desired depth of 4 inches. Final clean up was performed with a shovel, broom, and shop vacuum.

2 The cold planer method should be adopted as a standard method of preparing spalls for  
3 placement of a rapid-setting spall repair material. The cold planer equipment can be  
4 purchased as an attachment to skid-steer loader. While the time to prepare a spall depends  
5 upon the characteristics of the spall and the skill of the operator, use of this equipment  
6 requires about half the time to prepare the spall as compared to the control case of a manual  
7 jackhammer. The cold planer equipment, under the control of an experienced operator, can  
8 prepare a two foot square by 4 inch deep spall for placement of rapid-setting material in less  
9 than 15 minutes. Furthermore, spalls prepared with this method retain superior bond strength  
10 after aircraft trafficking and are expected to provide superior performance compared to those  
11 prepared with other conventional and experimental methods evaluated in the study.

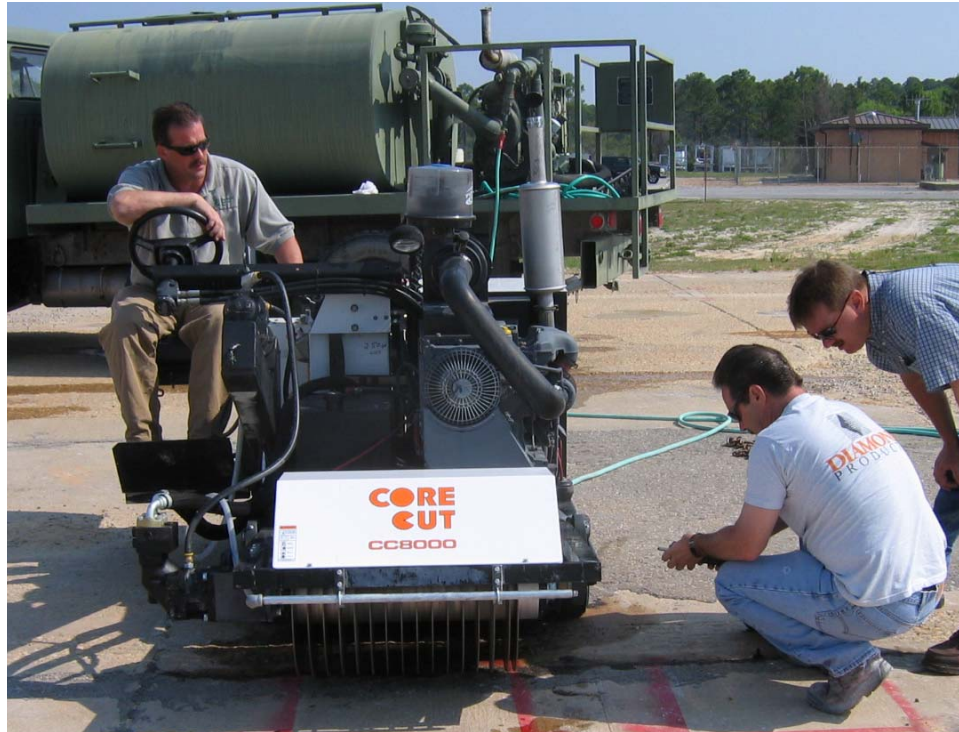
FIGURE 3 Gang Saw.

The final sets of excavations were performed using a prototype multiple-blade (gang) saw developed by Diamond Products. The total width of the saw blades was 24 inches. The saw consisted of a blade shaft with multiple 18-inch-diameter diamond-tipped saw blades as shown in FIGURE 3. The blade shaft was hydraulically driven by a Diamond Products CC8000 rider saw powered by a 78-hp diesel engine. The distance between the saw blades was variable, and two center-to-center spacings were employed ( $\frac{3}{4}$  inch and  $1\frac{1}{2}$  inches) for this research.

The saw was employed twice at right angles to produce an orthogonal grid of saw cuts. Three holes each were prepared with the saw blades spaced at  $\frac{3}{4}$  inch or  $1\frac{1}{2}$  inches. After the cuts were made, the material was removed with a 30-lb pneumatic jackhammer, and final clean up was performed with a shovel, broom, and shop vacuum.

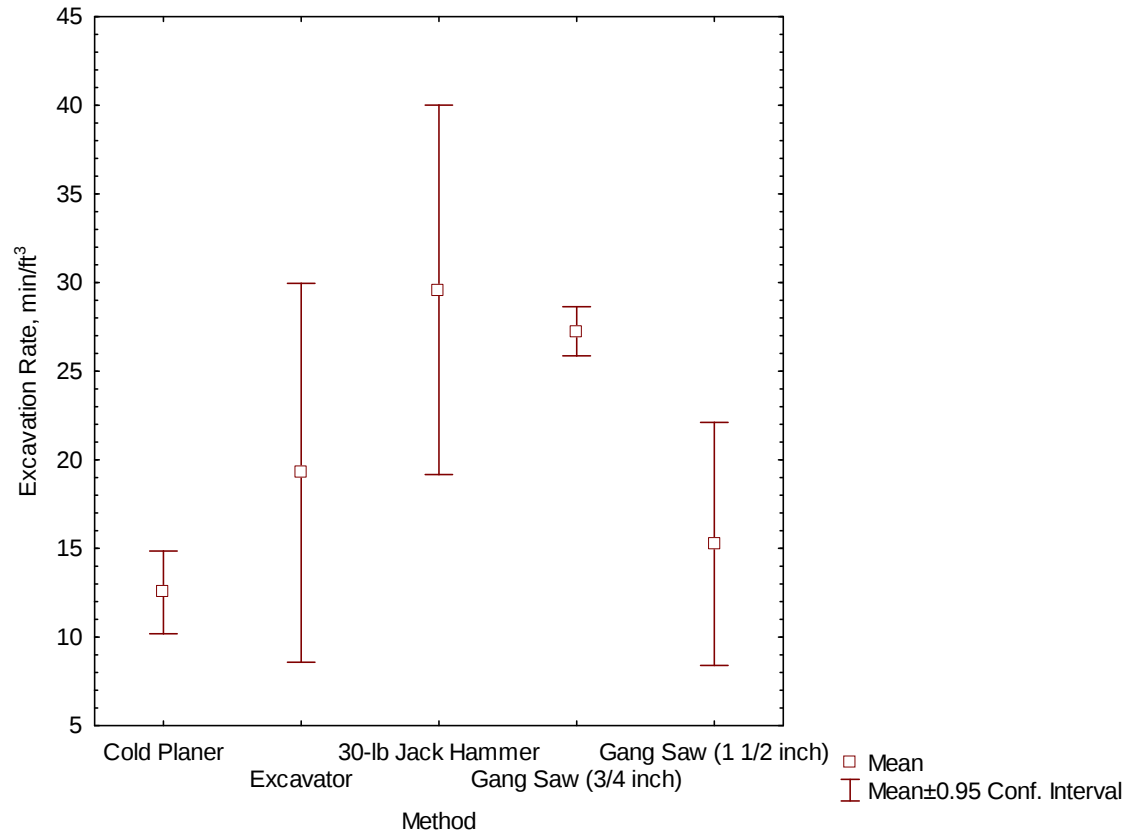
**FIGURE 4 Excavation Test Results.**

FIGURE 4 presents the results of the excavation rate measurements. The mean value of excavation rate is represented by the small squares, and the whisker bars represent  $\pm 95$  percent confidence intervals on the mean. There was considerable scatter in the data, as indicated by the magnitude of the confidence intervals. Comparing only mean values of excavation rate revealed that the 30-lb jackhammer, the typical method of excavating spall repairs, was the least efficient method. The most efficient method was the cold planer, which, on average, was approximately 58 percent more efficient than the jackhammer. The second most efficient method was the hydraulic breaker, followed by gang saw with spacing at 1½ inches and ¾ inch.

A pair wise t-test procedure was used to compare the means to determine if the observed differences in the mean value were statistically significant given the large scatter of the data. Using these analyses, we observed that the production rates for the 30-lb jackhammer are statistically different from those of the cold planer, hydraulic breaker, and the gang saw at 1½-inch spacing. We conclude that each of these methods is a significant improvement in production rate over the 30-lb jackhammer.

A similar analysis was performed for total production rate. The results were similar to that for excavation rate, except that the difference between the mean values for jackhammer method and the hydraulic breaker were significant in this case.

The control case was the 30-pound jackhammer. Each of the four methods tested had a significant improvement in production rate over the 30-pound jackhammer. The most efficient method was the cold planer, which, on average, was approximately 58 percent more efficient than the jackhammer. The second most efficient method was the gang saw at 1½ inch spacing, followed by the hydraulic breaker, followed by gang saw with spacing at ¾ inch spacing. Only the cold planer can meet the requirement of being able to excavate 2-foot square by 4-inch deep spall in no more than 15 minutes.

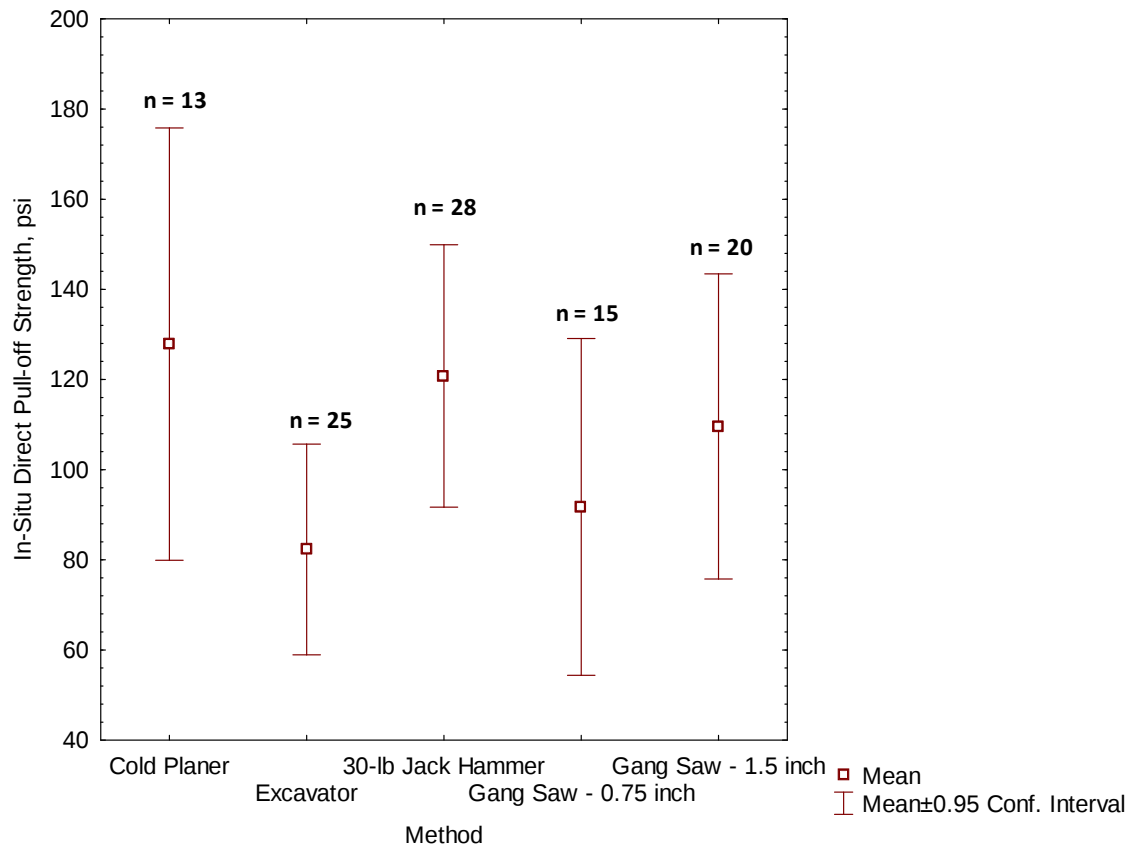
**FIGURE 5 Pre-trafficking In-situ Direct Pull-off Results.**

The results of the pre-trafficking in-situ pull-off experiments are summarized in the plot shown in FIGURE 5. The greatest observed mean pull-off strength was for the cold planer, followed, in order, by the jackhammer, gang saw at 1½ inches spacing, gang saw at ¾ inch spacing, and finally the hydraulic breaker. However, the scatter in the data is quite large, and statistical analysis was required to evaluate the significance in the observed means. Pair wise t-tests were conducted on each of the observed treatments, and they indicated that only the differences in the means between the hydraulic breaker and cold planer and hydraulic breaker and jackhammer were statistically significant at the 95 percent confidence level; thus we could not statistically distinguish between the means of the other treatments at the 95 percent confidence level.

In-situ bond tests were performed both prior to and after simulated aircraft trafficking. Pre-trafficking, the greatest observed mean pull-off strength was for the cold planer, followed, in order, by the jackhammer, gang saw at 1½ inches spacing, gang saw at ¾ inch spacing, and finally the hydraulic breaker. However, only the differences in the means between the hydraulic breaker and cold planer and hydraulic breaker and jackhammer were statistically significant at the 95 percent confidence level, and one cannot statistically distinguish between the means of the other treatments at the 95 percent confidence level.

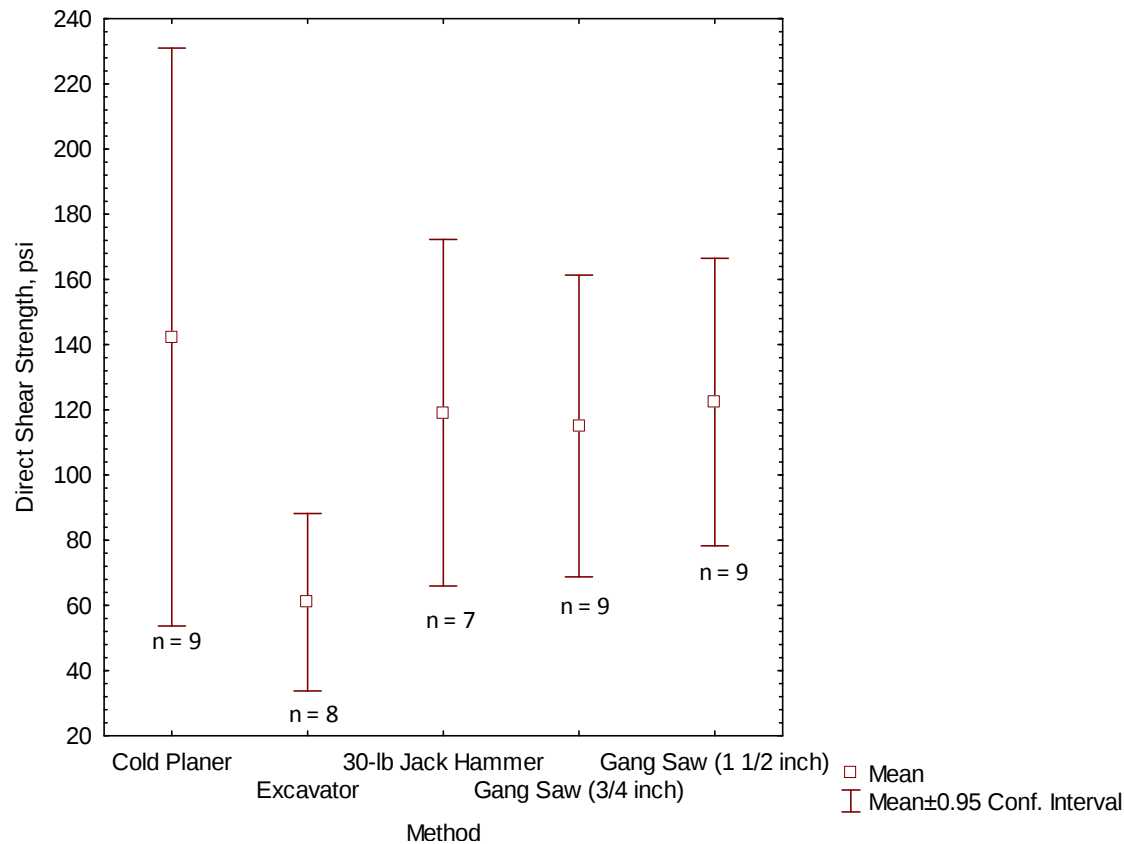
**FIGURE 6 Pre-trafficking In-situ Direct Shear Results.**

The results of the pre-trafficking in-situ pull-off experiments are summarized in the plot shown in FIGURE 6. The greatest observed mean direct shear strength was for the cold planer, followed, in order, by the jackhammer, gang saw at 1½ inches spacing, gang saw at ¾ inch spacing, and finally the hydraulic breaker. However, once again, the scatter in the data is quite large, and statistical analysis was required to evaluate the significance in the observed means. For these experiments, the t-tests indicated that only the differences in the means between the hydraulic breaker and jackhammer and gang saw were statistically significant at the 95 percent confidence level.

A regression analysis was performed to determine the strength of the correlation between these two indications of bond strength. This analysis indicated that the two metrics of bond strength are positively correlated with a correlation coefficient ( $R^2$ ) of 0.66. These results indicated that both the in-situ tension pull-off test and direct shear test are indicators of the bond strength, with additional testing and numerical analysis required to improve the correlation between the two test methods.

Because the direct shear strength test is not an accepted test method per ASTM, the results of the direct shear strength tests were not be used to draw conclusions concerning the efficacy of the methods until further development and analysis of this testing methodology is conducted.

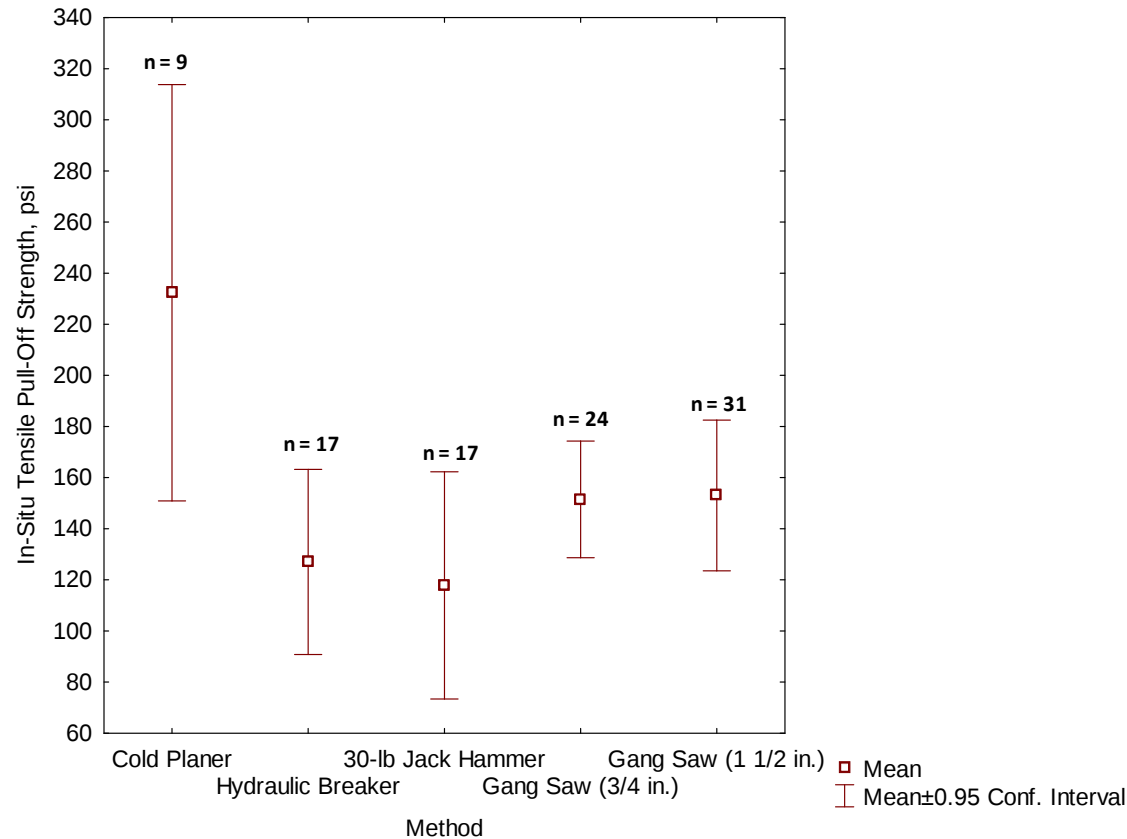
**FIGURE 7 Post-trafficking In-situ Pull-off Results.**

The results of the post-trafficking in-situ pull-off experiments are summarized in the plot shown in FIGURE 7. For all treatments the pull-off strength was non-zero, indicating that the bond was not broken during the trafficking of the spall repairs. The highest post-trafficking in-situ bond strength was observed for the cold planer, with the other methods having bond strengths approximately one-half that of the cold planer. A pair wise t-test analysis indicated

that the observed difference in mean value between the cold planer and all the other four methods were statistically significant at the 95 percent confidence level.

The highest post-trafficking in-situ bond strength was observed for the cold planer, with the other methods having bond strengths approximately one-half that of the cold planer. The observed difference in mean value between the cold planer and all the other four methods were statistically significant at the 95 percent confidence level.

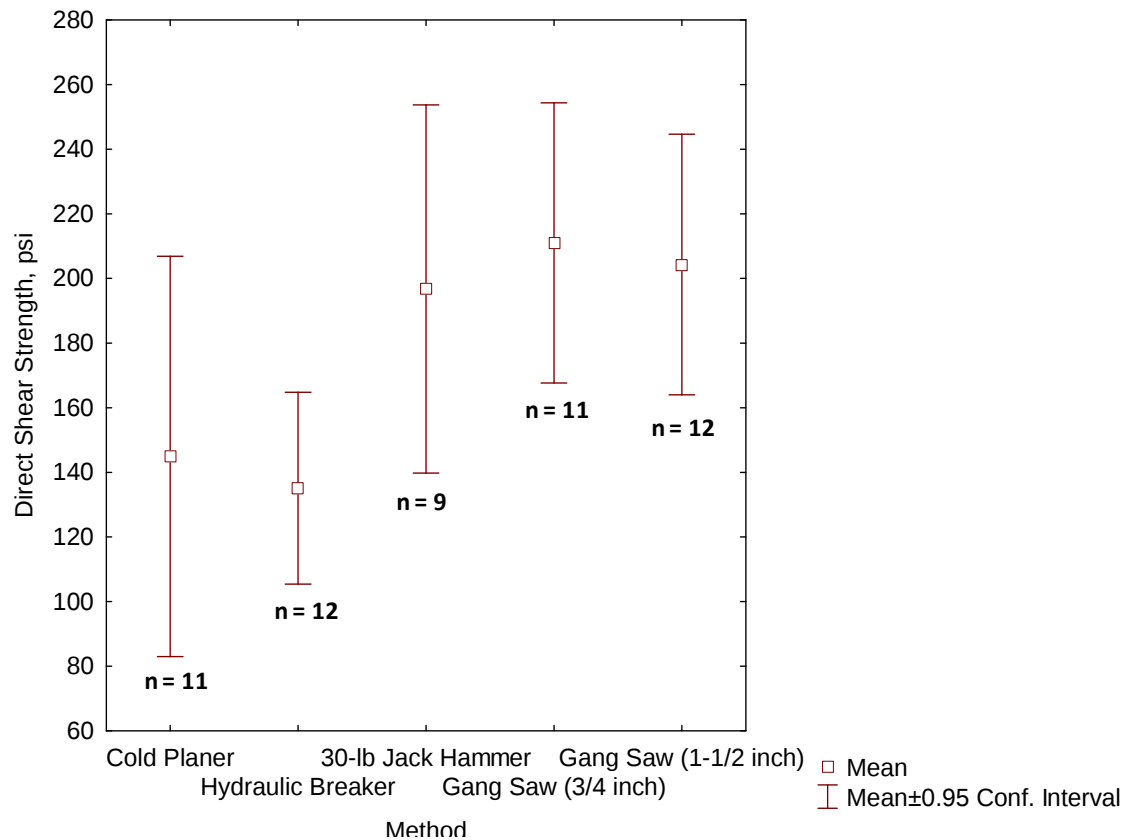
**FIGURE 8 Post-trafficking Direct Shear Results.**

The results of the post-trafficking direct shear experiments are summarized in the plot shown in FIGURE 8. The greatest observed mean pull-off strength was for the gang saw at  $\frac{3}{4}$  inch spacing, followed, in order, by the gang saw at  $1\frac{1}{2}$  inches spacing, jackhammer, cold planer, and finally the hydraulic breaker. However, only the hydraulic breaker was statistically significant.
