**AL KASIK LOCATION COMMAND  
AL KASIK, IRAQ**

**SIGIR PA-09-182  
OCTOBER 16, 2009**

## Al Kasik Location Command

### Summary of Report: PA-09-182

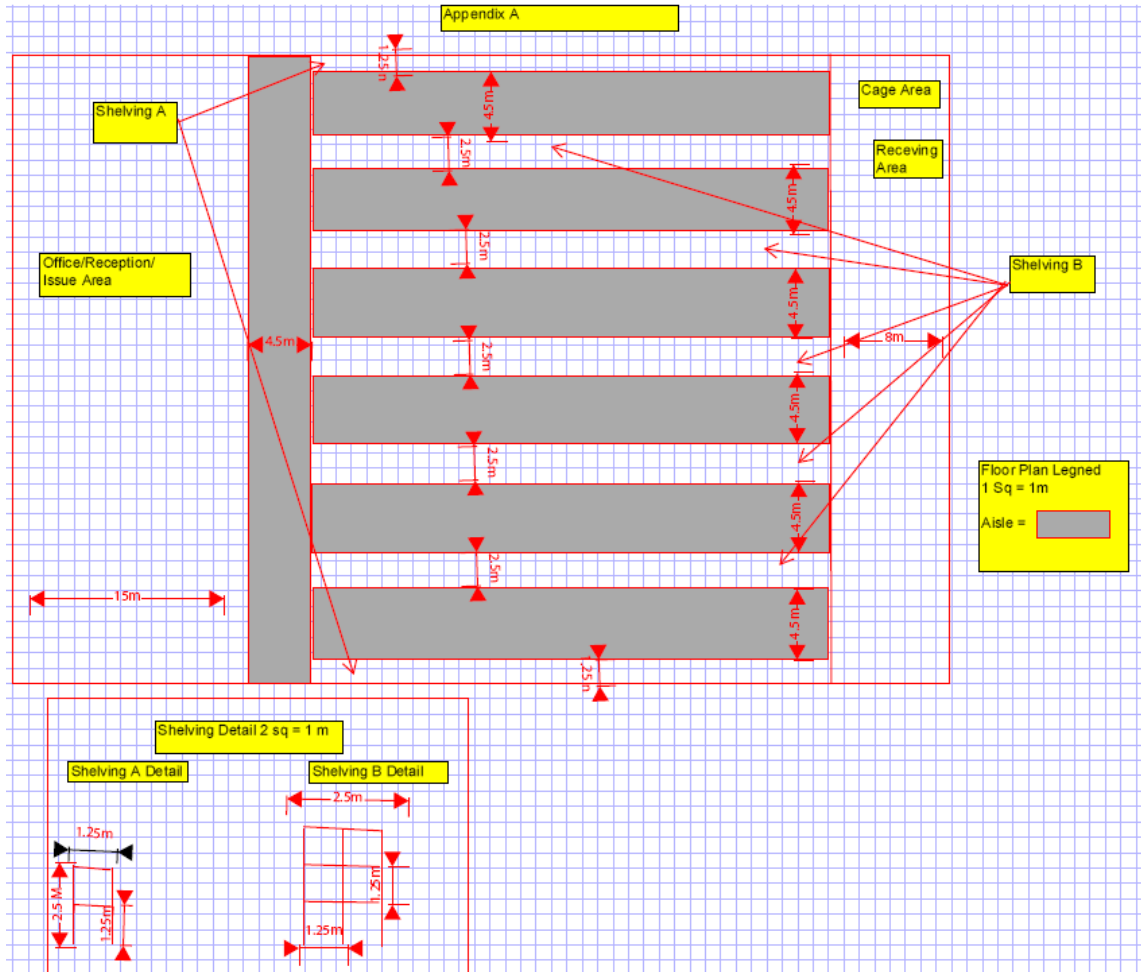
**Figure 8. Schematic of pallet rack configuration and layout (Courtesy of USACE)**

The SOW provided specific requirements for the pallet rack system<sup>8</sup> including overall rack dimensions, layout requirements, and specifications to support a minimum load of 1,000 pounds per 2m-long unit (Figure 8).

In addition, the contractor was required to secure the pallet racks to the floor to “...prevent the shelving system from tipping through normal day-to-day operations.”

The SOW did not specify the size of the base plate for the rack legs. The dimensions of the base plate are critical in determining the allowable capacity of the concrete floor slab. To prevent cracking and failure of the slab, the base plate sizes should be specified based on the thickness of the existing slab. The information provided by GRN did not include any submittals for the pallet rack system.

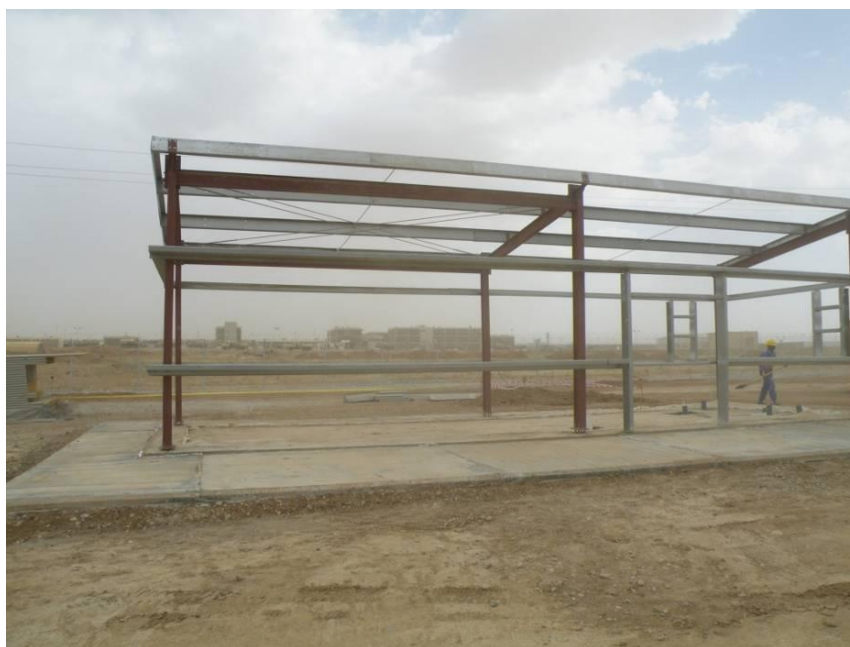
At the time of the site assessment, the foundation for the office building was constructed, and some of the structural steel was erected (Site Photo 9). Unlike other buildings constructed under this contract, the contractor included a restroom on the interior of the office building. The contractor constructed the plumbing beneath the concrete floor slab and extended the water and sewer piping through the foundation to the exterior of the building. SIGIR noted that the water and sewer lines were placed in the same trench, similar to other buildings at the Al Kasik Location Command project.

**Site Photo 9. Office building**

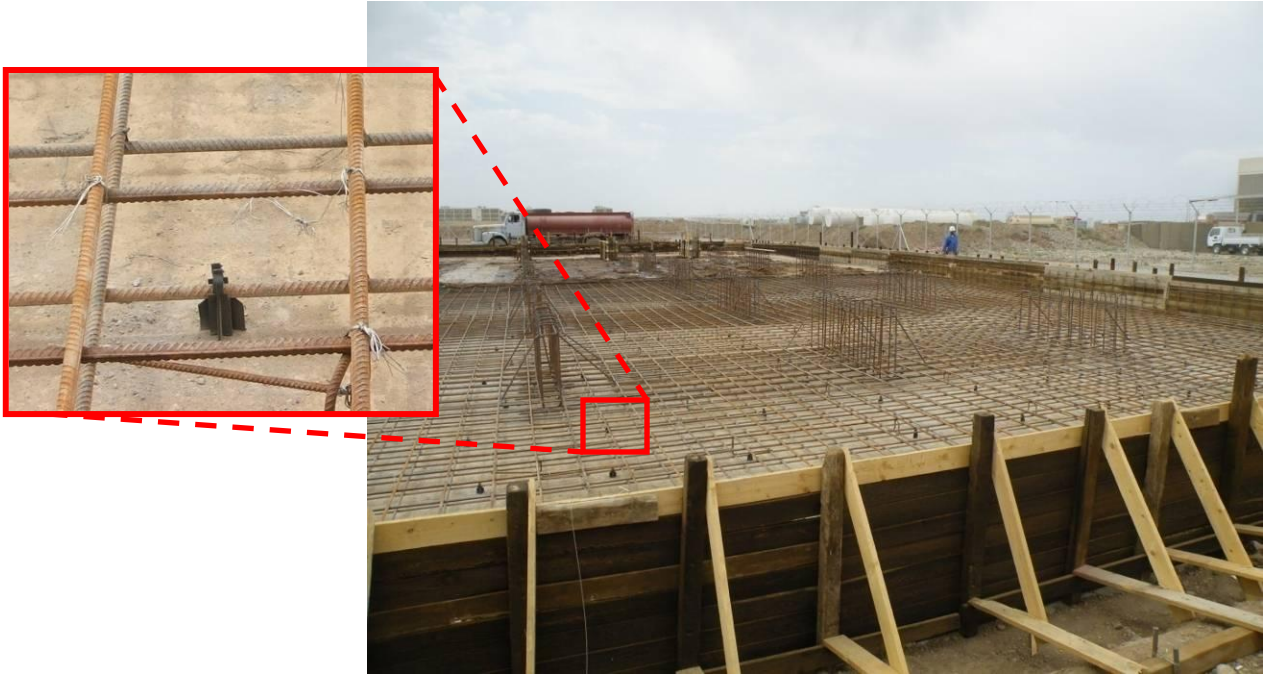
The contractor was constructing the raft foundation for the benzene storage for the distribution point, half of the foundation slab was poured, and the concrete was being cured. The remaining section of the foundation slab was formed and appeared to be ready for pouring (Site Photo 12).

SIGIR noted that the contractor had exercised good construction technique and was using spacers and chairs to elevate and hold the reinforcing mats for the slab (Site Photo 12 inset). In addition, the contractor installed temporary bracing to reinforce the piers to prevent displacement during pouring operations.

During the inspection of the raft foundation, SIGIR discovered one issue. It appeared that the contractor placed a construction joint near the middle of the foundation slab. It did not appear that provisions were made to continue the reinforcing steel through the construction joint or provide fuel proofing. There was also no evidence of a shear transfer mechanism at the joint—such as dowels or a shear key—and no fuel stop was noted.

**Site Photo 12. Raft foundation for benzene storage**

- The contractor should perform a final check of the rack system after construction completion and to verify that all bracing is installed and all legs are securely fastened to the floor slab.
- The water and sewer piping create a conflict with the installation of the sanitary manhole and could potentially contaminate the water supply.
- The raft foundation contained no provisions to continue the reinforcing steel through the construction joint or provide fuel proofing to prevent leaks.
