**TWA FLIGHT 800  
1/4-SCALE CENTER WING TANK JET A EXPLOSIONS**

**Larry L. Brown  
Applied Research Associates, Inc.  
5941 S. Middlefield Road, Suite 100  
Littleton, Colorado 80123  
(303) 795-8106; (303) 795-8159 (FAX)**

| Report Documentation Page | | | | Form Approved<br>OMB No. 0704-0188 | |
|---|---|---|---|---|---|
| 13. SUPPLEMENTARY NOTES<br><b>See also ADM001002. Proceedings of the Twenty-Eighth DoD Explosives Safety Seminar Held in Orlando, FL on 18-20 August 1998.</b> | | | | | |

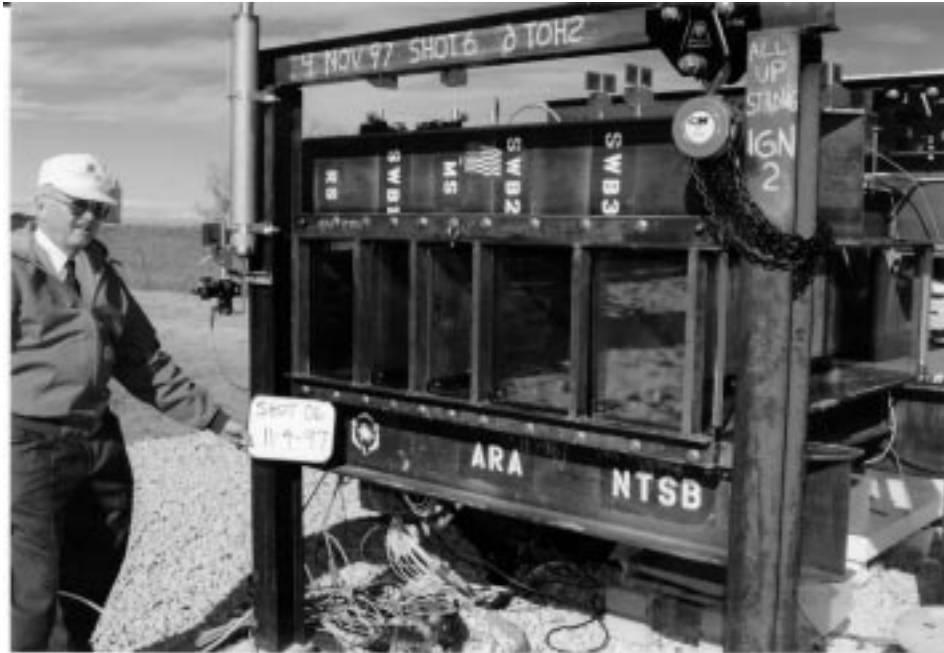
Figure 2 shows the 1/4-scale test fixture in position. The fixture was set on, and anchored to, concrete pads which allowed leveling of the tank pre-test and prevented tank movement during the combustion event. Figure 3 shows an overview of the 1/4-scale fixture and surrounding instrumentation housings.

Figure 2. 1/4-Scale Test Fixture in Test Position

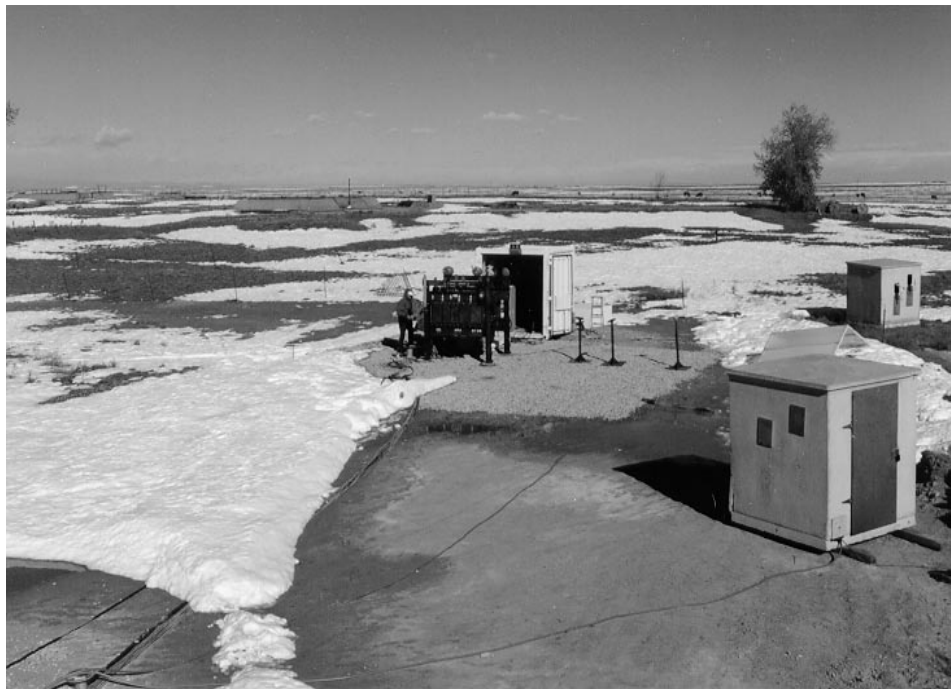
Figure 3. Overview of 1/4-Scale Structure and Test Site

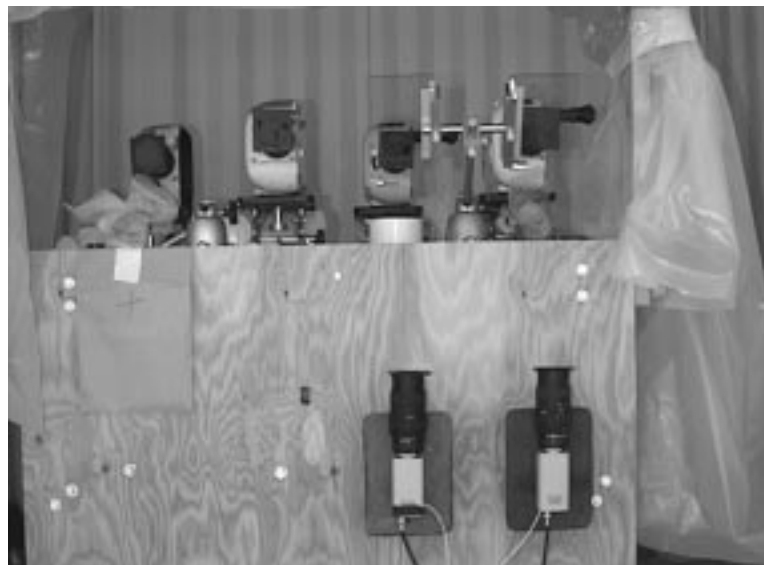
combustion photography light sources as viewed from behind the tank and Figure 6 shows the high-speed and video cameras used to record the images.

Figure 6. Combustion Photography Camera Station

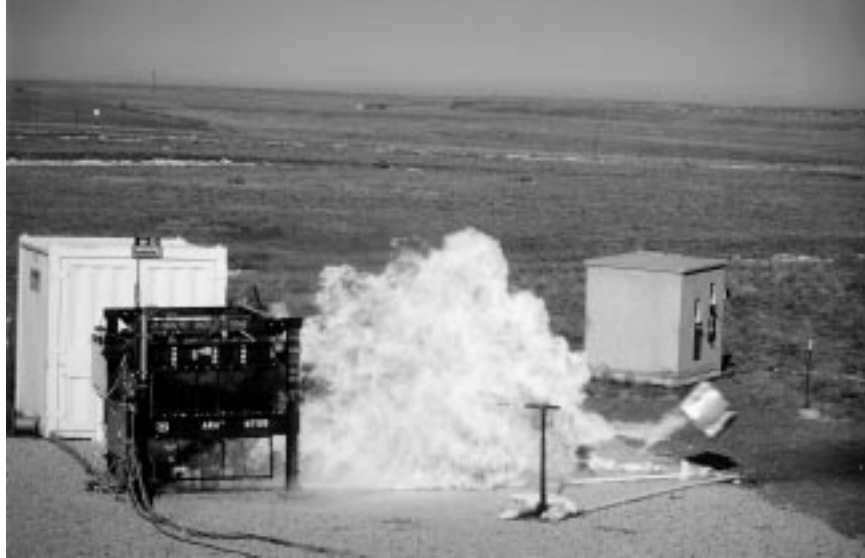
Figure 9.

Figures 9 and 10 show typical film records of a test with the surrogate fuel vapor with a Jet A liquid fuel layer on the bottom of the tank. Note the ejection of the weak partitions in Figure 9, and the extent and size of the fireball in Figure 10.
