**AL SHOFA WATER FACILITY  
NASSRIYA, IRAQ**

**SIGIR PA-08-124  
JULY 23, 2008**

SUBJECT: Report on Construction of the Al Shofa Water Facility, Nassriya, Iraq (Report  
Number SIGIR PA-08-124)

## Al Shofa Water Facility, Nassriya, Iraq

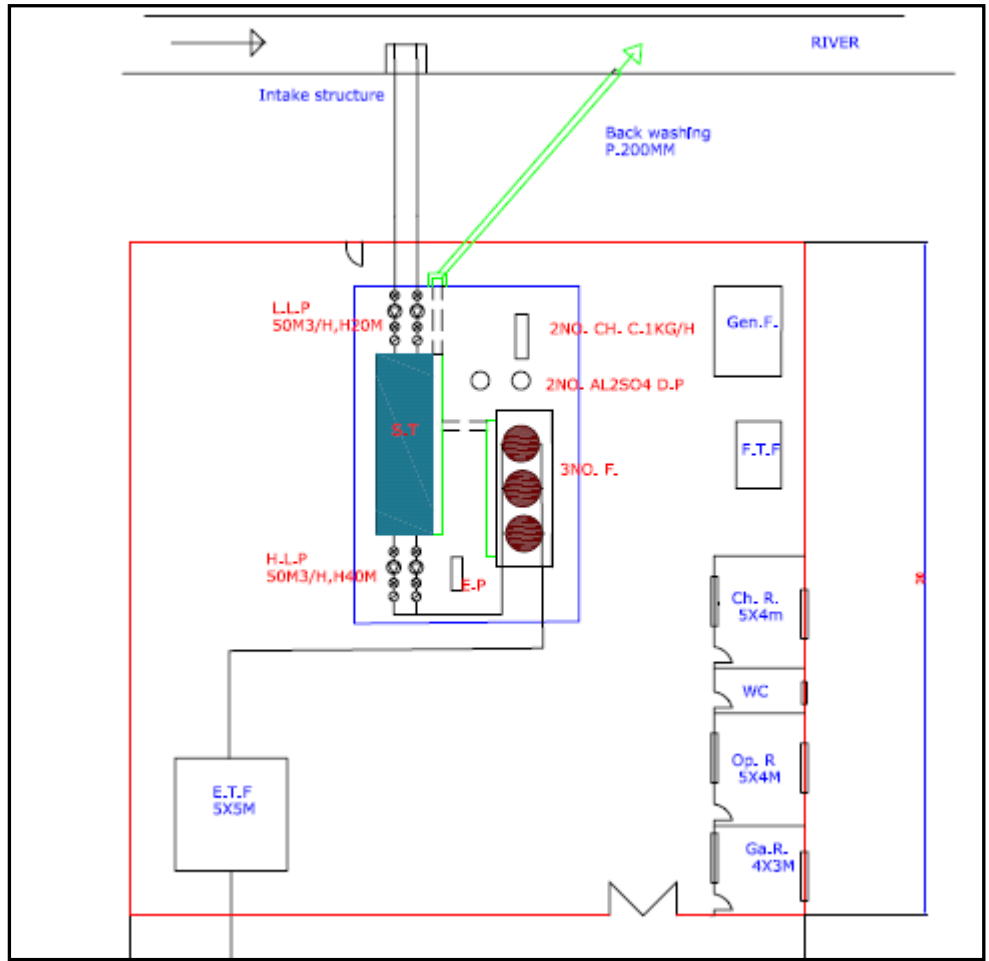
Figure 1. Al Shofa Plan (Courtesy of the USACE)

The USACE provided SIGIR with copies of the contractor's Al Shofa Water Facility project designs and specifications. The designs included the site layout (Figure 1), which provided the water compact unit layout and the building sizes. Also included in the contractor's design was the wall section design, which showed the expansion joint (Figure 2) and the cross-section of the wall (Figure 3).

After reviewing all available design drawings and specifications, SIGIR determined the design package was not complete and lacked sufficient details. Specifically, the designs did not provide any system overview detailing the process of raw river water entering the clarifier, being converted to drinking water, and then released to the end point (supply). In addition, the designs lacked necessary details, such as the sizes of pipes used, the potential need for pipe reducers, diameters for air and outlet nozzles for the high pressure filters, equipment lists, and diagram scales.

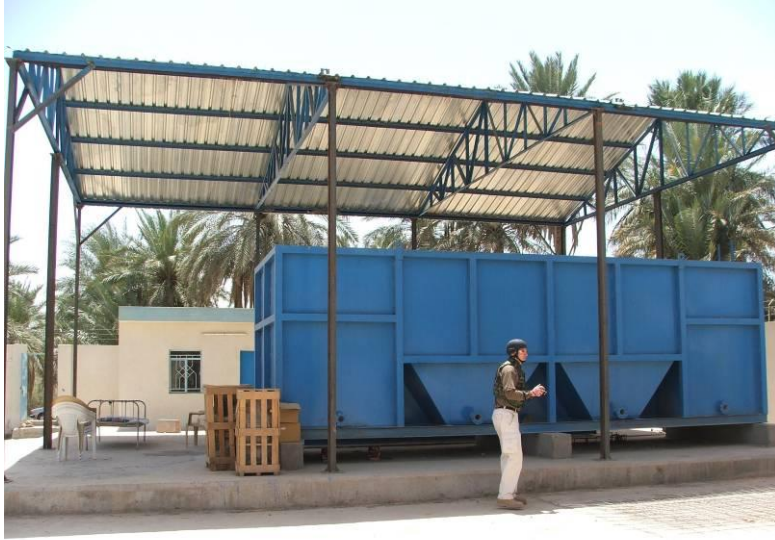
The contractor constructed a new reinforced concrete pad for the 50-m<sup>3</sup>/hour compact unit water treatment plant (Site Photo 4). According to a daily QA report, the contractor tested the concrete (Site Photo 5). The structural concrete observed by the SIGIR assessment team did not have any noticeable cracking, segregation, or

**Site Photo 4. Reinforced concrete pad for the WTP.**

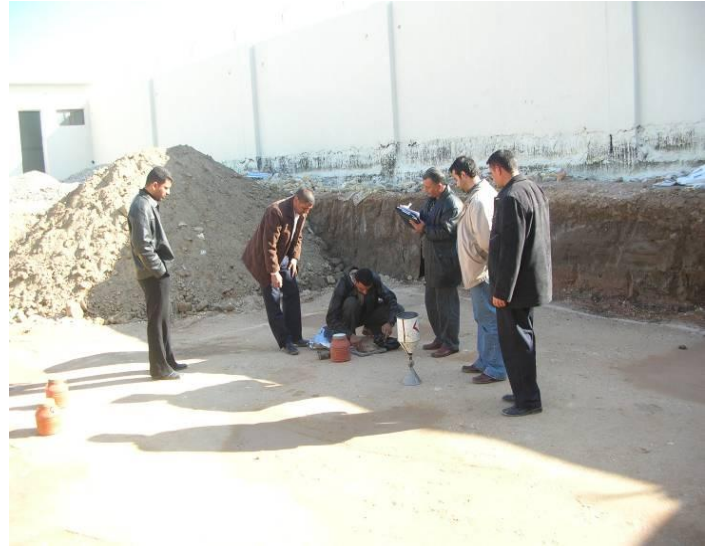
**Site Photo 5. Concrete testing being performed.**

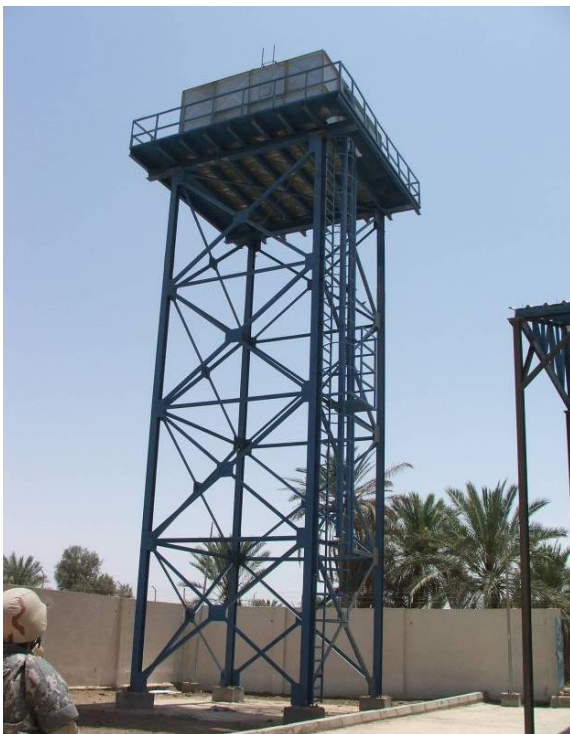
honeycombing areas. In addition, the contractor constructed a new elevated storage reservoir (Site Photo 6) and a sunshade for the generator and fuel tank (Site Photo 7). SIGIR observed no deficiencies in the completed work by the contractor.

**Site Photo 6. Elevated reservoir storage.**

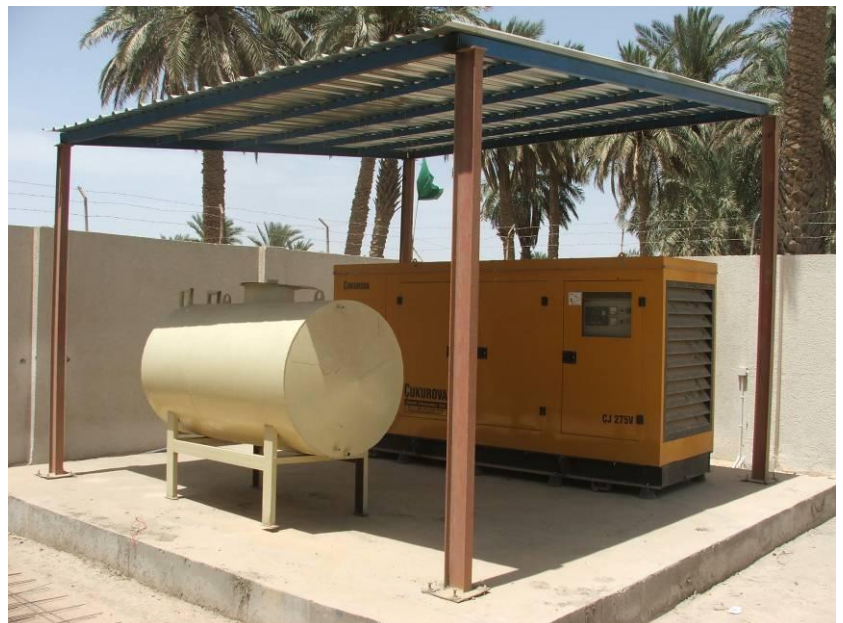
**Site Photo 7. Sunshade for the generator and the fuel tank.**

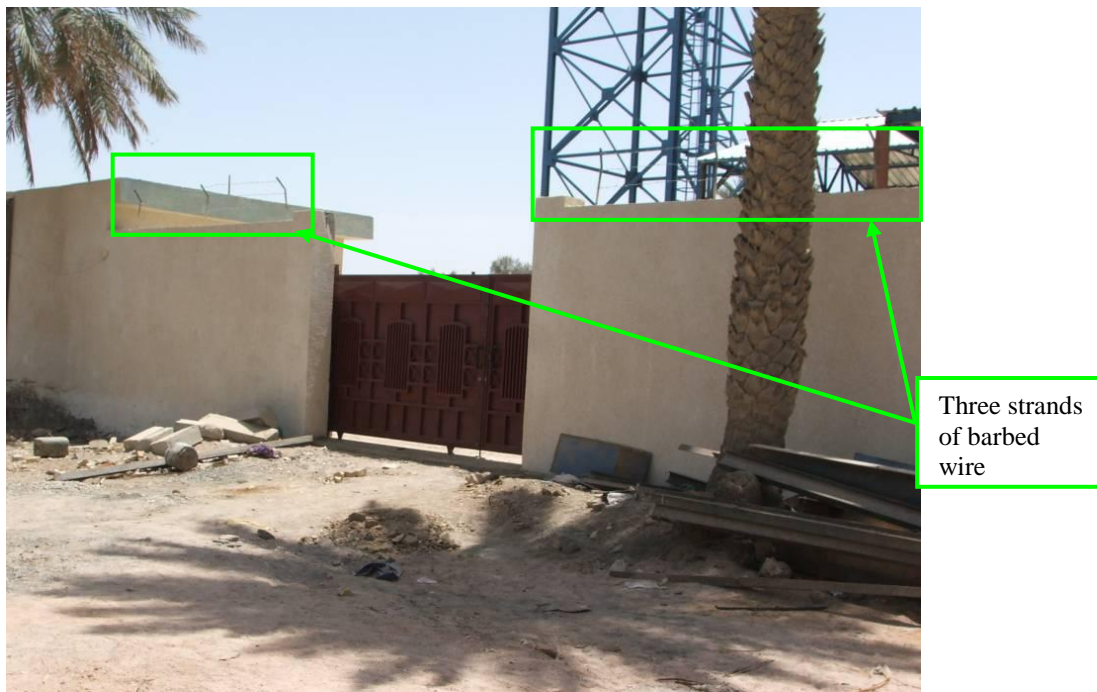
SIGIR observed significant work underway in the Al Shofa Water Facility construction area. For example, for the security of the plant and its operators, the description of work required exterior site fencing, consisting of brick and topped with three strands of barbed wire. During the second site visit SIGIR determined the exterior site fencing was nearly completed, including the three strands of barbed wire (Site Photo 8).

**Site Photo 8. Finished exterior site fencing**

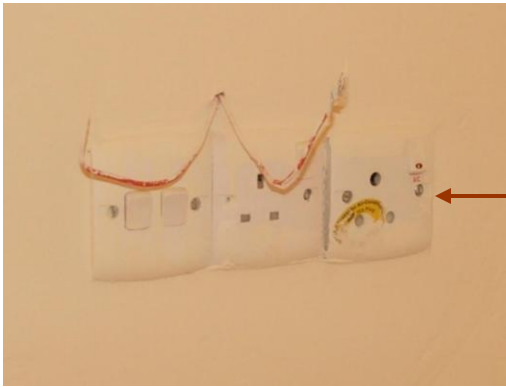
At the time of our second site visit, the contractor had not completed the chemical and operator buildings, water compact unit, light poles, and the sunshade for the water compact unit. For example, electrical work was still required in both the chemical and operator buildings (Site Photo 9). In addition, the contractor had not installed the crane for the chemical building (Site Photo 11). The water compact unit sunshade and individual pieces of equipment still need to be bolted into the concrete slab (Site Photos 12 to 14).

Site Photo 9. Inadequate electrical work

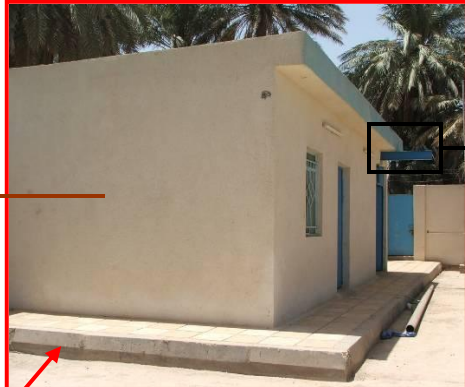
The contractor's site plan layout (Figure 4) included the following: elevated water tank, chemical building (Site Photo 10), water compact unit, operator building, light poles, and individual sunshades for the water compact unit, generator, and fuel tank.

Site Photo 10. Chemical building

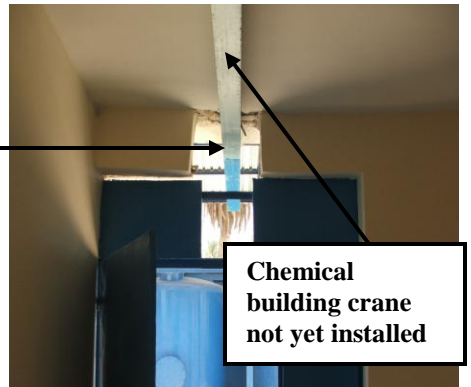
Site Photo 11. Chemical building interior

Chemical building crane not yet installed

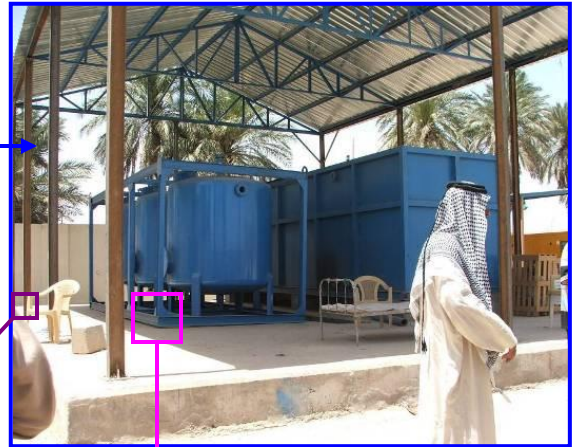
Site Photo 12. Water compact unit sunshade

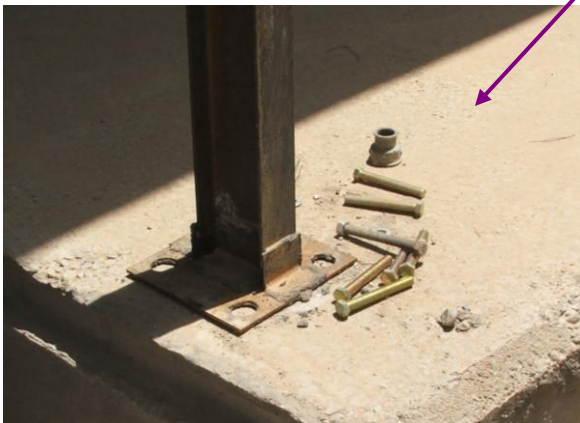
Site Photo 13. Unbolted sunshade post

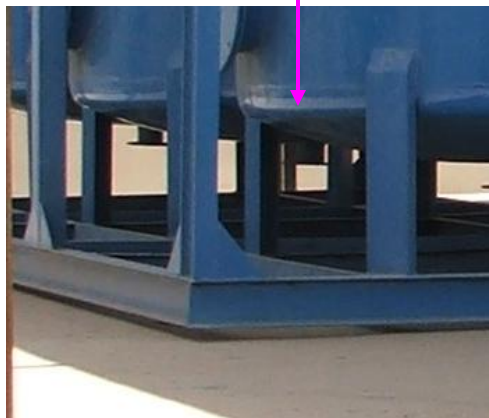
Site Photo 14. Equipment not bolted to slab.
