## POST-BUCKLING TEST RESPONSE AND ANALYSIS OF FIBER COMPOSITE GRID-STIFFENED STRUCTURES

A composite grid-stiffened cylindrically curved panel was fabricated and tested in static compression. Joint tension test coupons were fabricated from an unused portion of the panel construction and tested to failure in direct tension (rib/skin pull-off). Pre- and posttest analyses were performed to assess initial and overall buckling response. Comparisons to test data were made to assess: a) the influence of skin pocket buckling on overall structure response, b) the predictability of overall structure response through the range of operational load application, and c) probable causes of failure in this test panel and in future tests with rib and skin configuration optimized for specific spacecraft fairing applications.

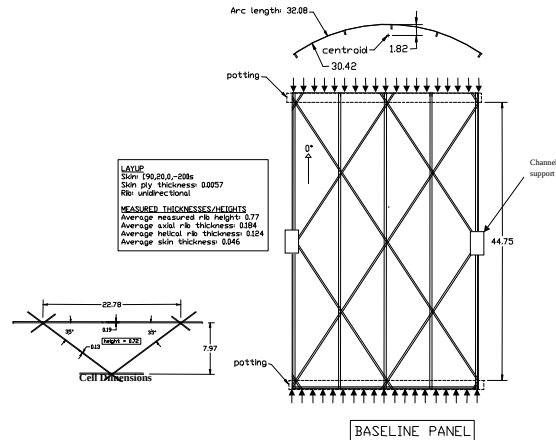
Figure 1. Baseline Panel Design

In the spring of 2001, Boeing (Van West, 2002) fabricated a cylindrical test panel using a representative grid-stiffened fiber composite design (Figure 1). This cylinder was subsequently partitioned into three test panels and several small test coupons. The larger test panels included a baseline design with no extraneous features such as pad-ups, portal block-outs, or connections. This panel was subjected to a compressive static load test at Boeing Phantom Works. The top and bottom surfaces of the panel were potted in epoxy to allow more uniform distribution of bearing stress into both the rib grid and the skin at the loading platens. The baseline panel design was subjected to a constant displacement rate to failure. Active instrumentation included a distribution of unidirectional strain gages on the ribs to monitor axial strain and bending effects, combinations of unidirectional and Rosette strain gages on the skin, and acoustic sensors to assess timing of damage events (Figure 2). Also, high-speed video monitoring of the grid side of the panel and an array of 250 reflective targets applied to the external skin surface were used to monitor the progression of displacement patterns on the skin (Figure 3).

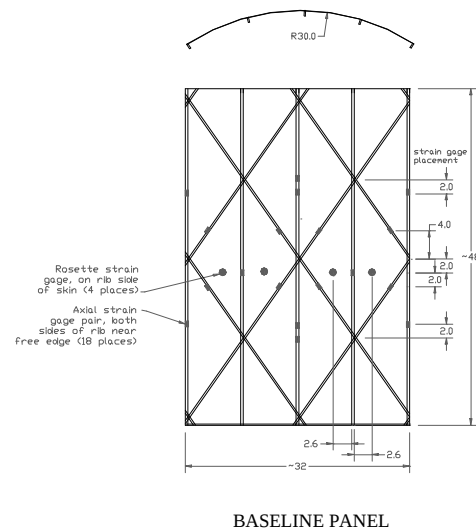
Figure 2. Active Instrumentation Layout.

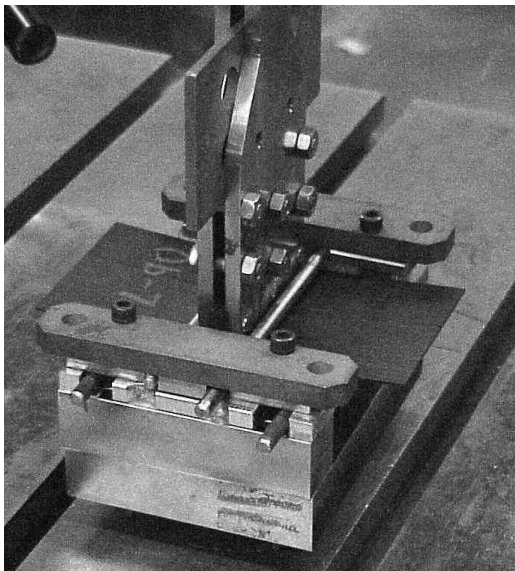
Photo 1. Pull-off Tee Test Fixture

Boeing also performed tension tests on segments of axial rib/skin joints for the baseline panel to obtain estimates of tension capacity per inch of joint length (Figure 4 & Photo 1).

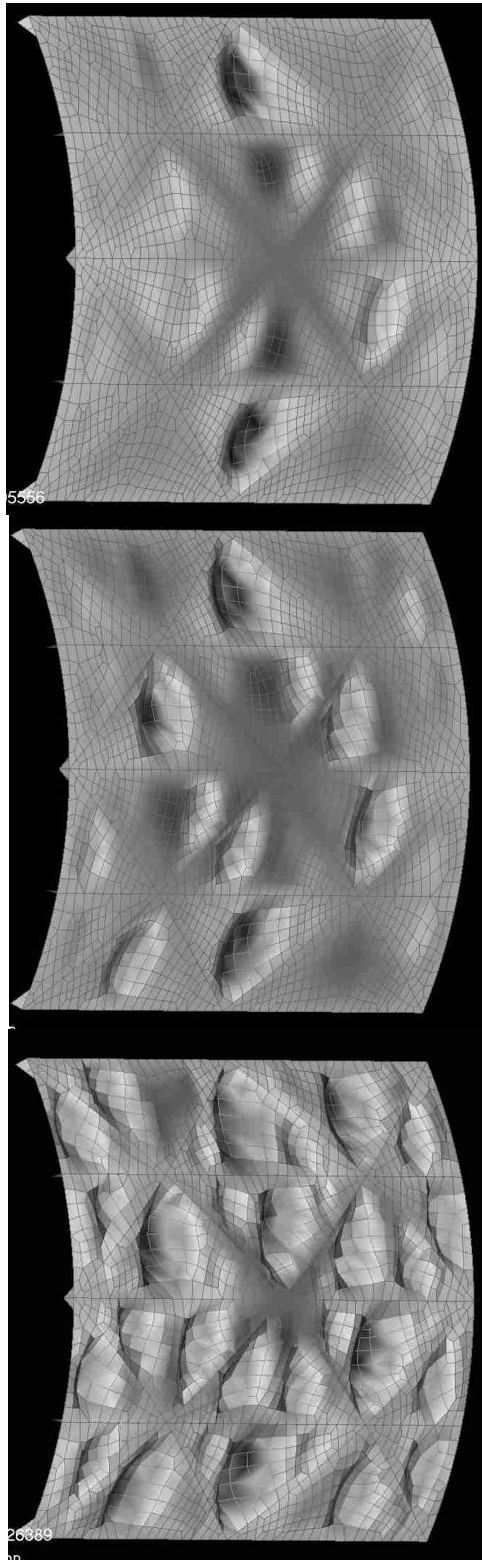
Figure 5. Progression of Skin Pocket Buckling Response of Baseline Panel at Total Panel Loads of 60,309 N, 79,370 N, and 189,326 N (Collier 2002)

During the test sequence an initial pattern of radial skin deformation emerged, growing progressively into a pattern of undulations between ribs. Boeing observed the beginning of local skin buckling at about 31,115 N total load. This buckling began to be accompanied by acoustic events at loads above 50,137 N. The pretest prediction for initial buckling generated by Craig Collier was 60,466 N. By this analysis skin buckling gradually increases as overall panel buckling load is approached (Figure 5).

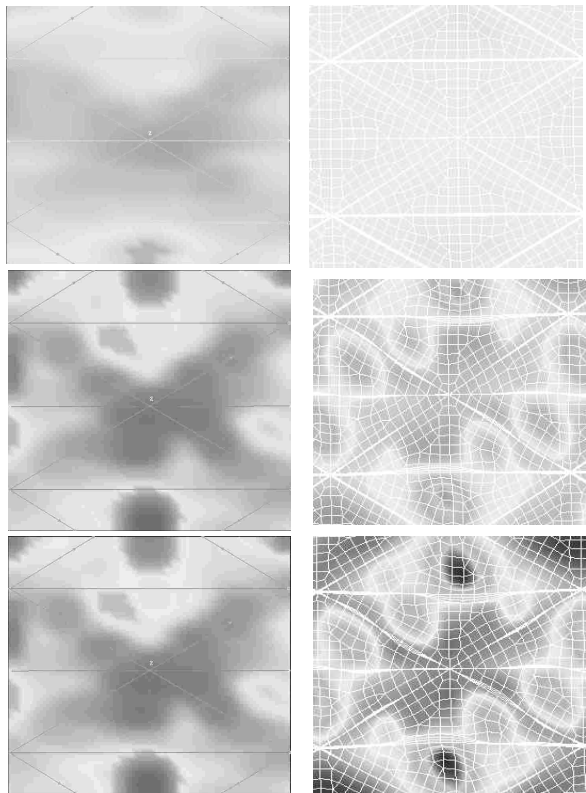
Figure 6. Skin Displacement Patterns at 44,443 N, 111,122 N, and 177,801 N Total Load from BVMS Data (left) and AFRL Analysis (right).

Large deformation calculations were performed by AFRL for progressive load stages as reported for the Boeing Video Measurement System (BVMS) data. Comparison of skin deformation evolution is very similar in pattern and deformation magnitudes between experiment and calculation (Figure 6) for loads above 44,443 N, where skin pocket buckling becomes evident. The additional zero load deflections resulting from manufacturing processes are neglected in this calculation. The approximate range of radial deformation for BVMS (experimental) and AFRL calculations are given in Table 1.

Table 1. Approximate Range of Radial Deformations Illustrated in Figure 5.

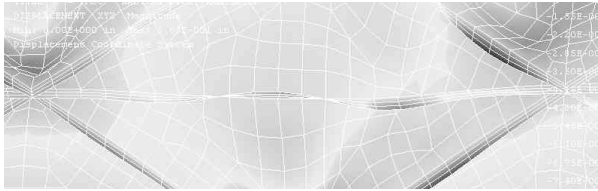
Figure 7. Circumferential Displacement Fringe from AFRL Analysis (10x) at 177,801 N Panel Load at the Location of the Initial Buckle in the Test

Complex rib deformations are also seen to develop in the AFRL deflection analysis (Figure 7).

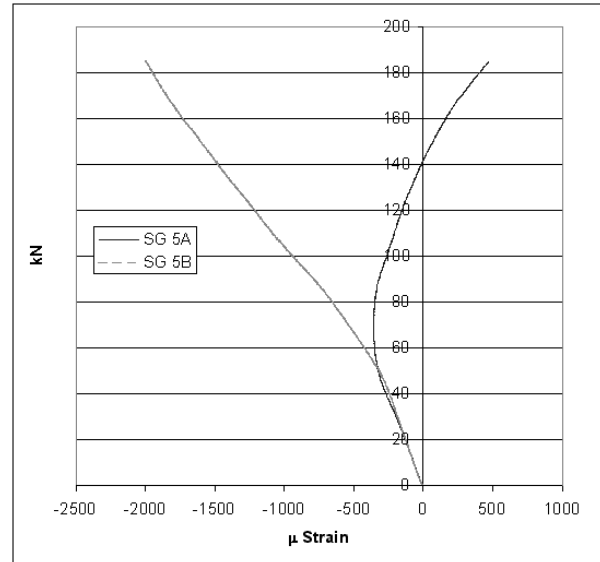
Figure 8. Strain Gage Pair near Center of Initial Axial Rib Buckle (Bending Develops for Panel Loads above 50 kN).

Multiple curvature reversals are seen in the axial ribs at panel loads above 111,122 N in the large deflection calculation. This curvature is reflected in strain gage pairs on axial ribs for the baseline panel (Figure 8). These rib deformations may be interpreted as resulting from skin forces resulting from skin pocket buckling. These deformations constitute partial constraints on the pre-buckled shape of the axial ribs and could have beneficial effect on the first buckling mode shape and critical buckling load for these axial ribs. These effects of the skin deformations on rib curvature, axial stiffness, and possibly buckling stiffness are secondary considerations when compared to the primary design considerations of rib cross-section dimensions and the pattern of axial and helical rib layout. Skin buckling did not significantly influence the ability of the panel structure to bear the design loads up to the point of overall panel failure.

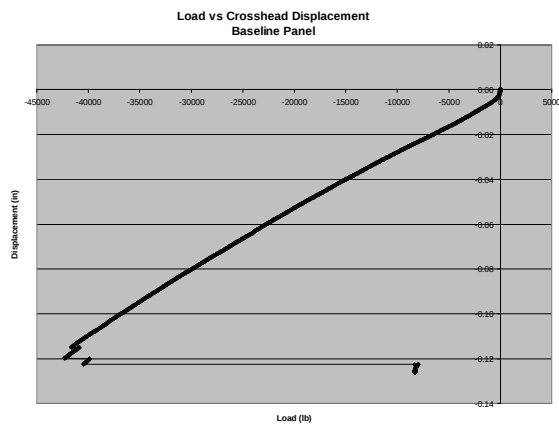
Figure 9. Load –Deflection Measurement for Baseline Panel Test

The baseline panel in the Boeing compression test responded with roughly linear load-deflection resistance to failure at 188,160 N maximum load with some cracking and softening behavior above 177,801 N (Figure 9). This is in good agreement with the Collier post buckling analysis for this test reporting a maximum buckling load of 189,806 N.

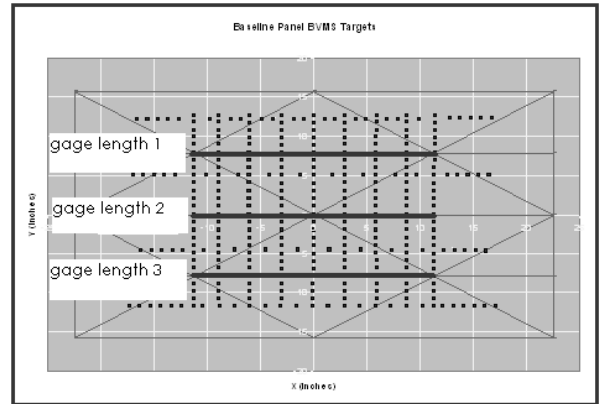
Figure 10. Gage Lengths for Axial Stiffness Assessment

Comparison of axial rib deformation under increasing panel load was made between the BVMS/load cell test data and the large deflection analysis using the three gage lengths selected in Figure 10. Comparisons of gage length change with load are illustrated in Figure 11. Gage length 1 is along the rib that first buckled. Note that the measured response in this rib was about 21 percent less than in the symmetrically placed rib in the opposite side of the panel corresponding to gage length 3. Slight axial softening is apparent for panel loads above 40,815 N in both the BVMS data and the calculations. This softening behavior is further reflected in axial strain gage data that was averaged to remove rib-bending effects (Figure 12). As cited above, this strain gage data demonstrates significant rib bending for panel loads above 40,815 N. The average strain data for these paired gages suggests the same axial softening as observed from the BVMS displacement data and analysis for these ribs. The effect is particularly apparent in gage length 1 (along the rib that first buckled).

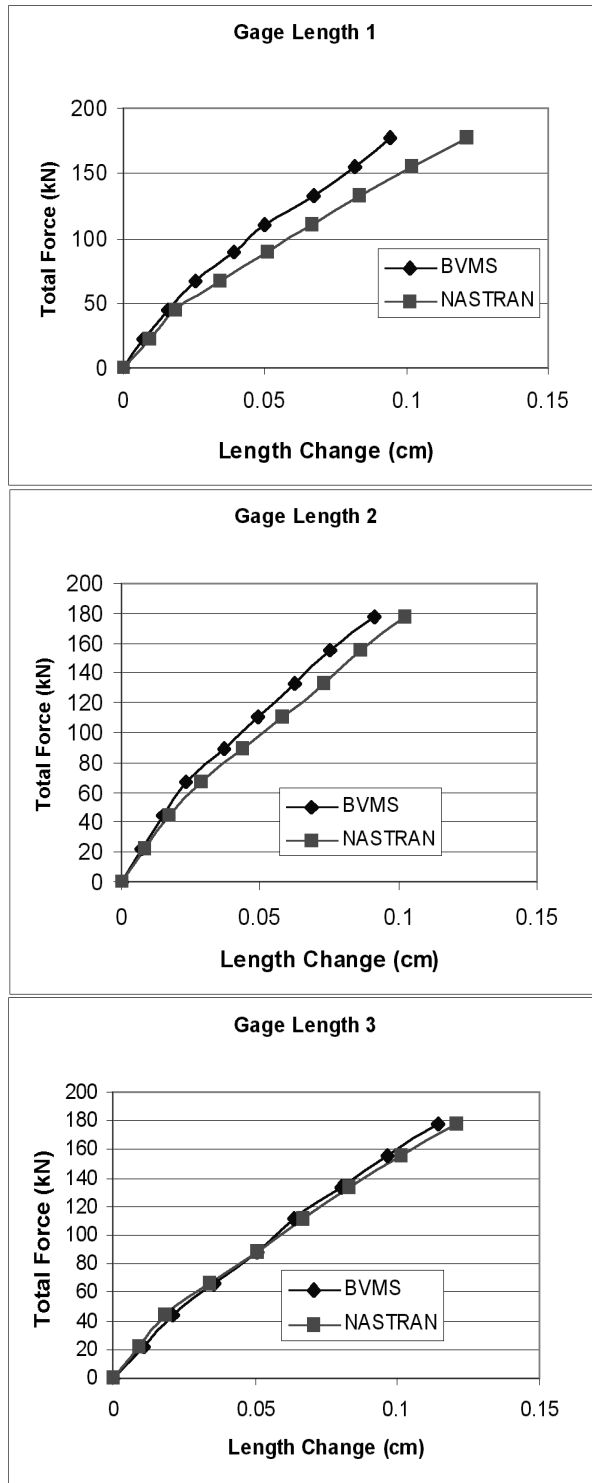
Figure 11. Comparison of BVMS Measured and AFRL Calculated Axial Rib Response.

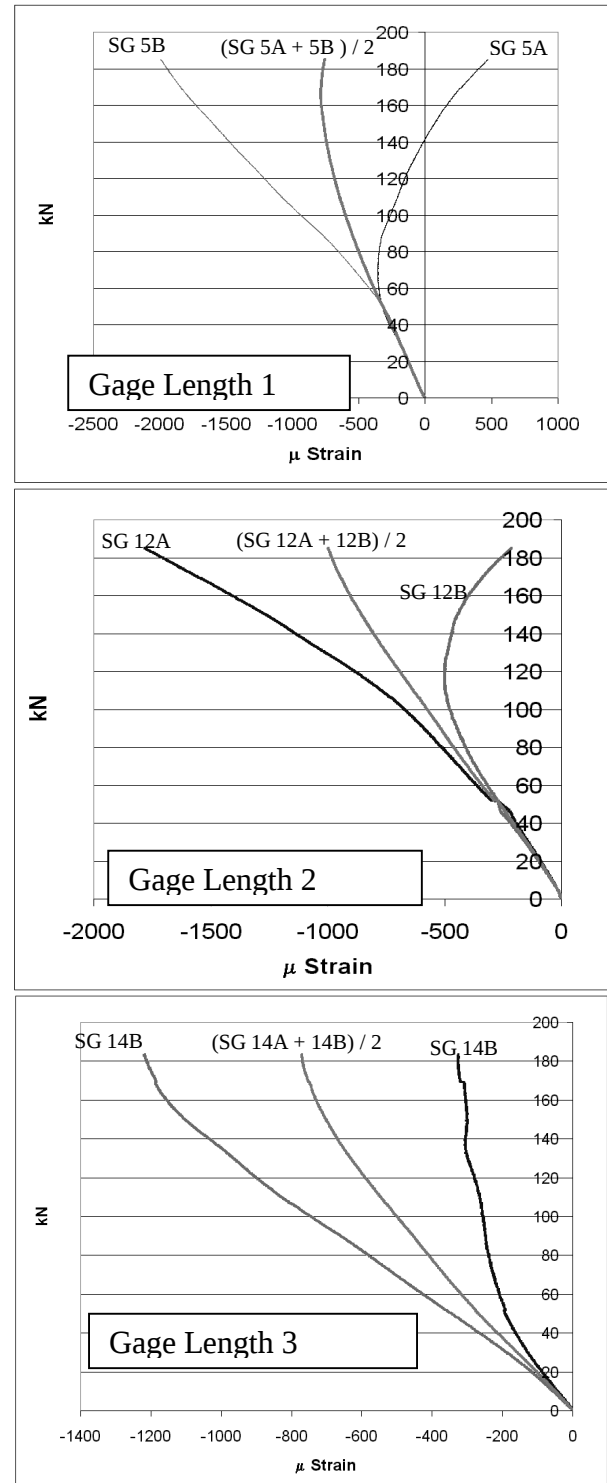
Figure 12. Axial Strains at Points along Axial Rib Gage Lengths 1, 2, and 3.

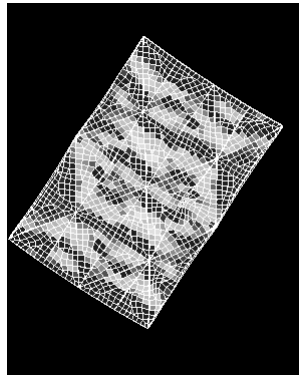
Figure 13. Maximum Principal Stress (Hoop Skin Stresses).

maximum total load of 177,801 N. In this analysis stresses are reported for the middle shell location to omit bending effects in the various structural components and to more clearly show the distribution of primary forces in the panel (hoop and axial). The maximum principle stresses in the skin were oriented in the circumferential direction and did not exceed 62,052 kPa (tension). Tensile hoop stress bands were distributed axially in this calculation (Figure 13). The minimum principle stresses in the skin were oriented axially and averaged less than 13,789 kPa (compression) in regions away from the axial ribs (Figure 14). The minimum principle stress in the ribs was oriented along the direction of the ribs. Axial rib stresses typically exceeded diagonal rib stresses by factors of 2 to 4 and reached average values or roughly 275,790 kPa in the middle shell.

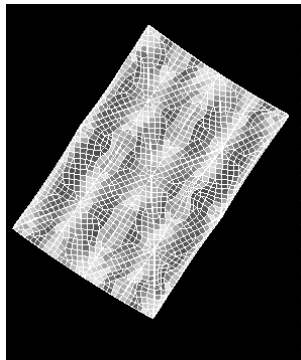
Figure 14. Minimum Principal Stress (Axial Skin Stresses)

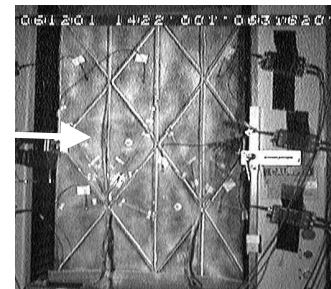
Photo 2. Initial Axial Rib Buckle (105,350 N).

High-speed video suggested that joint de-bonding and concurrent axial rib buckling might have initiated in one rib just prior to failure (Photos 2 and 3).

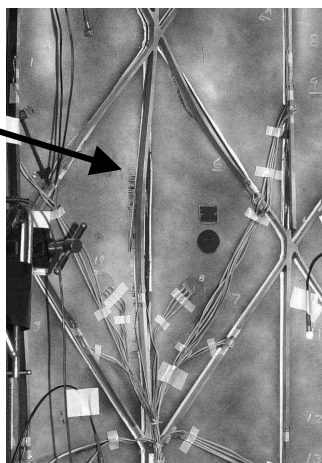
Photo 3. Close-up of Initial Rib Buckle and Joint Failure.

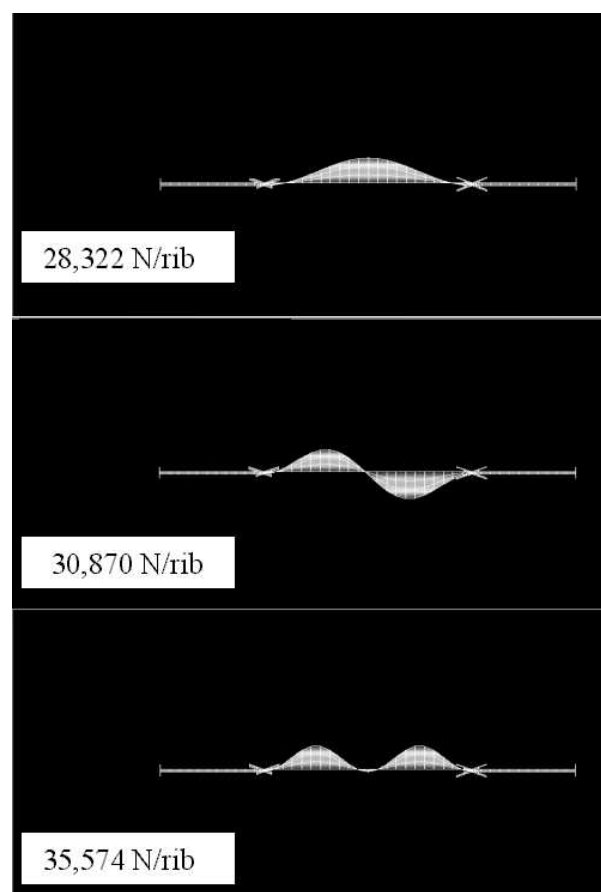
Figure 15. First Three Axial Rib Buckling Modes from Approximate Boundary Condition Analysis.

Additionally, a simplified buckling calculation was performed for one axial rib (the rib initiating failure in the test) using approximate boundary conditions: rib intersection nodes were clamped except in the axial direction, the inner radius rib edge was free, and the outer radius rib edge was restrained against circumferential and radial displacement (approximating the confinement of the skin). The first few buckling modes demonstrate buckling loads consistent with the observed buckling failure assuming that the axial ribs carried 75 to 95 percent of the total panel load (Figure 15).

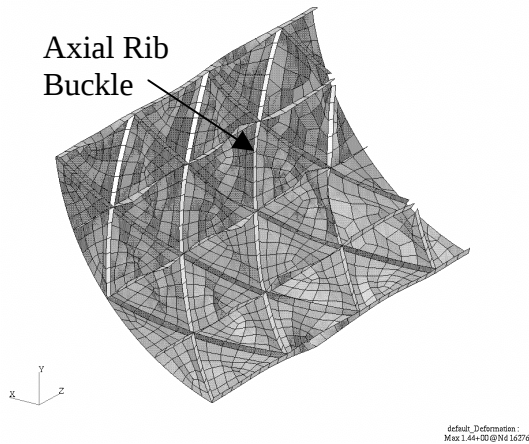
Figure 16. Deformed Shape at Final Converged Load Step of Post Buckling Analysis, Scale 2:1

For example, in preparation for tests of optimized panel designs to be conducted in February 2001, Boeing performed post-buckling analysis of a panel with a three-ply skin (90/0/90). The skin buckles very early, but still provides lateral support to the ribs (Figure 16). The maximum predicted panel load was 132 kN (Figure 17). Buckling of axial ribs is indicated by the rapidly increasing radial displacement of the ribs in the region of buckling (Figure 18). Note that rapid growth in radial rib deformation occurred at loads above 104 kN, or about 20% below the panel critical load.

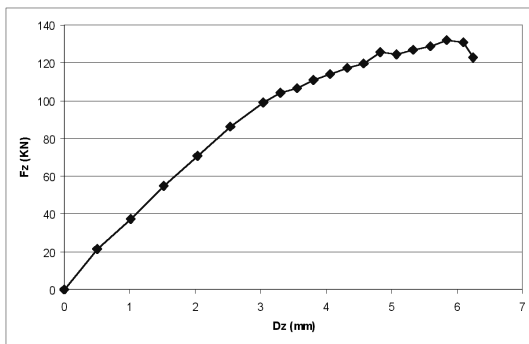
Figure 17. Analysis of Optimized Panel, 2-tows Axial Stiffeners, Total Axial Load vs. Axial Deformation

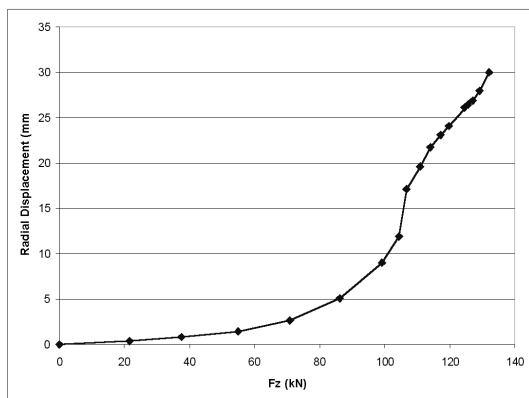
Figure 18. Optimized Panel, 2-tows Axial Stiffeners, Rib Radial Displacement vs. Panel Axial Load

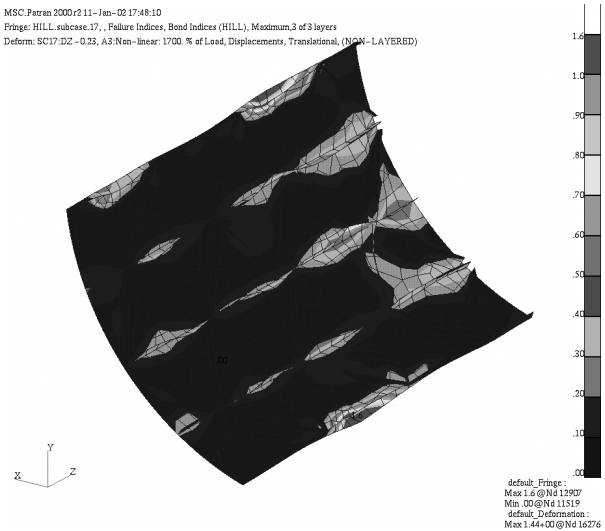
Figure 19. Optimized Panel, 2-tows Axial Stiffeners, Hill Failure Index

Localized peaking of the Hill Failure Index in the region of the rib buckling is high enough to indicate skin failure might occur prior to the buckling critical load (Figure 19). However, actual test data and more
