ANALYSIS AND DOCUMENTATION OF THE  
“MITHOLZ” UNDERGROUND AMMUNITION STORAGE  
ACCIDENTAL EXPLOSION IN SWITZERLAND

Twenty-Seventh DoD Explosives Safety Seminar  
Department of Defense Explosives Safety Board  
Las Vegas, Nevada

August 20 - 22, 1996

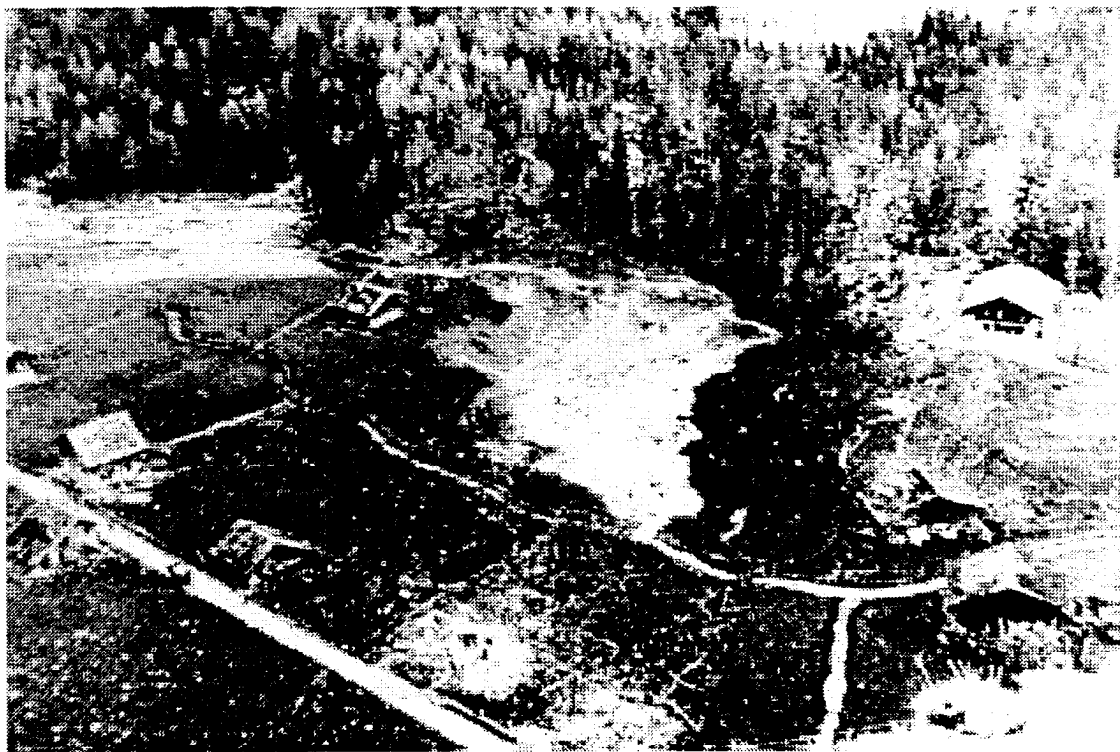
*Figure 9. Photograph Showing Fragment Density Post-Blast.*
