# **TESTING OF PROTOTYPE CONDUIT**

**INTERIM REPORT  
TFLRF No. 401**

**U.S. Army TARDEC Fuels and Lubricants Research Facility  
Southwest Research Institute® (SwRI®)  
San Antonio, TX**

**for  
U.S. Army TARDEC  
Force Projection Technologies  
Warren, Michigan**

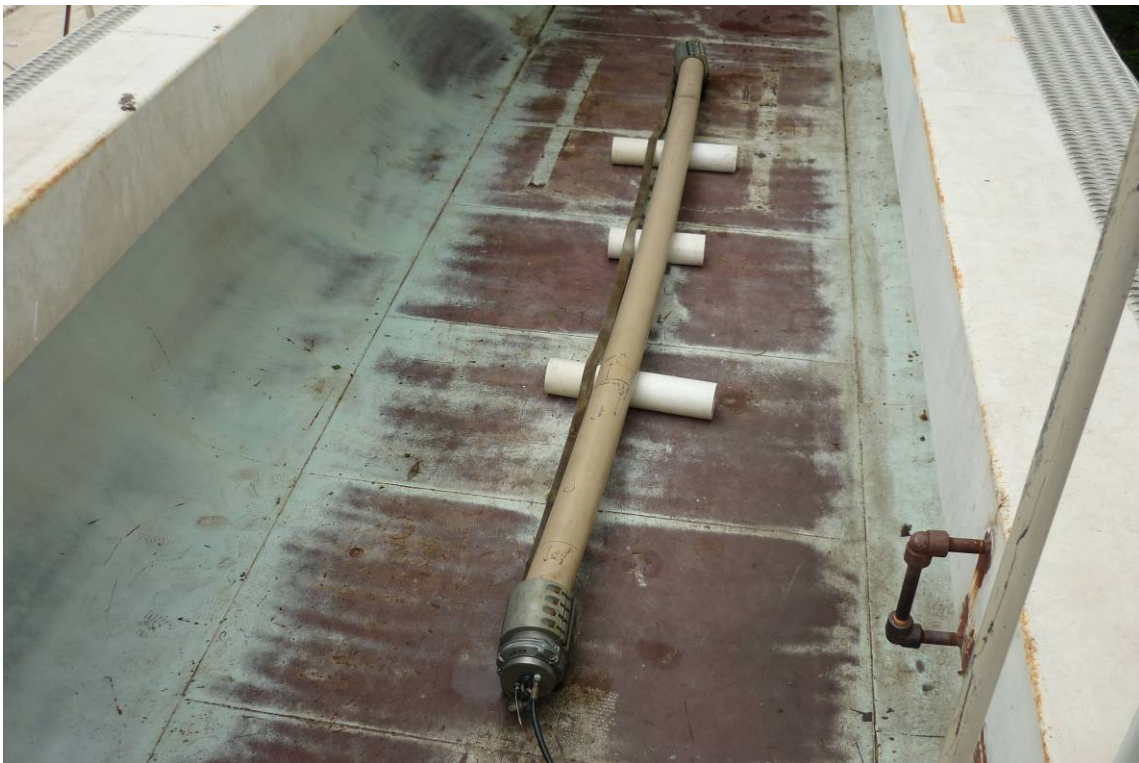
**Figure 3.4 – Hose Sample C Burst Test Setup**

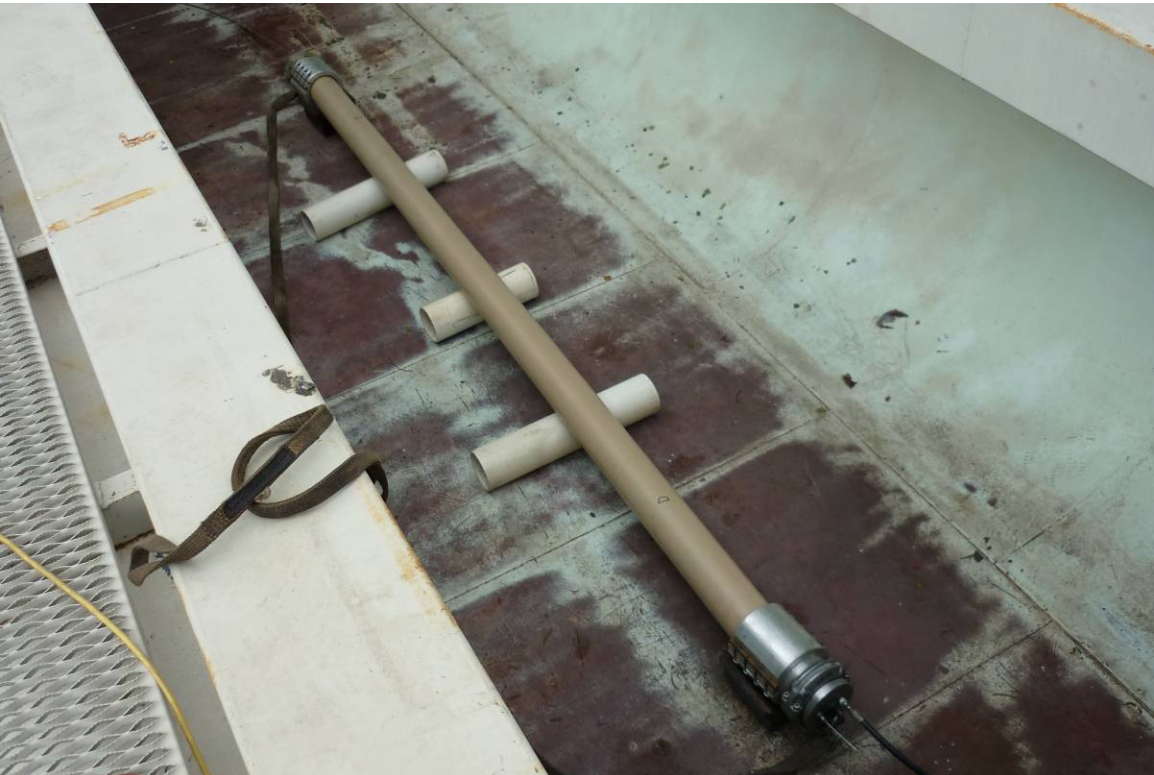
**Figure 3.6 – Hose Sample D Burst Test Setup**

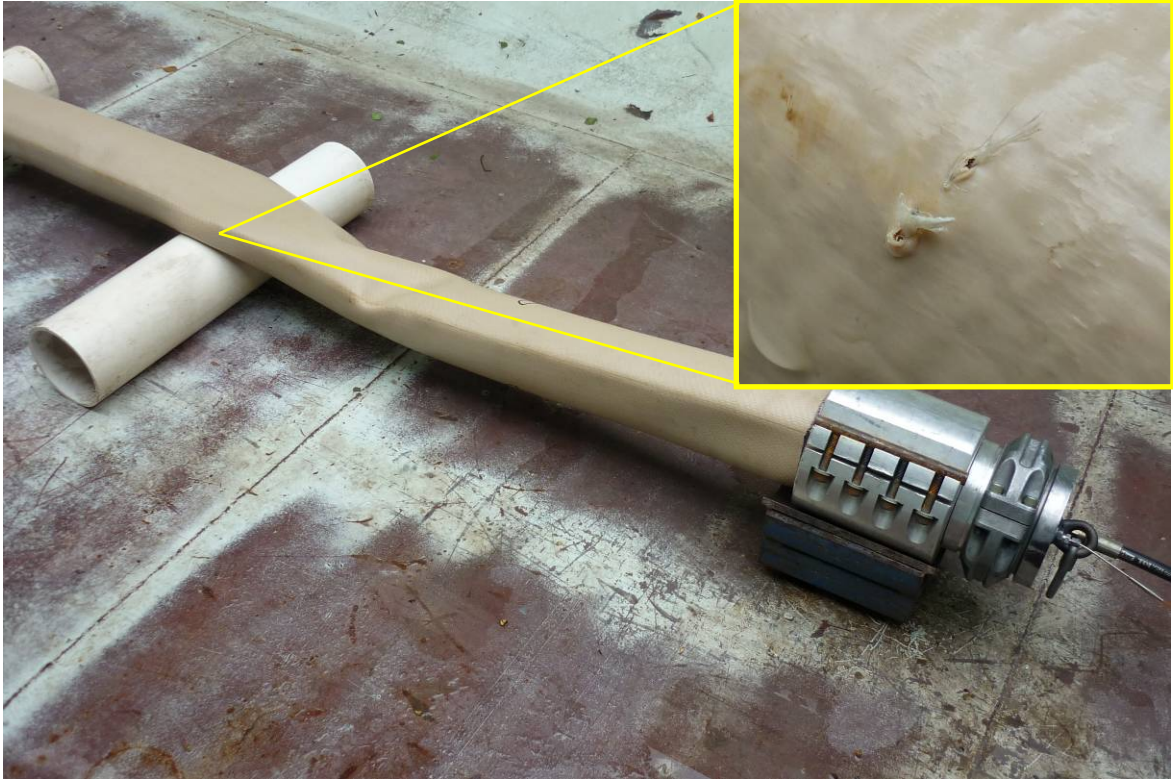
| Sample | Length (ft.) <sup>1</sup> | Burst Pressure (psig) | Failure Mode | Cycled Tested Before Burst Test |
|---|---|---|---|---|
| D | 14.92 | 1896 | Small hole, 1-2 weft yarns broken/protruding | No |

**Figure 3.7 – Hose Sample D Failure**

| Peak Pressure (psig): <u>1896</u> | Failure Mode: <u>crack (split)</u> <span style="margin-left: 20px;"><i>←</i></span> |

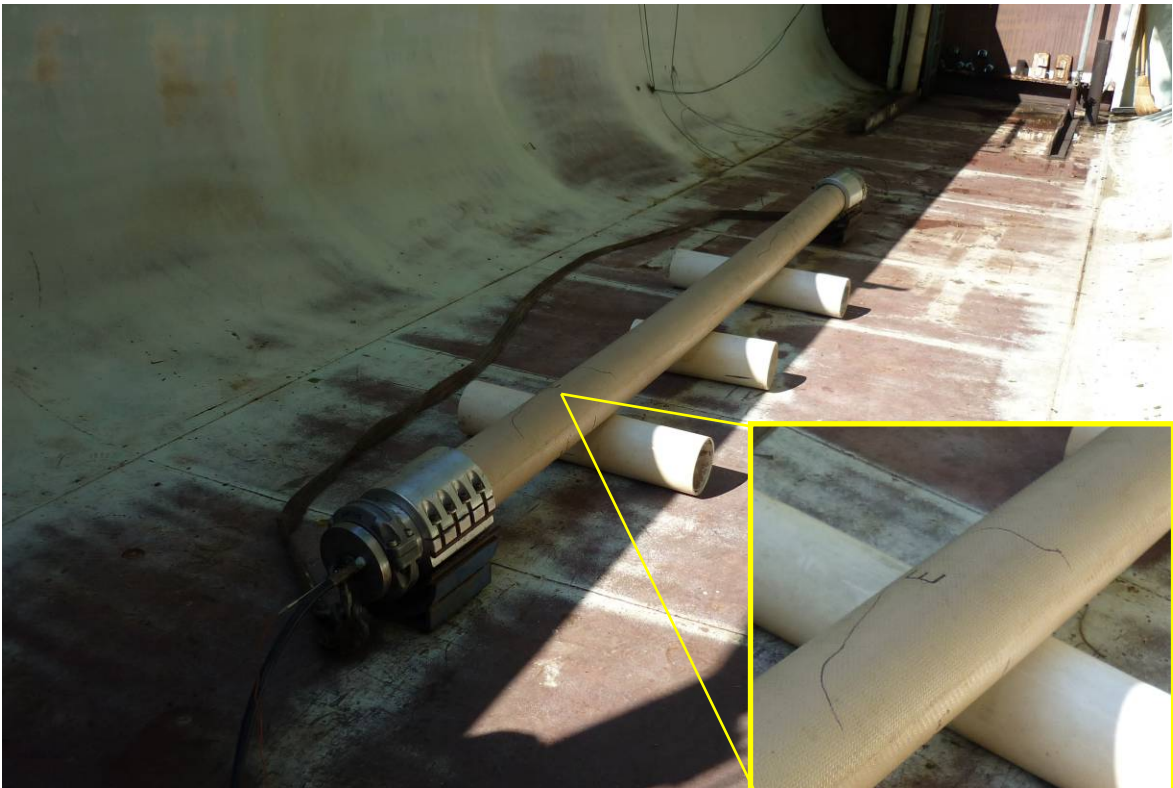
**Figure 3.8 – Hose Sample E Burst Test Setup**

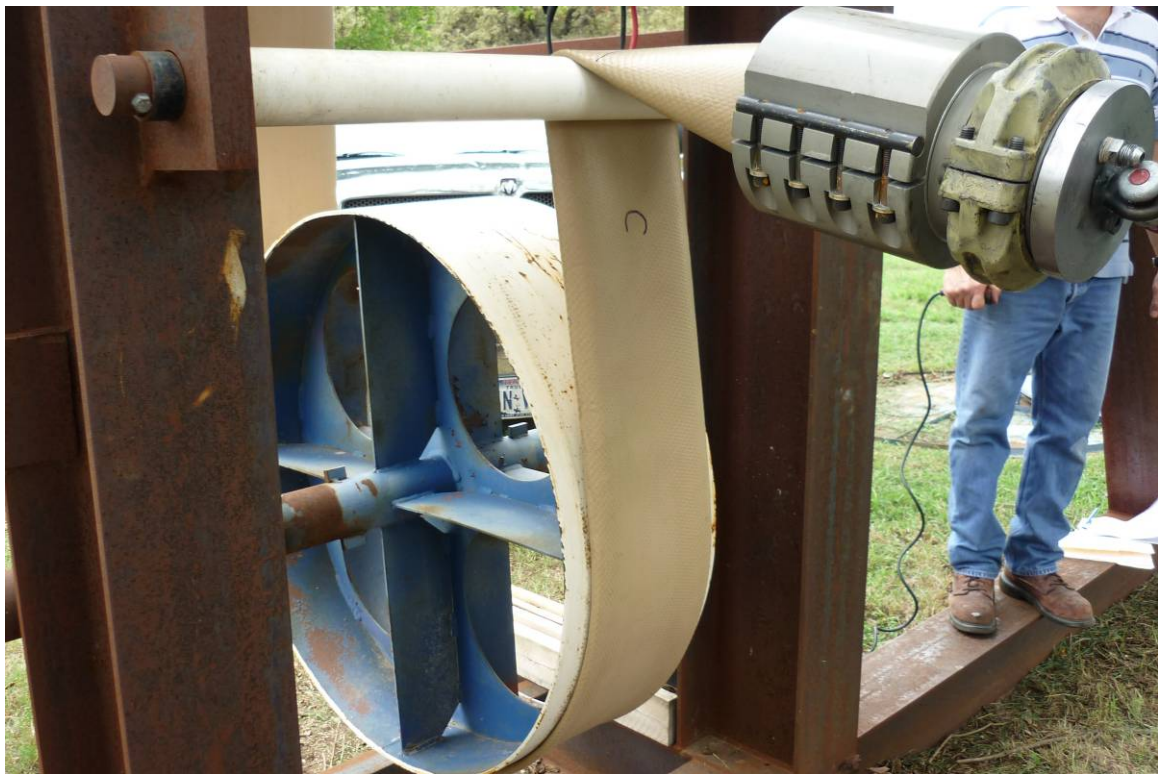
Figure 4.3 – Cyclic Bend Testing of Hose Sample C (View 1)

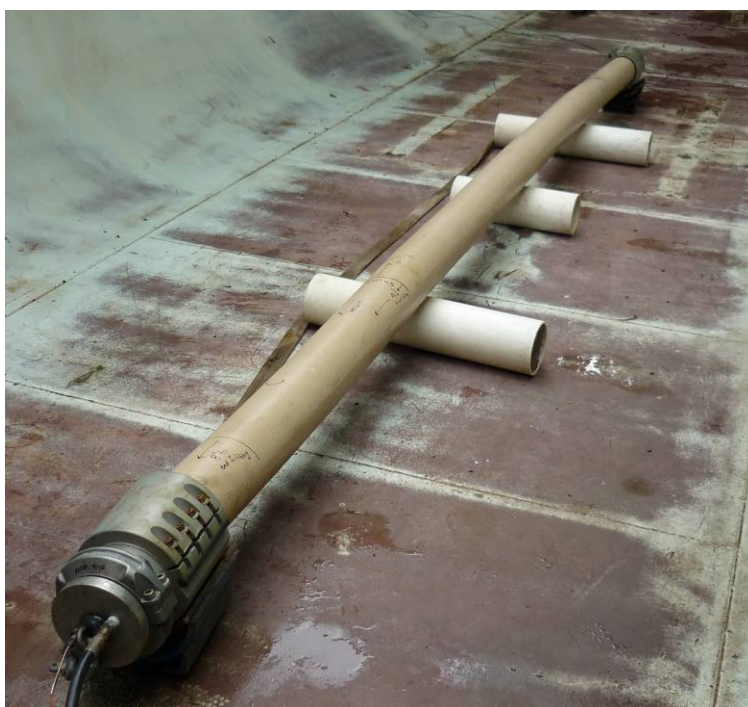
**Figure 4.5 – Cyclic Pressurization Testing of Hose Sample C**

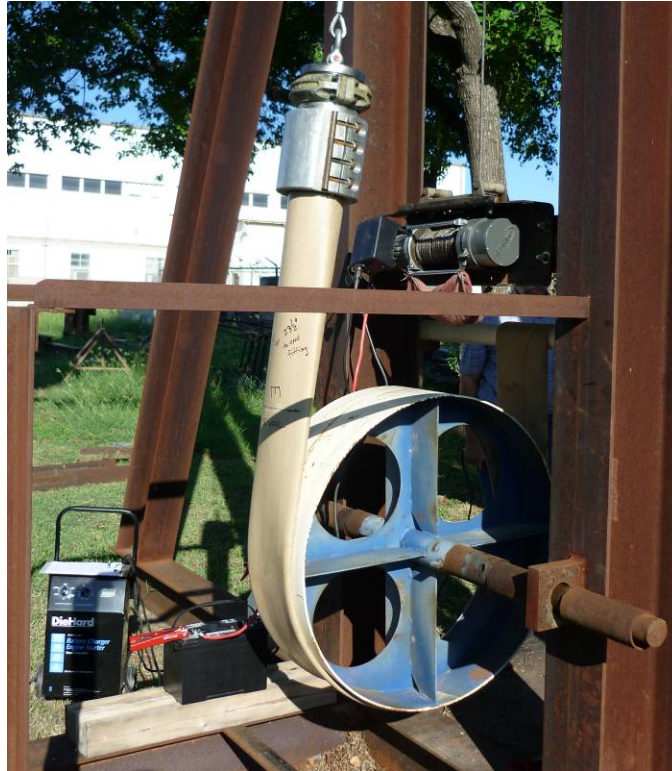
**Figure 4.6 – Cyclic Bend Testing of Hose Sample E**

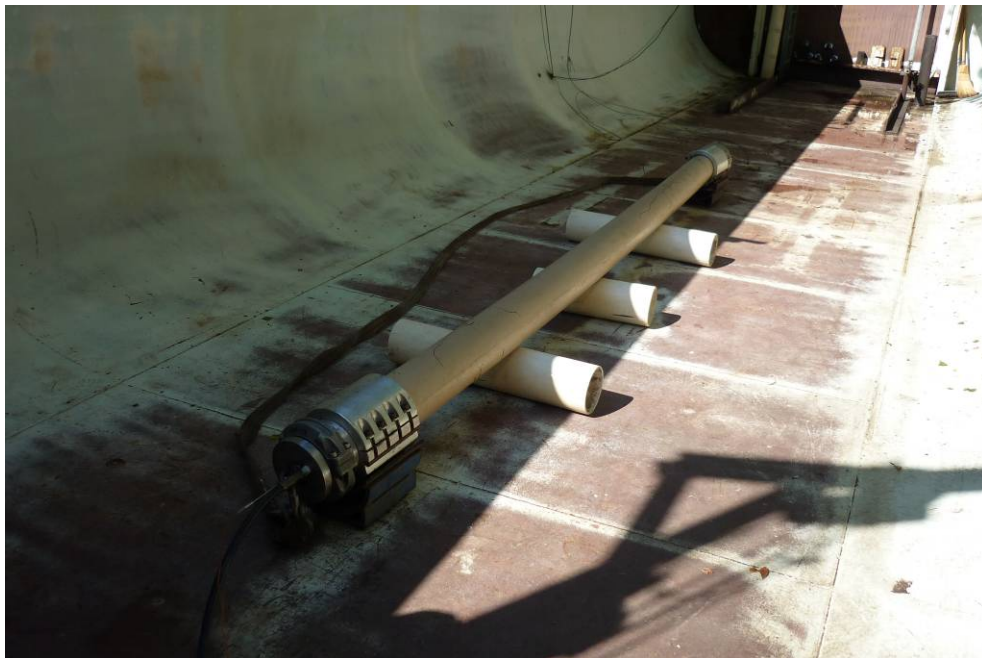
**Figure 4.7 – Cyclic Pressurization Testing of Hose Sample E**

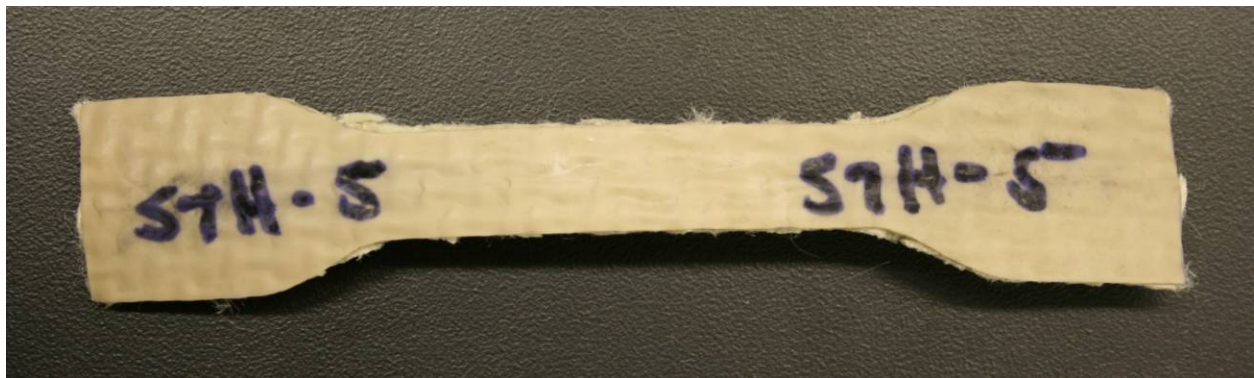
Figure 6.2 - Representative Tensile Coupon after Removal from Parent Hose Material

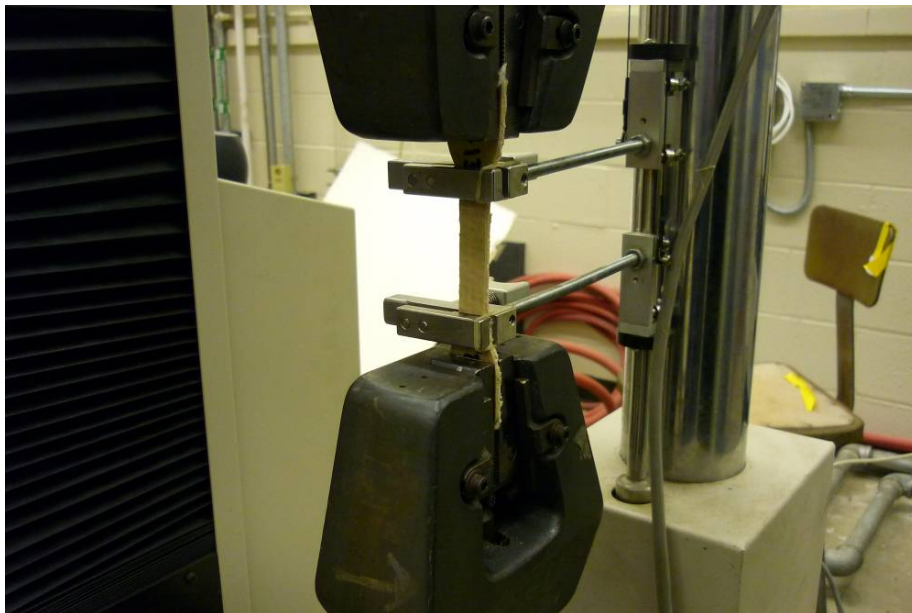
Testing was performed per ASTM D412 at a displacement rate of 20 in/min. A 20-kip servomechanical test frame (Figure 6.3) was used with a 2.5-kip load integrated into the load train given the anticipated loads. Mechanical clamping grips were used to secure each coupon end during testing. A high elongation extensometer was utilized to measure gage length extension during each test. The initial gage length for each test was 2-in and the post-test strain calculations were based on a nominal gage length of 2-in. Testing was performed in laboratory ambient conditions; nominally 72°F and 30-40% RH. It is important to note that the conditioned coupons remained in a bath of their respective conditioning fluid until just prior to testing.

**Figure 6.3 – Test Sample Mounted in Tensile Test Frame**
