US Army Corps  
of Engineers®  
Engineer Research and  
Development Center

## **Corrosion Prevention of Rebar in Concrete in Critical Facilities Located in Coastal Environments at Okinawa**

Final Report on Project FAR-16 for FY06

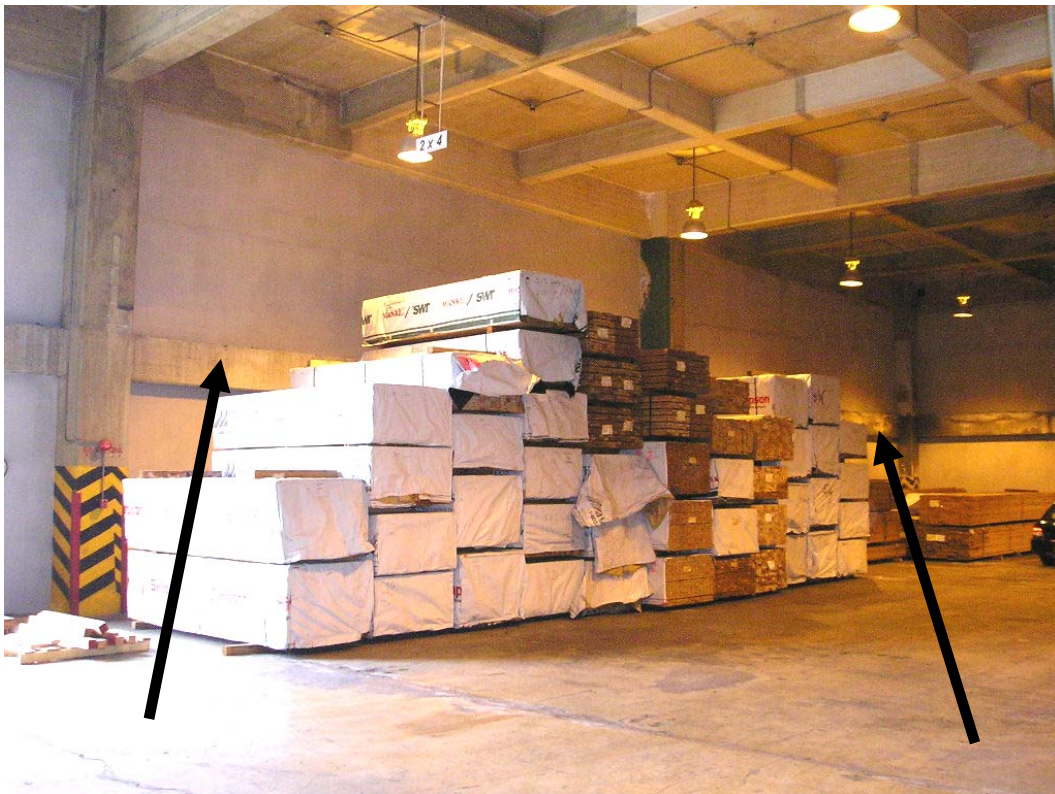
Figure 2.1. Building 306 warehouse, inside ring girder, side 1 (left) and side 2 (right).

One structure selected for demonstration of the technologies was Building 306, a warehouse located at Naha Military Port. Two equal-size portions of a ring girder in area A of the building were designated for treatment, positioned on opposite sides of the darker column shown near the center of Figure 2.1. Side 1 was designated for application of the Surtreat corrosion inhibitor system, and side 2 was designated for application of the NASA-developed LGC. Figure 2.2 shows the condition of side 2 of the ring girder before treatment.

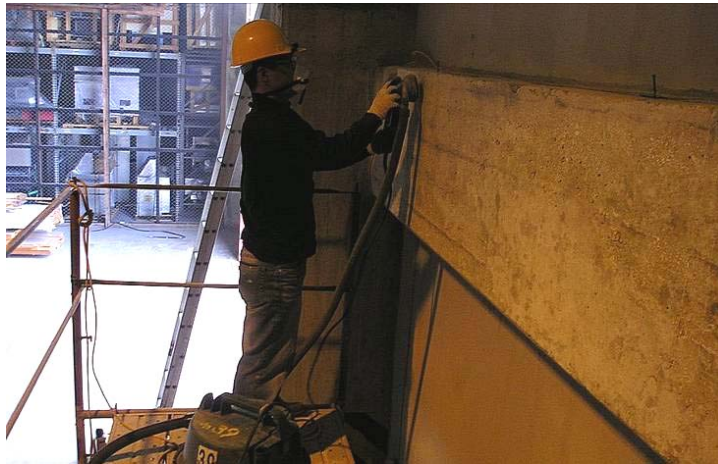
Coatings were removed using a grinder with a dust-collection system.

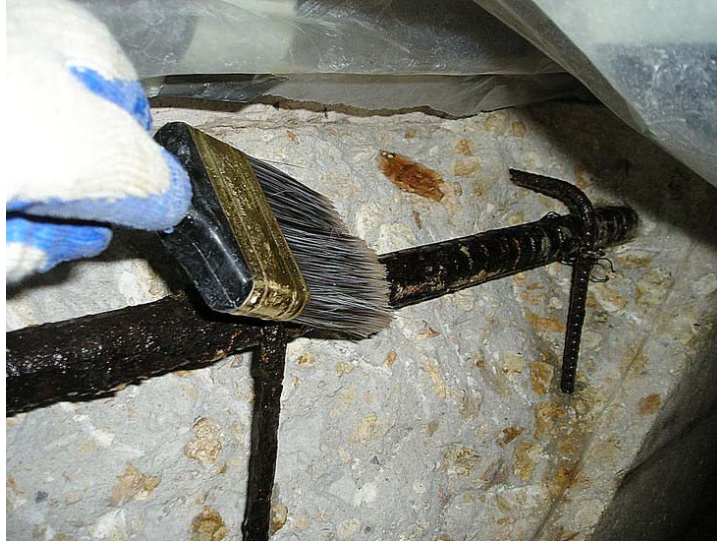
Rust Converter direct contact corrosion inhibitor was applied to the exposed rebar in demolished repair areas.

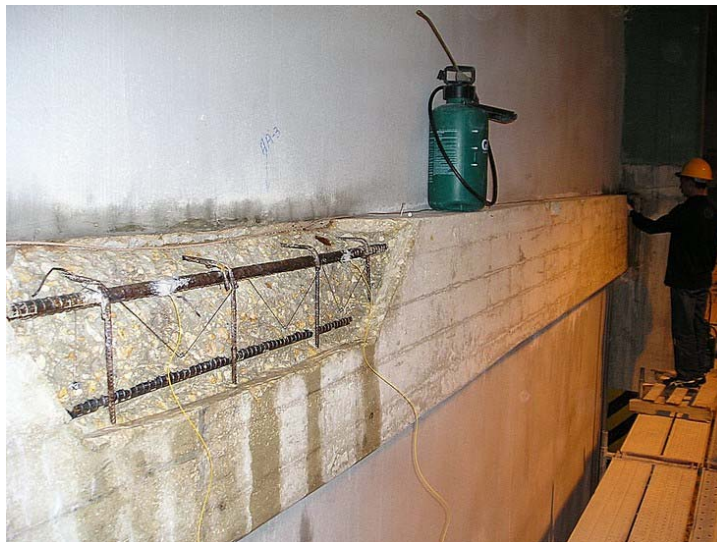
Organic vapor phase corrosion inhibitor and inorganic migratory corrosion inhibitor were applied to the demolished repair areas in sequence followed by intermittent water spray and additional washing following the application. A hand pump was used to facilitate application.

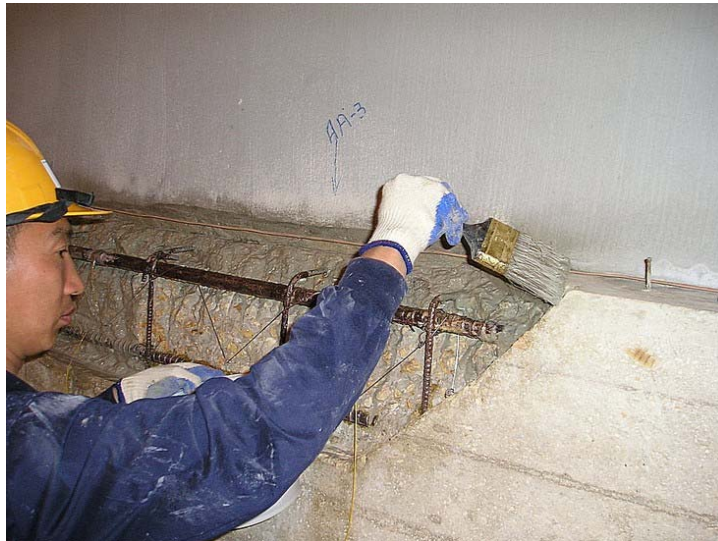
Repair areas were primed prior to concrete placement.

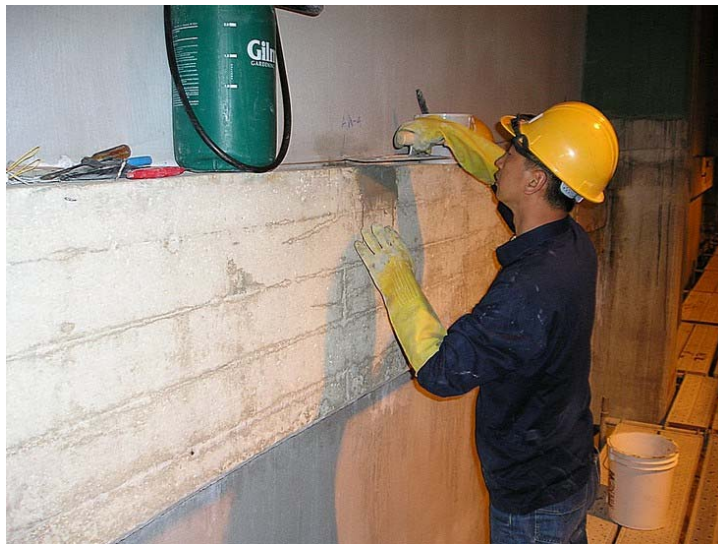
Concrete repairs were placed and finished in accordance with generally accepted construction practices in all locations on the ring girder side 1 (Surtreat system) and 2 (LGC)

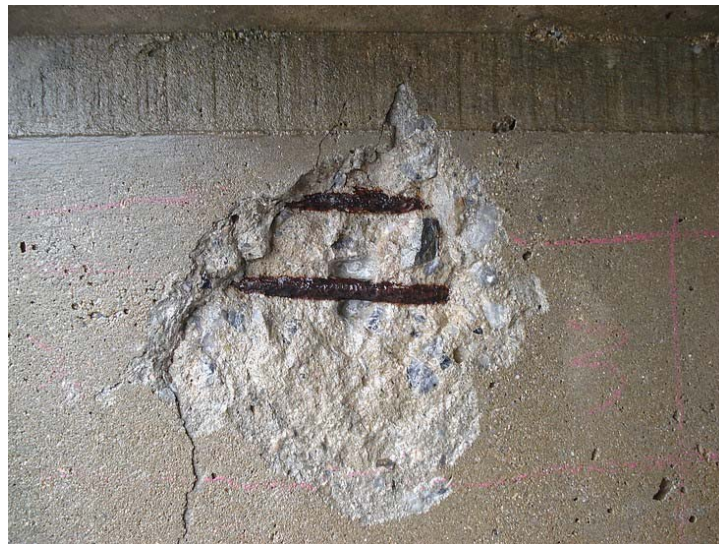
Deterioration and spalling pattern common to Culvert 2.

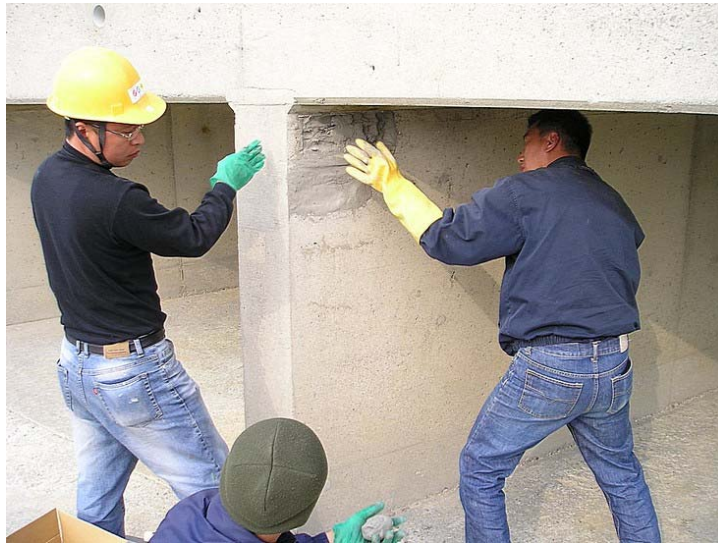
All repair areas were “squared” and patched using locally manufactured overhead mortar.

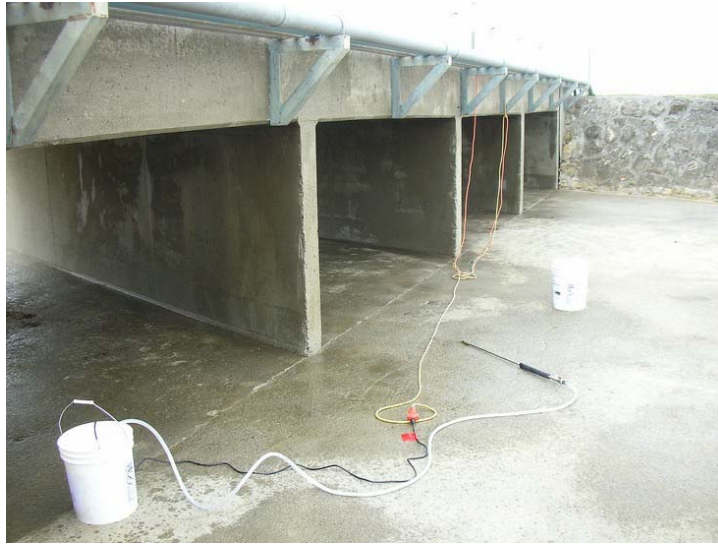
Several days passed between applications of organic vapor phase corrosion inhibitor and inorganic migratory corrosion inhibitor.

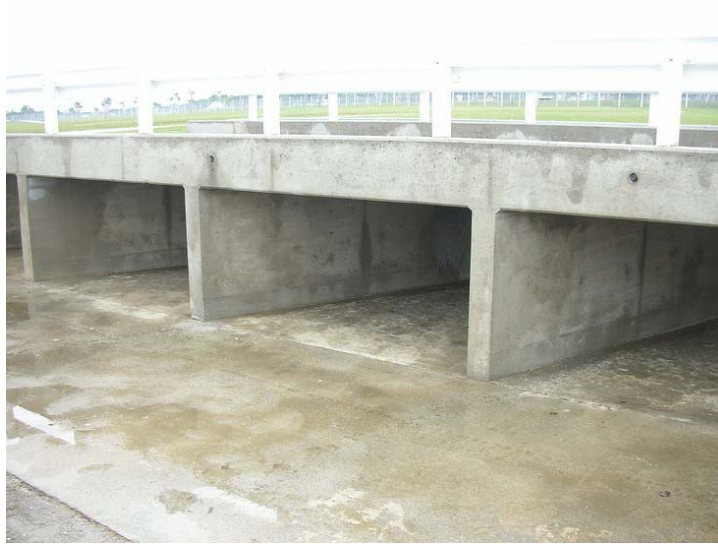
Culvert 2 appearance immediately following corrosion inhibitor system application.

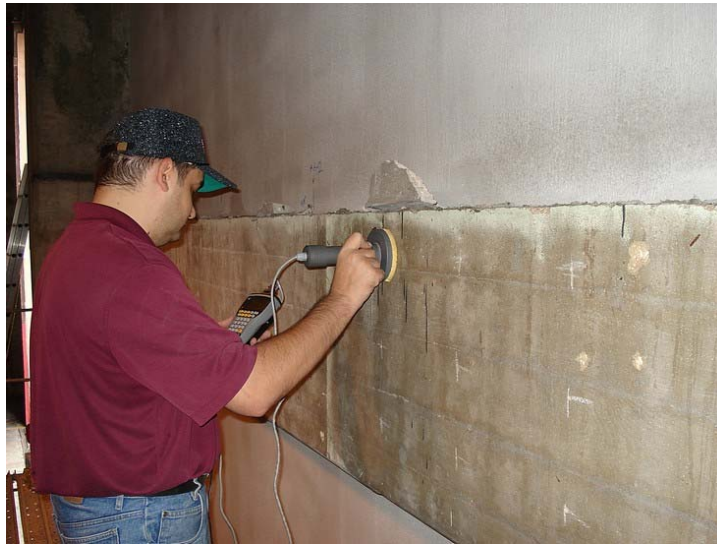
Corrosion testing using Galvapulse® method. Sections of both sides of the Ring Girder were tested before and after corrosion mitigating components were applied/installed (Naha Military port Building 306 Ring Girder Sides 1 and 2.)

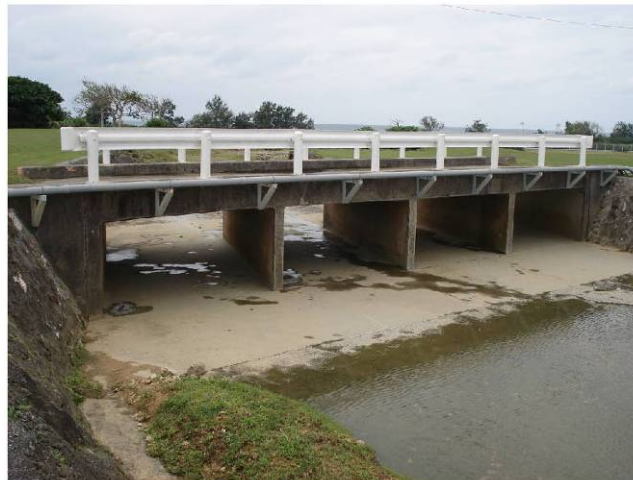
Figure 1. Overview of Culvert #2, looking downstream toward the East China Sea.

Culvert #2 is located in the middle of the spillway section within the tank farm. Figure 1 shows a general overview of the culvert, looking downstream toward the East China Sea. Light rains with periodic heavy rain throughout the first day of inspections resulted in brisk water flow through the culvert, as much as a foot deep. Sketches 2 and 3 (Appendix A) depict the existing condition of the pier walls on Culvert #2 as well as the location of all tests conducted. Generally, the form dimensions were easily visible and could be used as reference points.

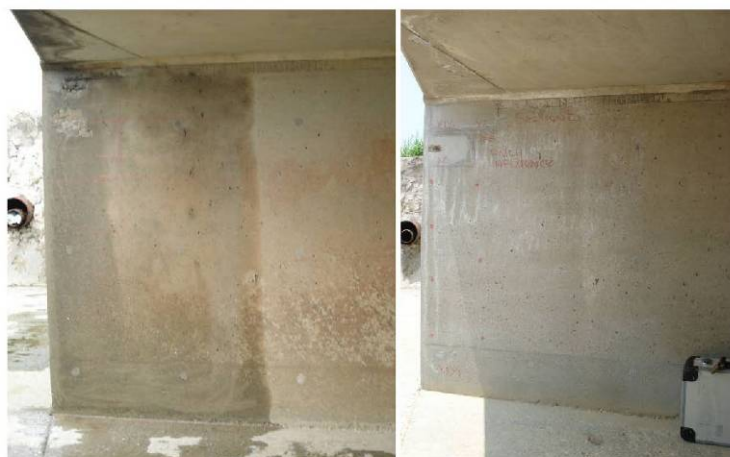
Figure 5. Typical appearance of culvert before (left) and 6 months after (right) inhibitor application.

Several small patches of cementitious repair material were noted on the structure at the July inspection. These patches were applied by others between completion of the Surtreat work and our July inspection. Details regarding the reason for repair and the procedures used are not known. Figure 6 shows typical repairs. Note that the repair material has a rough appearance and is beginning to exhibit cracking.

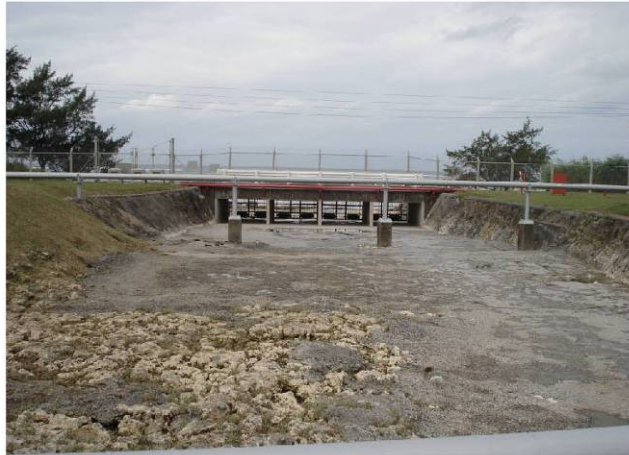
Figure 11. Overview of Culvert #3, looking downstream toward the East China Sea.

No corrosion or water transmission data was taken on this culvert either before or after application of the inhibitor.

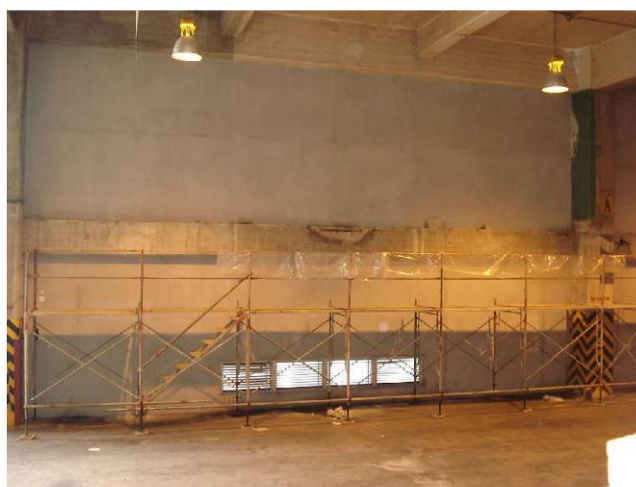
Figure 15. Overview of “Beam 1” at Naha Port Building 306.

On January 18, Surtreat personnel exposed rebar under spalled concrete in two locations on each beam. The exposed rebar was heavily corroded. While the corrosion could not be measured precisely, there was evidence of several millimeters of corrosion. Figure 17 shows a typical section of exposed rebar. The rebar was approximately 1¼-inch diameter running along the beam. The rebar spacing was approximately seven inches with the top bar approximately three inches from the top of the beam. Vertical rebar “cages” were smaller and placed approximately every 13 inches. Rusted attachments were scattered along the surface of the beams (cut off screws, staples, anchors, etc). Beam 2 had some type of paint applied in the past. It was fairly thin (several mils), gray paint which was peeling in most areas.

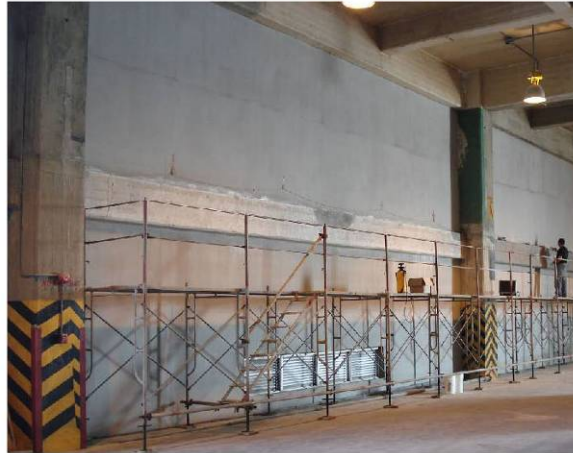
Figure 18. Overview of Beam 1 in July, 2007.  
Note patch repairs (darker appearance). Compare to Figure 15.

The portion of the ring girder designated “Beam 1” was treated with the Surtreat inhibitor system and had delaminated sections repaired in early February, 2007. Figure 18 shows the beam during our July visit. Several patches are evident along the top of the beam, including one large patched area to the right of center and smaller ones at either end of the beam. The edges of the repair material appear to be well bonded. Aside from the patches, the remainder of the beam is cleaned to a uniform appearance. Compare Figure 18 (after) to Figure 15 (before).

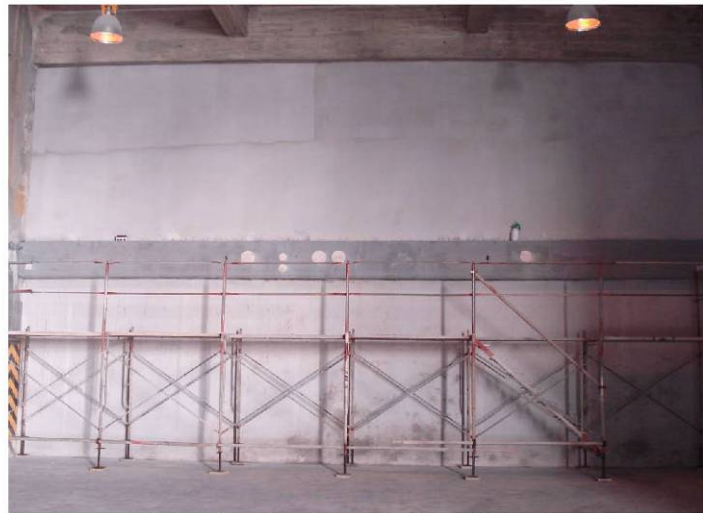
Figure 22. Overview of Beam 2 with the NASA sacrificial coating applied.

Figure 22 shows an overview of the beam during our July visit. The circular areas are where the coating has been ground away to facilitate corrosion rate and electrochemical potential measurements. These areas of missing coating should not impact the overall performance of the sacrificial coating. The applied coating had some thick areas, evidenced by visible cracking or sagging. Generally, the coating appeared to be well adhered and uniformly covered the concrete surface. Three titanium mesh strips are embedded in the coating lengthwise along the beam. These strips provide redundant collection points to be connected to the reinforcing steel. Figure 23 shows a closer view of the three mesh strips. The yellow wires provide electrical continuity between the mesh strips and the reinforcing steel.
