NEW 2ND BRIGADE BASE  
KIRKUK, IRAQ

**SIGIR PA-06-041**  
**APRIL 20, 2006**

SUBJECT: Report on Project Assessment of the New 2<sup>nd</sup> Brigade Base, Kirkuk, Iraq  
(Report Number SIGIR-PA-06-041)

## New 2nd Brigade Base, Kirkuk, Iraq

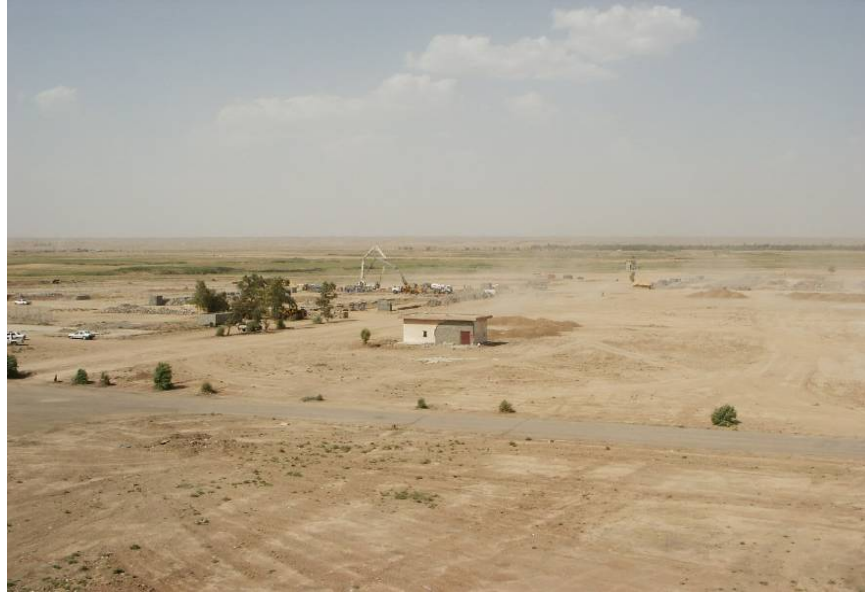
The description of the facility (preconstruction) was based on information obtained from the contractor, AFCEE personnel, and the AFCEE project file. The Kirkuk area Military Base is located within the Tameem Governorate area, approximately 240 kilometers north of Baghdad, Iraq. The project site was approximately ten acres in size and triangular in shape. The site was a former helicopter base, generally level with an existing runway. Utilities for the new site were to be located and connected in coordination with the city of Kirkuk. Since local electricity is not reliable at this time, generators were required to provide primary and backup electricity. The Dibis water treatment plant, renovated under TO 0003, provided water for consumption, life support, and fire suppression, in addition to benefiting the local community. The base water system distributed the water.

**Site Photo 1. Preconstruction location of future 2<sup>nd</sup> Brigade Base**  
(Photo courtesy of ECC)

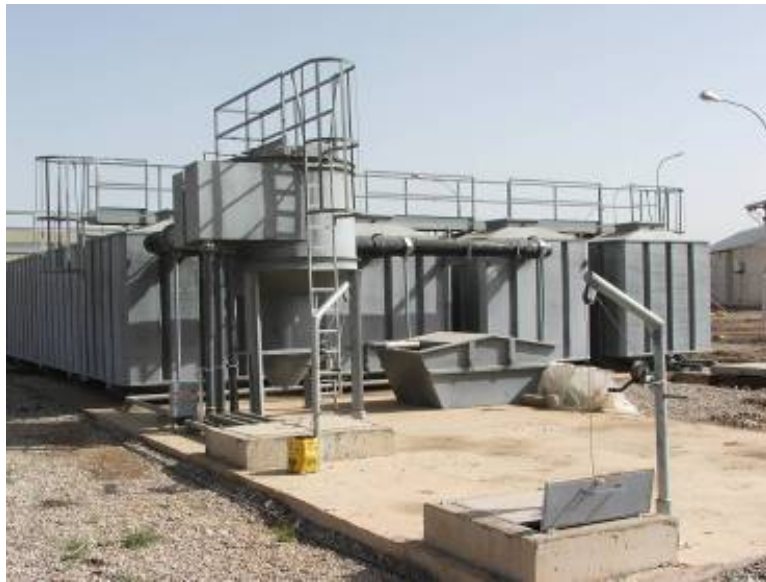
At the time of the assessment, the selection and fabrication of the wastewater treatment system was complete and the system was in-use (Site Photo 2). The treatment system used physical, biological, and chemical processes to purify the water before discharge. Site Photos 3 and 4 show the flow diagram and a filter press for the wastewater treatment plant, respectively. The wastewater treatment plant appeared to meet the contract requirements.

Site Photo 2. Waste water treatment plant

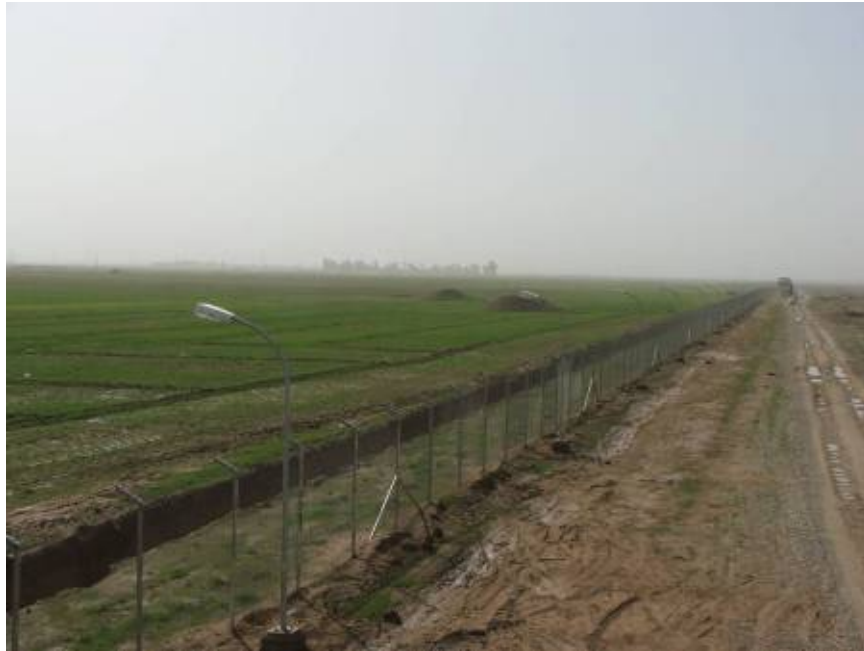
The contract required the construction of a perimeter security fence. The design specifications required a lighted fence around the perimeter of the base with a concrete wall, berms or a trench, and observation posts. We observed a perimeter fence, trench, and observation posts manned with armed guards, as shown in Site Photos 8 and 9, respectively. Concrete walls, berms, and trenches were installed to prevent vehicles from easily driving through the fence. The fence, vehicle obstacles, and manned guard observation post observed during the assessment appeared to meet the design specifications and be practical and functional.

**Site Photo 8. View of fence and trench from observation post**

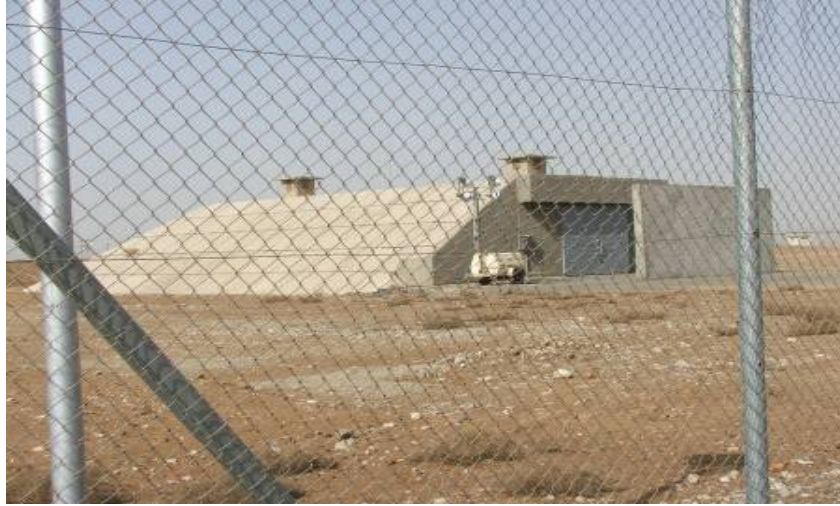
At the time of the assessment, the design and renovation work for the ammunition supply point (ASP) was complete (Site Photo 10). The SORS originally required the new construction of an ASP facility, with the size of the facility 40 meters by 60 meters and 4 meters tall. A subsequent contract modification cancelled the construction of a new ASP facility and required the renovation of an existing building to meet ammunition storage requirements. We were told that the ASP was in use for the intended purpose.

**Site Photo 10. Ammunition supply point**

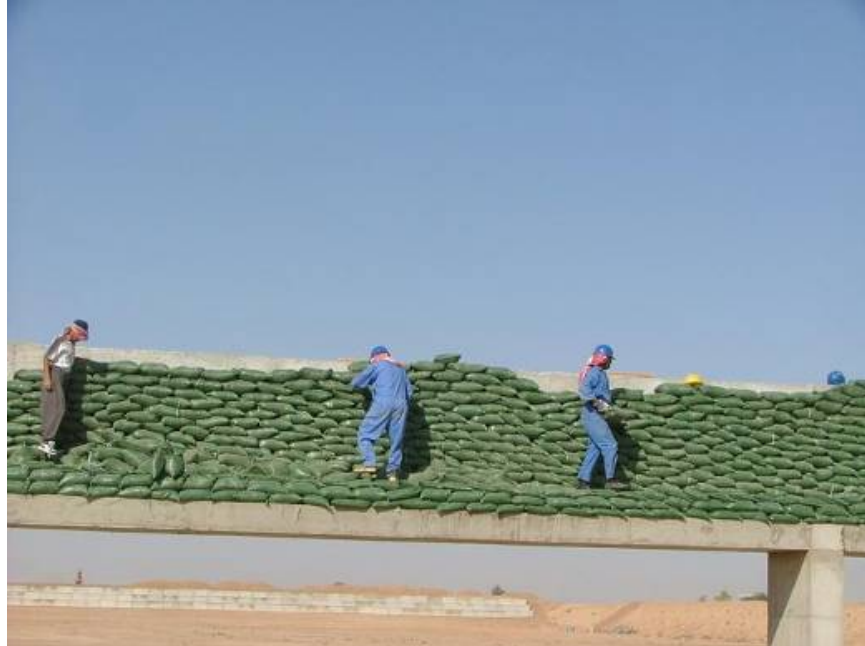
At the time of the site assessment, the design and construction of three small arms ranges was complete. A TO modification required the use of a baffle system designed to minimize ordnance from being fired over the firing range backstop. We observed the small arms ranges constructed with baffles so that projectiles could not go over the backstop berms. Site Photo 11 shows one of the small arms ranges and baffle system. The lower section of the picture is the target area and berm with Iraqi workers installing green sandbags on the concrete baffle.

**Site Photo 11. Small arms range baffle under construction (Photo courtesy of ECC)**

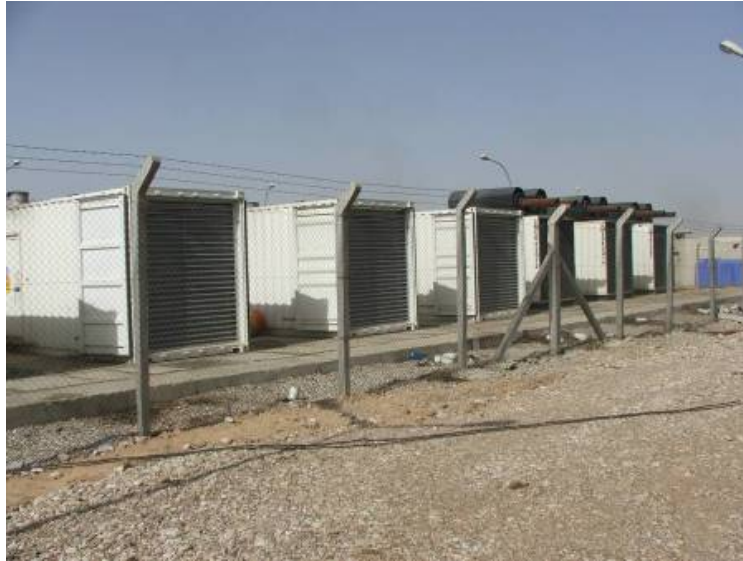
power. A group of eight self-contained 1 MW diesel generators were installed and in-use for their intended purpose of providing electrical power to the base (Site Photo 12).

**Site Photo 12. Eight 1MW electrical generators**

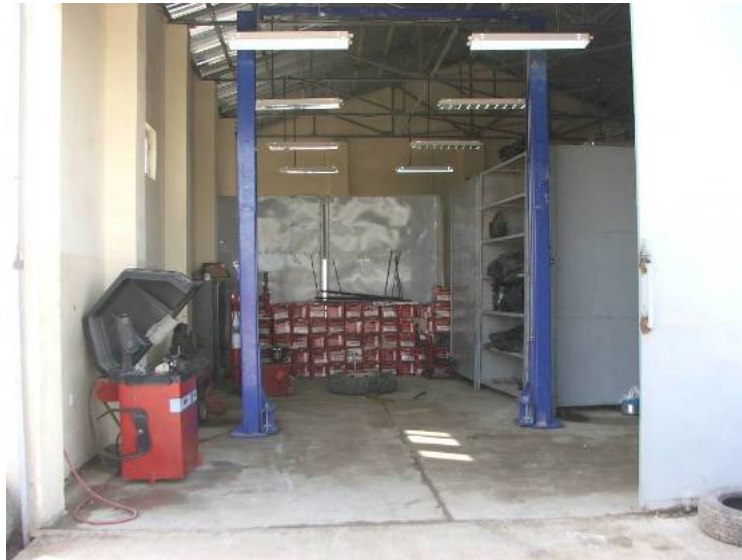
**Site Photo 16. Maintenance shop bay**

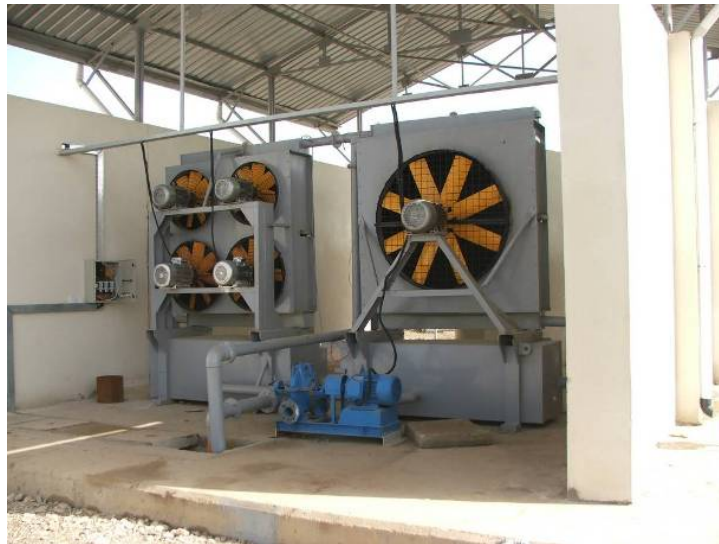
Work was pending on the installation and commissioning of the second bank of generators for the primary power distribution system. The two remaining primary power generators were government furnished equipment that was surplus from another site outside of Iraq. Each of the diesel generators was rated to produce 2.5 MW of electricity. The generators had been installed on a new concrete pad with a new generator building constructed around them. The contractor was in the process of connecting and commissioning the generators. Synchronization and load sharing of the power generation system was required to complete the contract. Site Photo 30 shows one of the generators inside the new generator building. We observed the installation of supporting equipment for the power generation system, such as the fuel supply and the cooling system (Site Photo 31), which appeared to meet the contract requirements.

**Site Photo 31. Generator building cooling system**
