SHEAR REINFORCEMENT IN DEEP SLABS

Stanley C. Woodson, PhD, PE

US Army Engineer Waterways Experiment Station

13. SUPPLEMENTARY NOTES See also ADM000767. Proceedings of the Twenty-Sixth DoD Explosives Safety Seminar Held in Miami, FL on 16-18 August 1994.					
14. ABSTRACT

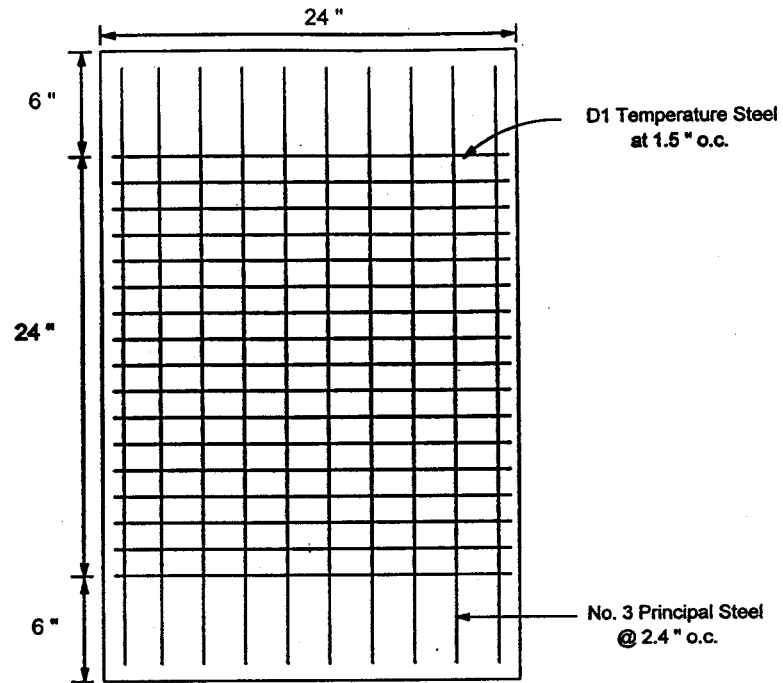
Figure 1- Plan View of slabs No. 1, 2, and 3

Figure 1. Plan View of Slabs No. 1, 2, and 3

In general, the experimental program was designed to study the behavior of uniformly-loaded deep slabs, including a comparison of the effects of lacing bars and stirrups on the behavior. It was important that the ratio of principal steel spacing to slab effective depth (s/d) was held nearly constant among the slabs. Data from previous studies indicated that this ratio should be less than 1.0 in order to enhance the large-deflection behavior. The s/d ratio was maintained at a value of approximately 0.5. Three shear reinforcement spacings were used: $0.17d$, $0.31d$, and $2d$ ($d/2$ is the value typically given in design manuals for blast-resistant structures). Figures 1 through 3 are plan views showing slab proportions and the principal steel and temperature steel layouts for each of the slabs. The temperature (transverse) steel spacing was identical for all of the slabs, but one difference in the temperature steel placement occurred between the laced and nonlaced slabs. The temperature steel is typically placed exterior to the principal steel in laced slabs, but it is placed interior to the principal steel in the slabs having stirrups or no shear reinforcement.

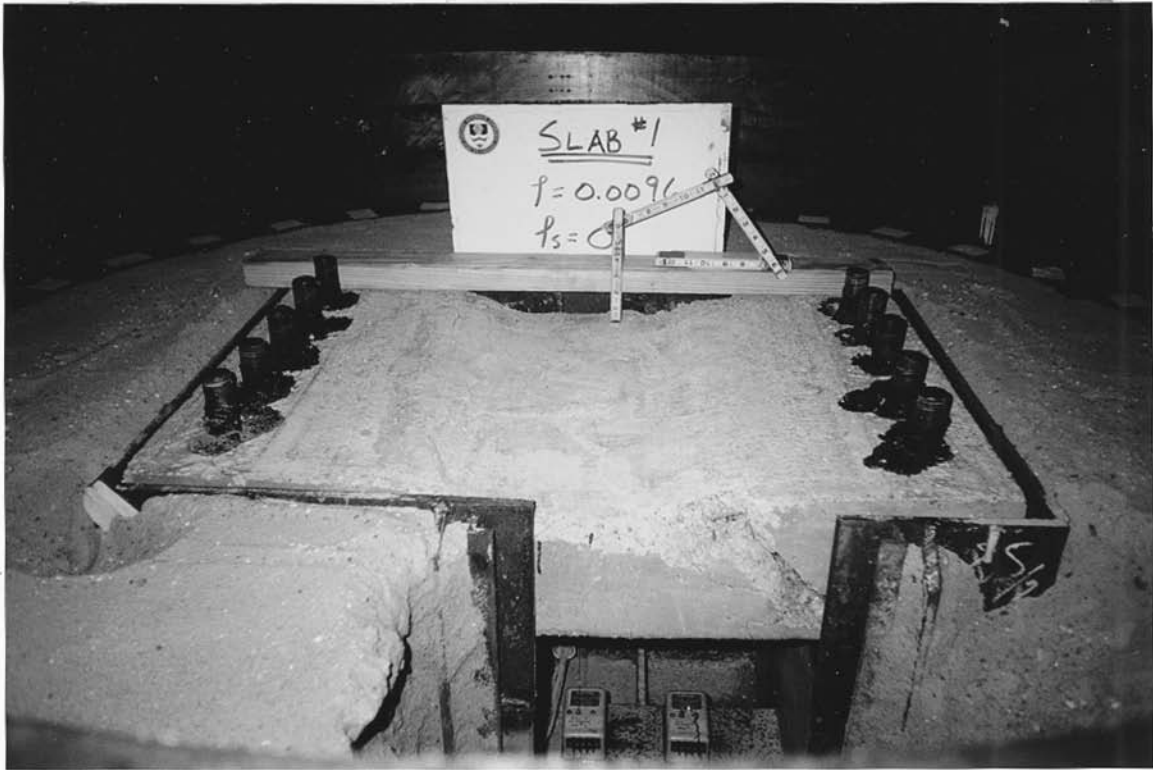
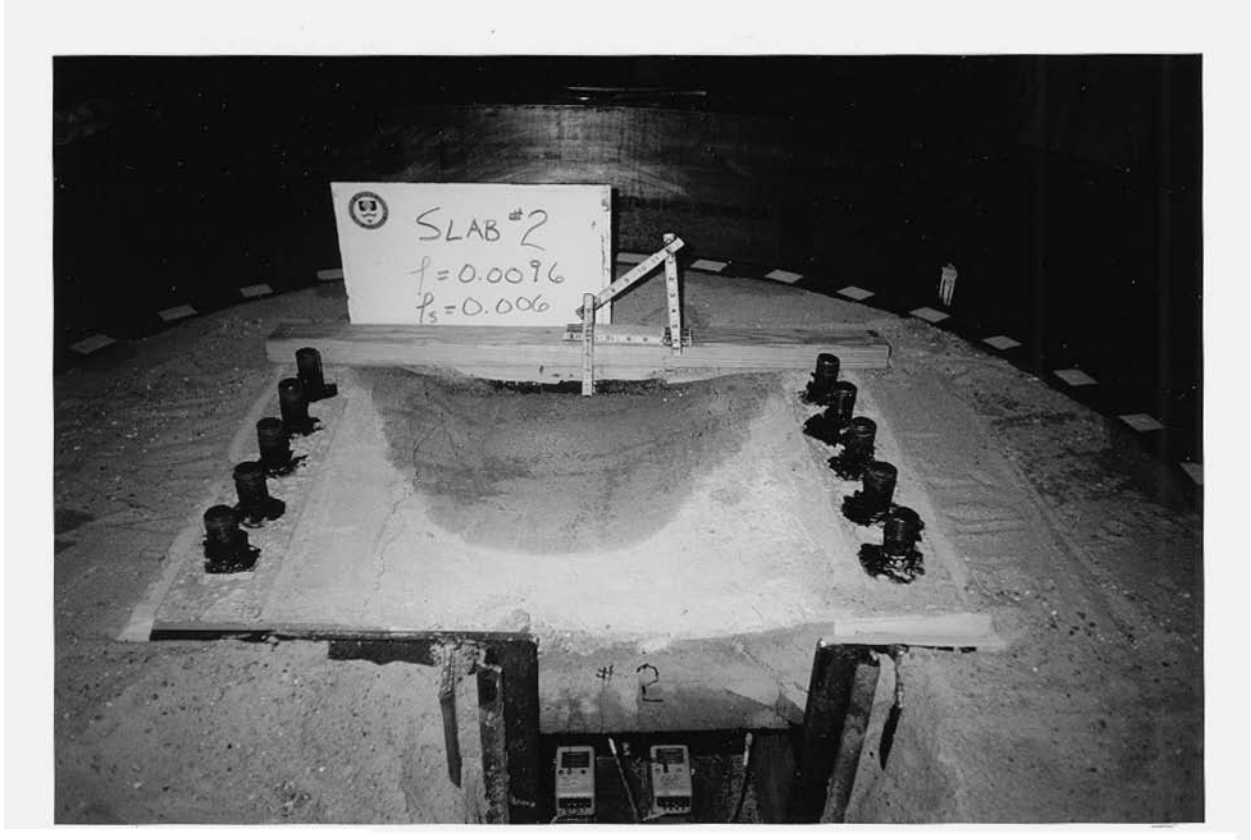
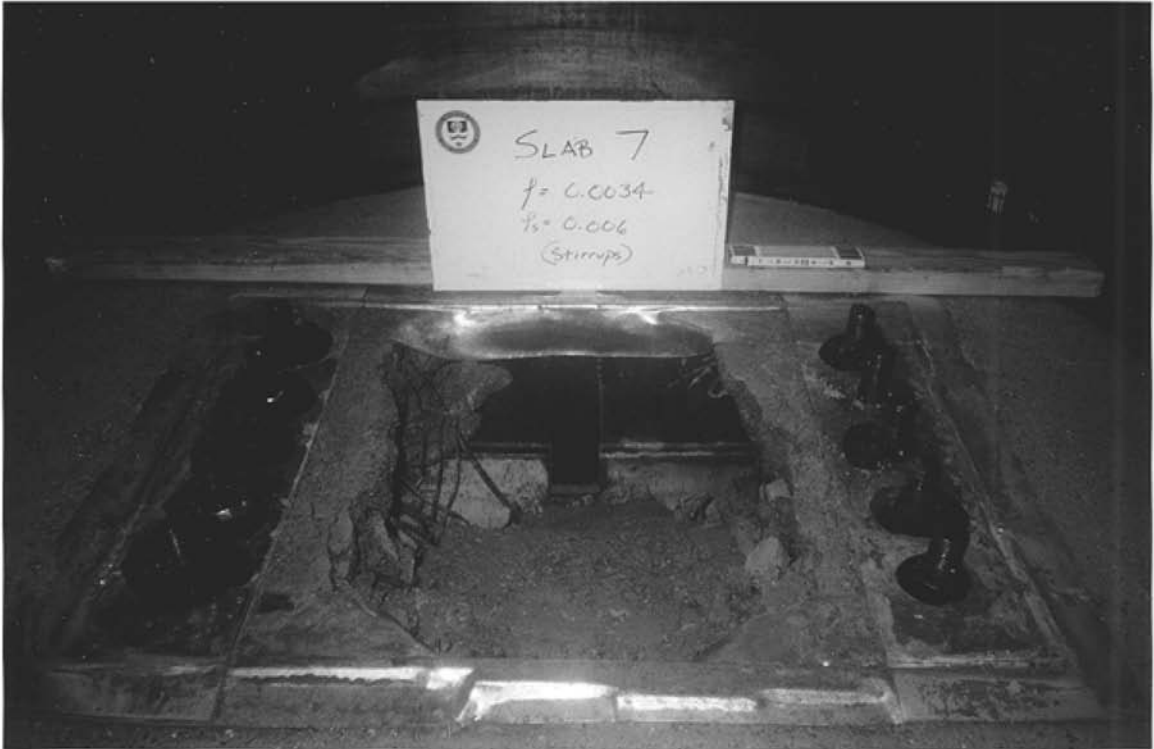
Posttest measurements and inspection provided a data check and damage assessment of each slab prior to removal from the reaction structure. Indicating the types of damage incurred in the series, Figures 17 through 20 show the posttest condition of four of the slabs (slabs no. 1, 2, 7, and 13).

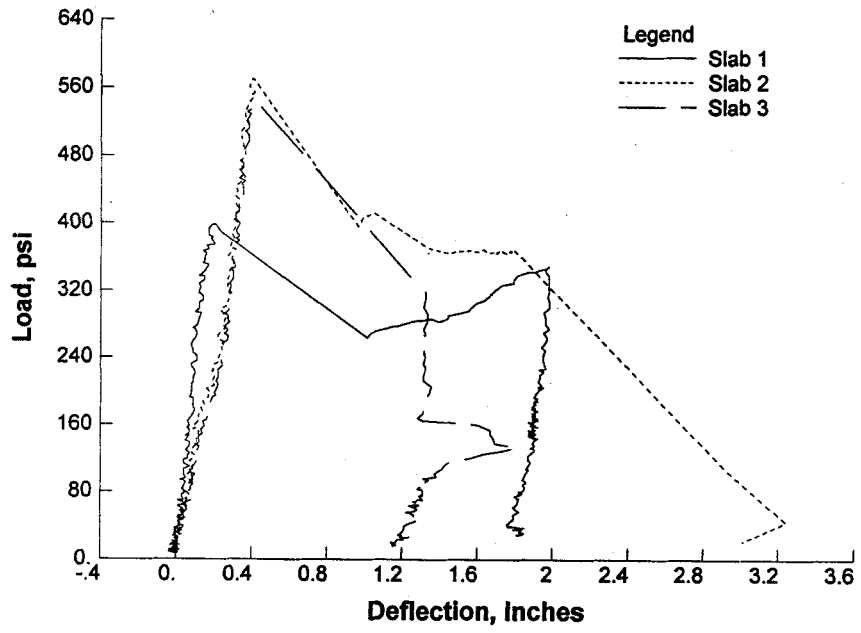
Figures 22 through 28 present composite graphs of the load-deflection curves of the slabs. Figure 22 demonstrates the significance of shear reinforcement (see Table 1) in that slab no. 1 was not able to achieve the value of ultimate resistance for slabs no. 2 and 3. Lacing bars and stirrups apparently provided approximately the same level of contribution to the shear strength of the slabs.

Figure 22. Composite Midspan Load-Deflection Data for Slabs No. 1, 2, and 3

Figure 25 compares the effects of stirrups, lacing, and no shear reinforcement of the slabs with an Lid of 3. As was shown in Figure 22 for the slabs with an Lid of 5, shear reinforcement did make a significant contribution to the ultimate resistance and lacing and stirrups were of approximately equal effectiveness. Figure 26 indicates that the data are consistent in that the smaller amount of shear reinforcement (slab no. 10) was less effective than the larger amount. In all Figures containing slab no. 10, the data shown past the ultimate resistance for slab no. 10 is not true data since the deflection transducer cable apparently broke loose from the slab shortly after the ultimate resistance was reached.

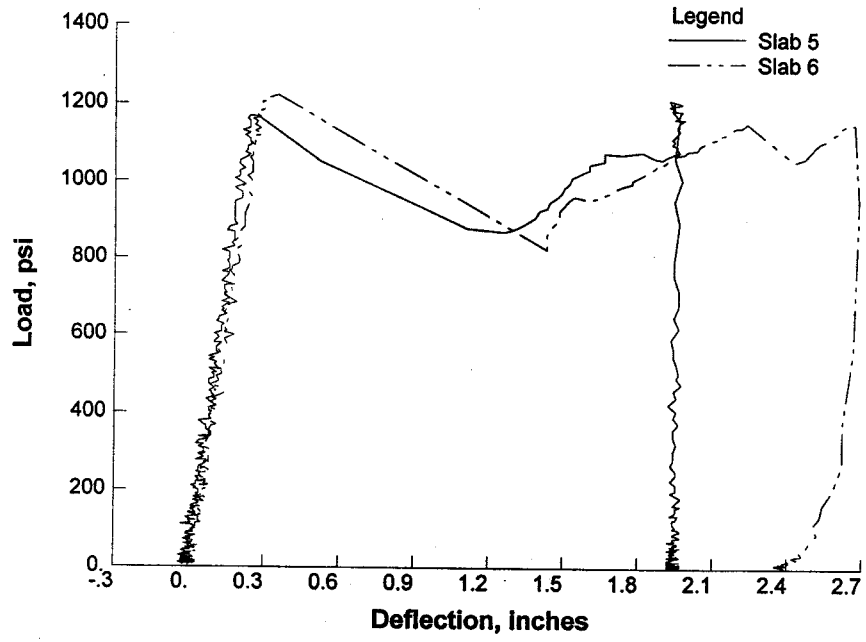
Figure 23 simply indicates the differences in strength due to the Lid values. Figure 24 shows that the replication associated with slabs no. 5 and 6 provided very similar results.

Figure 24. Composite Midspan Load-Deflection Data for Slabs No. 5 and 6

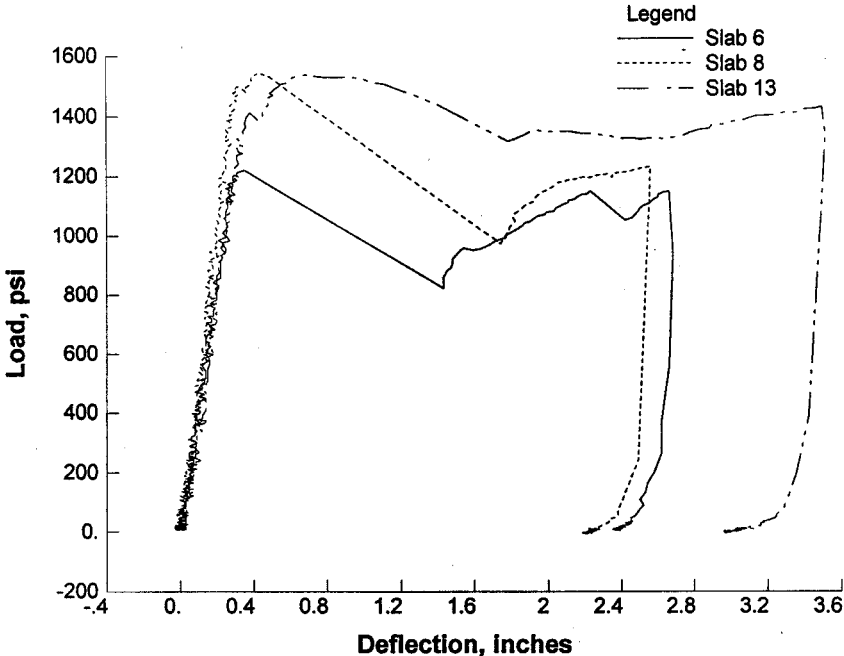
Figure 25. Composite Midspan Load-Deflection Data for Slabs No. 6, 8, and 13

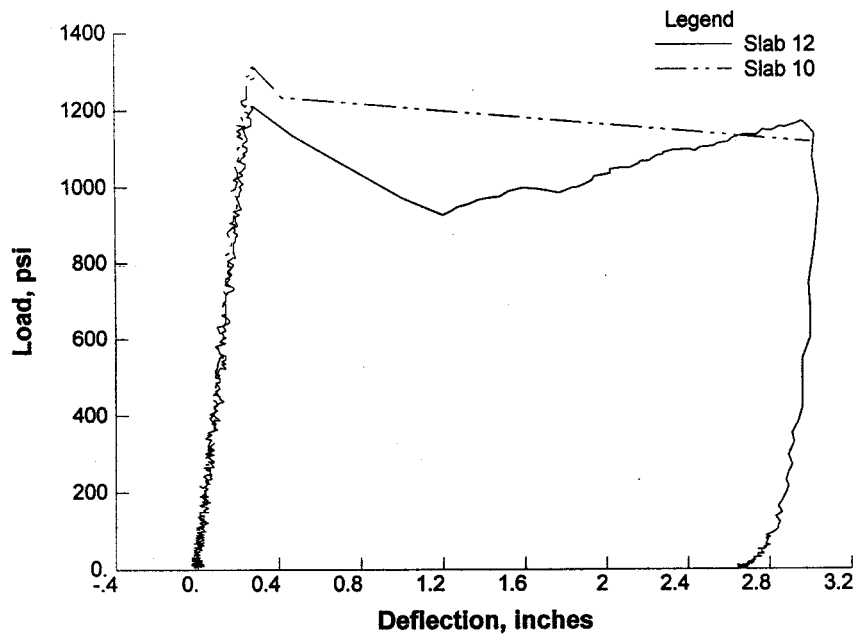
Figure 27 further supports the previous observation that the lacing bars and stirrups are similarly effective in enhancing ultimate shear resistance. However, this data indicates that stirrups may be slightly more effective at these steel ratios. Figure 28 further supports the considerable difference in effectiveness for large and small quantities of shear reinforcement.

Figure 27. Composite Midspan Load-Deflection Data for Slabs No. 12 and 10
