**US Army Corps  
of Engineers®**  
Engineer Research and  
Development Center

## **Pseudo Dynamic Testing and Seismic Rehabilitation of Iraqi Brick, Bearing and Shear Walls**

April 2008

Final Report

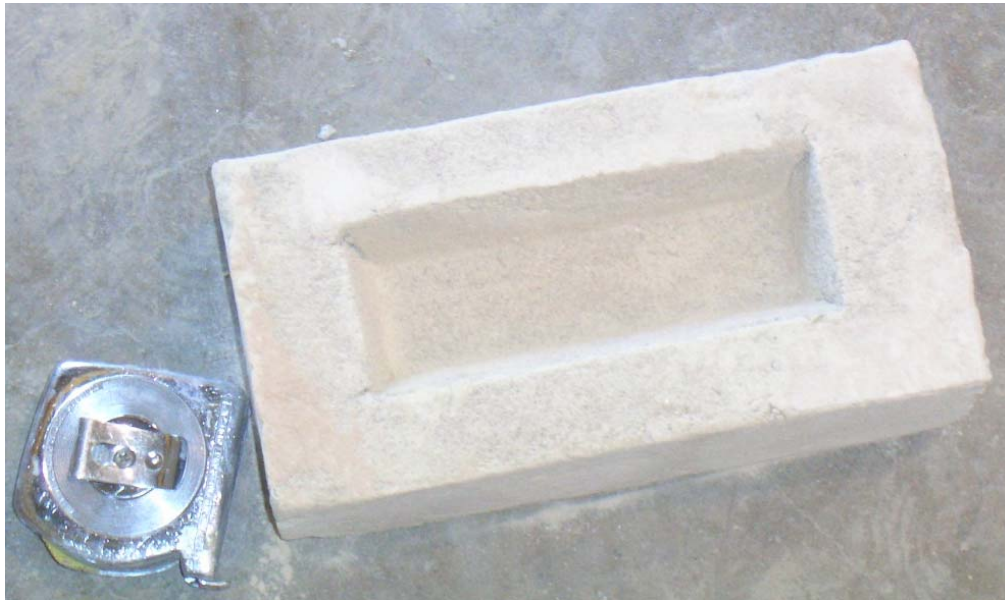
**Figure 1. Single brick unit.**

Compressive strength tests of the brick were performed according to the ASTM C67. The brick units have grooves, which is atypical of U.S. units, therefore they were tested both with and without mortar filling the grooved area. Compressive strength for the mortar-filled brick is calculated based on the cross-sectional area while the compressive strength of brick units with no mortar fill (equivalent to face shell bedding with concrete masonry units) was calculated based on net facial area around the grooves. Figure 2 shows a typical brick setup before testing and Figure 3 shows a typical failure of single brick unit under compressive load. Figures 4 through 13 show the different modes of failure of various specimens. Figures 14 through 21 show stress-strain curves for these tests. Table 3 lists maximum compressive stress and corresponding strain of single brick units. The average flat-wise compression stress for the units is 766 psi.

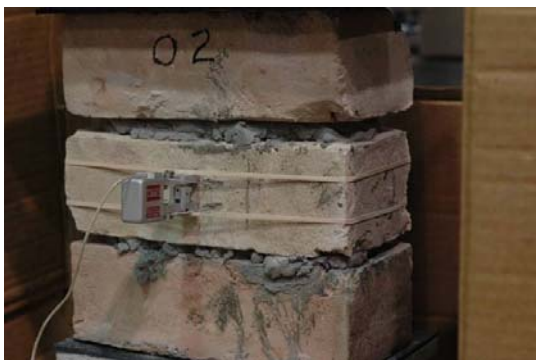
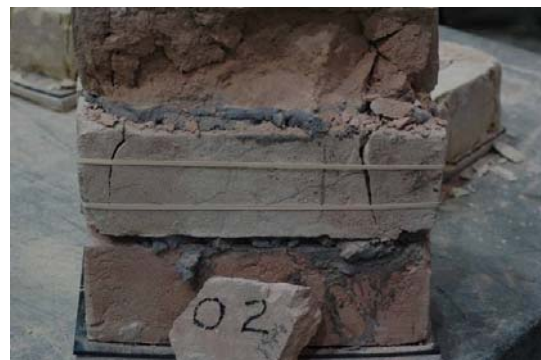
Figure 30. Prism from old batch #2, before (left), after (right).

The nature of failures in the brick prisms varied. Splitting, cone shapes within the units, and crushing were all observed. Figures 30 through 38 show the typical prism setup and samples of their modes of failures. Per ASTM, to obtain the maximum compressive strength factor  $f'_m$  a correction factor of 1.07 for a three brick prism is required. Figures 39 through 46 show the stress strain curves for the tested prisms. Table 5 lists the maximum compressive stress and corresponding strain of all the tested prisms. The average  $f'_m$  values for the bare prisms, prisms with Saint Gobain Cement, and prisms with Sika Wrap were 488 psi, 462 psi, and 737 psi, respectively.

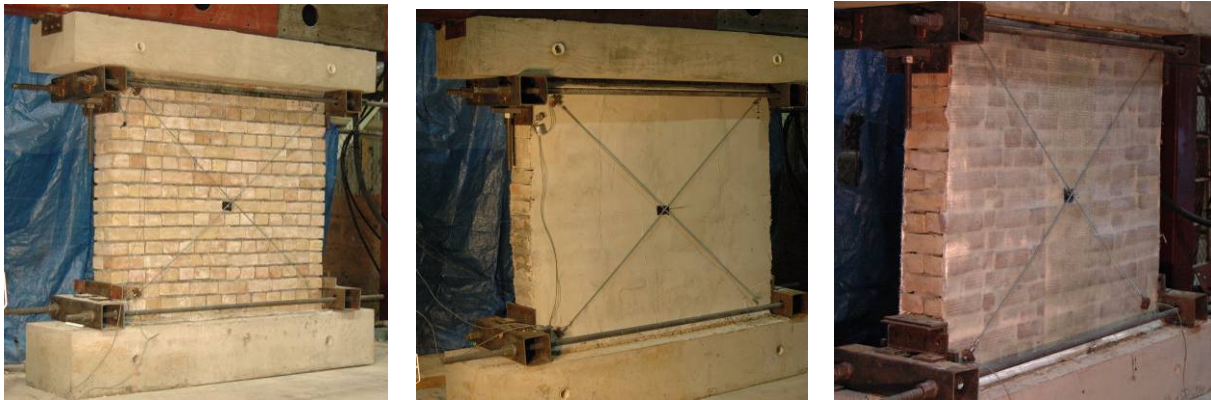
**Figure 47. Bare wall (left), Saint Gobain cementitious FRP System (center), and SikaWrap FRP system (right).**

The walls (Figure 47) were built as instructed by the sponsor with every stretcher course topped by a header course, totaling 18 courses. The top and bottom courses were designed to be partially embedded in the concrete beam to prevent failure at the interface surfaces. Figure 48 shows brick configuration detail.

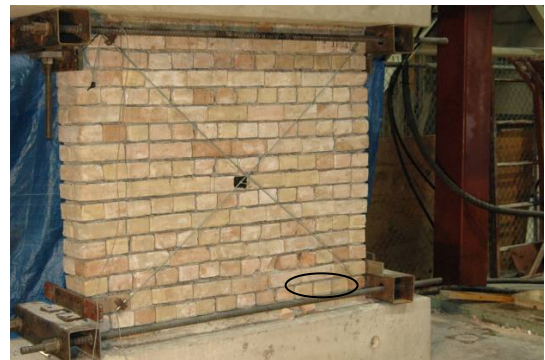
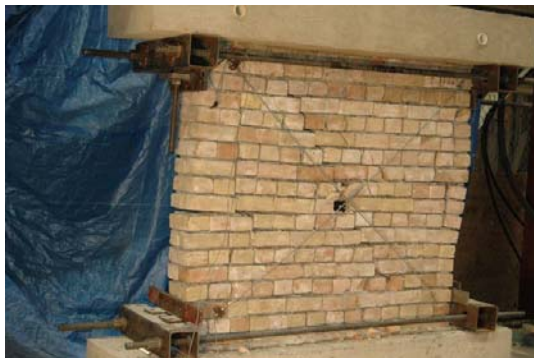
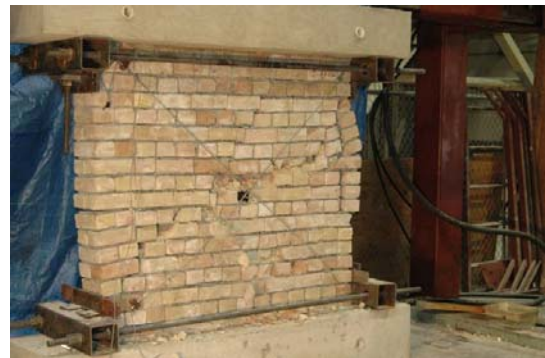
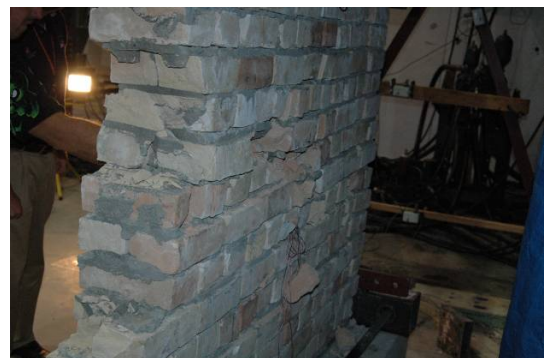
**Figure 60. The modes of failure for IP-02 specimens.**

b. Wall spalling in a brick in the 4th course.

c. Wall formation of X cracks under cyclic loads.

d. Cambered wall edge.

f. Collapsed edge of the wall (Section view).

This specimen was tested supplementally with four steel tubes to provide direct loading to the upper and lower corners of the wall. Figure 60 shows failure at several stages of the test. The first indication of damage was spalling observed on a single brick along one of the diagonals (Figure 60b). Figure 60c and 60d show the "X" shear cracks formed as the wall deformed under increased cyclic loading. Spalling of brick units occurred in many places. One edge of the wall failed under the vertical load and collapsed (Figure 60e and 60f).

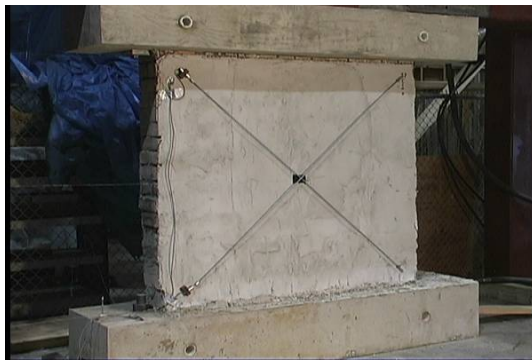
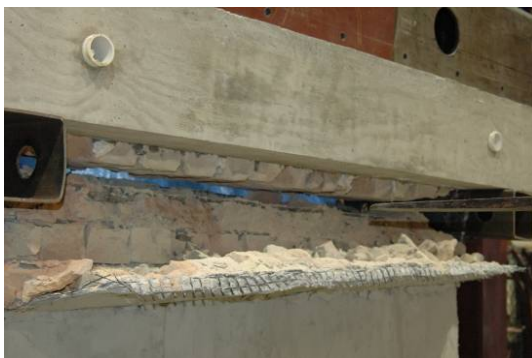
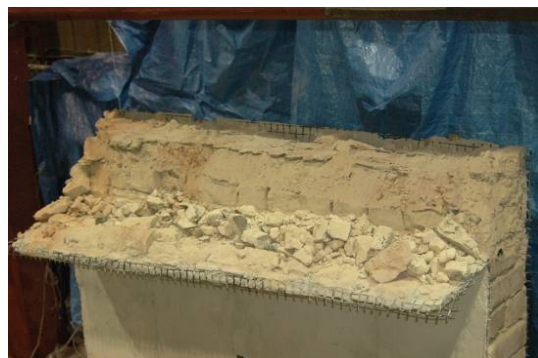
**Figure 62. The modes of failure for IP-C1 specimens.**

a. IP-C1 Wall prior to testing. Direct load on the header concrete beam.

b. IP-C1 Wall after testing horizontal shear failure in the top course of the brick.

c. IP-C1 Wall prior to testing with loading tube steel beam at the corners.

e. IP-C1 Wall after monotonic loading follow the above cyclic testing. Horizontal shear failure through the FRP.

f. IP-C1 Wall after monotonic loading and after removing the unsound brick along the failure surface.

This run was tested without the corner loading steel tubes. All load transfer from the loading beam to the wall had to occur through shear between the concrete loading beam and the brick. Because the FRP overlay was not bonded to the concrete loading beam, the FRP did not contribute to the transfer of load. Because of this, a weak shear plane existed, and horizontal shear failure in the top brick course was observed.

This mode of failure is not desirable because the wrap is not effective in this section and test results will not capture the contribution of the overlay wrap system. No damage to the wall other than debonding of the wall to the load beam occurred.

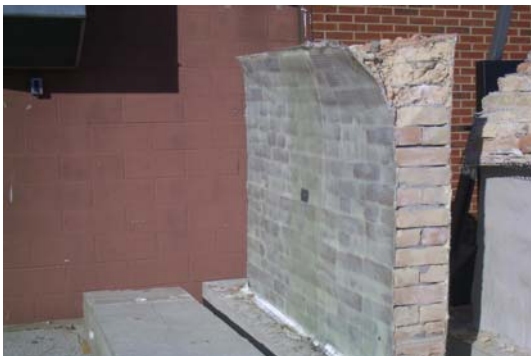
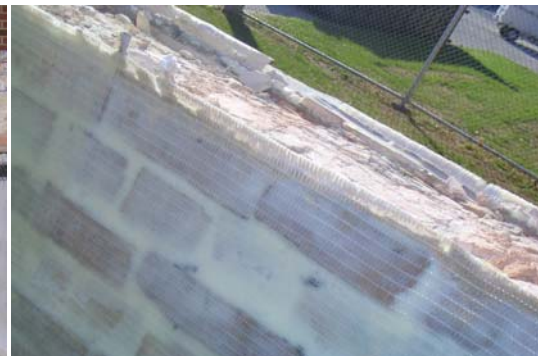
**Figure 66. The modes of failure for IP-G1 specimens.**

d. IP-G1 Wall after monotonic loading follow the above cyclic testing. Horizontal shear failure underneath the FRP is evident.

e. IP-G1 Wall after monotonic loading and after removing the unsound brick along the top failure surface.

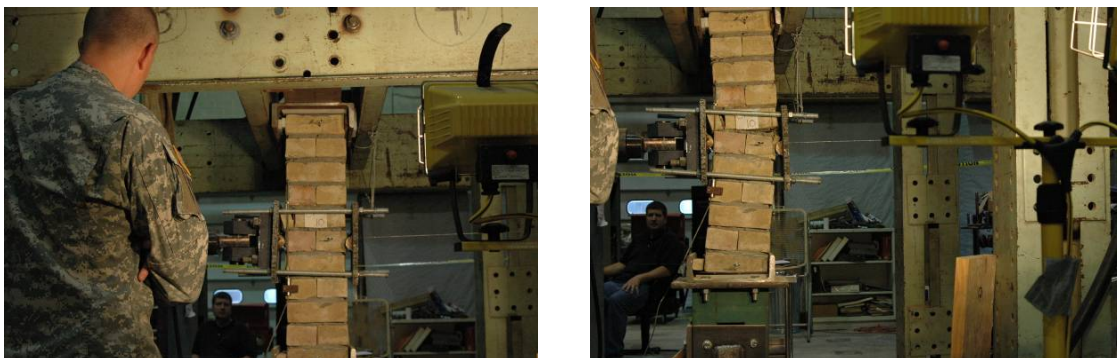
Figure 73. Bare Specimen 010, before test (left) and after test (right).

Failure initiated with spalling of the 7<sup>th</sup> course followed by rocking about the hinge that formed at the point of loading (Figure 73).

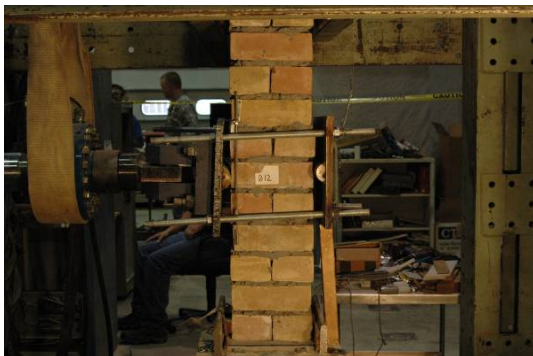
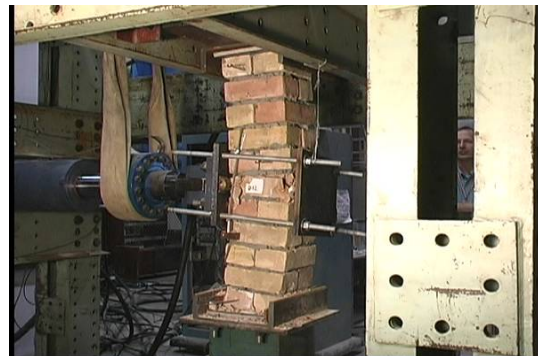
b. Bare Specimen 012, before test (left) after test (right).

This specimen also failed with sudden local crushing of the masonry. This specimen failed at mid-height at the point of loading. The brick units at the middle course crumbled (Figure 75b).

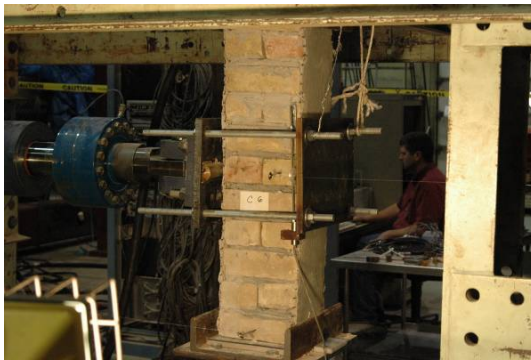
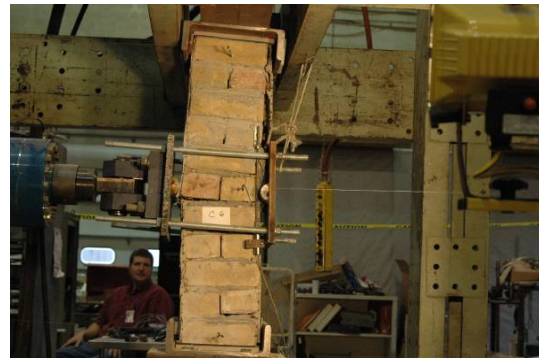
a. Saint Gobain Cement-Base Specimen C6, before test (left) after test (right).

Failure initiated with many vertical cracks in the 5<sup>th</sup> course followed by spalling and local crushing. The FRP delaminated on one side of the specimen between the 3<sup>rd</sup> and 5<sup>th</sup> fifth course. Diagonal cracks appeared also on 2<sup>nd</sup> and 3<sup>rd</sup> courses. The test was stopped as it was observed that load is decreasing while displacement is increasing, indicating the specimen has reached its deformation beyond its ultimate stress (Figure 77b).

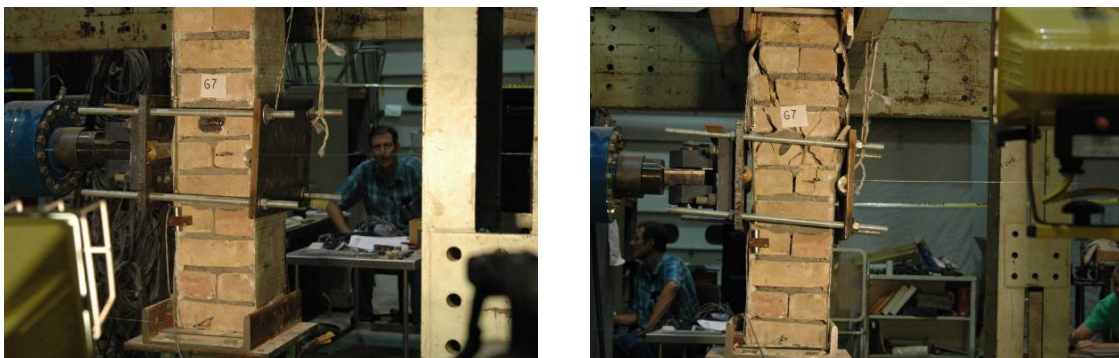
**b. Specimen G7 with SikaWrap Hex, before test (left) after test (right).**

Shear cracks in the 7<sup>th</sup> through 9<sup>th</sup> courses formed, followed by brittle crushing of the masonry just above the loading point (Figure 82a).

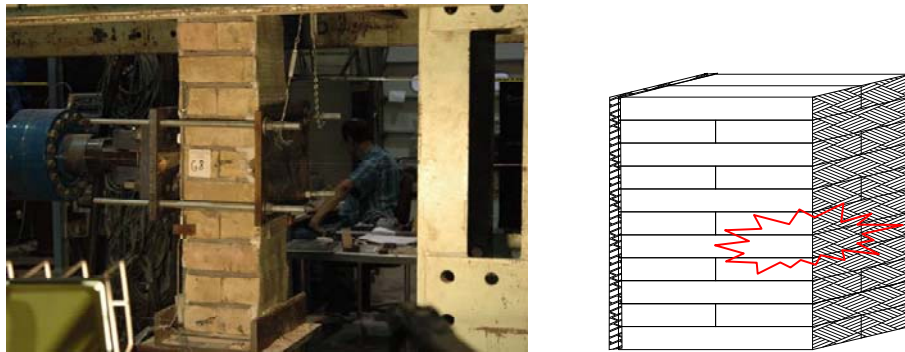
**Figure 83. Specimen G8 with Sika Wrap Hex, before test (left), and sketch showing the point of failure (no picture is available) (right).**

This specimen failed in a very sudden and brittle fashion, just below the loading point and resulted in loss of the specimen (Figure 83).

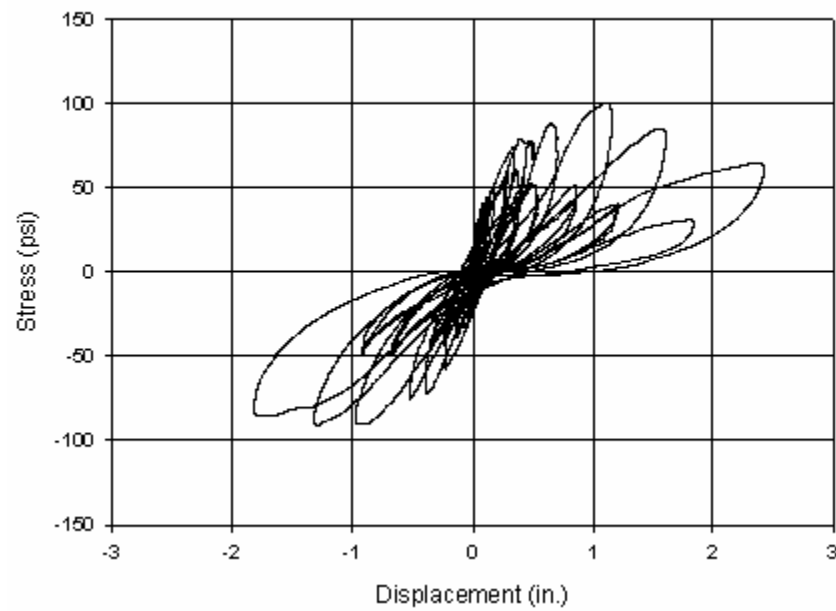
**Figure 87. Hysteresis for Specimen 07 Bare Wall, 50 percent.**

Figures 84 through 102 plot the Stress-deformation hysteresees for all test specimens. Table 18 lists the maximum stresses, their corresponding displacements and maximum displacements, and their corresponding stresses. Note that, although these figures do not show “backbone curves,” they can be drawn similarly to Figure 61 by simply connecting the starting point of the each curve with its ultimate point value and the intersection points of the hysteresis loops.
