COMBAT DAMAGE ASSESSMENT TEAM
A-10/GAU-8 LOW ANGLE FIRINGS
VERSUS
SIMULATED SOVIET TANK COMPANY (ARRAY 21)
AEROJET LOT NUMBER AJD 79A181-001
(30 OCTOBER 1979)
R.H.S. STOLFI
R.R. McEACHIN
MAY 1980

TARGET TANK DAMAGE SUMMARY

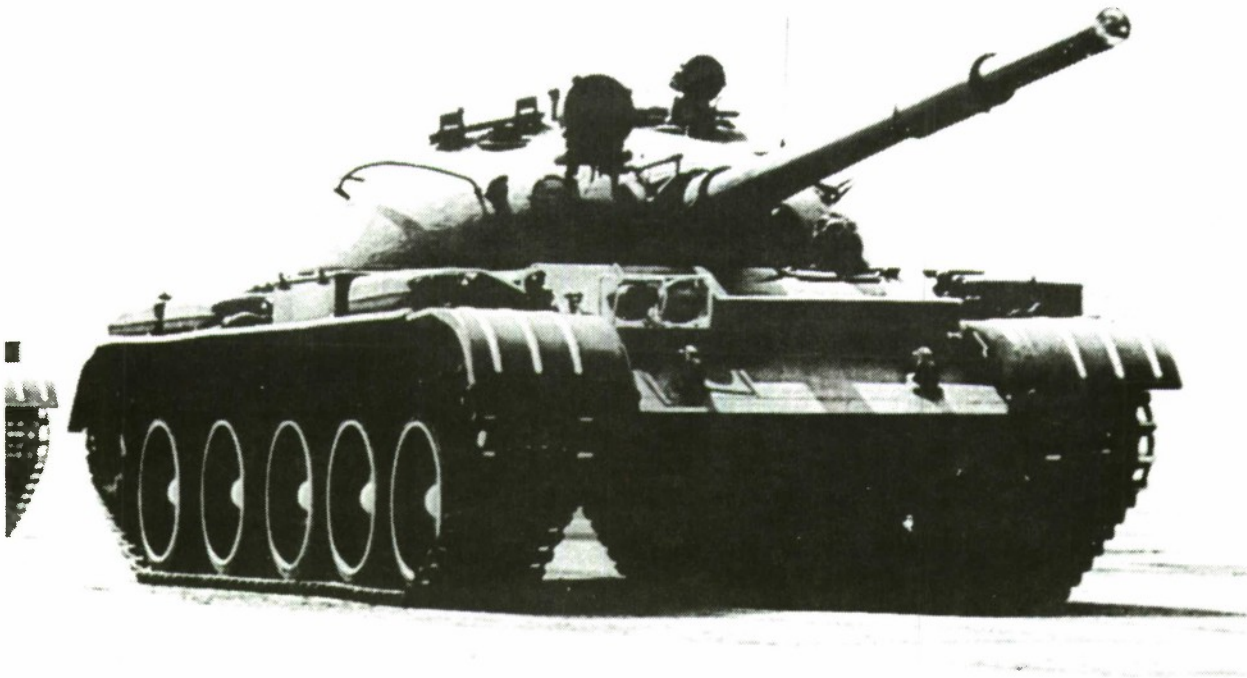
FIGURE 1. Russian T62 Medium Tank

The most effective targets available in sufficient numbers to simulate Soviet T-55 and T-62 (Figure 1) tanks were the US M-47 tanks. Both of the Soviet tank models are similar in armor protection to the M-47. With the appropriate purging of the gasoline fuel system of the US tanks, the CDAT managed to field a target similar in survivability to the T-55 and T-62 tanks from the viewpoint of ignitable internal material. Few data are available on the Soviet T-64 and later model tanks from the viewpoints of armor protection and the arrangement of internal components. The decision was made, accordingly, to simulate the earlier model Soviet tanks with the readily available US tanks.
