## **Dynamic Pressure Testing of a 155-mm Howitzer Ballistic Window Using a Closed Bomb Vessel**

**ARL-TR-5266**

**August 2010**

# **Army Research Laboratory**

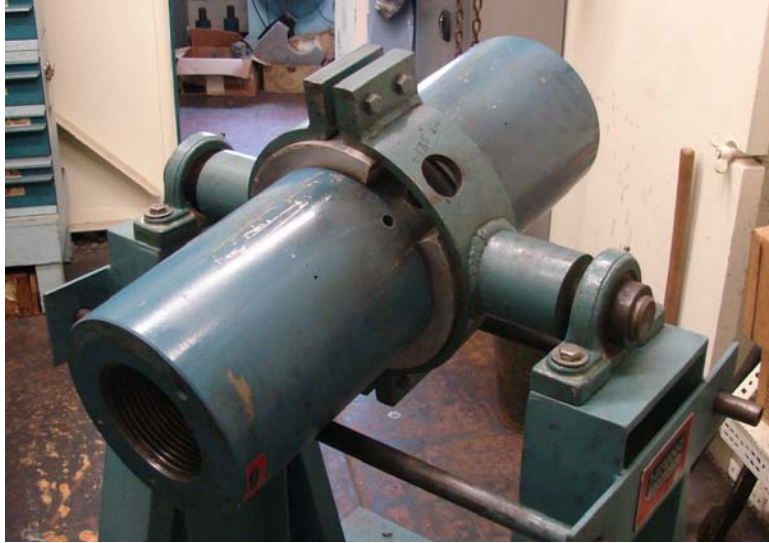
Figure 1. Double-ended closed bomb apparatus.

The equipment used for testing consisted of a Harwood Engineering double-ended closed bomb vessel (figure 1), a Kistler Type 607C high pressure sensor, a Kistler model 5100B1 dual-mode charge amplifier, fffg black powder, electric matches, M232A1 MACS propellant, and the XLCB data acquisition and reduction program (3, 4). However, in this experiment the only function of the XLCB program was to record a pressure-time history for each shot. Propellant properties and characterizations were irrelevant for this set of experiments.

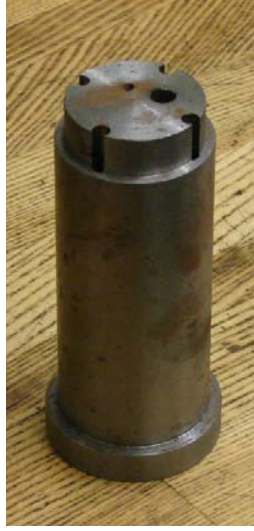
Figure 3. Modified closure cap/steel slug insert for closed bomb volume reduction.

The double-ended bomb had a chamber volume of ~465 cc and closure components identical to the Harwood 200-cc closed bomb, which is widely used for standard propellant testing (5). Because the chamber volume was much larger than needed, we designed and implemented a modified face plate/steel plug (figure 3) in order to take up volume inside the bomb, thus reducing its effective volume. This modification reduced the amount of propellant needed to reach desired pressures, and in turn, reduced the amount of stored energy in the closed bomb, therefore reducing associated safety risks. The appendix provides detailed drawings of the closed bomb modification needed in order to satisfy the testing requirements.
