Test Report:

Assembly and Structural Loading of  
Army Research Lab's  
High Strength Low Alloy - Vanadium  
(HSLA - V) Bridge

Submitted by: Jim Stankewitz, Eric Osterland

April 28, 2010

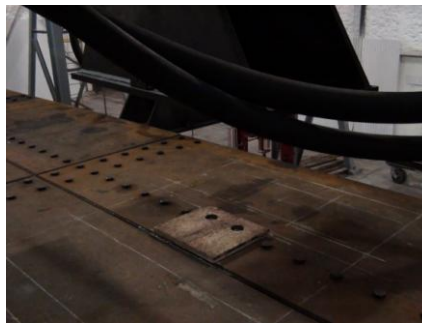
The bridge was supported along the underside of the end diaphragms with an 8" x 8" plastic reinforced composite beam. The pressure was applied to the deck thru ½ OSB wood sheet cut to 14" along the length of the bridge and 12" wide. All testing was conducted in load control and the cylinders were checked to be acting vertically prior to each load test.
