**US Army Corps  
of Engineers®**  
Engineer Research and  
Development Center

## **Rio Grande Lidar Bank Erosion Monitoring: Preliminary 2007-2008 Results and Survey Design Considerations**

September 2010

Final report

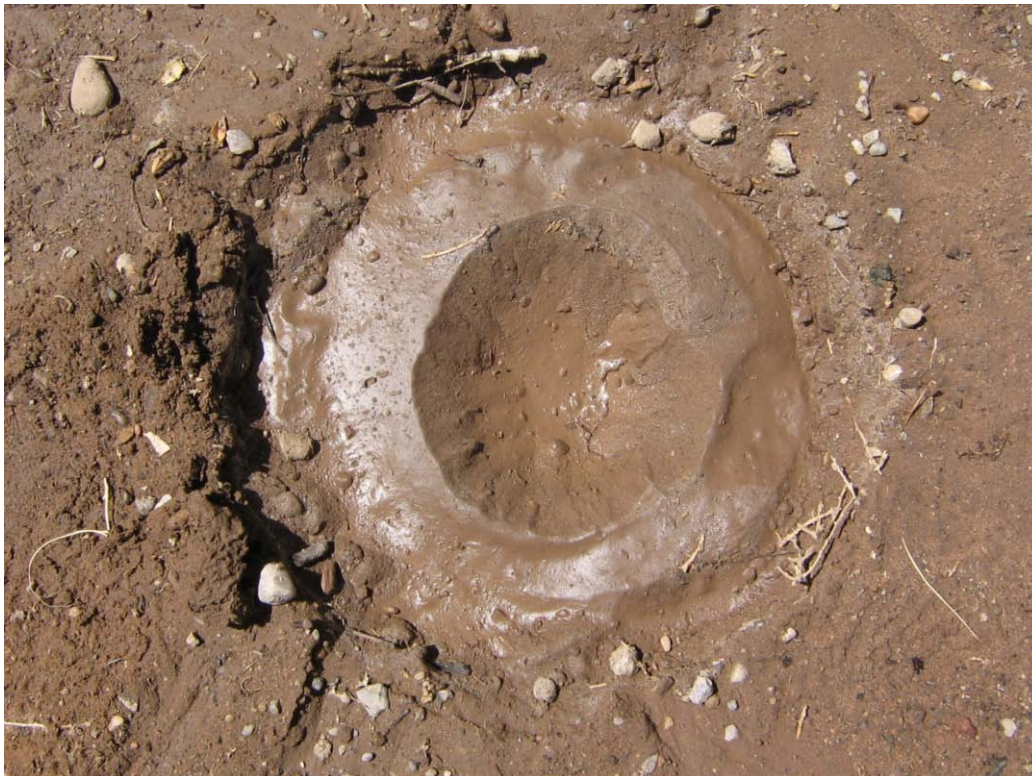
Figure 2. Observed scour at conclusion of test using submerged jet erosion apparatus.

A photograph of the jet erosion apparatus is shown in Figure 1. The principal component of the apparatus is a cylindrical, open-bottomed submergence tank that is driven into the ground. Water is introduced into the top of the tank by means of a nozzle that creates a jet of water. The water erodes or scours the soil in the bottom of the submergence tank. A point gage is used to measure the depth of scour as a function of time and head used to create the jet. A standpipe fed by a pump is used to supply water under the desired value of head. Scour depth versus time data is interpreted to provide estimates of critical shear stress (the initiation of erosion) and erodibility (erosion rate). The scour created by the jet device at the conclusion of a test is shown in Figure 2.

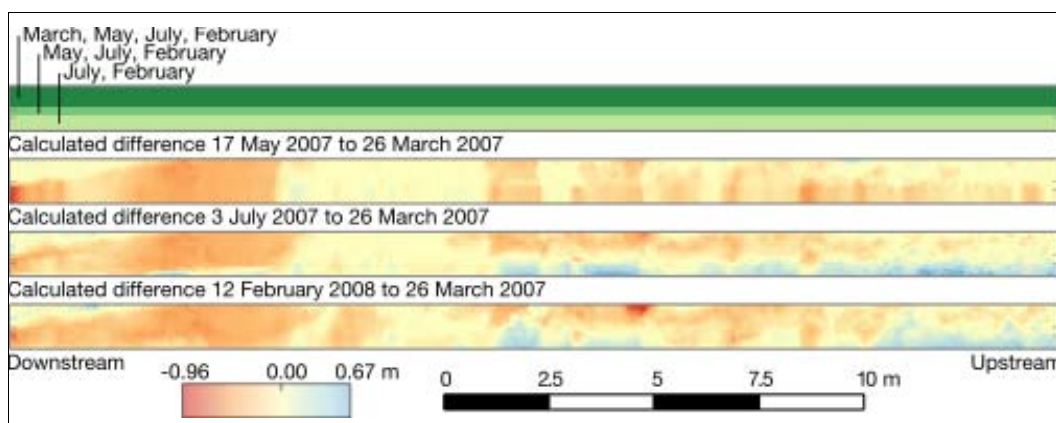
Figure 7. Calculated changes in bank location downstream of City of Albuquerque's drinking water diversion dam relative to first scan collected on 26 March 2007. Map plane is oriented parallel to dam's abutment with the waterline at bottom of each panel and upstream end of bank, toward dam, on right. Top panel shows degree of overlap between scans. Dark green area is only area where no extrapolation was performed.

To estimate the volume of sediment lost downstream of the dam, the TLS point clouds were imported into GRASS GIS and 2D raster distance maps oriented parallel to the dam's abutment were interpolated using a grid resolution of 2 cm. These maps were then subtracted to calculate differences relative to the March 2007 scans (Figure 7). Finally the differences were summed to obtain volumetric estimates of sediment loss. This analysis was limited to the area downstream of the riprap where erosion was greatest and vegetation growth was minor.

The interpolated grids were produced in two steps. First the raw points were aggregated into an initial raster map containing the mean distance to points within the cell. In addition to reducing the number of points used in later processing steps, this also normalized mean point densities that varied from  $0.24 \pm 0.38$  pts/cm<sup>2</sup> in the May 2007 scan to  $2.0 \pm 0.95$  pts/cm<sup>2</sup> in the July 2007 scan. Next an inverse distance squared (IDW) weighting function was used to calculate the final distance map using the initial raster map as input. These calculations were performed using the data region of the July 2007 scan, which imaged the largest amount of the bank. As a result the distance maps produced from the scans collected during higher discharges contain significant extrapolations in the lower portion of the map (Figure 7). Because an IDW function was used for the interpolation these extrapolated points are largely equivalent to projecting the bottom rows of the scan vertically.

It is arguable whether this much extrapolation is valid, therefore volumes were calculated both with and without the extrapolation. If the maximum data region is used then the change in volume between March 2007 and February 2008 is -3.5 m<sup>3</sup>. However, if the minimum data region is used the change is -3.2 m<sup>3</sup>. Both of these are minimum estimates, as the bottom of the channel was never imaged. The relatively small difference between the two estimates can probably be attributed to the apparent accretion near the base of the upstream bank (Figure 7). This apparent accretion is probably an artifact of the near vertical extrapolation performed by the IDW, when in reality the submerged bank sloped toward the channel.
