**FALLUJA WASTE WATER  
TREATMENT SYSTEM  
FALLUJA, IRAQ**

**SIGIR PA-08-144  
SIGIR PA-08-145  
SIGIR PA-08-146  
SIGIR PA-08-147  
SIGIR PA-08-148**

**OCTOBER 27, 2008**

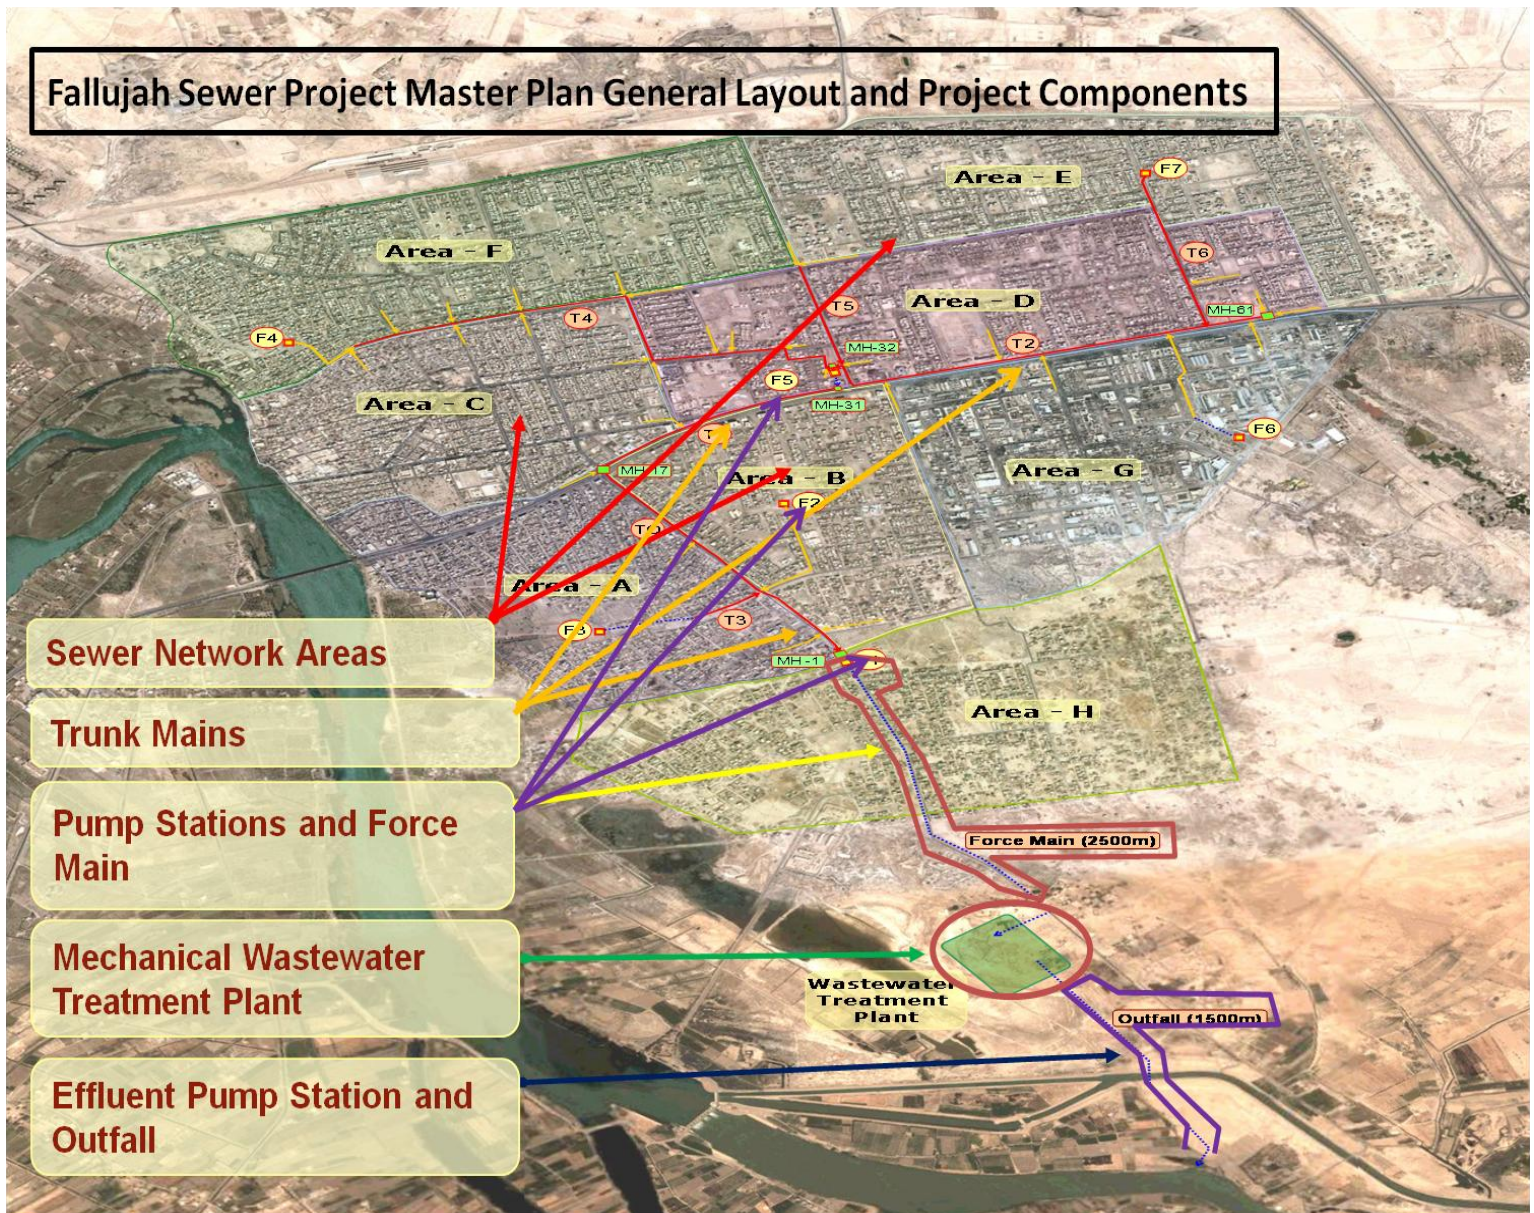
Figure 1 is an illustration of the original design for the entire Falluja Waste Water Treatment System.

Figure 1. Original design for the entire Falluja Waste Water Treatment System  
(Courtesy of the ITAO)

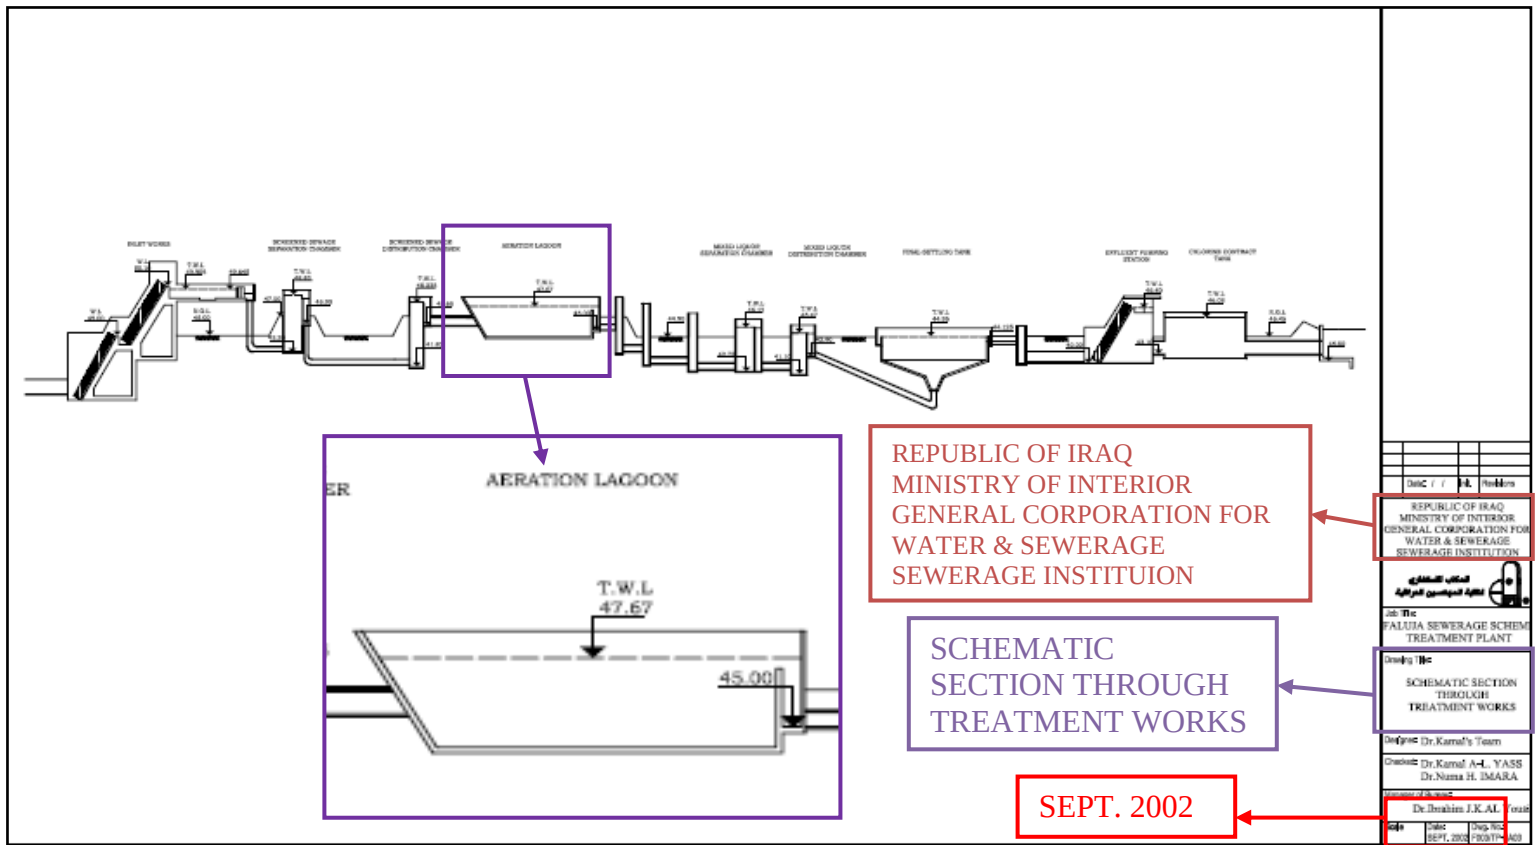
Figure 2. Ghadak's original schematic layout of the WWTP, which was designed to use a lagoon system (Figure courtesy of the USACE)

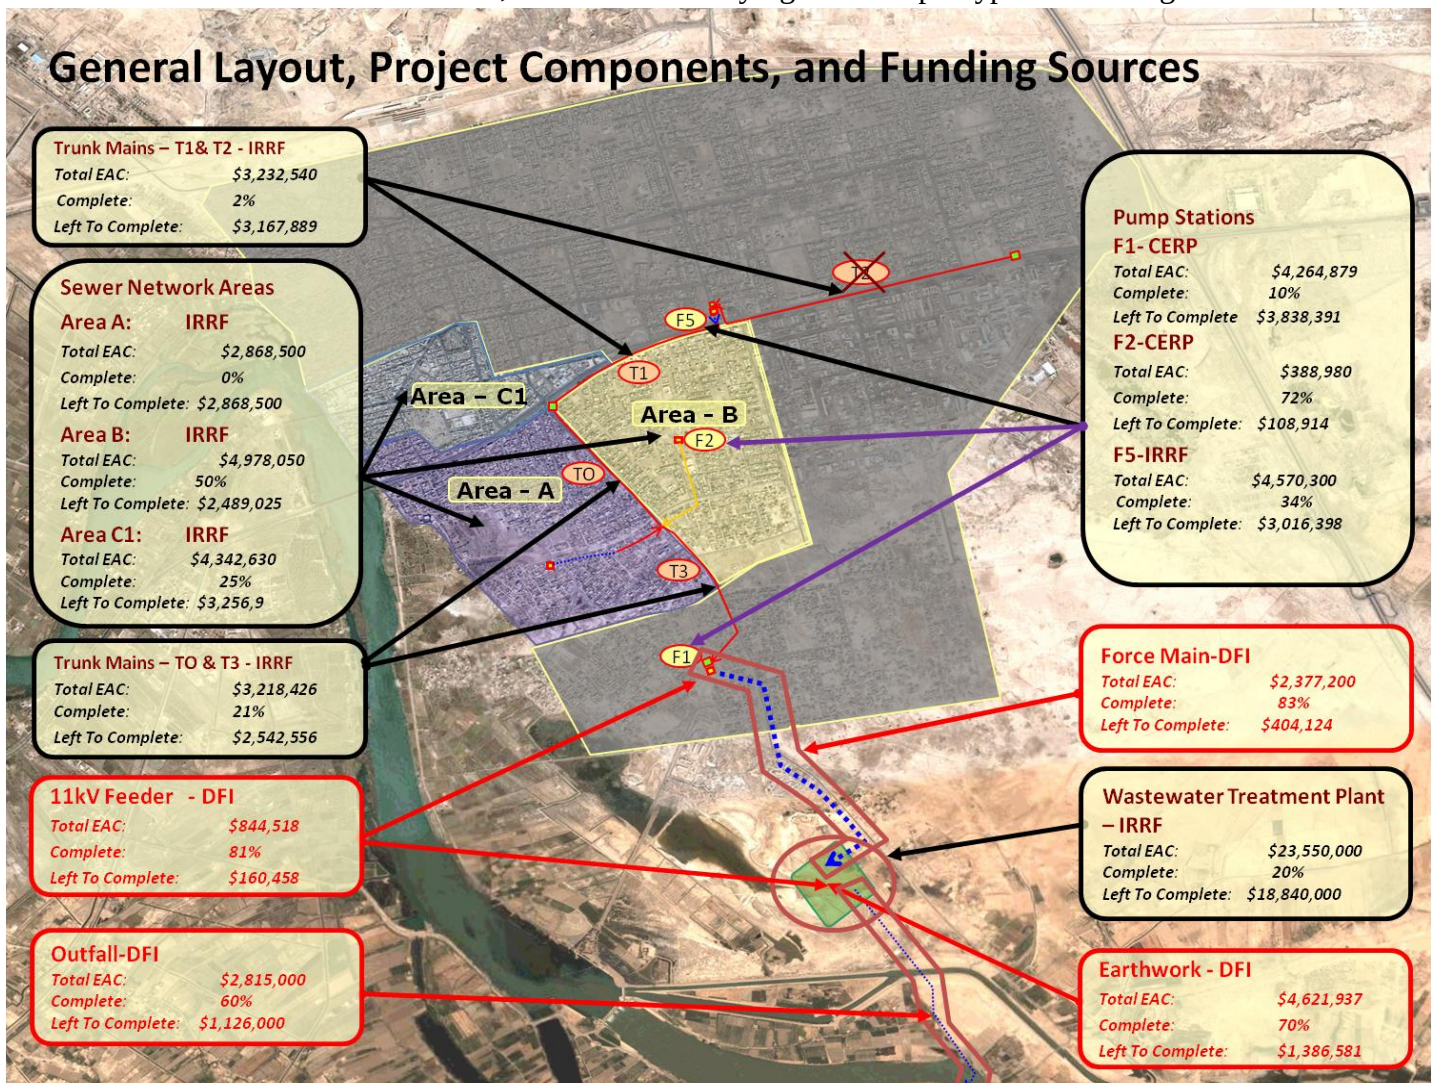
Figure 3 illustrates the complexity of this project in terms of interdependence between only the construction contracts; while also identifying the multiple types of funding sources.

Figure 3. General project layout and funding sources system

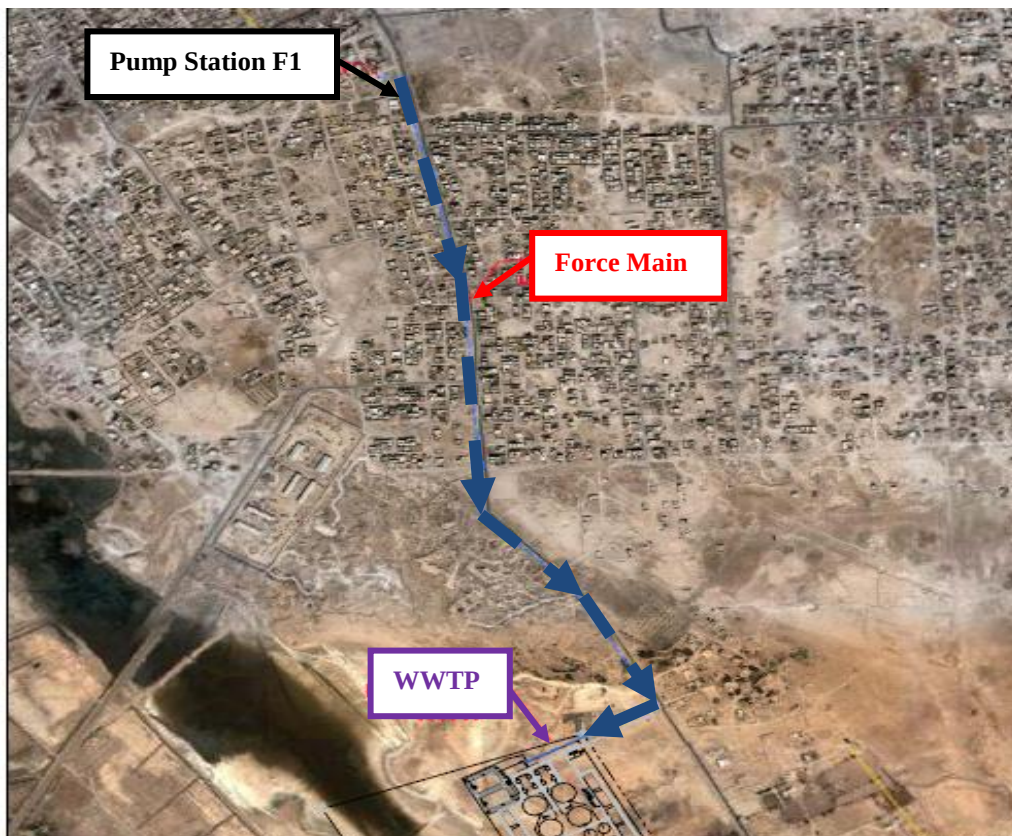
**Figure 4. Location of Force Main (between the Pump Station F1 and WWTP)  
(Figure courtesy of the USACE)**

According to Camp Falluja Resident Office documentation, this project was constructed without delay and has been fully flow tested and hydrostatically tested. In addition, the contractor submitted his close-out package, including as-built drawings, test results, hydro-test results, equipment listings, and spare parts. The Camp Falluja Resident Office has identified this contractor as “one of the best we have experienced here in Fallujah to date.”

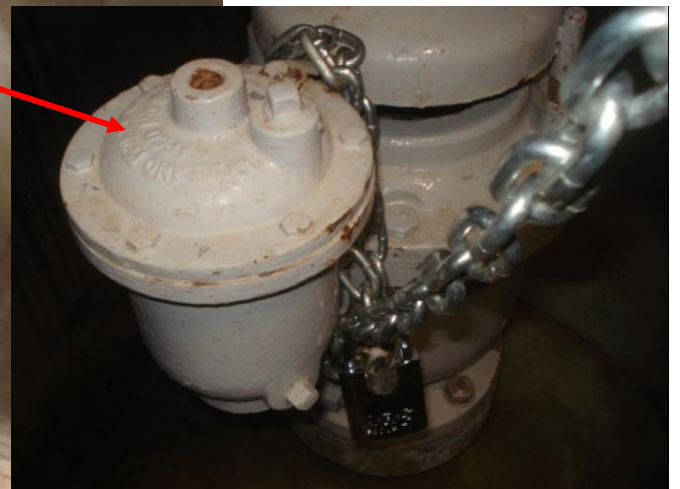
**Site Photo 5. Close up of Site Photo 4**

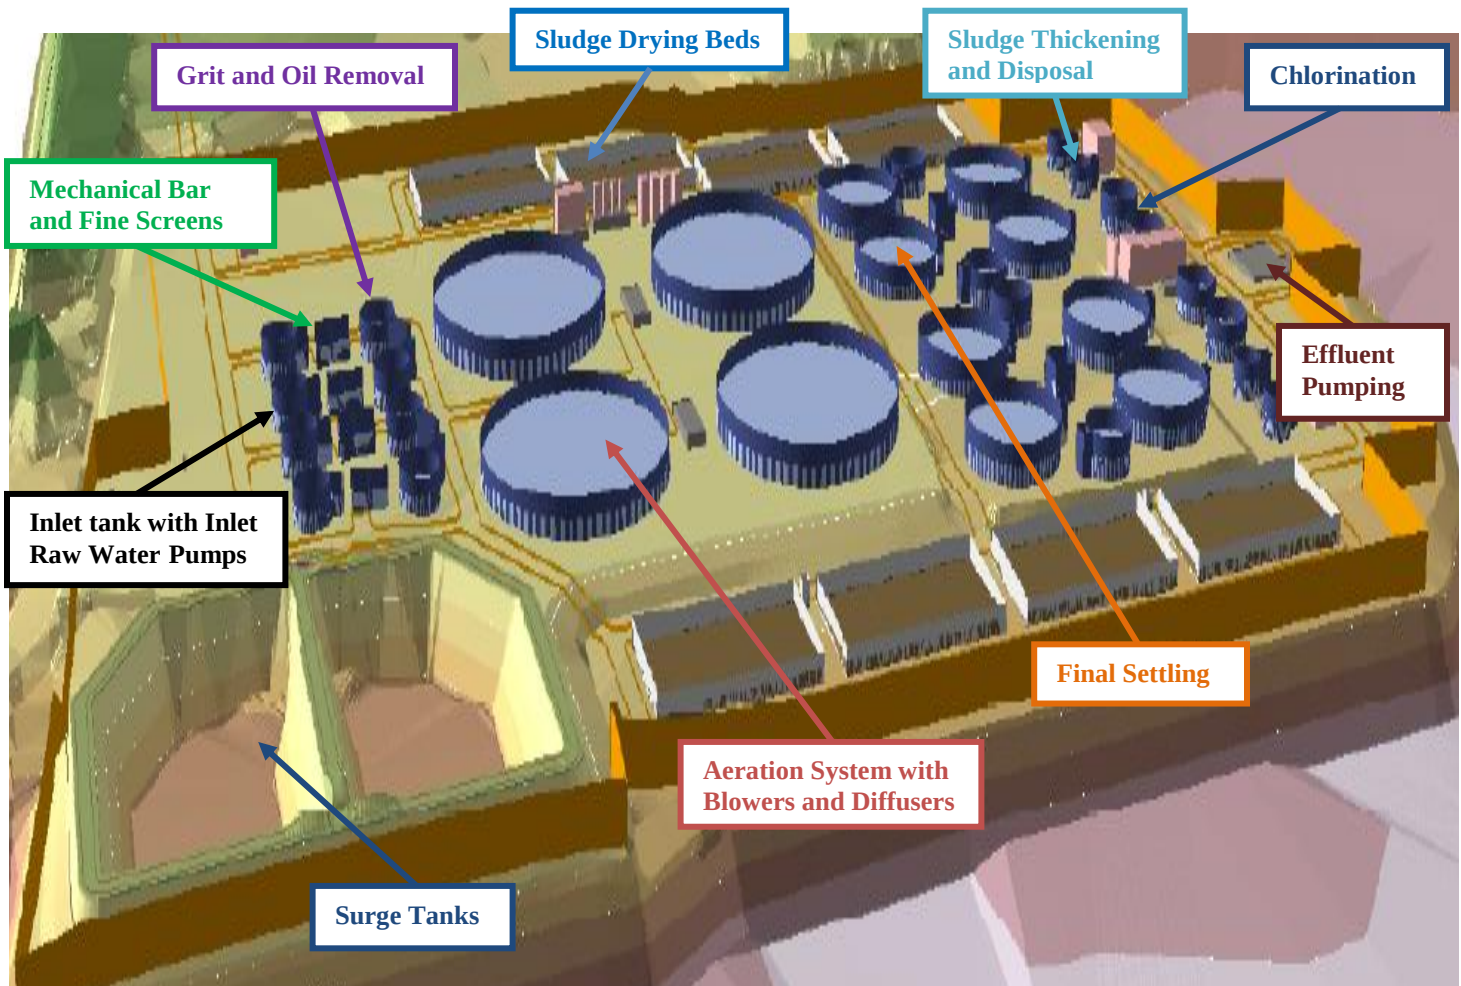
- inlet tank with inlet raw water pumps
- manual bar screen and mechanical fine screen
- grit and oil removal
- aeration system with blowers and diffusers
- final settling
- chlorination
- effluent pumping
- sludge thickening and disposal

The design later included surge storage basin capacity to the layout, along with a bypass system, to accommodate anticipated influent wastewater flows that exceed the combined ability of the packaged treatment system. Sludge will be thickened and placed on the sludge drying beds, after which it will need to be removed and properly disposed. The treated wastewater will then be discharged directly into the Euphrates River. Figure 6 provides an illustration of the WWTP and its components/processes.

Figure 6. General site arrangement of the WWTP

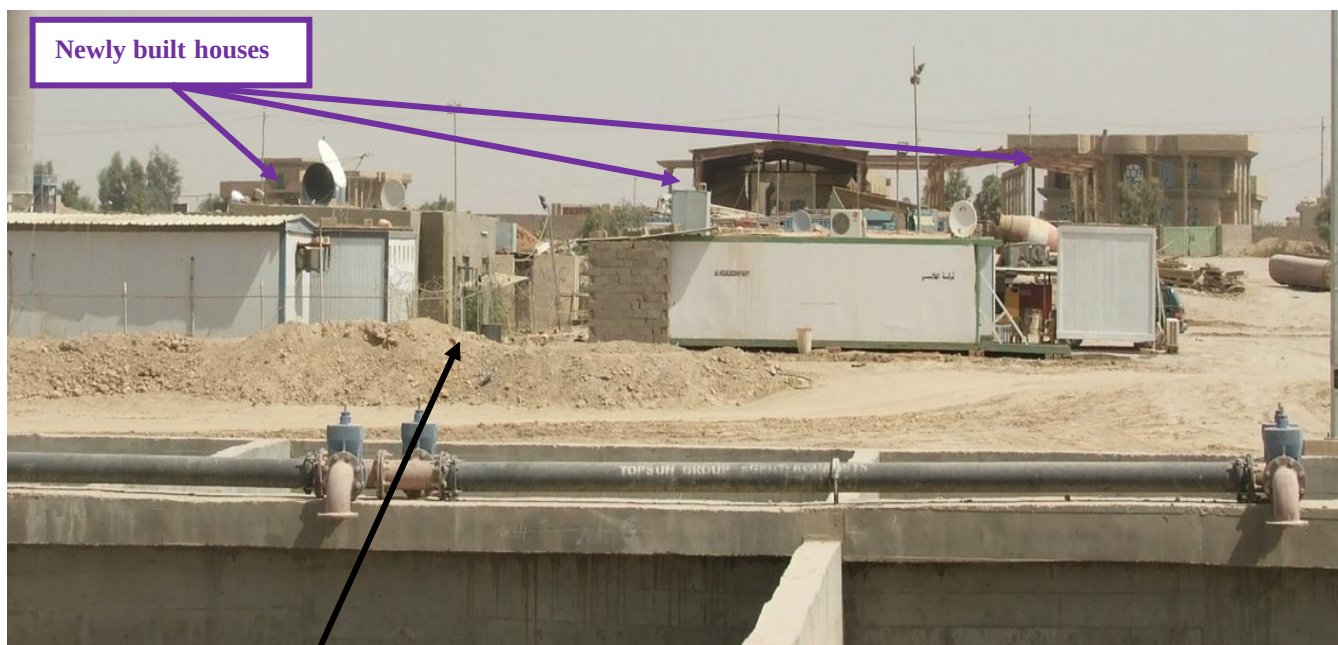
Odor from a WWTP is caused by the release of hydrogen sulfide gases into the atmosphere. These gases can be swept by winds to nearby populated areas and cause complaints from residents. In a mechanical (activated sludge) WWTP, the problem areas for odors are generally at the headworks, the sludge digestors, the sludge drying processes, and the surge storage tanks.

One of the primary reasons the MMPW rejected the use of the original design of a lagoon system was that it would lead to the “arising of stinking odor.” However, the MMPW’s design for the WWTP using the activate sludge units did not provide for odor control. Specifically, there are no odor control facilities furnished with this plant. According to Camp Falluja Resident Office representatives, the surge tank, inlet tank, and inlet works will generate undesirable odors. In addition, the area near the WWTP is fast developing into a residential area (Site Photo 6 and Figure 7), and it is anticipated that there will be complaints from the residents about the odor. Also, these residents may become angry because they are not part of the collection system. Consequently, these residents will see and smell the WWTP, yet will not benefit at all from it. Further, the residents near pump stations F1 and F5 may experience a “big stink” once the plant goes into operation. During the design review process, the lack of odor control facilities was identified; however, the potential solutions to the odor problem at the WWTP and pump stations are expensive, ranging from at least \$1 million to \$8 million. Due to project funding constraints, this was not remedied.

**Site Photo 6. View of new houses near the WWTP sludge drying beds, where a significant odor will occur (photo taken from sludge drying beds)**

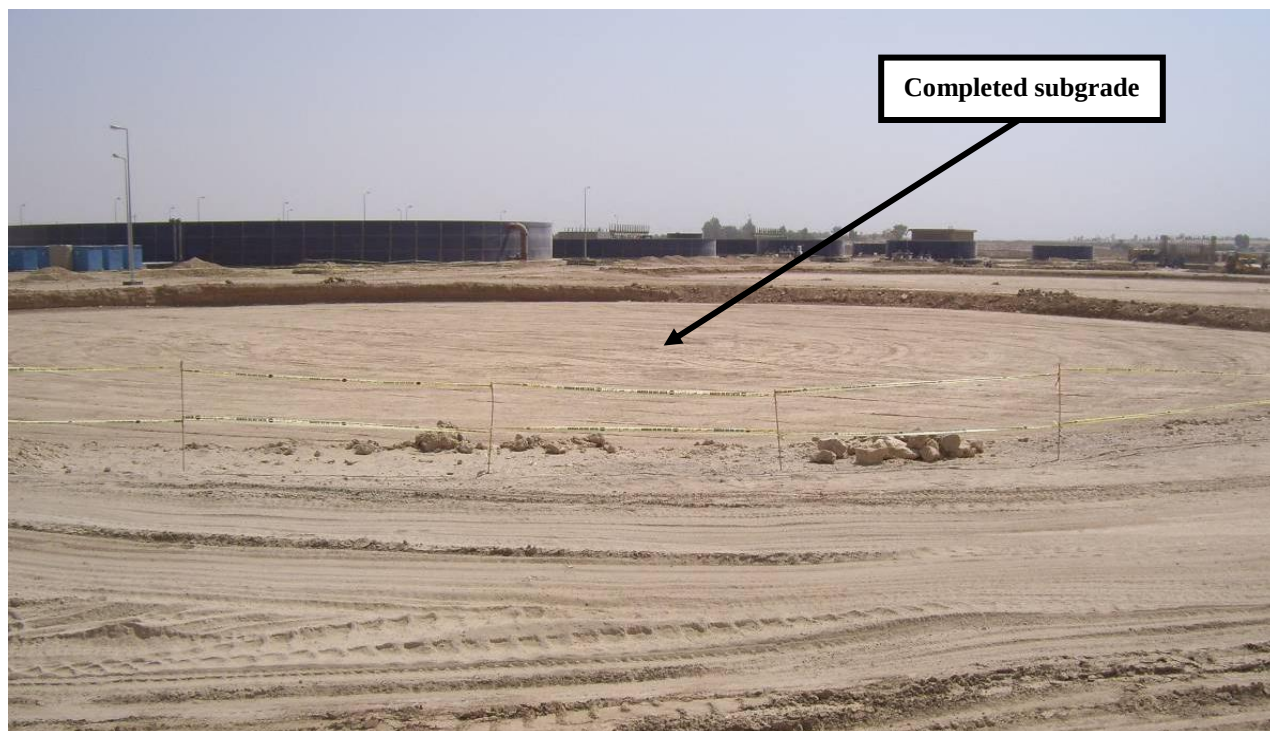
At the time of our site visits, the contractor had completed approximately 70% of the contract. The WWTP appeared to be filled to a consistent elevation of several meters above the adjacent dry lake bed, which should make the facility safe from potential flooding. The earth fill was consistent and appeared to be well compacted. According to Camp Falluja Resident Office representatives, the contractor used a "sheepsfoot" type roller to compact the fill. While the rough grading was complete, the finish grading activities had not yet begun. Site Photo 7 provides an example of the contractor's work, specifically the aeration tank subgrade.

**Site Photo 7. Aeration tank subgrade**

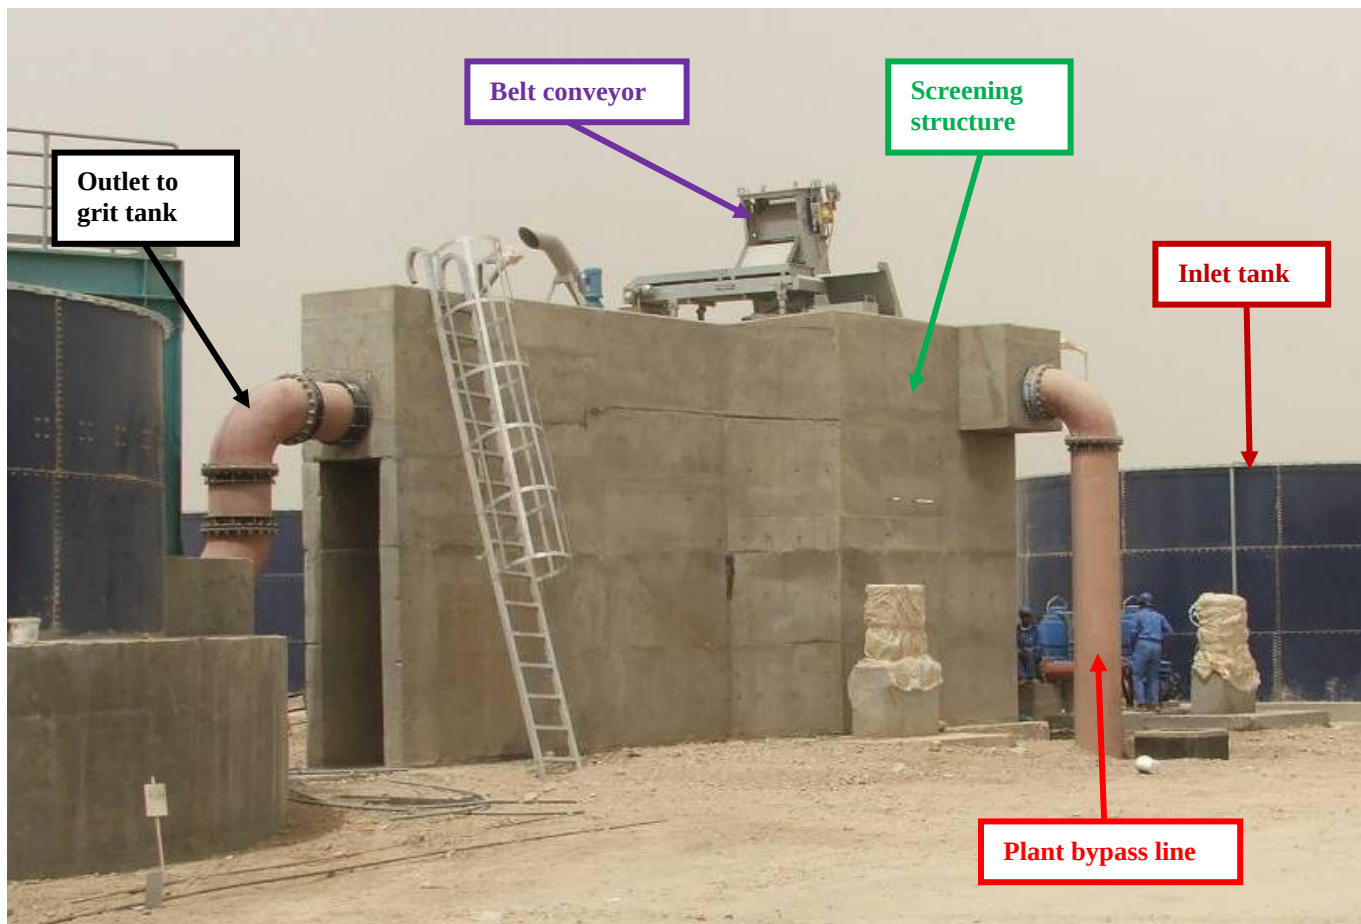
We observed the steel inlet tanks (Site Photo 8) and concrete foundations, which appeared to be constructed appropriately. The inlet screens were installed but could not be inspected. Camp Falluja Resident Office representative stated that hydraulic testing of the installed tanks had been completed.

**Site Photo 8. Inlet tank and screen structure**

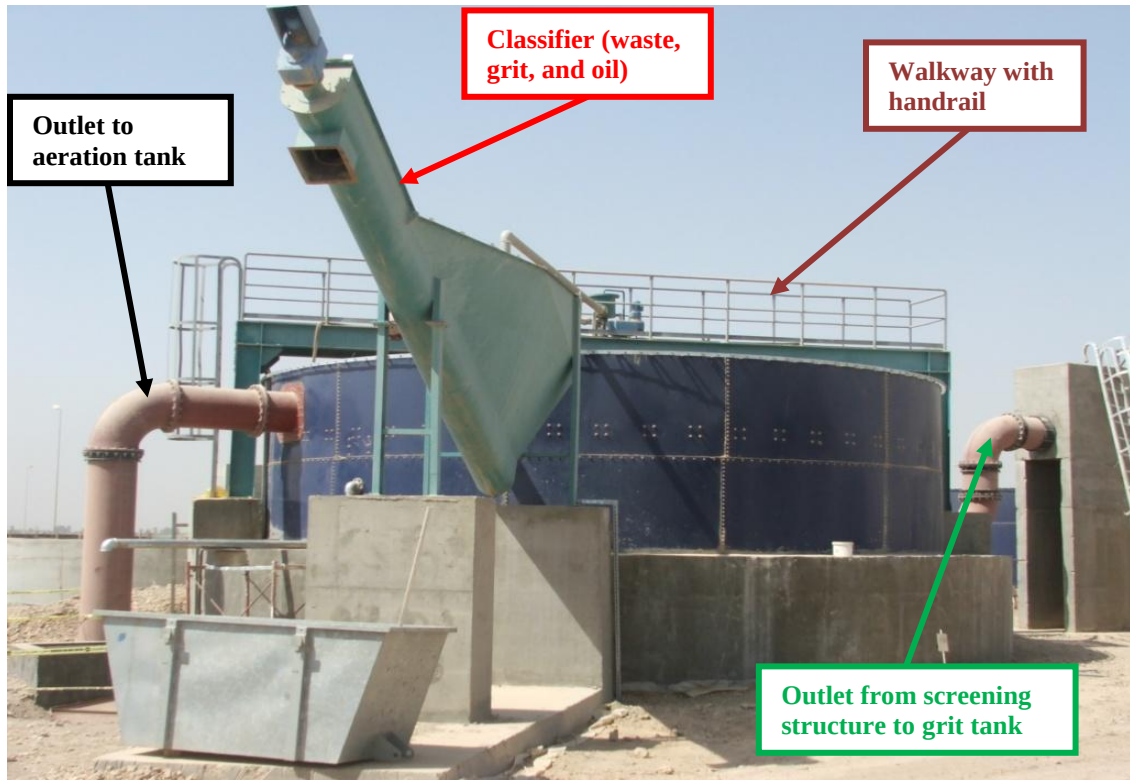
The grit and oil removal steel tanks and concrete foundations appeared to be adequately constructed (Site Photo 9). Camp Falluja Resident Office representative stated that the water stops at the connection between the steel tanks and the concrete foundations had leaked in several areas of the plant. This required the removal of some of the concrete so that the water stop could be repaired. The repairs appeared to be an epoxy-cement and are solid, which should result in satisfactory performance. We observed the top of the several tanks' foundations showing signs of this repair (Site Photo 10).

Site Photo 9. Oil and grit tank and classifier

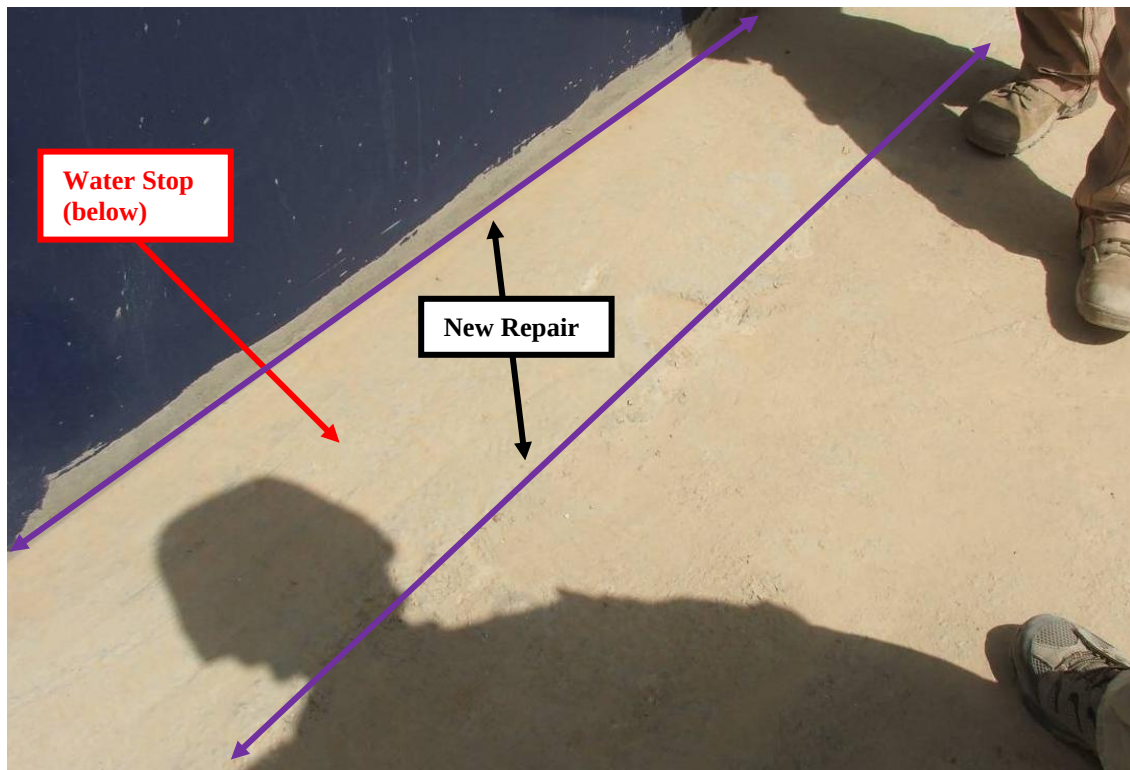
Site Photo 10. Example of concrete repair

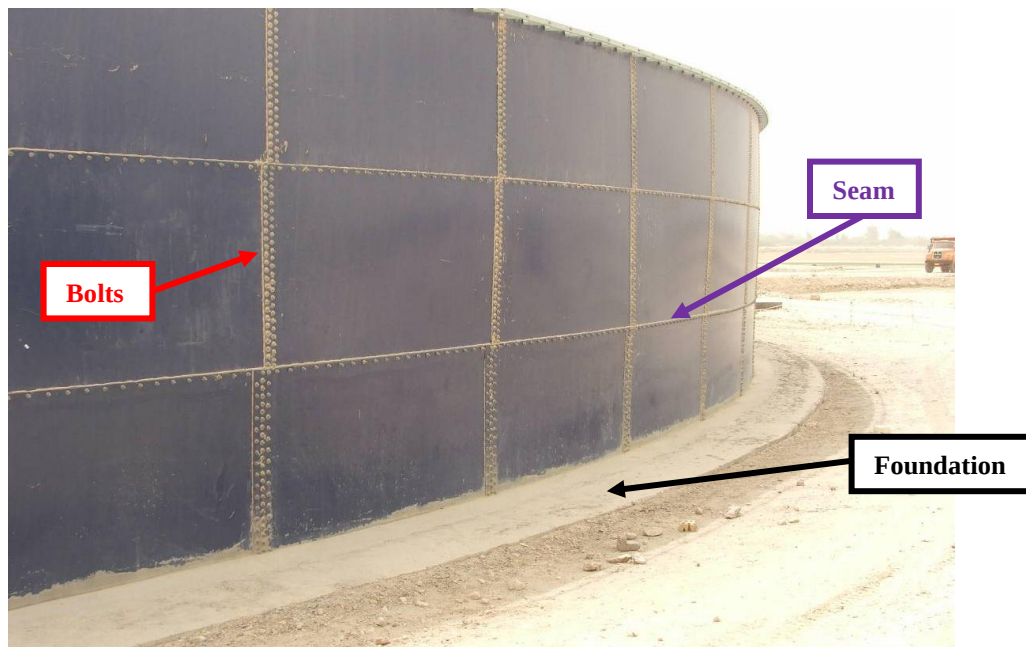
At the time of the site visits, two of the large steel aeration tanks had been installed (Site Photo 11). The tanks are constructed in sections and are bolted together on site. Each bolt and tank seam appeared to have sufficient amounts of sealant, and according to a Camp Falluja Resident Office representative, the hydraulic testing of the tanks has been completed. The Camp Falluja Resident Office representative stated some of the PVC diffusers in the tanks have been exposed to sunlight and will need to be replaced before commissioning. Some PVC materials degrade when exposed to sunlight, but once operational, the materials will be under the surface of the water and will not be exposed to sunlight except for during maintenance periods. The subgrade for two more aeration tanks was compacted and was ready to start constructing the foundations.

**Site Photo 11. Aeration tank**

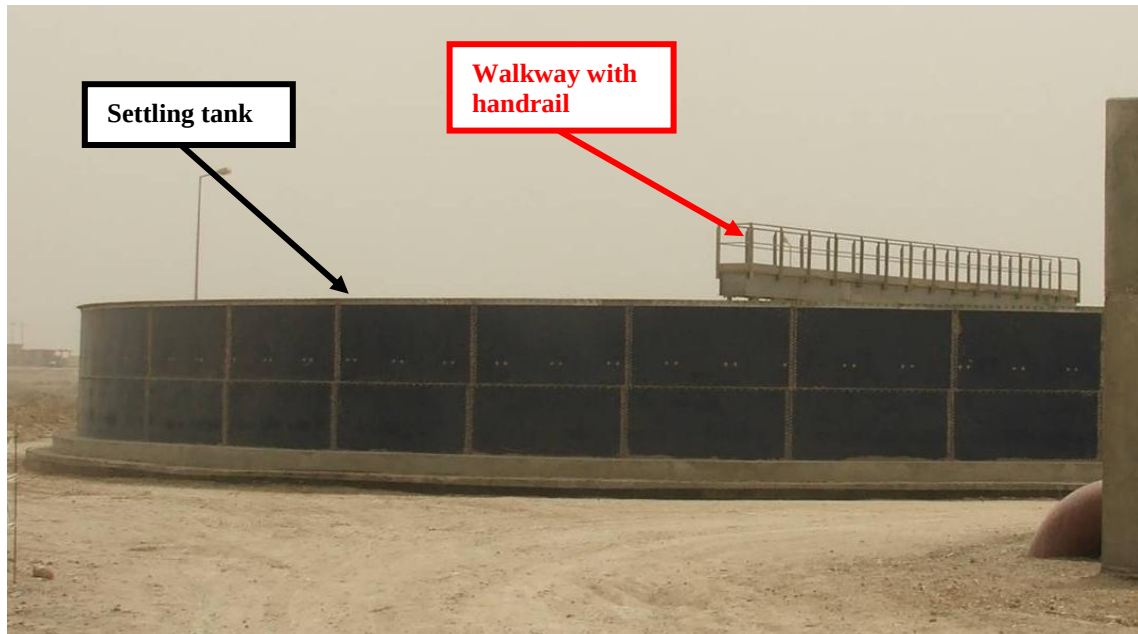
We inspected the final settling tanks for two of the treatment trains (Site Photo 12). The steel tanks, concrete foundations and mechanical equipment appeared to be installed in accordance with the design drawings. Camp Falluja Resident Office representative stated the underground piping and underground electrical wiring has been installed; however, the electrical wiring has not been completed in the Electrical Building.

Site Photo 12. Settling tank and concrete foundation

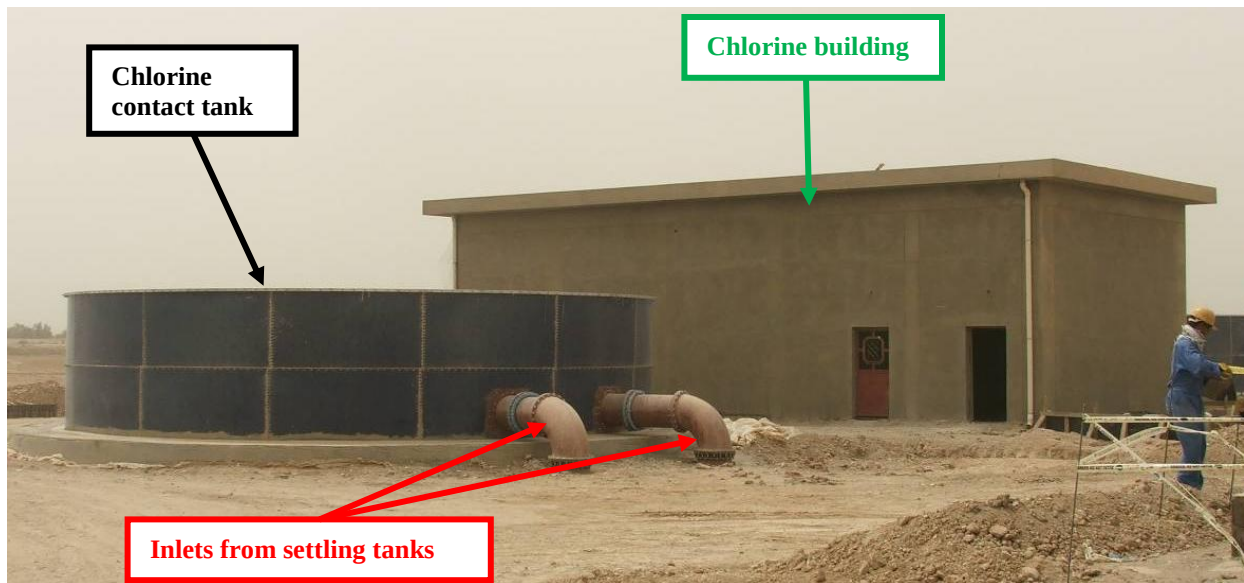
At the time of the site visits, the chlorine contact steel tanks and concrete foundations had been installed for the first two trains (Site Photo 13). The tanks and foundations appeared to be adequately constructed and in accordance with design drawings. The Chemical Building was not complete and no equipment was installed.

**Site Photo 13. Chlorine contact tank and chlorine building**

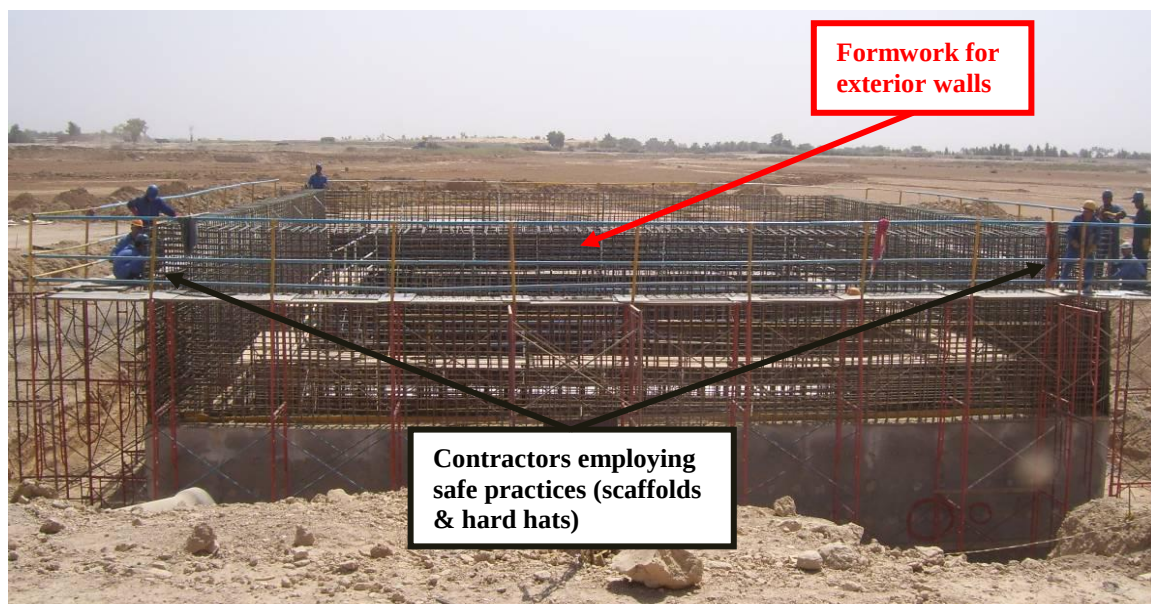
At the time of the site visits, the effluent pump station was partially constructed (Site Photo 14). The reinforced concrete walls were being formed to pour in the near future. The pump installation, piping connections, and backfill around the pump station still need to be completed.

**Site Photo 14. Effluent pump station construction**

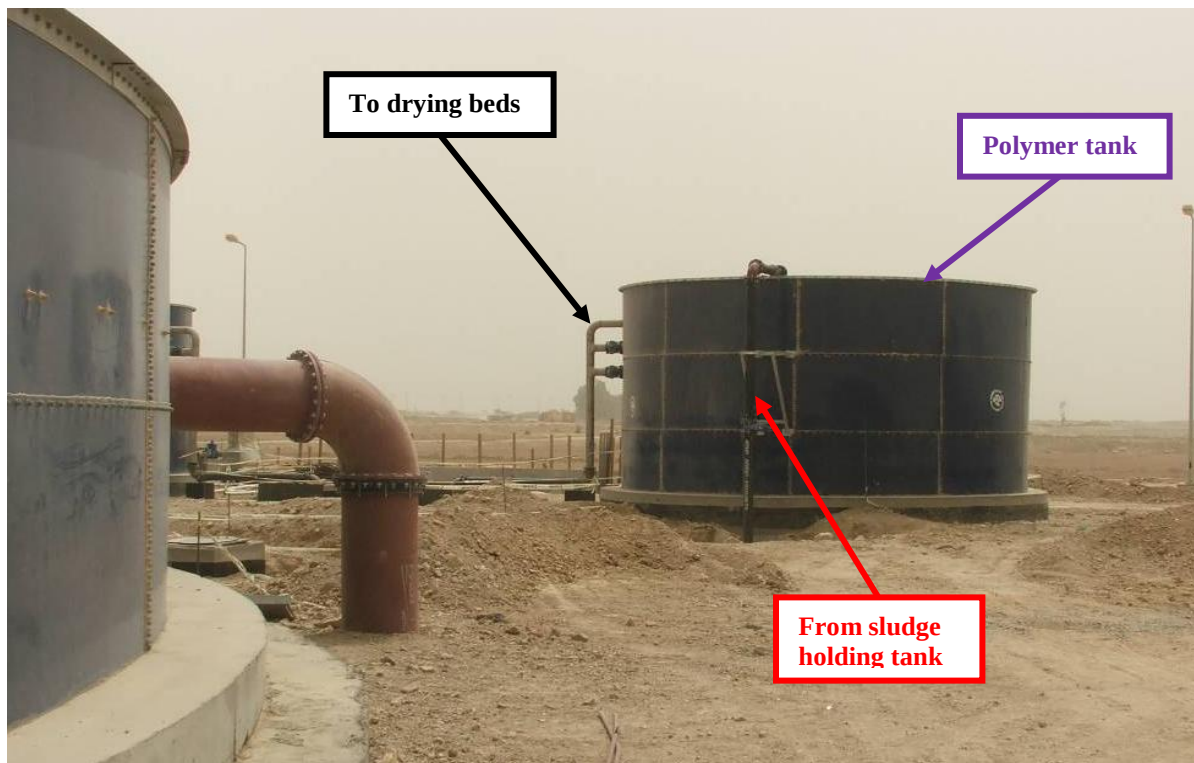
During our site visits, we observed two installed polymer mixing tanks<sup>14</sup>, which appeared to be constructed in accordance with design drawings (Site Photo 15). Camp Falluja Resident Office representative stated that initial commissioning will not use the polymer mixing tanks to its full potential because the gravity belt thickener is not being purchased with this contract; rather the interim process will be to inject the polymer into the sludge and send it to the sludge drying beds. The Camp Falluja Resident Office representative was concerned with using the polymer mixing tanks without having a gravity thickener to process the sludge. The primary concern is that the sludge polymer mixture would become too solid and the pumps would not be able to move the mixture to the drying beds. Pumping solid materials could result the clogging of the pipes and reduce the life of the pumps.

**Site Photo 15. Polymer mixing tank**

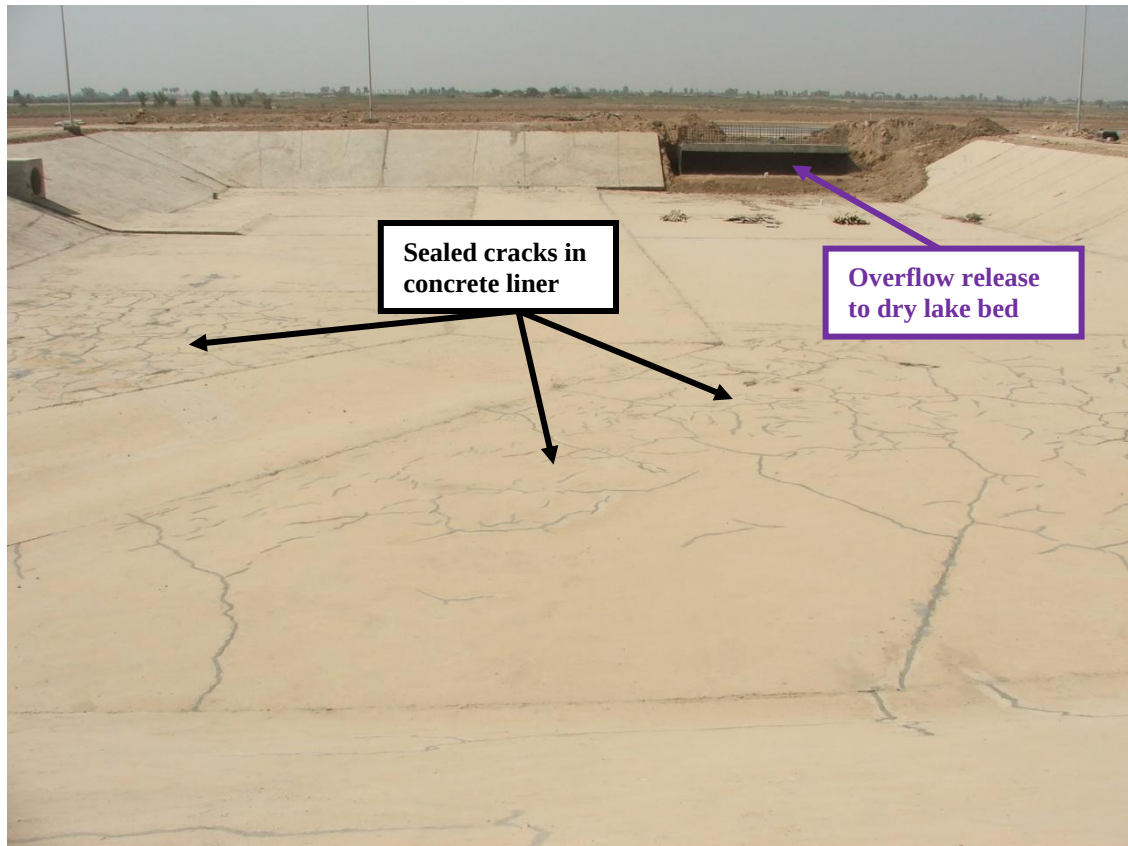
We observed the two constructed surge basins (Site Photo 16). The configuration of the surge basins appeared to match that of the construction specifications. An emergency overflow structure was constructed in the first basin and an equalization pipe was installed in between the two basins. The basins were constructed of earth fill material and were lined with concrete. According to the Camp Falluja Resident Office representative, the contractor requested to use concrete for the liner instead of the specification requirement of a cement/earth mixture. We noticed several cracks in the liner; however, the cracks appeared to be adequately sealed.

**Site Photo 16. Surge basin**

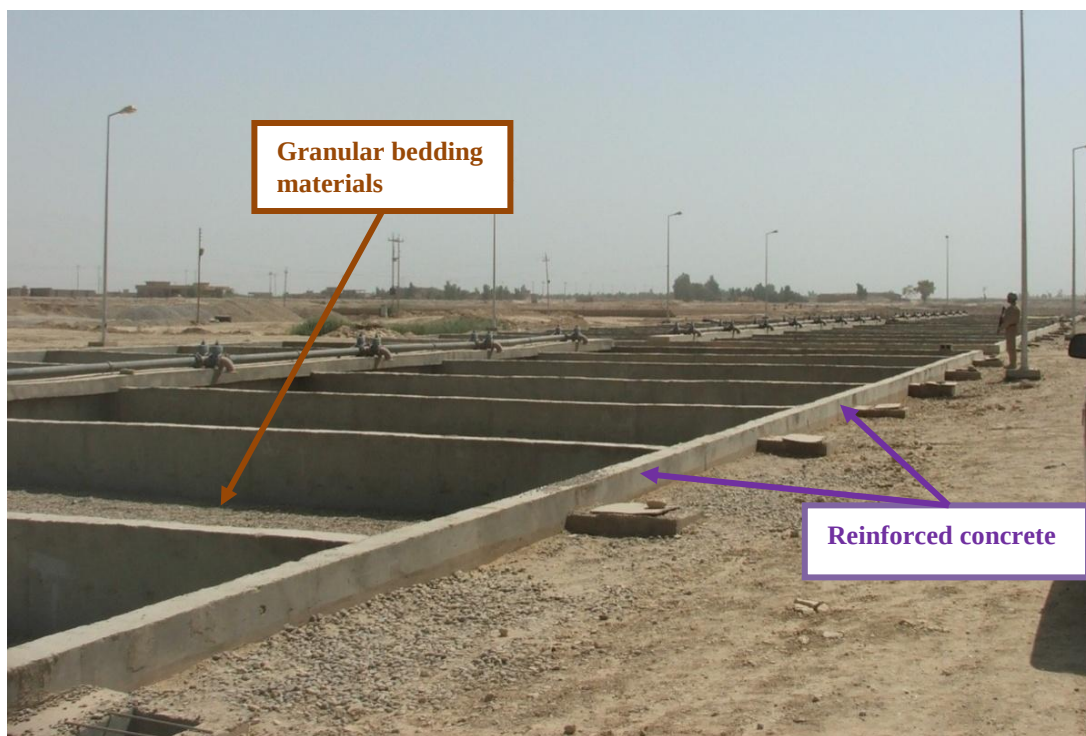
We observed the sludge drying beds (Site Photo 17), which were constructed of reinforced concrete with granular bedding materials installed to filter the sludge/water mixture. The sludge drying beds appeared to be constructed in accordance with design specifications. The water flows through the granular media and is pumped back to the inlet tank. The sludge is trapped on the media and when sufficiently dried is removed and disposed of off-site.

Site Photo 17. Sludge drying beds

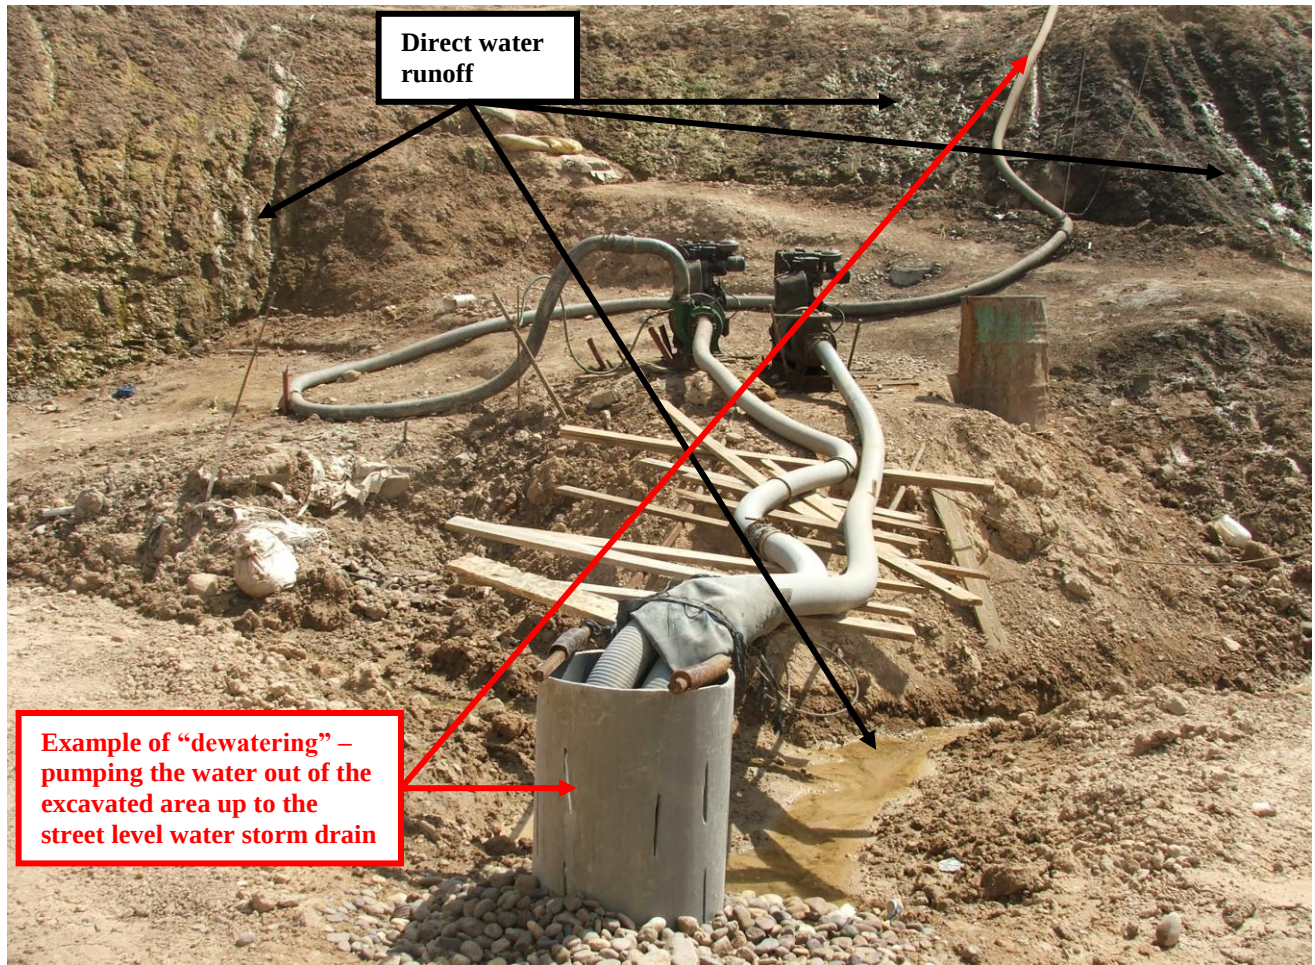
**Site Photo 18. Water runoff and dewatering system**
