## Microelectronics Reliability

## Role of stress voltage on structural degradation of GaN high-electron-mobility transistors

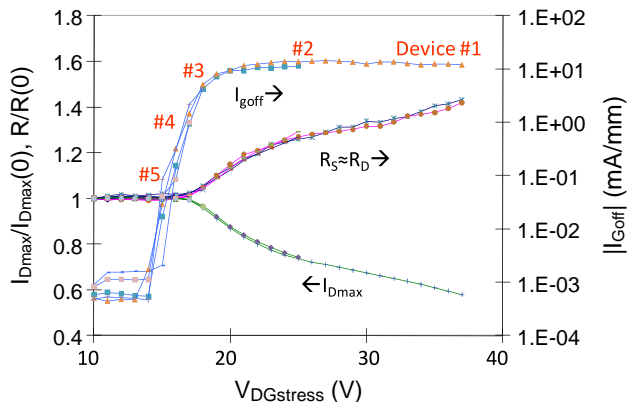
Fig. 1 shows the evolution of normalized  $I_{Dmax}$  ( $I_D$  at  $V_{DS} = 5$  V and  $V_{GS} = 2$  V),  $R_S$ ,  $R_D$  and  $I_{Goff}$  ( $I_G$  at  $V_{DS} = 0.1$  V and  $V_{GS} = -5$  V) in five different experiments as a function of stress voltage. As shown here,  $I_{Goff}$  sharply increases around a stress voltage of 17 V, and  $I_{Dmax}$  starts to decrease and  $R_D$  and  $R_S$  start to increase at around the same voltage. This is what we term the critical voltage. A higher critical voltage is expected at room temperature [19]. Devices #1–6 represent different stages of degradation:

- Device #1: Most heavily degraded ( $V_{DGstress} = 37$  V).
- Device #2: Medium-level degradation (25 V).
- Device #3: Onset of  $I_D$ ,  $R_S$  and  $R_D$  degradation with large  $I_G$  degradation (17 V).
- Device #4: Medium-level  $I_G$  degradation (16 V).
- Device #5: Onset of  $I_G$  degradation (15 V).
- Device #6: Unstressed reference device.

Fig. 1. Evolution of  $I_{Dmax}$ ,  $R_S$ ,  $R_D$  (normalized to its initial value) and  $I_{Goff}$  in  $V_{DS} = 0$  step-stress experiments ( $T = 150$  °C).

As it can be seen in Fig. 1, the pattern of degradation is very reproducible from device to device. This well matched set of devices enables us to study the evolution of degradation as the stress voltage increases as if we had observed it in a single device.

the data of Fig. 1. The most heavily degraded device (#1) exhibits about 35% of permanent degradation and 15% of current collapse after the stress. On the other hand, the devices stressed up to 16 and 15 V (devices #4 and 5, respectively) show negligible electrical degradation in the drain current, whether transient or permanent. The average value of current collapse for all devices in their virgin state is 0.2%.

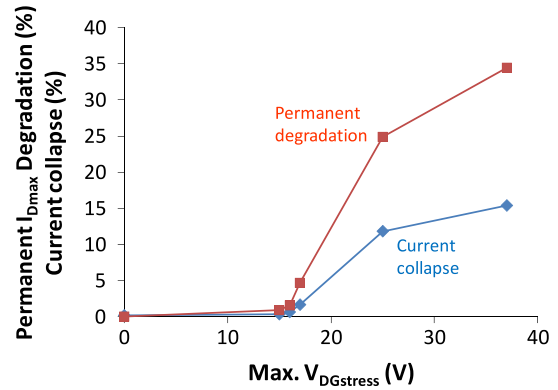
Fig. 2 summarizes the evolution of current collapse and permanent degradation as a function of the final or maximum stress voltage in each sample. As shown in Fig. 2, both current collapse and permanent degradation increase the higher the stress voltage beyond a critical voltage of about 17 V. This is in agreement with

Fig. 2. Permanent degradation in  $I_{Dmax}$  and current collapse as a function of maximum stress voltage in the samples of Fig. 1.

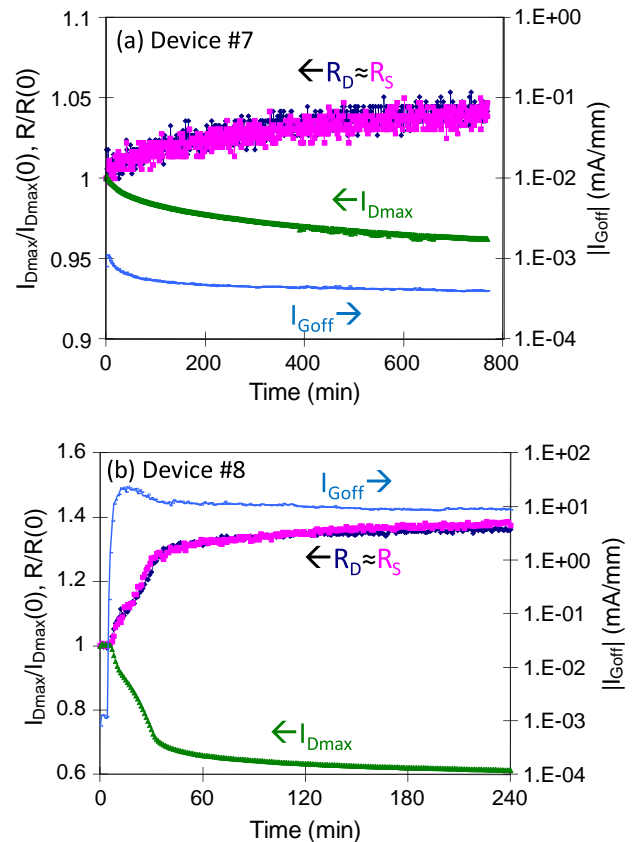
Fig. 3. Change in  $I_{Dmax}$ ,  $I_{Goff}$ ,  $R_S$ , and  $R_D$  during long-term stress in the  $V_{DS} = 0$  state. The stress voltage is: (a)  $V_{DG} = 11$  V (device #7) and (b) step-stressed from 10 to 40 V for the first 30 min and kept at 40 V afterwards (device #8).  $T = 150$  °C.

As shown in Fig. 3a, long-term stressing below  $V_{crit}$  shows no degradation in  $I_{Goff}$  although  $I_{Dmax}$  and the series resistances

slightly degrade over time. For this device, permanent degradation and current collapse after the stress was 5% and 0.6%, respectively. Although current collapse remained at the level of the virgin device, there was a small degree of permanent degradation that is not observed during short-term step-stress below  $V_{crit}$  (device #5 above). This suggests that there is a separate long-term degradation mechanism below  $V_{crit}$  (and perhaps unrelated to  $V_{crit}$ ) that permanently degrades  $I_D$  without introducing traps.

The device stressed at high voltage for a long time (#8) shows significant degradation in all figures of merit (Fig. 3b). Permanent degradation and current collapse after the stress were 42% and 14%, respectively. Compared to the device stressed up to nearly the same voltage in step-stress experiments (#1), current collapse is almost the same, while there is additional permanent degradation presumably a consequence of the device being held for much longer time at the maximum stress voltage.

We have also investigated the impact of long-term stress at voltages below and above the critical voltage with the device biased in the  $V_{DS} = 0$  regime. First, a device (#7) was stressed at  $V_{GS} = -11$  V, which is below  $V_{crit}$ , for 12 h at 150 °C. Another device (#8) was first step-stressed up to  $V_{GS} = -40$  V in order to confirm the transition through the critical voltage and then stressed at  $-40$  V at 150 °C for an additional 210 min.

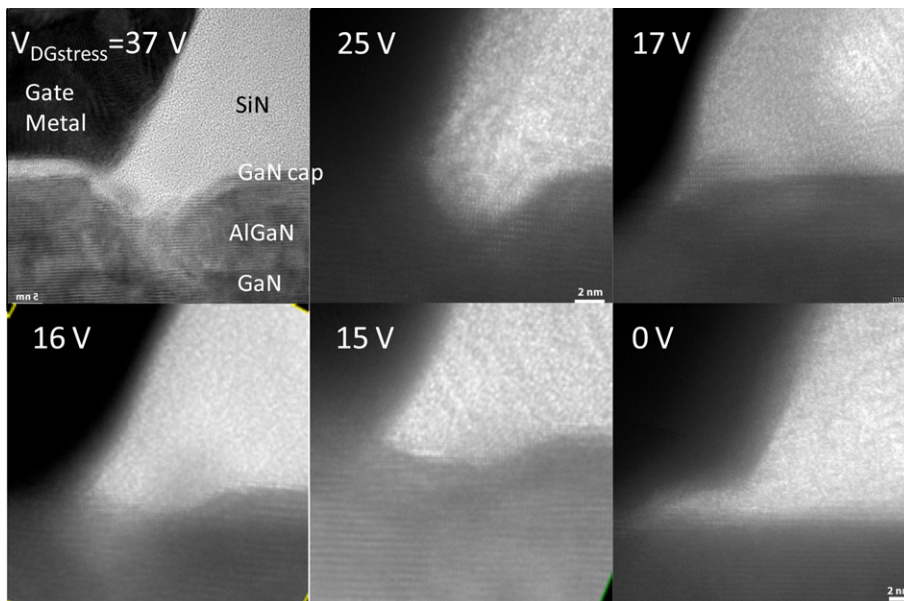
Fig. 4. Cross-sectional TEM images of the drain side of devices stressed at different voltages (device #1–6).

Fig. 4 shows TEM pictures obtained for selected devices from the step-stress experiments of Fig. 1. Near the gate edge, the control unstressed device (#6, labeled 0 V in Fig. 4) shows a smooth semiconductor surface. The devices stressed up to 16 V show minimal structural degradation. Only a small indentation less than 2 nm deep and 10 nm wide is observed on the GaN cap surface next to the gate edge. This seems to correspond to the groove that has been observed in a separate plan-view study [17]. For that reason, we will refer to this feature as a groove although TEM cannot confirm whether this feature is continuous in and out of the cross section. Devices that are stressed well beyond  $V_{\text{crit}}$  (25 and 37 V) show significant physical degradation in the form of deep pits (up to 4–6 nm in depth and 17 nm in width at the surface). For these devices, the pits penetrate into the AlGaN barrier layer. The device stressed at 37 V also exhibits a crack-like feature that extends at an angle from the bottom of the pit to the AlGaN/GaN interface. Since these devices are symmetrically stressed in both

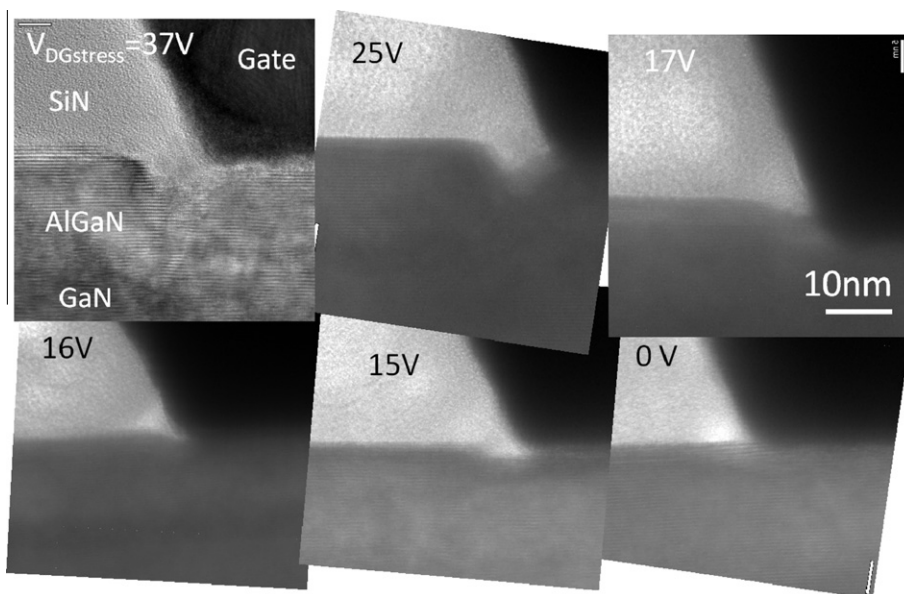
Fig. 5. TEM images of the source side of device #1–6.

the source and drain sides, similar observations were made on the source side (Fig. 5). These pictures reveal that short-term stress is enough to produce significant structural degradation if the stress voltage is higher than the critical voltage. It does also reveal the presence of small surface indentations for voltages below the critical voltage consistent with the grooves observed in [17].

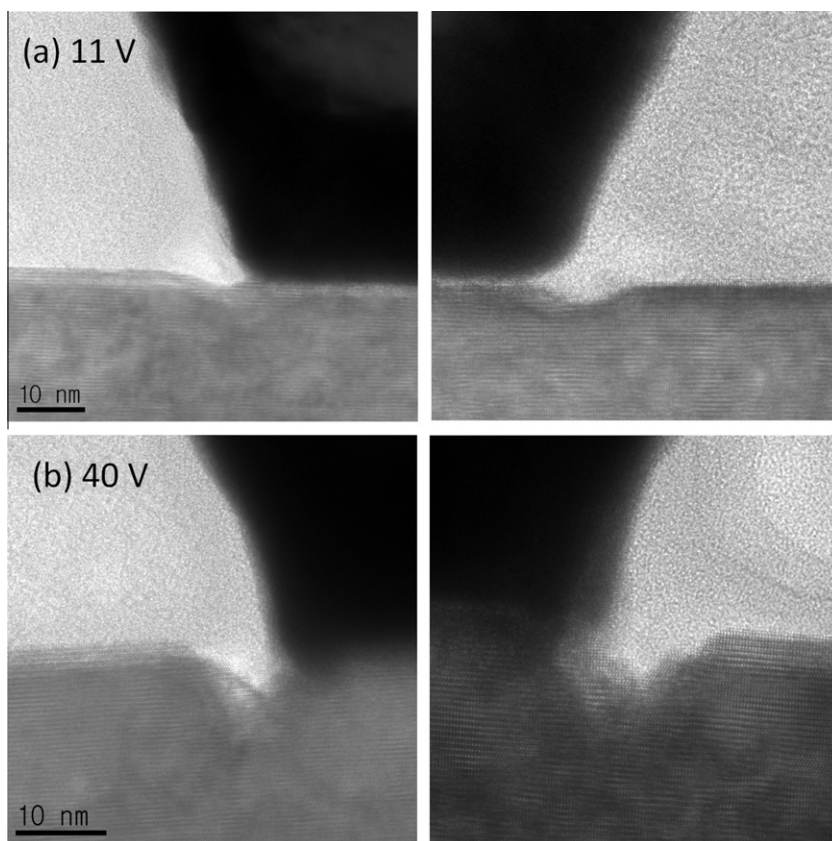
TEM images for long-term stressed devices are shown in Fig. 6. The device stressed below  $V_{\text{crit}}$  (Fig. 6a) shows a shallow groove of about 1.5 nm in depth and 6 nm in width at the gate corner. However, in spite of the extended stress time, this is again not deep enough to penetrate into the AlGaN barrier. This small structural degradation may account for the small permanent degradation in  $I_{\text{Dmax}}$ . The sample stressed beyond  $V_{\text{crit}}$  for a long time (Fig. 6b) shows a deeper (~6 nm) pit that reaches into the AlGaN layer. This result suggests that stress at voltages in excess of  $V_{\text{crit}}$  is necessary for deep pit formation.

Fig. 6. Cross-sectional TEM images for long-term stressed devices. The source (left) and drain (right) sides are shown. Stress voltages are: (a)  $V_{\text{DC}} = 11$  V (device #7) and (b)  $V_{\text{DC}} = 40$  V (device #8).

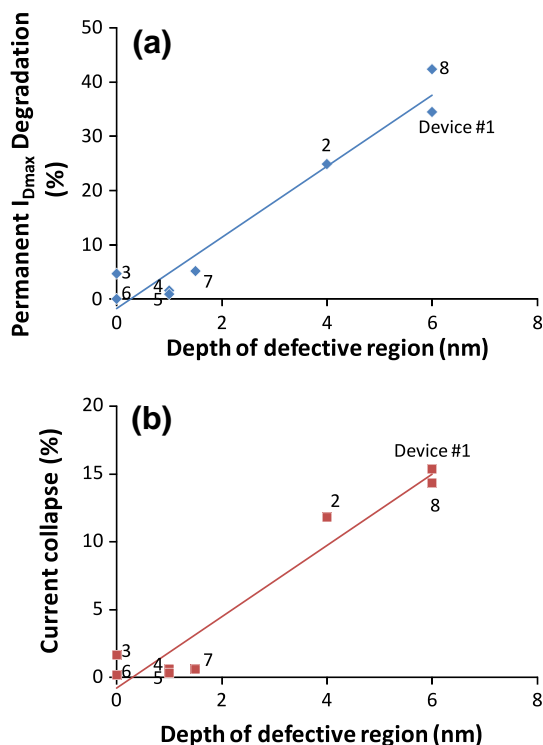
To provide a quantitative comparison between electrical and physical damage, we have measured the width and the depth of the pits that are observed in TEM pictures. We have then graphed the degradation in uncollapsed  $I_{Dmax}$  (in absolute amount) and the value of current collapse against the depth of the defective region. This is shown in Fig. 7. The permanent degradation in  $I_{Dmax}$  and the current collapse both correlate well with the depth of the defective region. Serious electrical degradation only takes place when the depth of the defective region exceeds the GaN cap thickness ( $\sim 3$  nm). It is noted that the long-term stressed devices (#7 and 8) also fall in the same correlation as the short-term stressed devices (#1–5).

Fig. 7. Correlation between electrical and structural degradation for all samples in this study: (a) permanent  $I_{Dmax}$  degradation vs. pit depth and (b) current collapse after stress vs. pit depth.

The correlation between electrical degradation, as measured through  $I_{Dmax}$ ,  $R_S$  and  $R_D$ , and structural degradation, as evaluated through the depth of the defective region observed in cross-section TEM, is entirely consistent with a similar study that utilized AFM and SEM mapping of the semiconductor surface after gate and dielectric removal [17]. This is true in spite of the fact that, in the present study, a single cut was made at a random location across the width of the device. It is not surprising that the prominent defects observed here and in [17] result in permanent (non transient) degradation of the drain current. The formation of deep pits should induce local strain relaxation which ought to result in a local reduction of piezoelectric-effect induced charge, and a decrease in the sheet carrier density. With stress in the  $V_{DS} = 0$  re-

gime, this should also result in a permanent increase in both the source and drain resistances. At the same time, it is reasonable to expect that the introduction of structural defects at the corner of the gate provides trapping sites for electrons leading to current collapse.
