## ROCK STRIKE TESTING OF TRANSPARENT ARMOR

David N. Hansen, Ph.D.  
Ashley Wagner

GVSS Paper  
NLE-01v2

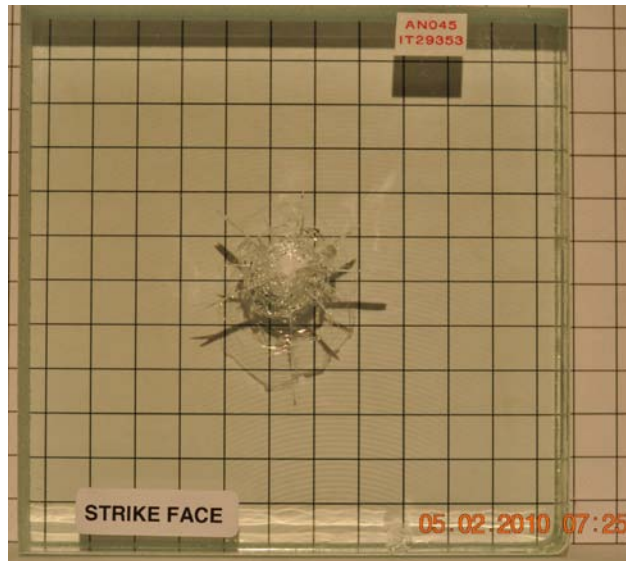
Photograph 3. Heavy but not Major Damage at 129 f/s.

As the average damage becomes larger, the spread in the data increase but this is not a good statistical variation. That is, because this is a ranking, and because the ranking is 0 to 7, the possible variability is probably largest near the middle of the ranking.

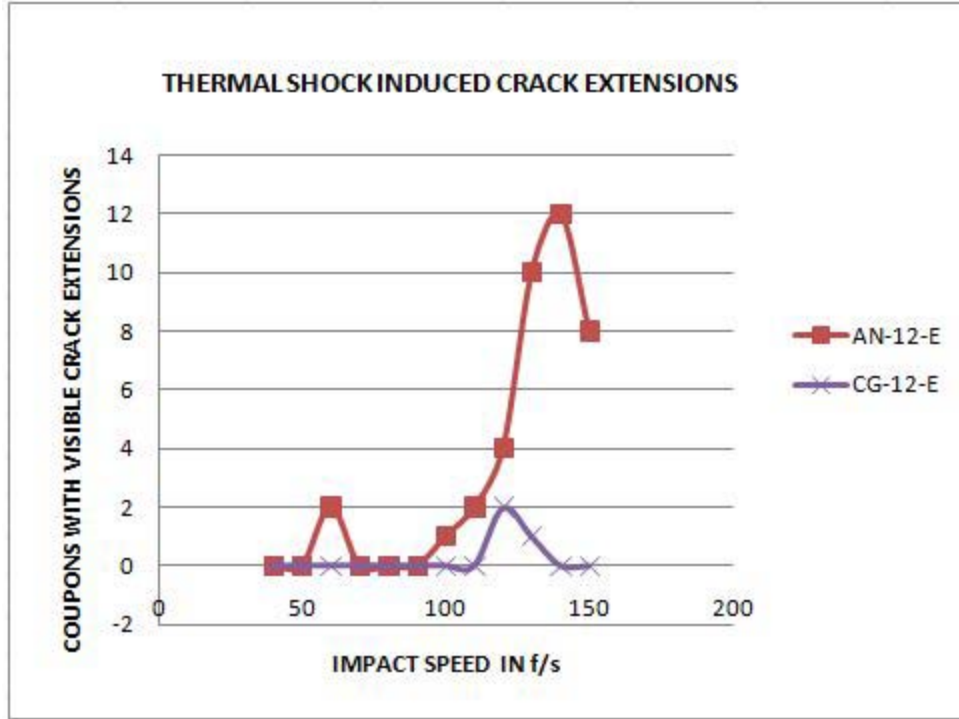
The extension of radial cracks was also followed and is presented in the following plot. Note that there were no crack extensions in the 6mm impacted coupons. Photographs 4a and 4b respectively present a before and an after thermal-shocking visualization.

Figure 1. Number of coupons with significant changes in ranking.

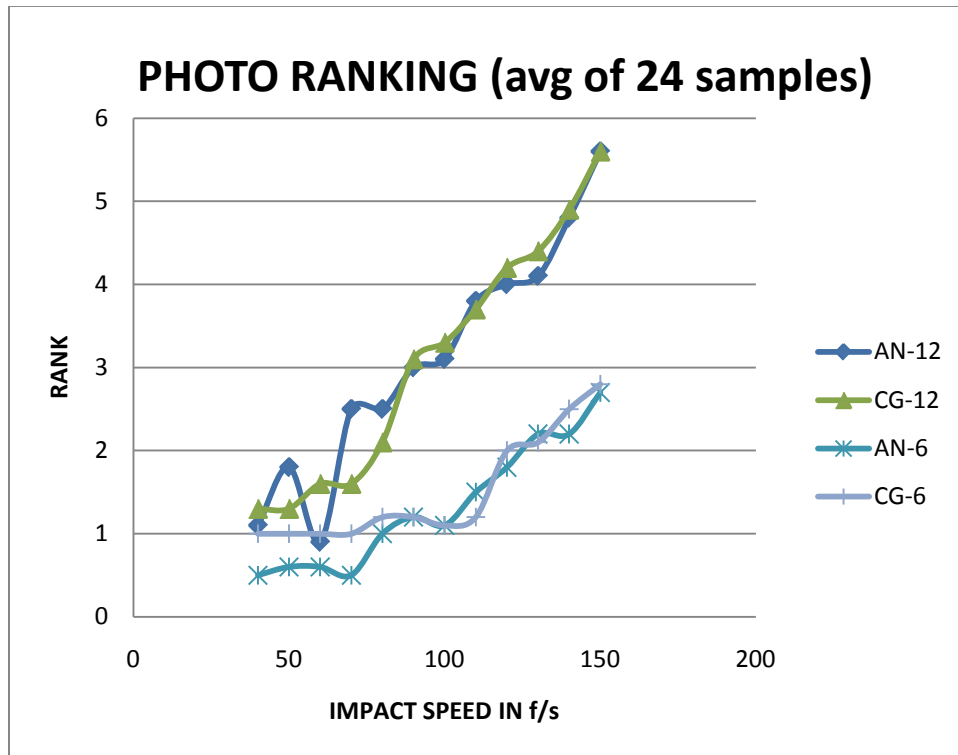
In Figure 2 the average rankings are presented. Note that the 12mm and 6mm results grouped despite the different lateral sizes of the AN and CG coupons. Also note that the 12mm results generate the largest cracks and that the 6mm cracks bottom out at 60 to 80 f/s. The fact that the ranking categories are not linear in terms of damage energy may be contributing to the non-zero values for the bottomed out 6mm values.

Figure 2. Results of Ranking of Coupon Photographs.

Dashes indicate that all 24 coupons in the group were damaged. This is different from Figure 2 in that Figure 2 is an average of an assessment where this table is a numbering of exceptions. Also, this table indicates that AN-12 had more exceptions than CG-6 contrary to the indication of Figure 2.
