# **Effects of Aging and Environmental Conditions on Ammunition/Explosives Storage Magazines – Paper 1**

The Defense Ammunition Center (DAC)/U.S. Army Technical Center for Explosives Safety (USATCES) recognized the need to establish the ‘structural health’ status of aging ammunition/explosives storage magazines. A recent accidental explosive event in an earth covered magazine demonstrated that legacy assumptions for structural failure may be unknown and potentially adversely affect safety. Aging and the effects of environmental factors may have an effect in the structural performance of the storage magazines when subjected to explosions. DAC requested the assistance of the University of Oklahoma, USACE-ERDC (Vicksburg), and USACE Engineering and Support Center to determine the ‘structural health’ of aging magazines, evaluate remediation methods, and perform structural analyses to duplicate structural conditions found in situ magazines. The key goals of the effort (July 2008 thru May 2010) are to gain an accurate estimate of scope of the problem of deficient magazines, to collect and archive data on the structural health of existing magazines, to identify practical remediation meth

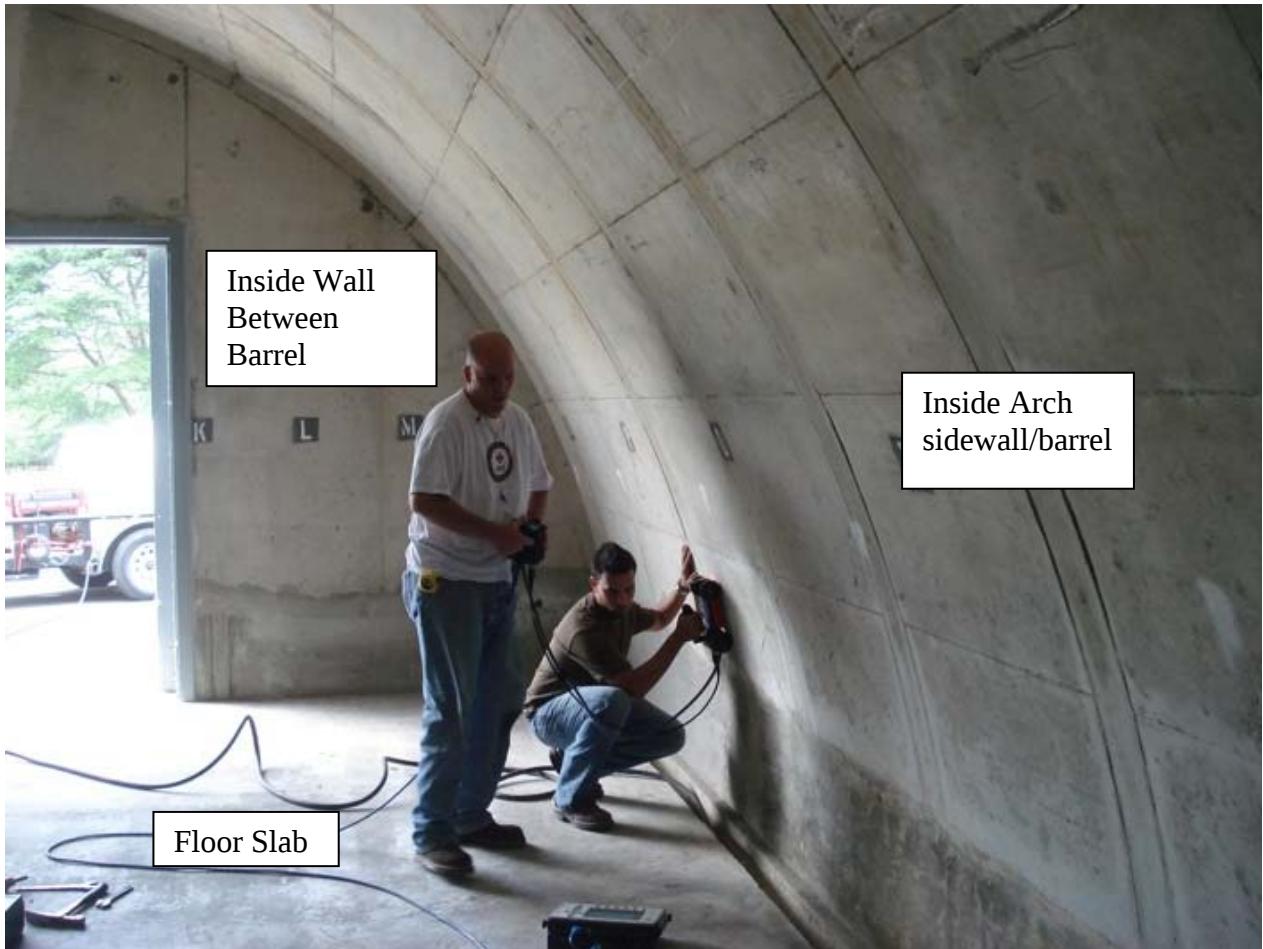
Figure 3 ECM Interior Components

- a reinforced concrete floor upon which volatile components such as explosives or sensitive fuels are placed. This floor may be sloped to permit drainage, and it rests on foundation soil.

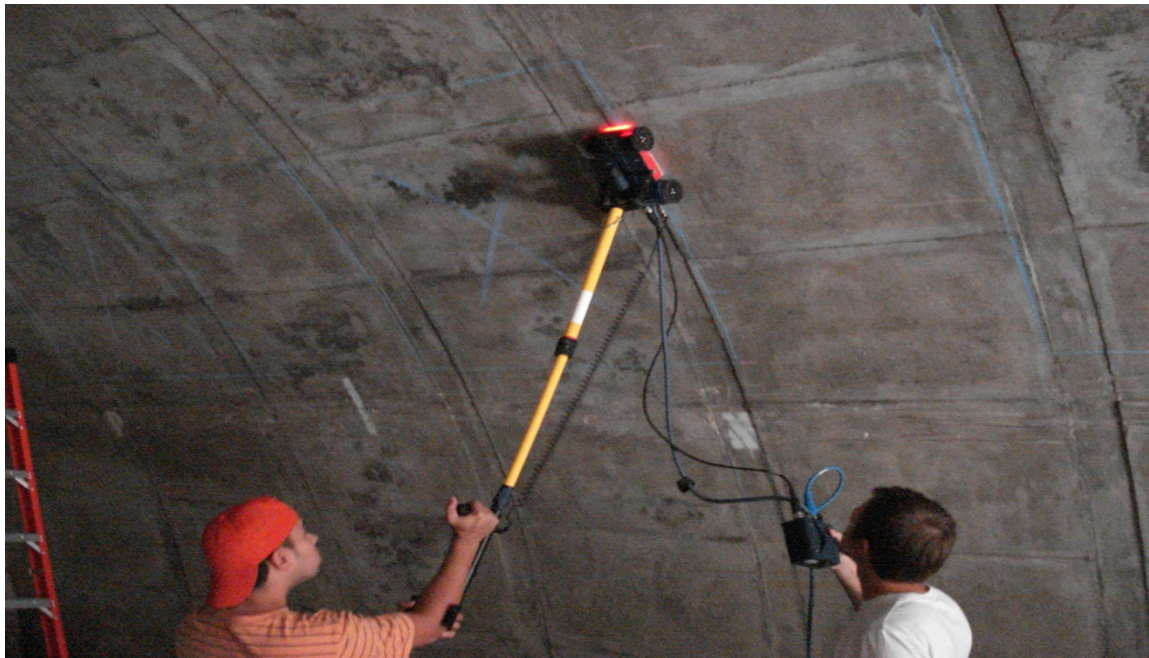
Figure 4 Non-Destructive Testing

Non-destructive (ground penetrating radar (GPR)) testing was utilized to locate steel reinforcement and to determine concrete cover.

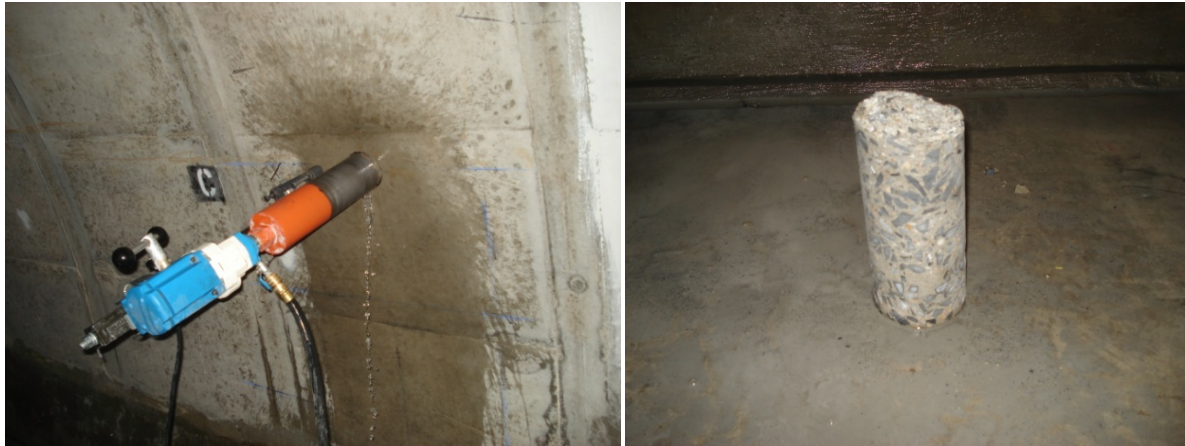
Figure 5 Destructive Testing

Destructive testing was performed to gather sample for laboratory analyses. See below for example of core drilling. Repairs were made for all areas where sample was intrusive.

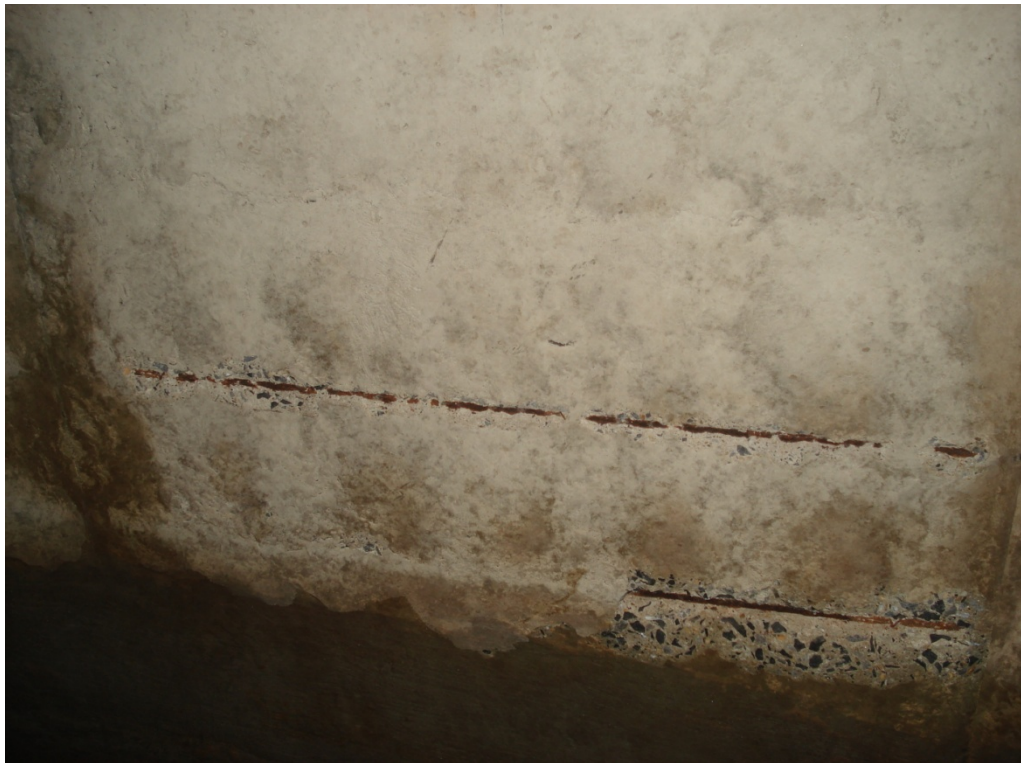
Spalling: Loss of concrete cover promotes corrosion and loss of steel reinforcement cross sectional area, which adversely affects concrete strength.

Figure 11 Spalling (insufficient concrete cover)

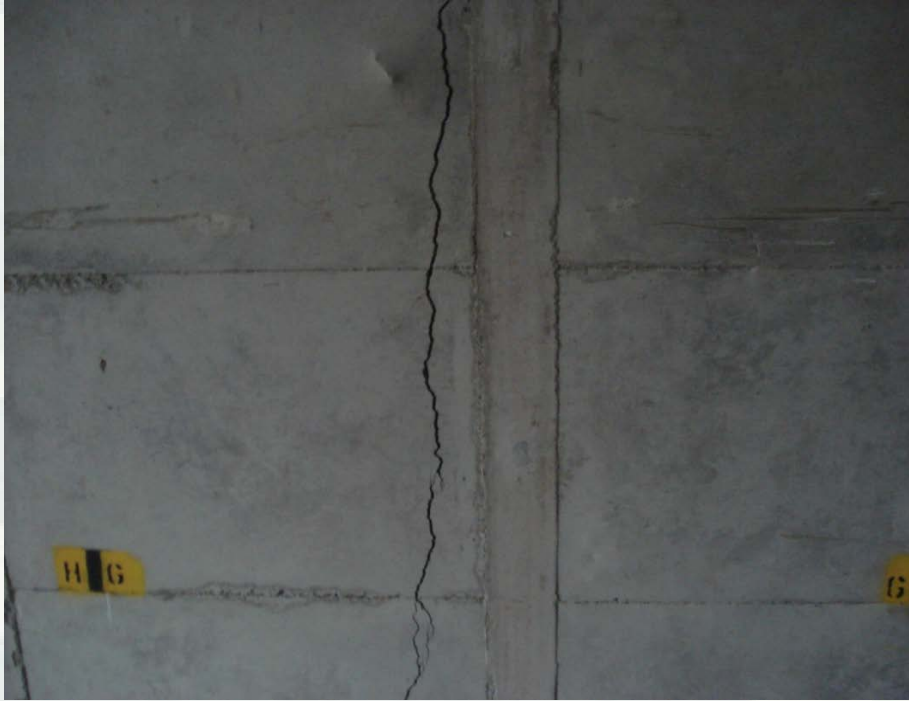
Transverse at Arch Sidewall

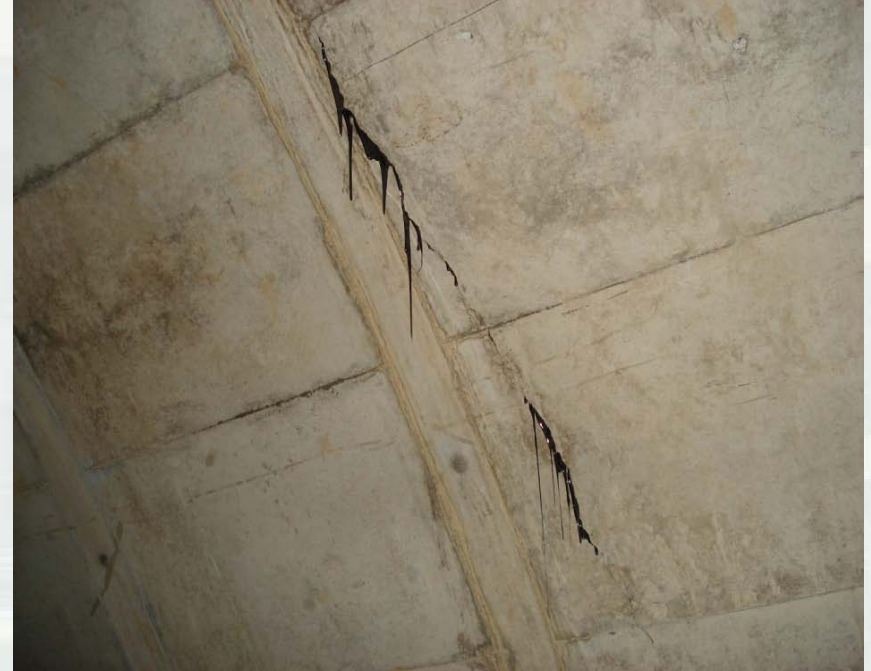
Transverse at Arch
