## **Effects of Aging and Environmental Conditions on Ammunition/Explosives Storage Magazines – Paper 2**

### **Abstract**

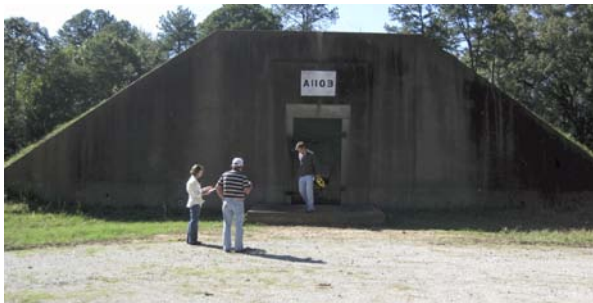
Figure 1. Exterior view of typical ECM.

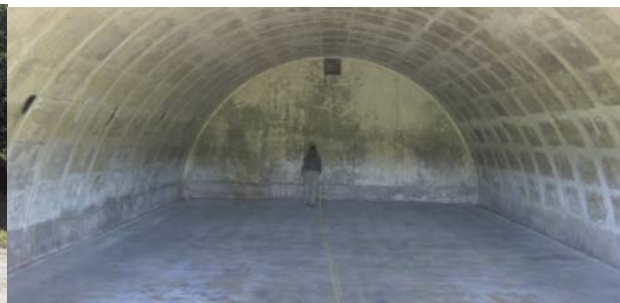
Figure 2. Interior view of typical ECM.

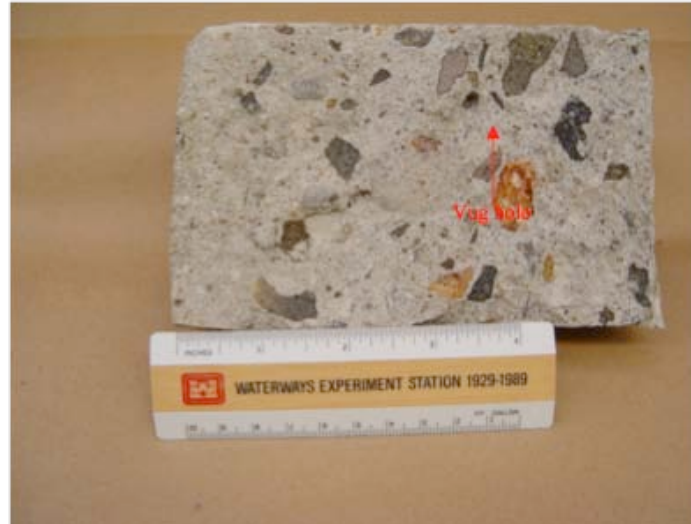
The aggregate particles in all of the core samples exhibit very dense and hard characteristics. The aggregates in the concrete cores that were sampled appeared well sorted, with little to no segregation or poorly consolidated concrete (Figure 9).

Figure 9. Concrete core from ECM.

However, there are some small vug holes that were noticed in one of the cores (Figure 9). These vug holes are generally caused by poor, improper, or incomplete consolidation of the concrete. Yet, it is impossible to get all the entrapped air out of the concrete, and the vug holes noted in these cores are minor.

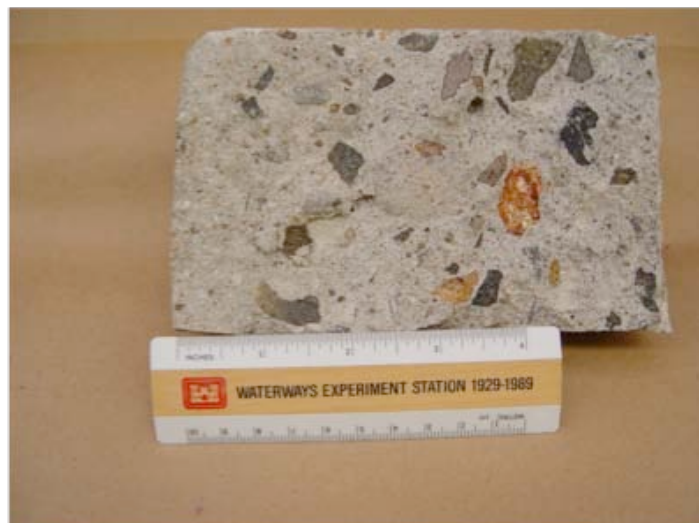
The carbonation test required a core sample to be broken so that a fresh surface could be saturated with phenolphthalein. Once the fresh broken surface had been saturated, the color of the concrete would change to purple if the concrete's pH is above 9.5. Figure 10 shows the freshly broken surface of a concrete core. Figure 11 shows the same core surface after phenolphthalein has been applied.

Figure 10. Freshly broken core sample for application of phenolphthalein.

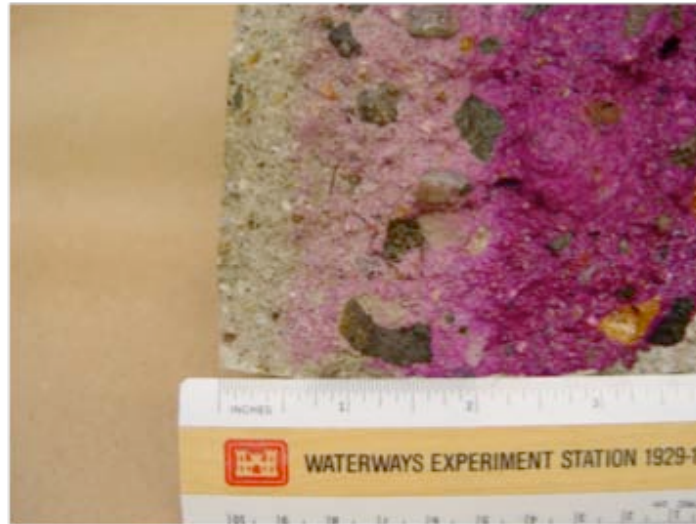
As can be seen in Figure 11, the pH has dropped around the concrete surface of the cores, however the internal portion of the core has a pH higher than 9.5. As can be seen Figure 11 below, the carbonation is severe at a depth of  $\frac{3}{4}$  inch and has moderate carbonation to a depth of

2 inches. The average depth of carbonation on all of the cores from Sierra is roughly 1 ½ inches. This condition is favorable for inhibiting steel corrosion provided the reinforcing steel has sufficient concrete cover. Table 2 details the average depth of carbonation for the different samples.

Figure 11. Core sample after application of phenolphthalein.

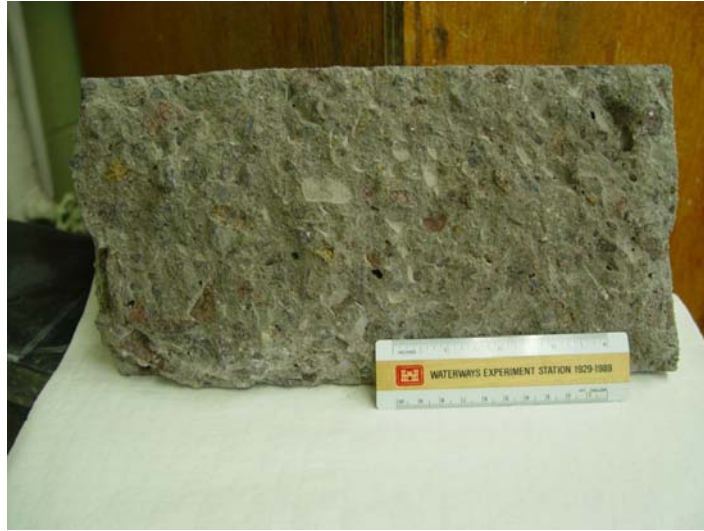
The ASR staining method uses a freshly broken surface of concrete. A core specimen was prepared by breaking open a core to provide a fresh surface. The concrete was washed and loose material was removed (Figure 12), and the sample was then treated with the two stains to determine if any ASR gel was present. The color change from the application of both, sodium cobaltinitrite (Figure 13), and rhodamine B (Figure 14) indicated a lack of ASR gel.

Figure 12. Core sample prepared for ASR staining test.

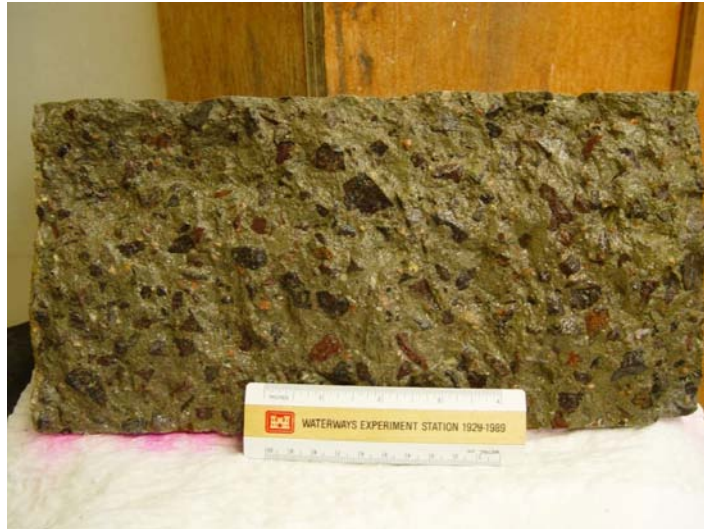
Figure 13. Core sample after application of sodium cobaltinitrite.

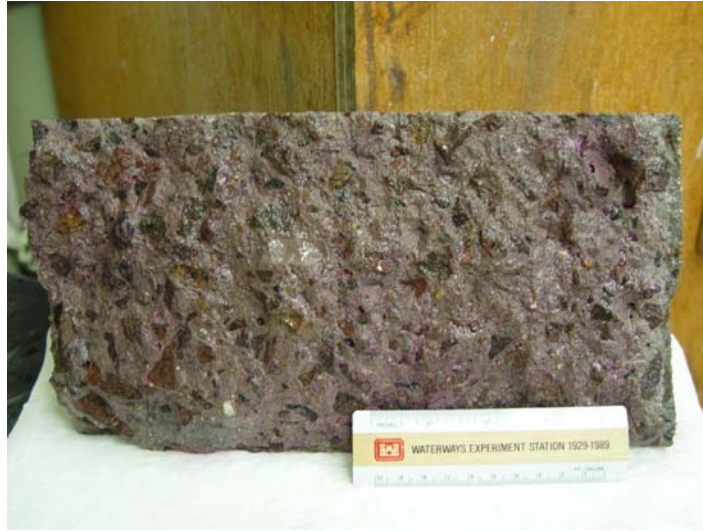
Figure 14. Core sample after application of rhodamine B.

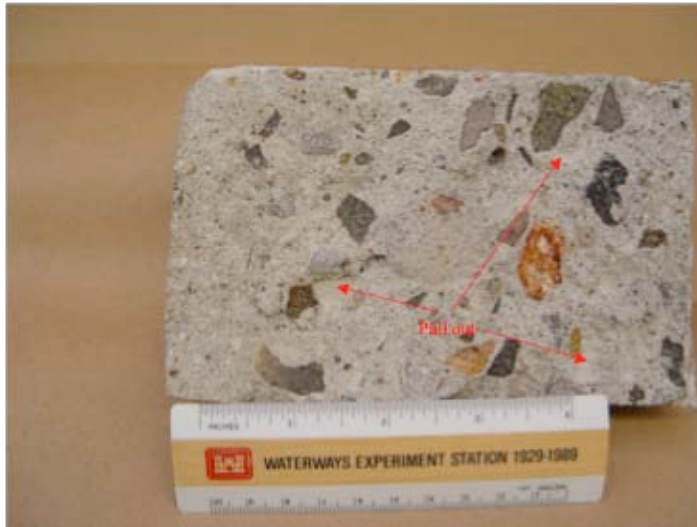
The compressive strength data reported in Table 3 indicate strong, sound concrete with a minimum compressive strength of 3092 psi recorded. In the compressive strength tests, there were very few coarse aggregate pullouts, which indicate that there is a strong bond between the paste and aggregate (Figure 15).

Figure 15. Fractured surface of concrete core (taken from Sierra).

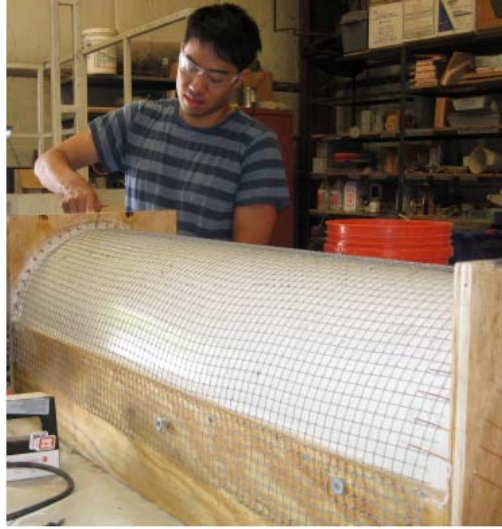
***Laboratory Scale Model Testing*** - Based on similarities in ECM response observed at disparate inspection sites, the project team constructed a simple scale model as depicted in Figure 17 of a reinforced concrete ECM vault structure, and loaded it to failure to determine whether common forms of ECM deterioration (e.g., longitudinal cracking at the apex of the vault, and lateral cracking midsection, etc.) could be simulated using laboratory testing. The simple scale model is shown in the figure below, where it is being constructed by OU graduate student Andrew Ngheim. The scale model utilizes a reusable vault mold (so that testing results can easily be repeated) that simulates reinforced concrete ECM structures using a mortar and wire fabric composite construction. The resulting scale model structure is placed in a loading box that restrains the structure from any displacement at its springing-line supports, and loads are applied to the top of the structure until it fails.

Figure 17. Vault scale model under construction.

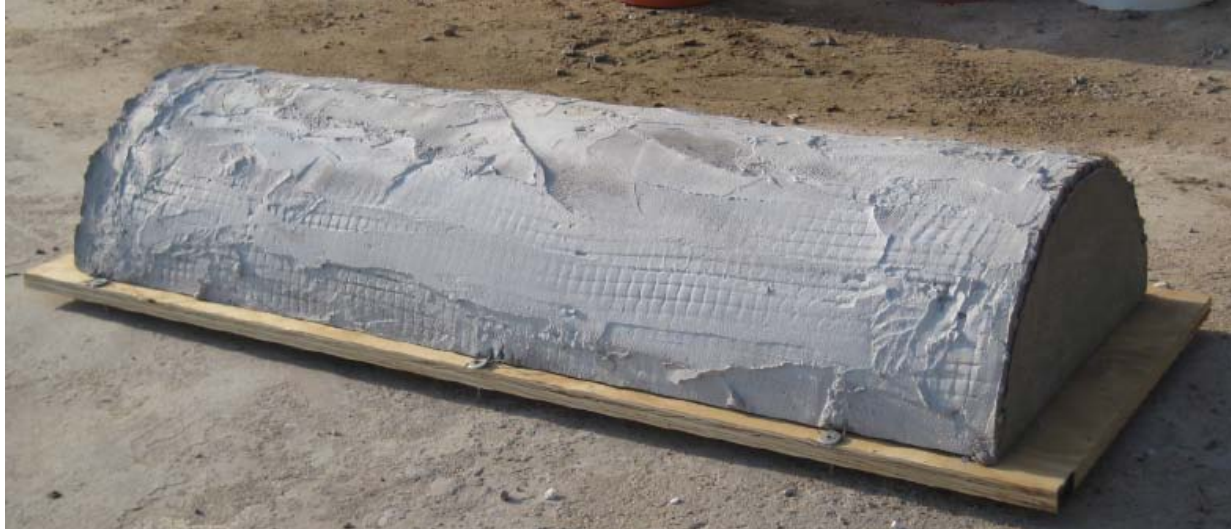
The model ECM used a wire fabric arranged in 1/2-inch squares composed of 19-gauge steel wire to simulate the embedded reinforcement. The mortar was approximately 1/2-inch thick, so that a wall thickness of approximately 10 inches was used for the actual ECM. The curvature of the scale model was obtained by using a 14-inch diameter PVC pipe for the mold. This provided both accurate geometry and it facilitated removal of the ECM scale model from the model. The resulting scale model is then constructed of mortar, and left to cure until the mortar has reached an appropriate strength as Figure 20 displays.

Figure 20. Finished ECM scale model.

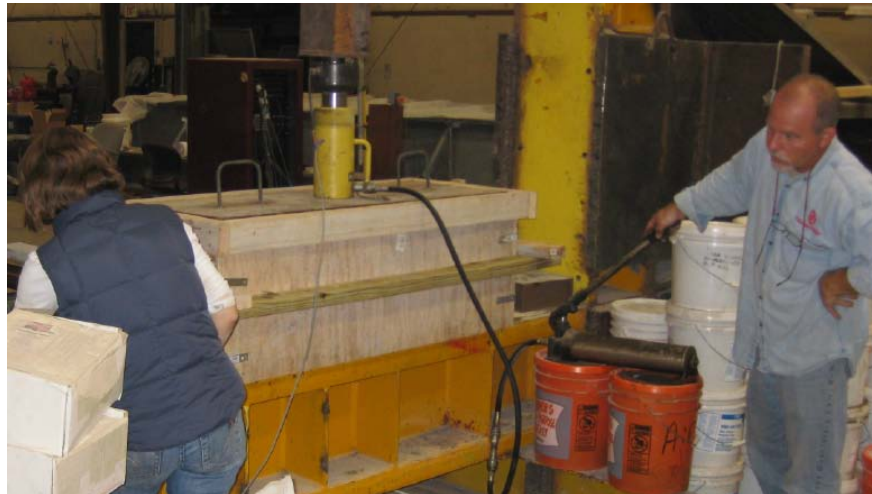
The scale model ECM was then loaded to failure in the University of Oklahoma's Donald G. Fears Structural Engineering Laboratory, as shown in Figure 21. The model was placed in a box and covered with sand. The sand was then covered with a large steel plate to distribute the load evenly, and a load cell was applied to the top of the plate. There was a hole in the bottom of the box that allowed a camera to be placed inside the structure to monitor the structure during loading.

Figure 21. ECM scale model under loading.

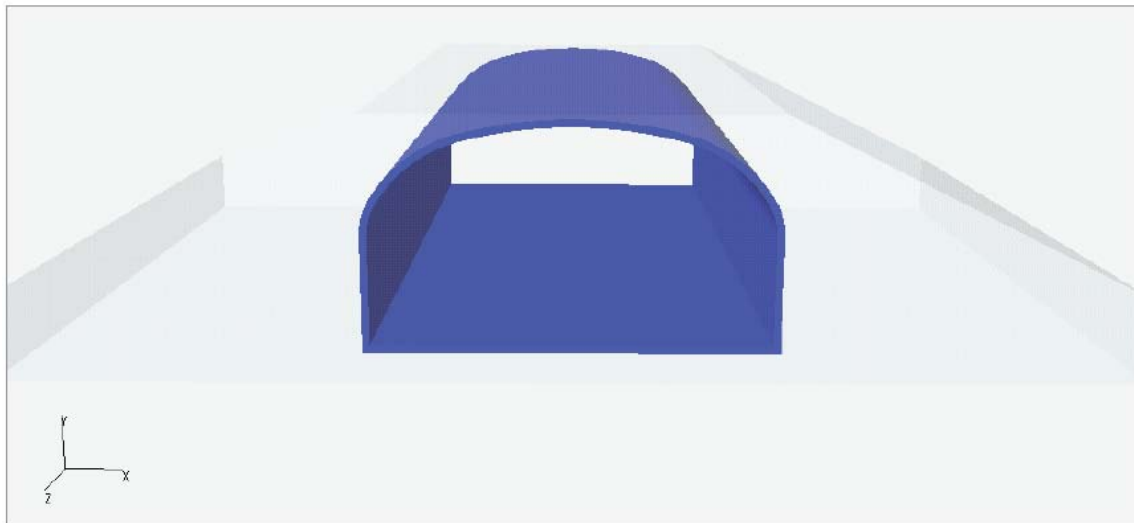
Figure 29. Concrete components for fully-coupled ECM/soil analyses.

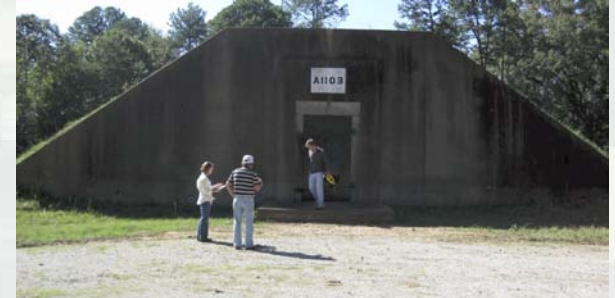
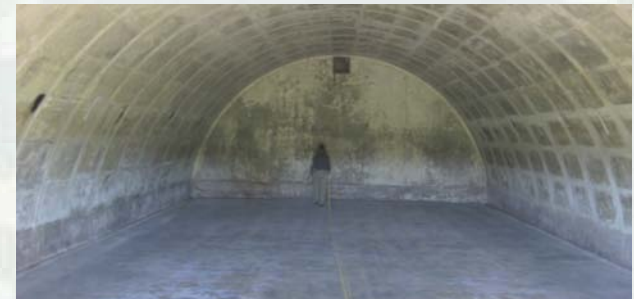
- significant spall on interior handwall due to heavy freeze thaw damage  
 - significant efflorescence on interior handwall  
 - floor slab cracking

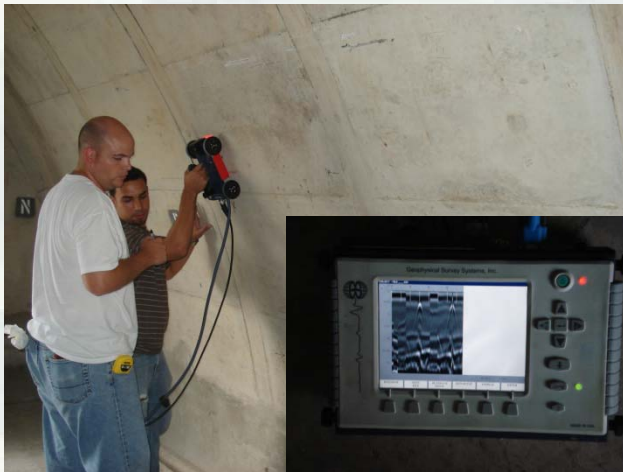
Ground Penetrating Radar

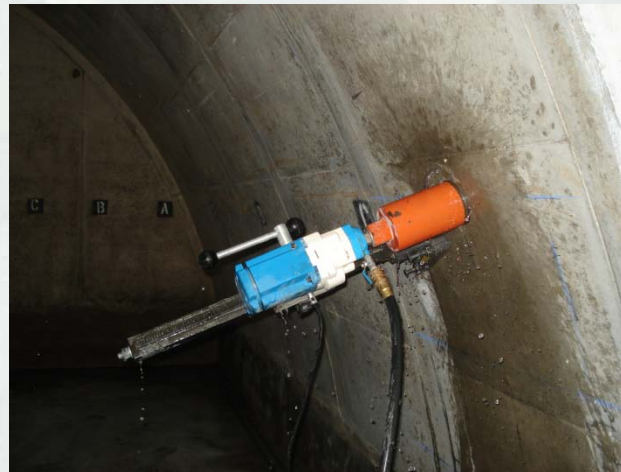
Shibuya 15 amp electric coring machine.

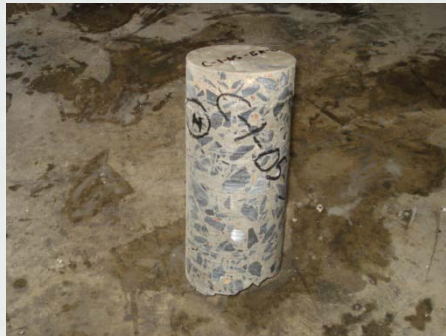
Concrete core produced from any of the coring equipment. All cores retrieved were 4 inches diameter. The lengths varied between 9 and 11 inches.

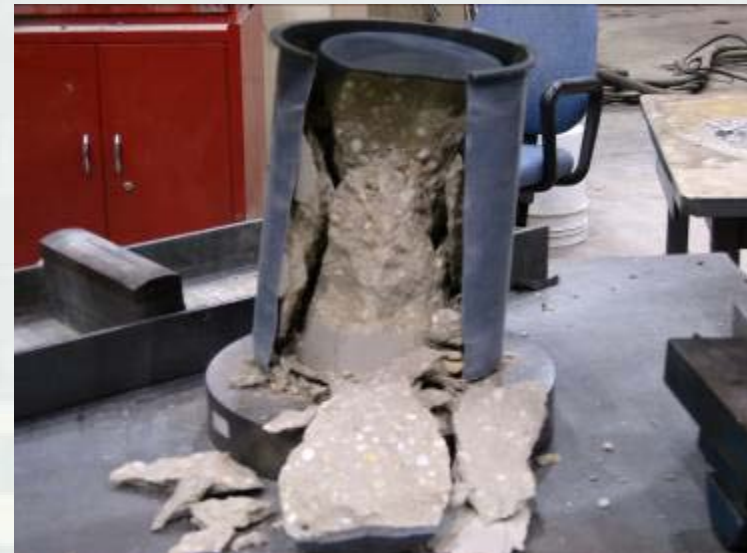
Broken specimen from Compressive Strength test.

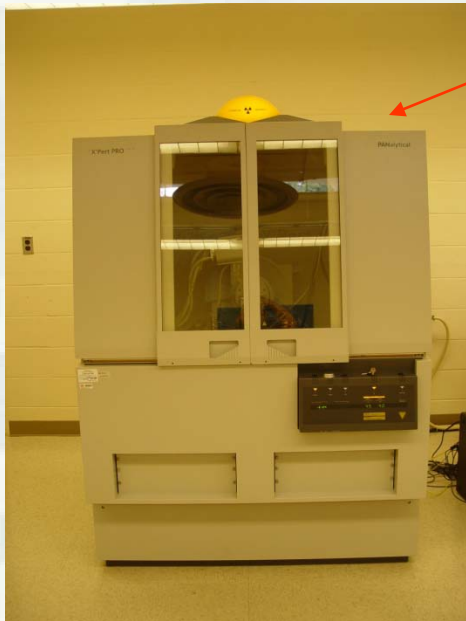
PANalytical X'Pert PRO  
DIFFRACTOMETER

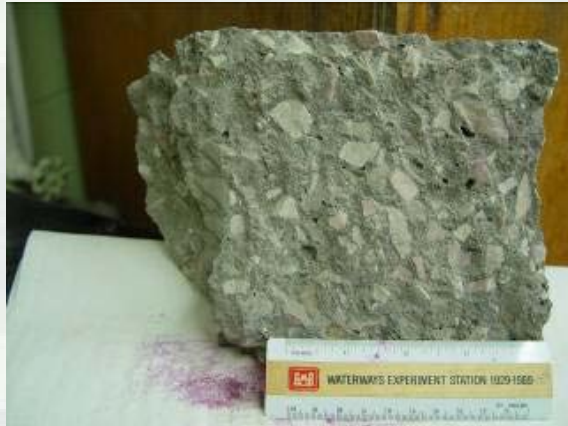
Freshly broken surface.

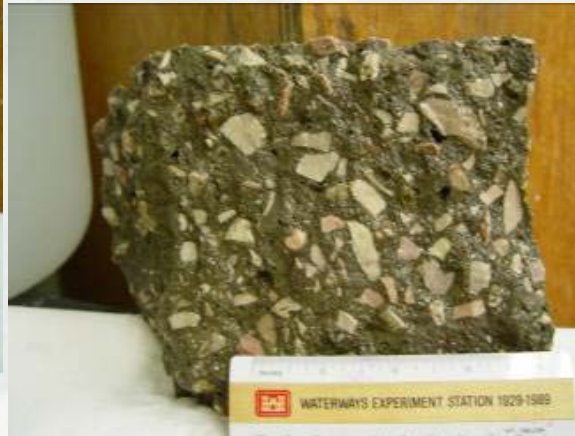
Surface after being flushed with sodium cobaltinitrite. No visible yellow stain indicates that there is no early stages of Alkali Silica Reactions (ASR) taking place

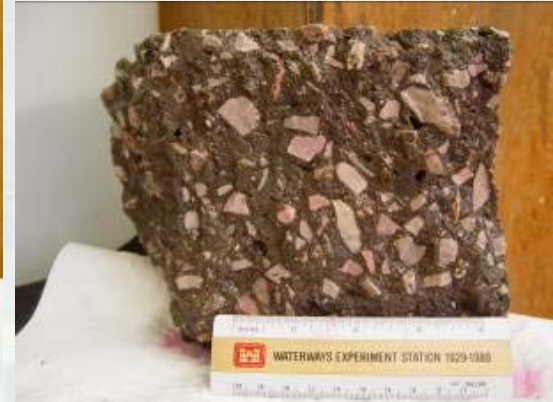
Surface after being flushed with rhodamine B. There was no visible pink staining, this indicates that there is no advanced ASR attack taking place

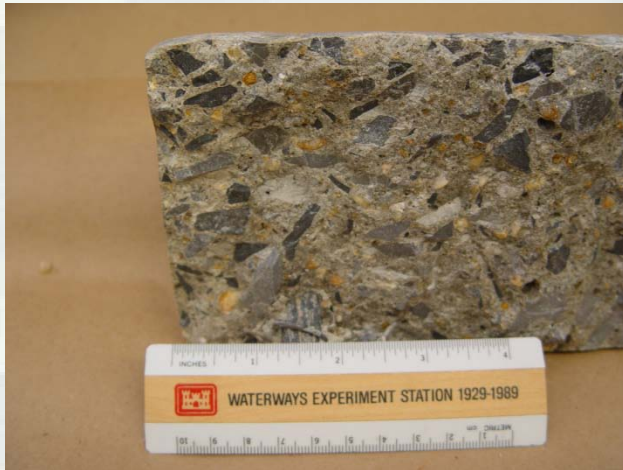
Freshly fractured surface.

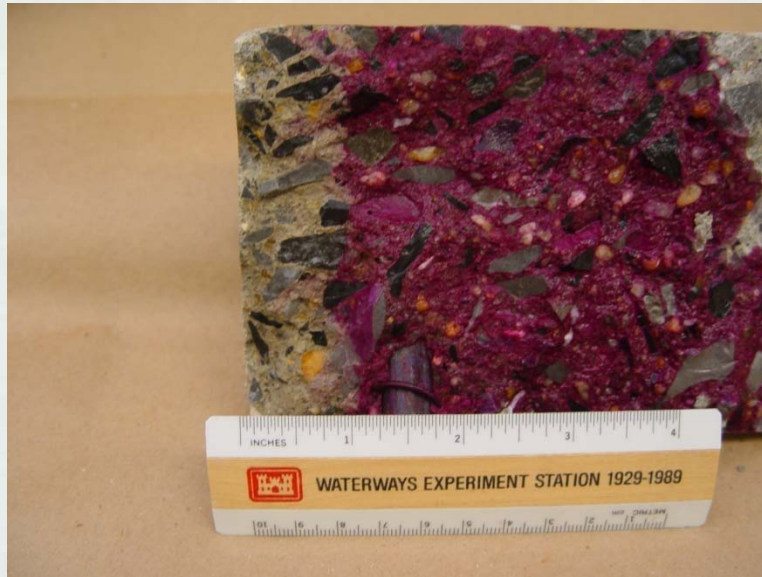
Surface flushed with phenolphthalein. Notice the dark purple color of the area.

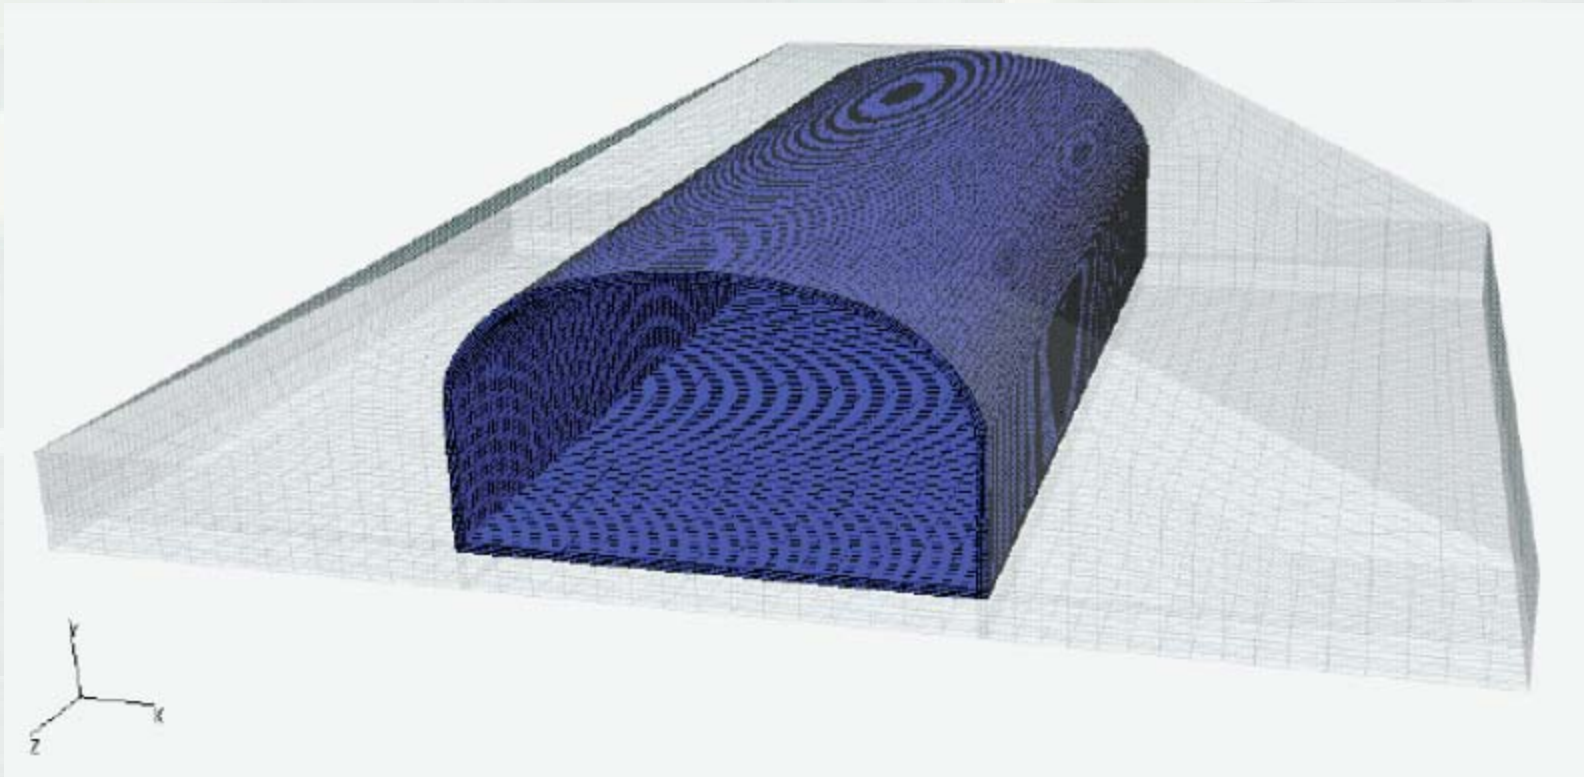
# Effects of Aging on ECMs Computer Model

- Computer and Laboratory Models recreated deformation patterns observed in the field.
- Terra Scale model verified:
  - ▶ Highest forces occur at the springing line reactions
    - Highest concrete displacement at arch apex
- Terra Scale is currently being pursued further (includes soil structure interaction)
