ENGINEERING SERVICE CENTER  
Port Hueneme, California 93043-4370

## **TECHNICAL REPORT TR-2352-ENV**

# **Application of a Bimetallic Treatment System (BTS) for PCB Removal from Older Structures on DoD Facilities**

November 2010

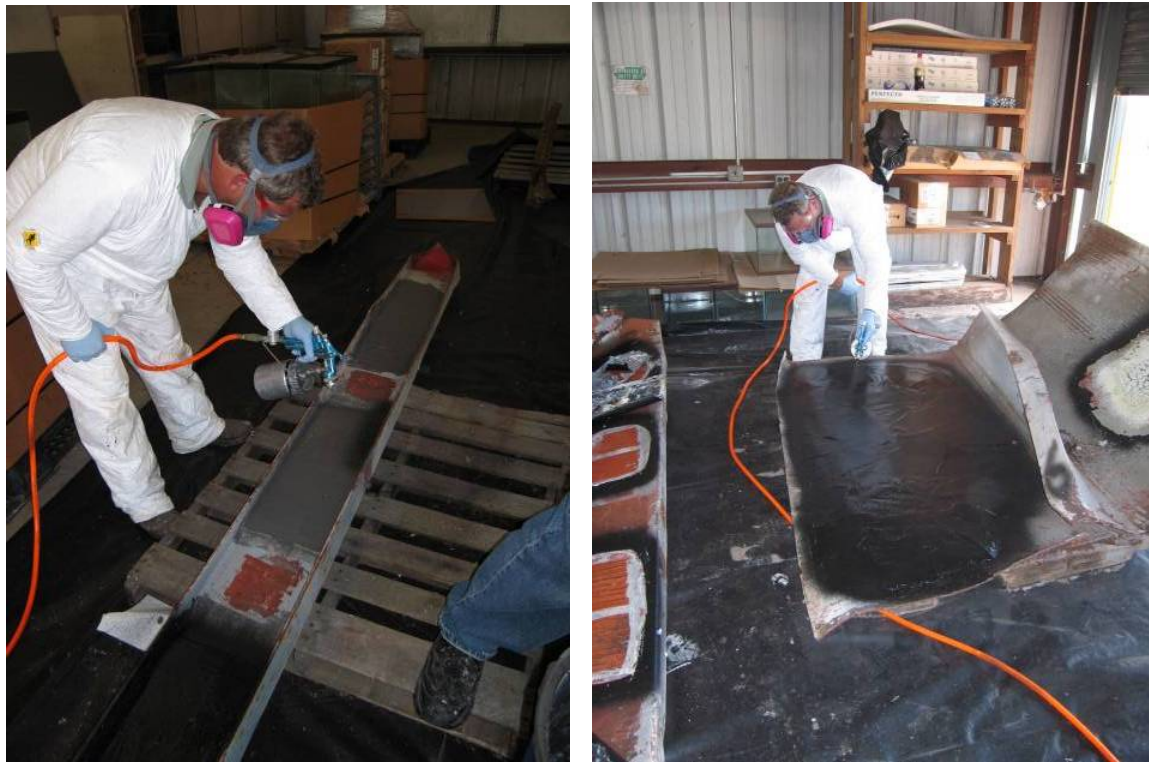
**Figure 5-11.** Application of coating material using HVLP sprayer.

Sealants were used to coat the surface of the BTS paste in an attempt to prevent loss of solvent from the BTS following application. Two sealants were tested, 1) a silicone roof sealant (Sil) (mineral spirits-based); and 2) a vinyl polymer truck bed liner (VP) (toluene-based). These were diluted with solvents (ethanol or mineral oil for the Sil, acetone for the VP) in a 3:1 coating: solvent ratio in order to allow for ease of spraying during application. They were both applied using a high volume/low pressure (HVLP) sprayer. Approximately 5 coatings of each material were applied to the BTS surfaces and at least an inch beyond the edge of the BTS paste, to seal the edge of the paste. Care had to be taken when applying the initial coating of sealant and the sealant allowed to set for a short period of time (roughly 5 minutes) before additional coatings could be used. If a heavy coating (high flow rate) of sealant was applied at the start, it tended to displace the BTS from the surface that was being treated. Once the sealant was in place, the BTS paste was allowed to react for the specified times (one, two three or four weeks). Figure 5-11 shows the application of the truck bed liner sealant material.

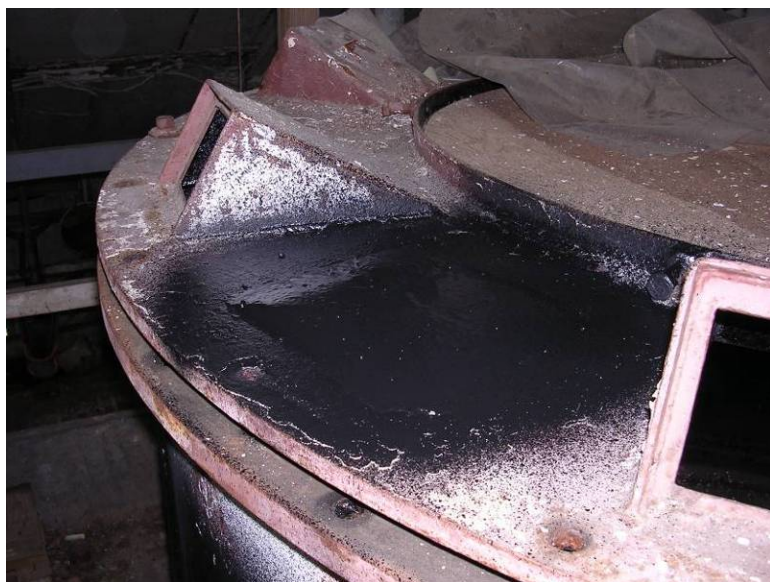
Figure 5-25. Large tank lid, treated with Mg/Pd-VP, immediately after application.

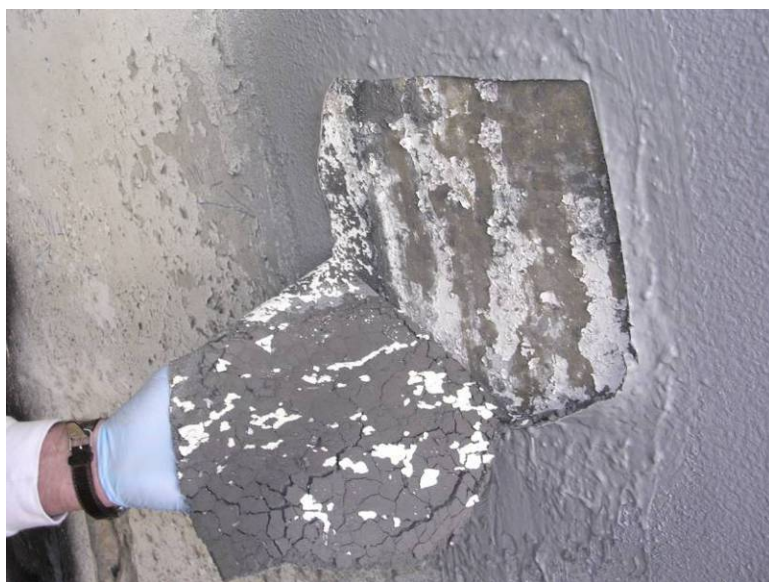
Figure 5-41. One week post application, during sampling, Mg/Pd-silicon, 6810-11.

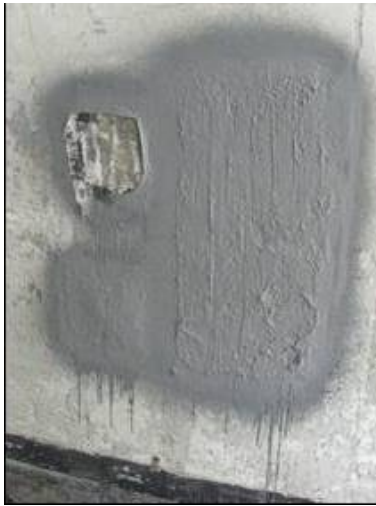
Figure 5-43. Mg/Pd-silicon prior to two week sampling event, 6810-11.

Figure 5-43 shows the Mg/Pd silicon site prior to taking week two samples and that the sealant had not failed at this location. Figure 5-44 shows the Mg/Pd-silicon site during the two week sample was taken.

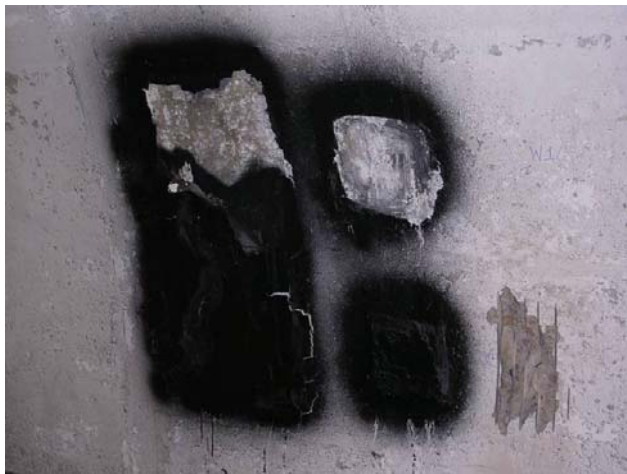
Figure 5-45. Mg/Pd-VP prior to three week sampling event, 6810-11.

Figure 5-45 shows the status of the 6810-11 Mg/Pd-VP treatment site prior to sampling after three weeks of treatment. It can be seen that the condition of the sealant did not change very much between weeks two and three. The three week sample for this treatment location was taken from the 1 ft<sup>2</sup> area that was still intact. Figure 5-46 shows the NM-VP treatment location, prior to taking the three week sample. It can be seen that a portion of the VP sealant broke loose between week two and week three sampling. Figure 5-47 shows the Mg/Pd-silicon treatment area and it can be seen that the 3 ft<sup>2</sup> section is still intact. Figure 5-48 shows the Mg/Pd-silicon site after sampling. Figure 5-49 shows a sample of concrete being taken from the Mg/Pd-silicon site after three weeks of treatment.
