# SEED FINAL REPORT

## Assessment of Historic Concrete and Masonry by Broadband Vibration Testing

SERDP SEED Project RC-1653

August 2010

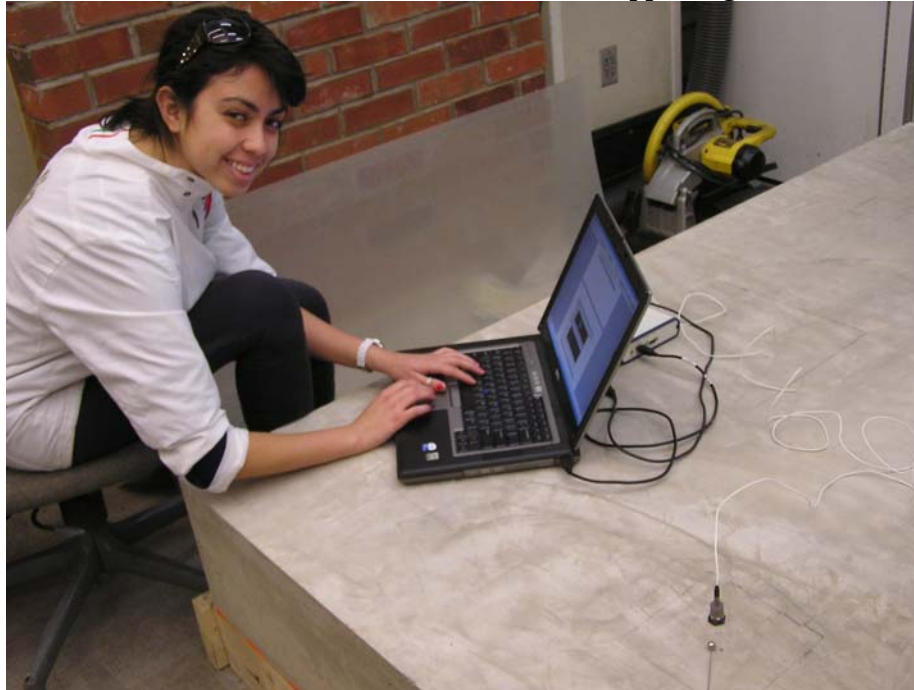
Figure 1: Accelerometer testing of a test slab, including operator, computer, data acquisition module (partially concealed behind computer and accelerometer).

*Accelerometers:* PCB model 352A78 ceramic shear accelerometers were selected for the prototype EMA/IE system. These accelerometers were chosen because their flat calibrated frequency response characteristics ( $\pm 2.5\%$  from 5 Hz to 10 kHz, and  $\pm 5\%$  from 10 to 15 kHz) enable their use for both EMA and IE assessments. Actual achievable frequency response is dependent on accelerometer mounting technique. Threaded stud mounts are incorporated in the accelerometers to which adhesive mounting bases are attached with a light film of silicone grease to improve vibration transmissibility. When cyanoacrylate or epoxy adhesives are used to attach the mounting pad to the material under test at each measurement point, this technique can yield acceptable performance up to 20 kHz. The application of this equipment is depicted in Figures 1 and 2.

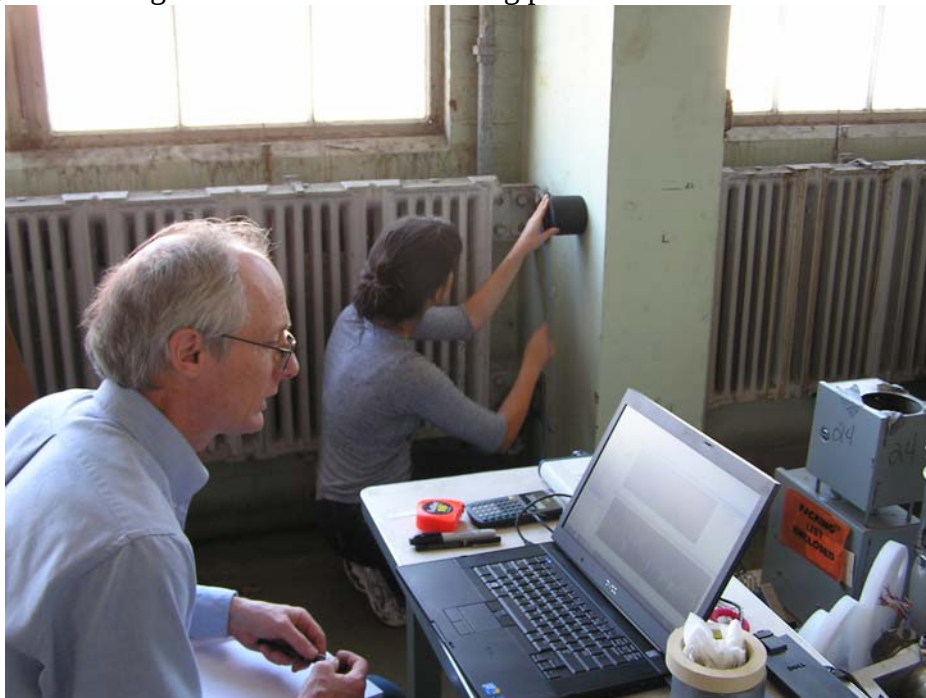
Many of the plain concrete pedestals supporting the columns in Building 19 display patterns of cracking. The most commonly occurring crack is a horizontal crack through the pedestal at approximately mid-height, but in other cases diagonal cracking initiating at the horizontal crack and stand-alone diagonal cracking are observable. Impact-echo testing was performed on a number of the pedestals, some with observable cracking, and some without observable cracking. A sample of the pedestals in Building 19, was also tested using air-coupled impact-echo analysis. The pedestals have dimensions of 12"  $\times$  24" in plan, and a height of 72" above the floor. The pedestals were tested at three elevations across the 12" width, along the 24" length, and also tested once along the height. The aspect ratio of the pedestal in the 12" (transverse) direction qualifies it to be considered as a plate structure, and is the most favorable for impact-echo testing, while in the perpendicular direction, the pier is considered as transitional between a plate and a rod. In testing along the height, the pier is considered to behave as a rod. The pedestals have designations N (north) or S (south), and are numbered from 1 to 10 beginning at the east end of the building. The pedestals on the north side of the building display the greatest damage, while those on the south side appear substantially undamaged. The pedestals tested were 3N, 6N, 7N, 8N, and 8S. Figure 12 illustrates the testing procedure.

Figure 12: Air-coupled impact-echo testing of pedestal in Building 19.

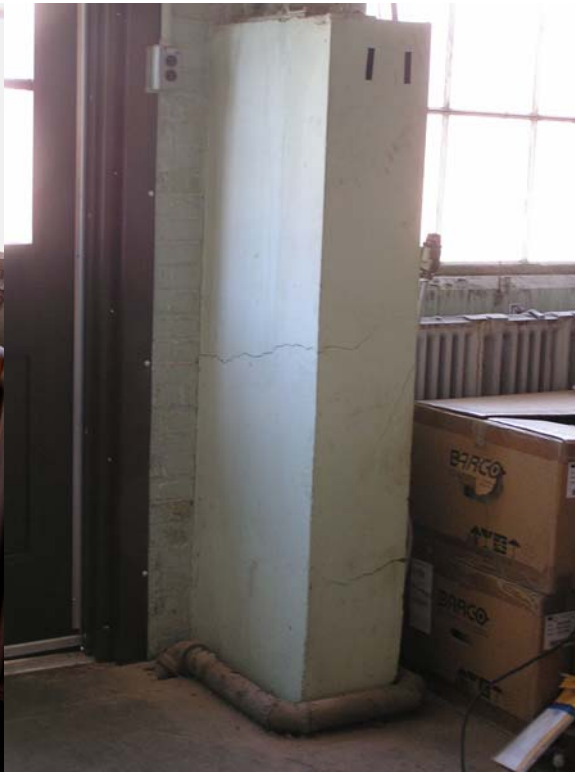
Figure 28: Pedestal 1 north: severely damaged pedestal.

5.1 kHz and very few higher-frequency return signals, indicating very little disruption of the sound wave through the thickness of the pedestal. If there were a reinforcing layer at the far side of the pedestal, it would show as a larger signal at a slightly higher frequency. Most tests on the pedestals in Building 19 did not show the presence of reinforcement. A spectrum (Figure 26) taken on the same pedestal in the region of a small, but apparent, crack shows the disruption in the pattern of frequencies caused by the internal crack. The additional peaks at 10 and 15 kHz indicate that sound waves are being reflected by an internal obstruction, such as a crack or an inclusion, at approximately one half (10 kHz) and one third (15 kHz) of the thickness of the pedestal. Illustrations of typical patterns of damage in the pedestals are shown in Figures 27 and 28.
