**OFFICE OF THE SPECIAL INSPECTOR GENERAL
FOR AFGHANISTAN RECONSTRUCTION**

**INSPECTION OF IMPROVEMENTS TO THE
KHOWST CITY ELECTRICAL POWER SYSTEM:
SAFETY AND SUSTAINABILITY ISSUES
WERE NOT ADEQUATELY ADDRESSED**

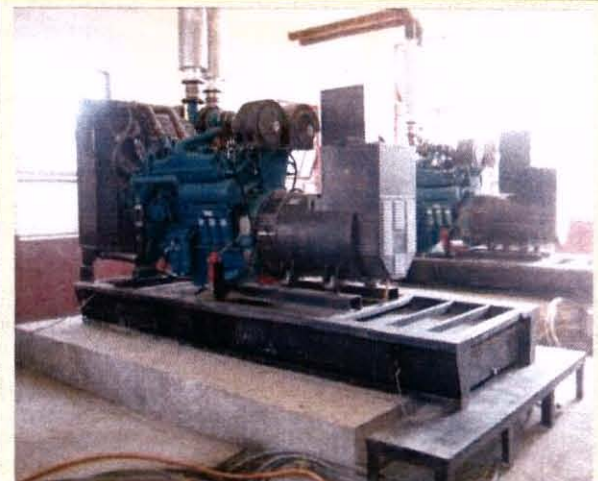
Photo: One of the three new generators installed at the Khowst City Power Plant 1 using CERP funds through a project initiated and overseen by the Khowst PRT: (Photo—SIGAR)

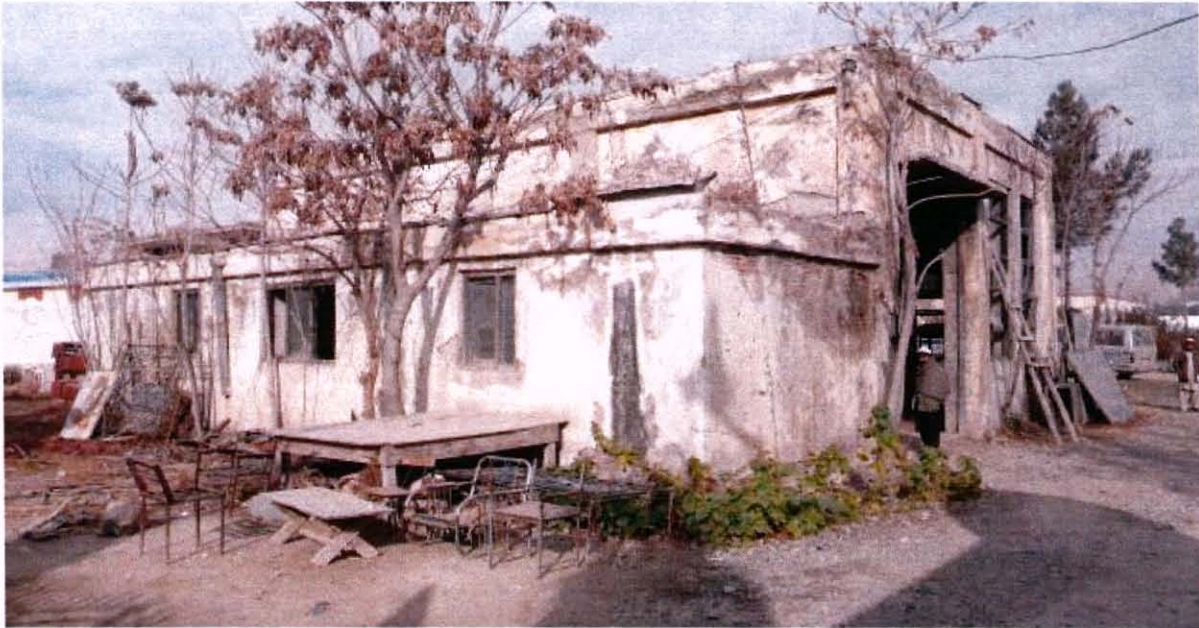
Photo 1: Power Plant 1 PRE-IMPROVEMENT Condition of Power Plant 1, Spring, 2008 (Courtesy of Khowst PRT)

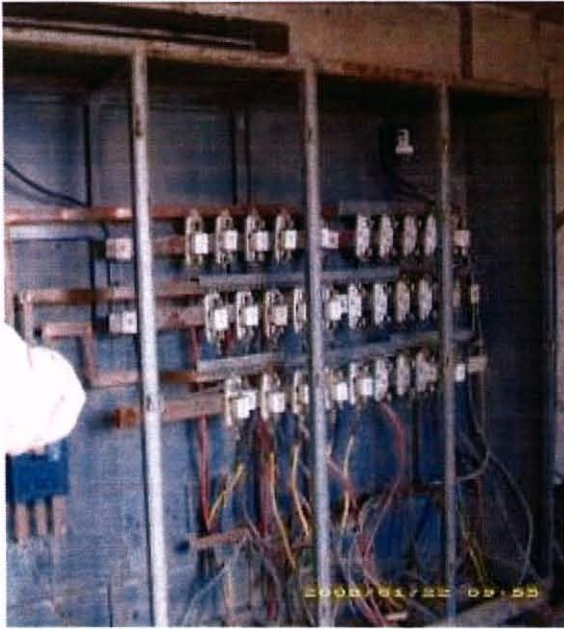
Photo 2 and 3: Power Plant 1 PRE-IMPROVEMENT—The main power distribution panels at Power Plant 1 as they appeared prior to the renovation work done in the spring 2008; showing no cover doors and high voltage wires lying exposed on the ground instead of being run through power cable canals that lead to the generators. (Photo courtesy of Khowst PRT)

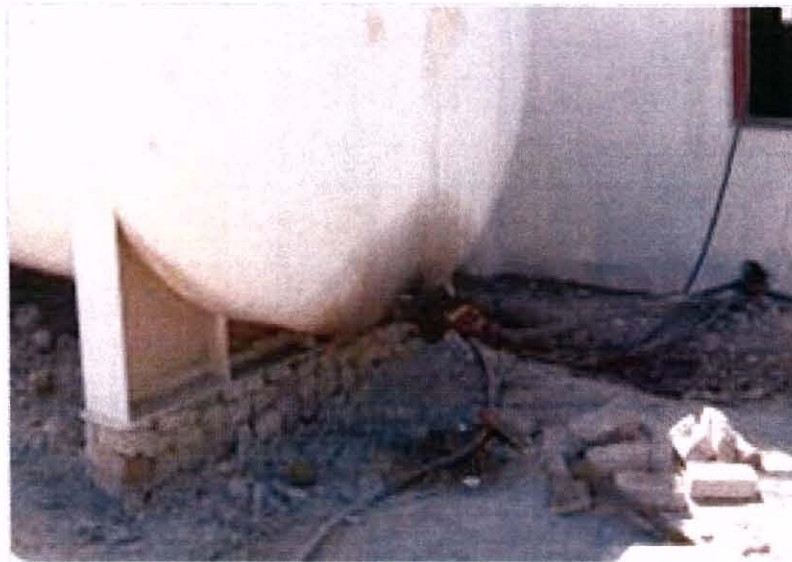
Photo 4: Power Plant 1 PRE-IMPROVEMENT—The 20,000 liter diesel fuel storage tank located at the outside rear wall of the main Power Plant 1 building. The tank is balanced on a platform of loose bricks with no spillage containment. Hoses are leaking fuel into the ground. The support deficiencies and lack of a spill containment area were documented requirements for the project in January 2008; however, no provision to improve this condition was made in the final scopes of work for the project. This photo documents the conditions observed by the SIGAR Inspection Team in May 2009. (Photo courtesy of Khowst PRT)

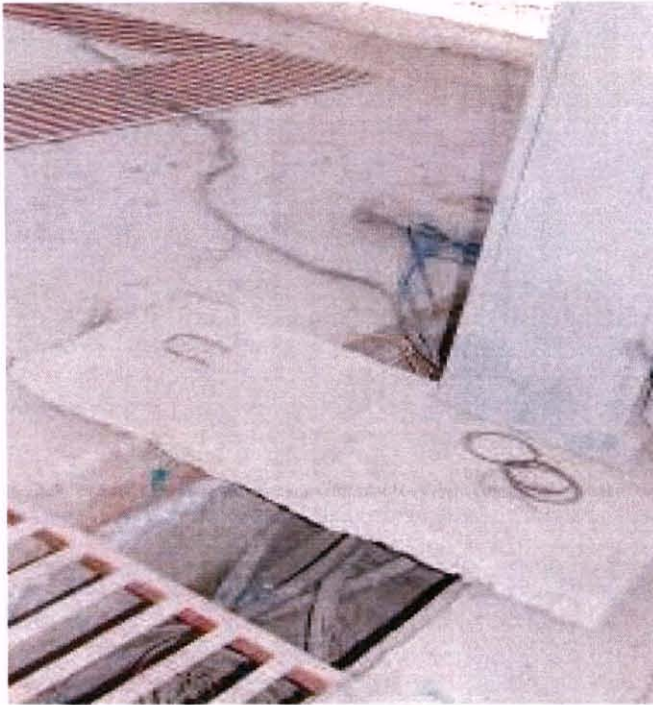
Photo 9: Power Plant 2 - View of the power distribution panel being balanced on one of two concrete slabs without any other means of support. (Photo—SIGAR)
