## **Laboratory Testing of Architectural Exterior Wall Fins**

Leonard Zabilansky, William Burch, and Tommie Hall

January 2009

Final report

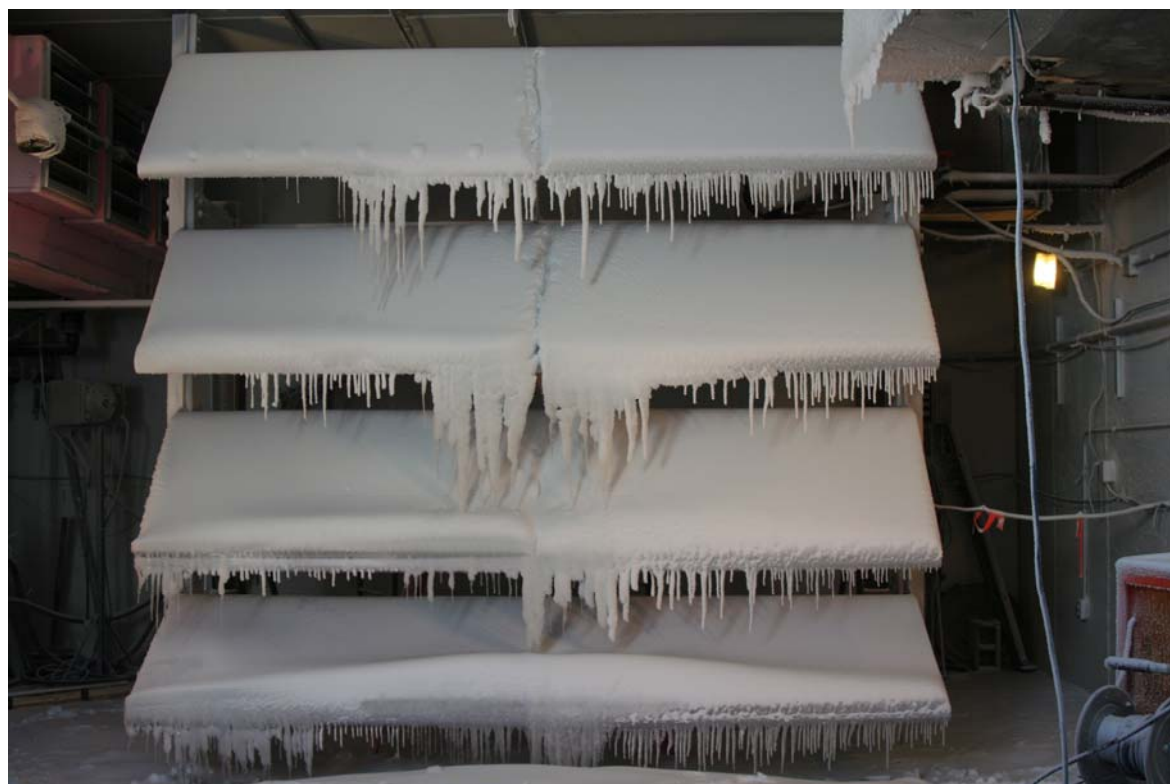
*COVER*: Initial condition of mock-up covered in snow and ice of varying thicknesses from 2.5 to 7 inches; ice retention devices are installed on the left side of the fin and the right side is used as the control.

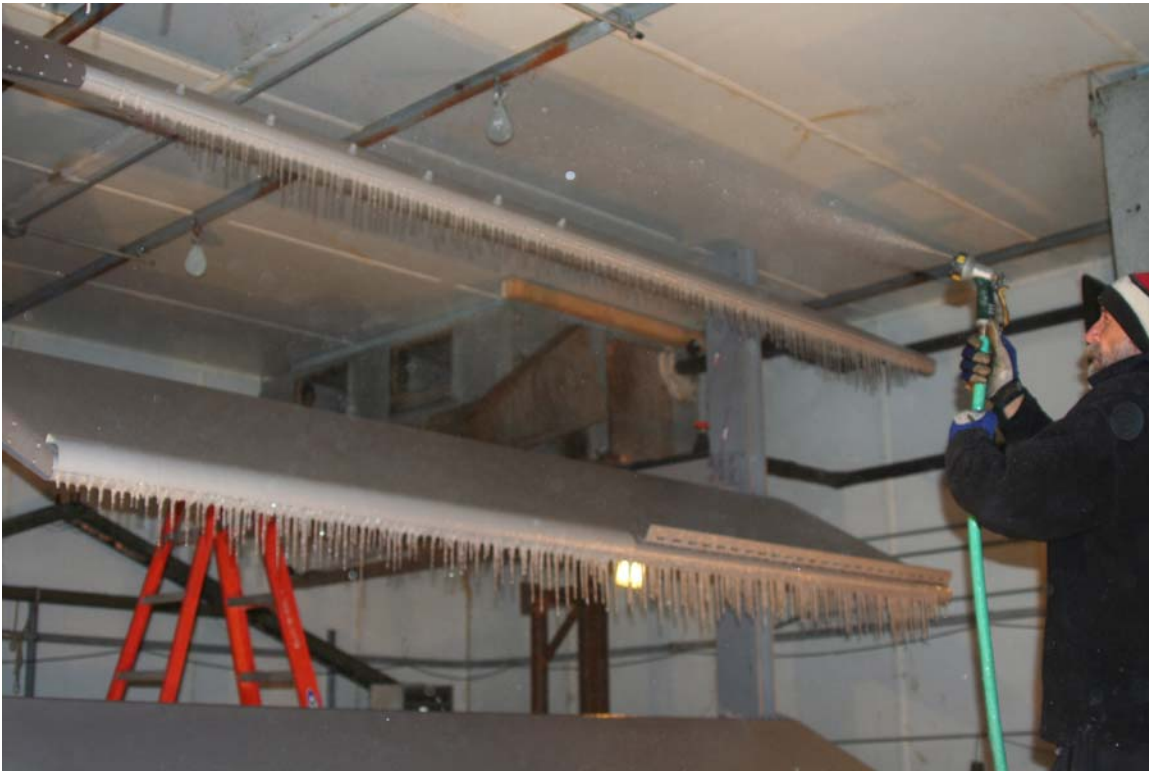
Figure 10. Icing of the model with a spray nozzle on a garden hose.

The fin wall mock-up was tested in the Materials Evaluation Facility (MEF) at CRREL. Ambient temperature was maintained below freezing while the fins were subjected to either icing or snow conditions. The model was iced by successively wetting the fins' surface with misting nozzles on a garden hose as shown in Figure 10. A commercially available snow gun adapted with an articulating wand was used to cover the model with snow. A low-velocity fan was used to create a light wind in the room to assure the snow was evenly distributed near the structure (Figure 11). Once the desired layer of ice or snow accumulated on the fins, the refrigeration air units were defrosted to recover cooling efficiency. With the air units defrosted, the room temperature was cooled to stabilize the accumulation before starting the test sequence.

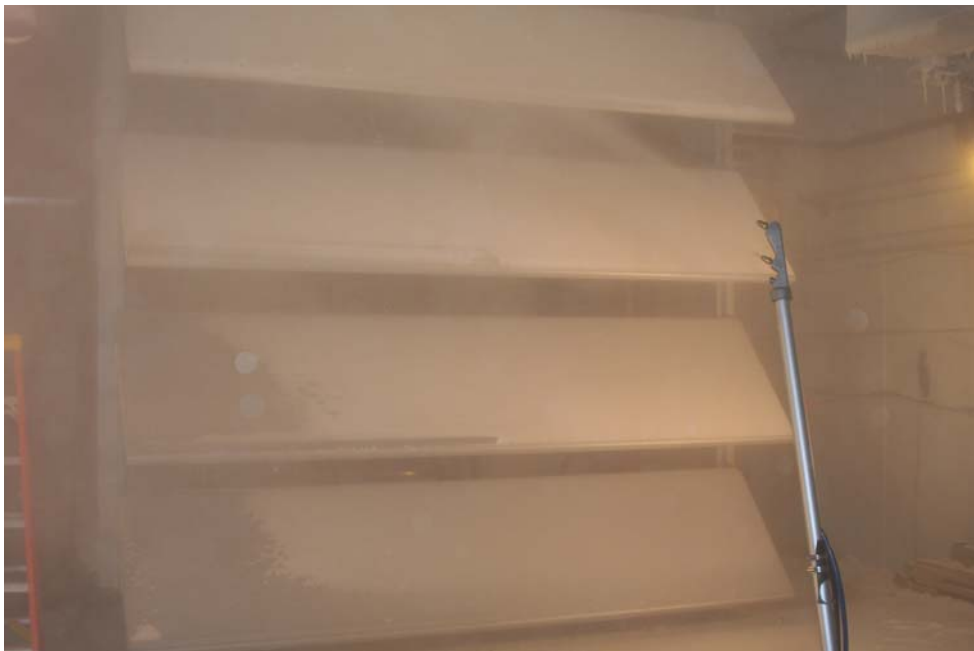
Figure 11. Snowmaking using a commercially available snow gun with an articulating head. A low-velocity fan is used to provide even distribution of the snow.

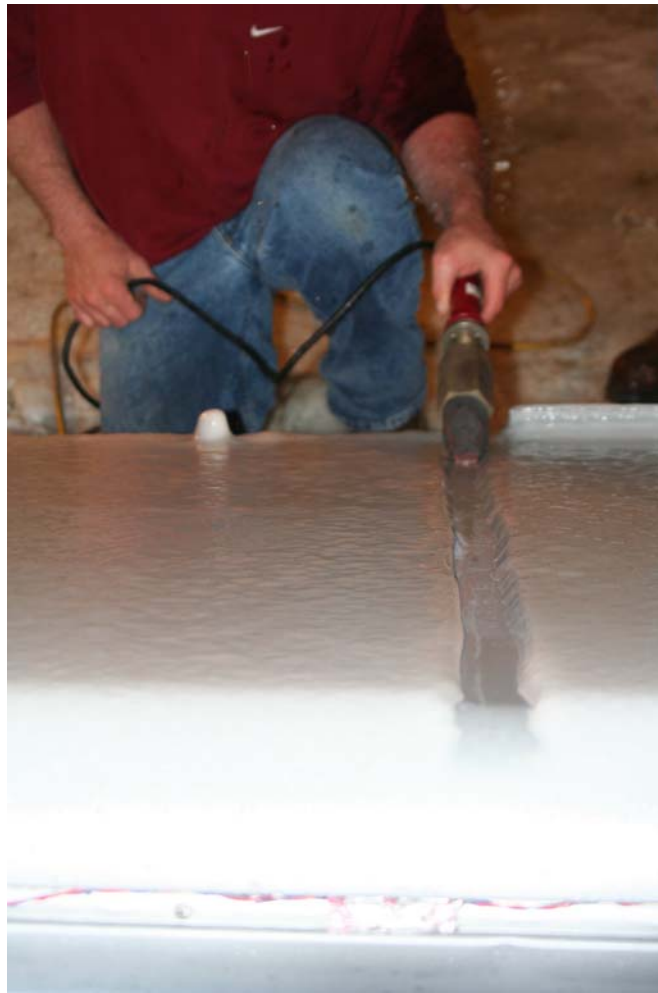
Figure 12. Deicing a vertical slot to isolate the modified side ("A") from the control side ("B").

To assure that the ice shedding process on the A and B sides of the fins were independent, a narrow strip on the vertical centerline of the fin was deiced before starting the test procedure. A hot iron as shown in Figure 12 was used to melt the ice or snow to minimize the area affected by the deicing procedure.

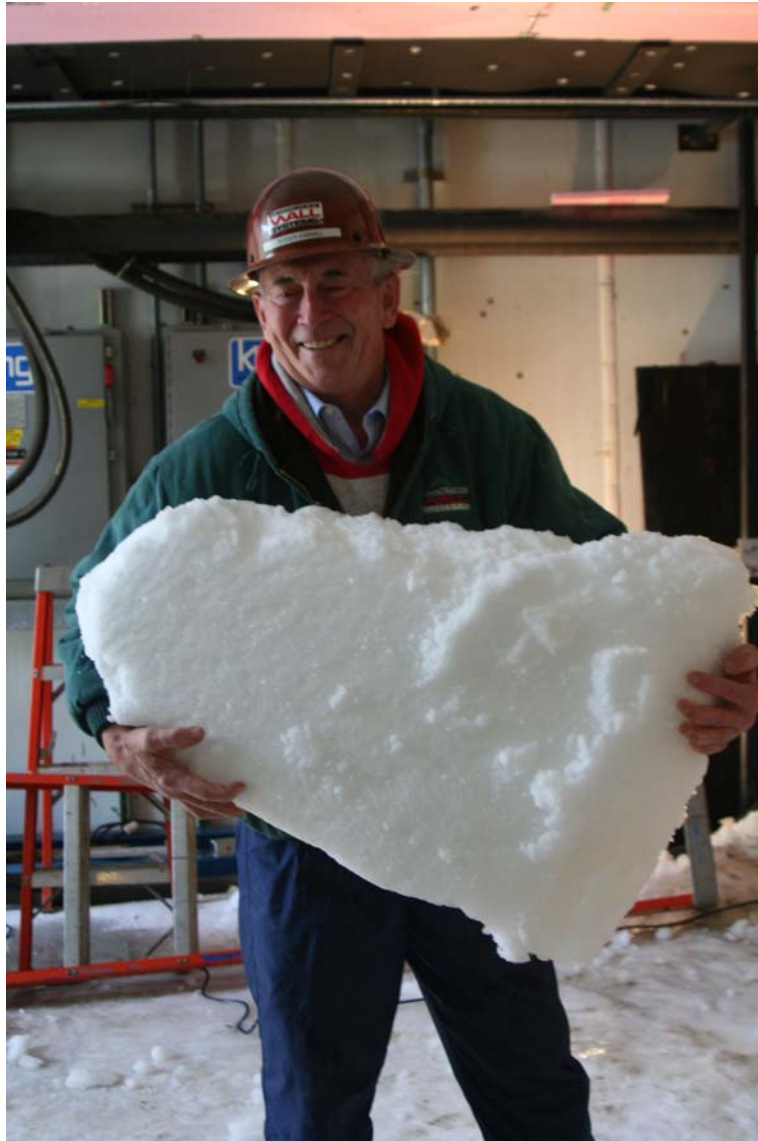
Figure 14. Piece of snow that fell off standard fin without the IRDs.

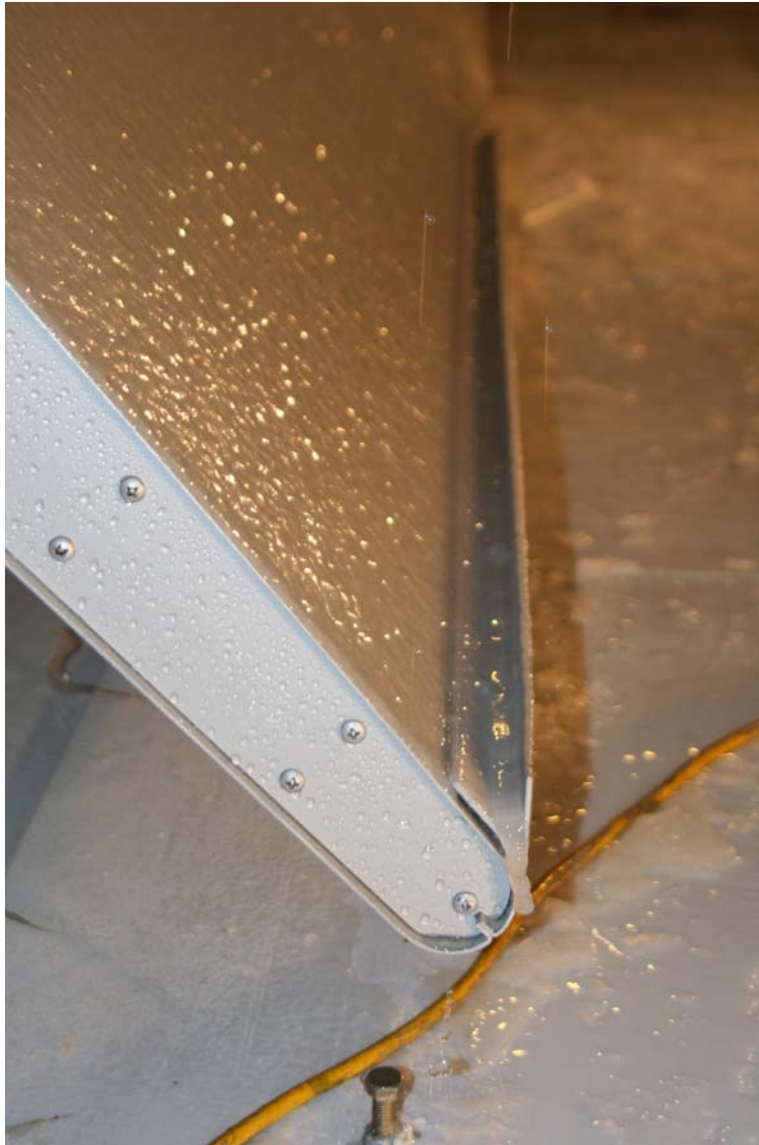
Figure 15. IRD option 1; with a frozen drainage path, the water is diverted to the end of the fin.

The continuous IRD options 1, 2, and 3 are problematic especially in icing conditions. The device is mounted along the lower edge of the fin and spaced off the fin 3/16 of an inch to allow water to drain under the IRD. In icing conditions, water freezes under the IRD and blocks the drainage paths. Water draining off the fin is redirected to the end of the fin. Ice forming in the trough between the fin and the top edge of IRD options 1, 2, and 3 is shown in Figures 15, 16, and 17, respectively.

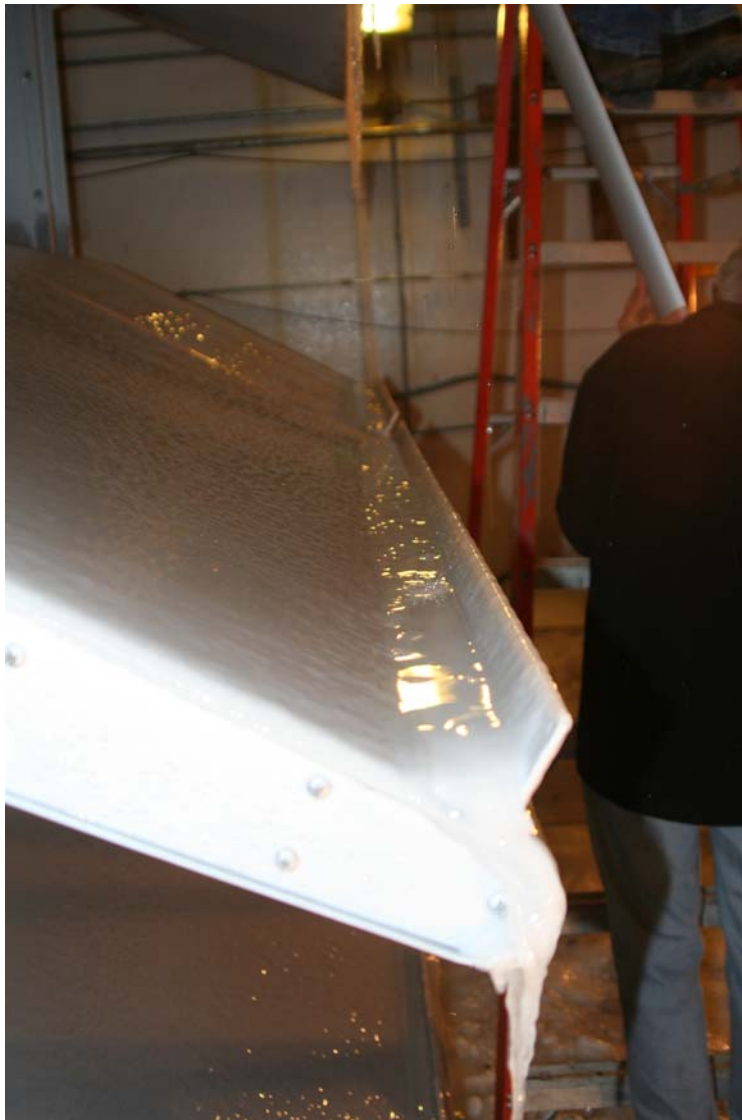
Figure 16. Similar to IRD option 1 shown in Figure 15, when the drainage path is frozen, the water is diverted to the end of the fin potentially forming a column of ice between adjacent fin stacks.

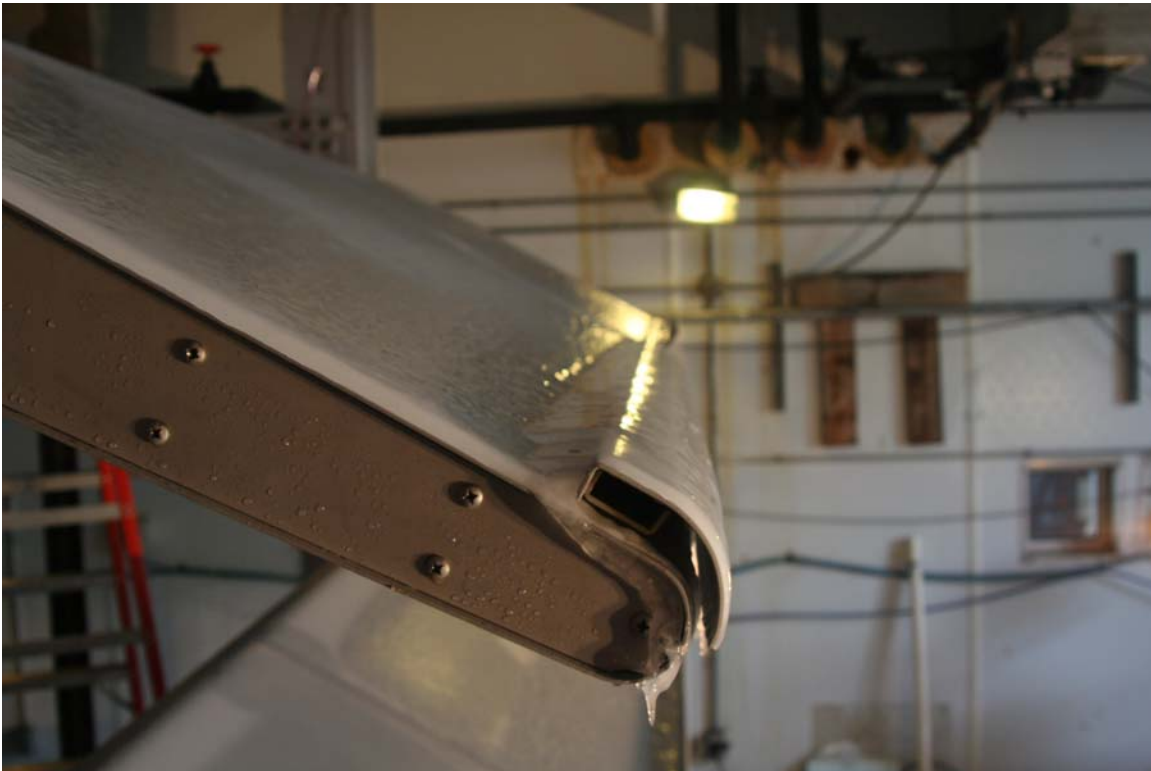
Figure 17. Top side of IRD option 3 showing the blocked drainage paths similar to IRD options 1 and 2.

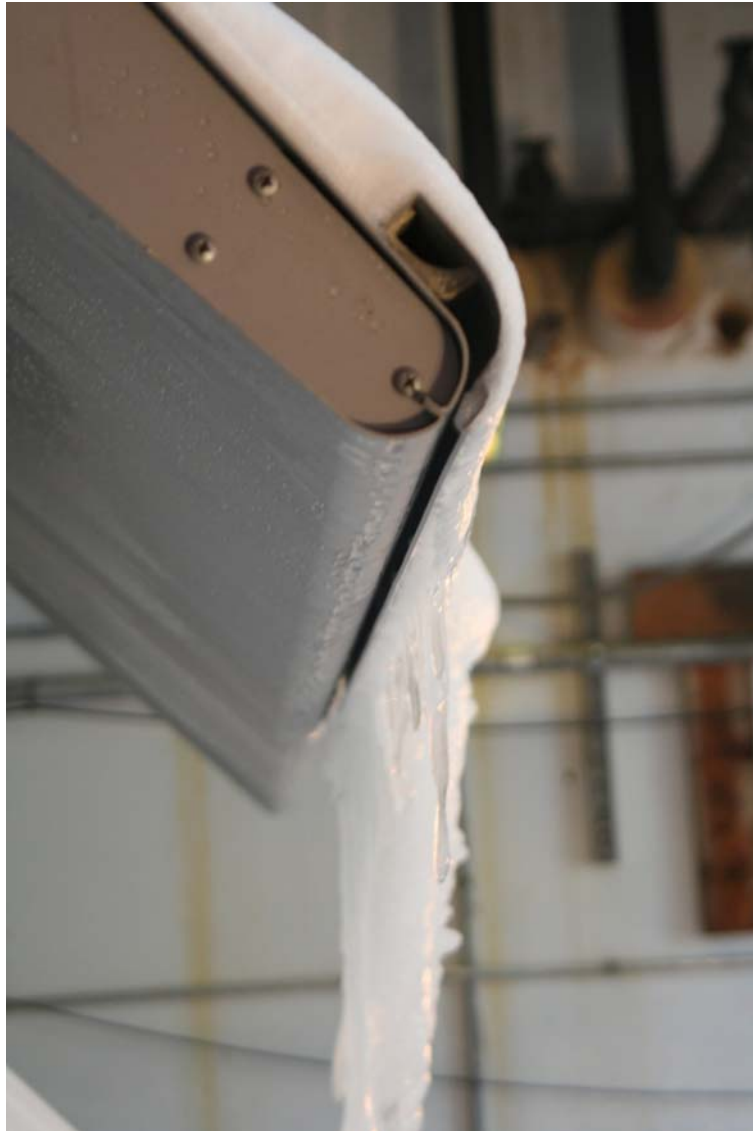
Figure 19. Underside of fin A3 during snow test.

The underside of fin A3 during an icing and snow test is shown in Figures 18 and 19, respectively. Icicles on the fin in Figure 18 indicate that water passed under the IRD before the drainage path froze. In contrast, the accumulated snow impedes the flow of water under the IRD, which freezes and blocks the drainage when saturated with water. The curved front face of the IRD does not provide any mechanical lock for the icicles, and it is conceivable that the warm air could melt the ice bond from the underside, leaving the icicles with limited attachment. Any wind could easily break the icicles free.

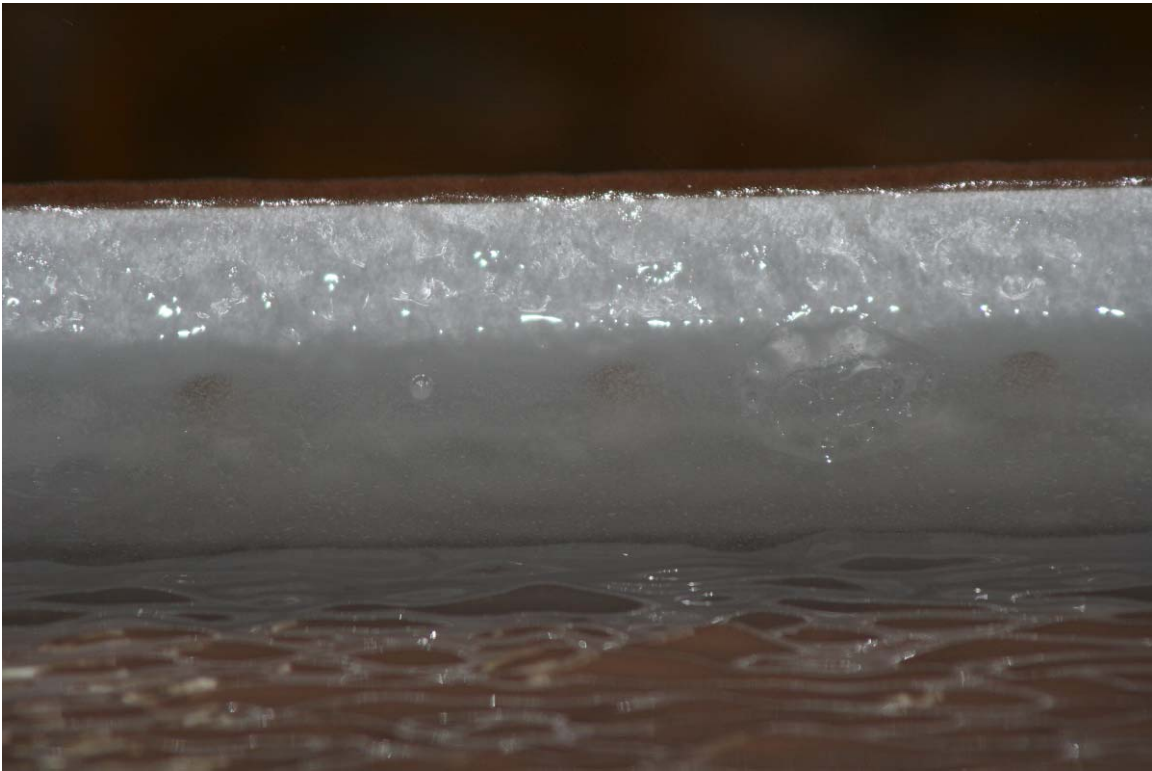
Figure 22. Top view of IRD 2a after 90 minutes of icing; the holes are iced over.

Although the drainage holes were significantly increased, they eventually plugged with ice (Figures 22 and 23) and the water was diverted to the end of the fin (Figure 24). It was concluded that the continuous barriers were not a viable IRD because the melt water was diverted to the end of the fin. Until the trough formed by the fin and the upper edge of the IRD was filled with ice, water would be diverted to the end of the fin. Collectively, the water from the adjacent stacks of fins could form a column of ice in the gap between the fins, presenting a new hazard. Once the ice was above the top edge of the IRD, water would flow over the IRD and form icicles on the leading edge of the fin. Icicles were attached to the fin by the adhesion and mechanical locking with the panel seam on the front edge of the fin. Solar heating could melt the surface adhesion, leaving just the limited strength of the mechanical locking with the panel joint to hold the icicles (Figure 25).

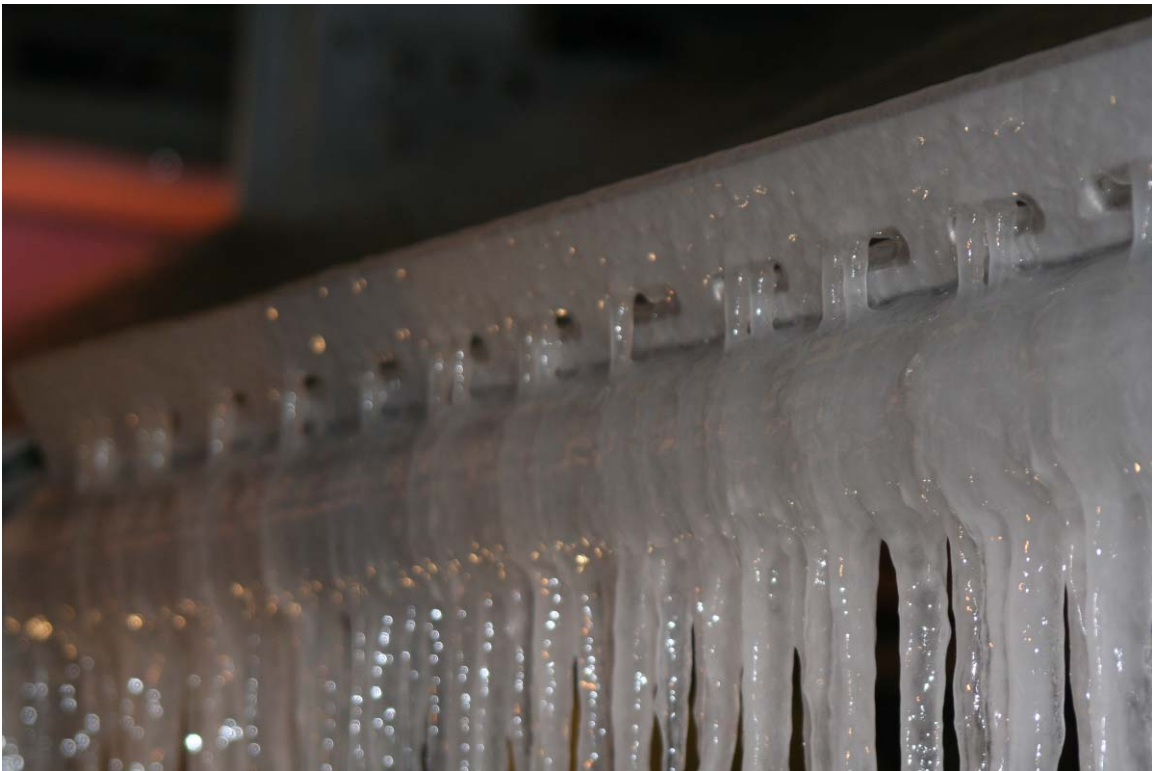
Figure 23. Lower edge of IRD 2b after 90 minutes of icing; although the slots are still open, they will eventually plug.

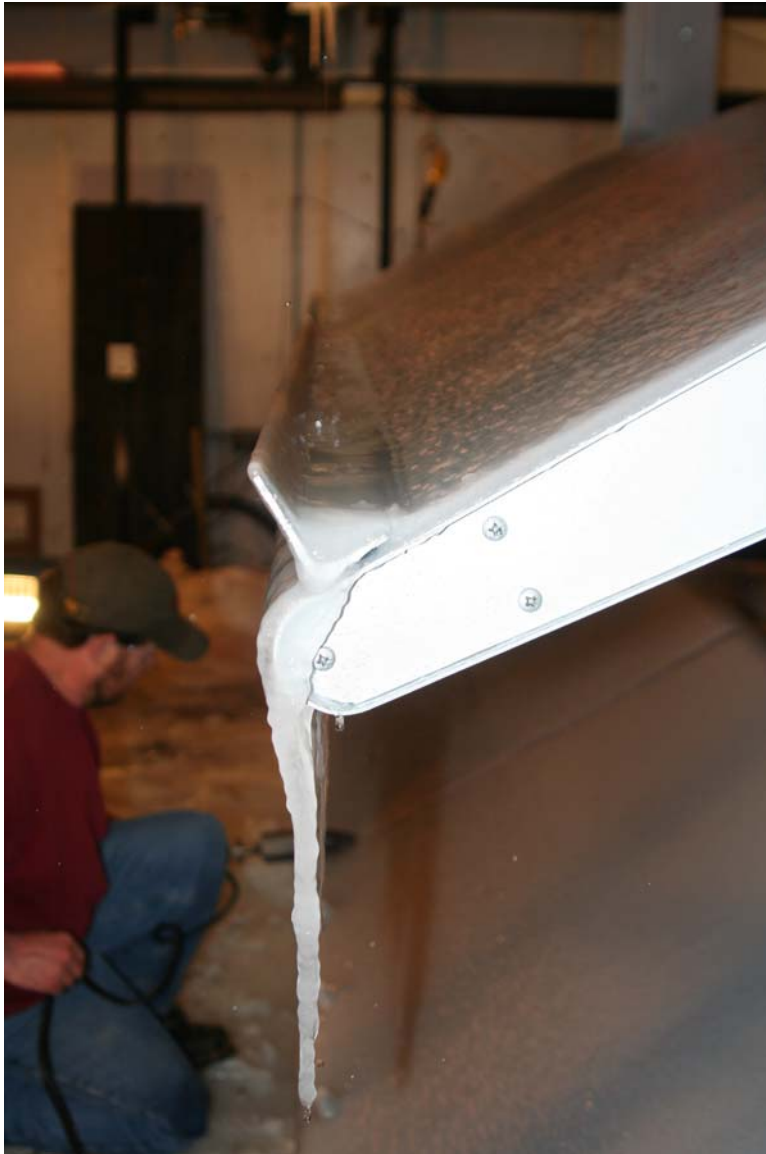
Figure 24. End view of fin 3b with IRD 2a in the foreground and IRD option 2 in the background. Drain paths and holes in the upright leg are frozen and the water is diverted to the end of the fin.

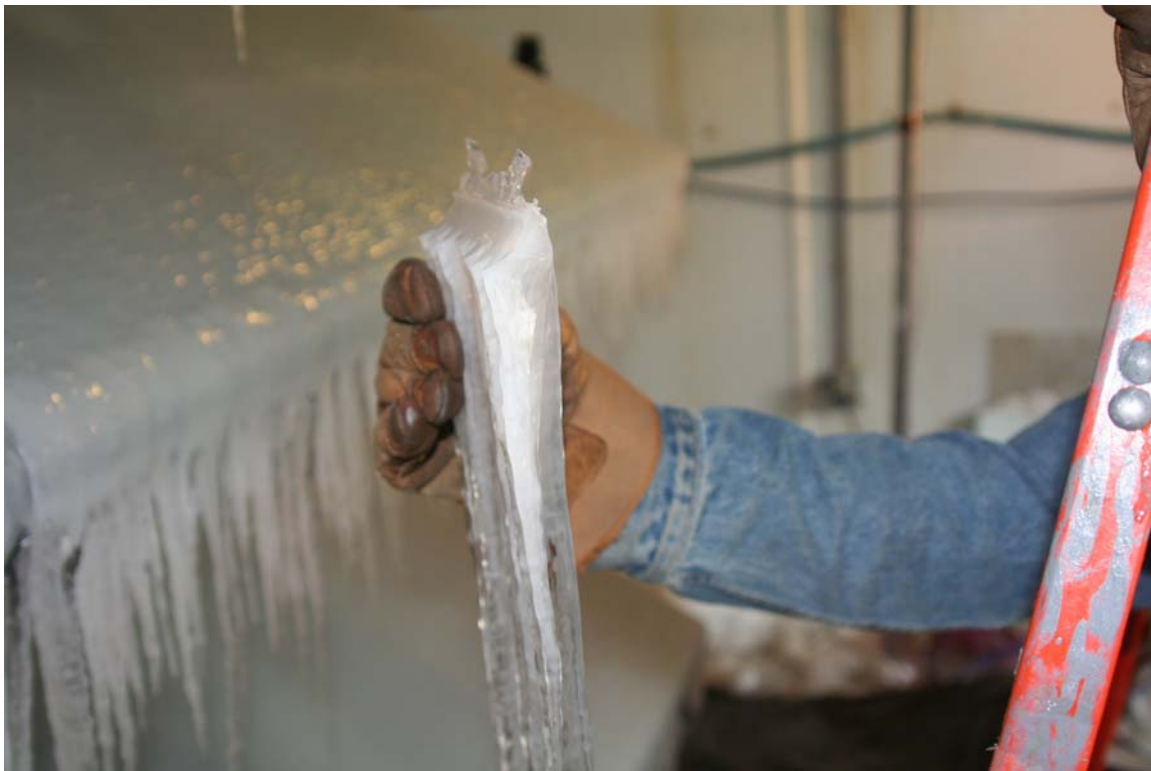
Figure 25. Mechanical locking of the icicles by the panel joint on the leading edge of the fin.

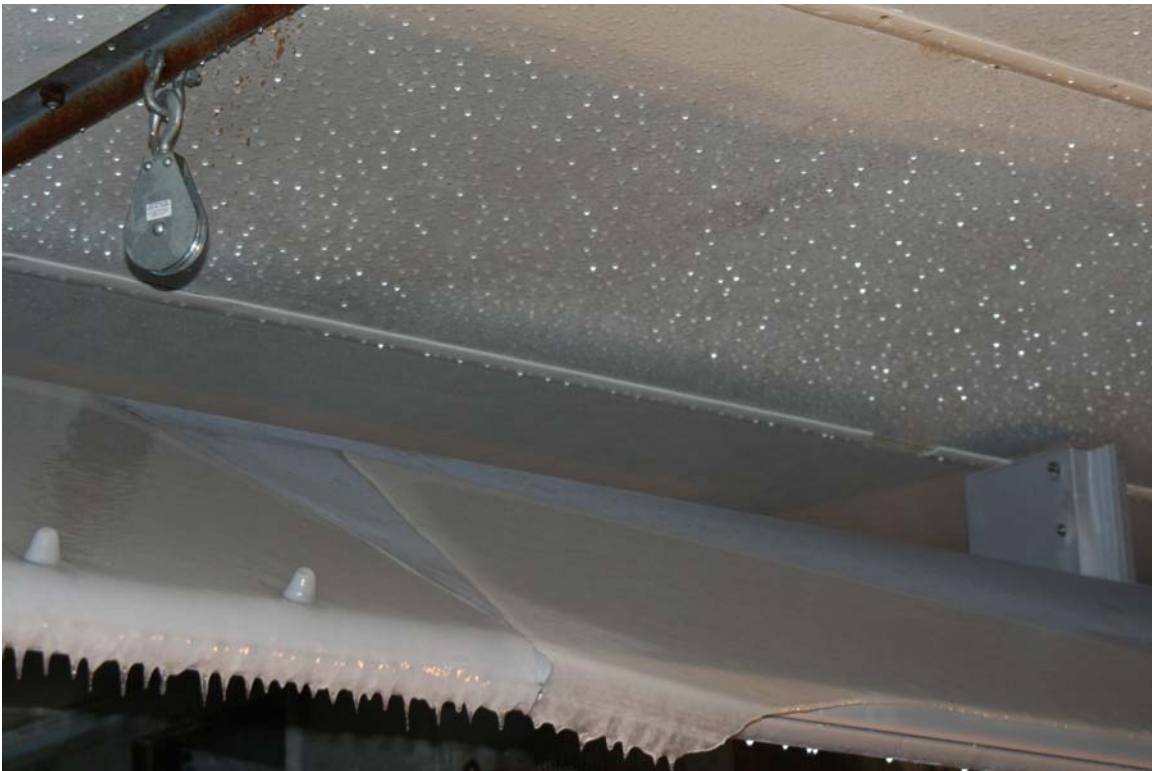
Figure 27. IRD option 4. The buttons 12 inches on center are encapsulated in ice and retain the sheet of ice (left), while the ice slides off without the IRD (right).

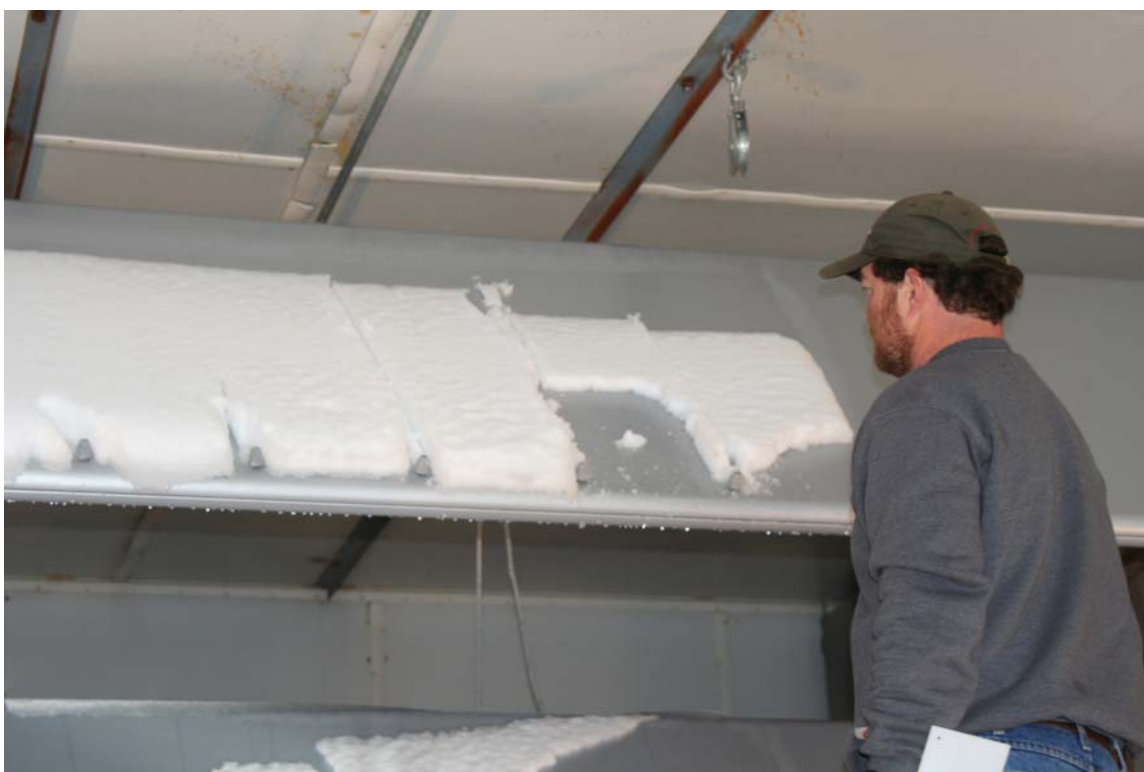
Figure 28. Separating the snow accumulation from the IRD to assess the size of the snow pieces falling off the fin.

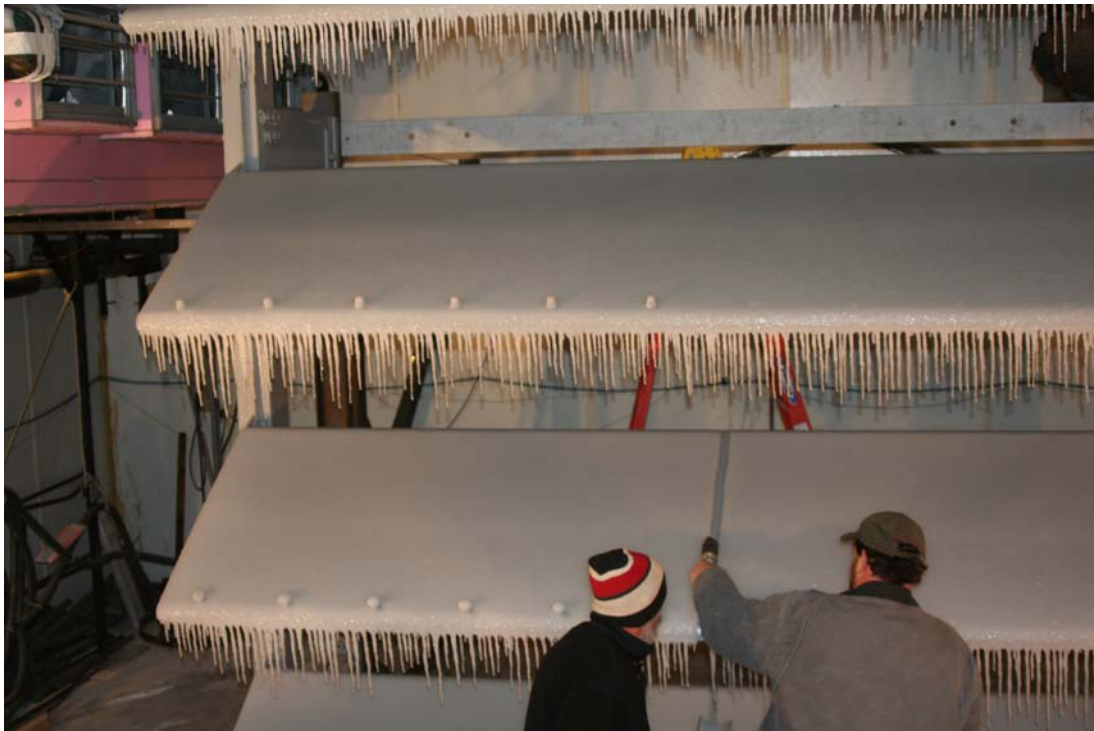
Figure 29. Initial condition for Test 5 with IRD option 4 installed on the A side of the fin. The B side is the standard, or control, fin.

IRD option 4 is a very simple device that is effective in stabilizing the accumulation without the limitations of the continuous IRDs. The consensus of the test team was that the buttons were the best alternative for retaining the ice. For the last test, the buttons were installed on the fins on the A side. The B side of the fin was the standard, or control, fin without any IRDs. The mock-up was covered in ice, varying in thickness from 3/8 to 1/2 inch. The initial conditions are shown in Figure 29 as the slot between the A and B sides is being deiced.

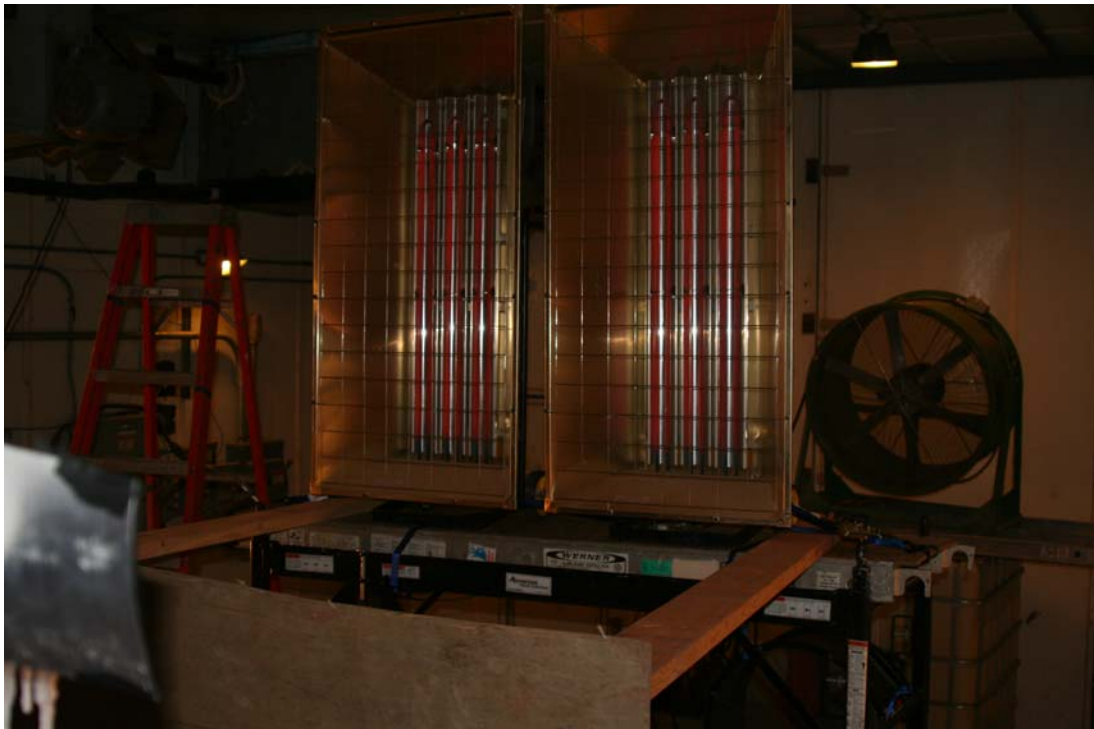
Figure 30. Using radiant heaters to simulate solar heating of the top fins (A3 and A4) while the bottom fins (A1 and A2) are shaded by the plywood.

The ramification of a heat source on the upper fins (e.g., an exhaust fan or solar heat) that melted the accumulation—with the melt water refreezing on the lower fins—was assessed in Test 5. Radiant heaters were used to heat the upper fins (A3 and A4) while the lower fins (A1 and A2) were shaded (Figure 30); the room was approximately 23°F. In the first phase, the heaters were cycled on until the water started dripping off the fins (approximately 15 minutes) then shut off to allow the melt water to refreeze (approximately 10 minutes). Seven cycles were conducted with melting on the upper fins and refreezing of the water on the shaded fins. In the second phase of testing, the heaters were moved away from the fins with the heaters on continuously for the next 6 hours while the room temperature was

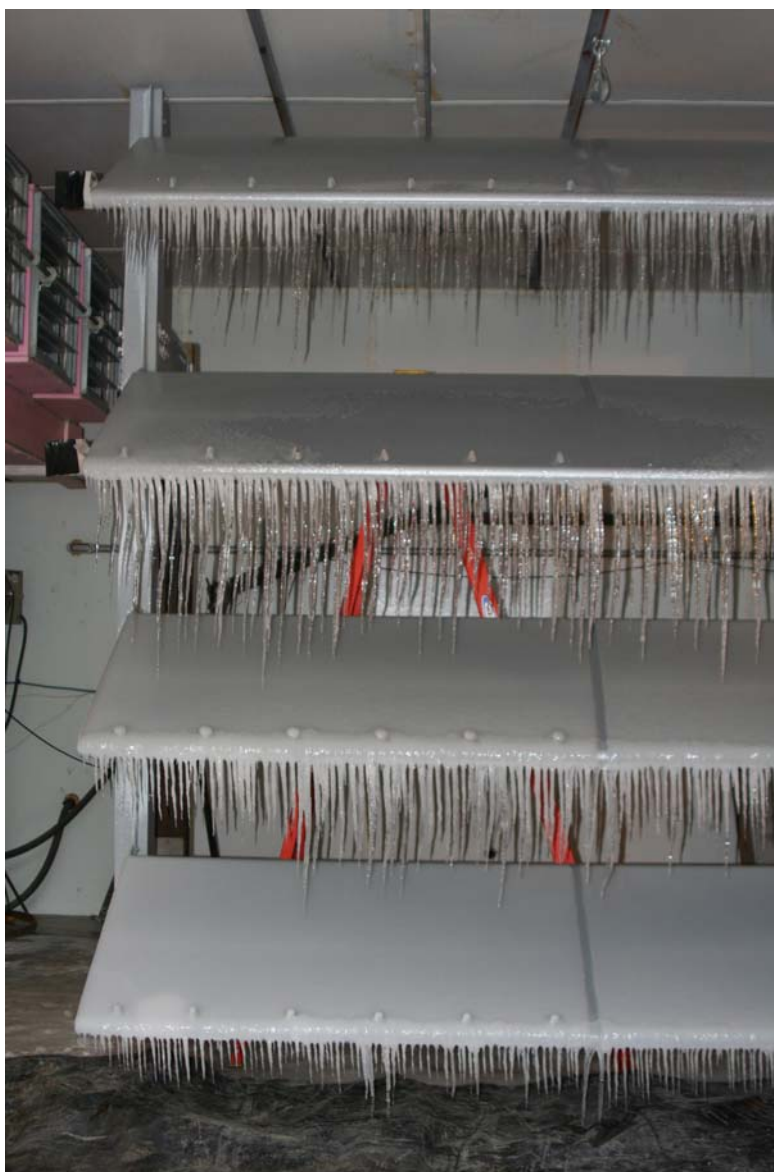
Figure 31. Icing conditions at the conclusion of heating fins A3 and A4 with radiant heaters while shading fins A1 and A2. The room temperature was approximately 23 °F, and the melt water refroze on the lower panels.

maintained at 23°F. Ice conditions at the conclusion of phase 2 are shown in Figure 31. For phase 3, the refrigeration system was shut off and the ambient temperature was allowed to increase. A similar procedure was used in the previous tests. As in the previous test, the ice on the B side slid off as a sheet, while the ice on the A side melted in place. As shown in Figure 31, icicles will form and if they present a potential hazard they will have to be physically removed.

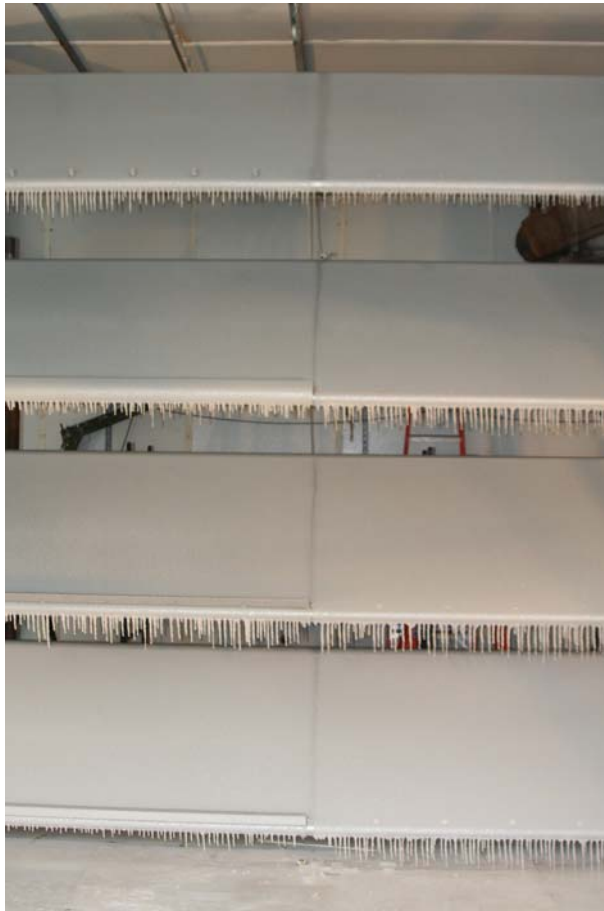
Figure 1.1. Initial conditions of fins with the vertical centerline deiced. The ice retention devices are installed on the A (left) side of the fins. The B (right) side is used as the control. IRD options 1, 2, 3, and 4 are installed on the A side of the fins, starting with option 1 on the bottom fin (A1) and progressing to option 4 installed on the top fin (A4).

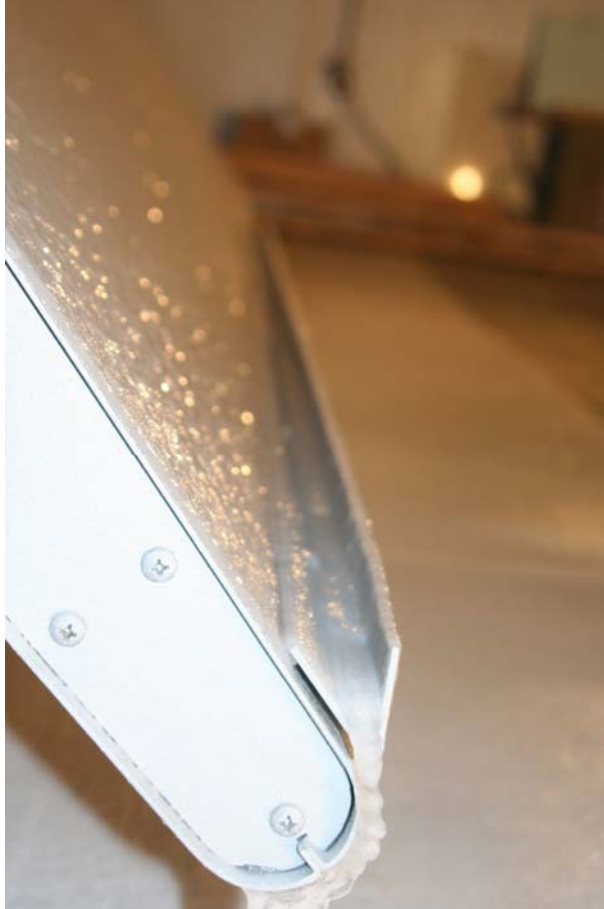
Figure 1.2. Fin A1 with IRD option 1 installed. Note the drainage paths are blocked with ice and the continuous IRD serves as a gutter.

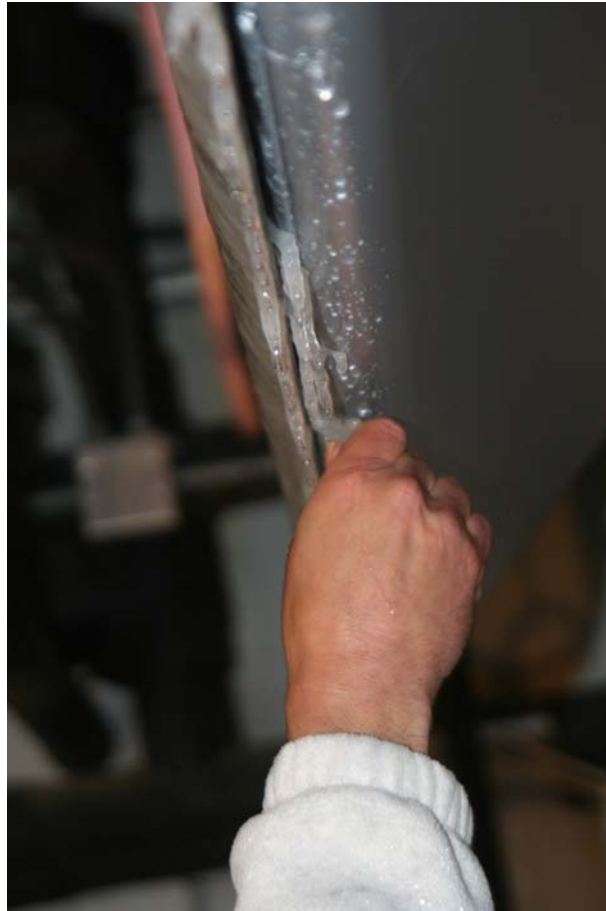
Figure 1.7. Removing the securely anchored icicles from the gap between the fin and IRD option 3 on fin A3 as the ice is melting.

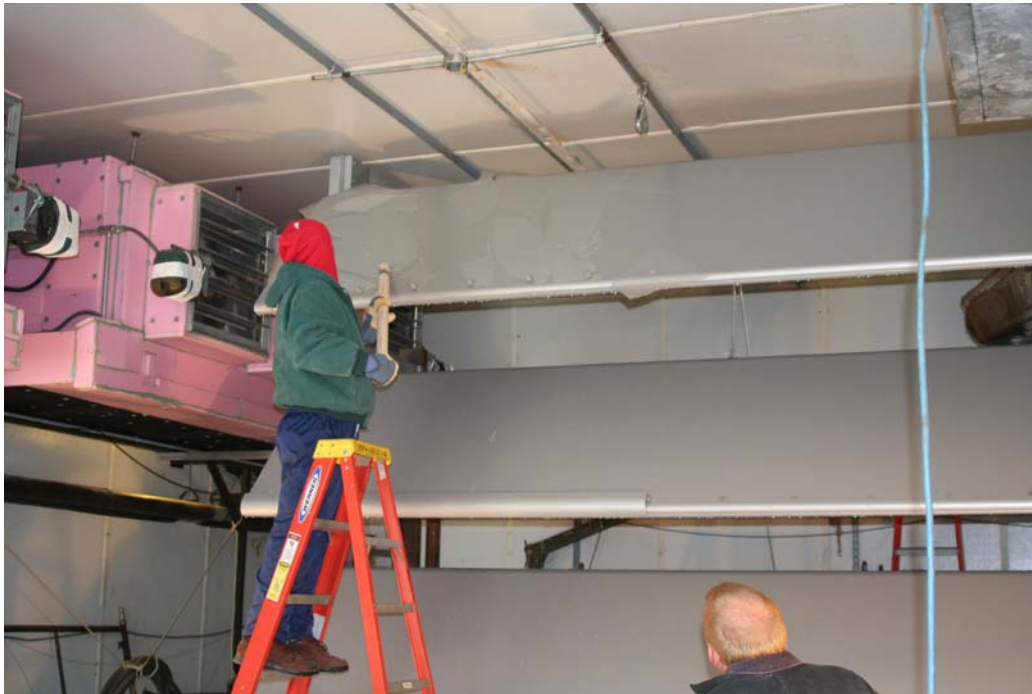
Figure 1.14. Manually removing the ice above the IRD on fin A4 is a very labor-intensive process.

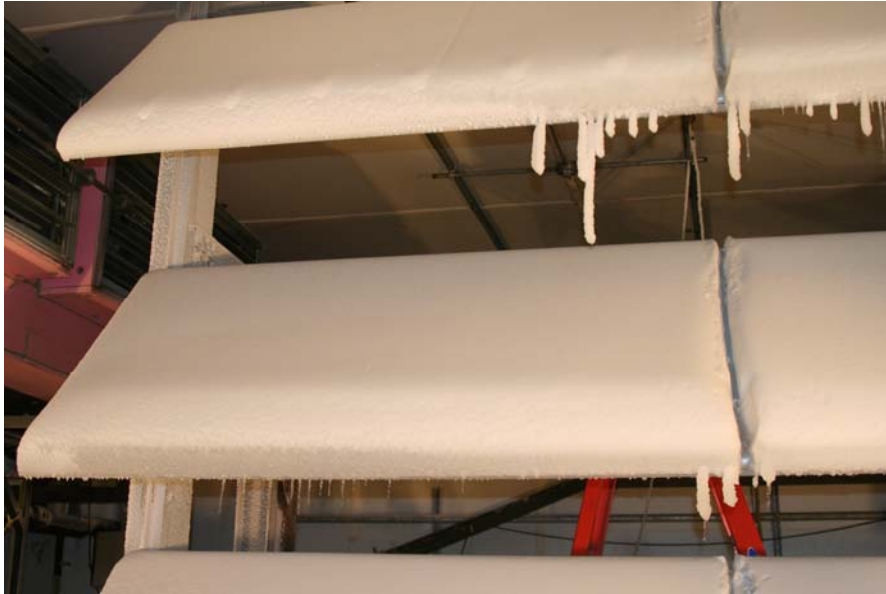
Figure 2.1. The initial condition of the top fins with the vertical centerline deiced. IRD option 4 is installed on the left side the top fin (A4), and the right side (B4) is used as the control. IRD option 3 is mounted on the left side of the lower fin in the photograph (A3) while the right side (B3) is used as a control.

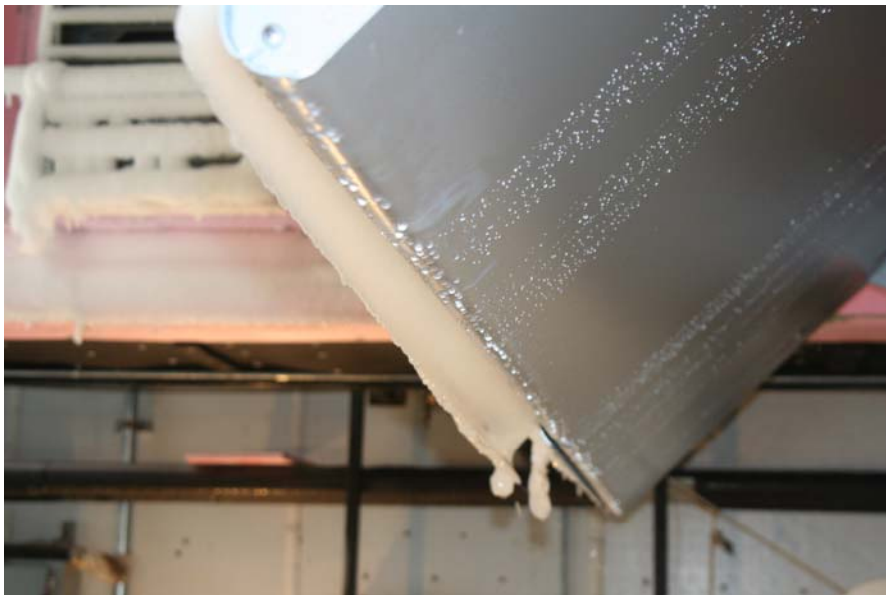
Figure 2.2. Underside of fin 3 with the ice sliding off the near side (B3) and while the ice is retained by IRD option 3 installed on the far side. The drainage path under IRD option 3 appears to be open on the bottom.

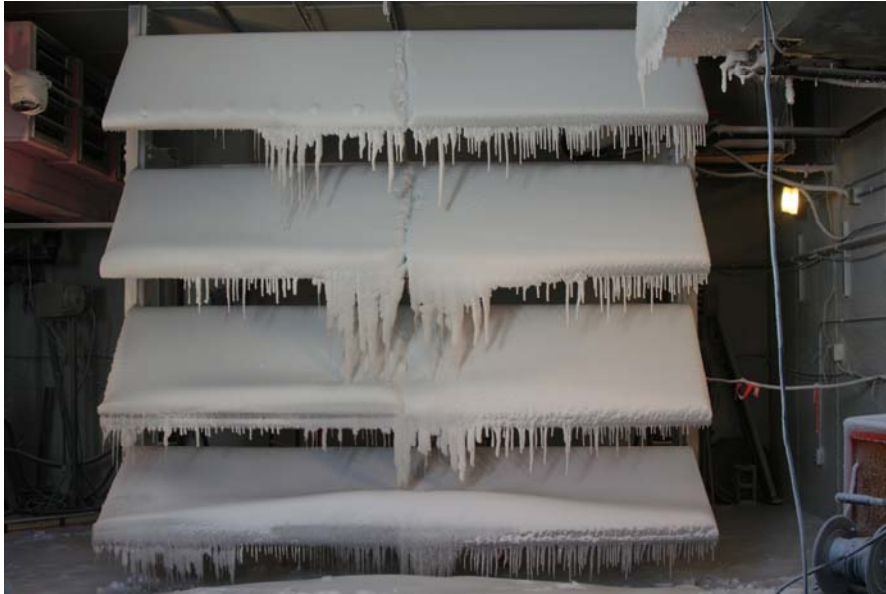
Figure 3.1. Initial condition of mock-up covered in snow and ice of varying thickness from 2.5 to 7 inches. IRDs are installed on the A, or left, side of the fin. The B, or right, side without the IRDs is used as the control. Fins are in configuration 3, i.e., top three fins are at 50° and the bottom fin is at 30°.

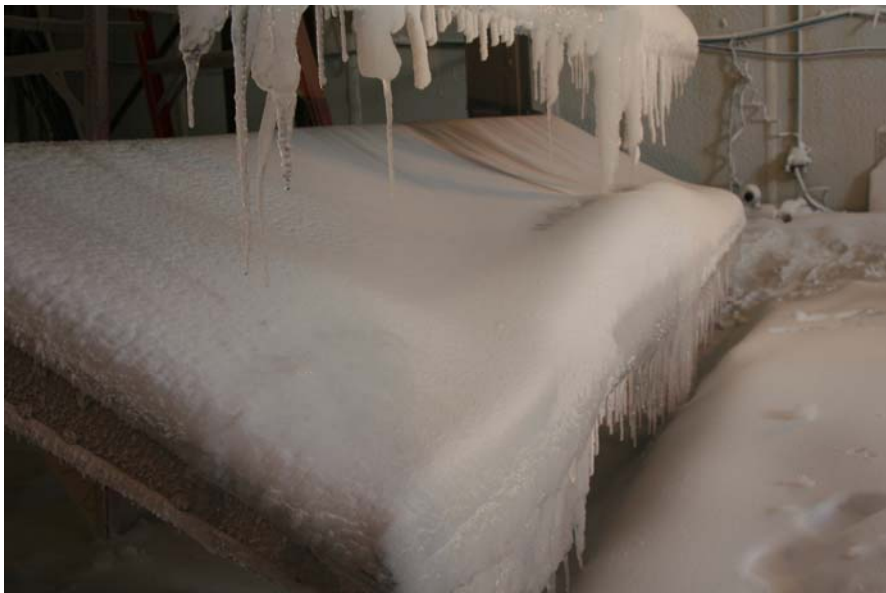
Figure 3.2. Initial condition of the bottom fin 1. IRD option 1 is on the near side (A1) and the control fin (B1) is on the far side.

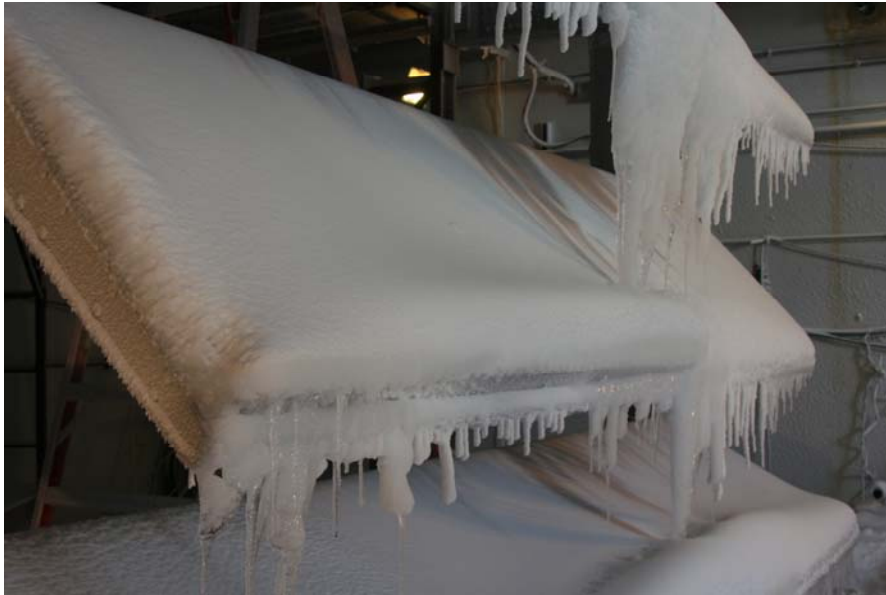
Figure 3.3. Initial condition of fin 2 with IRD option 2 on the left (A2) and the control (B2) on the right side of the photograph. Note the exposed bottom edge of the IRD that could be deiced by solar heating and subsequent shedding of the icicles.
