## **Laboratory Testing of Architectural Exterior Wall Fins**

Leonard Zabilansky, William Burch, and Tommie Hall

January 2009

Final report

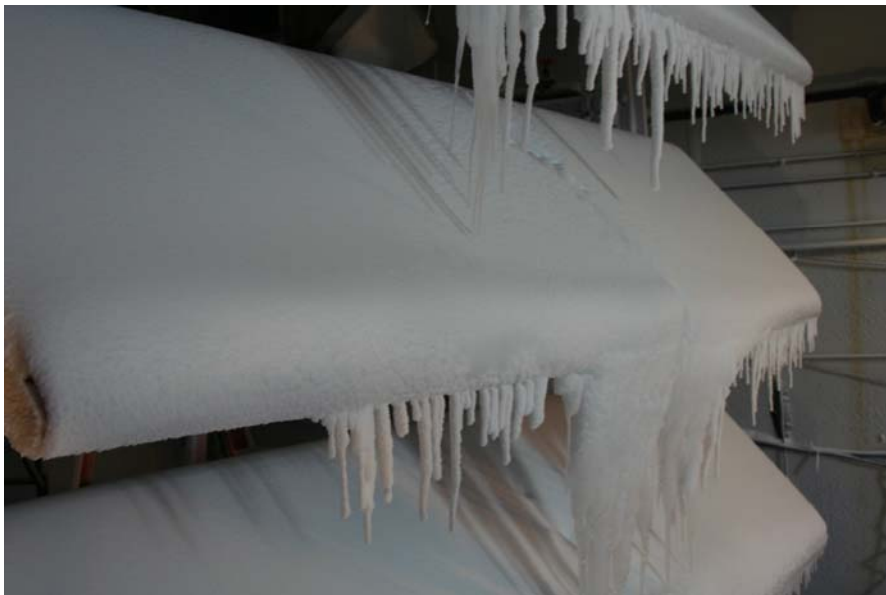
Figure 3.4. Initial condition of fin 3 with IRD option 3 on the A (left) side and the control on the B (right) side.

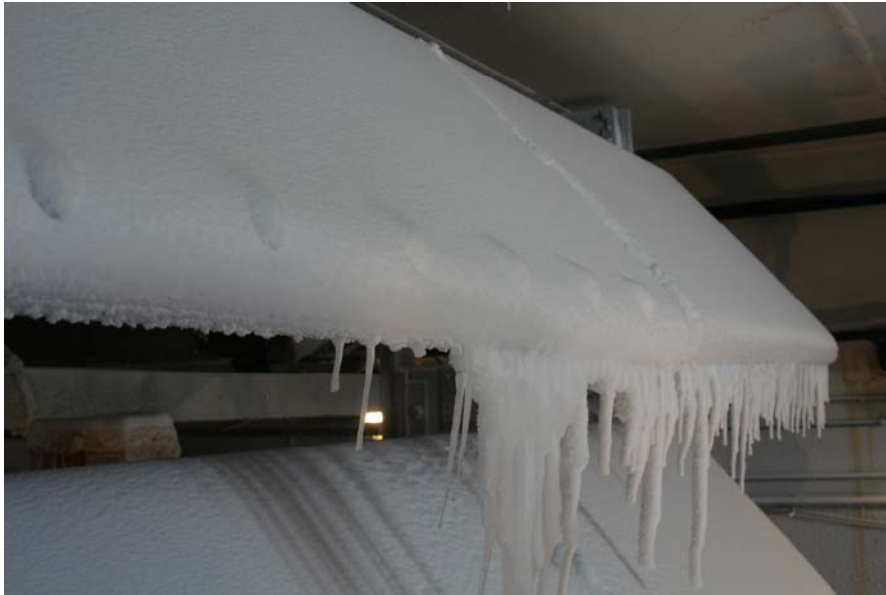
Figure 3.5. Initial condition of fin 4 with IRD option 4 on the A or left side (A4) and the control on the B or right side (B4).

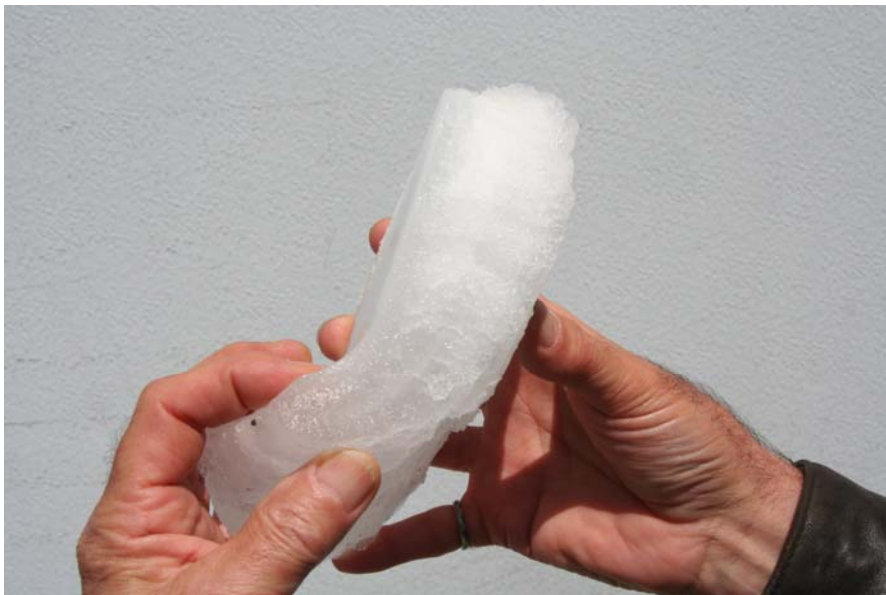
Figure 3.6. Cross section of ice that fell off fin B4. Note the layering of ice and snow, typical of a wet snow.

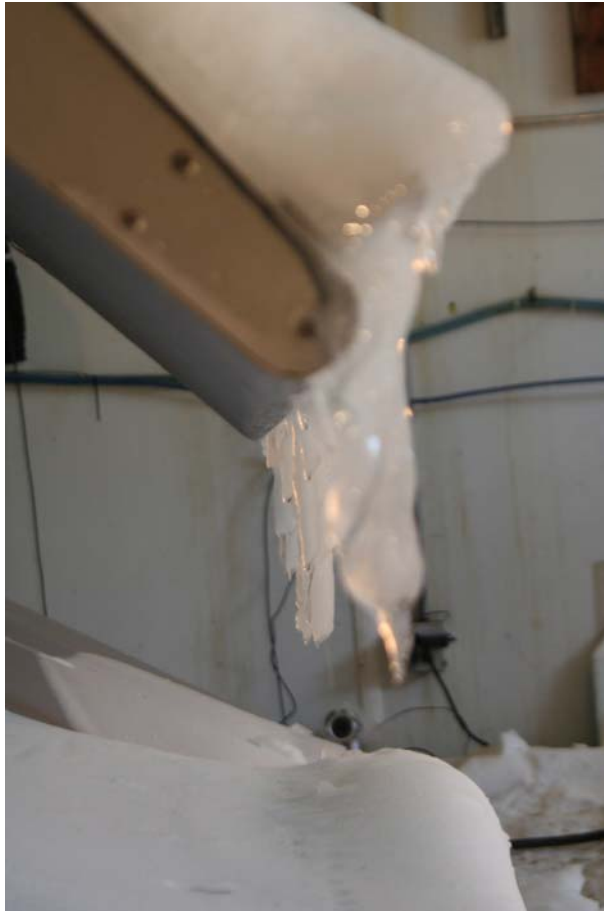
Figure 3.9. Melt water dripping off fin A2 at 50° onto the fin A1 at 30°. The concern was that the bottom fin extended beyond the edge of the upper fins due to the shallower angle. Melt water from the upper fins accumulated on the lower fin resulting in an excessive accumulation on the lower fin. As observed in the previous tests, the drip lines are uphill from the IRD. It was concluded that mixing the fin's slopes does not significantly change the size of the accumulation on the lower fin.

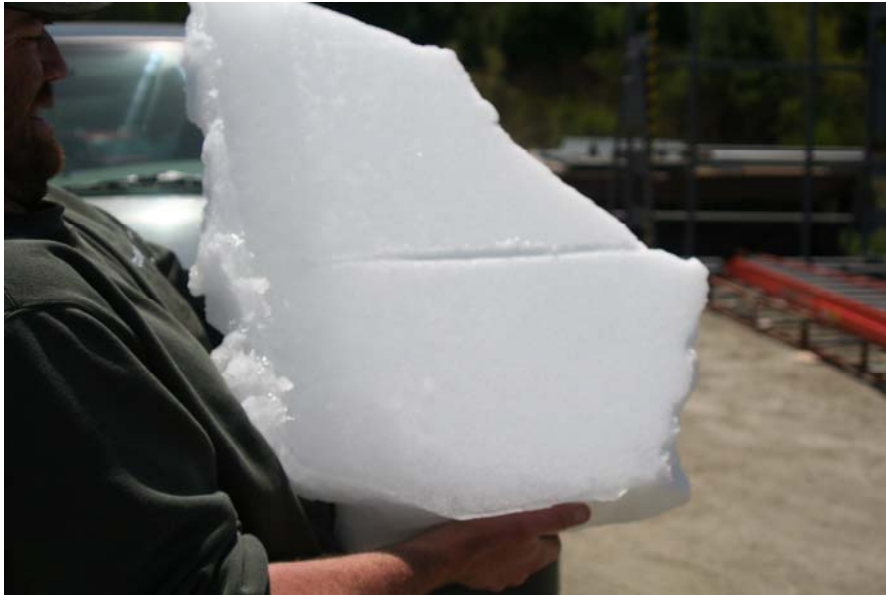
Figure 3.10. Piece of ice from fin B3. Note the scratch in the bottom of the piece that runs from the bottom of the fin on the left toward the top of the fin on the right.

When the IRD were removed from the B side of the fins, the metal skin had holes from the attachment screws, and a few holes had an upward dimple around the edge. To prevent the water from getting into the fins, the holes were covered with a 1-inch-diameter patch made from silver tape. During this test we observed that the dimples provide some mechanical locking between the ice/snow accumulation and the fin. In other words, the accumulations would slide off standard fins easier than observed in these tests (see Figures 3.10 and 3.11).

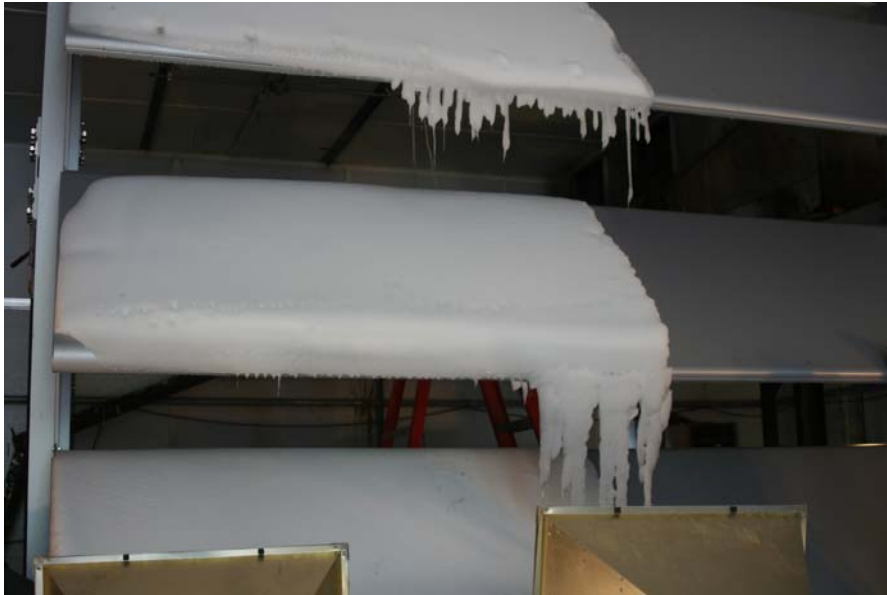
Figure 3.16. Condition of fins A3 and A4 after several hours of melting by ambient temperature and radiant heaters.

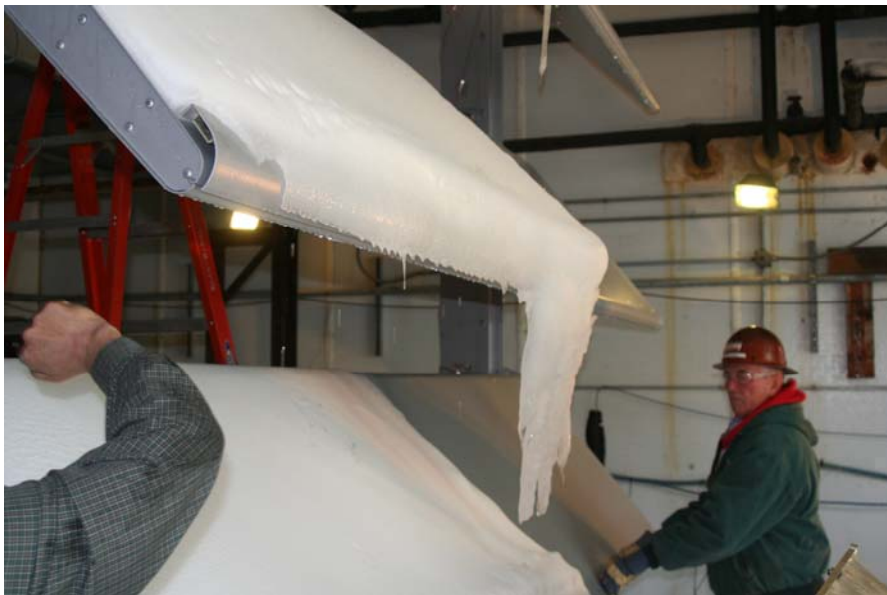
Figure 3.17. Even after vibrating the fins, the ice remains attached to the outer surface of fin A3 with IRD option 3.

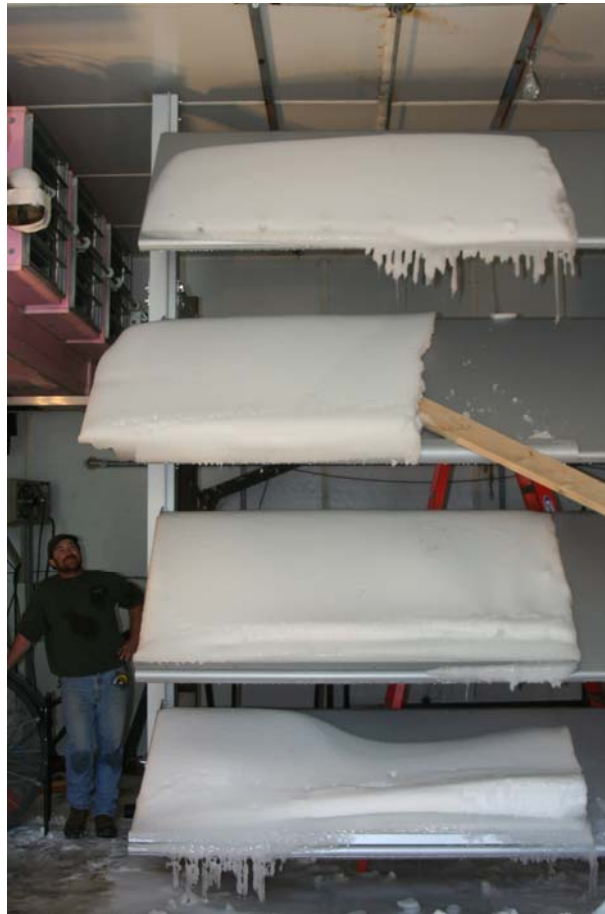
Figure 3.18. Snow mass can be pushed off the end of the fin, providing confidence that the IRDs retain the accumulation in place.

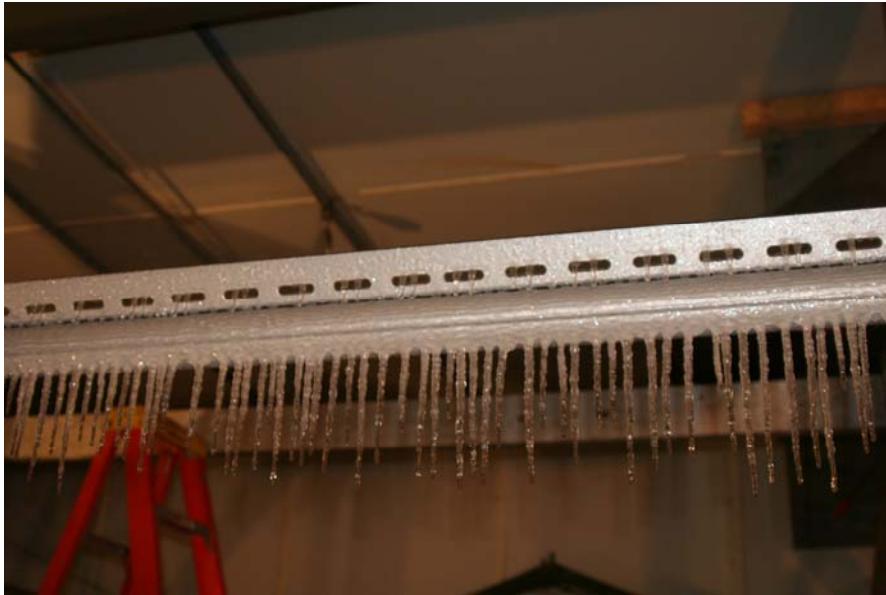
Figure 4.3. Condition of IRD option 3b (1/2- x 2-inch slots 3 inches on centers) on fin B3 after 40 minutes of icing.

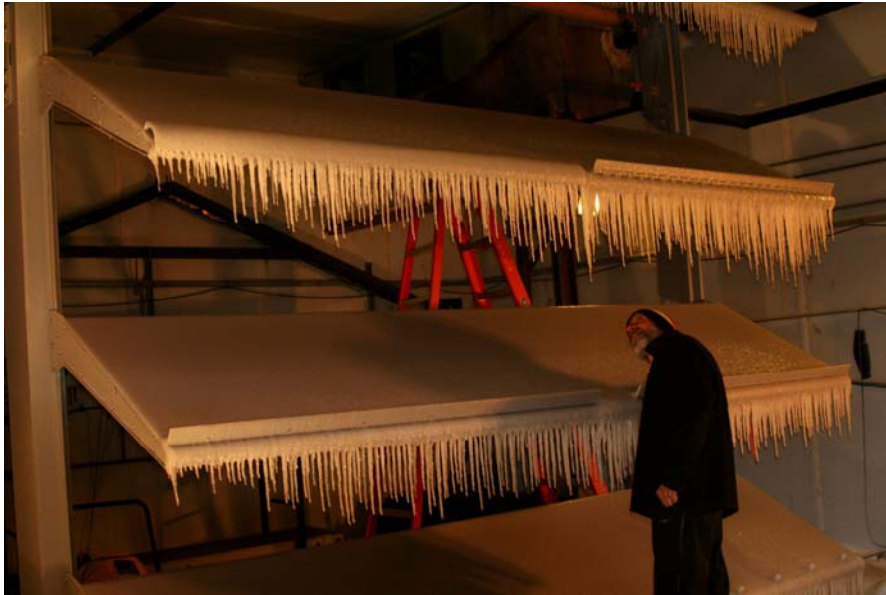
Figure 4.7. Icicles on fins 2 and 3 after 70 minutes of icing. Note the size of the icicles in the center of the fins.

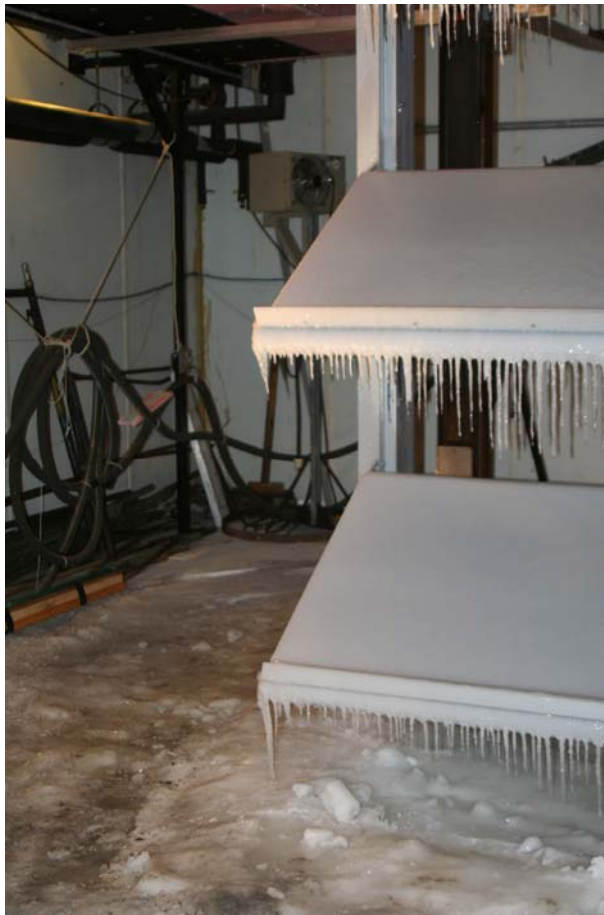
Figure 4.12. Left end of fins A1 and A2 with the larger icicles compared with the interior icicles.

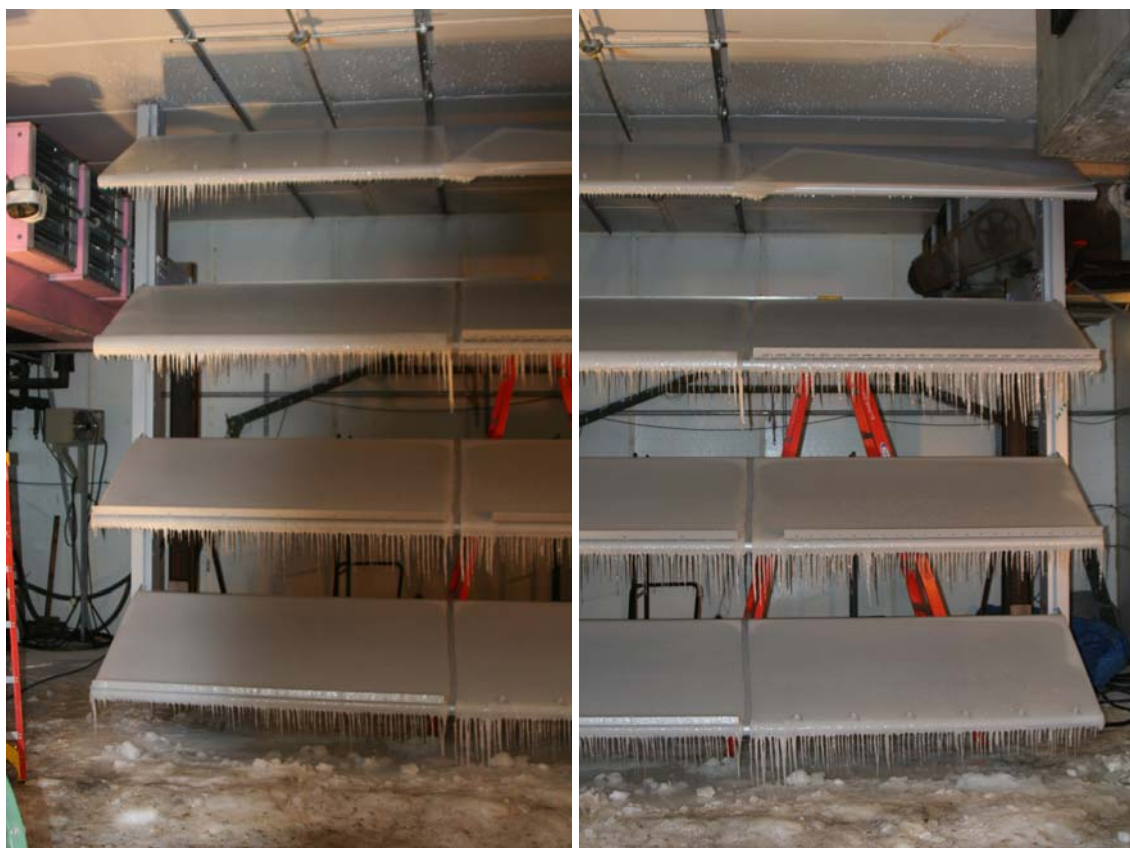
Figure 4.15. (Left) Fins on the A side after a couple of hours of warm up with most of the icicles melted. (Right) Fins on the B side with the ice still in place except on the top fin (B4) used as a control. The icicle melted in place on the fins with the IRDs.

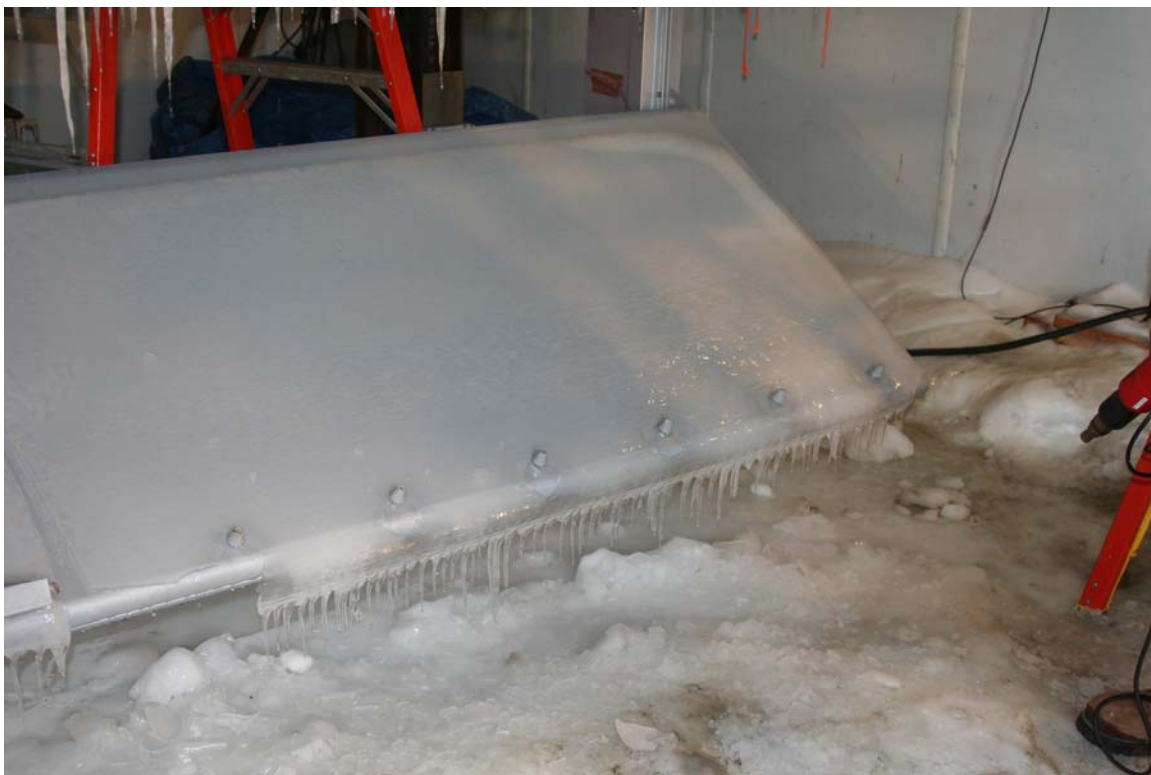
Figure 4.19. The ice around IRD option 4 on fin B1 was melted using a heat gun to verify the simple IRD would arrest sliding ice. Before all the IRDs were melted free, the ice sheet started to slide, reinforcing the recommendation that IRDs are necessary to prevent the ice from sliding off the fin. The IRDs did stop the moving ice sheet.

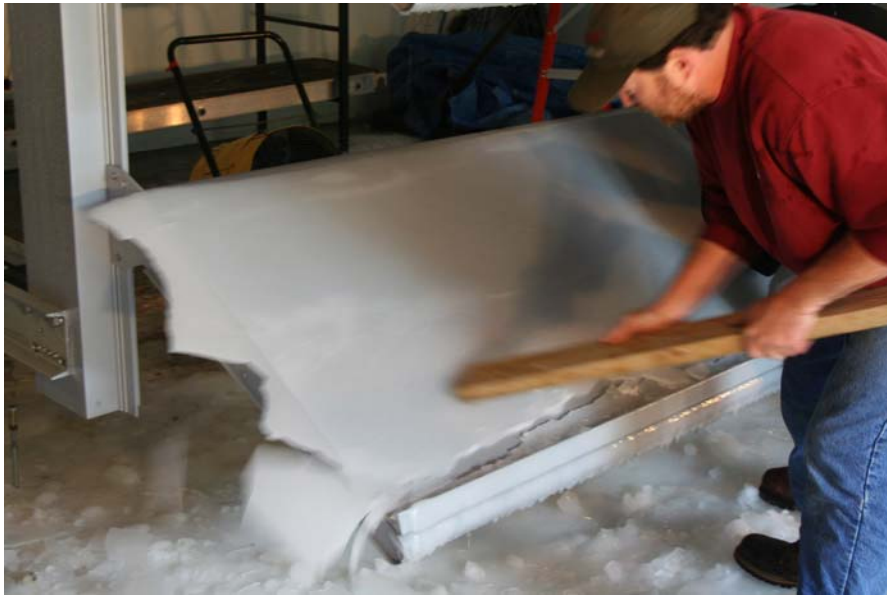
Figure 4.20. Breaking up the ice on fin A1, so it could slide off the edge of the fin.

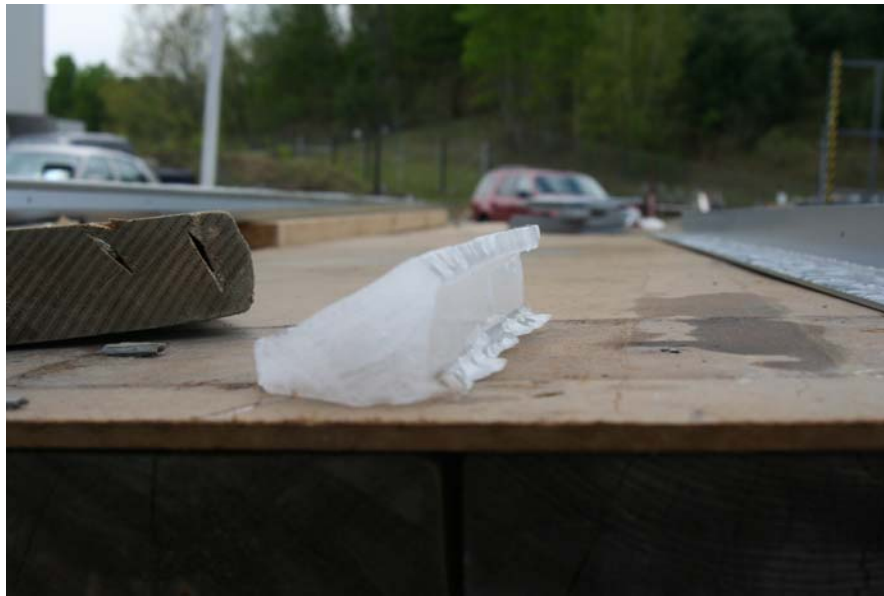
Figure 4.22. Similar to IRDs shown in Figure 4.21, the ice behind IRD option 3 also blocks the drainage path under the IRD. The surface on the right side of the ice mirrors the back of the IRD. The broken edges on the top and bottom are from the ice in the drainage path under the IRD and ice over the top of the IRD, respectively. Again, considerable melting would have to take place before the drainage paths would be open; in the meantime, the water would flow to the ends of the fin.

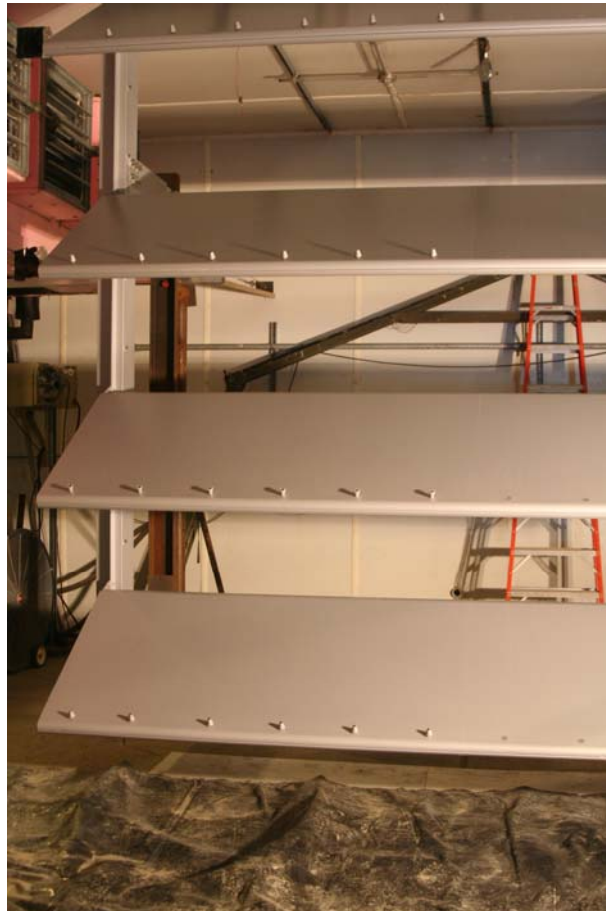
Figure 5.1. IRD option 4 installed on all the fins on the A side. The IRDs are inverted on fin A2 as shown in Figure 5.3.

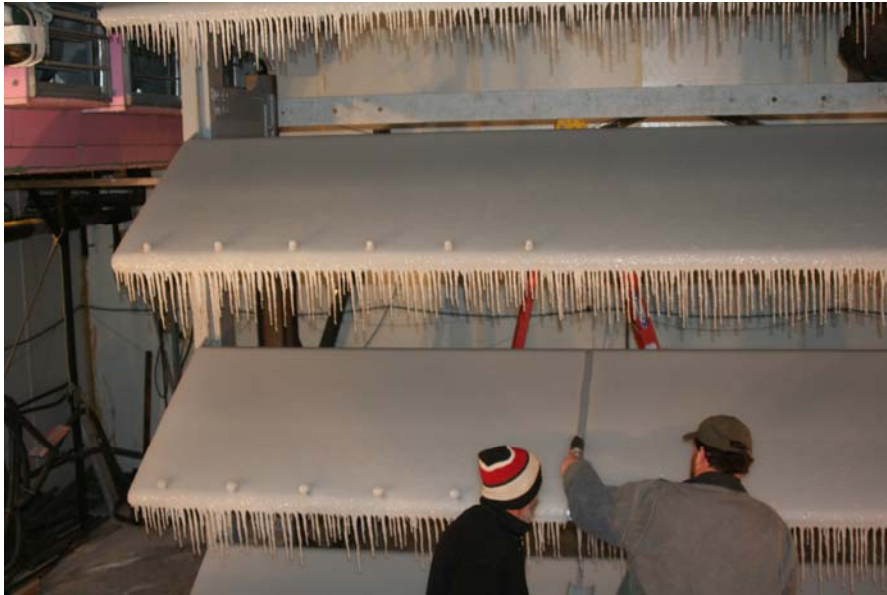
Figure 5.4 Initial condition of fins 2 and 3 while a slot between the A and B sides is being deiced with a hot iron.

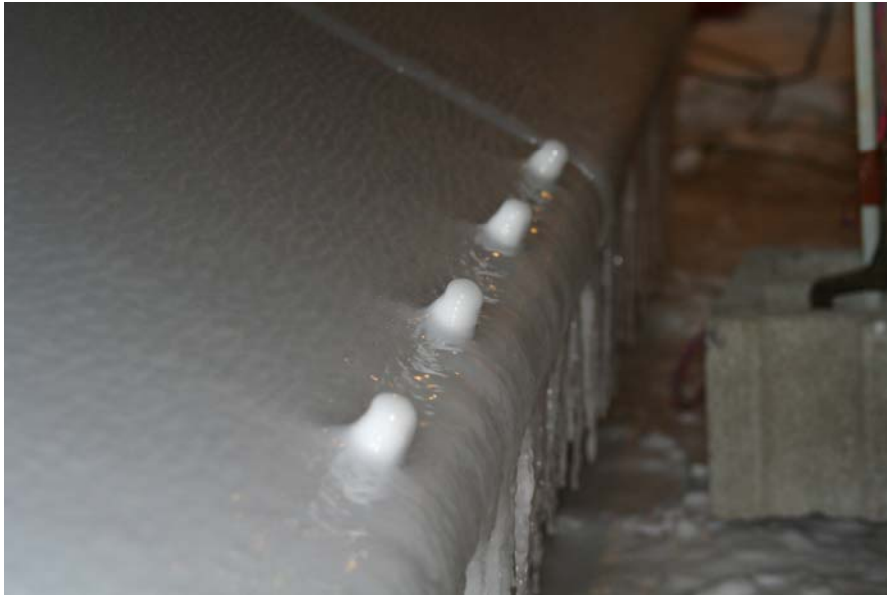
Figure 5.8. Condition of fin A1 following seven solar cycles.

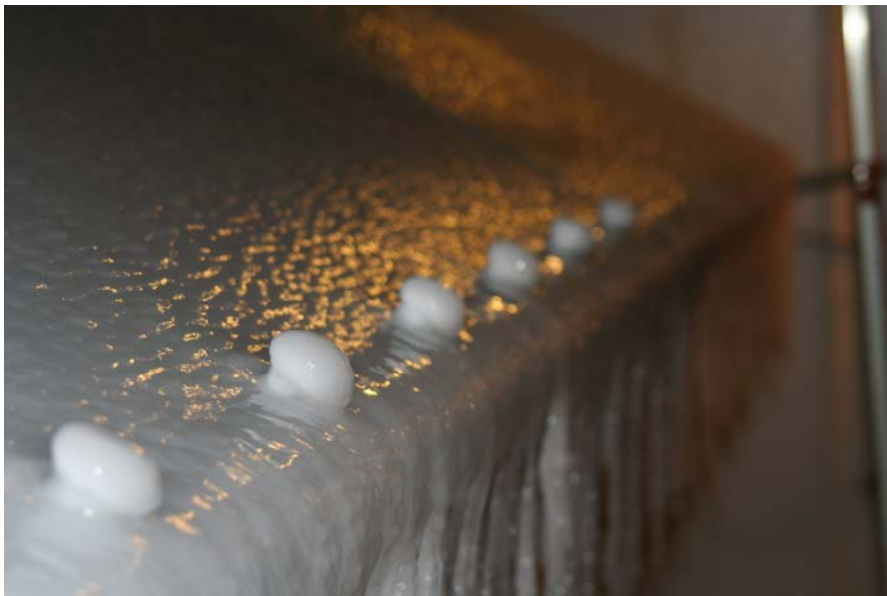
Figure 5.9. Condition of fin A2 following seven solar cycles.

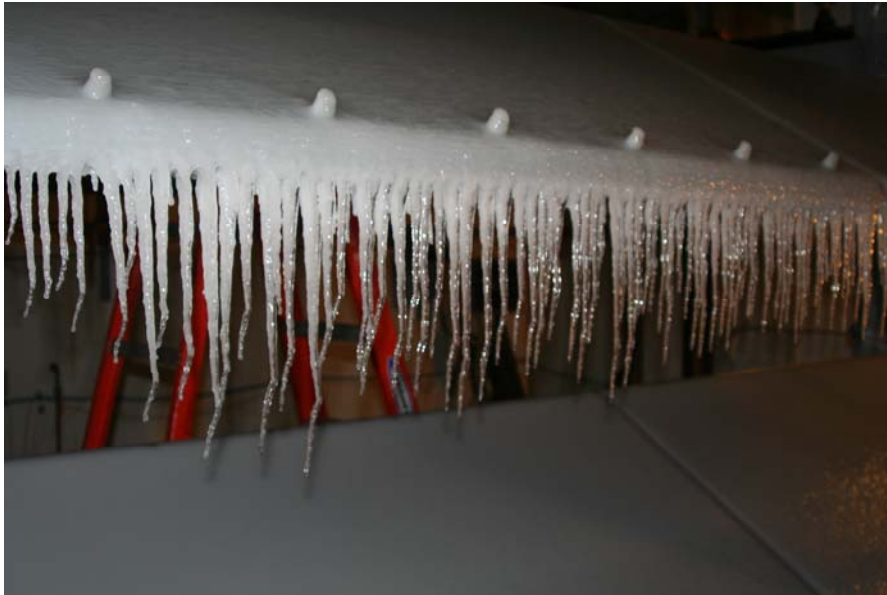
Figure 5.10. Condition of fin A3 following seven solar cycles.

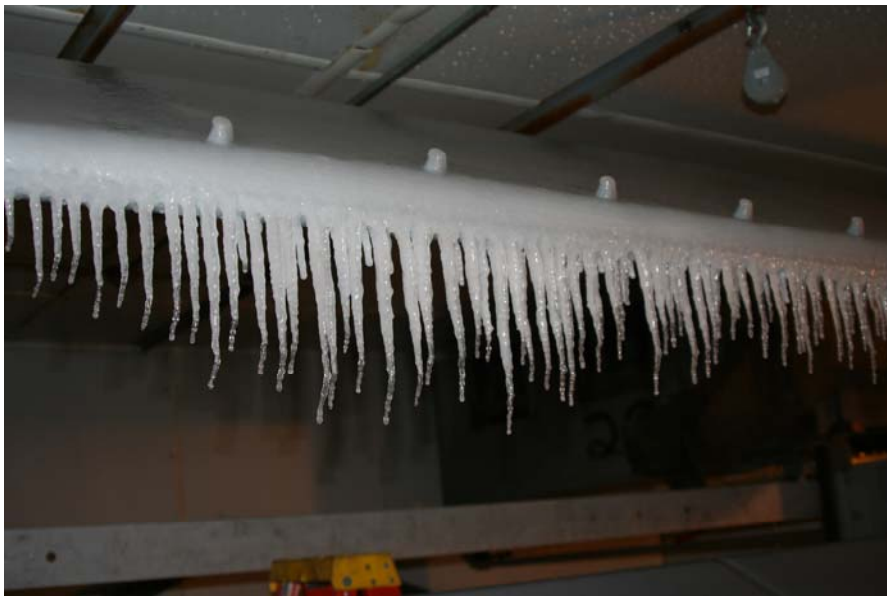
Figure 5.11. Condition of fin A4 following seven solar cycles.

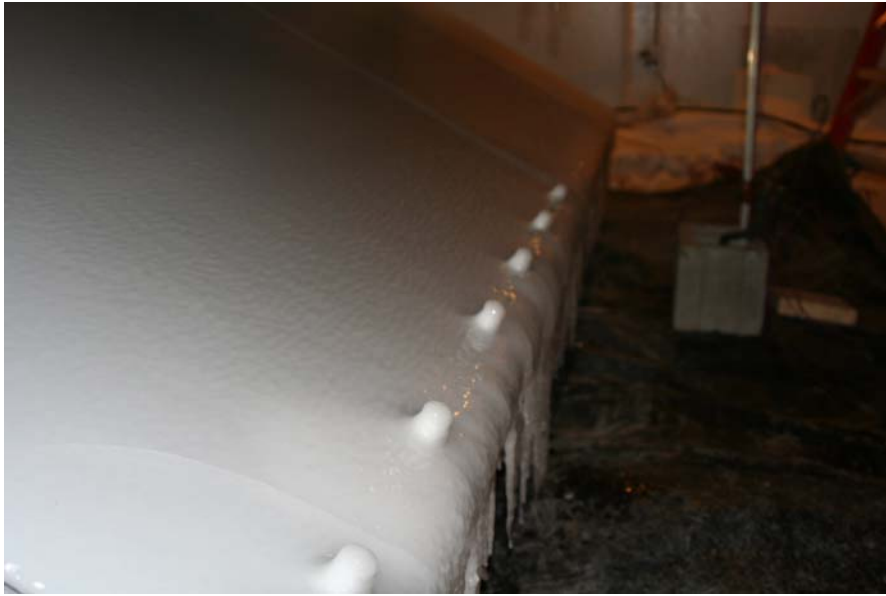
Figure 5.12. Condition of fin A1 after the infrared heaters were on for 5 hours with the room at approximately 23°F.

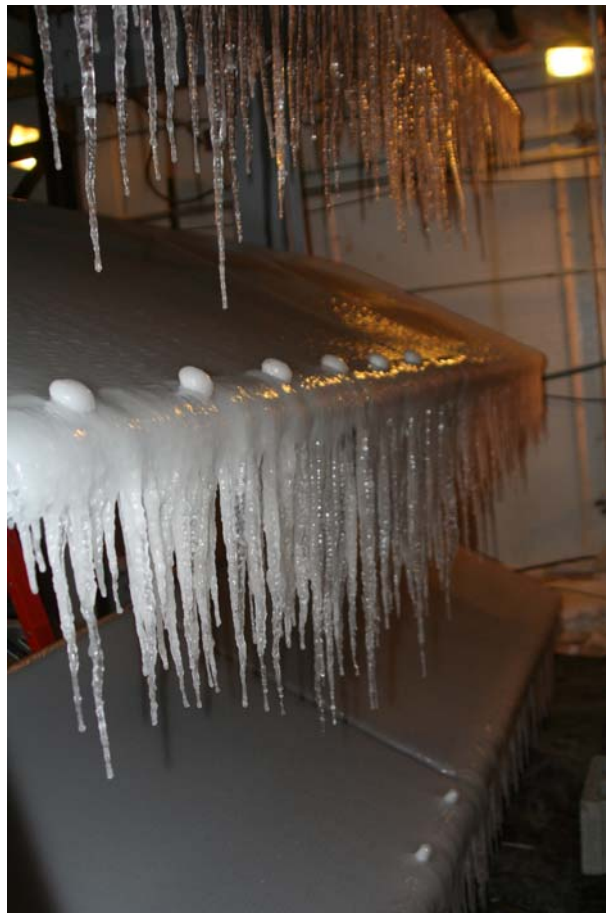
Figure 5.13. Condition of fin A2 at the same time as fin A1 shown in Figure 5.10. The melt water from fins A3 and A4 refroze on fin A2.

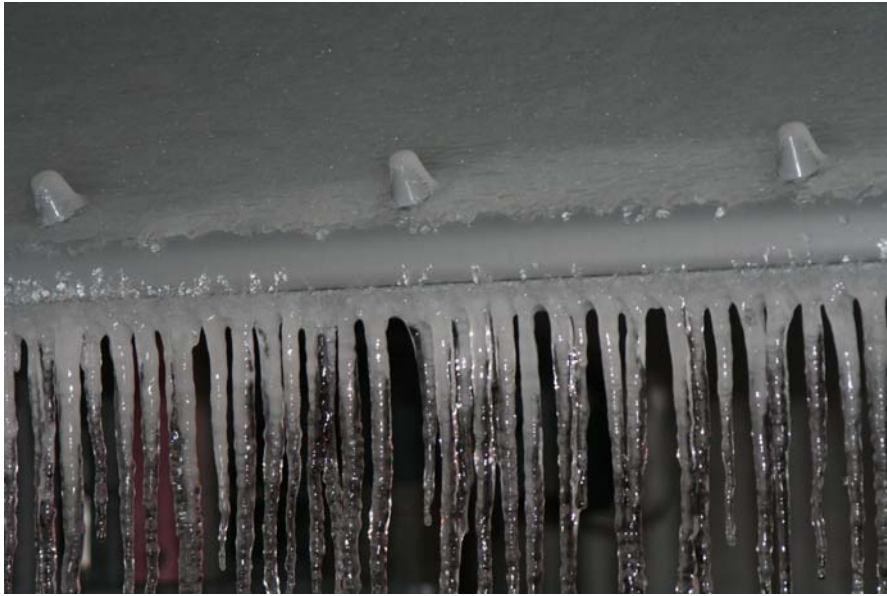
Figure 5.16. Close-up of the leading edge of fin A4 shown in Figure 5.13. The panel joint is providing mechanical anchoring for the icicles.

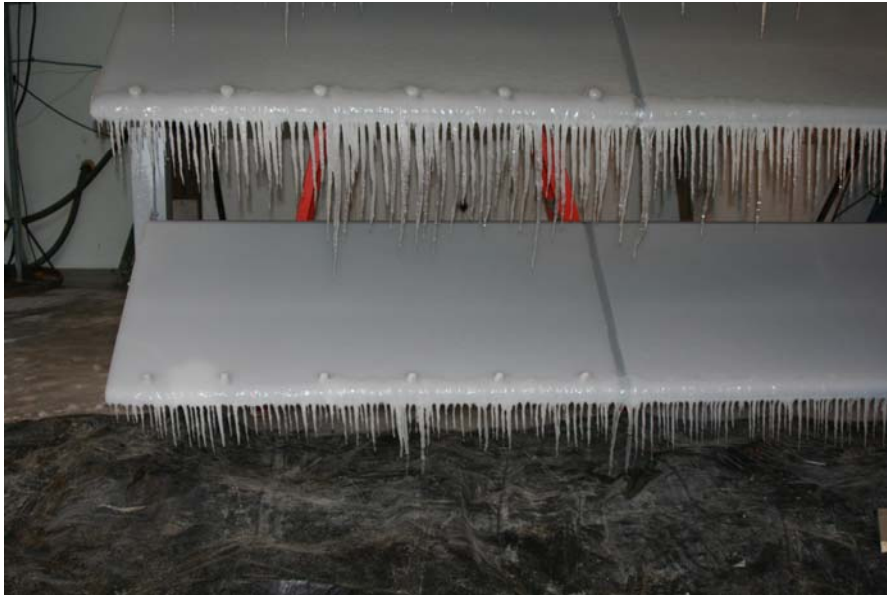
Figure 5.18. Close-up of fins A1 and A2. The bulk of the melt water from fins A3 and A4 refroze on fin A2.

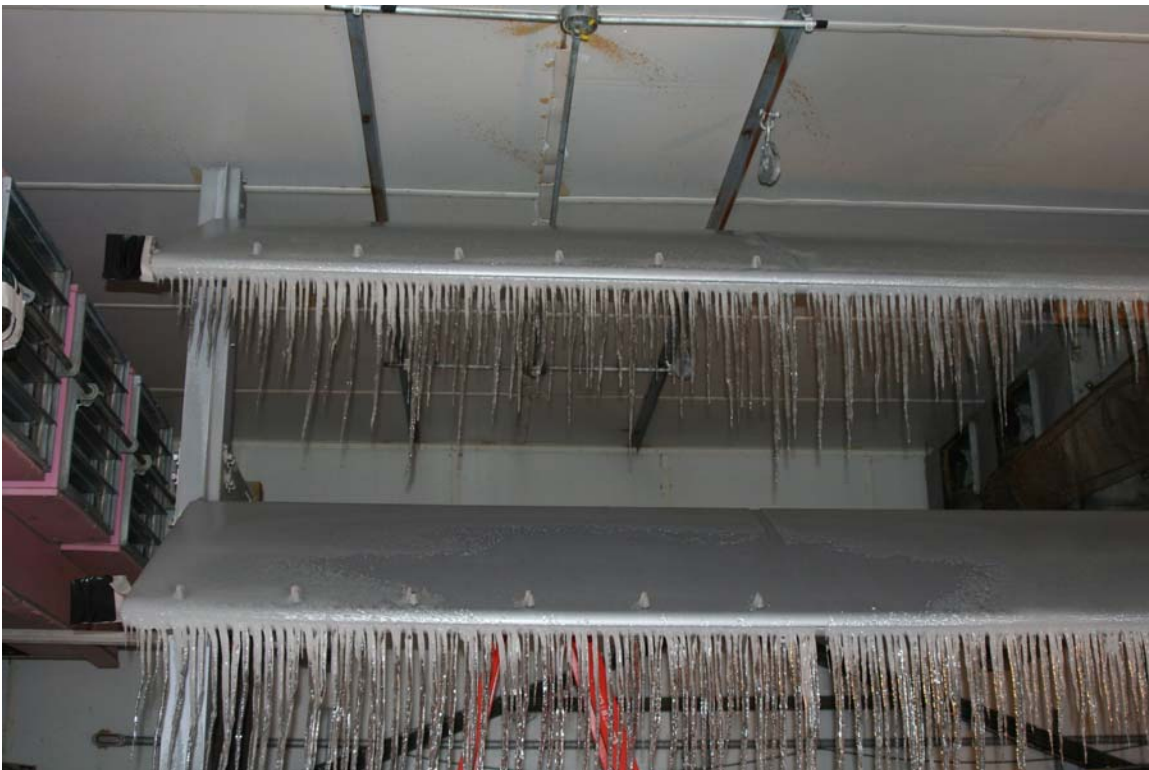
Figure 5.19. Close-up of fins A3 and A4; note the long thin icicles.

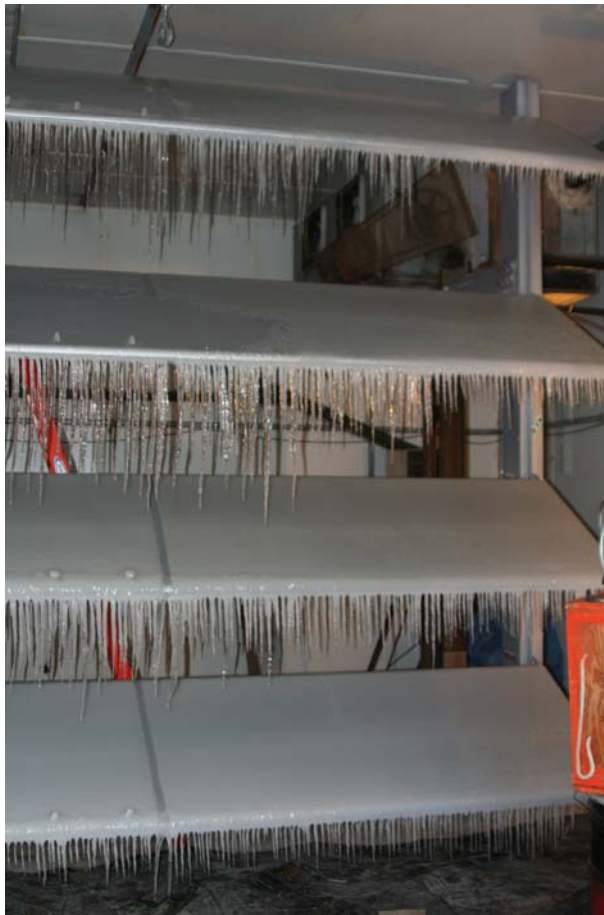
Figure 5.20. Fins on the B side; the radiant heaters on fins A3 and A4 did cause melting on fins B3 and B4.

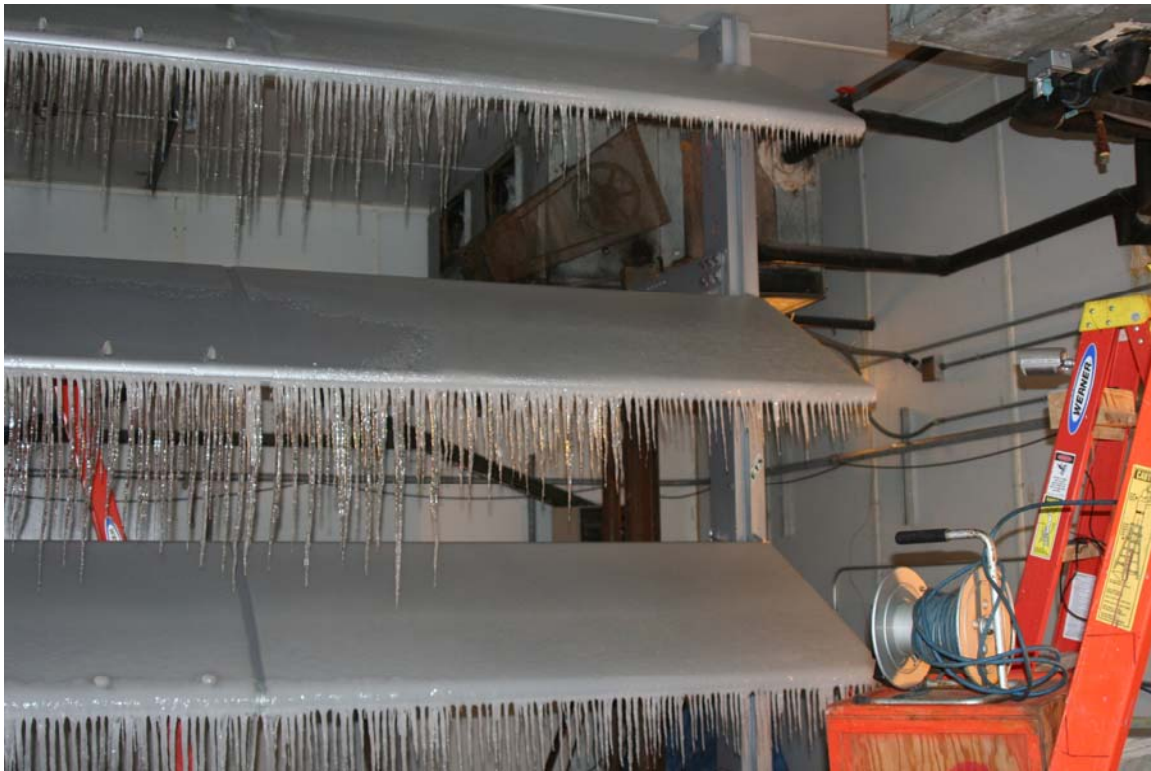
Figure 5.22. Fins B2, B3, and B4. Note the size of the icicles on the A side that was heated with the infrared heaters compared to the right side outside the range of the heaters.

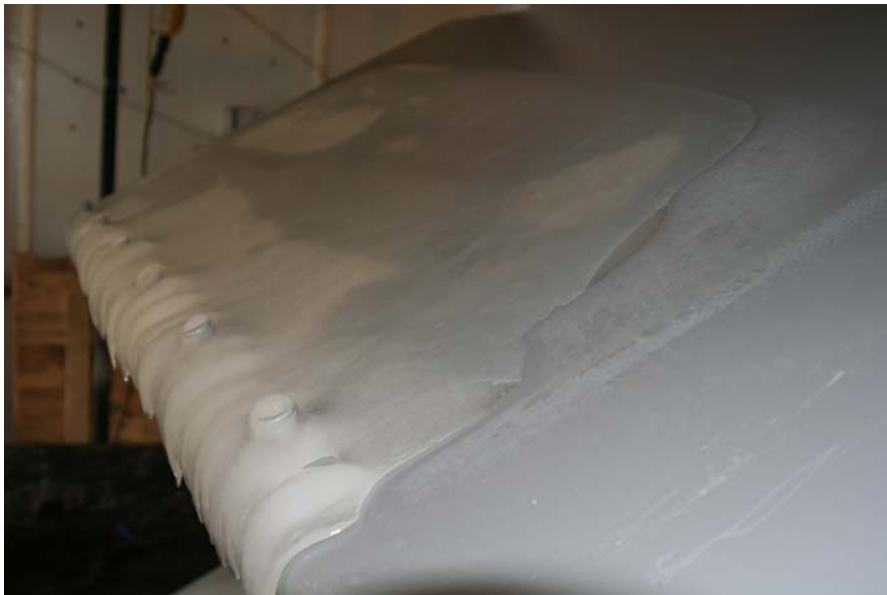
Figure 5.27. Condition of fin A2 after a day of melting with the inverted IRD option 4 protruding through the cover.
