BAGHDAD MUNICIPAL  
SOLID WASTE LANDFILL

**SIGIR PA-06-067**  
**OCTOBER 19, 2006**

SUBJECT: Report on Project Assessment of the Baghdad Municipal Solid Waste Landfill,  
Baghdad, Iraq (Report Number SIGIR-PA-06-067)

## Baghdad Municipal Solid Waste Landfill Synopsis

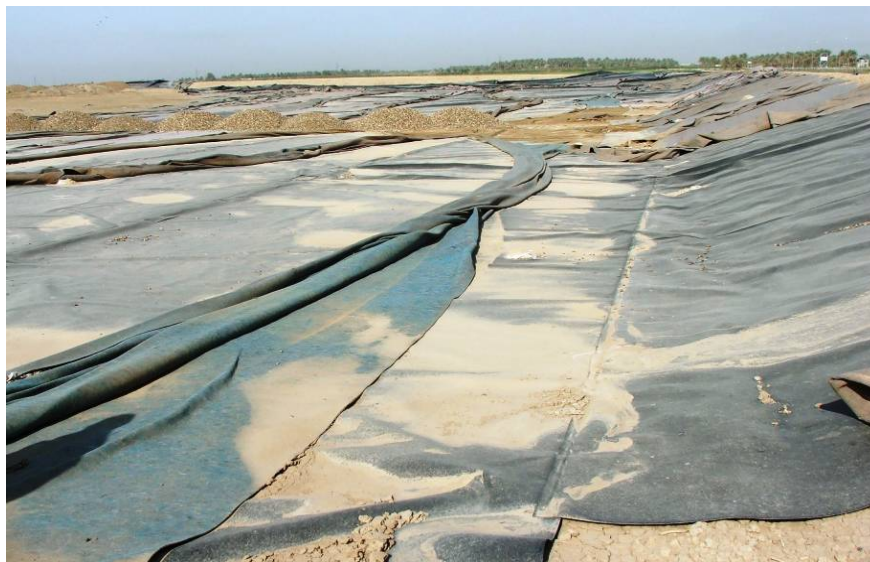
**Site Photo 1. Geotextile protective liner covering**

As mentioned previously, the cell construction was not completed when the project was closed out in November 2005. The geomembrane liner and geotextile cover were in place in every part of the 9.7 hectare cell. However, on approximately 25% of the cell in the northeast quadrant, the gravel base and sand cover (Figure 2) had not been spread over the liner and geotextile protective cover. Site Photo 1 shows part of the MSW landfill's northeast quadrant with the geotextile protective cover lying over the geomembrane liner. During our inspection, we noticed that in some areas of the unfinished section, the geotextile covering had stripped away from the geomembrane liner, as shown in Site Photo 2. It appeared wind action in the previous seven months had blown parts of the geotextile cover off of the geomembrane liner.

There was also wind blown sand covering parts of the geomembrane liner and geotextile covering as seen in Site Photos 1 and 2. If the landfill is commissioned into service, the geomembrane liner and geotextile cover will require remedial work to bring their condition up to standards. The contractor's geotextile cover specification states:

*"During placement of geotextiles, care shall be taken not to entrap in or beneath geotextiles stones, excessive dust, or moisture that could damage the geomembrane, cause clogging of drains or filters, or hamper subsequent seaming."*

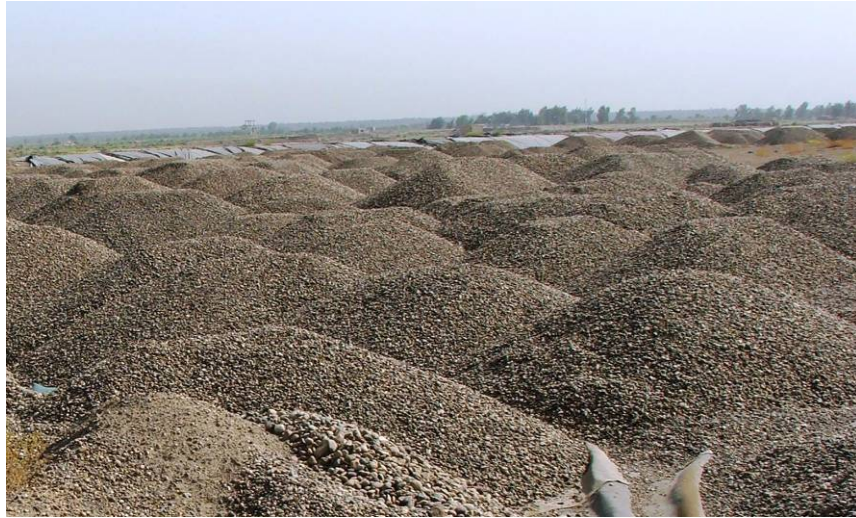
**Site Photo 3. Stockpiles of available gravel at landfill site**

In areas around the unfinished portion of the MSW landfill, we observed stockpiles of gravel that can be spread over the liner and geotextile cover. Site Photo 3 shows some of the gravel piles that could be used for constructing the gravel drainage layer over the liner system. Also, to ensure there is an adequate supply of gravel, an estimate of the amount required to finish the drainage layer is needed. We did not see any sand stockpiles, so sand would also need to be delivered to the site to complete the drainage layer.

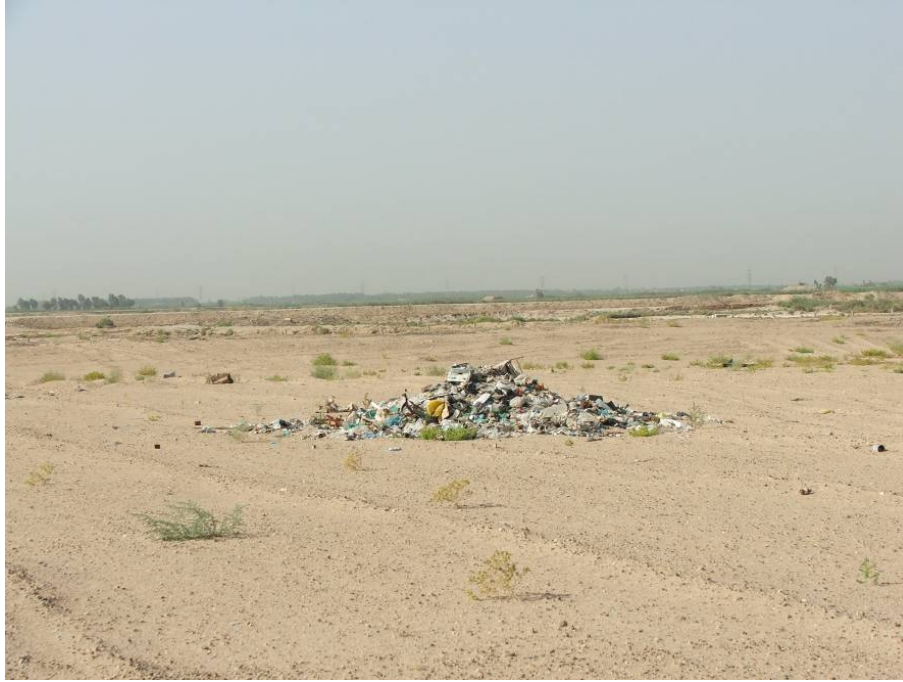
**Site Photo 5. Trash located in one section of the landfill.**

The finished portions of the landfill are ready to receive municipal solid waste, and in one small area, we observed a truck load of trash had actually been dumped (Site Photo 5).

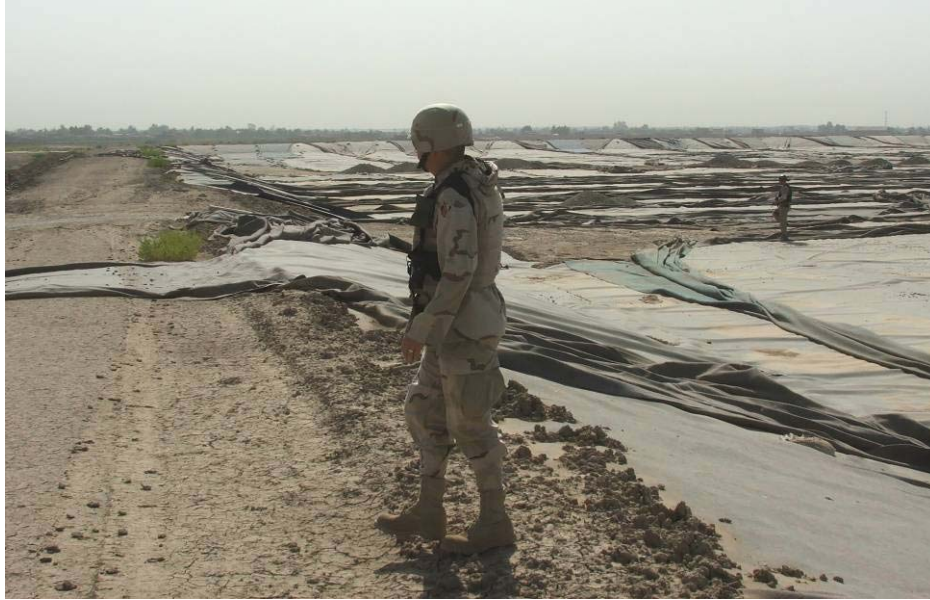
**Site Photo 6. Section of the perimeter berm requiring remedial work to anchor the liner**

We observed the berm in place along the perimeter of the MSW landfill. The design required the liner system to extend up the 3 horizontal to 1 vertical side slope of the berm and terminate in an anchor trench along the top of the perimeter berm. In the unfinished areas of the landfill, the liner along the inside of the berm, as shown in Site Photo 6, will require remedial work to ensure it is placed and anchored properly.

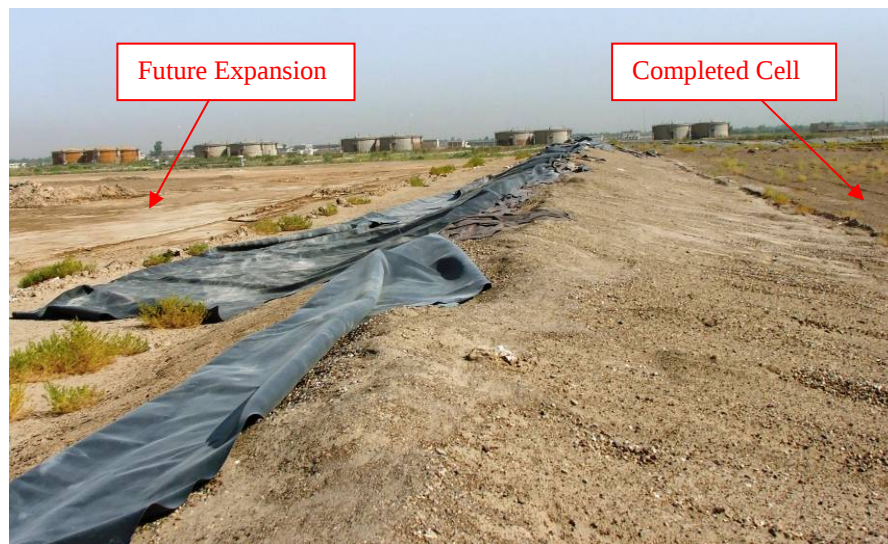
**Site Photo 7. Interphase berm bordering future expansion area**

The portion of the berm adjacent to the future expansion area of the MSW landfill cell, along the west side, was designed as an *interphase berm*, which would be integrated into the next landfill phase if the MSW landfill is expanded to the west. We found the interphase berm in place. However, along most of the length of this berm, we saw geomembrane liner material loosely lying on top of the berm, as seen in Site Photo 7. It appeared this geomembrane material was excess.

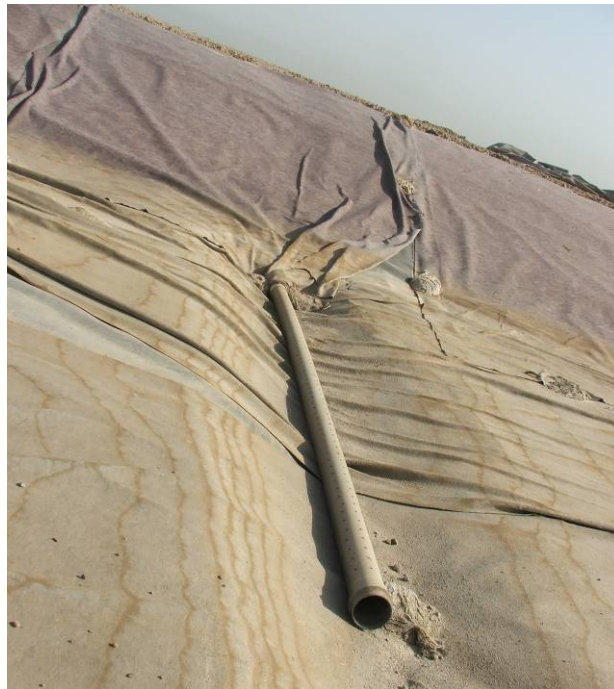
**Site Photo 8. HDPE Leachate Collection Pipe**

In the unfinished portion of the landfill, two of the collection pipes were exposed because the drainage layer had not been applied. The design required a 150 mm diameter, HDPE, perforated pipe. We measured the pipe and verified a 150 mm diameter, HDPE perforated pipe in place at the correct locations within the landfill. Site Photo 8 shows one of the pipes in the unfinished portion of the landfill.

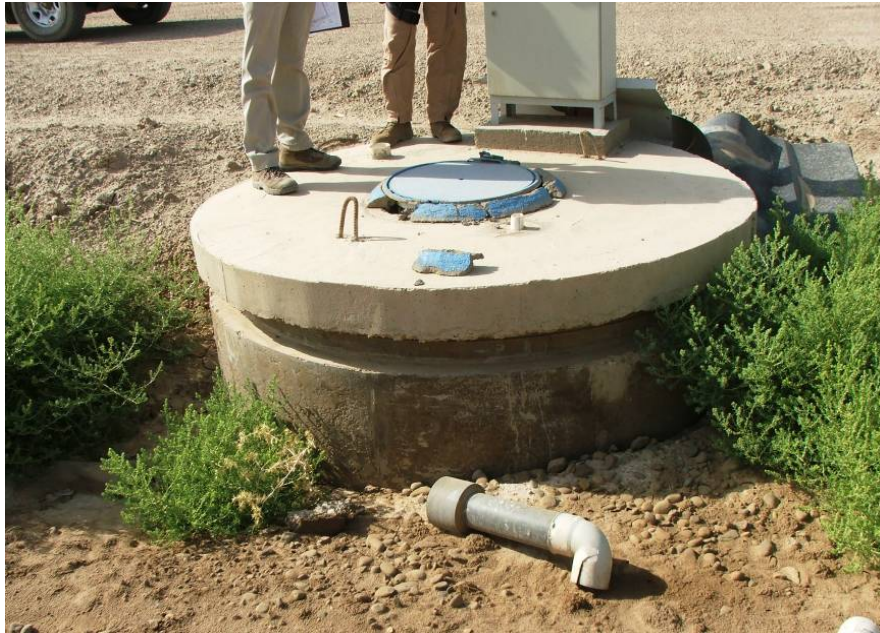
**Site Photo 9. Pump enclosure with broken vent pipe and access cover ring**

We also inspected the four leachate collection pump stations. The design called for submersible pumps inside a concrete enclosure. The access cover was locked on each station, so we did not inspect or verify the presence and the condition of the pumps. The exposed features of the pump stations (concrete housing, access cover, ventilation pipe, etc.) appeared to be constructed as designed. We did notice on two of the stations, the ventilation pipes were dislodged and no longer attached to the concrete cover of the pump housing. Also on one of the stations, the concrete ring supporting the access cover was crumbling (Site Photo 9). Additionally, on each of the pump stations, the electrical cable to and from the motor starter cabinet to the pump was exposed and not enclosed in conduit, as depicted in the design.

The design shows each pump station, connected to a HDPE solid wall force main, buried beneath the ground surface. The design shows the force main running parallel to the perimeter road around the MSW landfill. The original plan showed the force main transporting leachate to the Al Kerkh WWTP, located adjacent to the landfill site. However, the manager of the Al Kerkh WWTP refused to grant permission to connect the leachate collection system force main to the treatment plant because of concern regarding the effect of the leachate on the plant biological processes used to treat sewage. As a result, JCC-I/A directed the contractor to cap the force main at the property line.

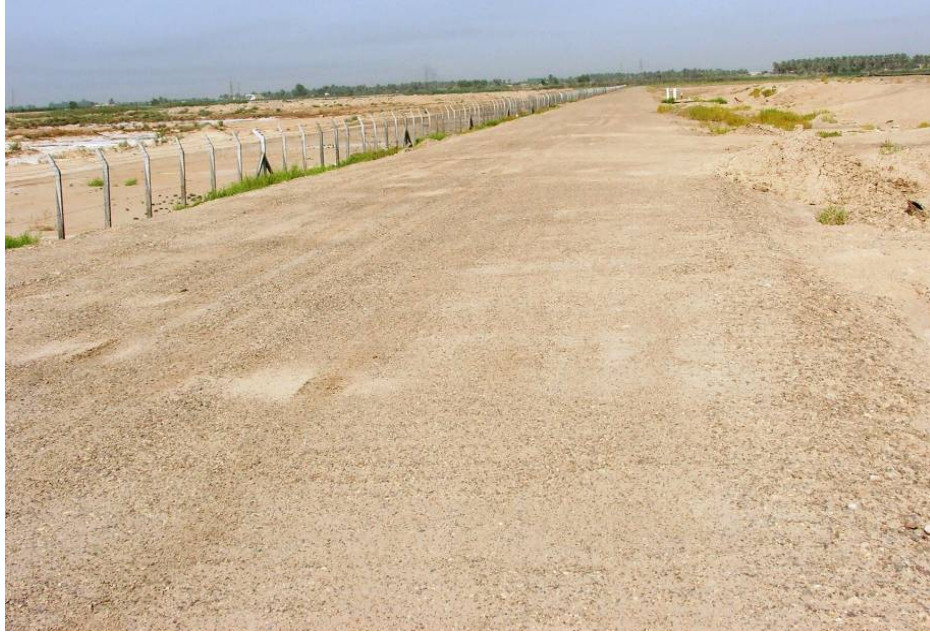
**Site Photo 10. Perimeter road along the MSW landfill cell**

The design required a crushed gravel perimeter road, 9 m in width, with V-shaped drainage ditches along both sides of the roadway with a cross section consisting of a base (surface) course of crushed stone (0.3 m thick), supported by a 0.3 m sub-base of well graded fill material. We drove on approximately 75% of the entire perimeter road and inspected the road at two locations. We did not observe any noticeable surface defects, such as wash boarding or eroded areas. The road appeared adequately constructed to support trash hauling trucks. Site Photo 10 shows one section of the crushed gravel road along the landfill perimeter.

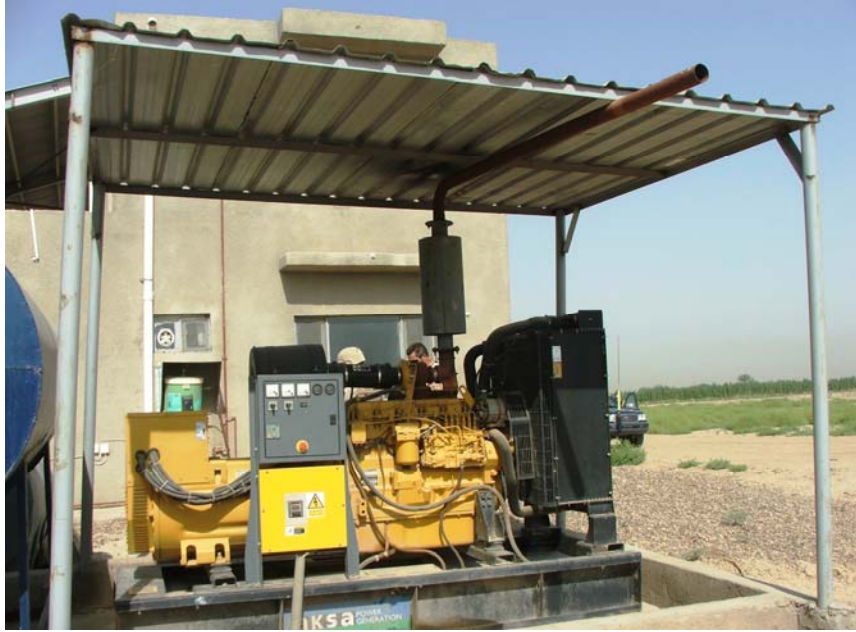
Site Photo 11. Landfill site electrical generator

- The exhaust stack, shown in Site Photo 11, was not properly supported. Also, it appears vibration of the generator could damage the roof and/or generator because the stack location being so close to the metal frame and the roof skin.
- The feeder cable shown in Site Photo 13 was not properly installed in conduit. The connection to the generator control panel was made with exposed wire, not enclosed in conduit. Further, part of the feeder cable was lying exposed on the ground surface. The cable was not in conduit as required by the design nor buried to a proper depth.
- The generator skid was not anchored to the concrete pad.

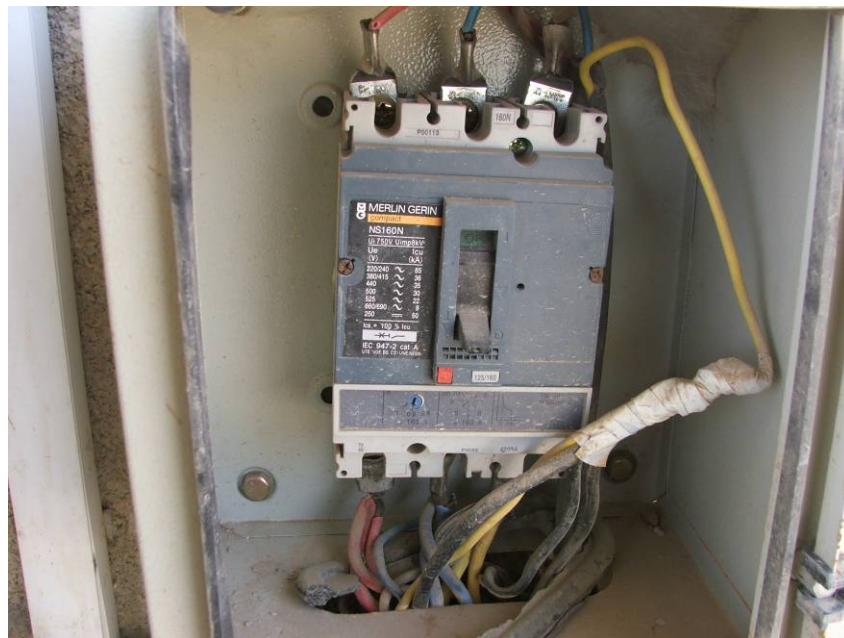
**Site Photo 14: Wiring to one of the dedicated circuits**

We also observed poor wiring installation on one of the dedicated electrical circuits in the maintenance bays (Site Photo 14). It appears there is a non-acceptable splice on the line side of the circuit breaker, as evidenced with the taped wiring. We also observed exposed wiring at other locations around the exterior of the building. In addition, the circuit breaker shown below should be in an enclosed circuit breaker panel.

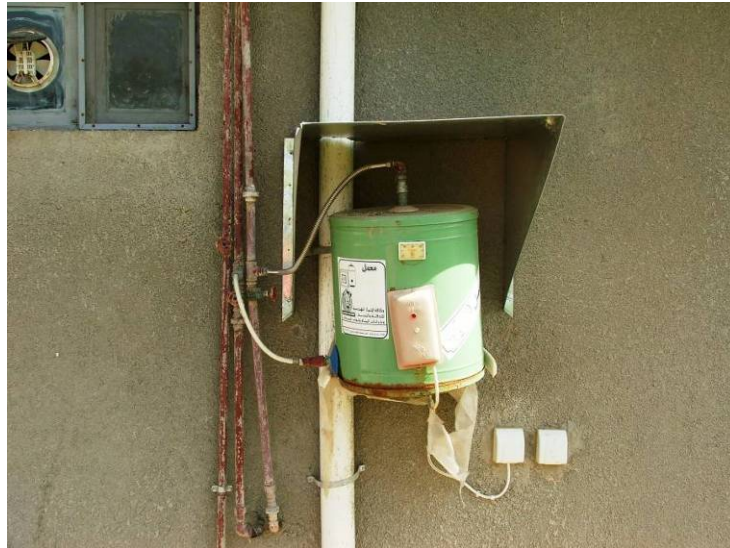
**Site Photo 15. Water heater outside administration building**

Although partially covered with a sheet metal sun shade, the water heater for the building was located outside and exposed to the elements. We also observed some cracking in the concrete perimeter sidewalk around the building. In addition, there was a need for touch up painting, particularly in areas where rust had started such as window frames, lighting brackets for exterior fixtures, and even structural steel components.

The design for the administration building showed a one story, 12 m by 5 m building. We inspected the exterior of the building and verified the building generally met the standards of the design. However, we noted some cracking in the perimeter sidewalk. Additionally, the partially covered water heater, shown in Site Photo 15, had started to rust. We also noted the building was surrounded on all sides by thick vegetation (Site Photo 16) that had grown since November 2005. The vegetation will require removal prior to the landfill becoming operational.

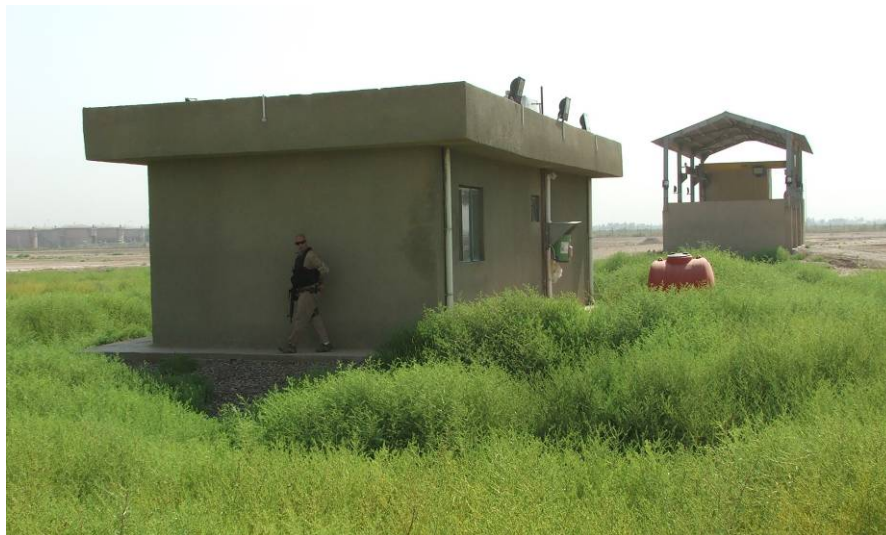
**Site Photo 16. Administration building (truck maintenance building to the right)**

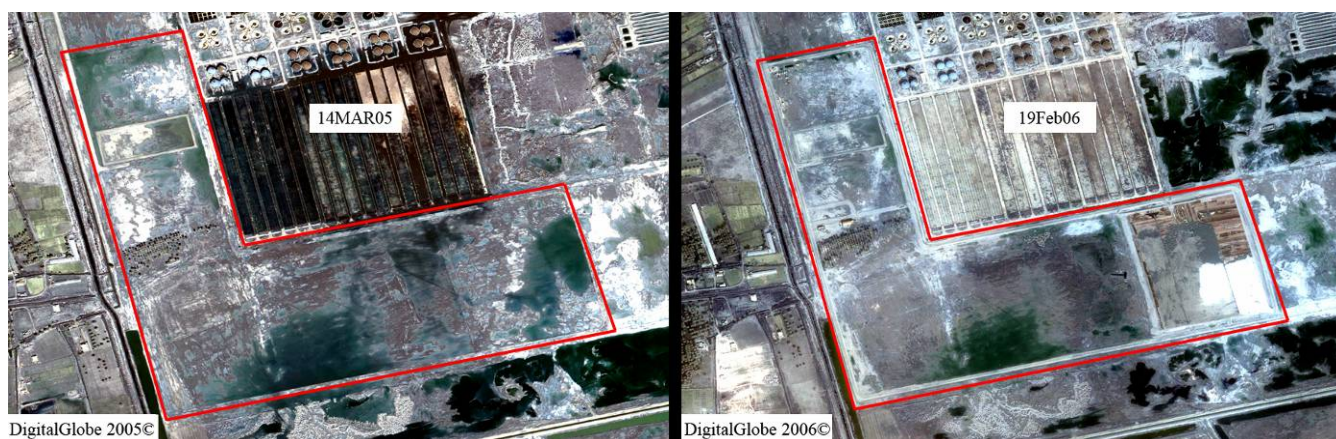
**Aerial Image 1. Baghdad Landfill imagery comparison 14MAR05 and 19FEB06.**

A comparison of two images taken on 14Mar05 and 19Feb06 shows construction progress of the Baghdad Landfill, outlined in red on Aerial Image 1. On imagery dated 14Mar05 the only noticeable construction is the ground preparation of the Construction Debris Landfill (Figure 1, pg. 5) portion of the Baghdad Landfill. Imagery dated 19Feb06 shows what appears to be a nearly completed landfill. Structures visible as of 19Feb06 consist of the Administration, Vehicle Maintenance, and Guardhouse buildings.
