## **Energy Optimization Audit at Humphreys Engineer Center**

September 2008

Final Report

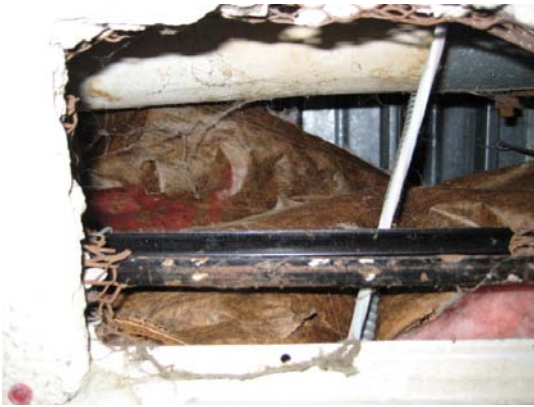
Figure 3. Kingman Building (lack of) insulation.

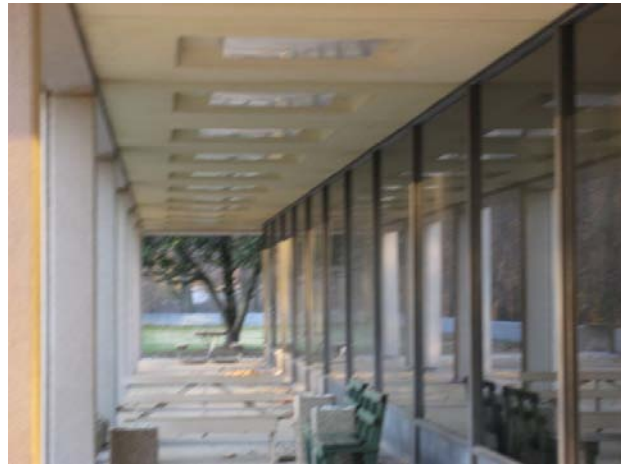
Figure 4. Kingman Building curtain wall.

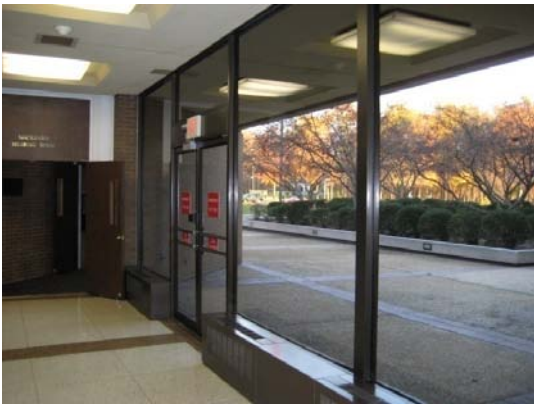
Extensive overhangs (Figure 5) are a major source of air leakage because they are connected to the interior plenums.

Figure 5. Kingman Building overhang.

Eliminate lighting in overhangs or replace the lighting fixtures with fixtures having an energy efficient design that does not leak air. Build an air-tight bulkhead over the storefront above the ceiling, seal it, and insulate with spray polyurethane foam (SPF).

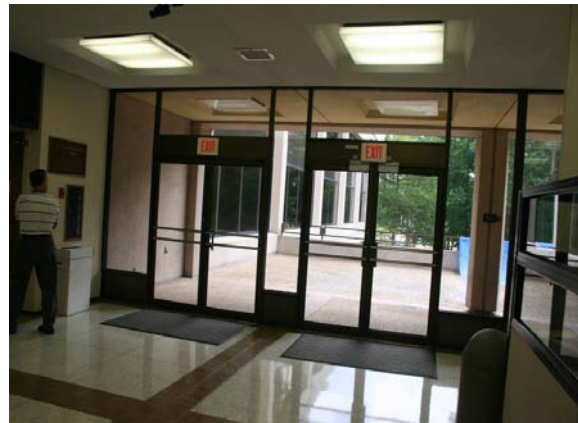
Figure 6. Kingman Building entryway doors.

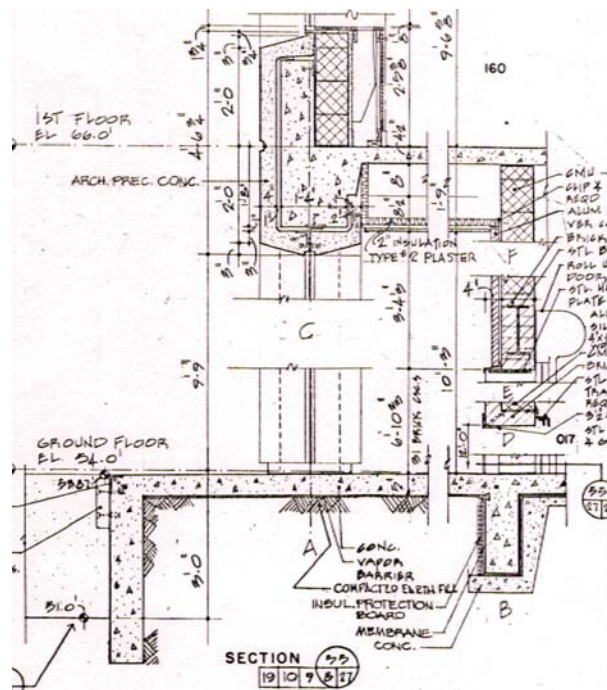
Figure 7. Kingman Building first-floor plan.

Add curtain wall with insulated low-E glazing (Figure 7), and with insulated metal backpan spandrel areas. The existing glazing will be removed and the zipper gasket area blocked as shown.

Take the ceiling in the hearing room down; insulate and seal the roof from the inside with 3-in. of spray polyurethane foam (SPF).

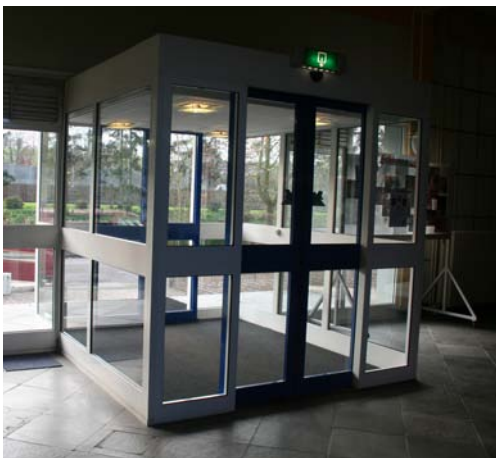
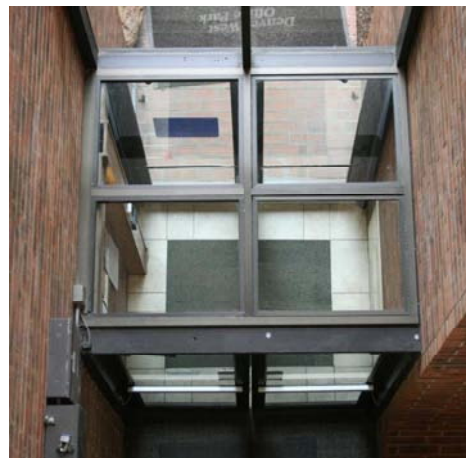
Figure 8. Examples of vestibules for high traffic doors of administrative buildings.

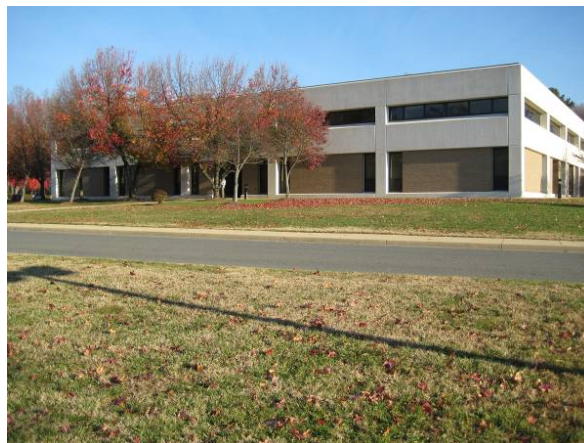
The Casey building (Figure 9), like the Kingman building, has a concrete structure with precast concrete cladding. Thermal bridging is extensive. The building is uninsulated.

Figure 9. Casey Building.

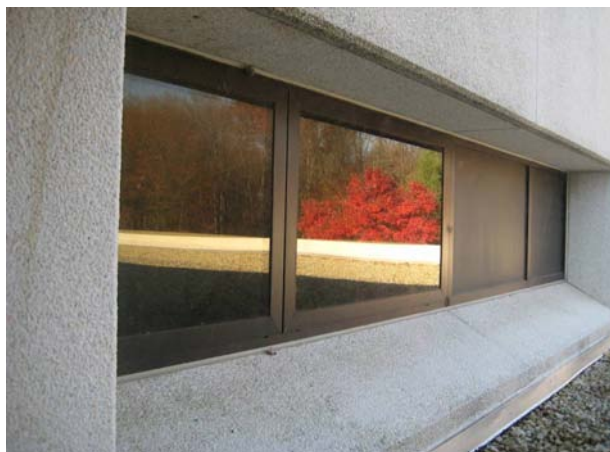
The windows are thermally broken aluminum with insulating glass (Figure 10).

Figure 10. Casey Building windows.

Reduce air leakage through windows by proving new gasketing for operable units.

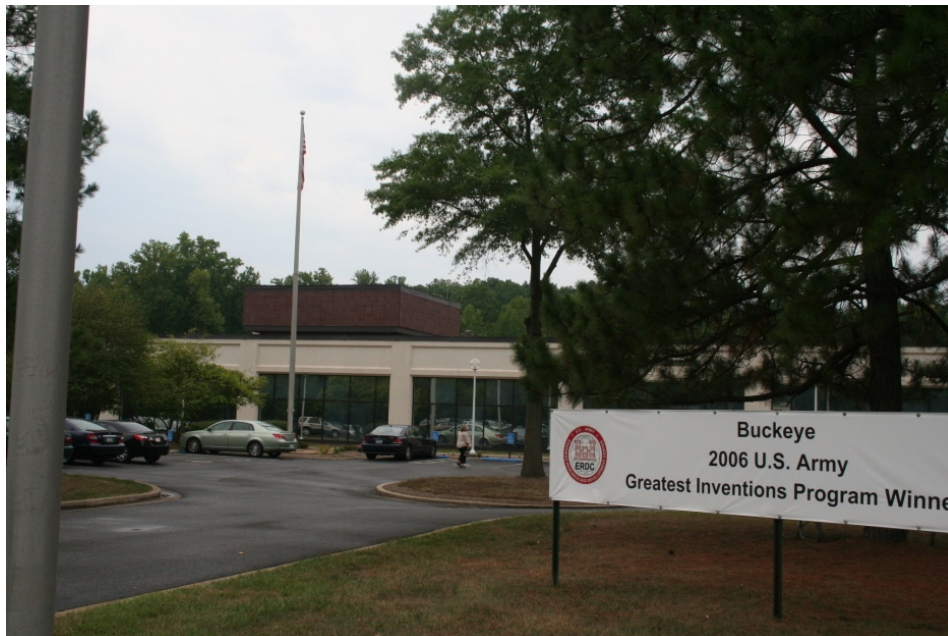
The TEC building (Figure 11) has a steel structure with precast concrete cladding.

Figure 11. Topographical Building (TEC).

Remove the single glazing adaptor, and replace existing single pane window glass with insulating Low E.

Drop the 12-ft ceiling height to the level of the horizontal mullion to reduce energy consumption by reducing the volume of the air-conditioned space.

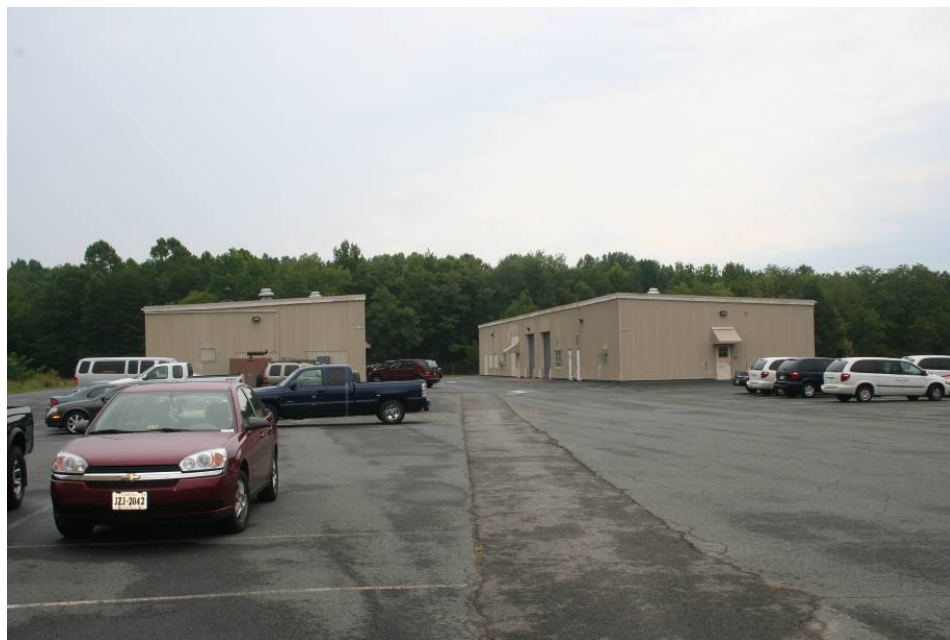
The warehouse buildings (Figures 12 and 13) are metal clad. The cladding (Figure 14) is rusting and in poor condition. The buildings are underused. The roofing is original.

Figure 12. Warehouse Buildings – side view.

- Seal and insulated buildings with spray polyurethane foam (SPF), furring and drywall or by installing EIFS.
- Replace windows.
- Add vestibules to spaces larger than 3000 sq ft.
- Change roofs with reflective and better insulated.
- Replace overhead doors.
- Replace cladding.

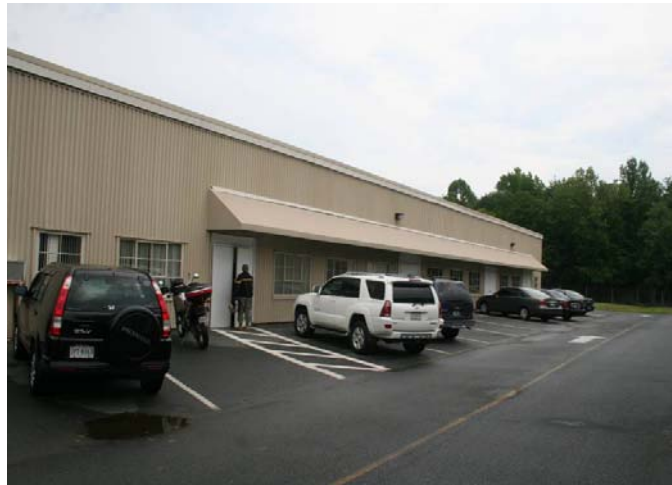
Figure 13. Warehouse Buildings – entry.

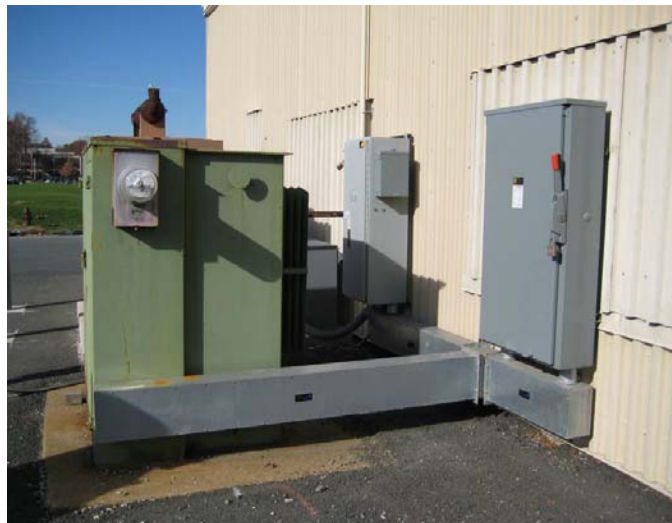
Figure 14. Warehouse Buildings – metal cladding.

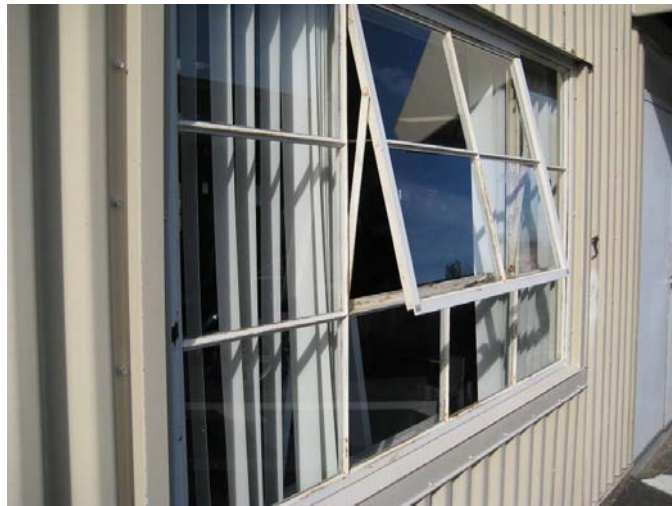
The windows (Figure 15) are steel, single glazed, and rusting—and have no weatherstripping.

Figure 15. Warehouse Buildings – windows.

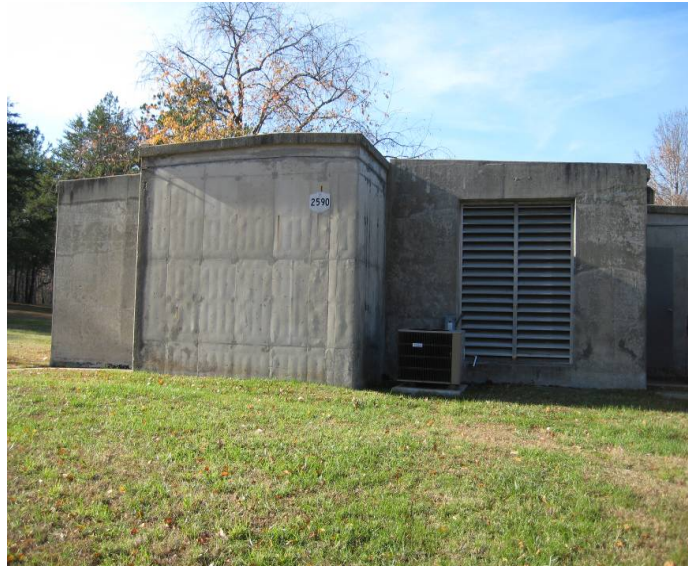
Figure 16. Bunker Building.

The Bunker buildings (Figure 16) are two-story structures that are under-used. They are heated and cooled even though several of them house no function.

Consider consolidating the space.

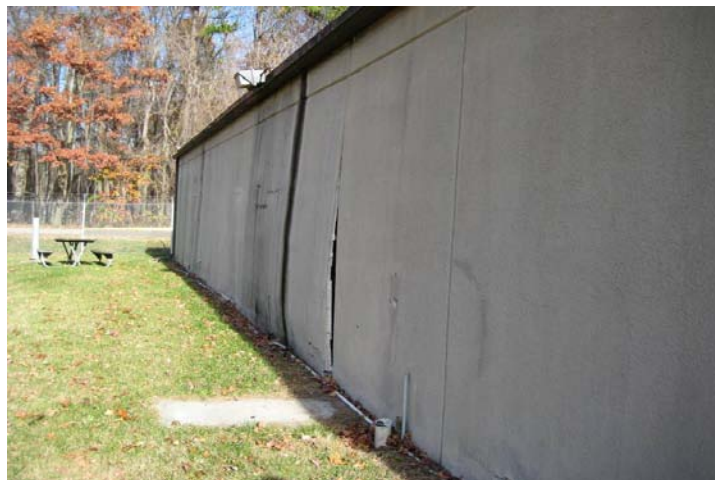
Figure 17. Failed EIFS on Bunker Building.

Insulate with drainable EIFS. Replace existing failed EIFS (Figure 17) with new drainable EIFS.

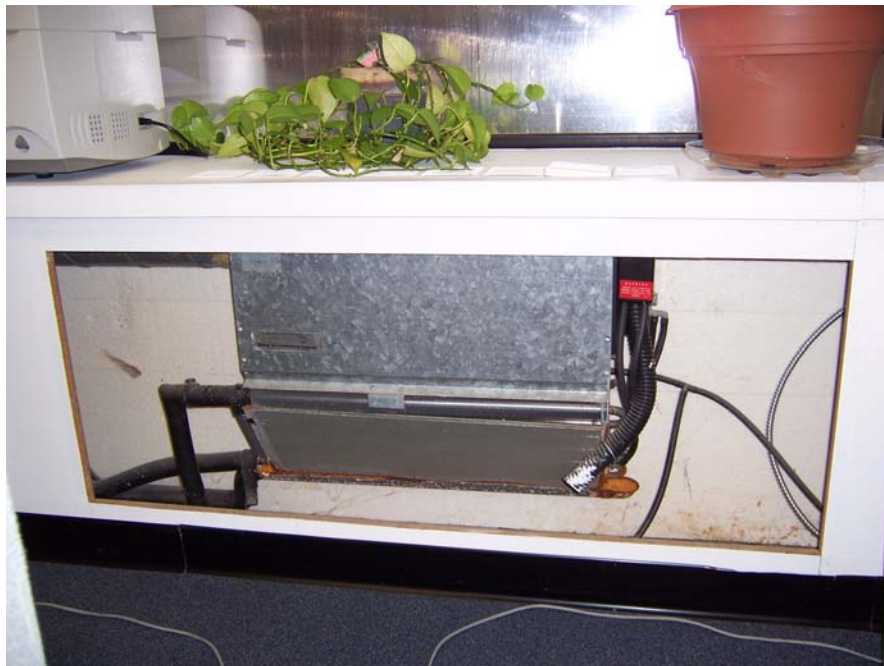
There are two air handling units (AHUs) that provide air to these spaces. One sends air to the induction units. There are four zones off this unit each with a booster fan to provide the needed pressure to achieve the induction of room air through the air terminal units. The induced room air passes through a heating/cooling coil located in the air terminal unit to provide individual room temperature control for those spaces along the perimeter of the building. The heating and cooling coils are supplied with tempered water that comes from one of four pumped water systems.

Figure 18. Induction unit with cover off.

The first and second floors of the building have a number of problems. The building envelope performs poorly with infiltration of outside air noticeable, significant heat loss/gain through the windows and huge swings in solar heating loads due to the sun's position relative to the building. The solar loads pose the greatest issue with discomfort of the building's occupants. Since the HVAC system does not respond well to changing loads, the offices on the east side are too hot in the morning and those on the west side are hot in the afternoon. These conditions influence adjacent spaces and interior offices are also uncomfortable. The degree of occupant discomfort is evident by the number of circulating fans and small space heaters located in most spaces. In one section of the first floor, a supplemental air-conditioning unit has been installed on the roof to provide additional cooling. Maintenance costs are rising since the HVAC system is old and it is getting quite difficult to obtain repair parts for the induction units and other components.

The existing air-conditioning system needs to be replaced or upgraded to accomplish individual room temperature control. The induction units need to be replaced with either new induction units having a remote thermostat, a variable air volume system, or a four-pipe fan coil system. A ceiling mounted radiant heating/cooling system combined with a dedicated outdoor supply air unit was also considered for this building, but its initial cost would exceed the other options.

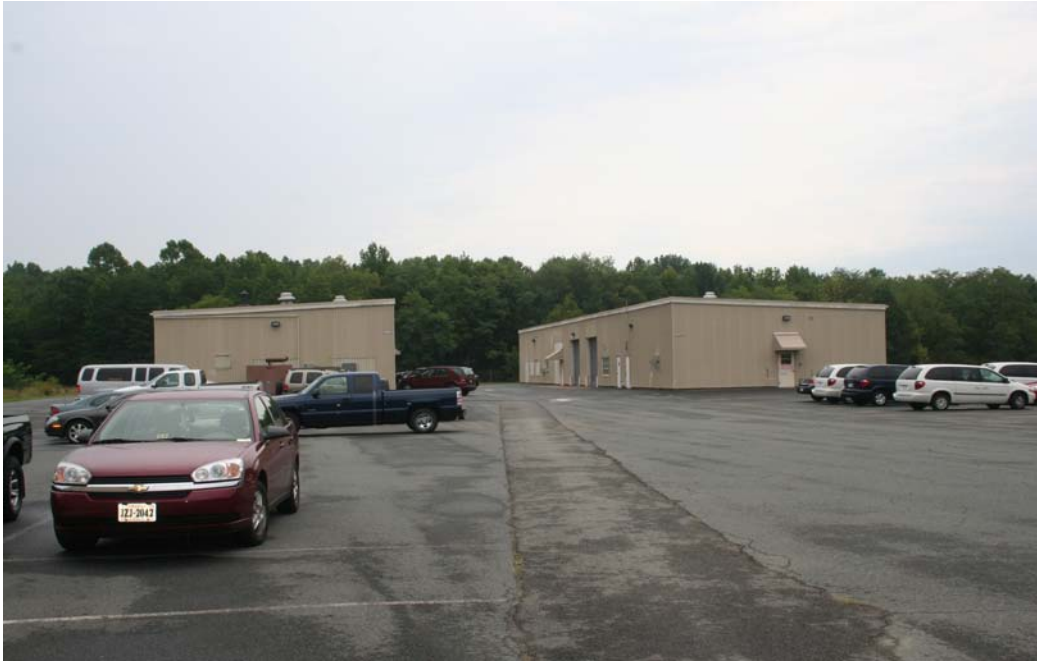
Figure 19. Fitness Center/Mailroom and Museum/Motor Pool Buildings

In several small buildings (cf. Figure 19), heating is accomplished by hot water unit heaters and radiators. These heaters are set to maintain a temperature during both occupied and unoccupied hours. There are no controls to adjust temperatures when the building is vacated.

Controls can be added to the heating systems of these building that would allow the space temperature to be set back to a less energy intensive level during unoccupied periods. This type of control is called “night setback.” The controls will also monitor the outdoor temperature and schedule the heating systems to warm-up the buildings so temperatures will be comfortable when occupancy begins.

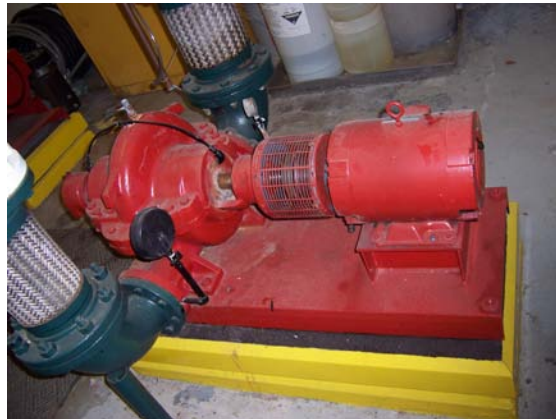
Electric motors are required to power a wide range of equipment and devices (e.g., Figure 20). The loads on the motors can vary or be relative constant. When selecting a motor, it is best to match the process load to the proper motor size. A partially loaded motor operates at a lower efficiency than one fully loaded. Since motors that are not a premium type were found at Bldgs 2592 and 2593; the situation probably exists site-wide.

Figure 20. Pump motor

It is recommended to replace these motors and others that fail at with premium efficient motors when they fail and need replacement. The following Tables show the annual savings and the cost of the premium motors compared to the use of standard efficiency motors. The analysis shown in the Tables assume that the motors operate continuously and are fully loaded. The cost used in the simple payback calculation is half the premium cost, which approximates the cost of a new motor compared to rewinding a failed motor. If such a motor replacement program is not provided, energy will be wasted since the most efficient equipment is not used.
