AFRL-RX-TY-TR-2010-0096

## **EVALUATION OF DETERGENT RUBBER REMOVAL SYSTEM UNDER EXPEDITIONARY CONDITIONS IN SUPPORT OF OPERATION UNIFIED RESPONSE**

August 2010

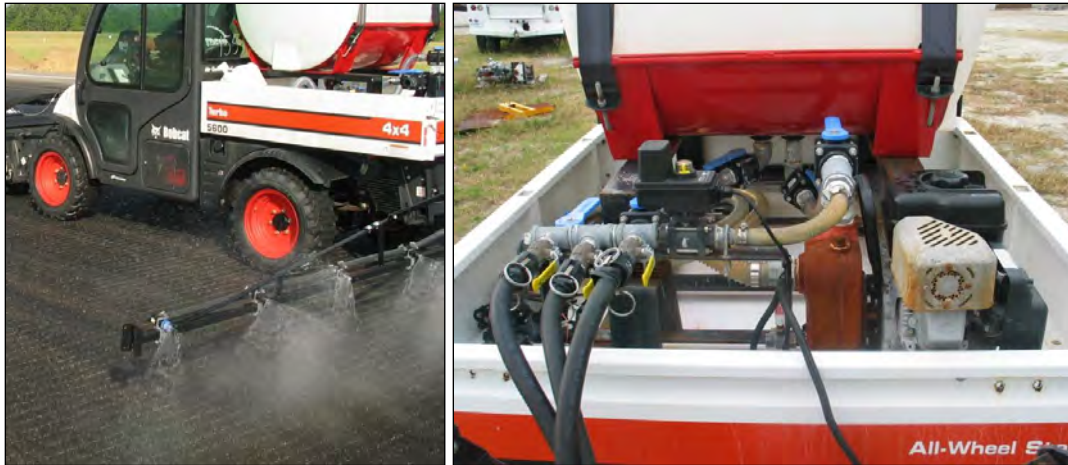
**Figure 5. The Folding Spray Bar System Includes a Pump and Water Tank**

The AFRL-modified agricultural sprayer system (Figure 4) includes a 200-gal poly tank, gas-powered pump, and 21-ft wide folding sprayer boom (Figure 5). Initial testing started with a smaller tank and pump system that was inadequate for rubber removal requirements. The new system is capable of supplying 20 gal/min at a pressure of 40 psi. The 200-gal polyethylene horizontal storage tank can store sufficient rubber removal detergent to treat approximately 40,000 sq ft of runway surface, depending on the thickness of the rubber build-up.

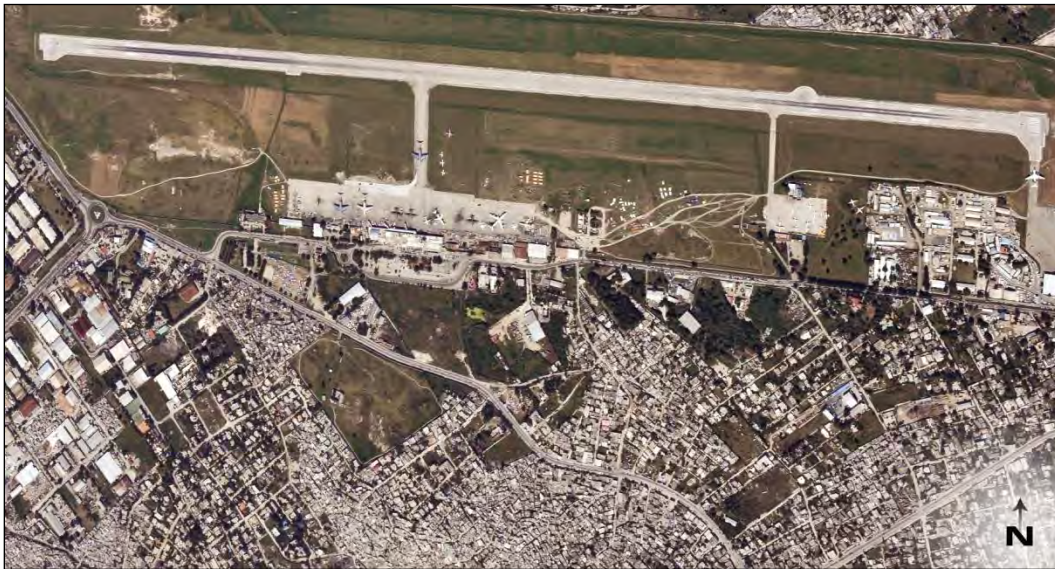
**Figure 14. Layout of Runway 10-28 and Apron at PAP**

After an initial survey of the condition of the runway, a plan for the operations was established and work began to stage the equipment and rubber removal detergents. In the weeks leading up to the deployment by AFRL the Airfield Pavements Evaluation Team (APE) from AFCESA had conducted a full evaluation of PAP Runway 10-28 and reported that the rubber build-up was medium to heavy over the touchdown and deceleration areas. This accumulation is visible in the image of the layout and Runway 10-28 at PAP shown in Figure 14.

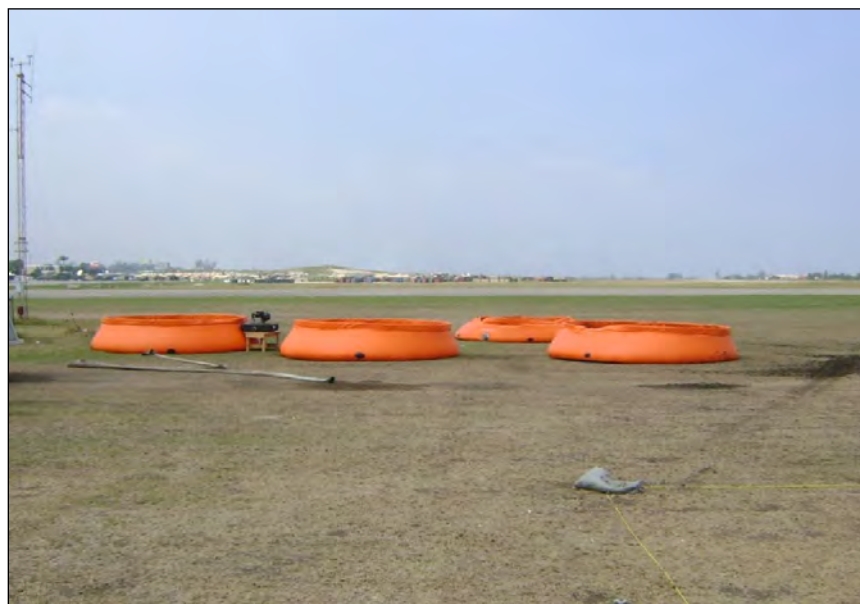
**Figure 18. Four 2500-gal Capacity Onion Bladders Stored Water for Later Use**

The Haitian contractor responsible for providing the requisite rinse water was not informed of the overnight operation and provided only a portion of the required water needed for rinsing (thus the staining shown in Figure 17). Alternate arrangements were made with the Fire Department to provide the additional water with one of their 5000-gal water tanker trucks for rinsing. It was decided that the team would borrow four 2,500-gal capacity onion bladders from the Fire Department to stockpile water for the second night of cleaning. During daylight hours the onion bladders were filled with water as shown in Figure 18.
