# **1 MA Breech Upgrade for the U.S. Army Research Laboratory's (ARL's) Rectangular 22- × 44-mm In-bore Cross Section Railgun**

**by Miguel A. Del Güercio and Alexander Michlin**

**ARL-TR-5619**

**August 2011**

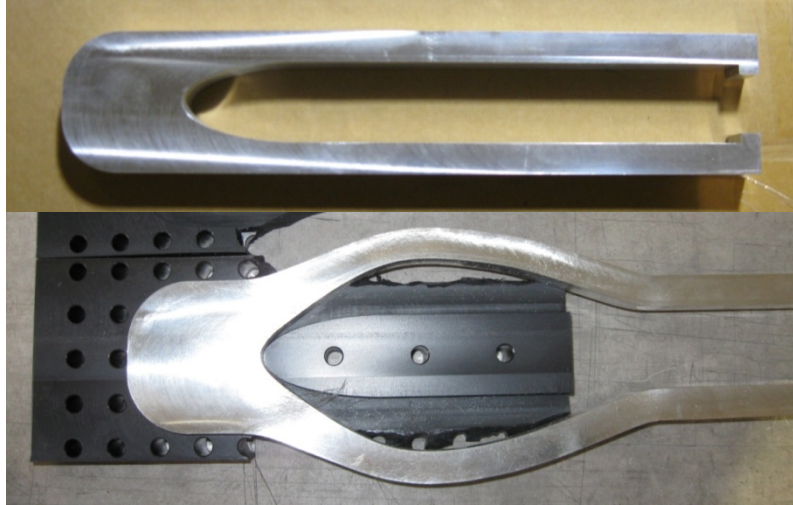
Figure 17. Typical “U” short at top and deformed “U” short due to the EM forces at bottom.

One way to discharge energy through the breech repeatedly without launching an armature is by the use of a “U”-shaped short secured to the breech. Due to the forces generated by the existing “U” short, we established that the discharge currents should not exceed approximately 600 KA when utilizing this short. The permanent deformation of the “U” short in figure 17 occurred during a 620 KA pulse compared with a new “U” short. To contain the lateral forces during testing, the “U” short was supported by a through-bolted, two-piece black nylon clamp structure as seen in figure 18a. The clamp was designed to operate at currents up to 600 KA peak.

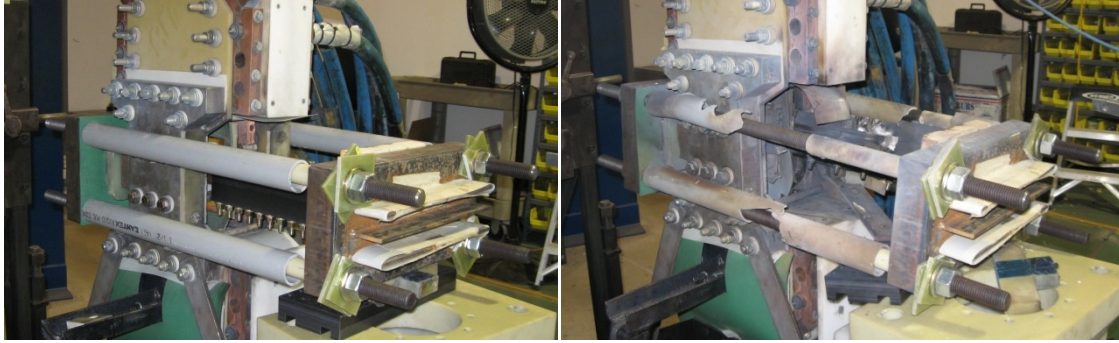
Figure 19. Pre-test assembly secured with extra brackets, and post-test failure from test 8 783 KA.

Testing continued after adding brackets (figure 19) to restrain the launch forces on the “U” short. The subsequent tests performed as expected until test 7, which had a lower than expected current. Test 8, which was a repeat of test 7, gave an expected peak current of 783 KA, however the “U” structure and the short failed catastrophically with extensive damage to the breech coaxial cables and other adjacent components.

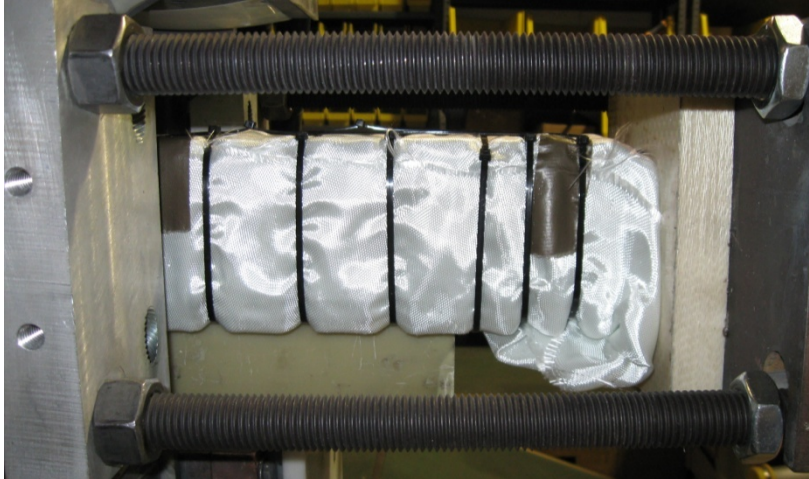
Figure 21. Kevlar cloth was wrapped around the nylon clamps containing the “U” short.

A test series with five and ten pulses was planned at a 620 KA current level. Kevlar cloth was wrapped around the “U” short containment (figure 21) before starting the series to help protect other components from damage if further “U” short failures occurred. The first five pulse series performed without any problems, and the copper inserts were evaluated afterwards.

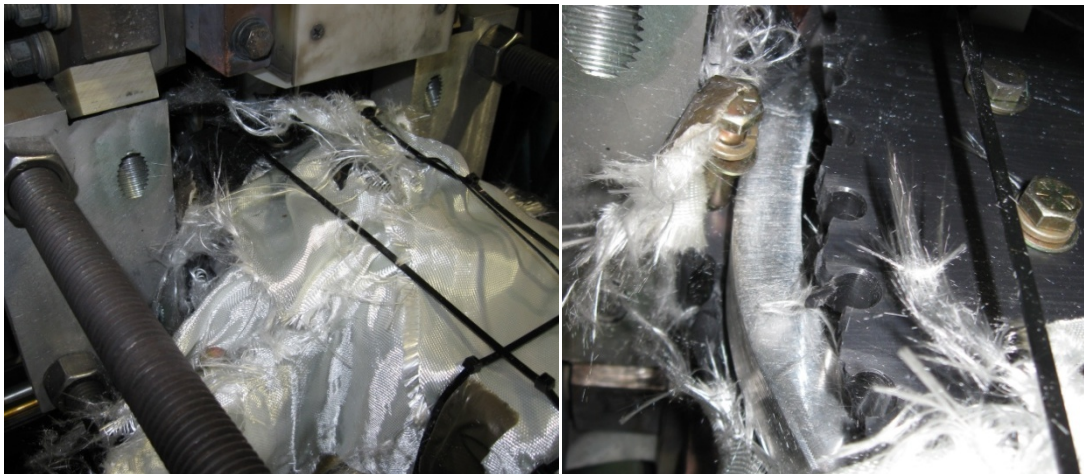
Figure 22. Kevlar wrapping destroyed by fragmentation of retaining bracket.

Another series of ten consecutive discharges into the shorted breech followed, so a new “U” short was installed in the same method as used in the previous consecutive series. The first discharge into the “U” short caused the short to deform and fractured the containment even though the same charge voltage and peak current had been used successfully in test 14. The failure was assumed to be caused by the short being made from a different grade of aluminum or unseen damage to the containment structure. The aftermath can be seen from figures 22 and 23.

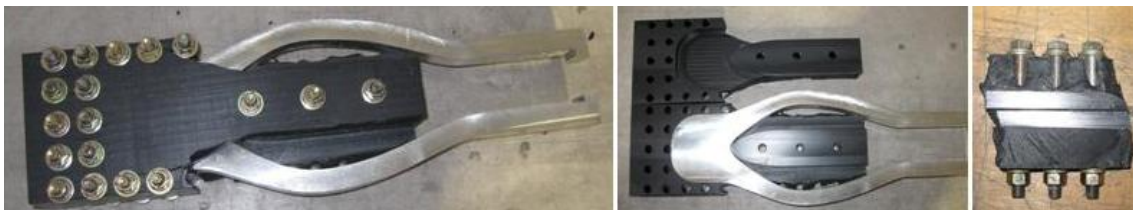
Figure 23. Post-test nylon bracket condition.

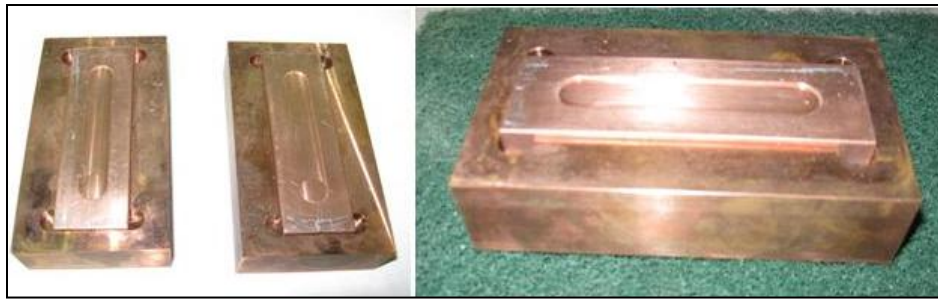
Figure 31. Full length pocket inserts in breech blocks.

Due to the nature of the film, that only record peak loads are recorded, some areas of the film may show a greater pressure than actually exists when all bolts are tightened. To obtain more consistent results, that can be quantified, the pocket pattern tests should be repeated on a precision hydraulic press. The inserts and blocks used should also be machined true and ground flat for optimum results. In spite the suboptimal tests, the results from the force transducers and pressure sensitive film have provided useful insight into the clamping loads applied to the rail interface of ARL's railgun. In order to enhance the interface within the current system, the slot pockets have been extended to a single, near full-length pocket as can be seen in figure 31. Subsequent shots at higher current levels have shown a remarked improvement in the joint integrity. Further study is still needed to refine the contact pressure distribution.
