## **ENCLOSURE FIRE TESTS FOR UNDERSTANDING AIRCRAFT COMPOSITE FIRE ENVIRONMENTS**

June 2011

# **Enclosure Fire Tests for Understanding Aircraft Composite Fire Environments**

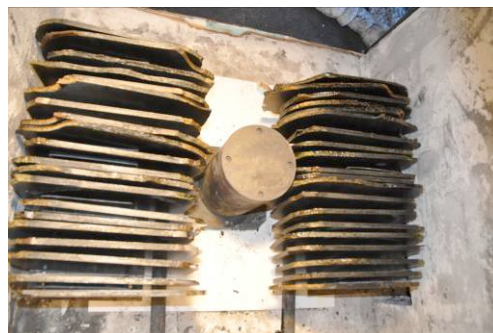
Figure 1. An illustration of the lay-up of Test 5 (A) with a photograph of the pre-test configuration (B).

In Test 5, we arranged a series of thick panels on two metal plates with wires welded to them to maintain spacing. The panels were made of the same material, but varied slightly in shape. The edges were not consistent or smooth, with some residual epoxy over-flow of varying thicknesses throughout the panel edge. The plates were somewhat oval, with major dimensions of 20 and 33 cm. The plates were approximately 1.0 cm thick, and had a flat surface area of approximately 600 cm<sup>2</sup>. A total of 40 plates were burned in the test. The total mass of the material was 36.6 kg (80.7 lbs), and the estimated surface area to volume ratio was 2.0 cm<sup>-1</sup>. An illustration of the lay-up is found in Figure 1 along with a corresponding photograph of the set-up.

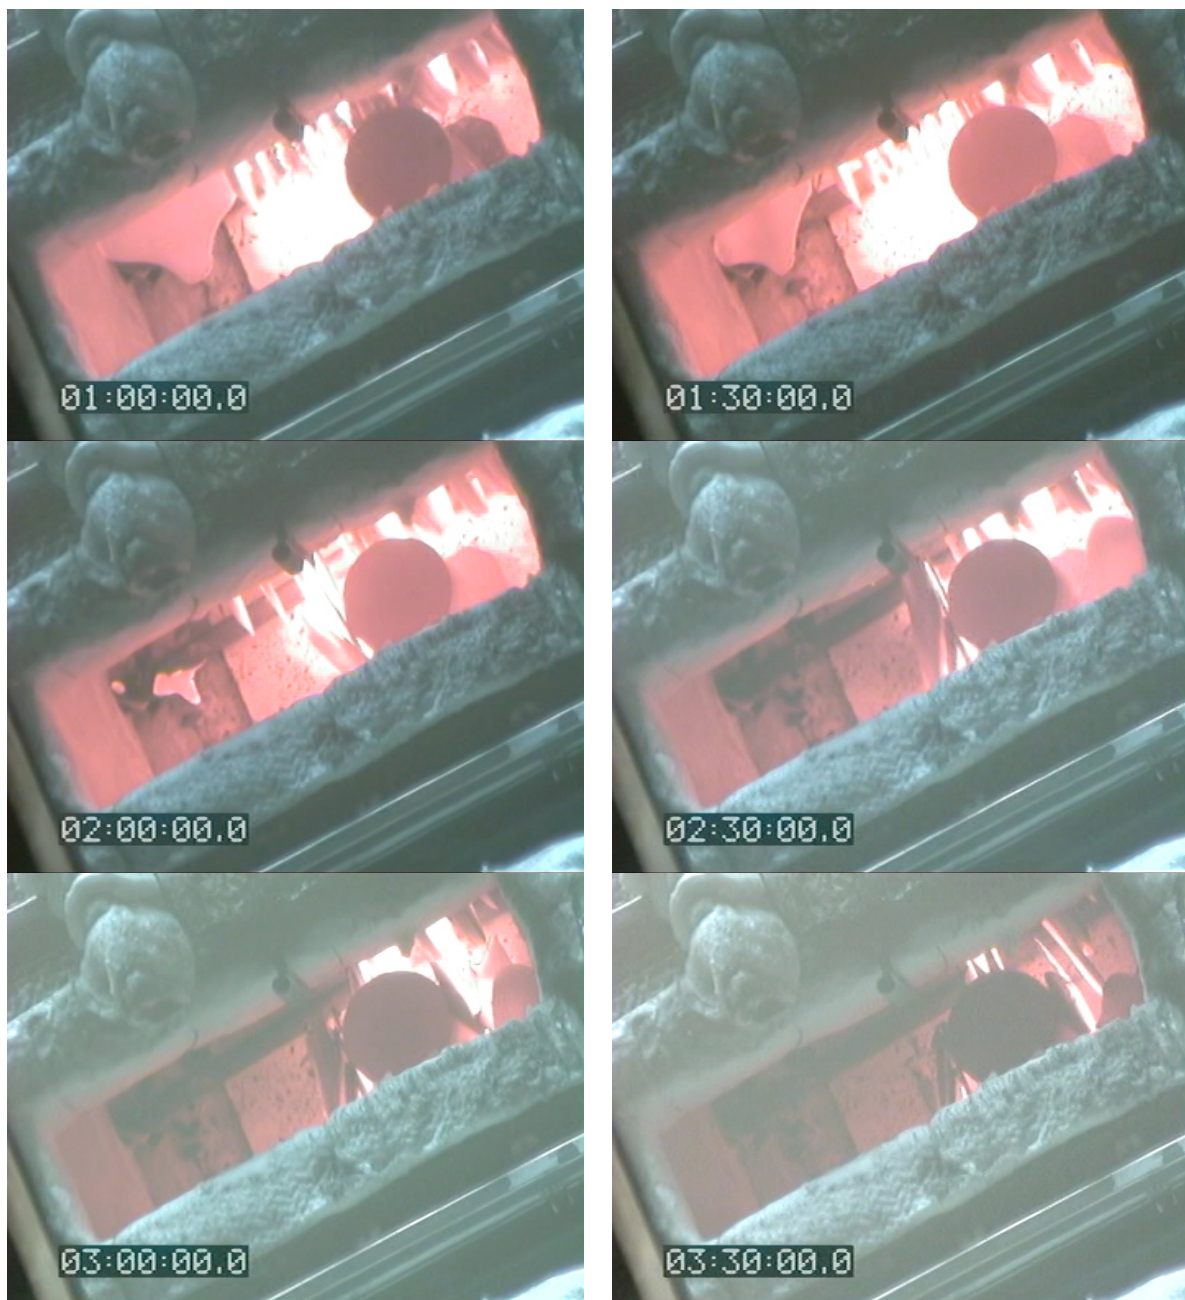
Figure 9. Test 5 video frames at regular half-hour intervals as time-stamped.

Figure 9 shows frames at half-hour intervals as captured by video during the test. On the left of the images, one of the composite pieces fell early in the test and is lying at approximately 90° orientation to the rest of the pieces in good view of the cameras. It is almost completely consumed by the 2 hour mark. It should be noted that this piece was located in the rack that was nearest the air inlet. This and its orientation likely played a significant role in its apparent early consumption compared to the other pieces on the same rack and those on the other rack.

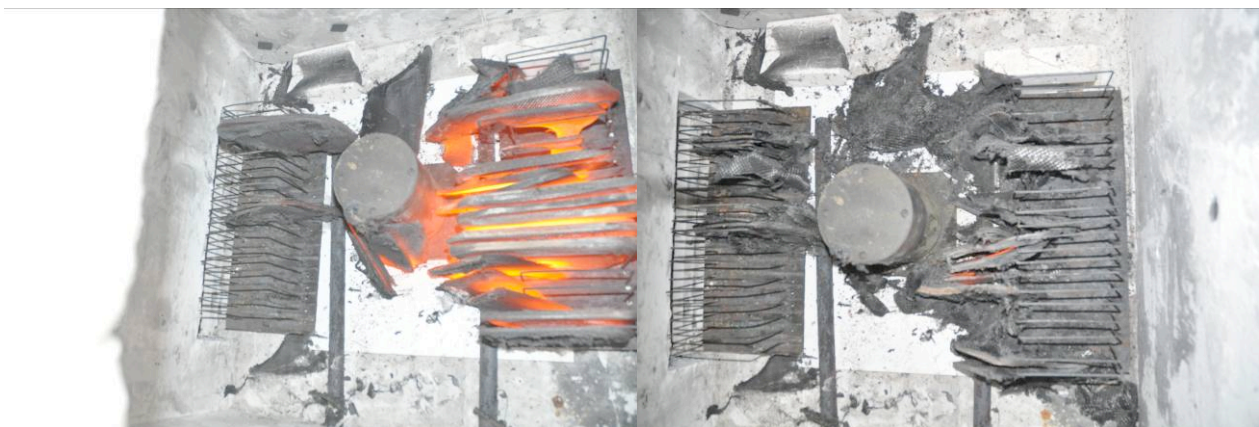
Figure 10. Test 5 photographs of the late-test burnout. The left photograph shows the east rack still glowing strongly, while the western rack near the air inlet is mostly consumed. The right photograph shows a similar view at a later time. Air enters from the left in these photographs.

Figure 10 shows two photographs taken beyond four hours into the test that illustrate the west rack (Rack #1) was consumed before the east rack. These photographs also show material lying against the calorimeter, supporting the assumption that a shift in material location caused a divergence of the calorimeter temperatures. The residual material was collected and weighed, and revealed that 97.3% of the material was consumed in the test. Most of the residual material was light and pliable, suggestive of fibers that had not fully consumed. There were some pieces that were still somewhat rigid and thick, albeit smaller and less dense than the original material. The residual strength is presumably due to the formation of char during the epoxy decomposition. After hours immersed in the thermal environment of the test, it is unlikely that these pieces contain epoxy that had not undergone some kind of thermal decomposition. A more complete analysis of these residues remains for future work.

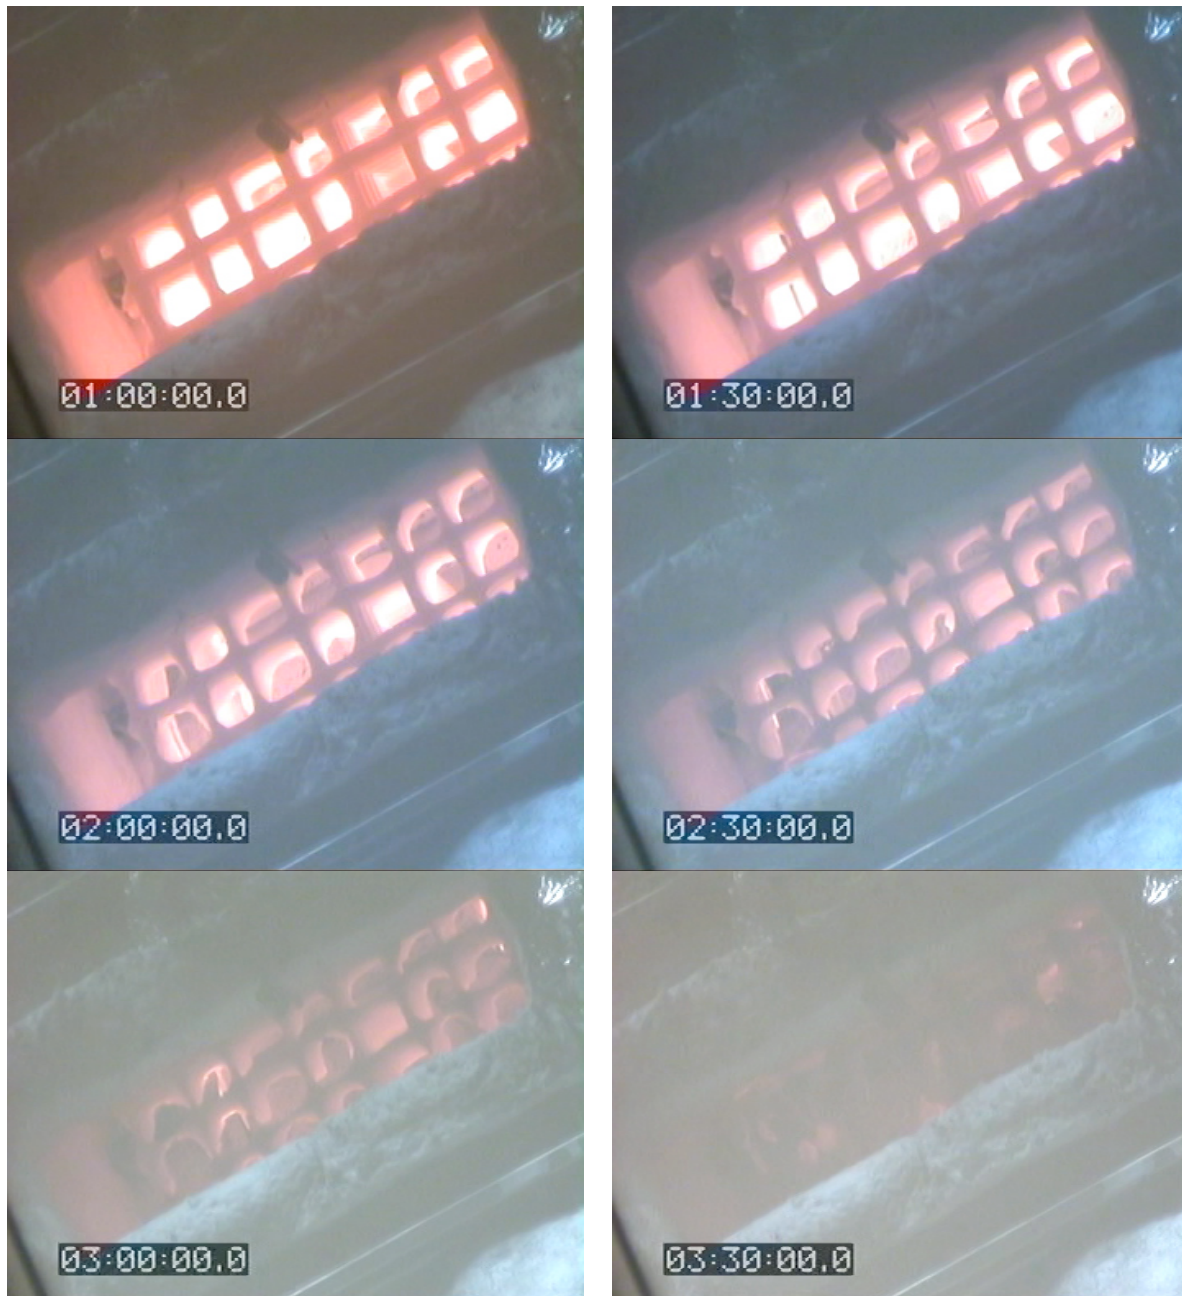
Figure 14. Test 6 video frames at regular half-hour intervals as time-stamped.

Figure 14 shows still frames from a video of the test taken at half-hour intervals. Some interesting observations can be made from these stills. First, the material appears to be glowing with increased intensity on the internal parts of the crib compared to the external. The crib also appears to consume preferentially from the more central material upward. The increased glowing and increased consumption rate in the interior of the domain could be related to an increase in oxygen in the center region of the crib due to the inlet air availability and to the radiative loss of energy to the external portions of the crib and the external surroundings. From the images and videos, it is difficult to identify independent decomposition of the individual strips; instead, the decomposition and recession of material appears to behave as if the crib is a uniform solid structure. This may be suggestive of interaction between the strips during early decomposition. Composites are known to swell and a char layer forms as they decompose, which could be a contributing mechanism to this observation. The swelling and char formation at the locations

were the strips are in contact with one another, could be causing cohesion and thus some structural integrity at these locations. In the 1:30:00 frame and the 2:00:00 frame, there is necking of the strips when compared to the contact locations where the strips cross each other. This is suggestive of the importance of the oxygen availability and ventilation to the consumption rate of the material. Video of the event does not suggest small pieces individually falling. When movement occurred in the crib, it was typically a shift of the entire structure together. The first of such shifts was recorded at 3:25:10, after which they occurred more frequently.

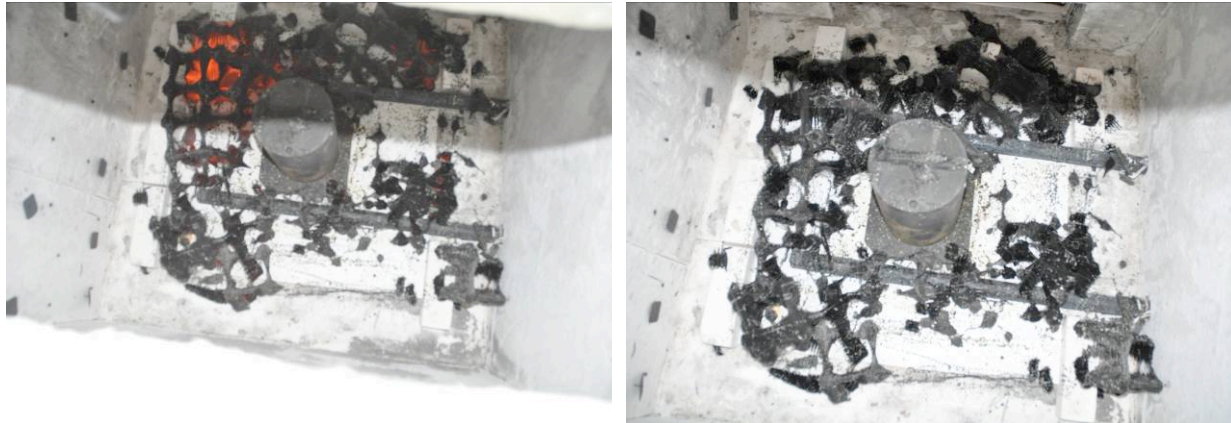
Figure 15. Test 6 photographs of the late-test burnout. The left photograph shows minor glowing in several regions of the collapsed crib. The right photograph shows a similar view at a later time. Air enters from the top of these photographs.

The post-test composite residual material was weighed and found to be 6.7% of the original material mass, or a mass loss of 93.3%. Figure 15 shows photographs of the final glowing combustion and of the final appearance of the crib. Curiously, the

majority of material and glowing is found near the air inlet, while the regions away from the air inlet show more sparse material. It is impossible to guarantee that the collapse of the crib happened vertically and that the distributions in Figure 13 were not caused by relocation during the collapse. But it is probable that the material as distributed is representative of the regional burnout, and that contrary to Test 5 results, the material furthest from the air inlet was preferentially consumed.
