US Army Corps  
of Engineers®  
Engineer Research and  
Development Center

*Airfield Damage Repair Civil Engineer Modernization Program*

## **Laboratory and Field Evaluation of Rapid Setting Cementitious Materials for Large Crater Repair**

May 2010

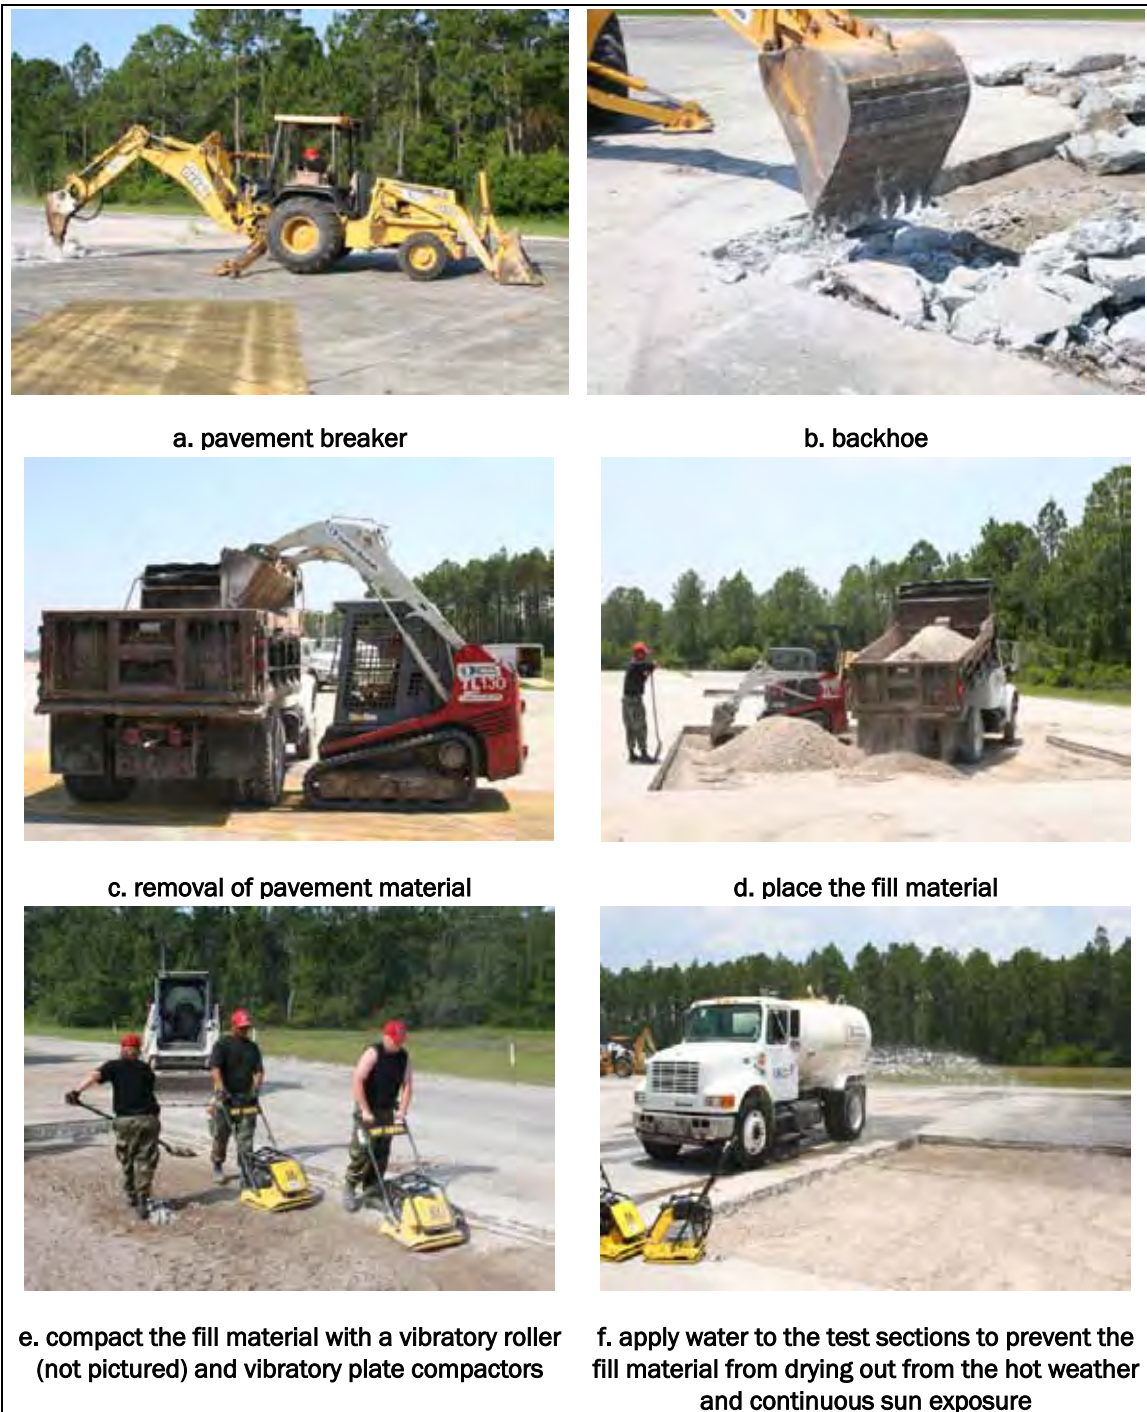
Figure 9. Preparation of the test craters showing the techniques and equipment used to break out and remove existing pavement.

To prepare the simulated craters for this study, the existing pavement was broken out and removed using a pavement breaker and a backhoe (Figure 9a and 9b), standard construction equipment.

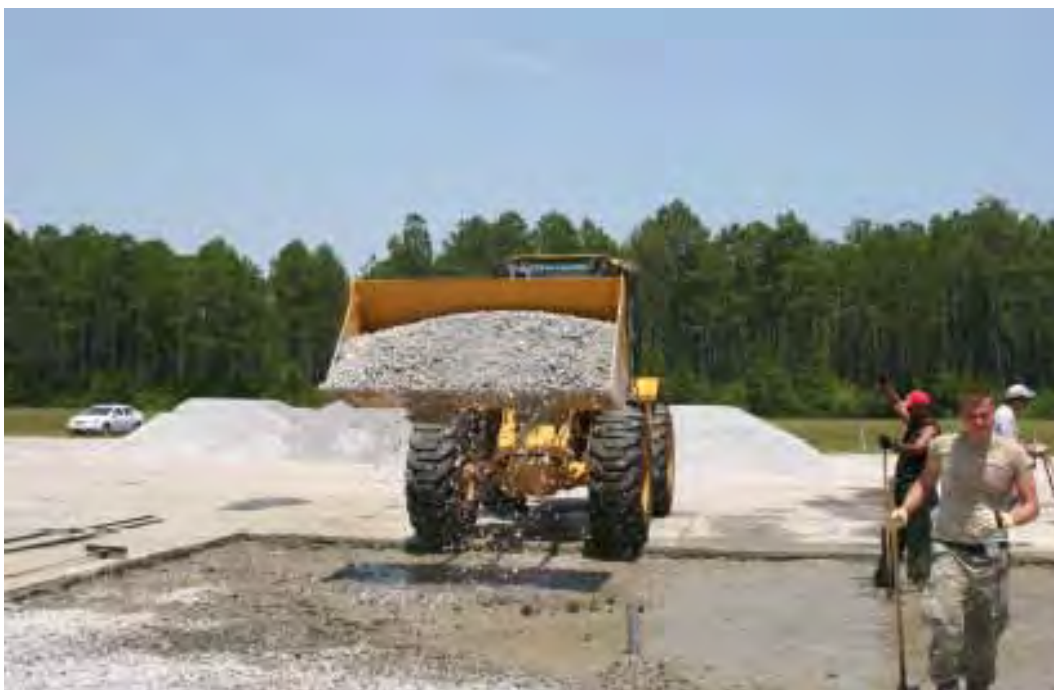
Figure 31. Adding stone to grout layer in Crater 1.

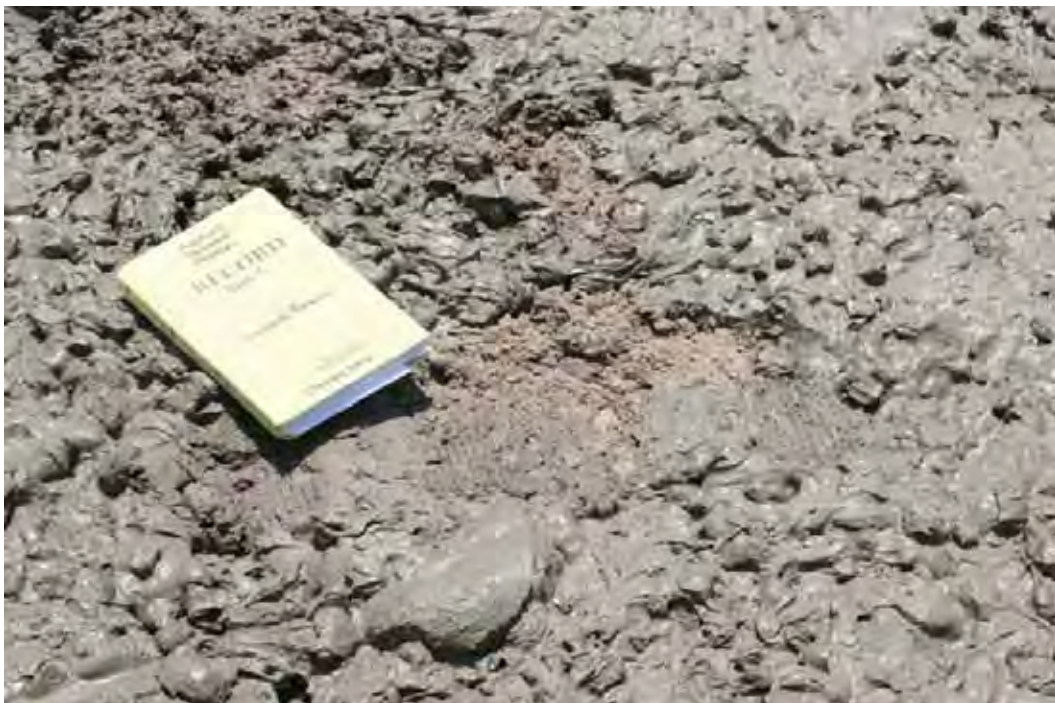
Figure 33. Adequate coating of grout around stone in Crater 1.

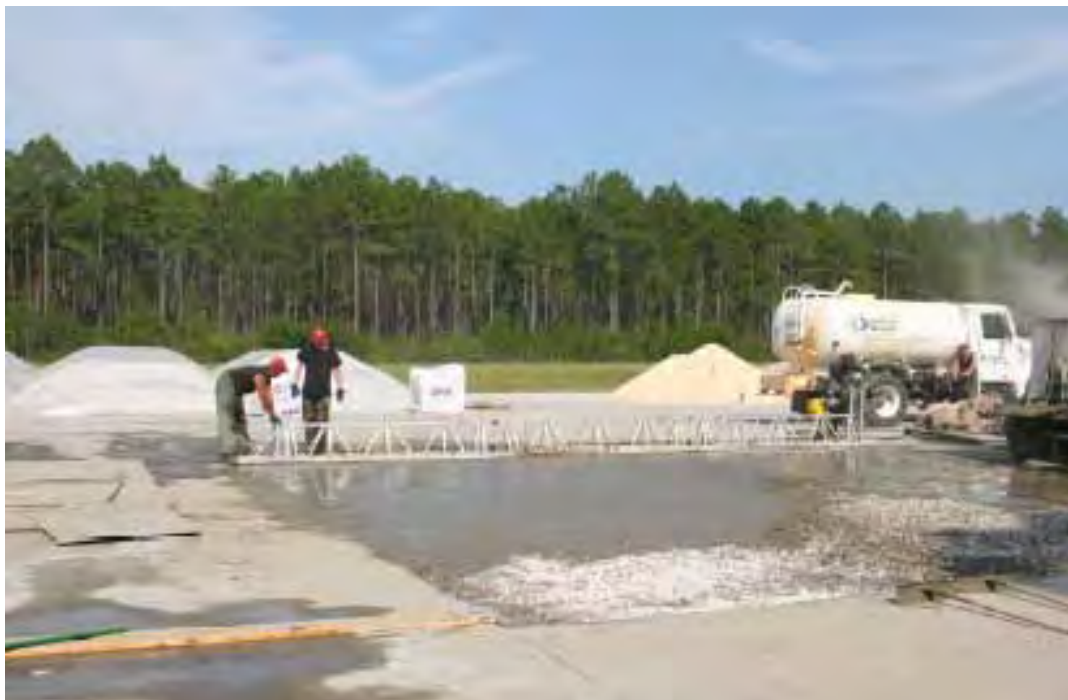
Figure 34. Setting up truss screed on east side of Crater 1.

When the mixer was repositioned a second time at the south end of the crater, a truss screed was moved into place on the eastern edge (Figure 34). Once the mixer was repositioned to the west side of Crater 1, screeding began as the surface of the grout was beginning to stiffen (Figure 35). On the west side of the crater, grout flooding continued, and then the mixer was backed further into the crater to flood the center.

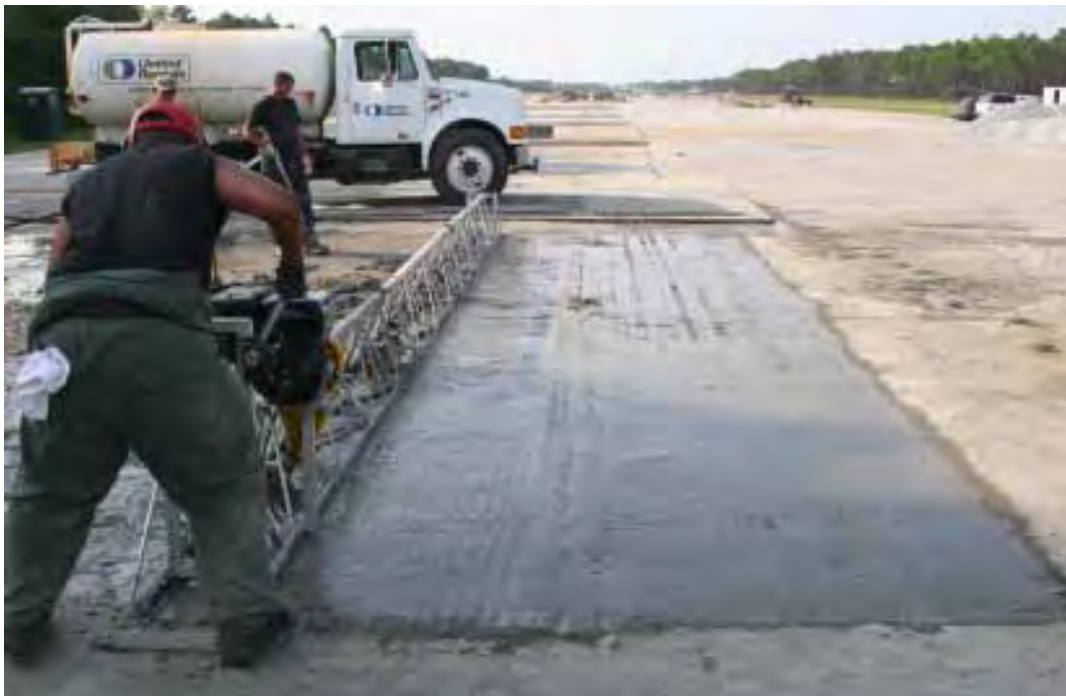
Figure 35. Crater 1, screeding the repair.

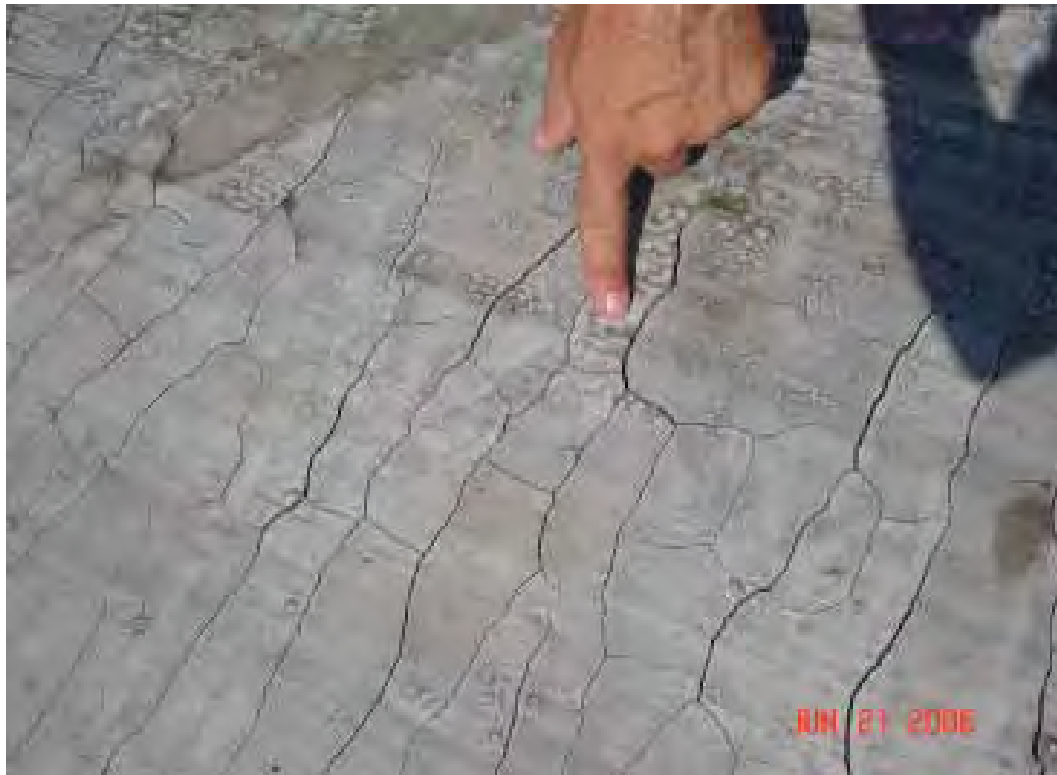
Figure 36. Shrinkage cracks in the surface of the stone and grout repair, Crater 1.

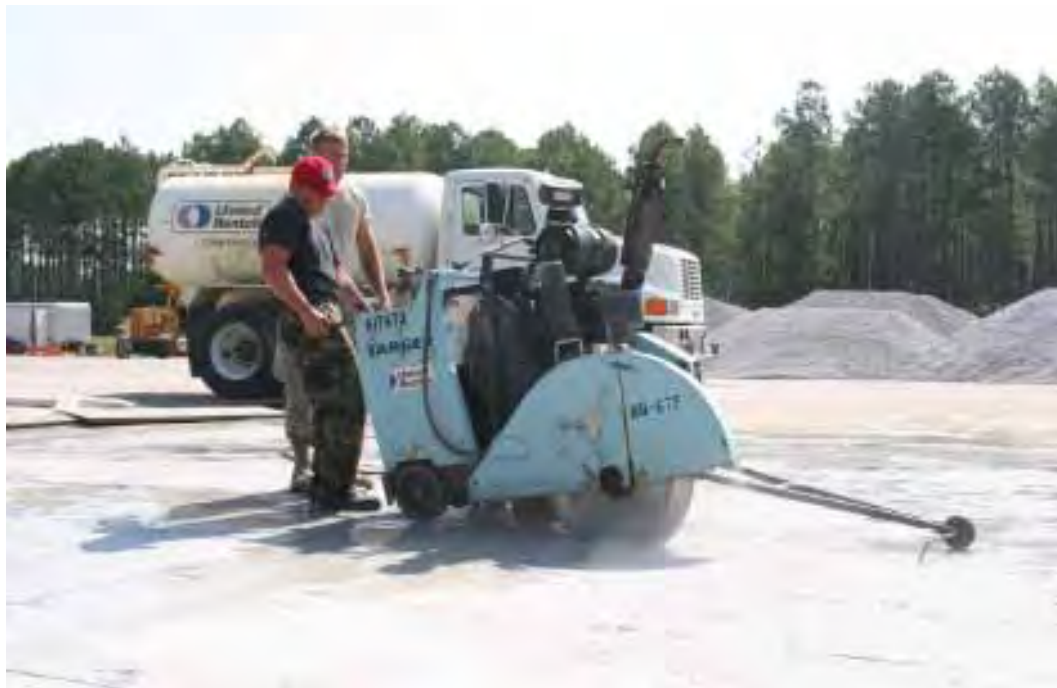
Figure 37. Saw cutting joints in Crater 1 stone and grout repair.

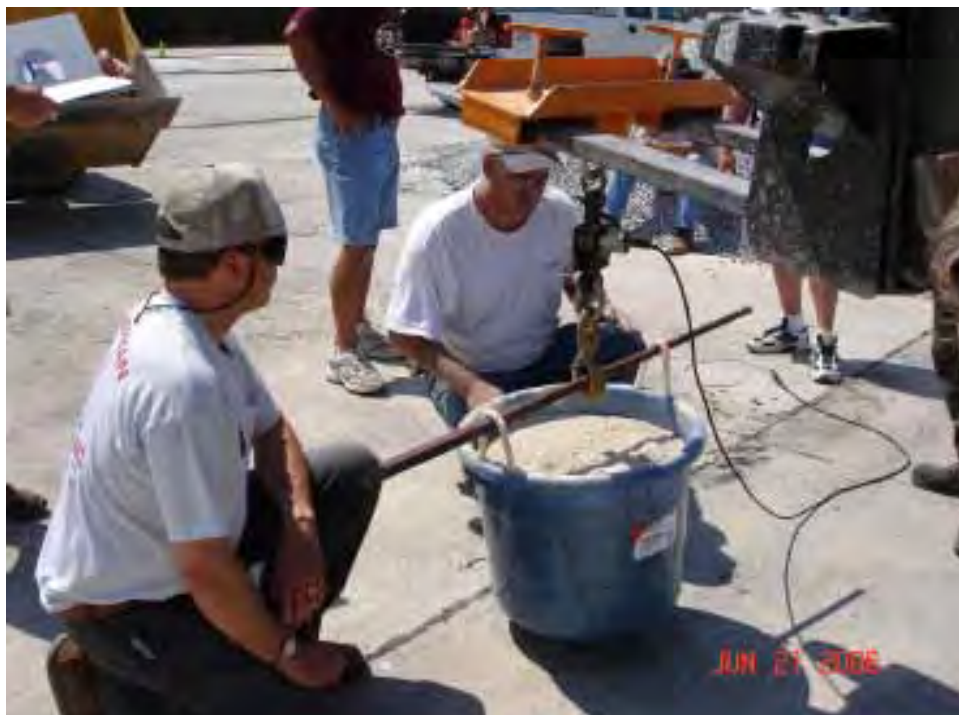
Figure 41. Calibrating the proportional mixer for Crater 6.

The afternoon prior to the repair, the machine was calibrated for the specific mix design (Figure 41). The mix called for 600 lb of cement, and was extended with sand and No. 57 stone. The calibration procedure

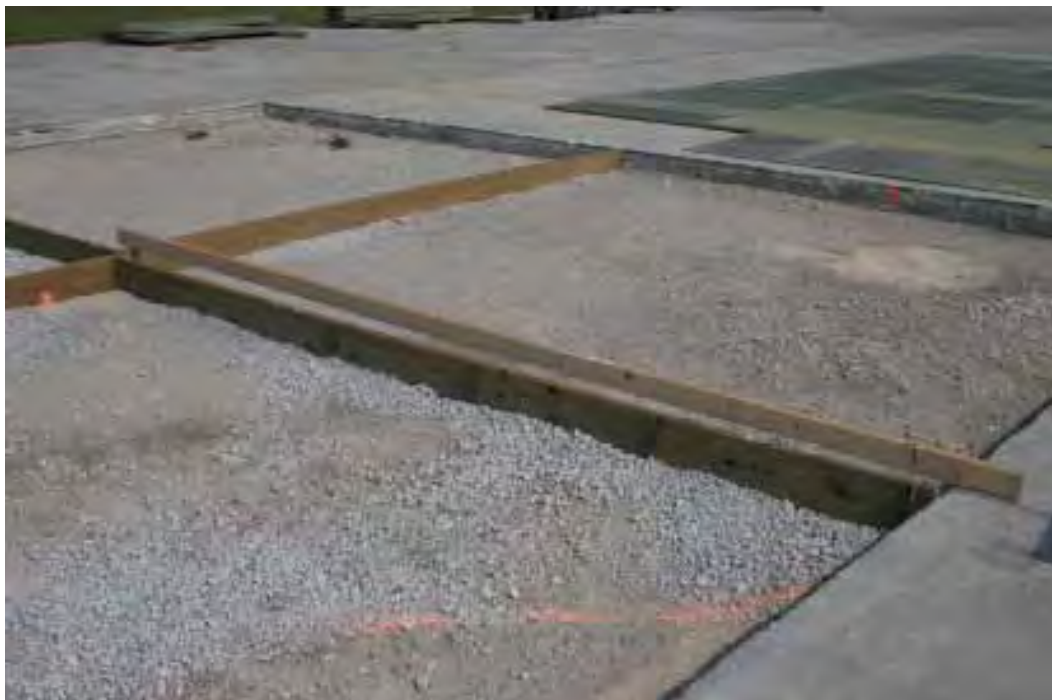
Figure 42. Formwork prepared for Crater 6.

The crater was divided into quadrants using forms made of 2 in x 10 in pieces of lumber, cut to length. The forms were held in place with metal stakes (pieces of steel rebar) and fastened together at the corners with screws (Figure 42). Using the forms replaces the need for saw cutting since the hardened concrete will crack along the cold joint.

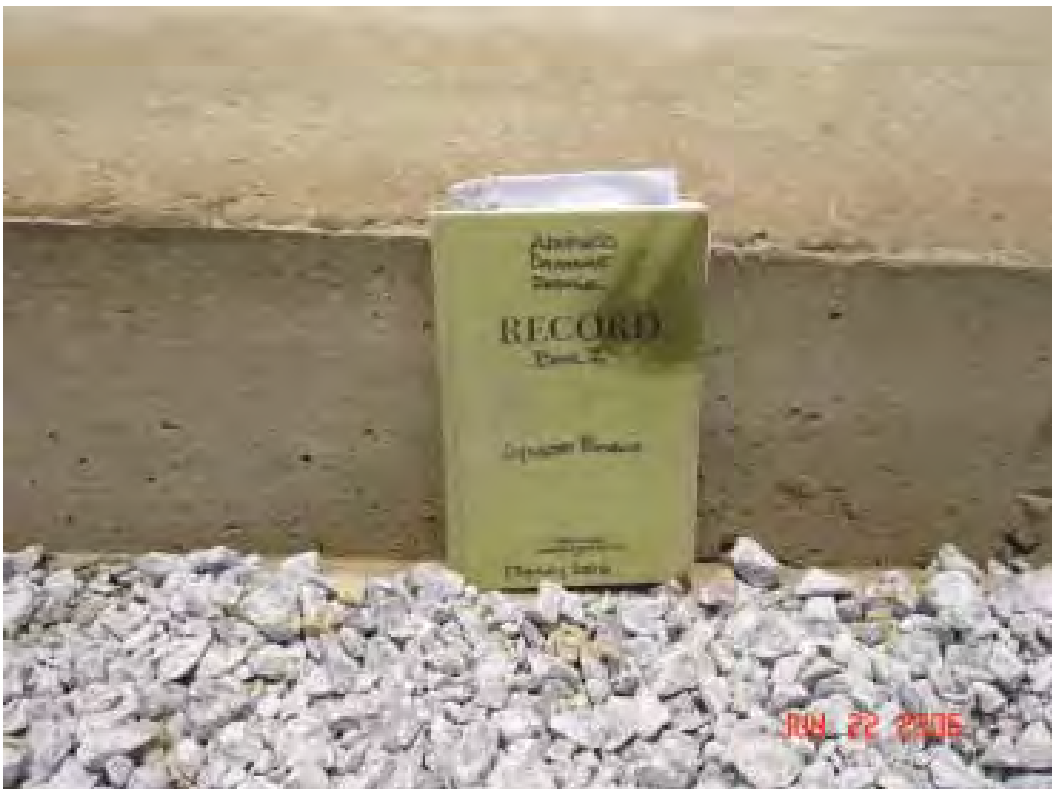
Figure 47. Profile of slab edge of Crater 6 after removal of the form.

The repair resumed at approximately 1300 hr with the removal of the forms. Figure 47 shows a profile view of one of the sides. At 1335 hr, the

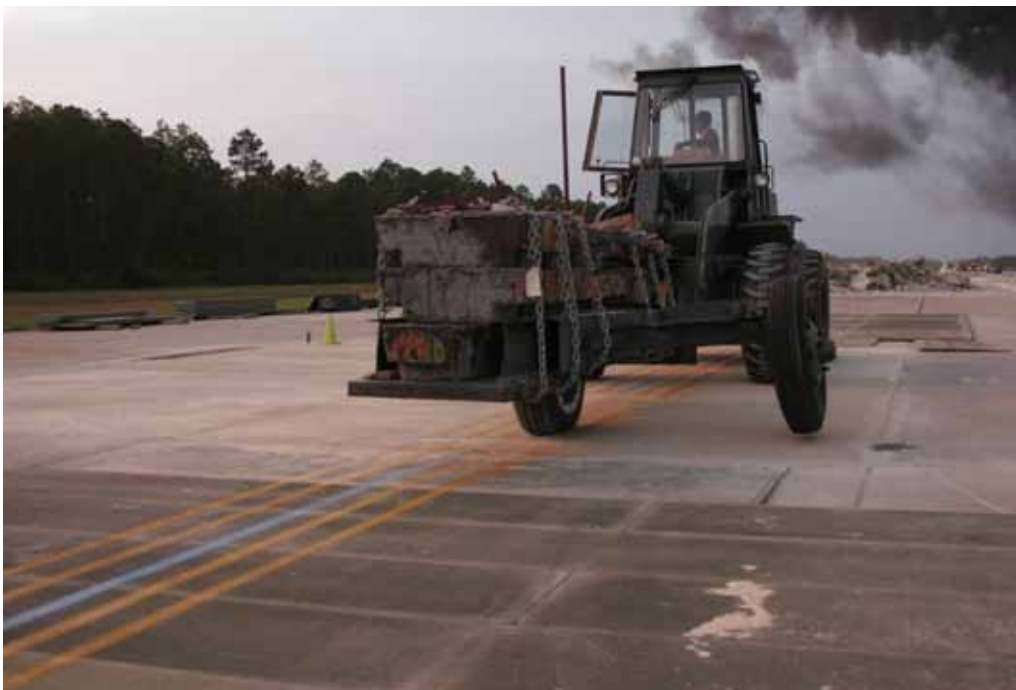
Figure 49. Crater 6, completed repair surface during trafficking.

RS material was poured into the northwest quadrant and this section was finished by about 1400 hrs. Again, the truck was refilled (Figure 48) and the final quadrant was completed before 1500 hrs. The final repair is shown in Figure 49 as it was trafficked with the load cart.

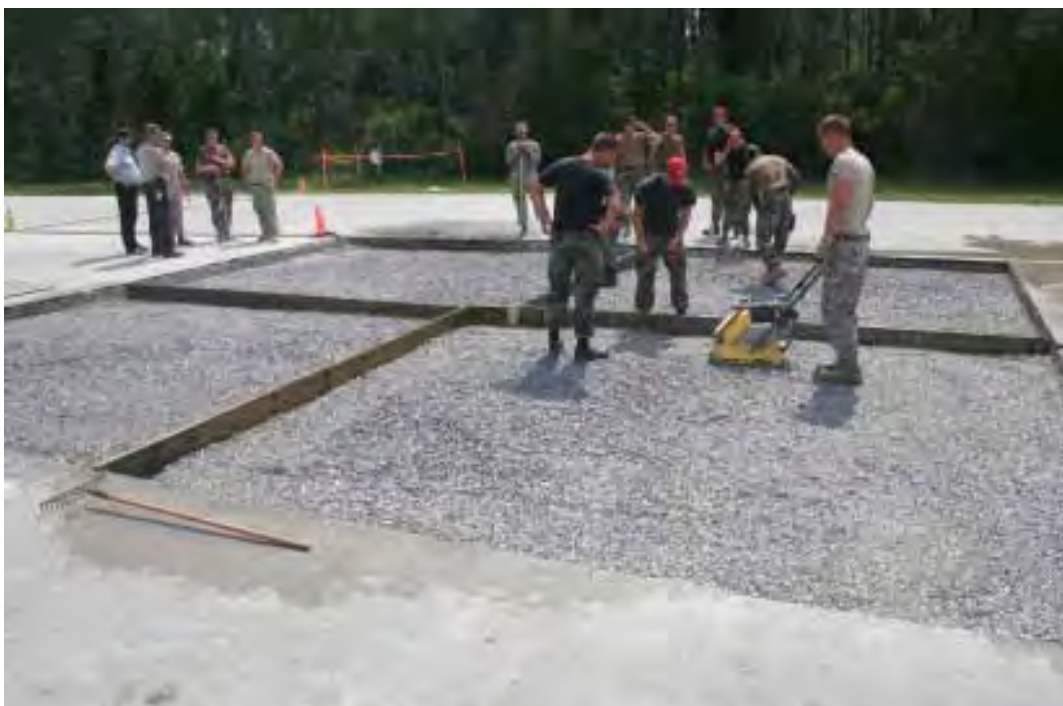
Figure 66. Crater 2 formed and layer of aggregate added.

Initially, to reduce the number of batches needed to complete the repair, the approach called for two supersacks of material and 2,850 lb of stone to be mixed at one time in the portable mixer. The crater was divided into quadrants using forms – this was completed the previous afternoon using 2 in x 10 in boards. The CeraTech representatives determined that a 6 in layer (instead of 8 in) of RS material would be sufficient for the cap layer of the repair. They opted to spread 2 in of the No. 57 aggregate over the base layer in each quadrant. This was done using the front end loader, multi-terrain loader, hand tools, and was compacted using the vibratory plate compactors. Water from the water truck was added to moisten the aggregate layer. The preparation required about 45 min (Figure 66).

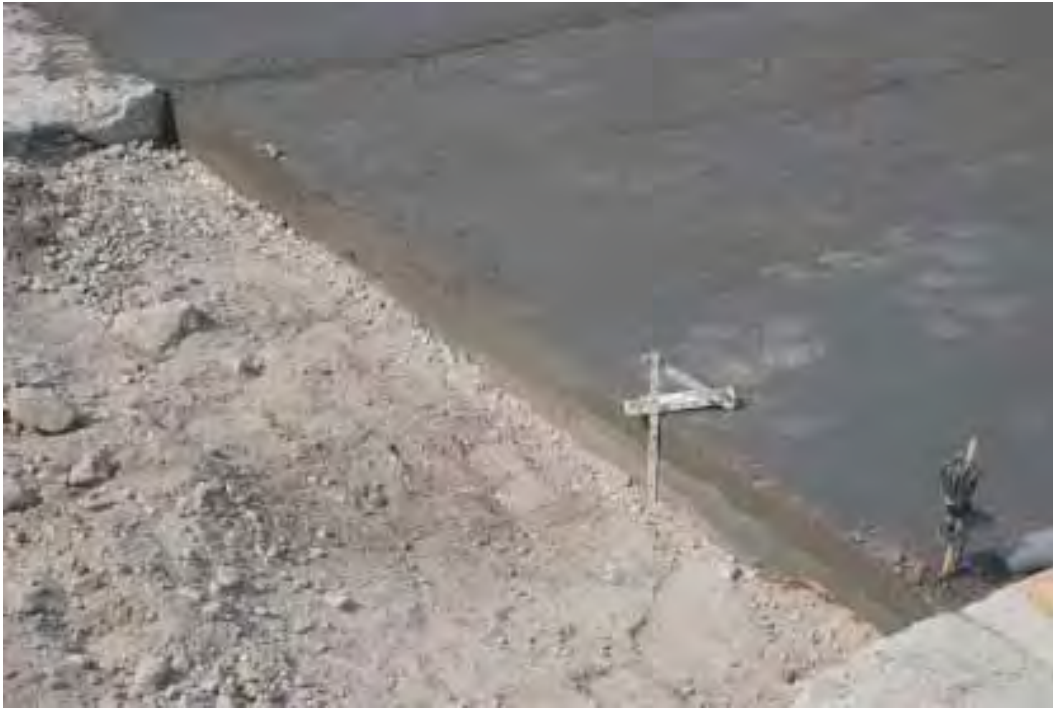
Figure 73. Layering of material poured in southwestern section of Crater 2.

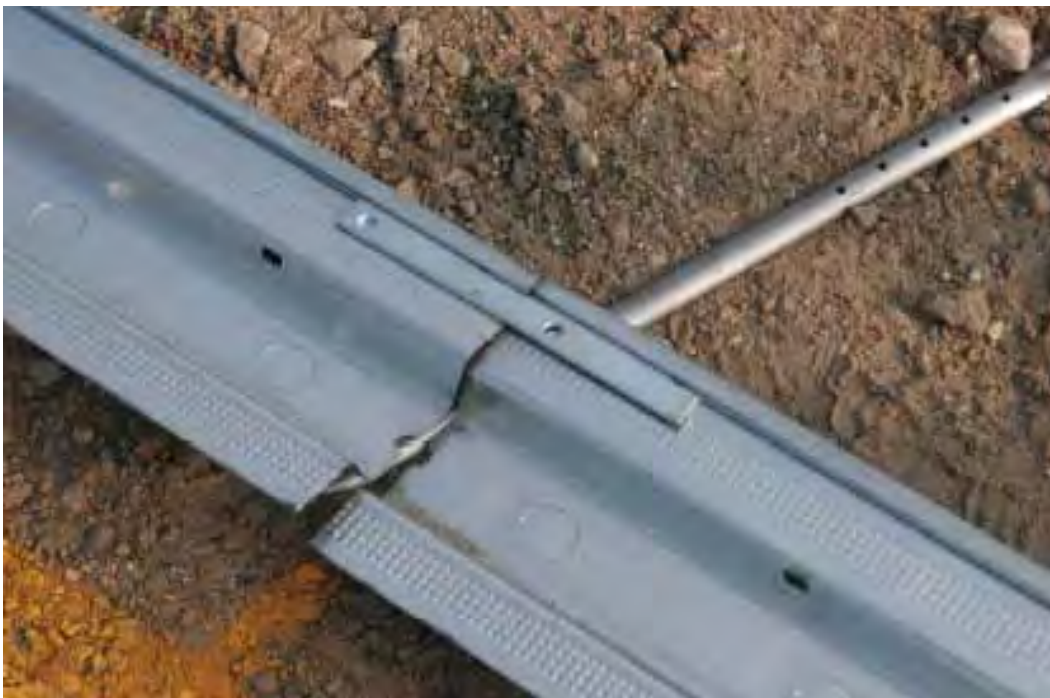
Figure 78. Stay-in-place aluminum forms with connecting tab used in Crater4 (Crater 3, too).

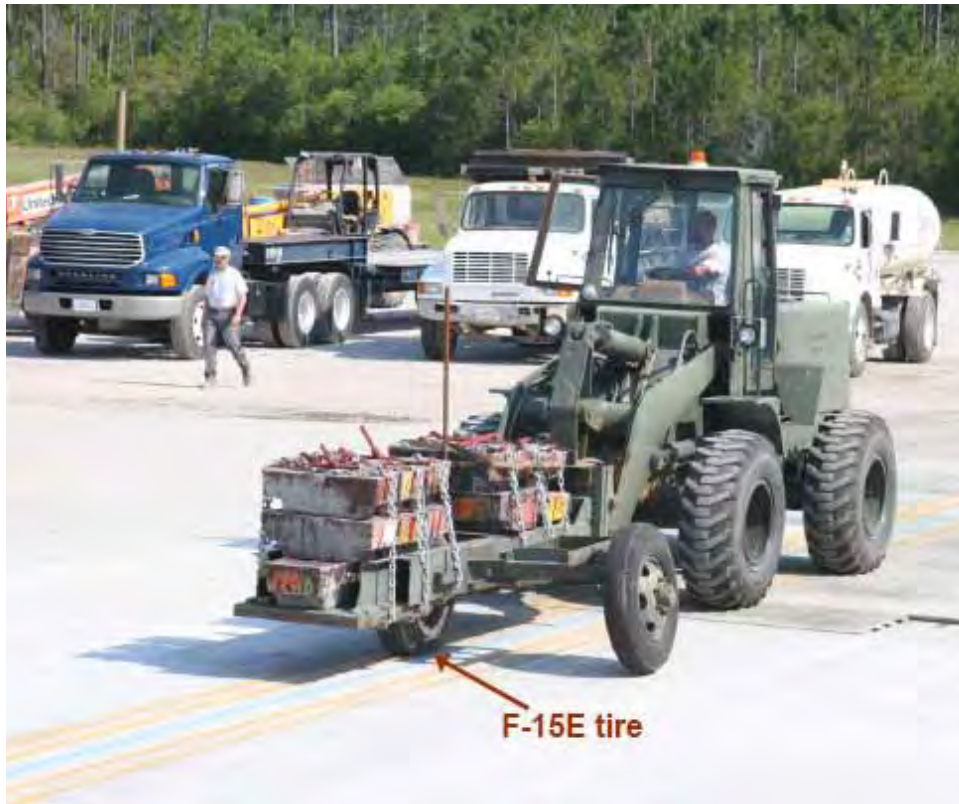
Figure 102. Photograph of F-15E load cart.

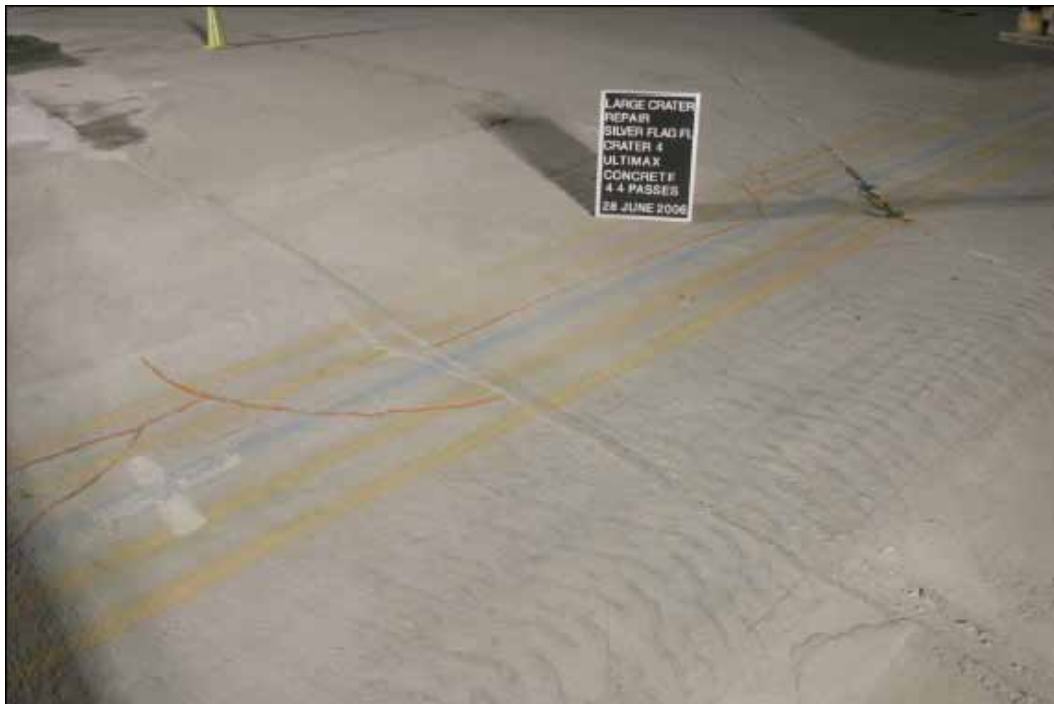
Figure 137. Intersecting cracks after 44 passes in Crater 4.

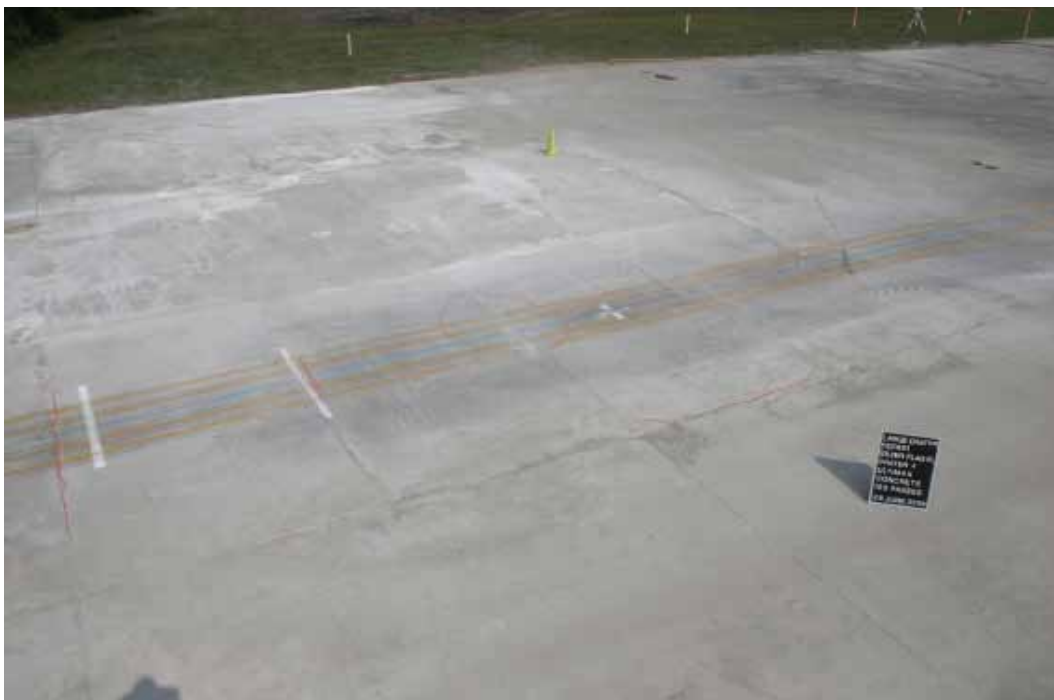
Figure 138. Cracking after 100 passes in Crater 4.

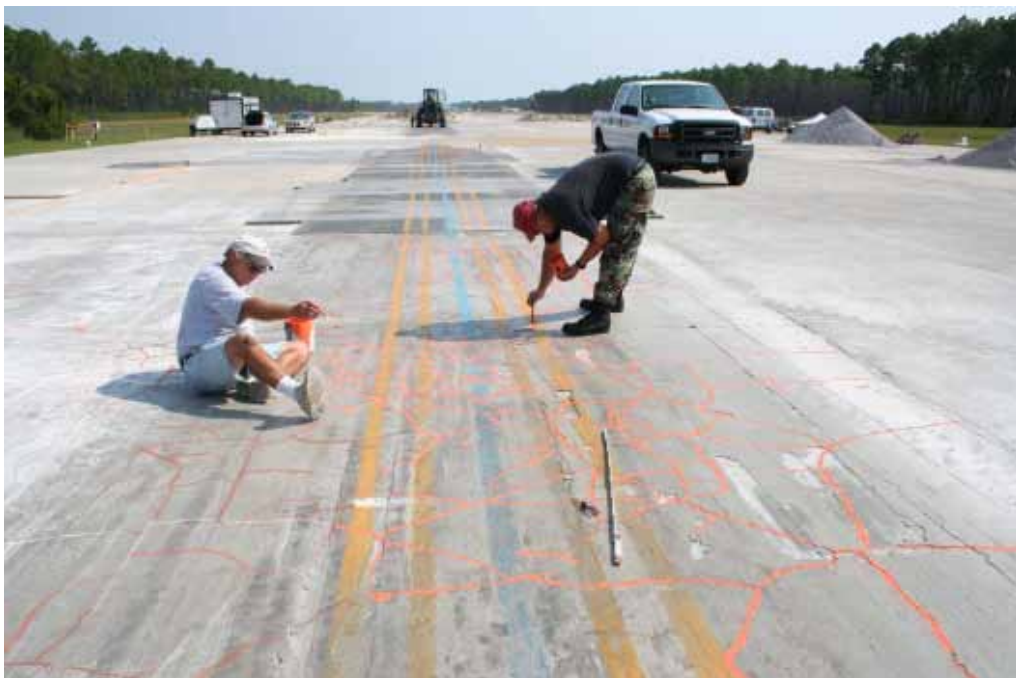
Figure 158. Highlighting cracks on the surface of Crater 1 after 5,008 passes of load cart.

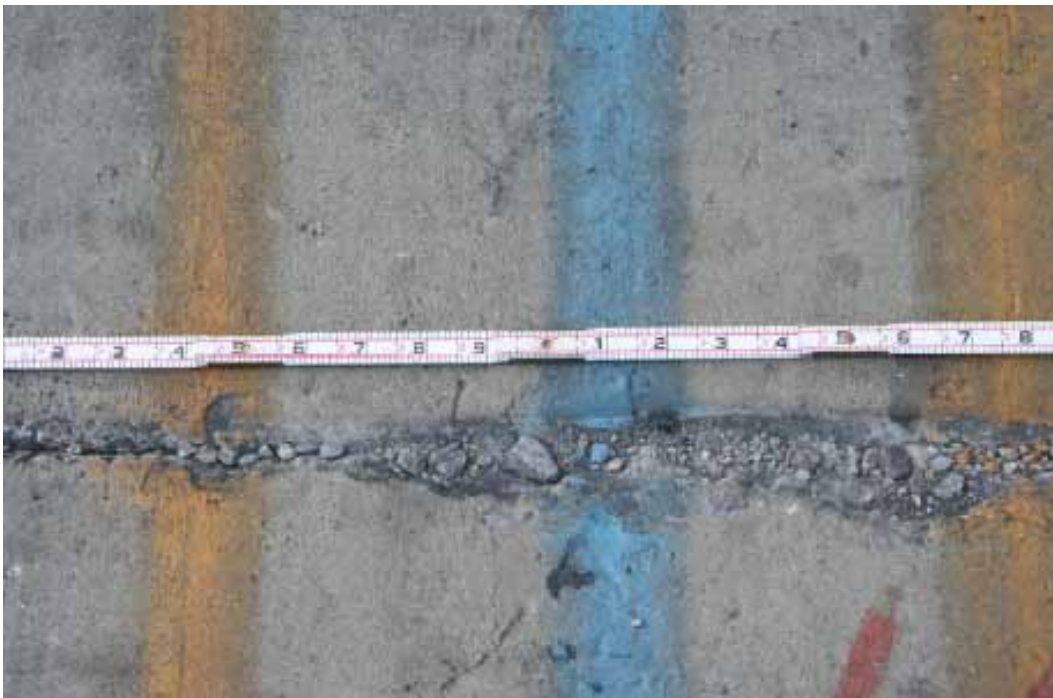
Figure 164. Close-up of joint spall between repaired slabs in traffic lane of Crater 6.

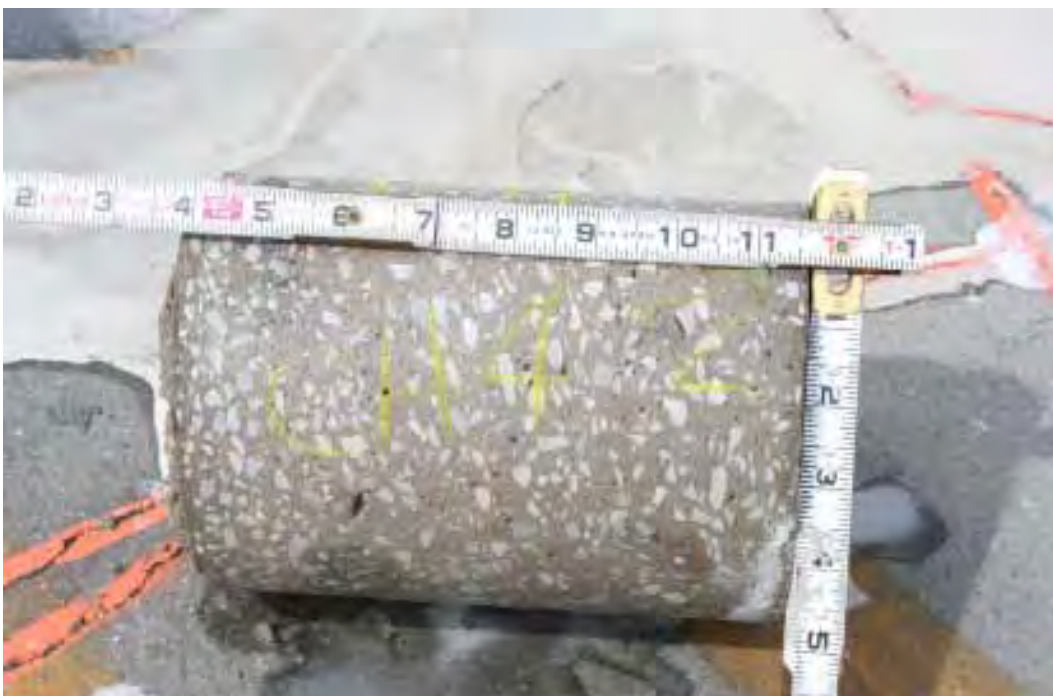
Figure 173. Core 2 from Crater 4 within traffic lane, Ultimex Concrete.
